Title: Routine & Nonredundant Steel Tension Member (NSTM) Inspection Report (Final) Property ID No. 43-0434 - Los Alamos Canyon Bridge

Inspection Dates: June 7-9, 2024

Property ID No. 43-0434 - Los Alamos Canyon Bridge

Los Alamos Canyon Bridge on NM-501 (Diamond Drive) over Omega and Dulce Roads

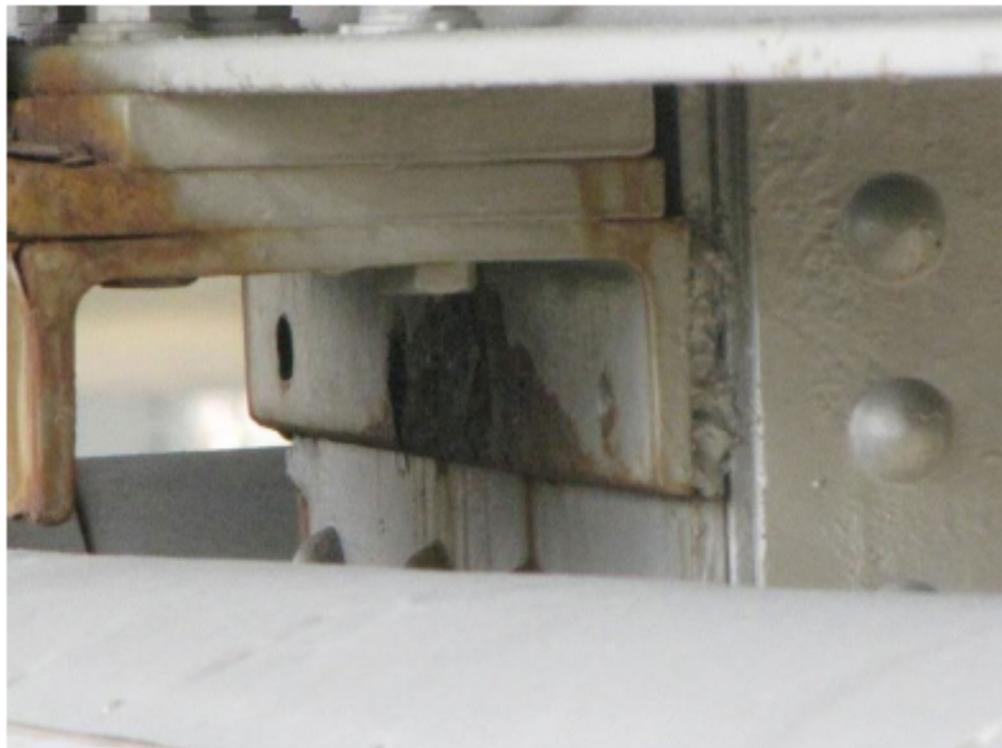
Photo 41- Missing bolts and poorly welded connection at top of arch column. No change since previous inspection.

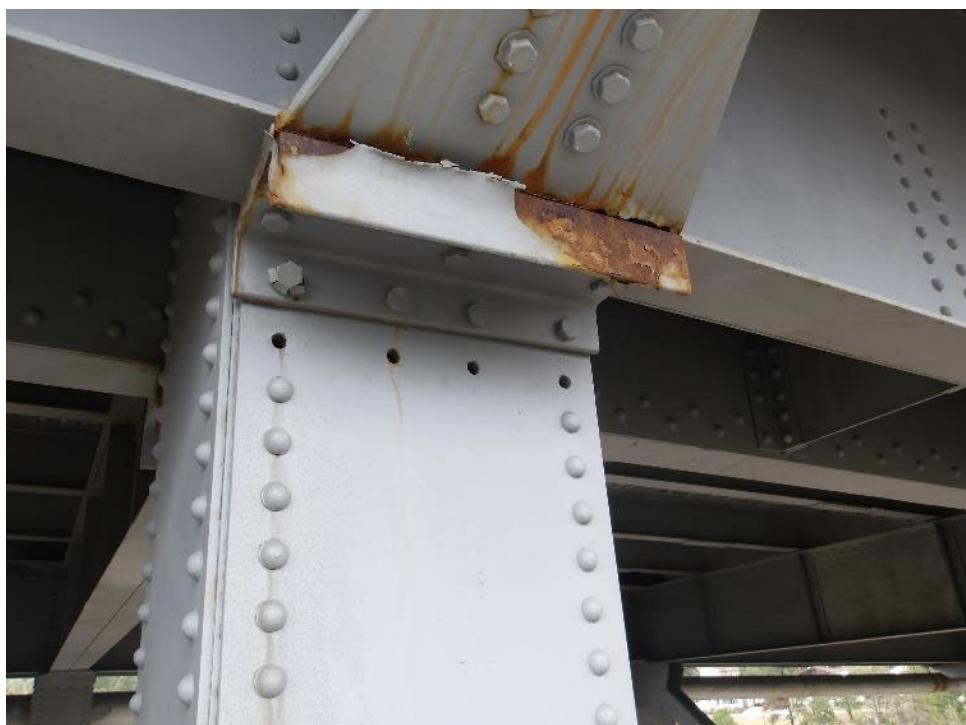
Photo 42- Mis-punched holes at top of arch column 14.

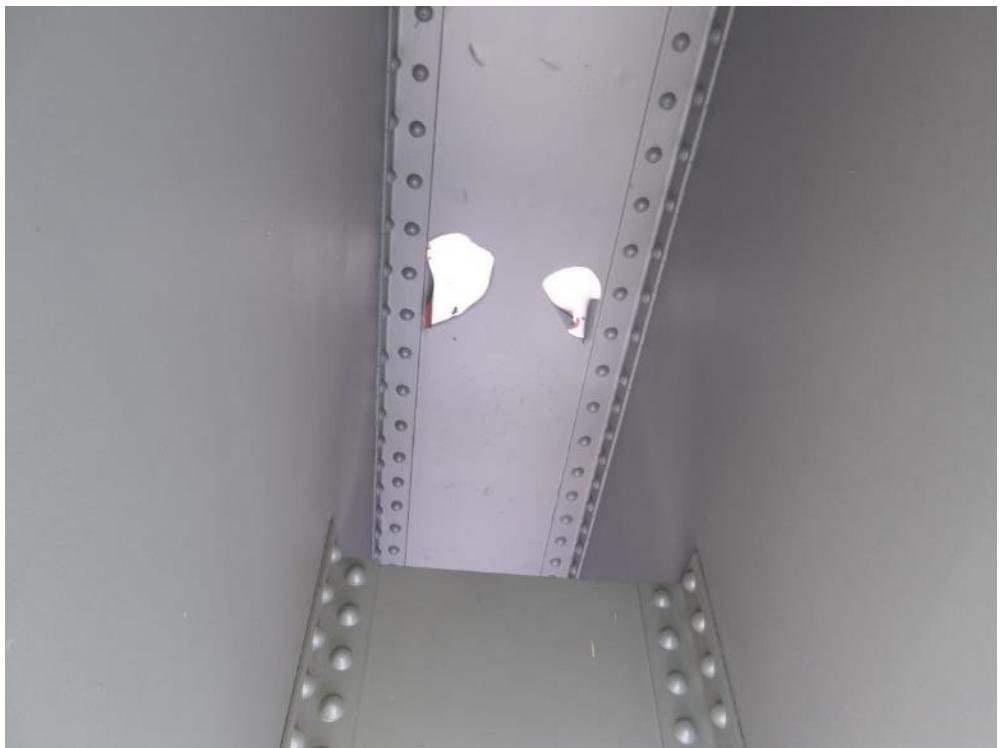
Photo 45- General view of inside top plate and angles of spandrel girder with small areas of failed paint with no corrosion, otherwise in good condition.

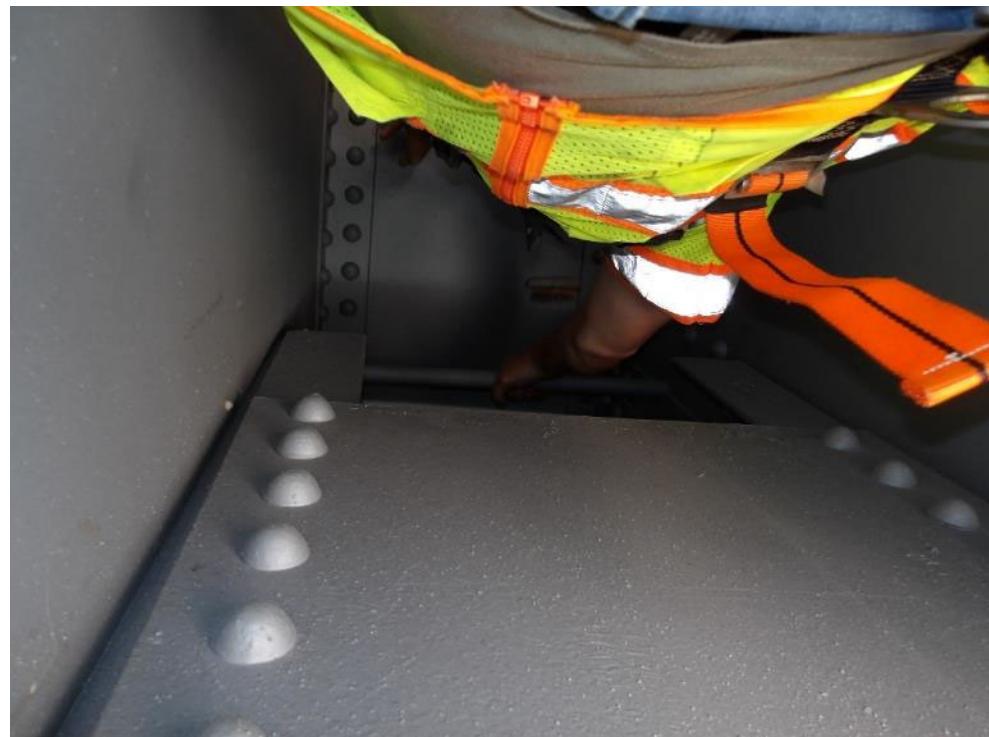
Photo 46- Hands-on inspection of top plate of spandrel girder and through anchor bolts for outriggers.

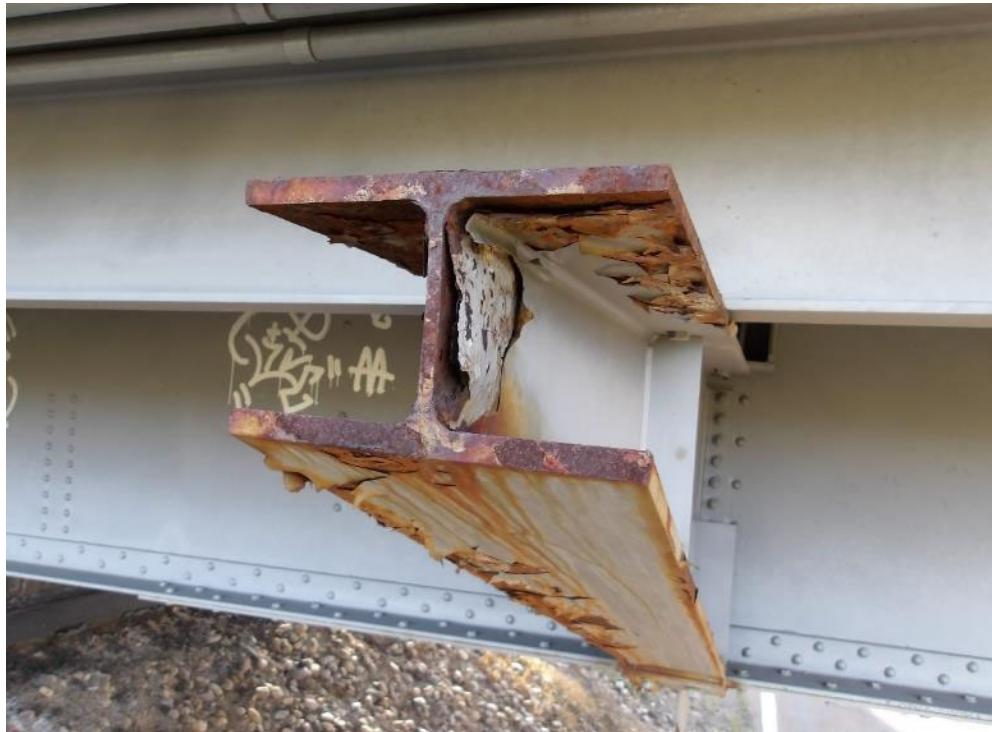
Photo 47- End of outrigger at FB27 west side, moderate corrosion and minor section loss in zero stress area.

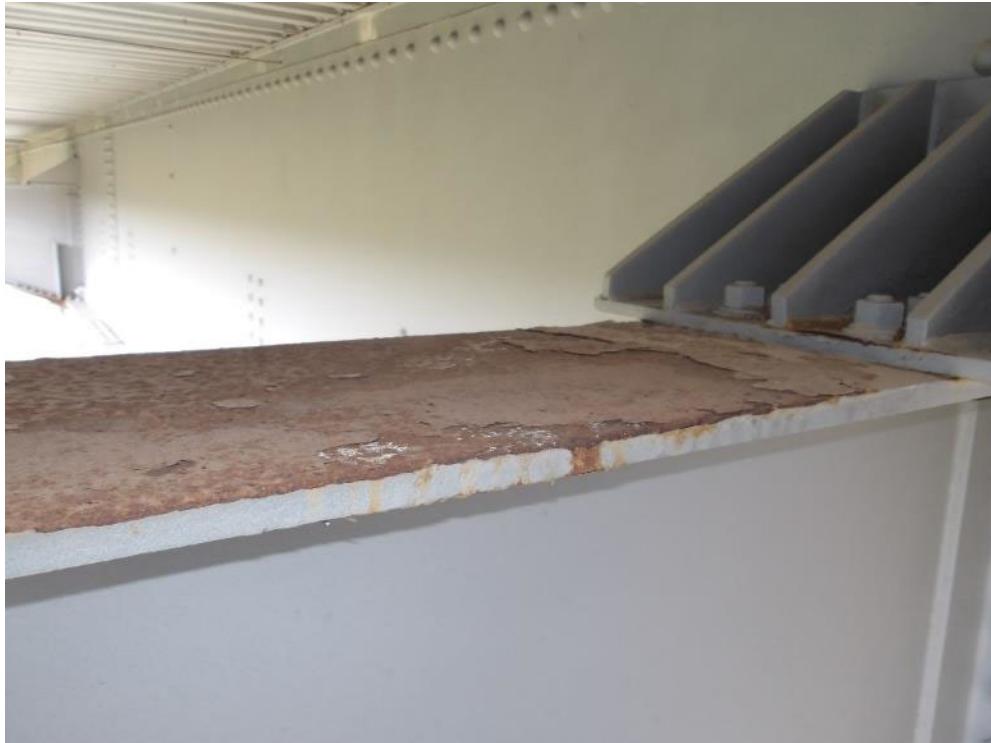
Photo 51- Top of outrigger at arch column 6 on east side, minor surface corrosion, no measurable section loss.

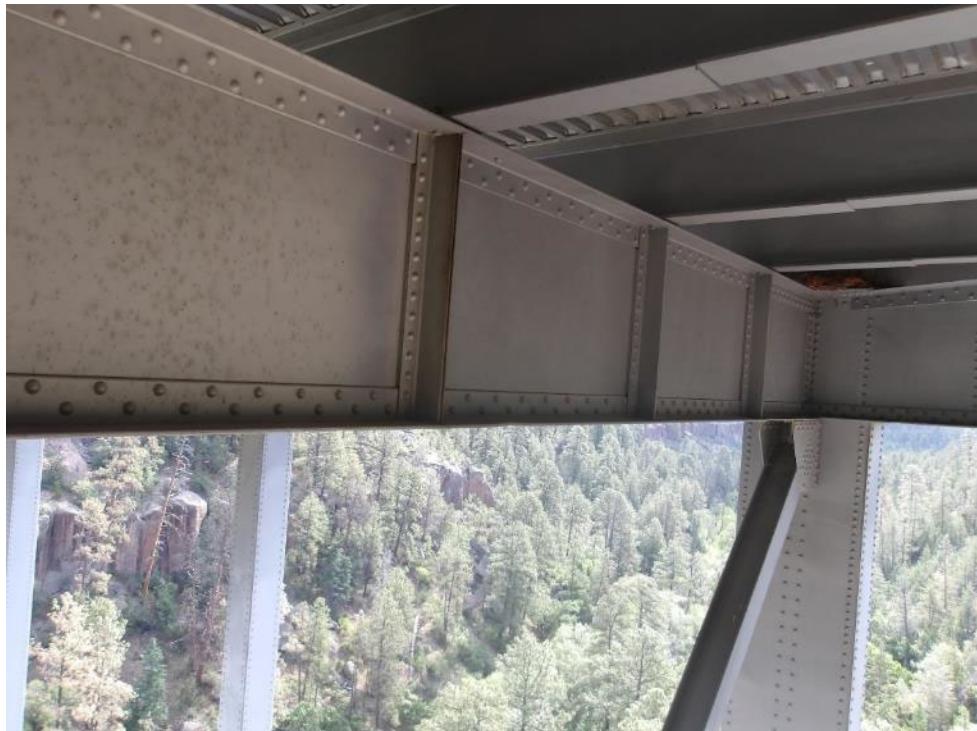
The floorbeams are in SATISFACTORY condition (**Photo 56**), with small areas of paint peeling noted (**Photo 57**). In the interior, there are several locations where the floor beams are missing a bolt at the top bracket connection to the spandrel girders (**Photo 58**). There are also isolated locations with impact damage on the bottom flange angle (**Photo 59**). Bird nests were noted in many locations, but did not appear to be causing deterioration (**Photo 60**).

Photo 56- Floorbeams are generally in good condition. Floorbeam at south skewback shown.

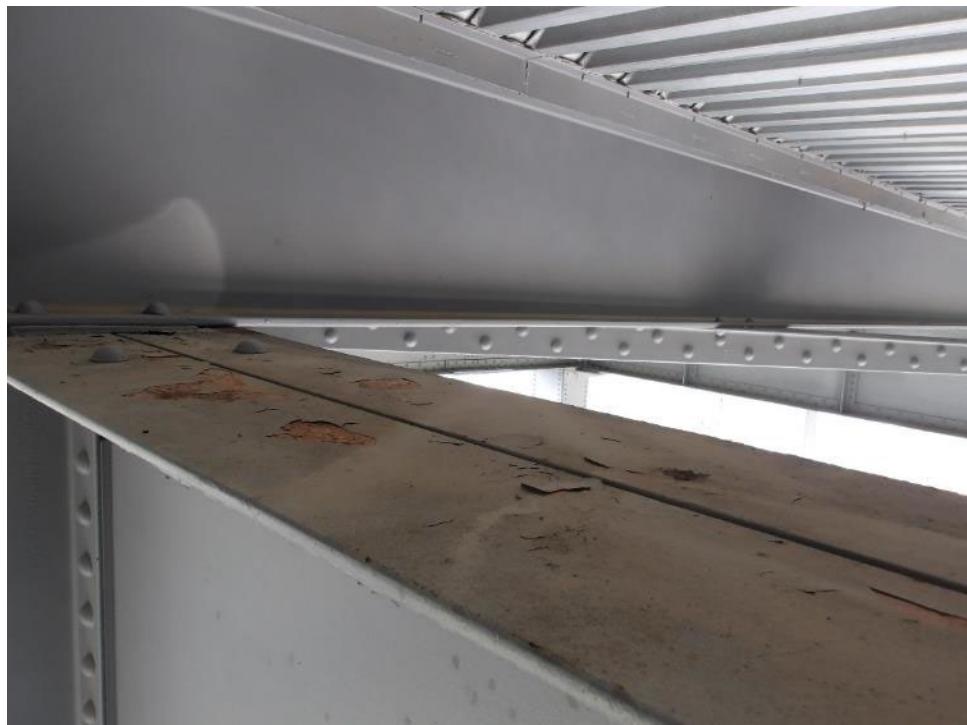
Photo 57- Minor paint peeling on top flange of floorbeam typical.

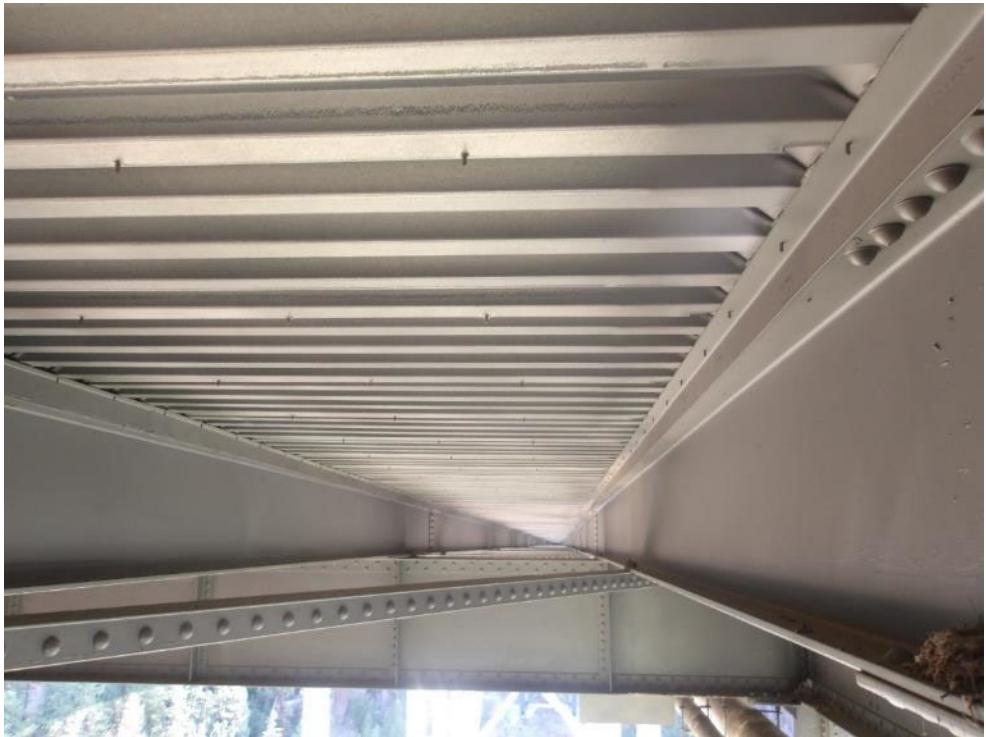
Photo 61- General view of the interior stringers in good condition.

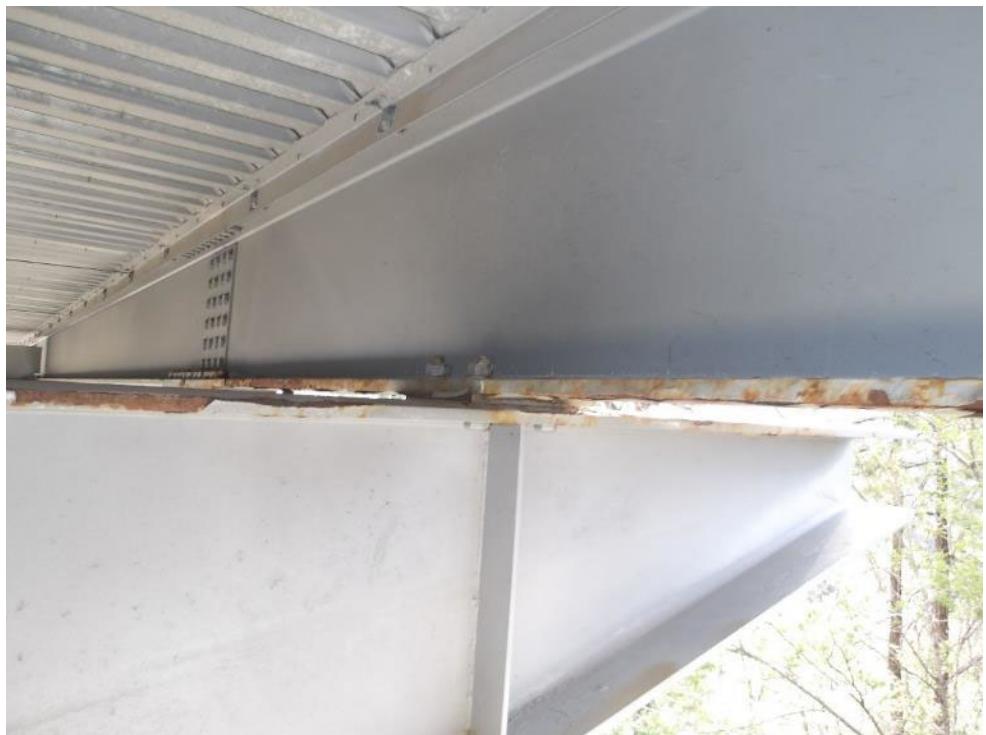
Photo 62- General condition of exterior stringer with peeling paint and surface corrosion on the bottom flange.

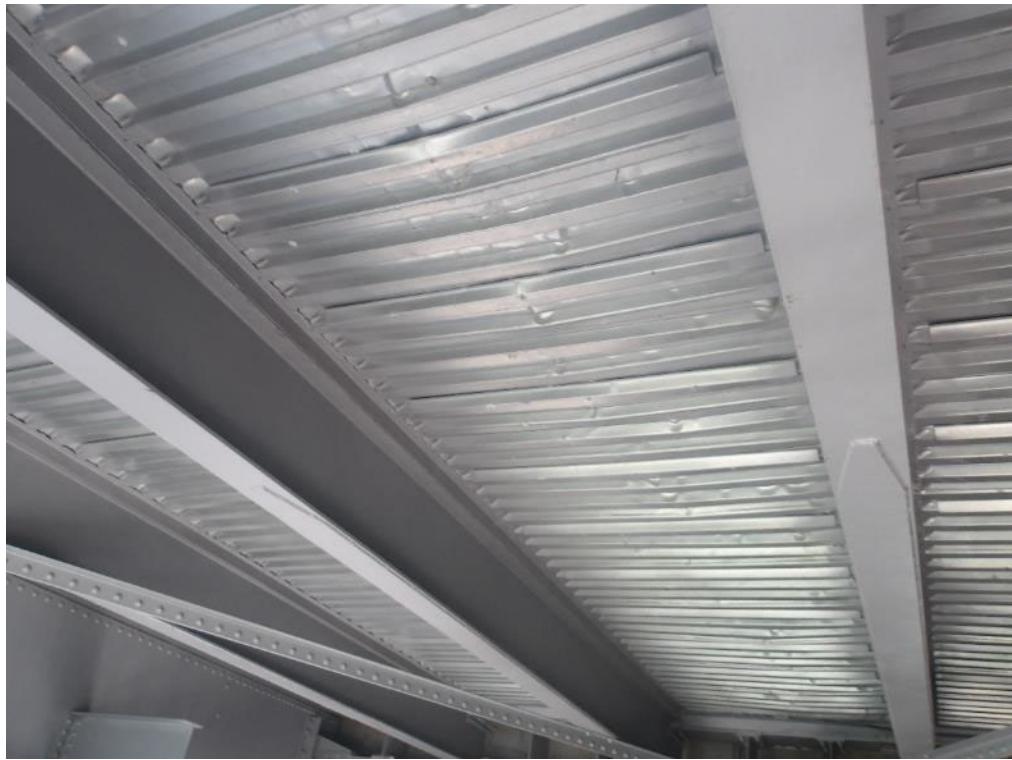
Photo 63- Ends of stringer cover plates in end spans. No defects noted.

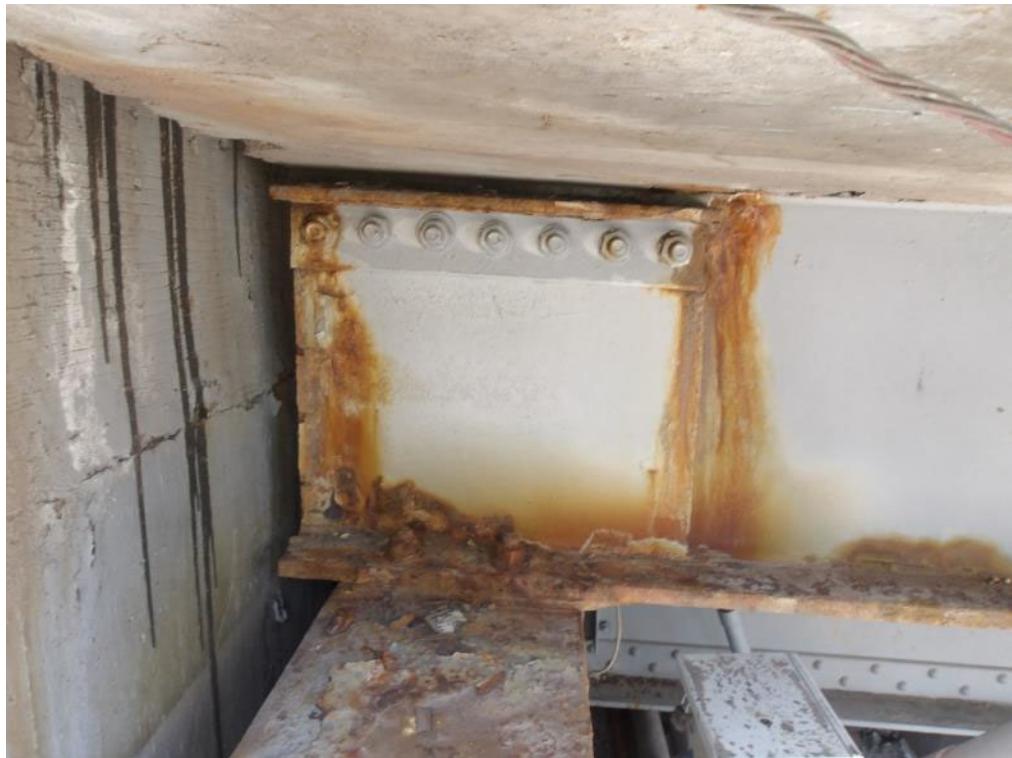
Stringers are in GOOD condition, but there are areas of paint peeling and corrosion on the top and bottom flanges particularly at stringers 1 and 6 (on the east and west sides of the bridge) (**Photos 61 and 62**). Welded cover plates, with a fatigue category E at the ends of the welds, exist on the stringers in the end spans (**Photo 63**). All of these welds were inspected, and no defects were noted. Moderate corrosion was noted on the bottom flange and web of the east exterior stringer at the south abutment (**Photo 64**).

Photo 64- East exterior stringer at south abutment, moderate corrosion in bottom flange and web.

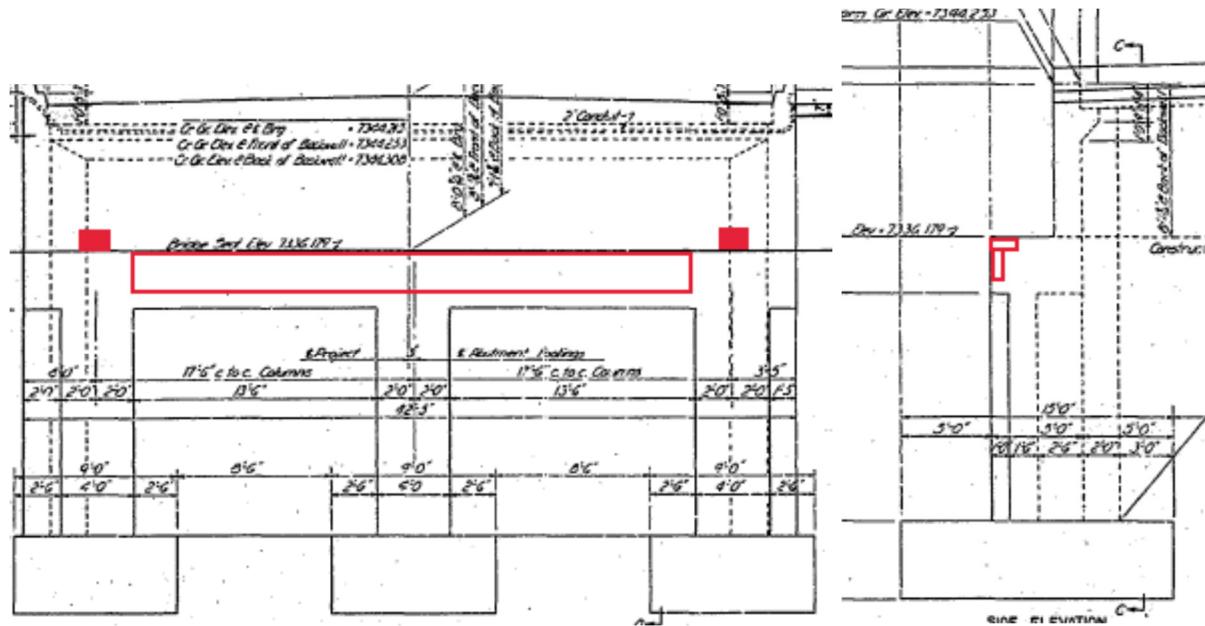
Figure 10- Sketch of concrete deterioration in top strut of south abutment. Solid red blocks indicate bearing locations, red unfilled squares indicate approximate location of concrete deterioration. Note deterioration ends at the columns that support the bearings. All concrete under bearings is sound.

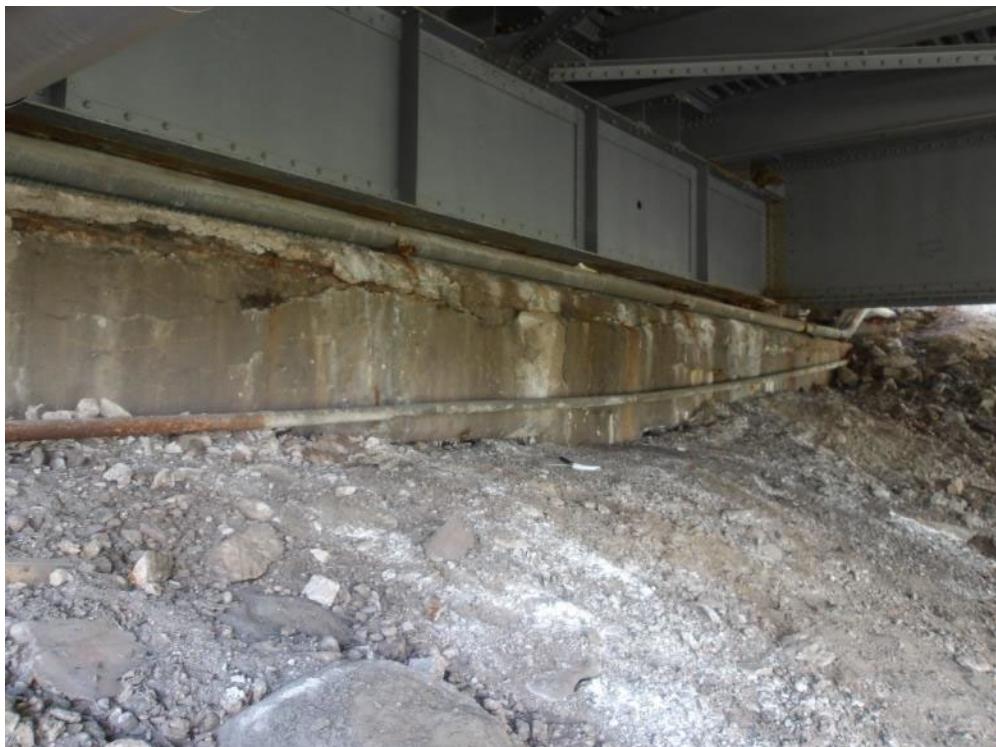
Photo 65- Delamination, spalling and exposed rebar at south abutment top strut. Minor erosion of soil around abutment.

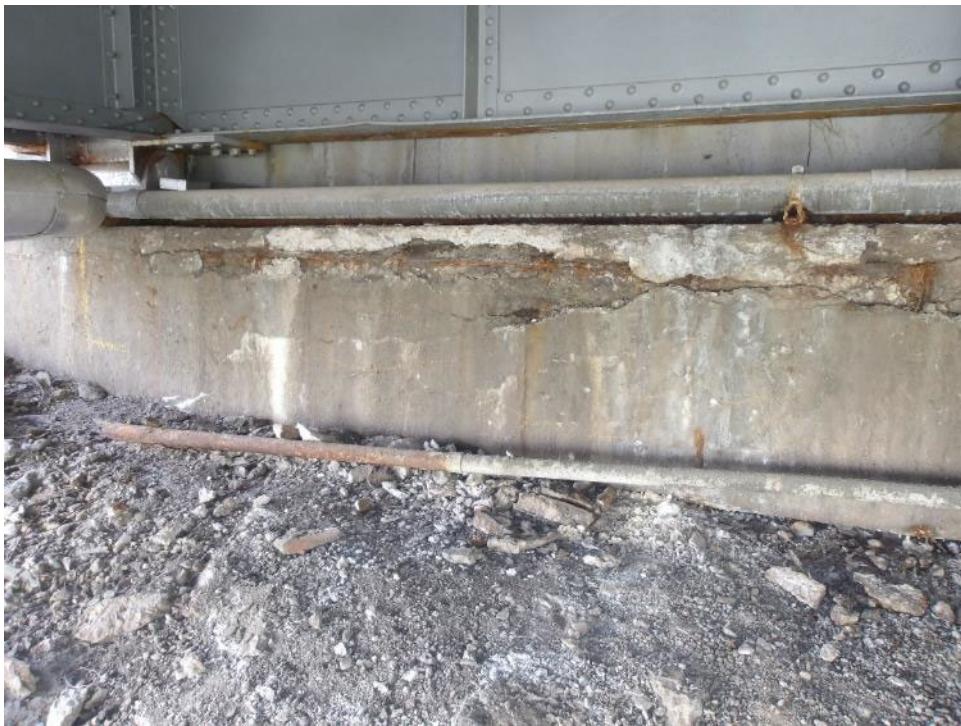
Photo 66- Delamination, spalling and exposed rebar at south abutment.

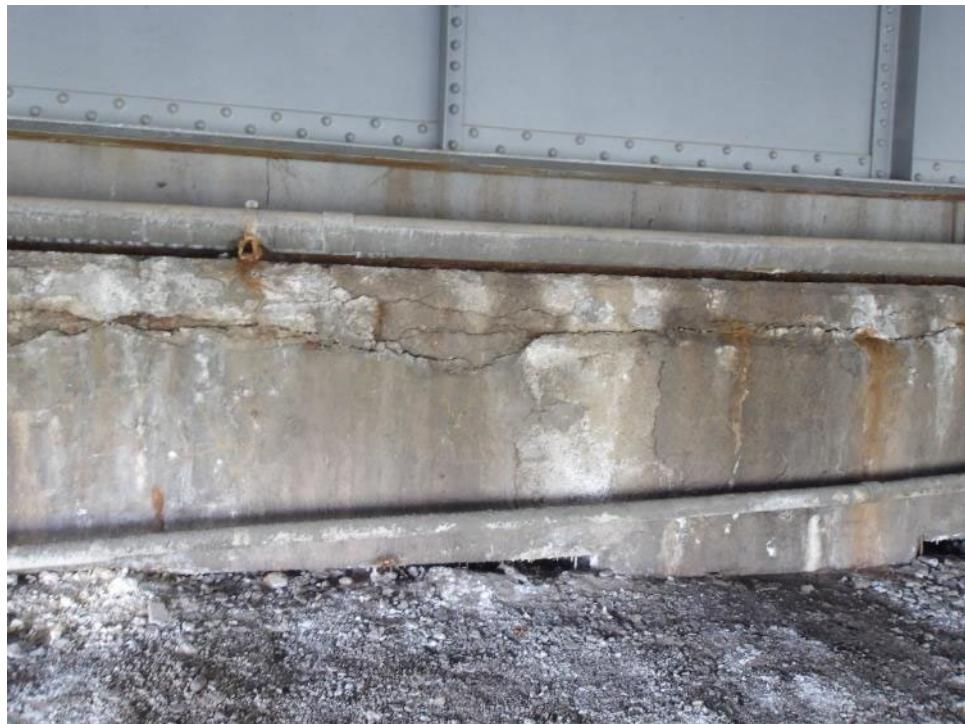
Photo 67- Efflorescence leaking down the face of the south abutment top strut.

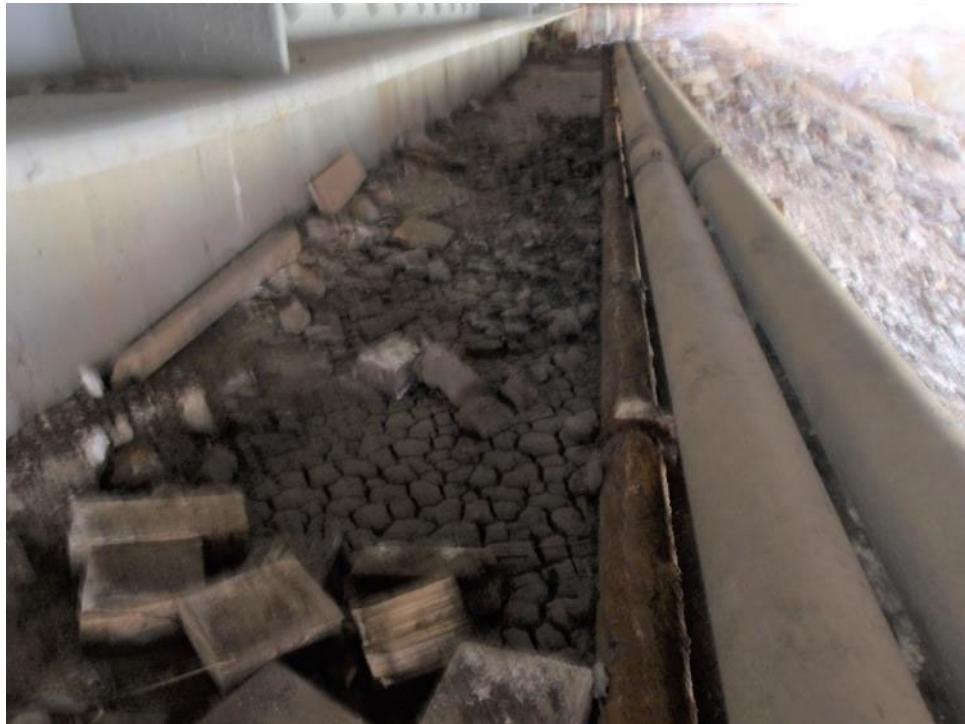
Photo 68- Top of south abutment strut. Three pipes with anchorages into the strut exist. The strut is covered in dirt and debris.

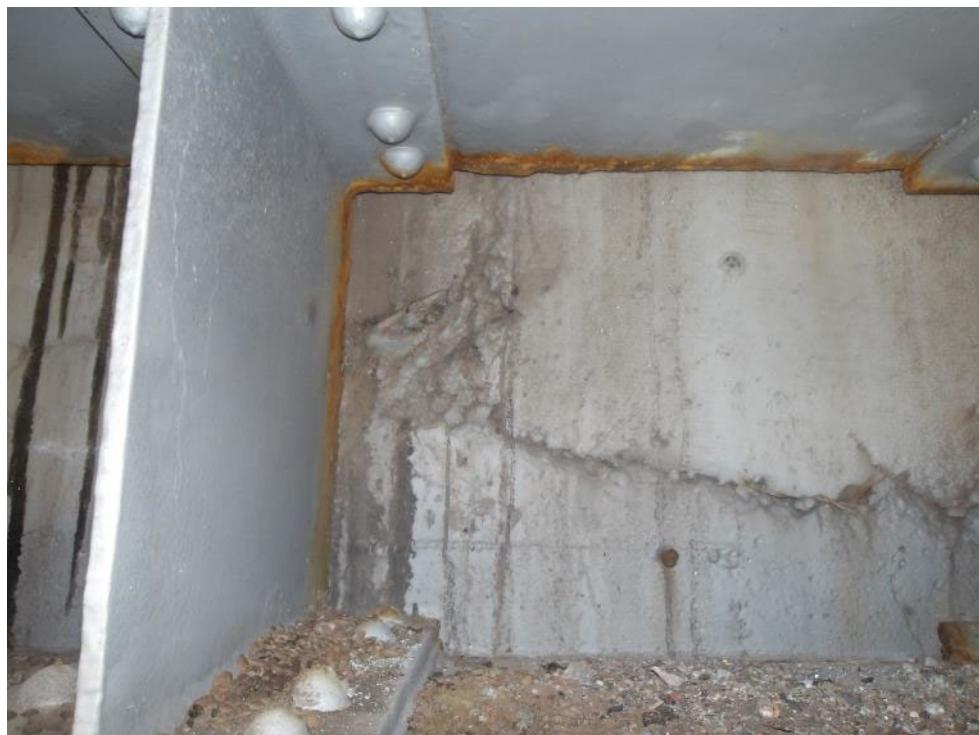
Photo 69- 6"x1' spall between stringers 4 and 5 at the south abutment.

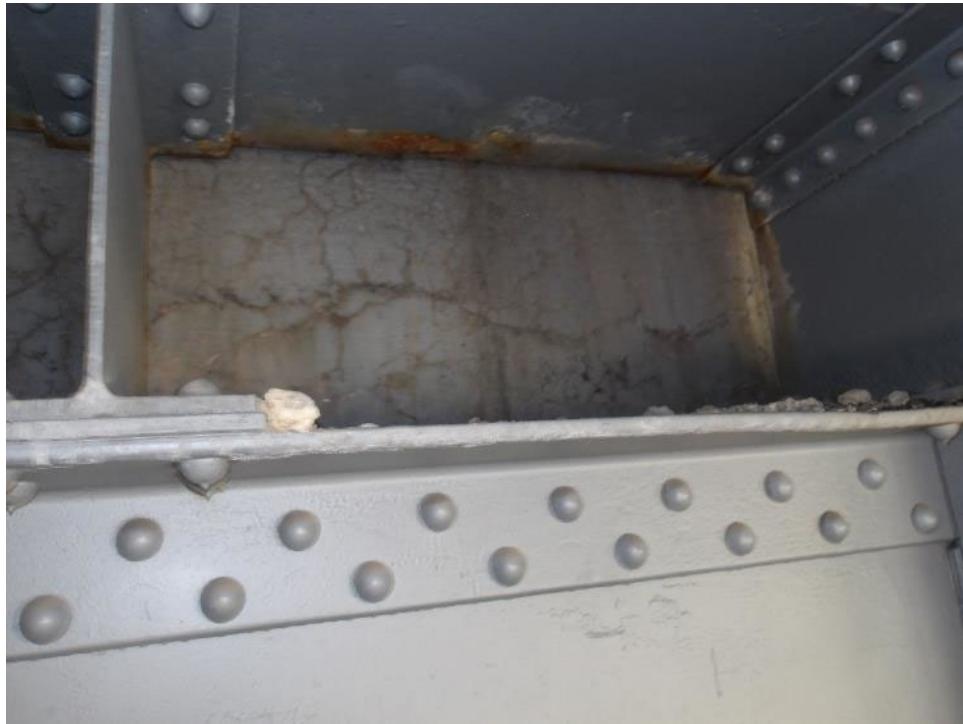
Photo 70- Cracking along southern abutment between stringers 2 and 3. Typical at the southern abutment.

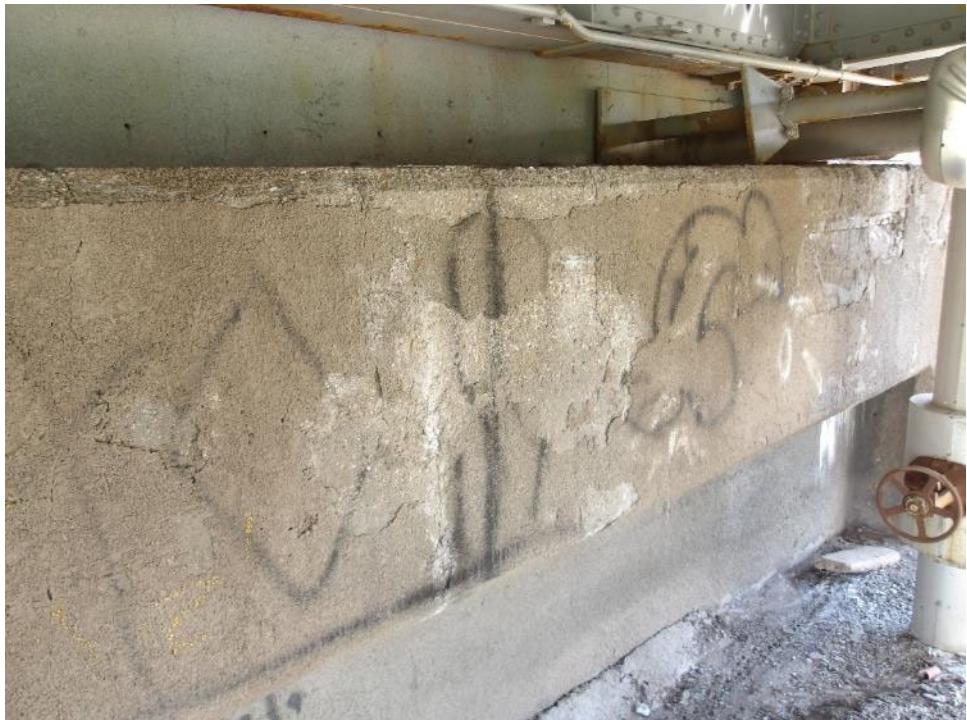
Photo 75- Debonding of concrete protective coating at north abutment. Also, hairline vertical and horizontal cracking along the top strut.

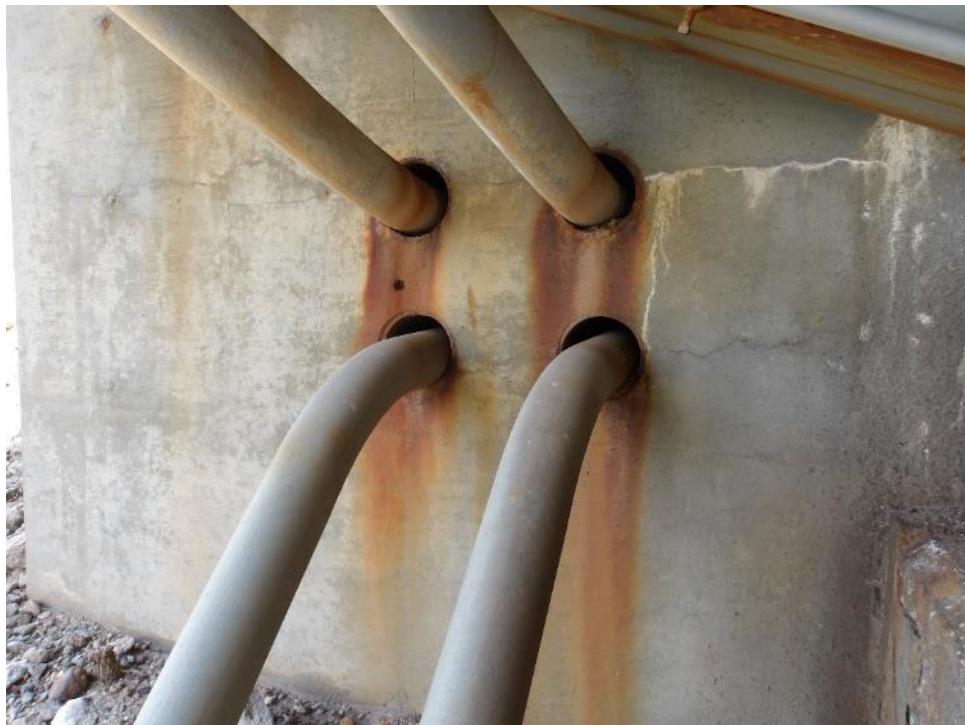
Photo 78- Rust staining and horizontal crack with efflorescence on west backwall at north abutment.

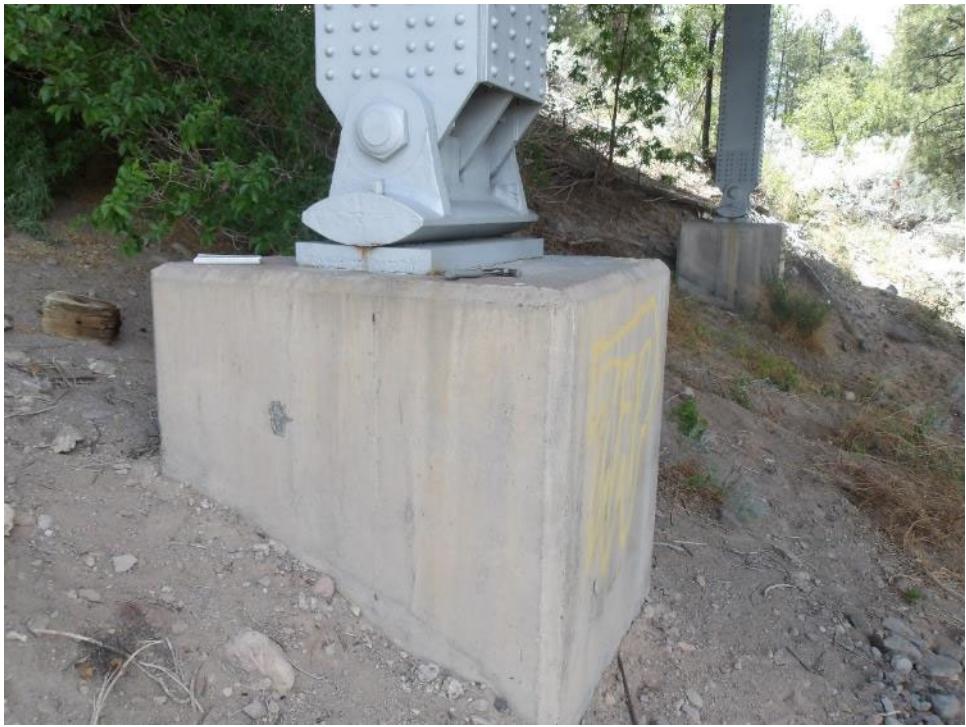
Photo 88- East face of concrete pier column 1, east.

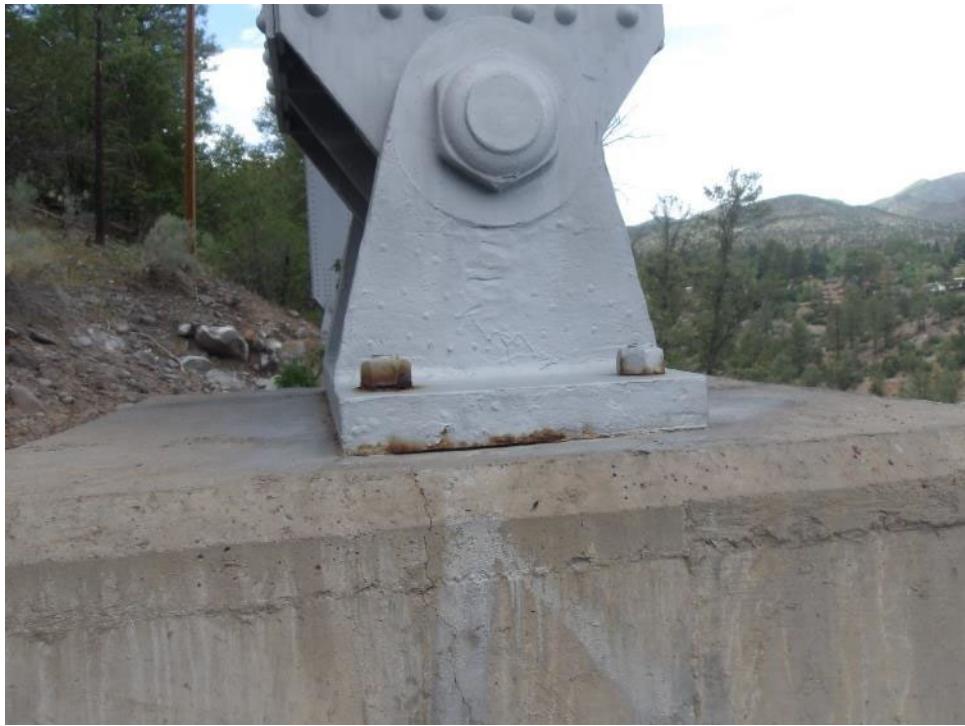
Photo 90- Minor paint failure of the eastern bolts and bottom edge of the bearing at concrete pier column 2, east. Note vertical hairline crack along eastern face and pier cap. This crack extends down the height of the pier column.

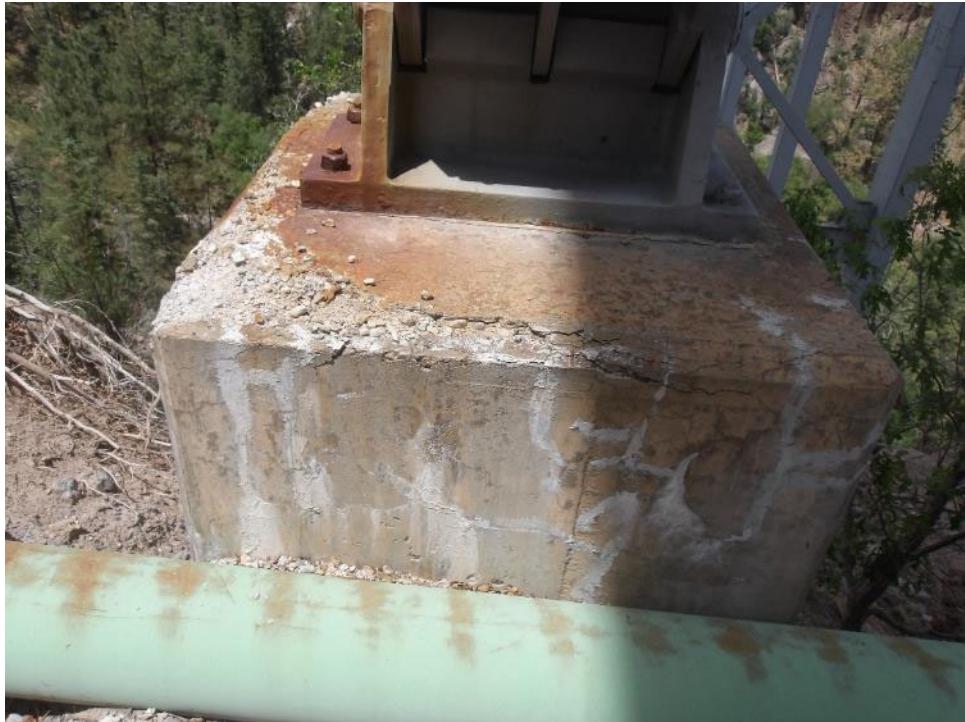
Photo 91- Large spall at the southwest corner and along the western and southern top edges of concrete pier column 2, west. Photo is looking north.

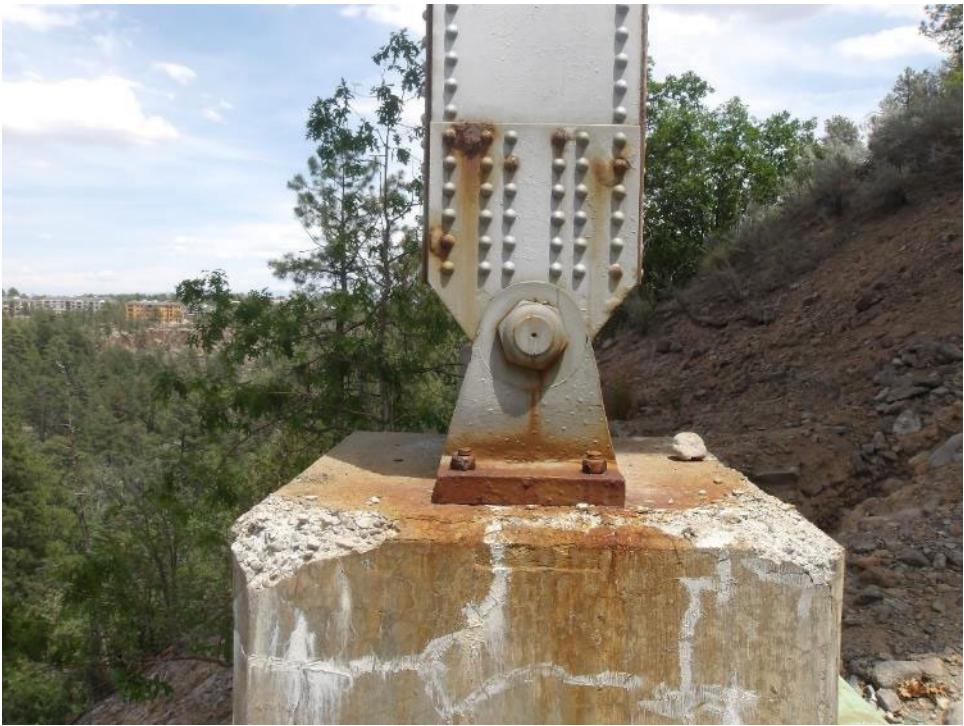
Photo 92- West face of concrete pier column 2, west, with efflorescence and crack repairs. Note 1'x1'x1/2" spall on northwest corner.

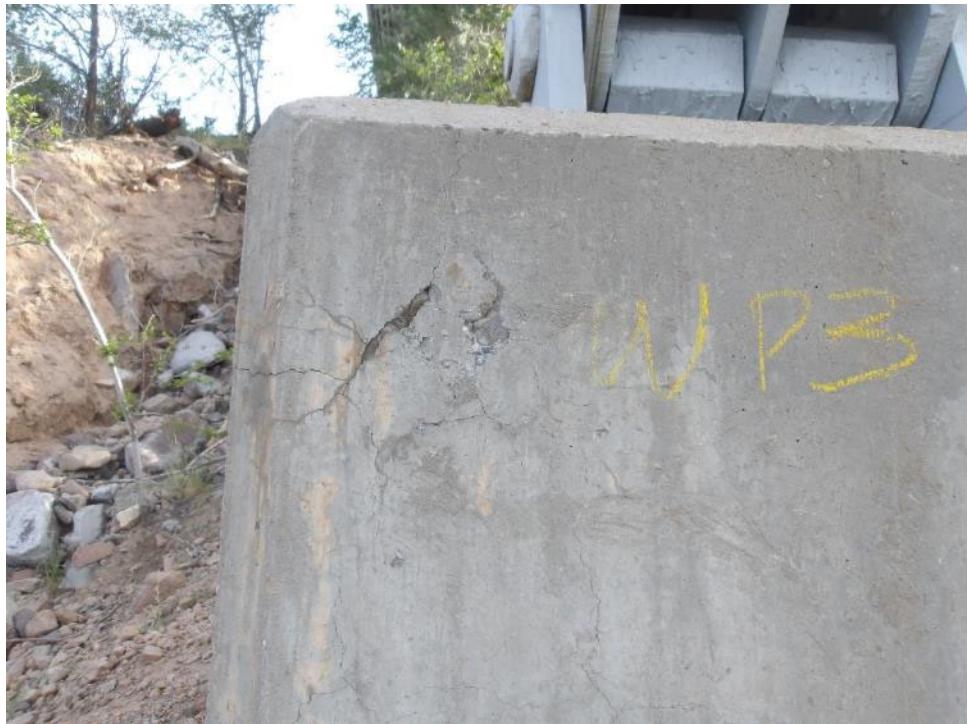
Photo 94- 8"x8" area of delamination with small spalls and associated cracking (hairline to 1/16") at southern face of concrete pier column 3, west.

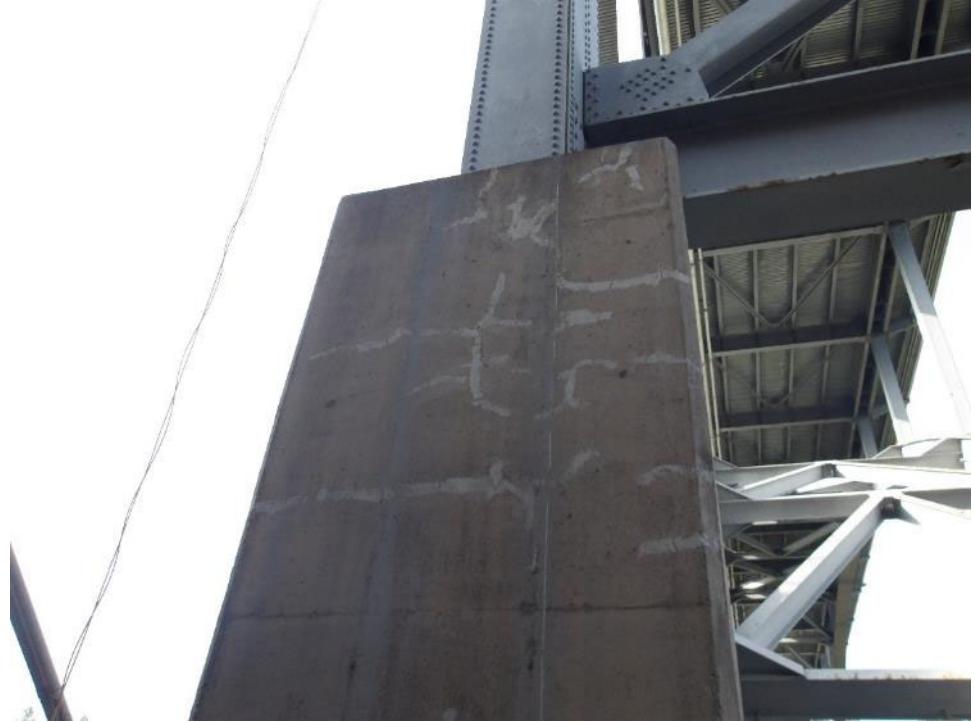
Photo 95- North face of northeast skewback column with patched hairline cracking.

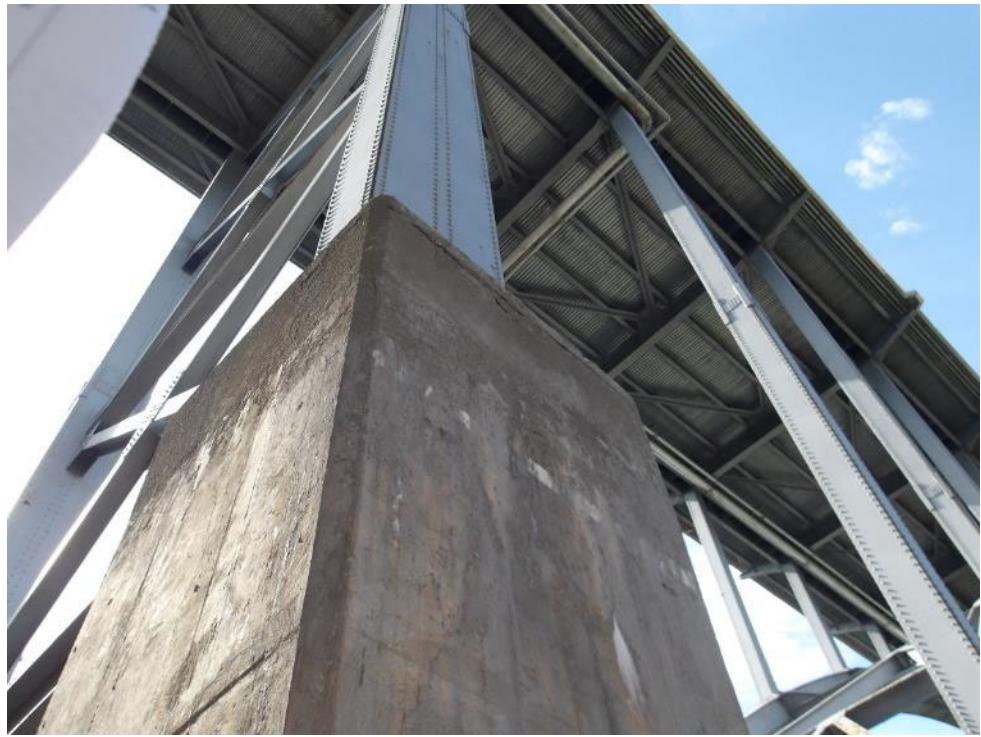
Photo 96- Spalling and debonding (6"x full width of column) of the concrete at the west face of northwest skewback column. This condition extends 2' into the north face of the column.

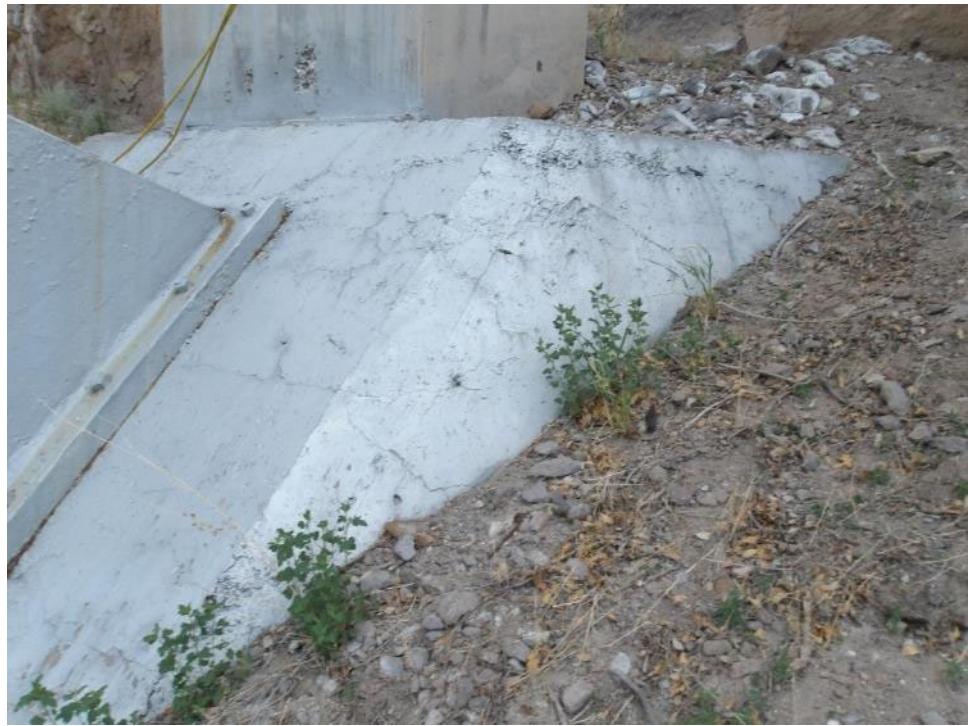
Photo 98- Map cracking throughout the east face of the northeast arch base.

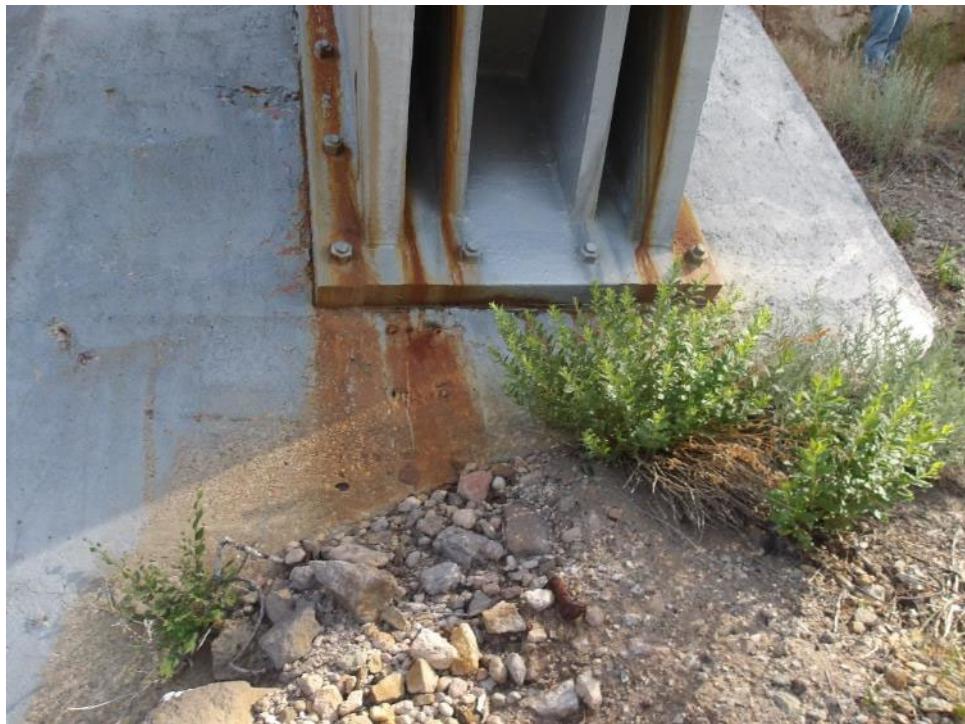
Photo 99- Map cracking and rust staining at south face of northwest anchor base.
