Title: Routine & Nonredundant Steel Tension Member (NSTM) Inspection Report (Final) Property ID No. 43-0434 - Los Alamos Canyon Bridge

Inspection Dates: June 7-9, 2024

Property ID No. 43-0434 - Los Alamos Canyon Bridge

Los Alamos Canyon Bridge on NM-501 (Diamond Drive) over Omega and Dulce Roads

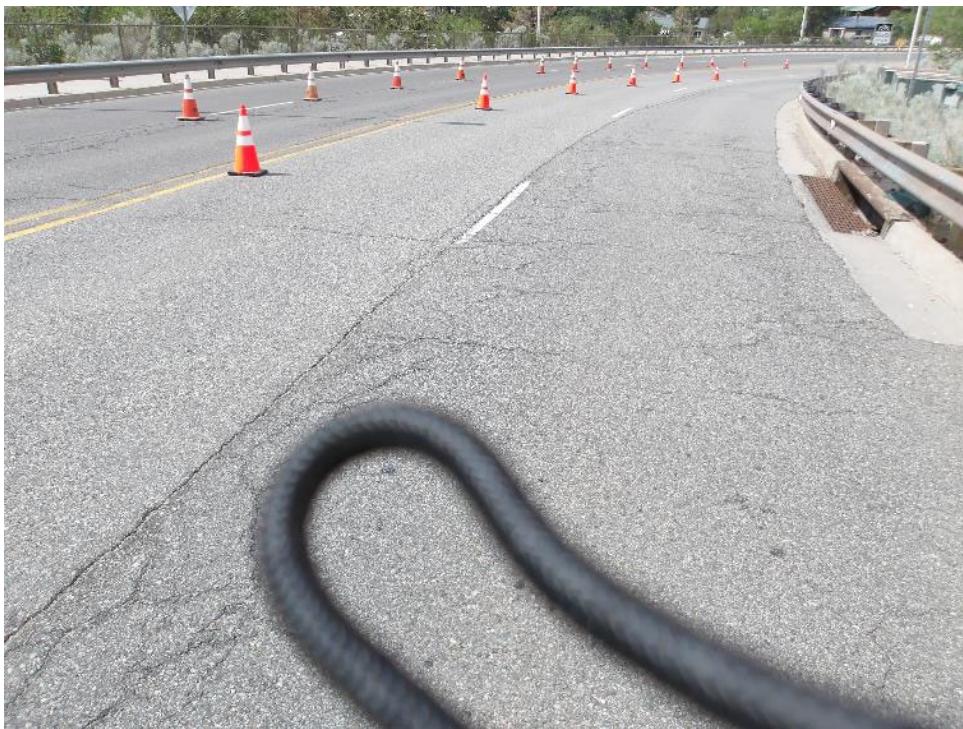
Photo 103- North approach looking north with random cracking.

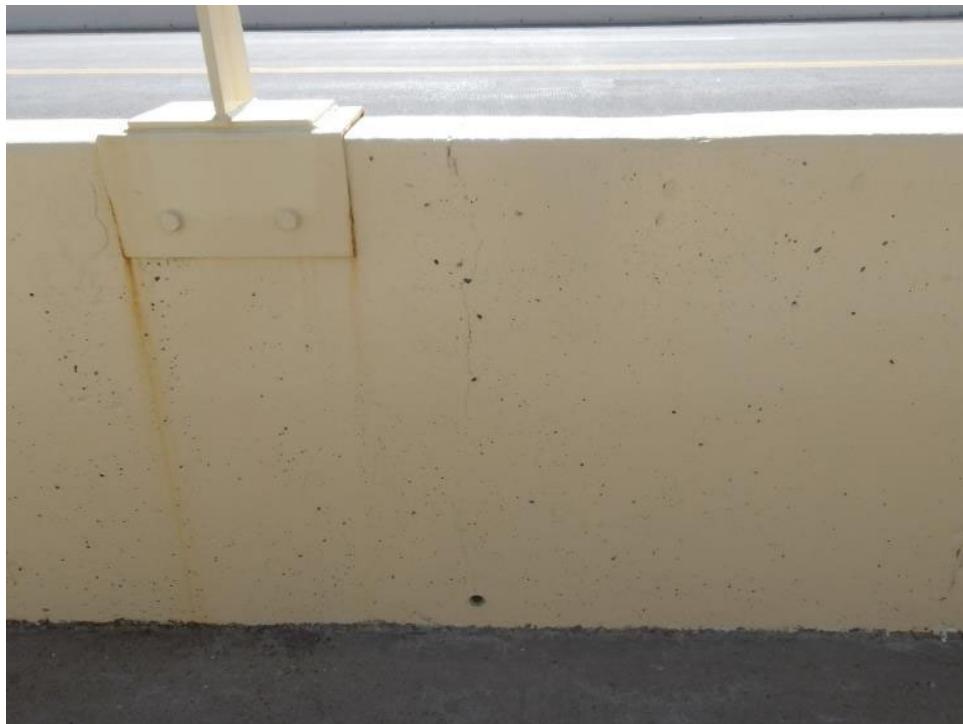
Photo 107- Vertical hairline crack in the west concrete barrier rail emanating from drain hole at bottom (TYP).

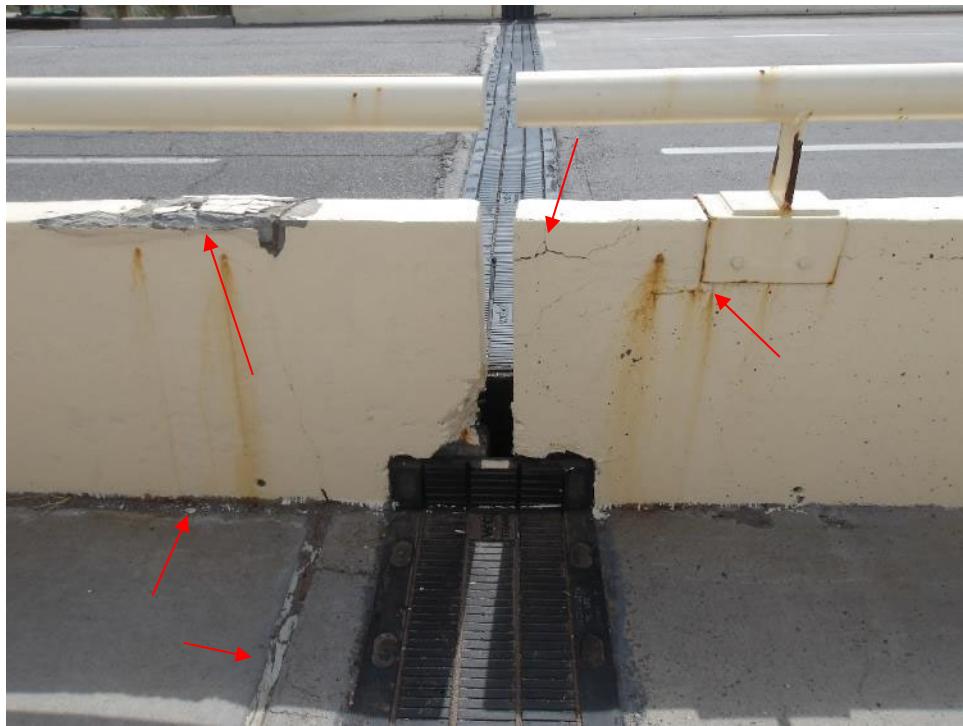
Photo 109- Spall (2'x Full Width x 1/2"), 1/8" cracks, section loss, and rust staining at the west concrete barrier rail at the north joint. Note undermining of concrete barrier rail and missing joint material.

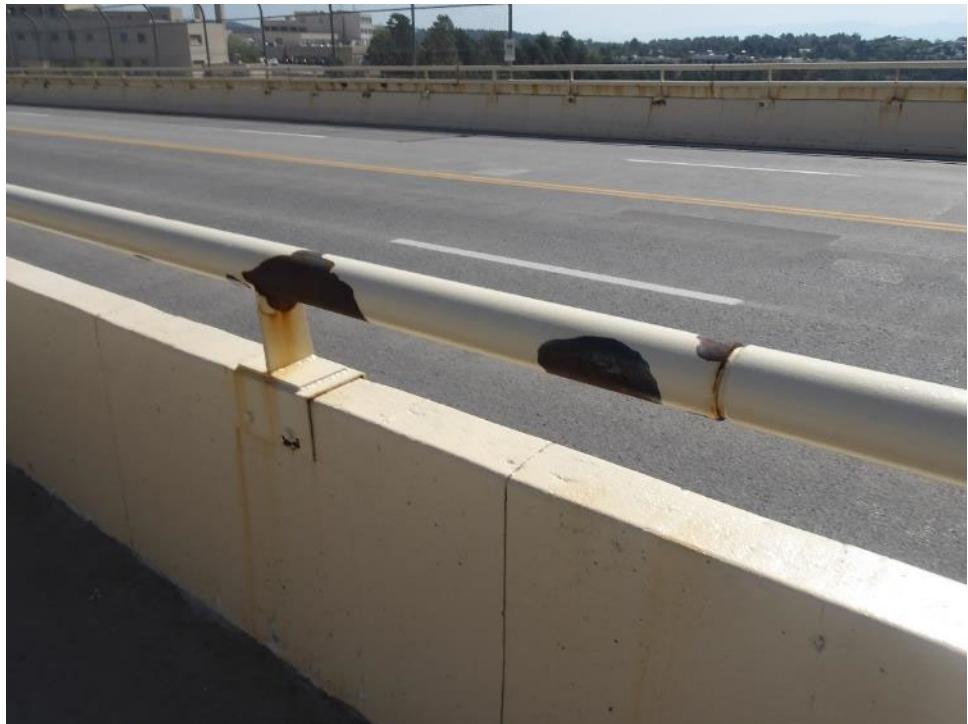
Photo 111- Paint failure along the western rail at midspan (TYP).

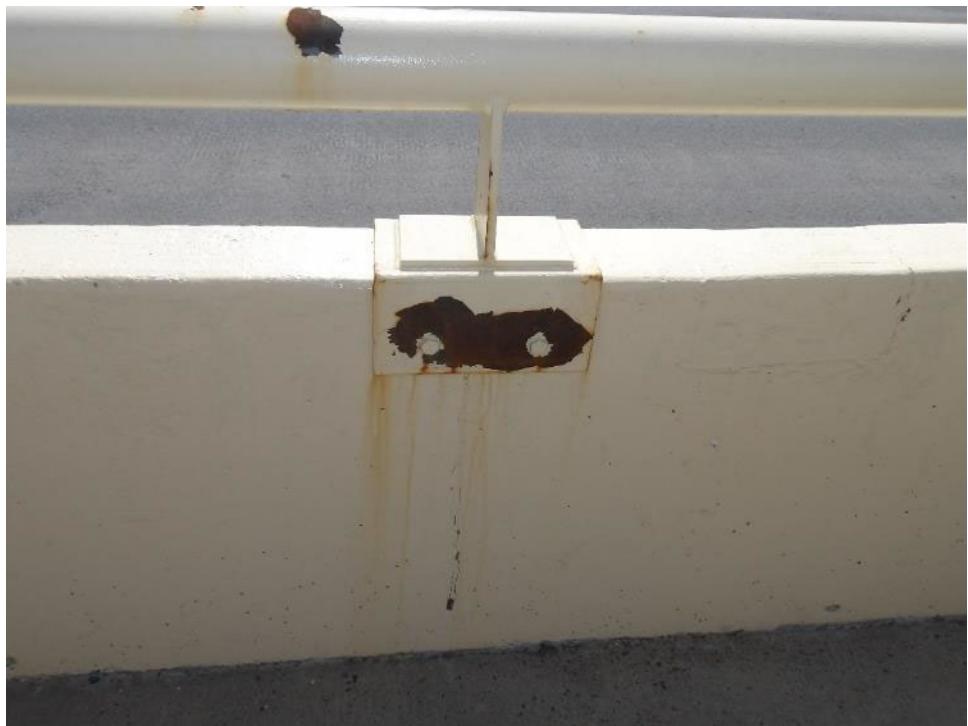
Photo 112- Paint failure at the west guardrail-concrete barrier rail connection.

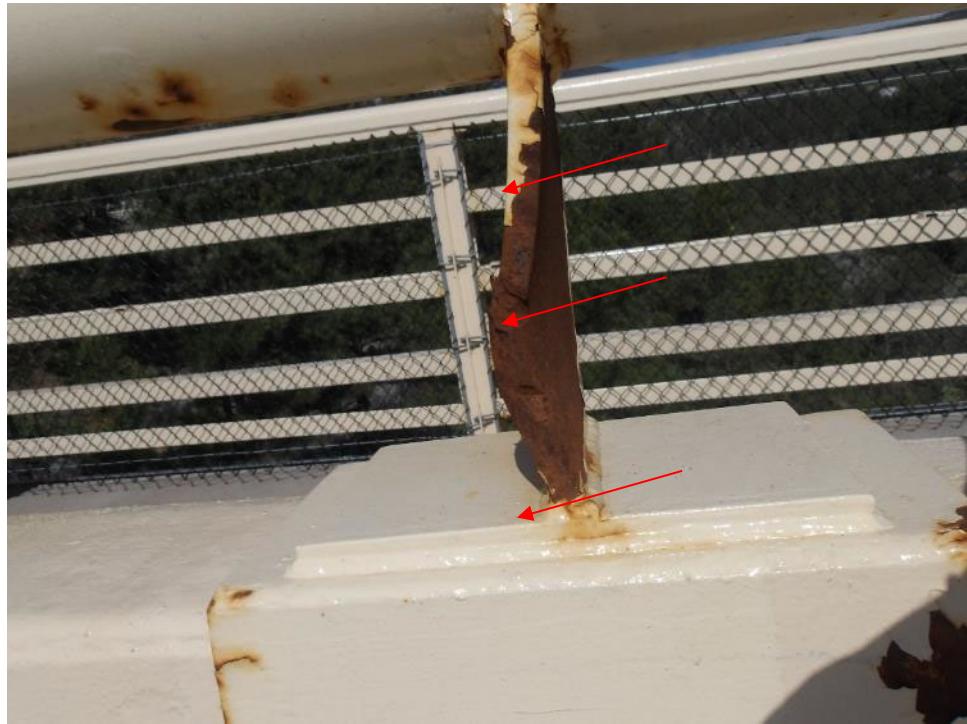
Photo 113- Impact damage to the western bridge rail-concrete barrier rail connection (TYP).

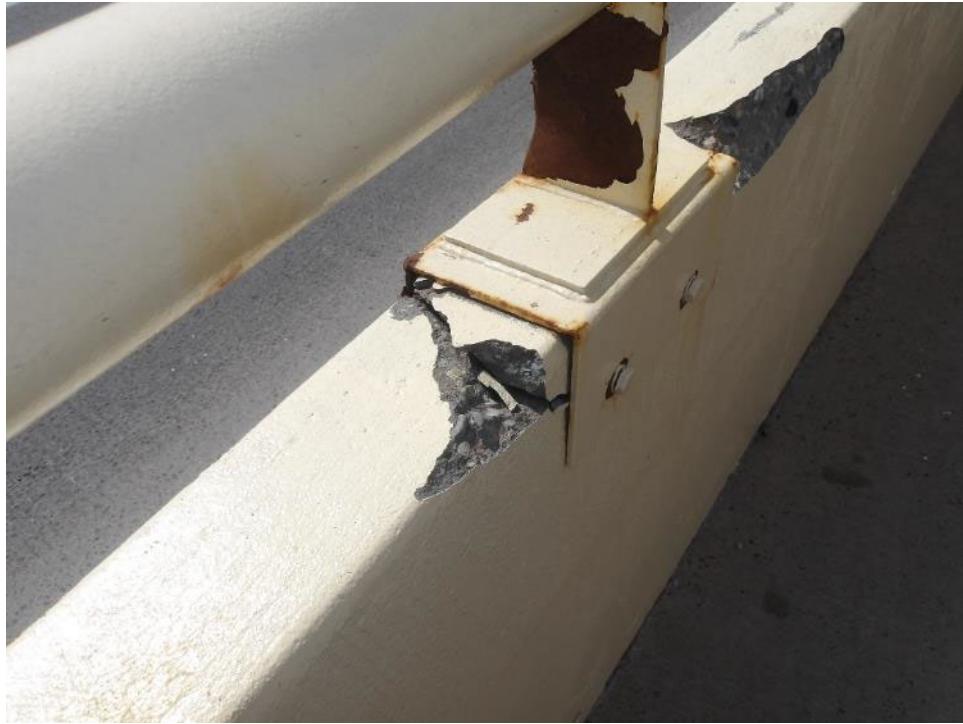
Photo 115- Spall and cracking of concrete at the west guardrail-concrete barrier rail connection towards the north end of the pedestrian walkway.

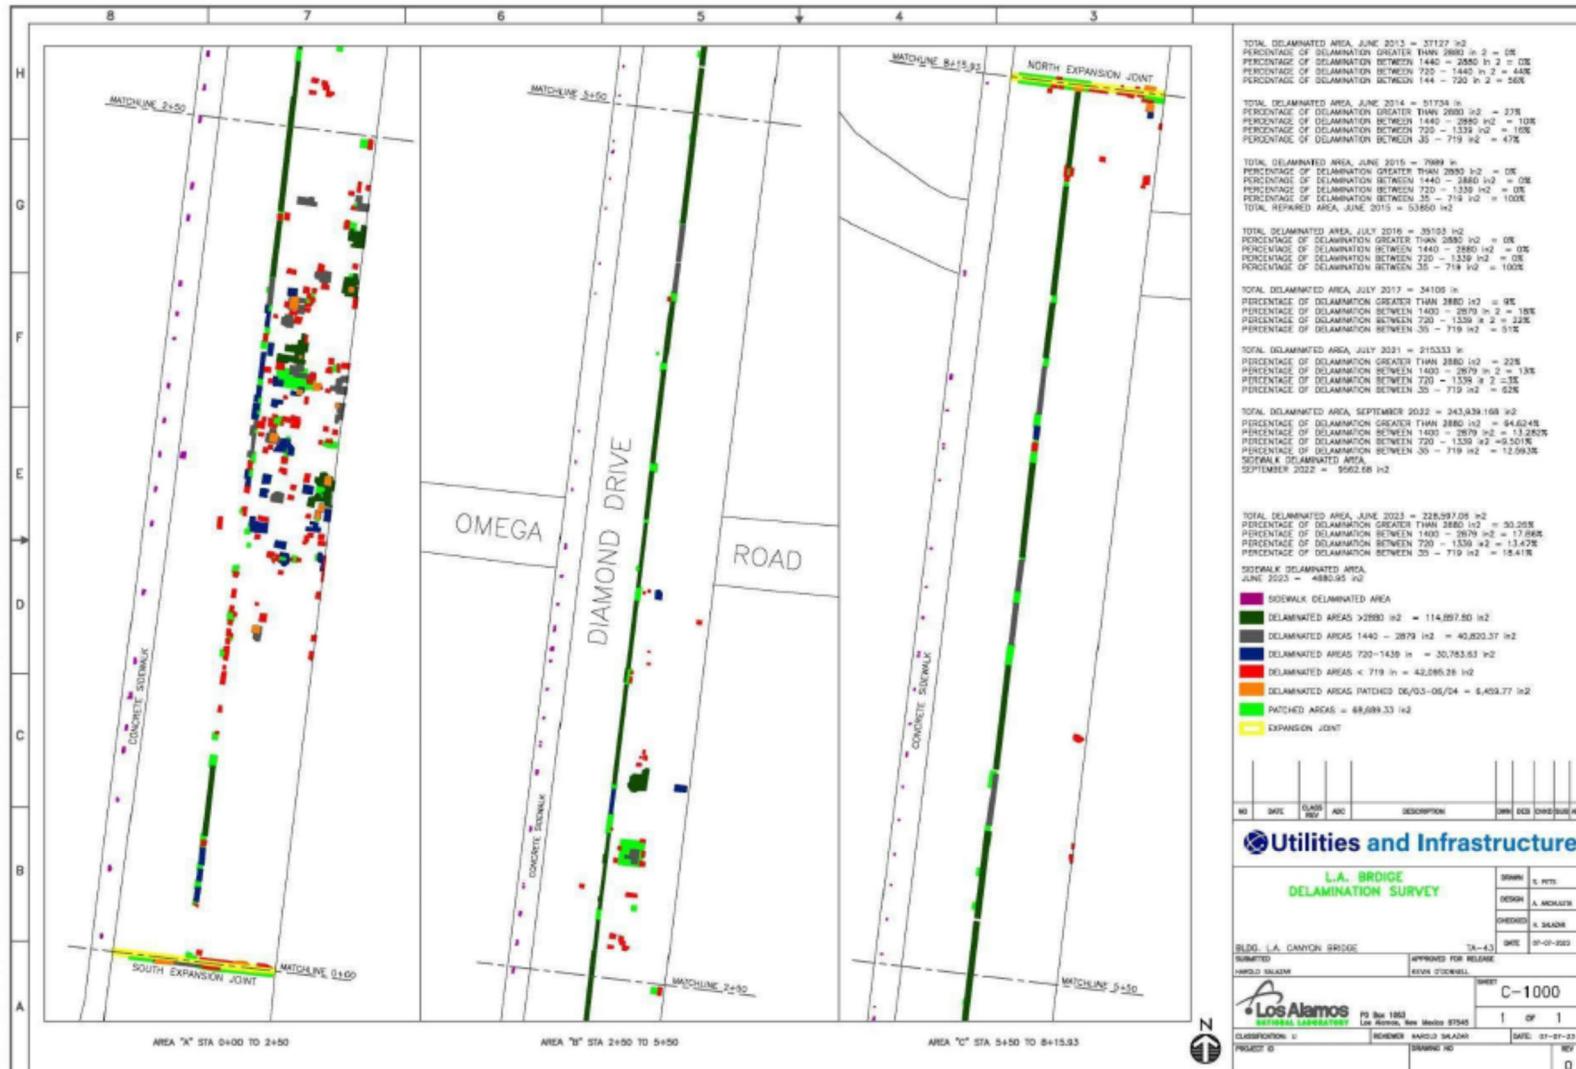
ATTACHMENT 3 - DECK DELAMINATION MAP

Sounding of the deck identified several delaminated areas. Most delaminations are concentrated adjacent to the south/ north expansion joints, in the closure joint of the deck near the bridge centerline, and near previously patched areas in the northbound lanes of the south end of the arch span (**Photo 1**). None of the delaminated areas have spalled and are still intact. All areas of delamination were marked using spray paint. The “Deck Delamination Map” provided by LANL for the 2023 inspection is included in this report as Attachment 3. The quantity of delamination remained generally unchanged since the previous inspection.
