DOE/ER/40150-327

**PROCUREMENT AND COMMISSIONING OF THE  
CHL REFRIGERATOR AT CEBAF\***

Continuous Electron Beam Accelerator Facility  
12000 Jefferson Avenue  
Newport News, VA 23606-1909 USA

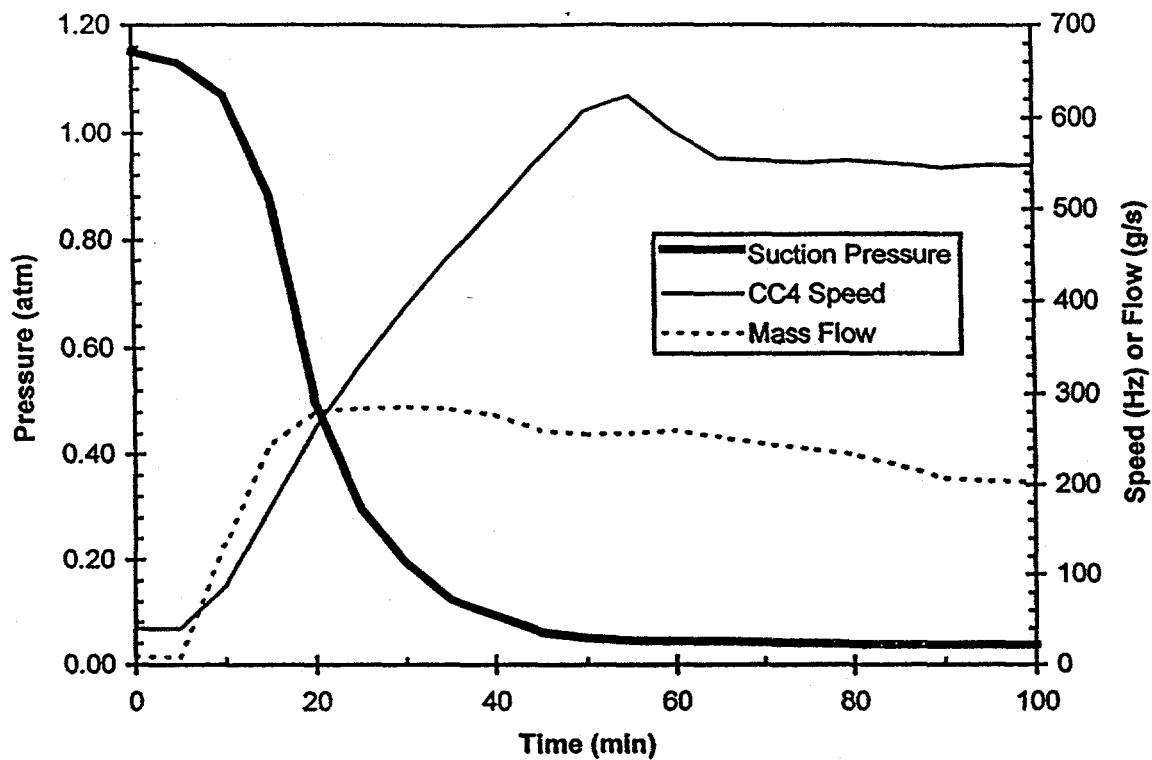
Figure 2. Repair and pumpdown cycle.

The initial pumpdowns of the linacs, after being at 4.5K for long periods of time, have required about eight hours to complete. The normal pumpdowns experienced, where a restart is possible within three to four hours, require about 2.5 hours. The pumpdown procedure has been modified several times and the latest procedure is to delay adding heat until a pressure of 40 mb has been reached. Additional information on the pumpdown is presented in reference 4. A typical pumpdown curve is presented in Figure 2.

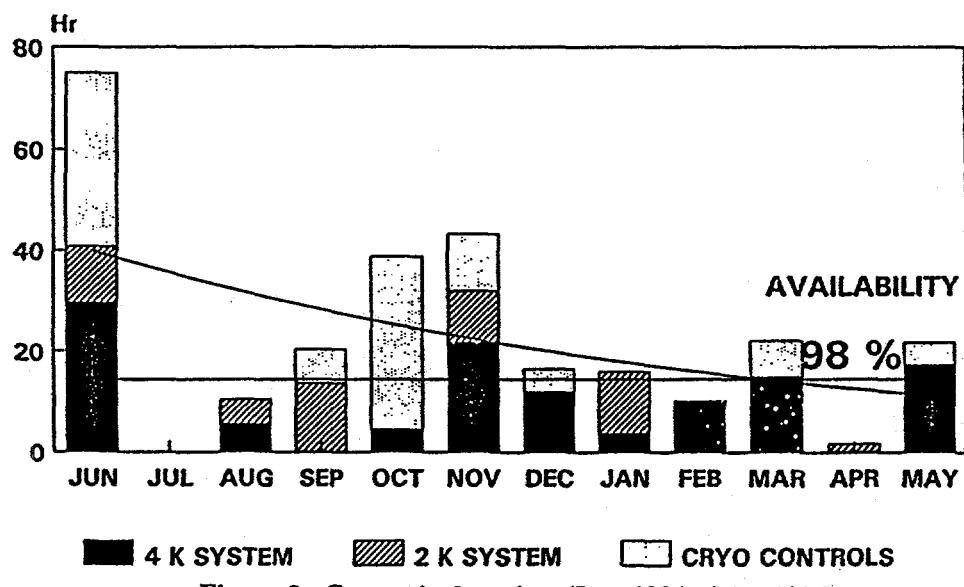
Figure 3. Cryogenic downtime (June 1994 - May 1995)

Cryogenic availability for the previous year has averaged 96.9% and 98.0% for the last six months; the downtime and its causes are shown in figure 3. The causes are split between the 4K system (1.4%), and the 2K system (0.6%), and the cryogenic controls (1.2%). The cryogenic controls category includes cryogenic software and hardware, as well as linac cryogenic instrumentation for the cavities. Not included in the downtime is another 0.8% of nonavailability charged to other sub-systems such as utilities; these included site power, city water, end station errors, and MCC problems.

The primary 4K system downtime was caused by contamination tripping the 25K and 15K turbines; the turbine trip in turn causes a temperature transient, which would trip the cold compressors. Other causes included the warm screw compressor trips and some control valves.

Only one of the 2K system downtimes was associated with the cold compressor hardware; with a valiant 14 hour all-night effort, it was possible to get the magnetic bearing electronics operational again. Six downtimes were due to excursions of the cold compressors out of their stable operating regions, and were not traceable to any equipment failures.

The unreasonably large cryo control downtime was due to three root causes: A) a failure of a supervisory LAN connection and/or board, B) intermittent failures of the linac serial highways which transmit load liquid level information, and C) overloading of memory allocations due to adding the third refrigeration system, ESR, to the network. The first was fixed by replacing several boards and reworking all the terminations, the second problem still remains, and the third has been partially fixed.
