ORNL/ER-374

### Technical Evaluation Summary of the In Situ Vitrification Melt Expulsion at the Oak Ridge National Laboratory on April 21, 1996, Oak Ridge, Tennessee

**Date Issued—July 1996**

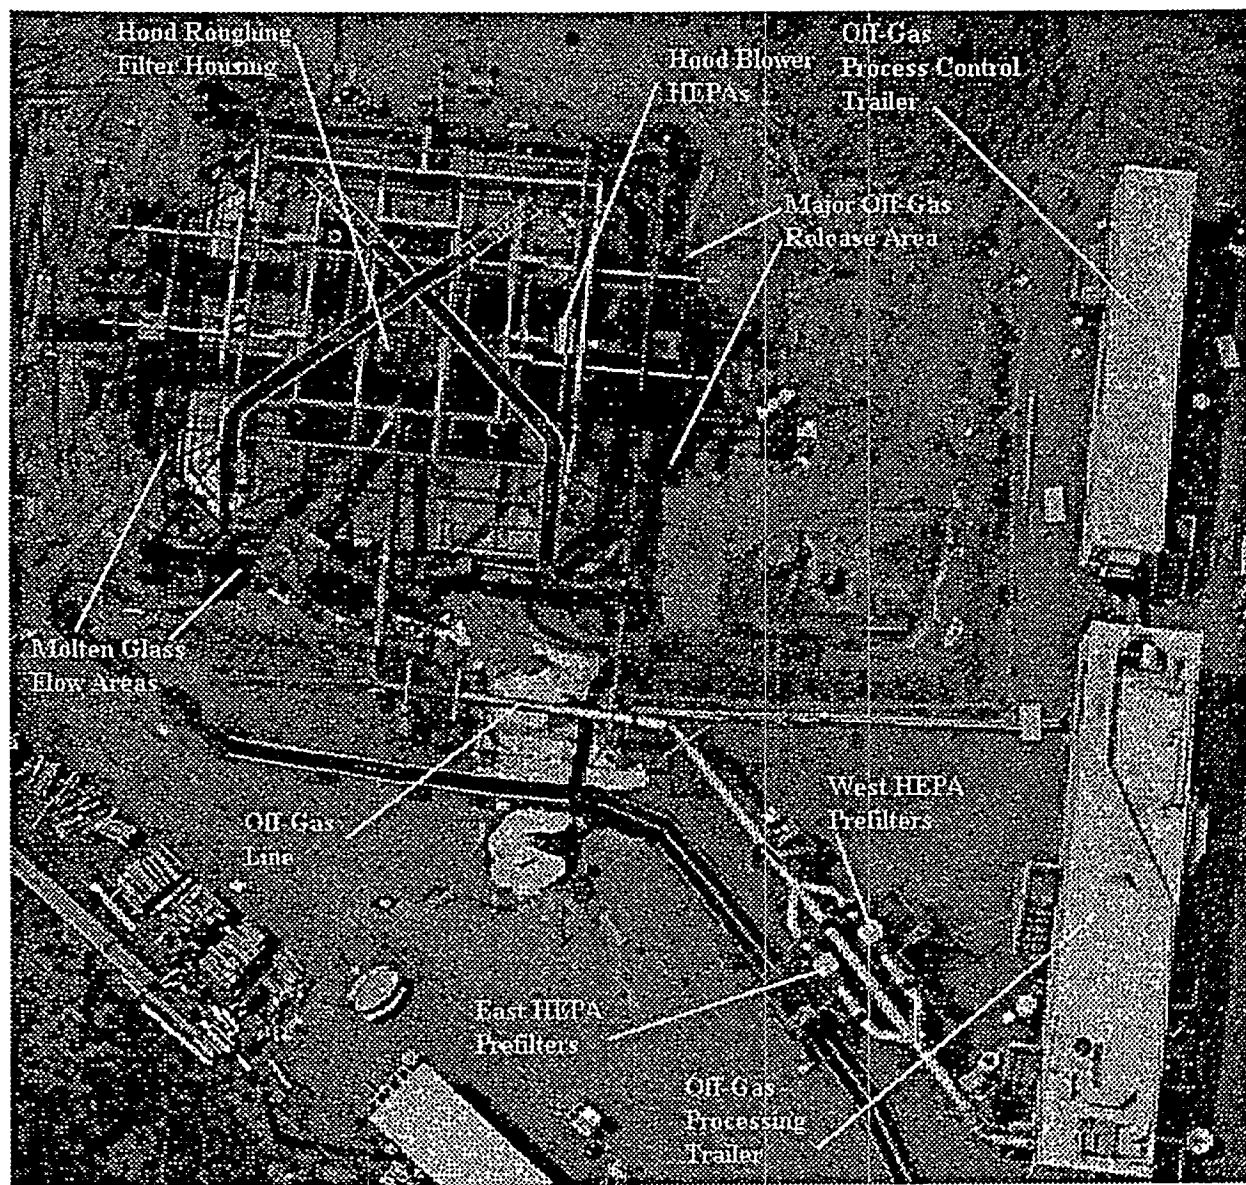
**Fig. 1. Aerial photograph of ORNL ISV site on April 22, 1996, with notations showing locations of key equipment and pertinent incident areas**

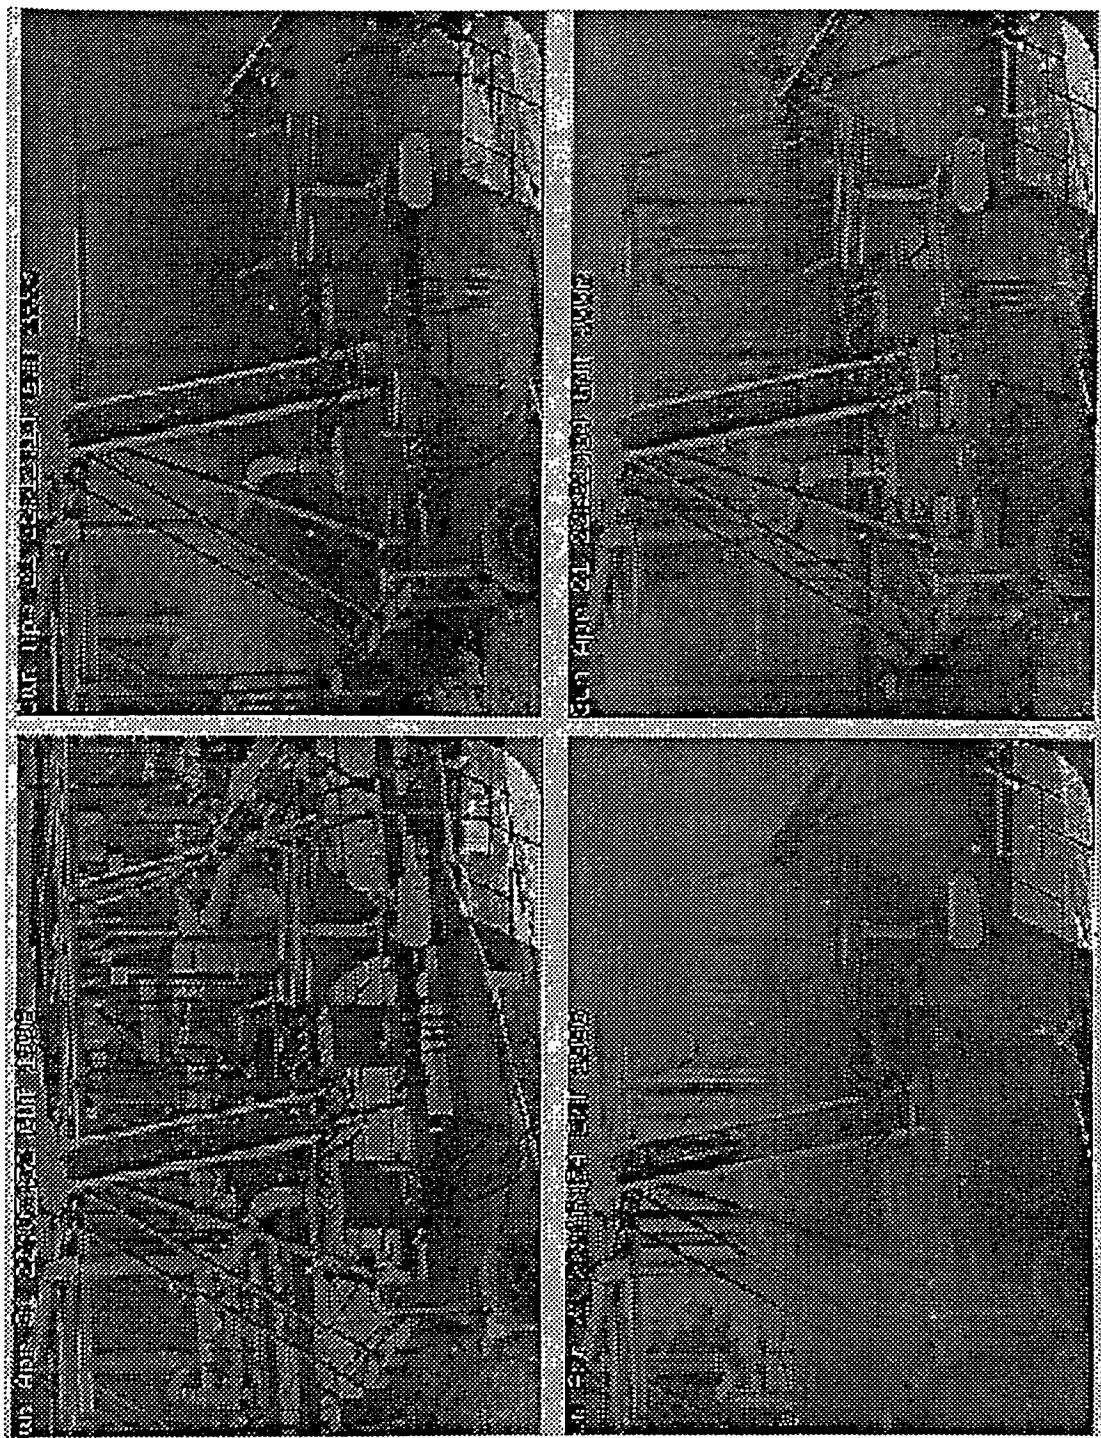
Fig. 2. Sequence of video monitoring images captured at five minute intervals immediately before to ten minutes after the ISV incident of April 21, 1996

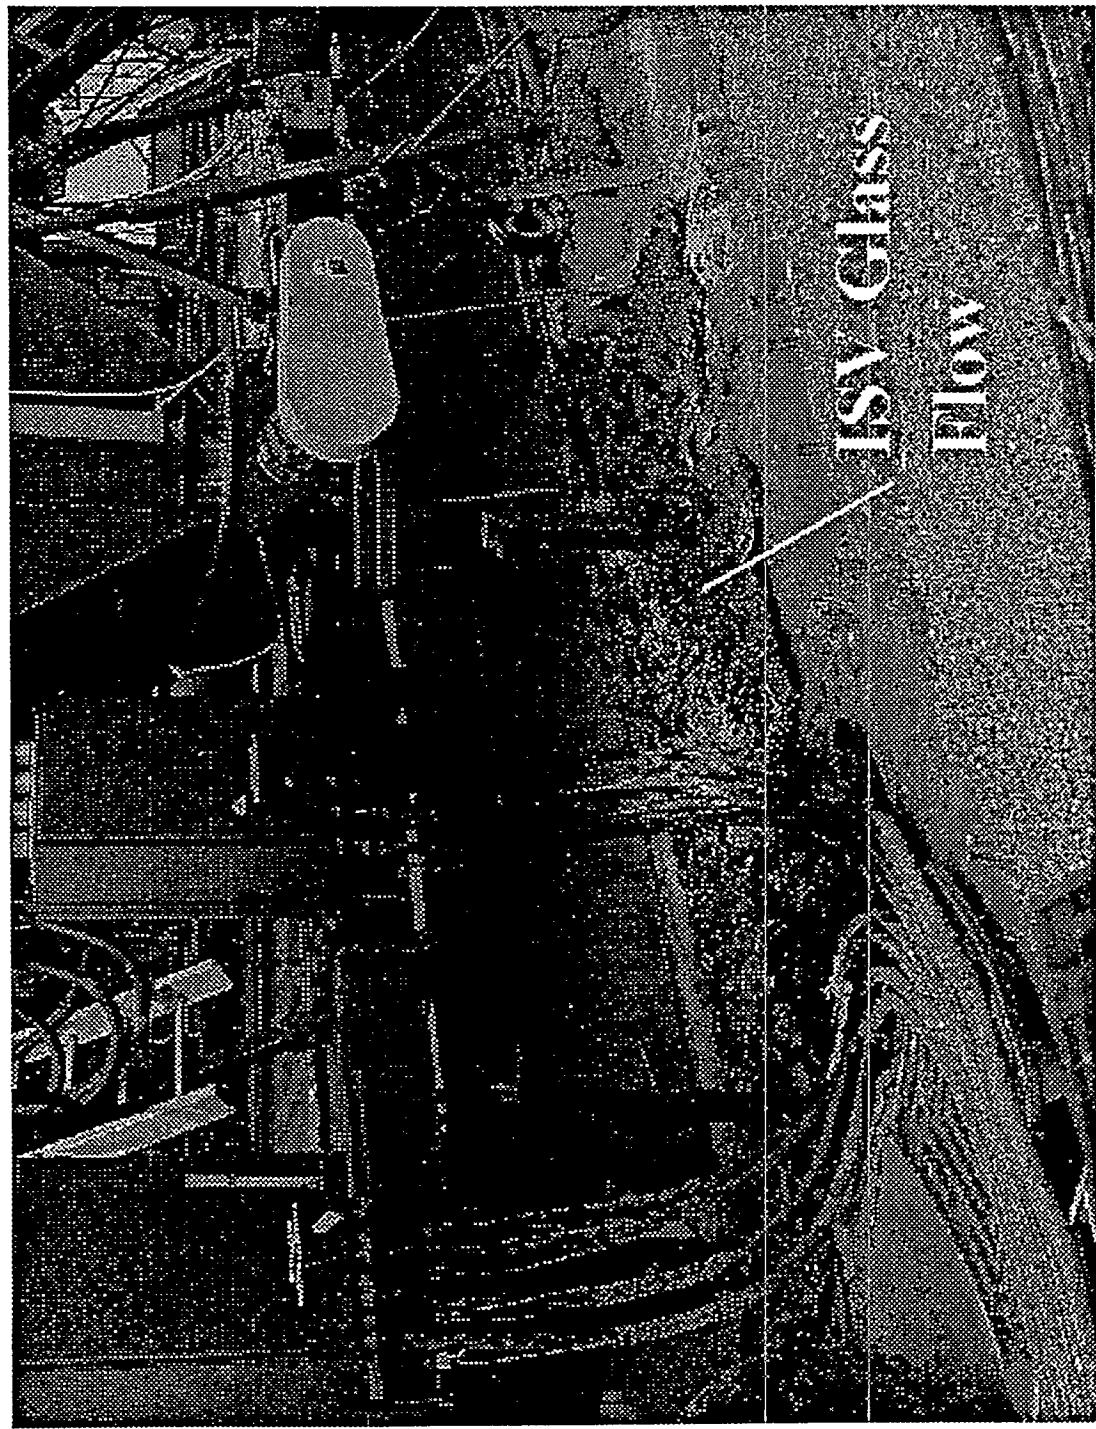
**Fig. 4.** Flow of ISV glass from under off-gas containment hood following the incident of April 21, 1996

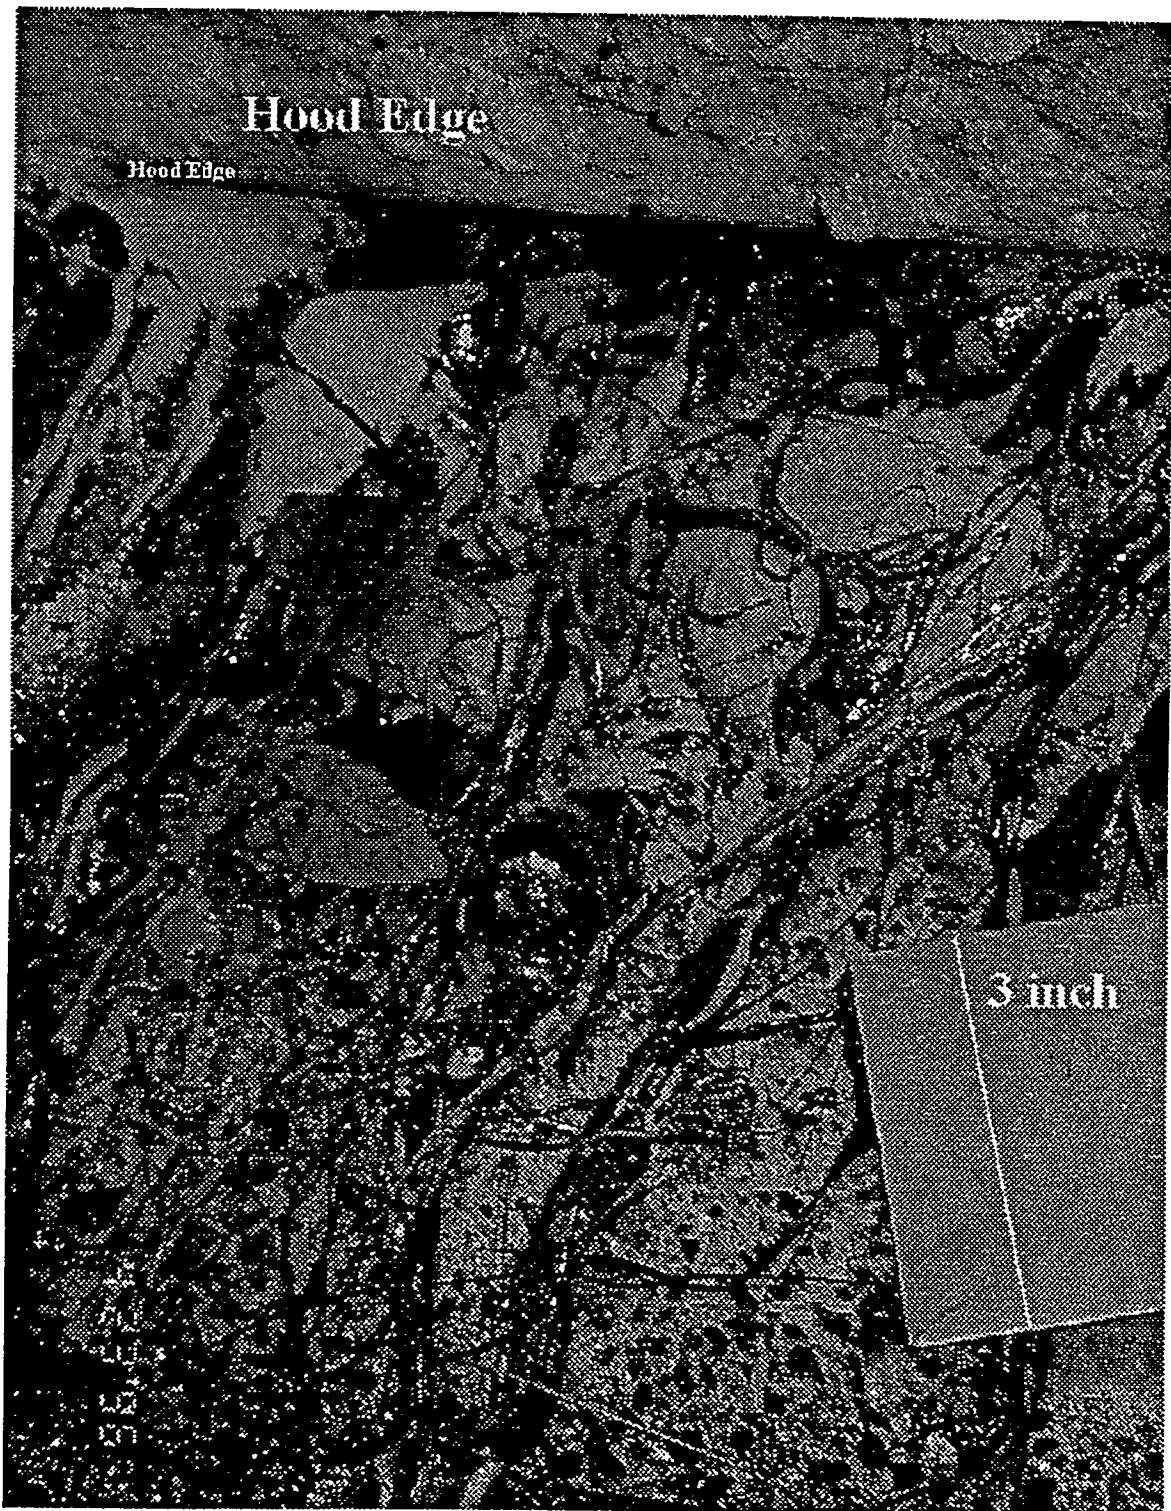
Fig. 5. ISV glass fibers frozen in forming process on ground surface near edge of off-gas hood panel foot

up to 300 ft away from the hood and must have had some aerodynamic attributes to be carried that far. Both of these types of expelled glass appear to have been formed by high velocity off-gas jetting over a molten surface from just underneath the hood panel foot. Actual glass fibers and globs, in the process of forming, when pressurizing and lifting of the hood had ceased, can be seen on the south side of the off-gas hood (Fig. 5).

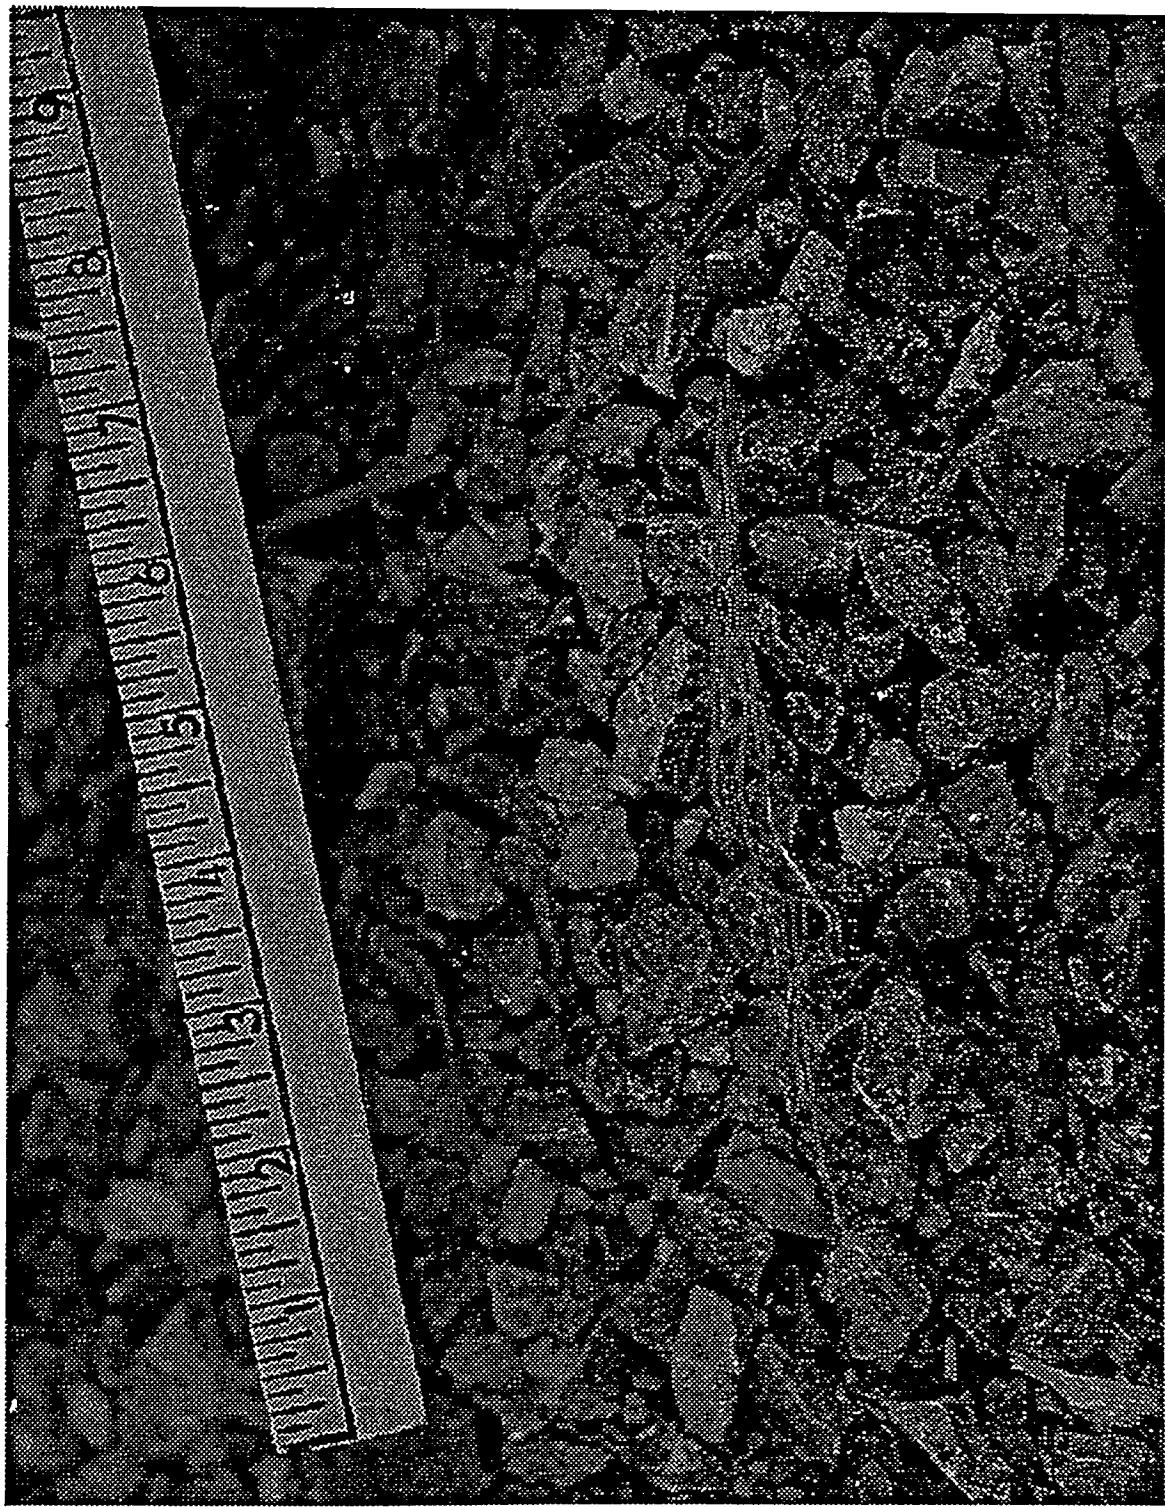
Two types of glass particles were observed around the off-gas hood unconnected with the bulk flow of glass under the hood panels. These were generally in the form of irregular globs (Fig. 6), which usually occurred within 20 ft of the hood, and fibers of glass, some quite thin (Fig. 7), which occurred

Fig. 7. Hair-like form of ISV glass expelled approximately 20 feet east of off-gas hood during incident of April 21, 1996

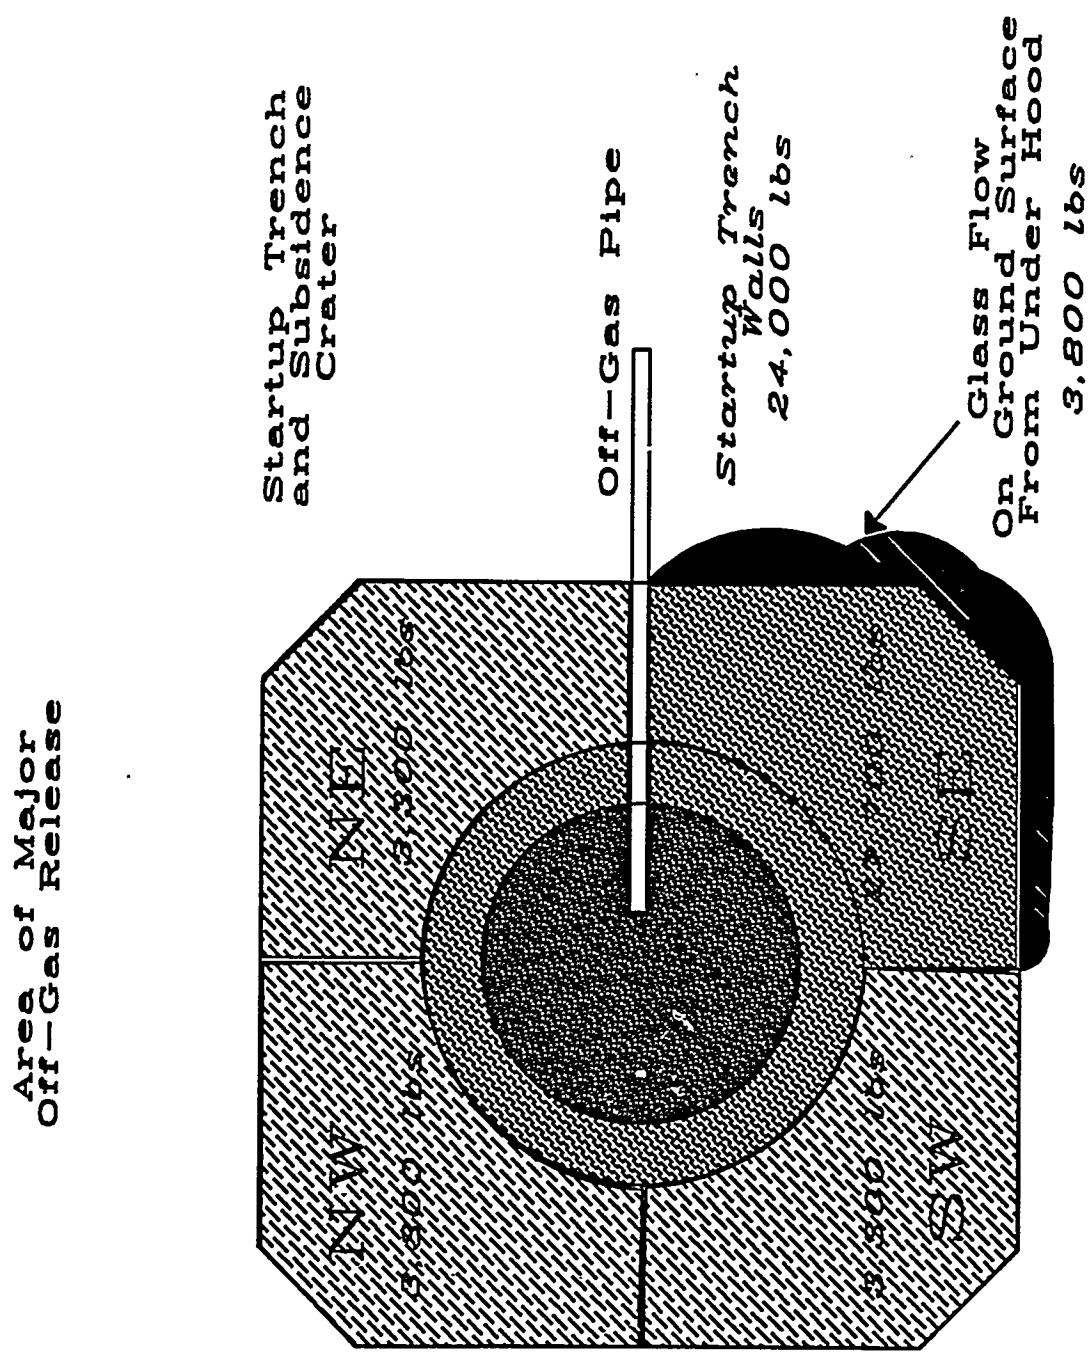
On the east side, there was a pile of gravel covering about the north half of the area between the hood and the graded slope of the pit. The gravel pile extended down to within about 1 ft of the base of the hood and was under all the electrical panels on the north end of the east side. There is melt flow out

Fig. 8. Estimation of distribution of ISV expelled glass within and around off-gas collection hood after April 21, 1996 incident

from under the hood on the south half of the east side. It extends out from the edge of the hood panels about 3 to 5 ft and is about 4 to 6 in. thick. The insulation on the high voltage cables is burned (about the last 10 ft of each of the 8 cables as they run into the junction boxes).

On the south side, melt flowed out of the east two-thirds of the hood; it extends 1 to 2 ft and is about 4 to 6 in. thick. Fiberglass grating in the area was burned but did not cause damage similar to that observed on the north side. All hydraulic and pneumatic rubber hoses in the southeast corner are heat affected and will need to be replaced.

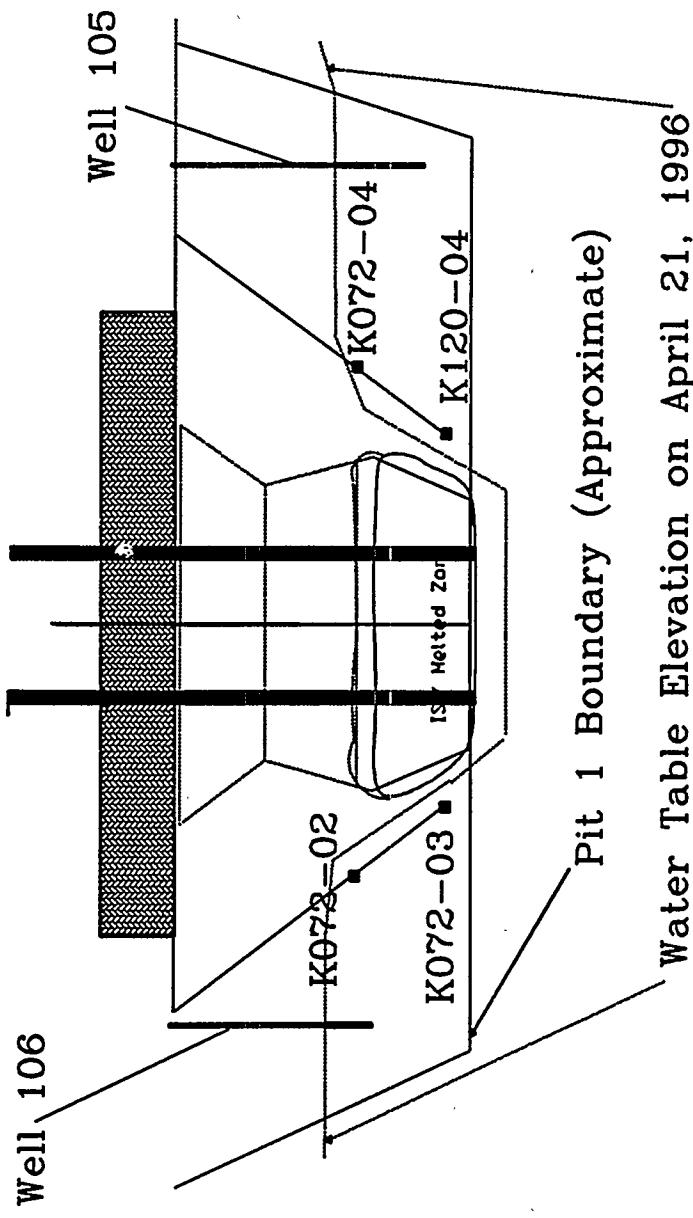
Fig. 17 Cross-section of ORNL pit 1 showing melt depth, perched groundwater, monitoring wells, and thermocouple positions immediately before the incident of April 21, 1996

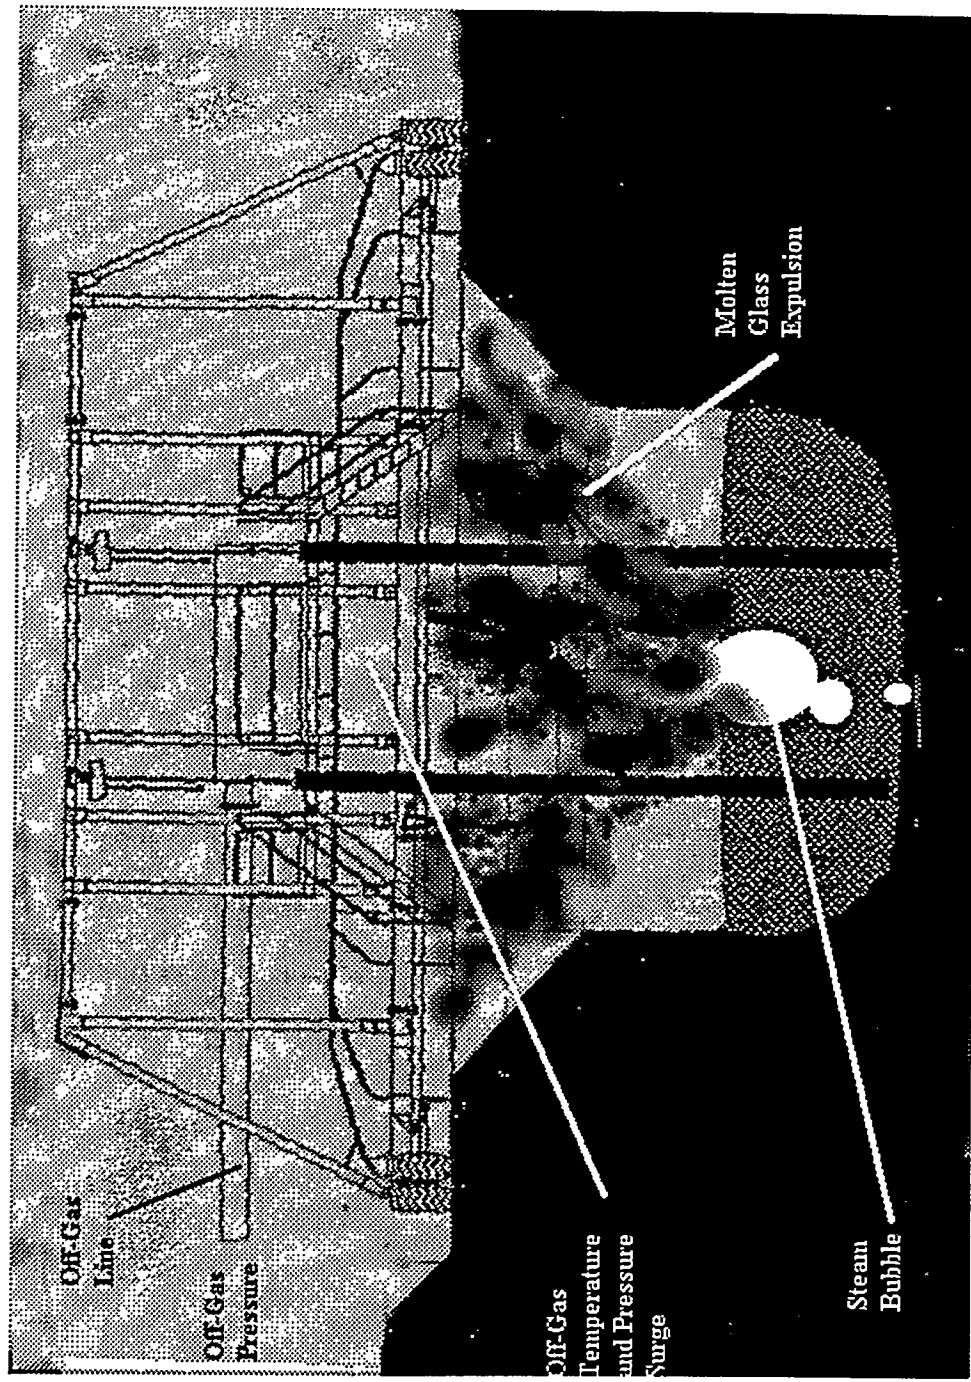
Gas permeability in the dry zone around an ISV melt body is not the only factor that restrains steam from entering the melt body. The weight of the molten fluid itself poses a significant barrier to steam entry. The density of molten fluid (2.83 g/cm<sup>3</sup> or 177 lb/ft<sup>3</sup>) provides a calculated hydrostatic pressure of 1.21 psi/ft of melt depth. The pit 1 melt body at the time of the expulsion was 8.97 ft thick and, thus, would have a hydrostatic pressure of about 11 psi at its bottom. Steam could enter the melt body only if its pressure were in excess of that hydrostatic pressure. Of course, steam could enter the melt body at lower pressure at a shallower depth and still result in a bubble of significant size, which could cause a melt expulsion (Fig 19).

Fig. 19. Conceptualization of steam-bubble mediated expulsion of molten glass during the April 21, 1996 incident at ORNL.

approximately 11 ft or 4.76 psi. Such a hydrostatic pressure would not be sufficient to overcome the melt body hydrostatic (more correctly, lithostatic) pressure and result in water movement to the melt body. But, a steam pressure of such magnitude would be quite plausible within the dry zone around the melt body. Of course, if that steam pressure were relieved rapidly, as during the melt expulsion event, then perched groundwater could flow rapidly into the depressurized dry zone. This could account for the disappearance of standing water in the two wells within pit 1 after the melt expulsion.
