PLASTIC DEFORMATION PROCESSES ACCOMPANYING STRESS CORROSION CRACK PROPAGATION IN IRRADIATED AUSTENITIC STEELS¹

M.N. Gussev¹, G.S. Was², J.T. Busby¹, K.J. Leonard¹.

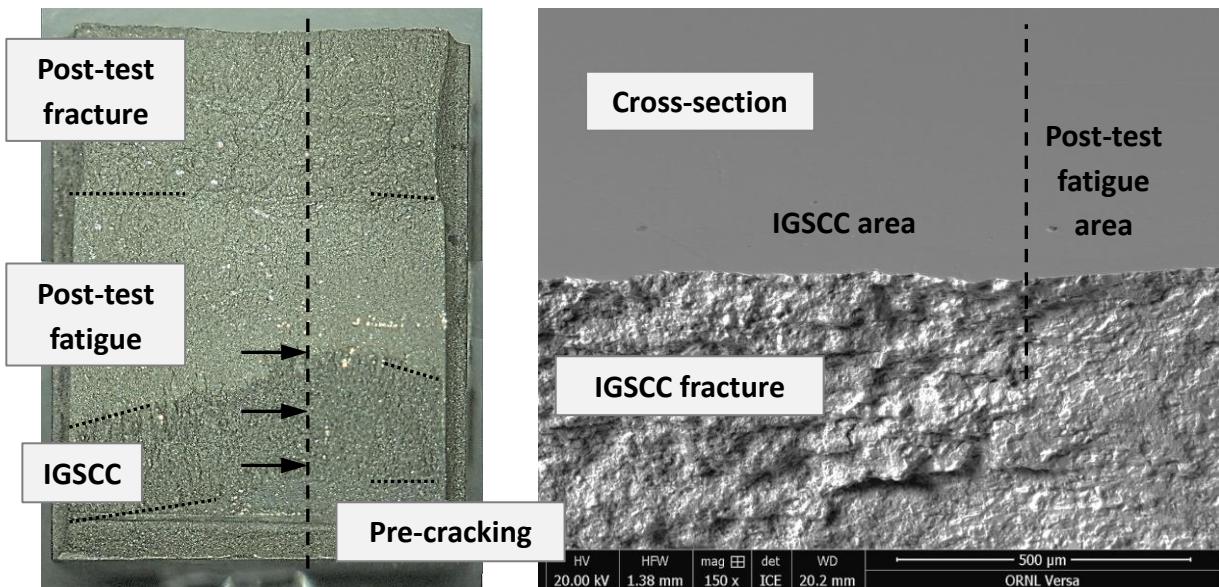
It is important to underline that, although the scan location was known, it was very difficult, if possible at all, to connect the collected EBSD data to the particular stress intensity factor value or other parameters during the CGR test [9]. The CGR testing provides an average crack length value [7,10] whereas crack front often had curved or complex shape (Figure 2), so only rough K-value may be estimated.

Figure 2. Left: Specimen surface showing different fracture mechanisms (Pre-cracking, Inter-granular stress corrosion cracking, etc.); dashed line and black arrow show the location of the prepared cross-section. Right: a tilted view of the specimen cross-section prepared for EBSD analysis; one may see the transition between IGSCC area and post-test fatigue.

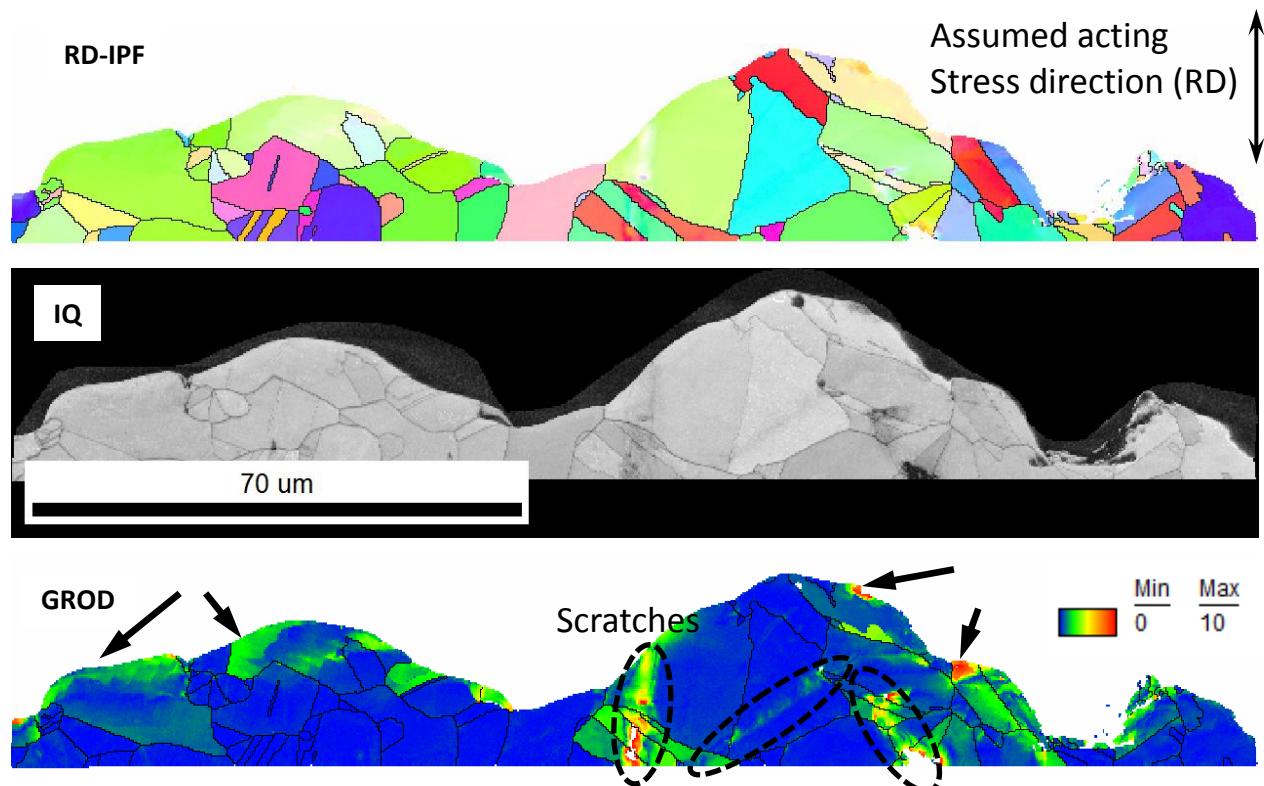
From the EBSD results, the crack-adjacent grains often have some signs of plastic strain; for the GROD map in Figure 4, plastic strain is visible as a smooth change in color from blue to green and yellow. The width of the crack-adjacent area with signs of plastic strain is \sim 10–15 μ m, and is slightly more in some cases. GROD value for the crack-adjacent grains may reach \sim 10° for some grains.

An important feature in Figure 4 is the absence or very low level of misorientation in many crack-adjacent grains. Instead of high strain level in the neighboring grains, significant grain fraction practically zero misorientation variations. Deformed and non-deformed grains interlaced along the crack path pointing on the strong plastic strain inhomogeneity.

Figure 4. Typical EBSD dataset for the crack-adjacent area: IPF (Inverse Pole Figure), colored in the RD (acting stress) direction, IQ (Image Quality), and GROD (Grain Reference Misorientation Deviation) maps. Black arrows mark locations with high local strain level; dashed ovals show scratches introduced during specimen preparation.

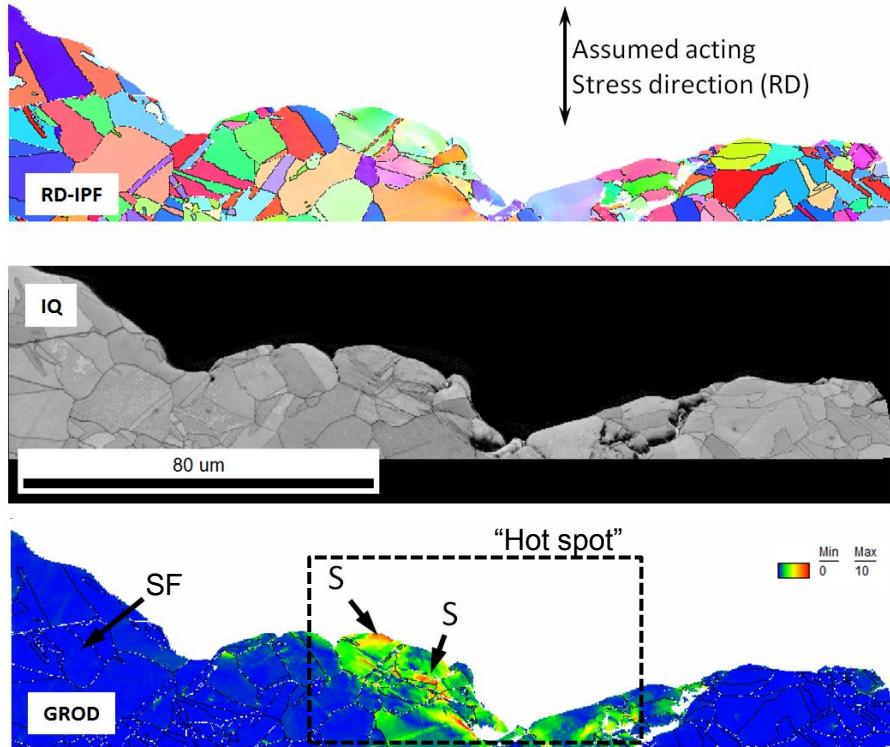
Figure 5 shows an additional EBSD data set with one specific feature. Many grains in the GROD map are strain free (blue color); however, grains in the image center show pronounced local misorientation. The deformed grains are grouped together, contrasting with the neighboring weakly or non-deformed area. These highly deformed areas, termed below as “deformation hot spots”, occupied \sim 10–15% of the overall analyzed crack path.

Figure 5. EBSD data for the crack-adjacent area showing a spot with high local strain level. S: areas with high local misorientation (GROD). The GROD scale here was limited by 10°.

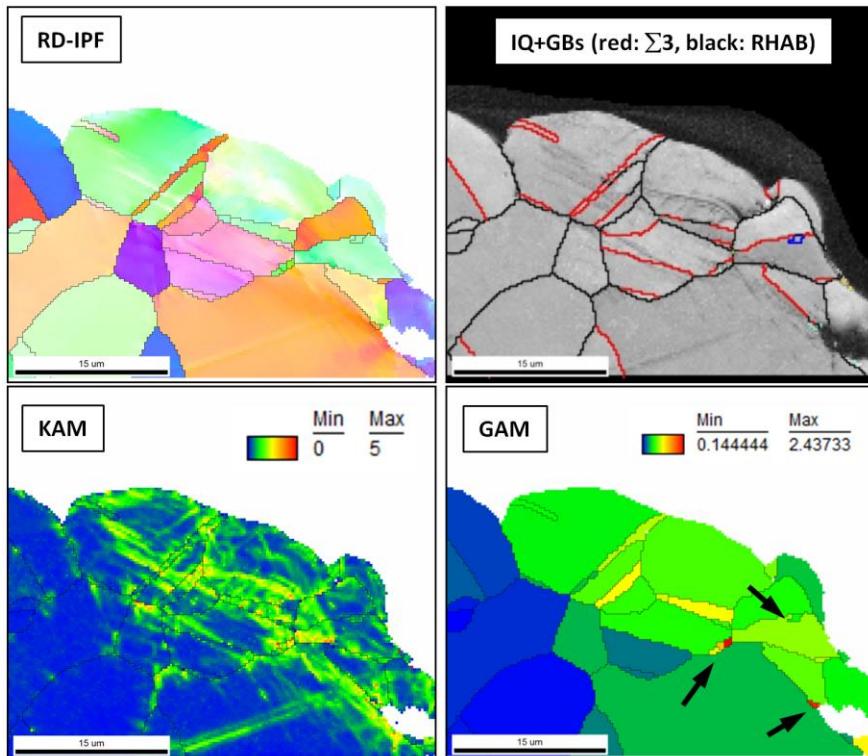
Figure 6 show the hot spot from Figure 5 in more detail providing GAM and KAM maps. One may see visible striations in KAM and GAM color codes images representing higher deformation values at this particular location, the depth of these features extending \sim 15–25 μ m. These features suggest the presence of pronounced slip lines or dislocation channels. Dislocation channels (slip bands), as a rule, are not expected to appear in the image quality (IQ) maps. However, for this particular location, Figure 6, some darker contrasting feature are visible in the IQ maps that correlate to the KAM and GROD maps. Grain boundary network map (overlaid on the IQ map of Figure 6) also demonstrated several small grains separated by low-angle boundaries. One may argue these subgrains formed during cracking.

Figure 6. EBSD data set for the highly-strained area (deformation “hot spot”). Black arrows point small grains, as believed, formed because of plastic deformation.

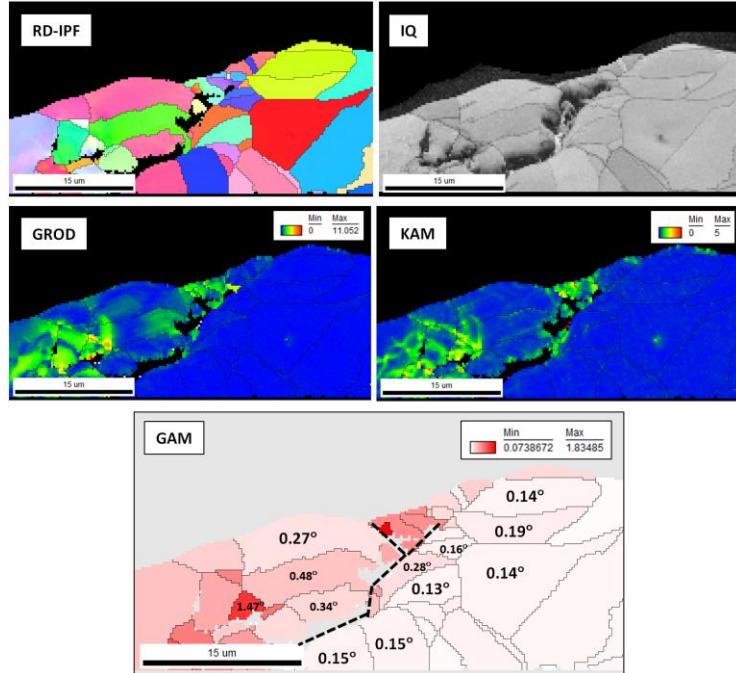
Figure 7 shows another unique region containing a small (\sim 20–25 μ m) secondary crack. Here, the IQ map shows some widening of the secondary crack away from the main crack; the lost of the crack edge material due to specimen preparation (electropolishing) may be estimated as \sim 2–3 μ m or less for each crack side. Additionally, one may see that electropolishing induced rounding of the crack edges making the analysis of the crack surface oxidation unobtainable.

By analogy with the above-discussed results, one may see strong inhomogeneity of plastic strain in GROD and KAM maps, Figure 7; many grains were strain free whereas others experienced pronounced plastic strain. Plastic strain quantification by the GAM parameter demonstrated that many grains are practically strain-free, with GAM $<$ 0.2°, which is close to the bulk value. These results suggest crack may propagate via the structure at stresses significantly lower than the material yield stress. In some cases, the crack tip movement through the structure did not induce plastic strain in many crack-adjacent grains.

Figure 7. EBSD dataset for the area with small secondary crack (dashed black line). Step size 125 nm. The map shows the GAM value for some crack-adjacent grains.

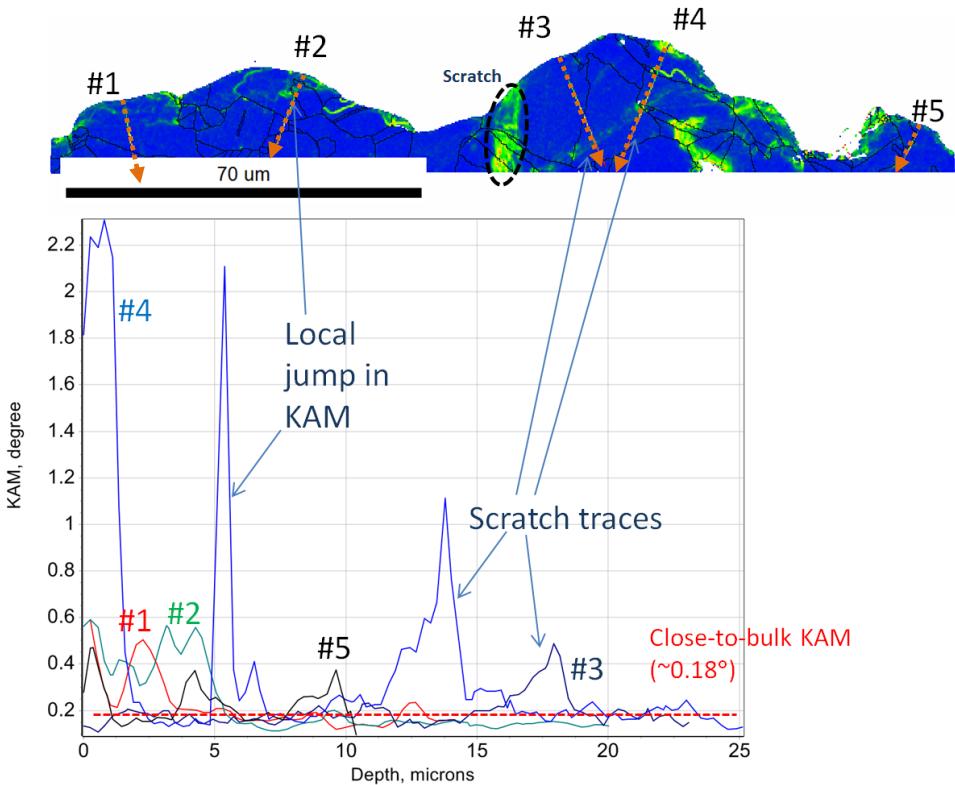
Profiles #1 and #2 intersect several strain-induced features at small depths ($<5\text{ }\mu\text{m}$), which look like low-angle ($<5^\circ$) in-grain boundary (LAB). LABs provide a small local increase in KAM (from $\sim0.15\text{--}0.18^\circ$, i.e., bulk level, to $\sim0.4\text{--}0.5^\circ$). Below $\sim5\text{ }\mu\text{m}$ the material appeared to be unstrained, and the KAM profile curves (#1 and #2) were close to the bulk values ($\sim0.18^\circ$). Interestingly, LABs often presented in the austenitic grains near the crack edge. These structure elements (LAB) might be seen as a sharp local increase in KAM, and often were also visible in the IQ maps. The LABs were much rarer in bulk, far from the crack edge.

Profiles #3 and #5 were taken in the grains without visible plastic strain. Indeed, regardless of the depth, the KAM value remained around bulk values ($\sim0.18^\circ$). It appears that material at these locations did not reveal plastic strains even in the crack vicinity. The local fluctuation in profile #3 at $10\text{--}15\text{ }\mu\text{m}$ of depth was caused by a scratch. Profile #4 had few maximums, related to both cracking and scratches. The first maximum, at the crack edge, was most likely induced by plastic strain. The second, at $\sim5\text{--}6\text{ }\mu\text{m}$ depth, corresponded to the LAB and the last one, at $\sim13\text{ }\mu\text{m}$ depth was caused by surface scratching. Thus, as follows from the KAM profiles, most plastic strain, if it appeared during crack propagation, was localized in the $\sim5\text{--}10\text{ }\mu\text{m}$ layers. The strain tended to be localized to some grains, whereas other grains near the crack edge remained un-deformed.

Figure 8. KAM profiles (#1–5) for the EBSD scan shown in Figure 4. The average width of 10 data points.

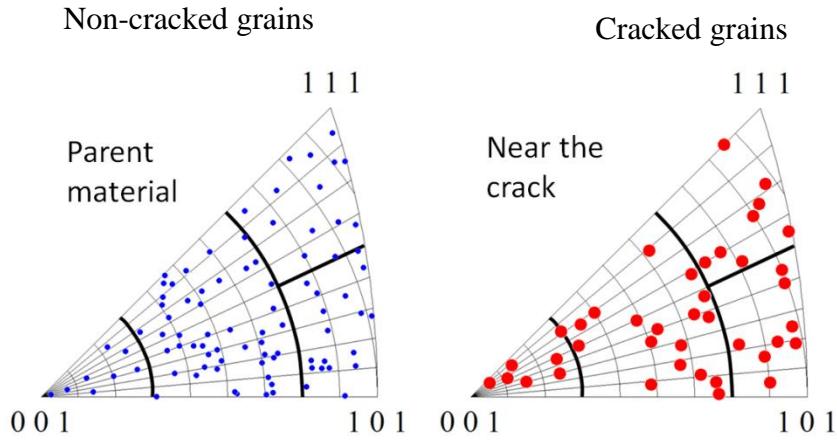
The complex character of strain localization required further analysis to explain the appearance of multiple strain-free grains. Grain orientation to the acting stress strongly influences the elastic and plastic behavior of the grain (Schmid and Taylor factors). If crack propagation depends on the stress field near the crack tip, and on the grain Schmid factor, grain population in the crack-adjacent area may be different than that of the bulk. Figure 9 shows this comparison between the crack-adjacent grains and that of the bulk material. The number of data points was limited (only two scans were included in the figure) to keep the image readable. As follows from the plot, there is no pronounced difference between cracked and non-cracked grain populations. At least, this difference was weak and did not lead to the pronounced depopulation of any unit triangle area.

Figure 9. The orientation of crack-adjacent grains compared to randomly selected grains in bulk. The IPFs are plotted with respect to the acting stress during the crack growth test.

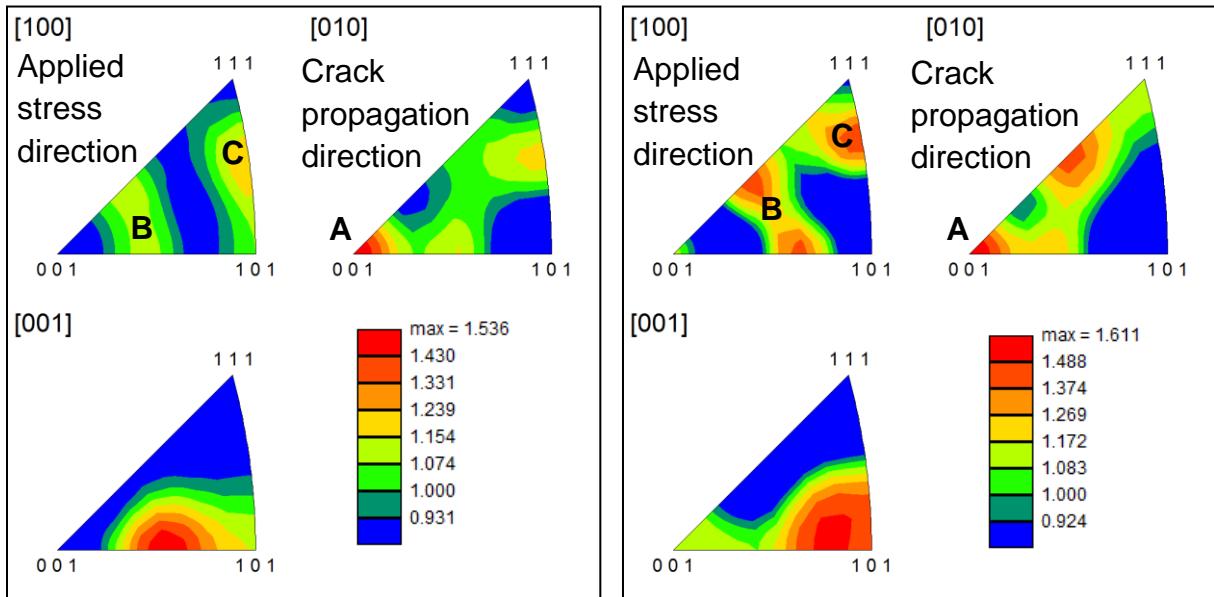
To analyze the grain orientation role in more detail, a series of EBSD scans (>250 crack-adjacent grains) were merged, and the orientation of the crack-adjacent grains was compared to the summary data for the grains farther from the crack (Figure 10). As shown in the texture plots, the general texturing in the bulk material, far from crack, was weak enough, only $\sim1.53 \times$ random. The most pronounced texturing component was an increased fraction of [001]-oriented grains in the crack propagation direction (A-group), [010] in Figure 10. Two other specific areas (B, C) were just slightly above the average (~1.1 and $\sim1.2 \times$ random, respectively).

Comparing the grain orientation patterns in bulk and near the crack, one may see that crack-adjacent grain orientations are, in general, close to the non-cracked ones. Grains with [001]-orientation with respect to the crack propagation direction (group marked as “A” in Figure 10) have a texture index of $\sim1.5 \times$ random in bulk and $\sim1.6 \times$ random near the crack. Two other specific areas (B and C) have similar texture indexes (B: $\sim1.1 \times$ random in bulk and $\sim1.5 \times$ random after cracking; C: $\sim1.2 \times$ random in bulk and $\sim1.6 \times$ random after cracking). Some weak secondary effects may be present; however, they appear to be insignificant.

Figure 10. The texture in the bulk non-cracked material (left) and summary texture plot for the crack adjacent grains. The summary plot for 8 scans (same step size and imaging conditions).
