Developing Technologies for Composite Overwrapped Pressure Vessels (COPV)

Comparing Traditional Inspections to Advanced 3-D Rendering Techniques

John Miers, PhD.

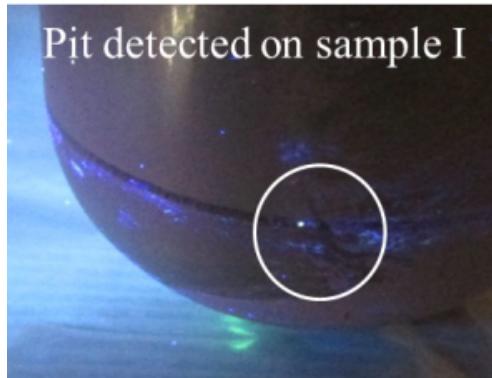
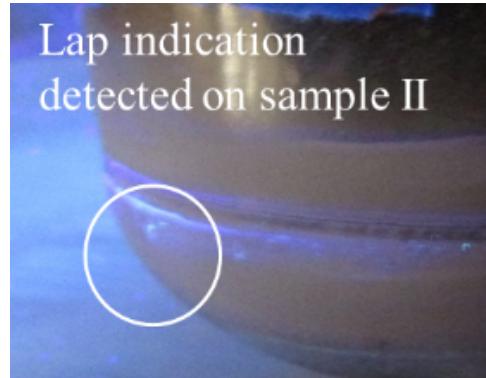
- Samples 01 and 02 showed signs of defects at the weld lines as shown below

Part No.	Indications	Notes
I	Yes, pit	A pit was detected on the weld surface during the penetrant inspection.
II	Yes, lap	Small lap was detected during the penetrant inspection.

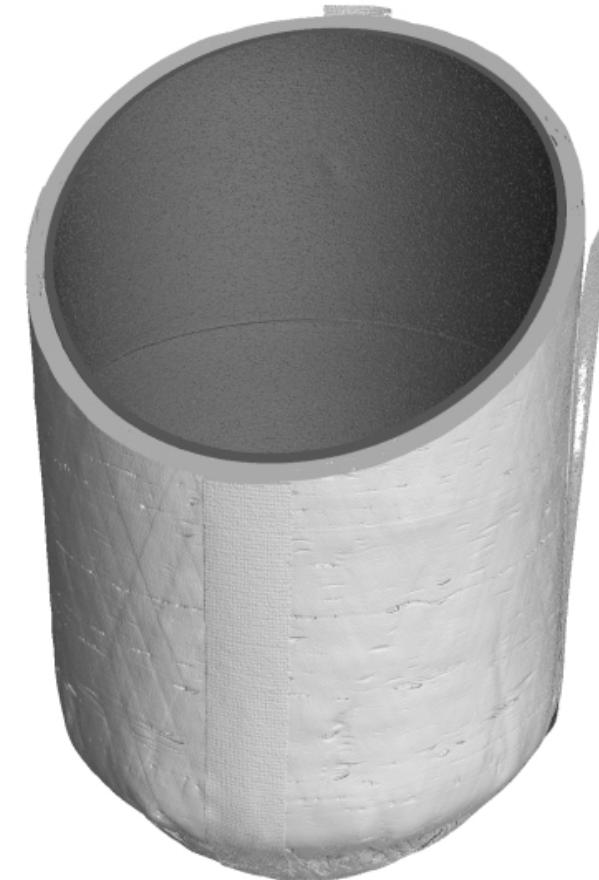
- No major defects
- Minor splatter in waist weld
- Minor misalignment in regions of waist weld

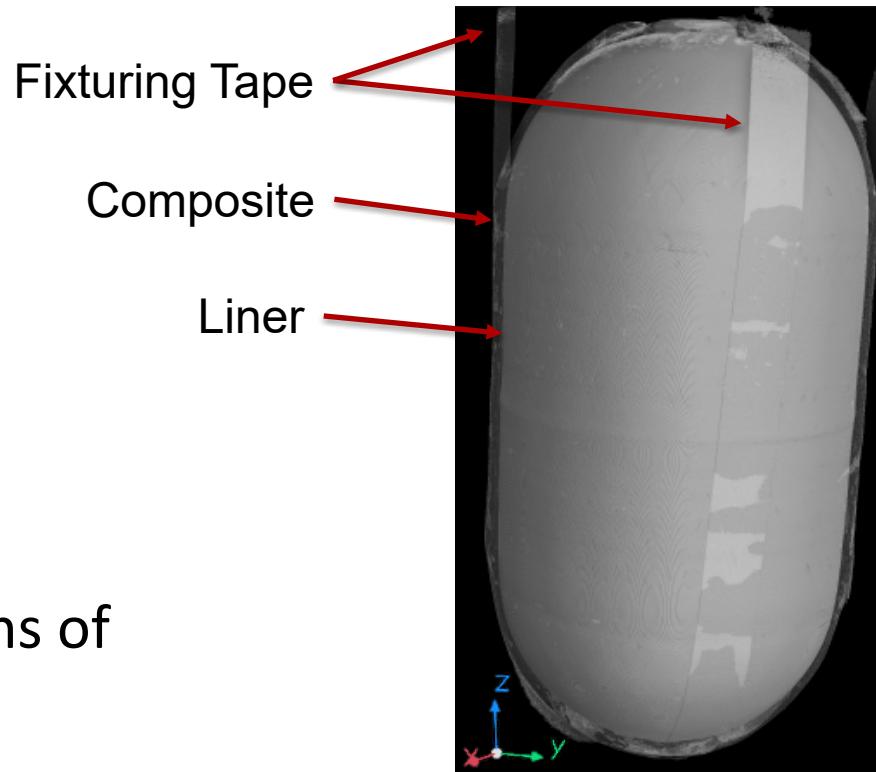
- Porosity/voids
- Well bonded to liner
- Quality decreases at transition from cylindrical to spherical surfaces of the liner

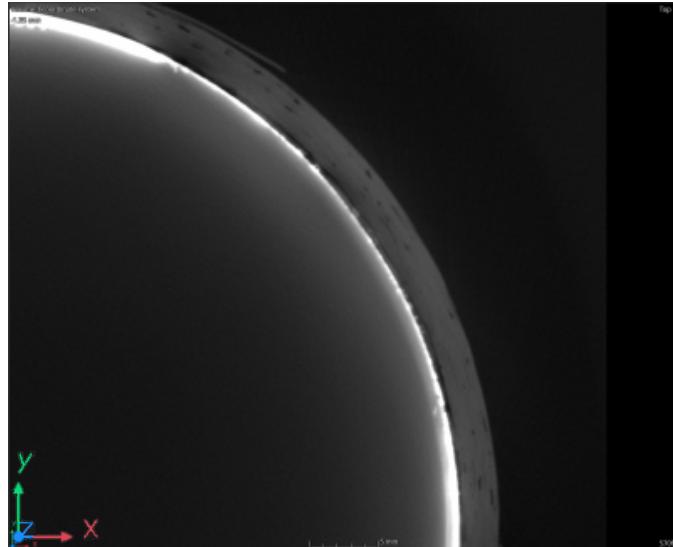
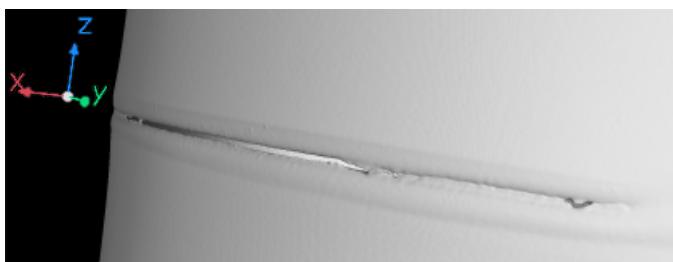
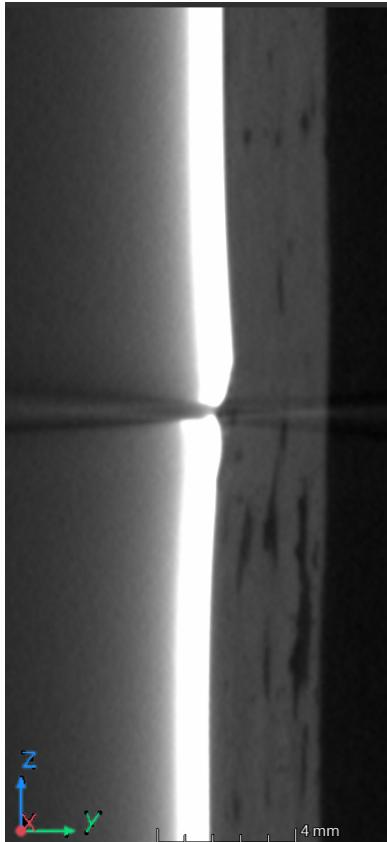
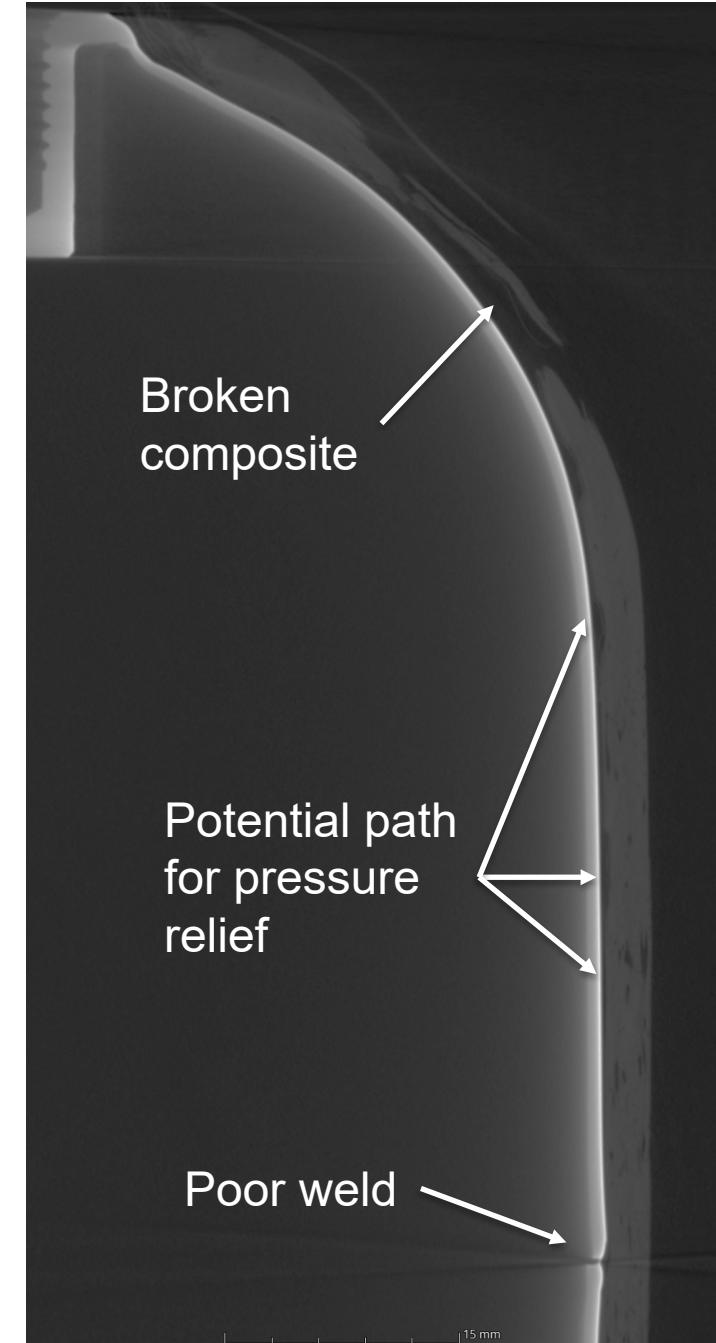
COPV-05

- Low pressure failure is due to break/gap in the waist weld
- Propagation of pressurized fluid along the poor bond between the liner and composite

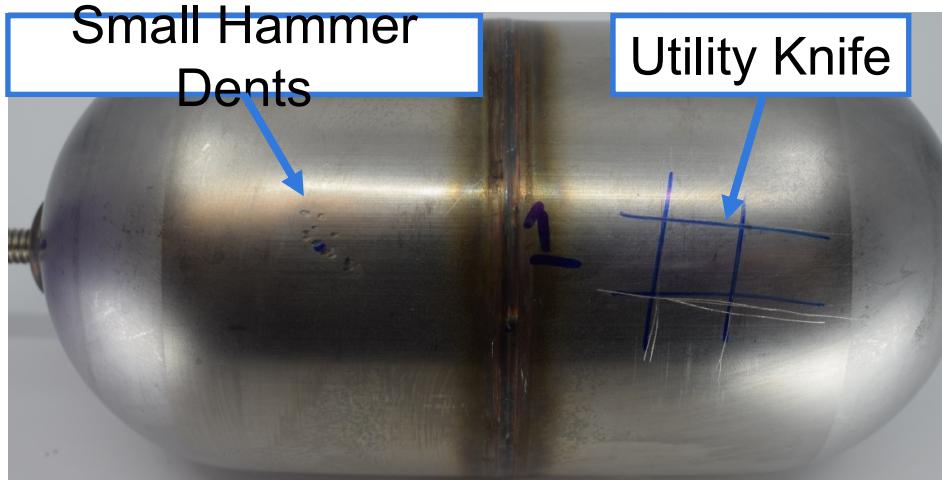
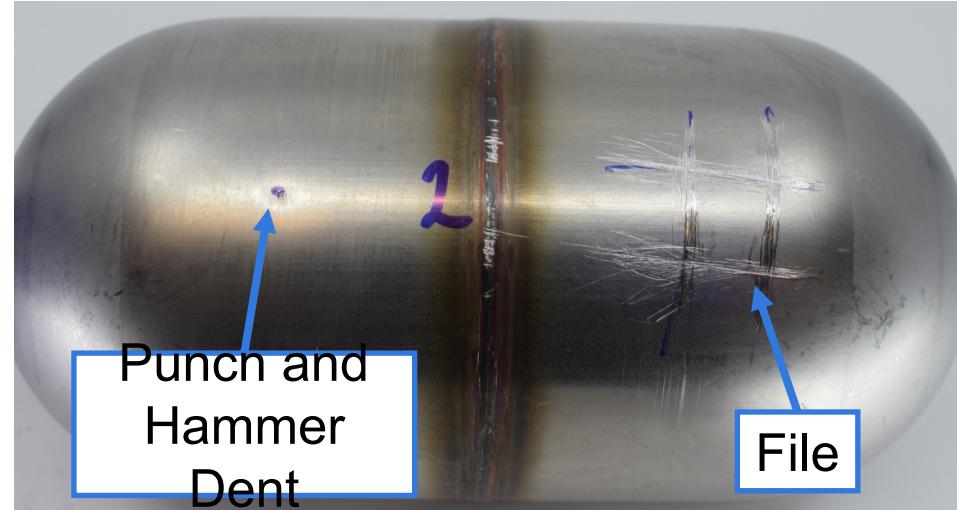
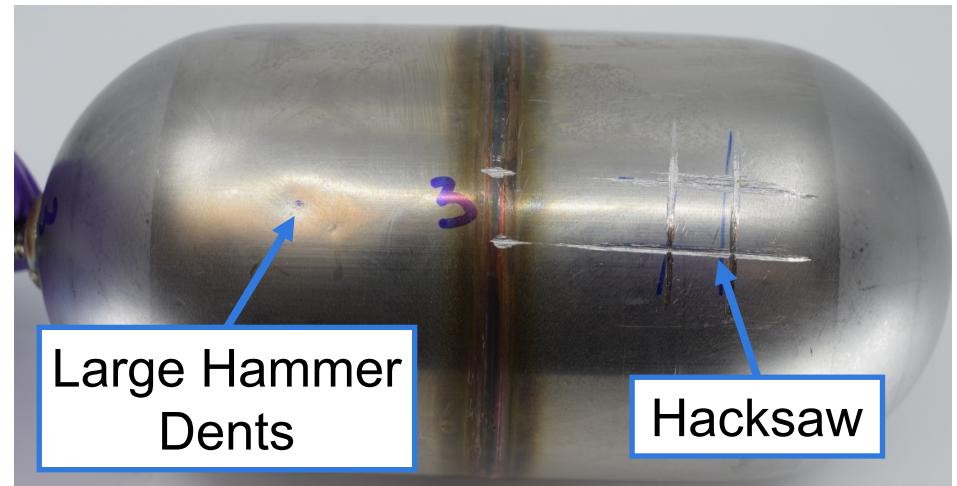
- Introduced intentional defects in metal liner
 - Linear defects with utility knife, file, and hacksaw
 - Point defects with hammer and punch
 - Determine if NDE can detect

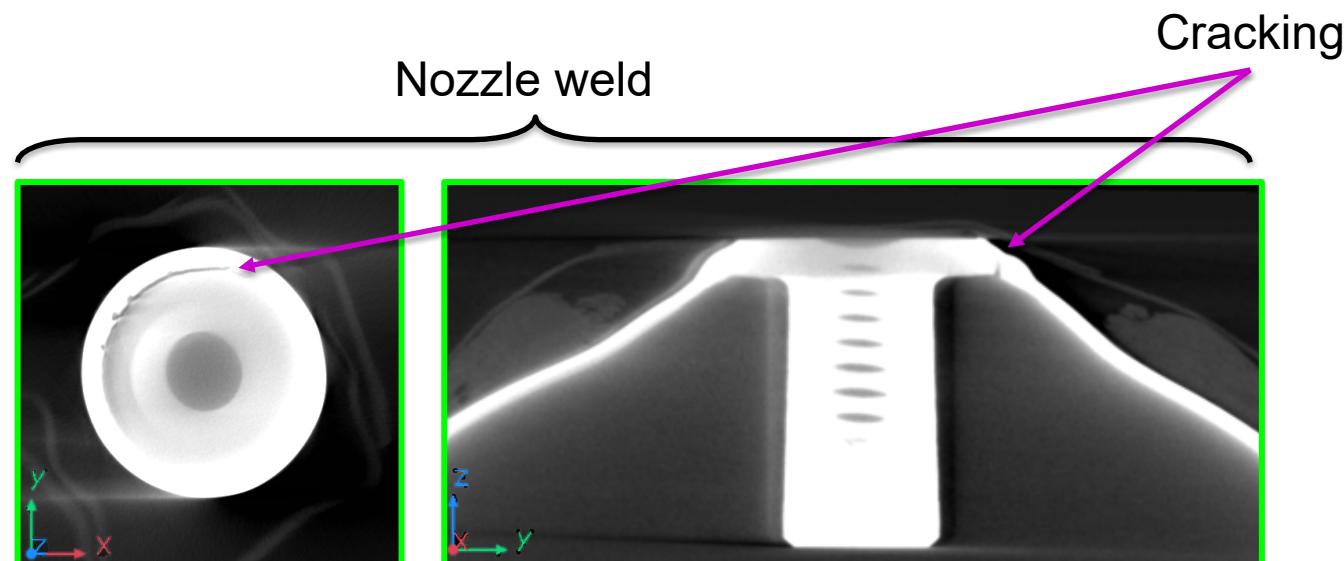
- Detection of non-intentional defects
 - Waist weld quality
 - Cracking in nozzle weld
 - Culprit for leaking in burst test

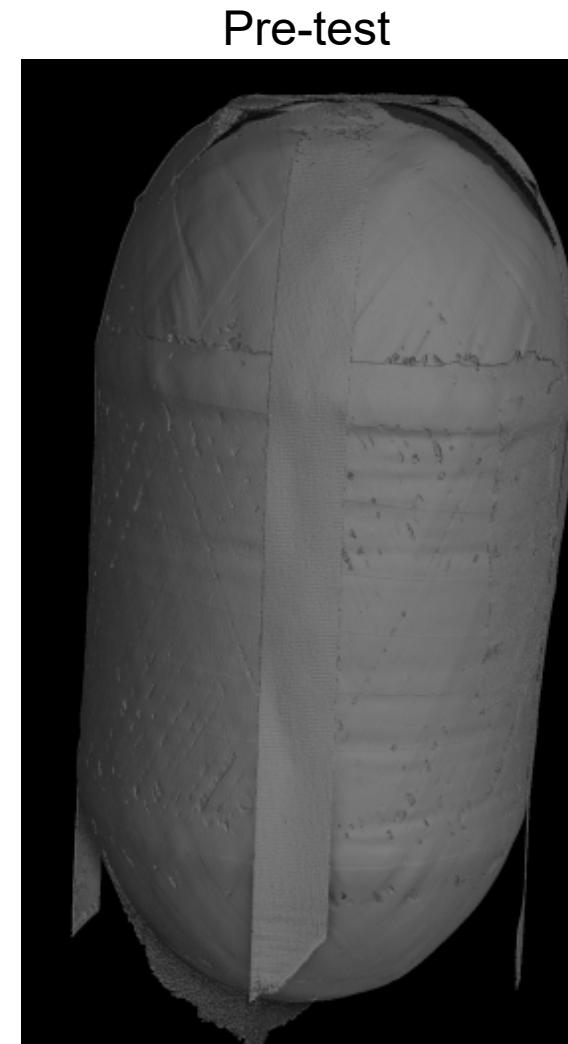
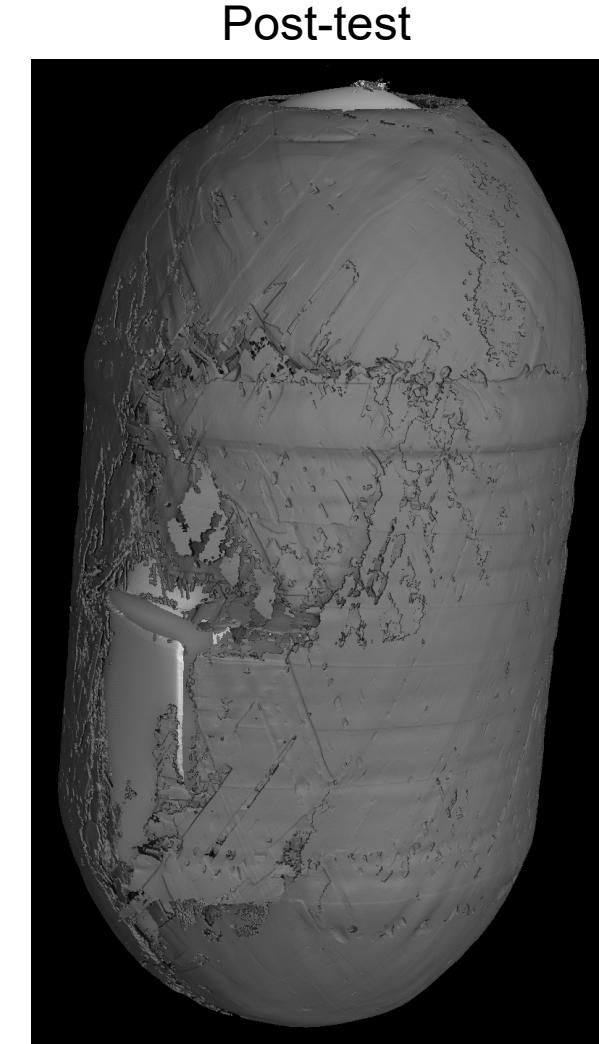
Results: COPV-4

- Pre and post pressurization XCT scans were performed
- Massive failure along weld line
- Inspection of pre-test scan for cause of failure.
- Register between scans based on natural geometric features in the composite

- The weld does not fail in the region where the weld was rough (high variation in weld depth along the circumference) but instead failed in a region where the 2 liners were slightly offset
- The weld appears slightly thinner than average in the region where failure occurred
- The non-ruptured regions of the weld in the post-test scan show signs of the weld being stretched along the length of the sample and thinning
- This gives some indication of the type of failure mechanism
 - Ductile thinning of weld >> failure

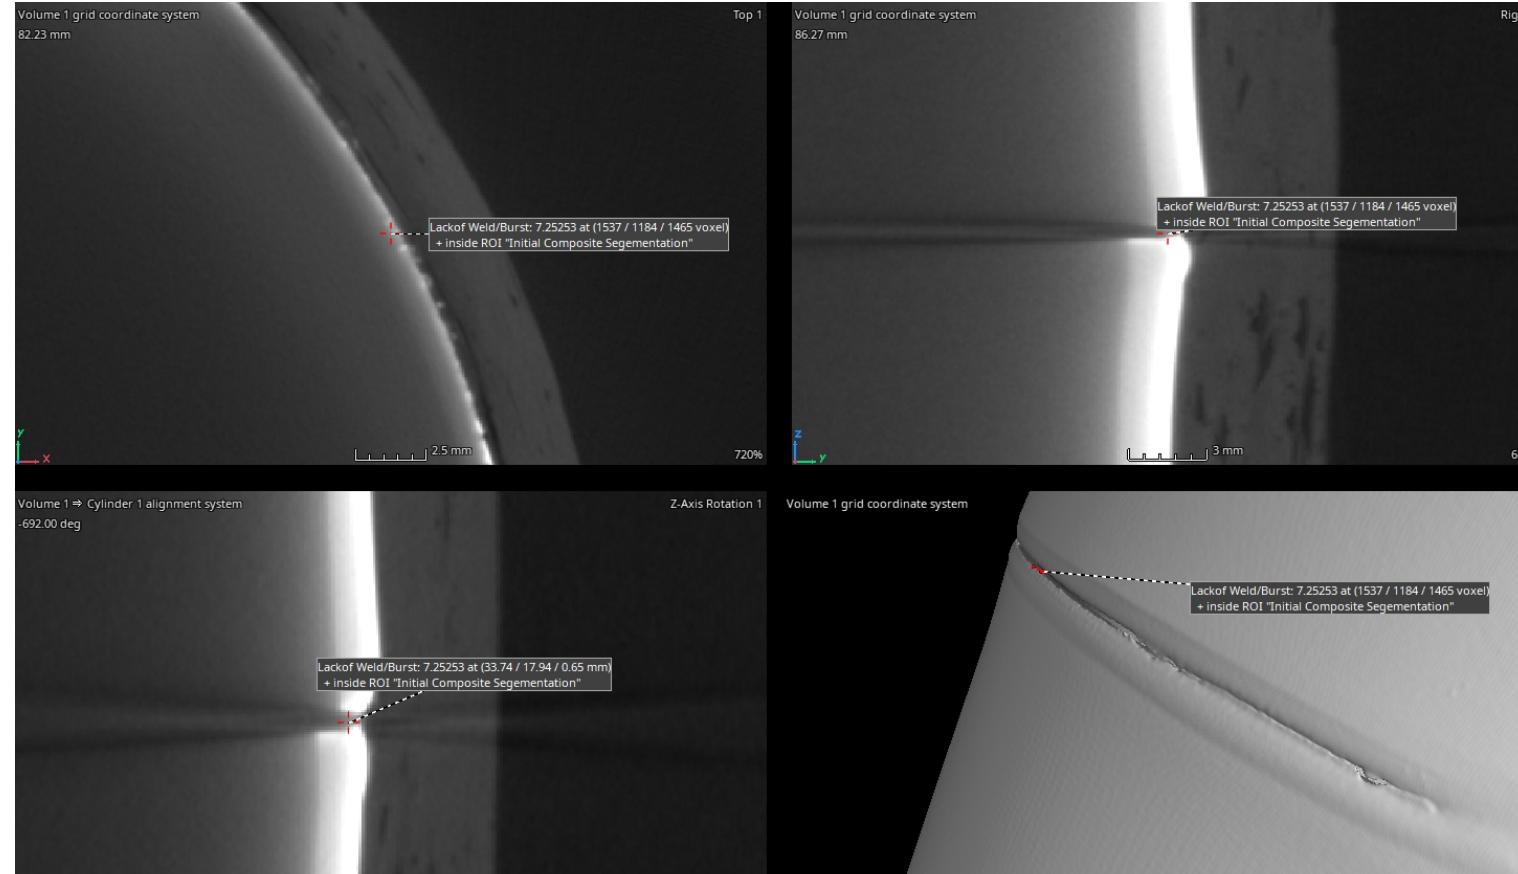
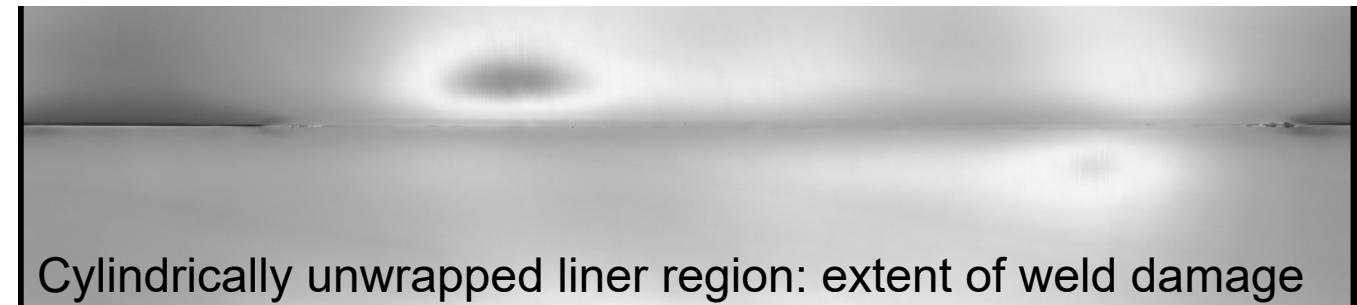
Results: COPV-5

- Low pressure failure of COPV-5 is due to break in the liner weld over significant portion of circumference
 - Curvature of the liner near the weld line suggests post test blow out

- COPV-5's early (low pressure) failure is a direct result of the poor weld quality
 - Pressurized water appears to have travelled along the liner of the COPV under the composite to fail at one of the poor composite quality sections at the geometric transition
- Ability of the pressurized material to seek out weak points in the composite is a function of composite bonding to the liner
- Slow leak in COPV-6 was likely due to hole in the weld line

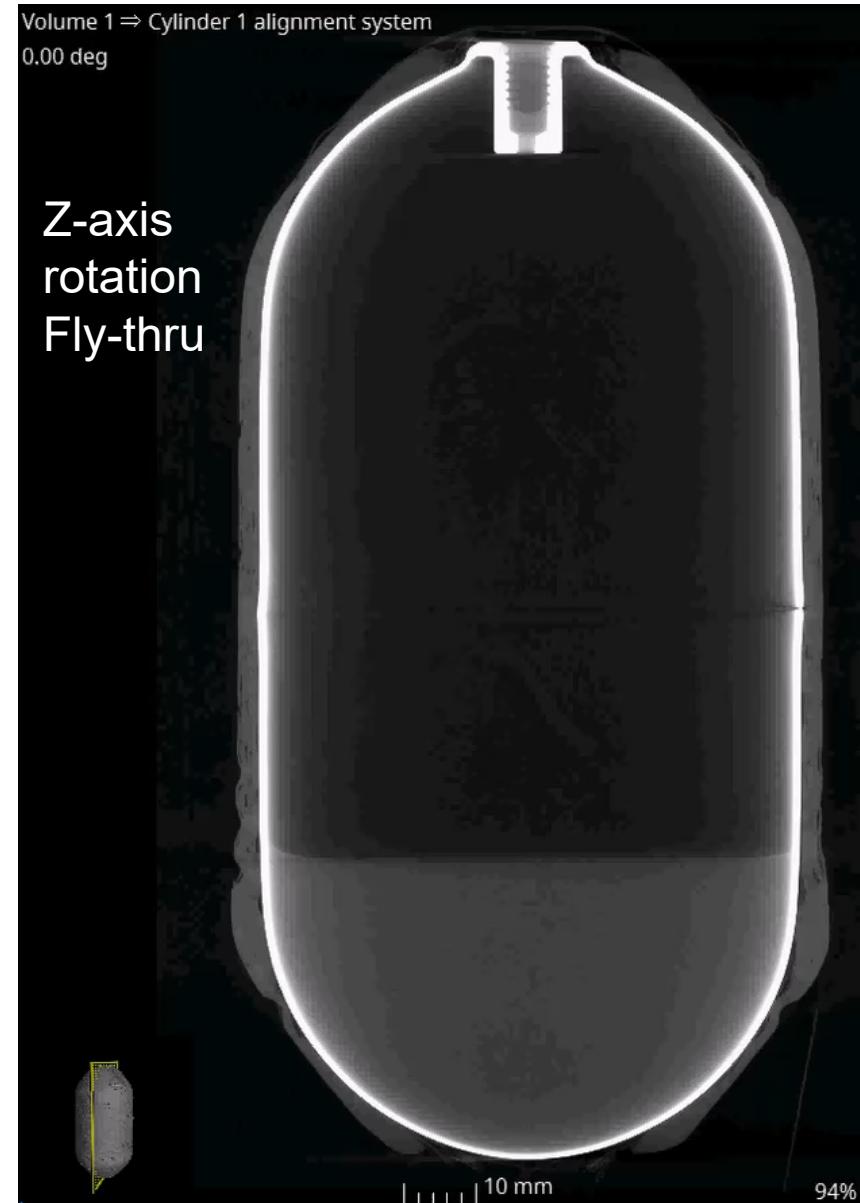
Results: COPV-5

- Minor liner misalignment
- Porosity in composite wrap
 - Poorest quality near transition between cylindrical and spherical regions

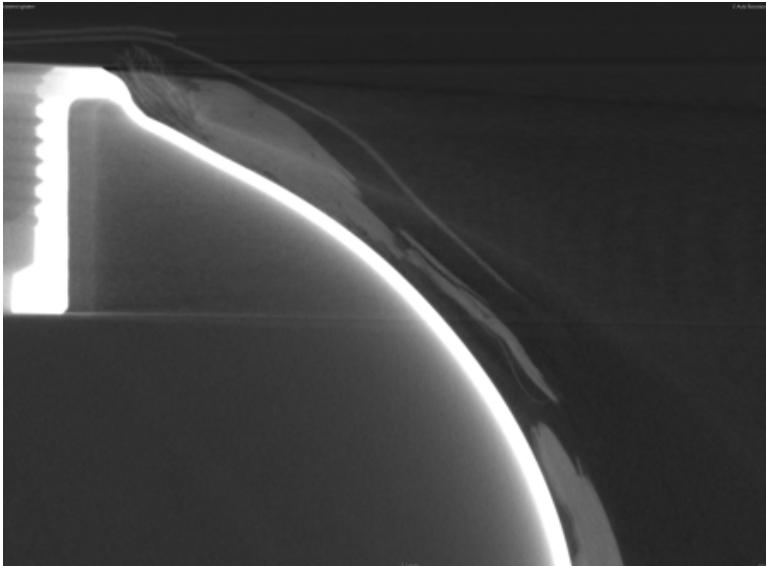
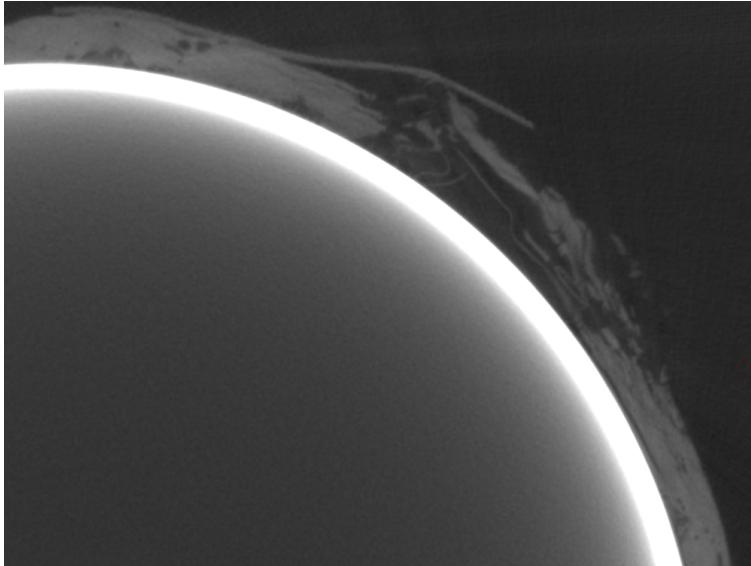
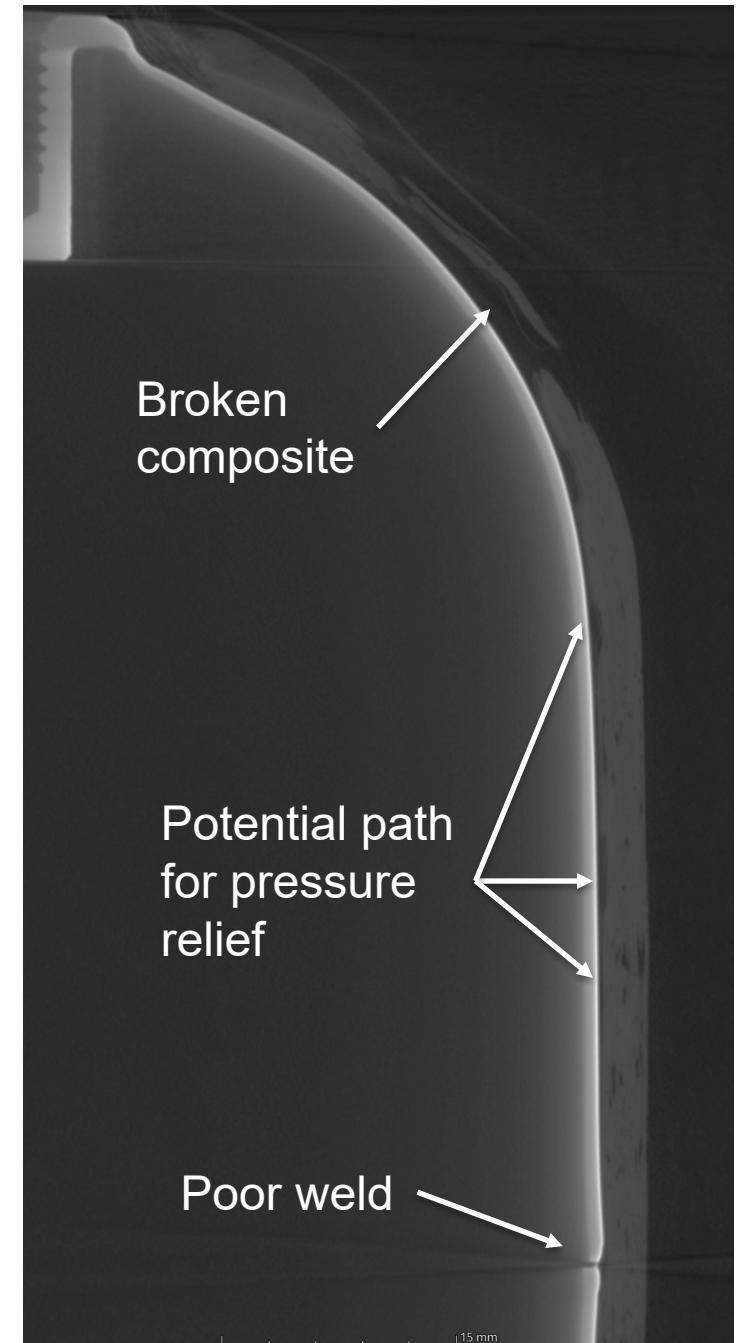
Results: COPV-5

- Broken composite near inlet end
 - No signs of liner damage in region
 - Unclear if pressure traveled “up-skin” under the composite layer from the poor weld region or if separate damage to composite
 - Could be result of poor composite bonding to liner

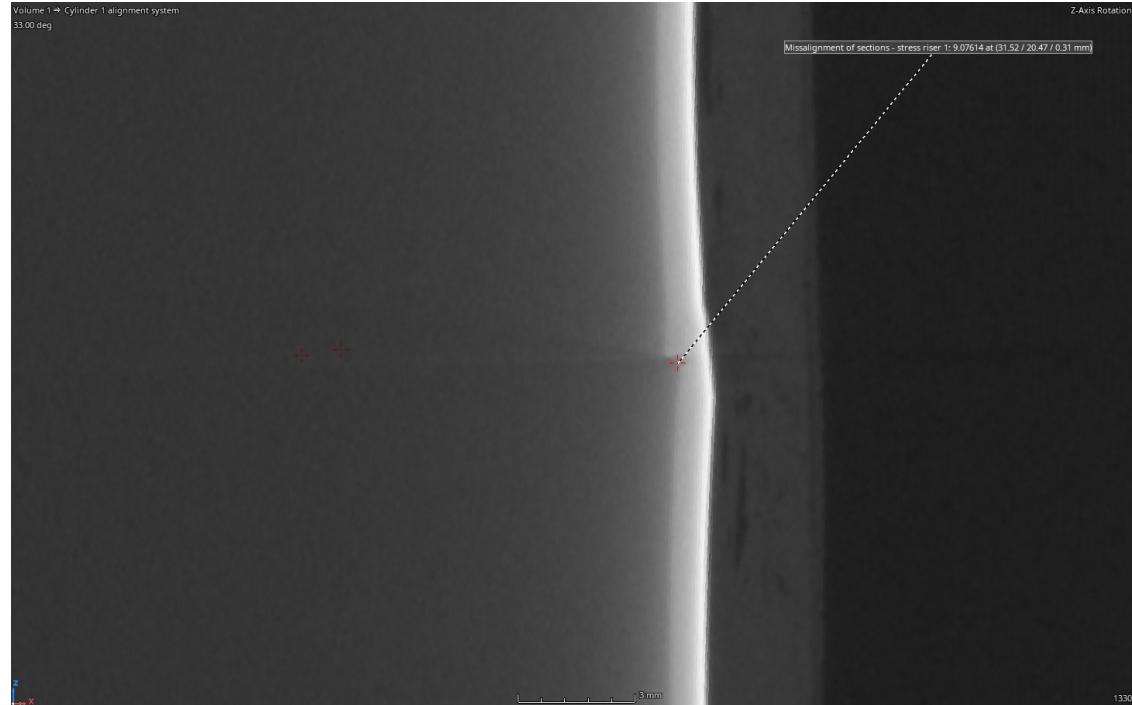
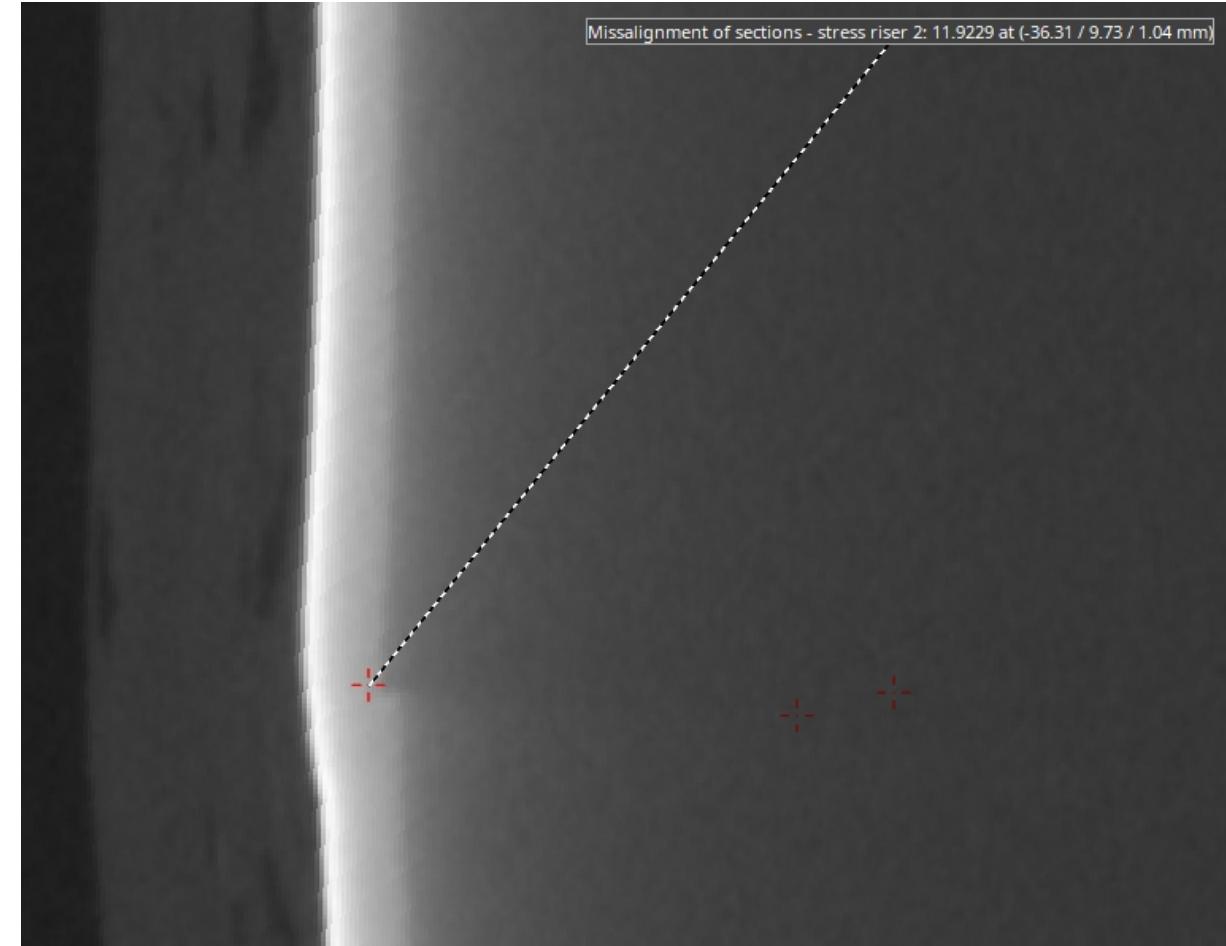
Results: COPV-6

- Some liner misalignment
- Difficult to align due to no access to internal geometry

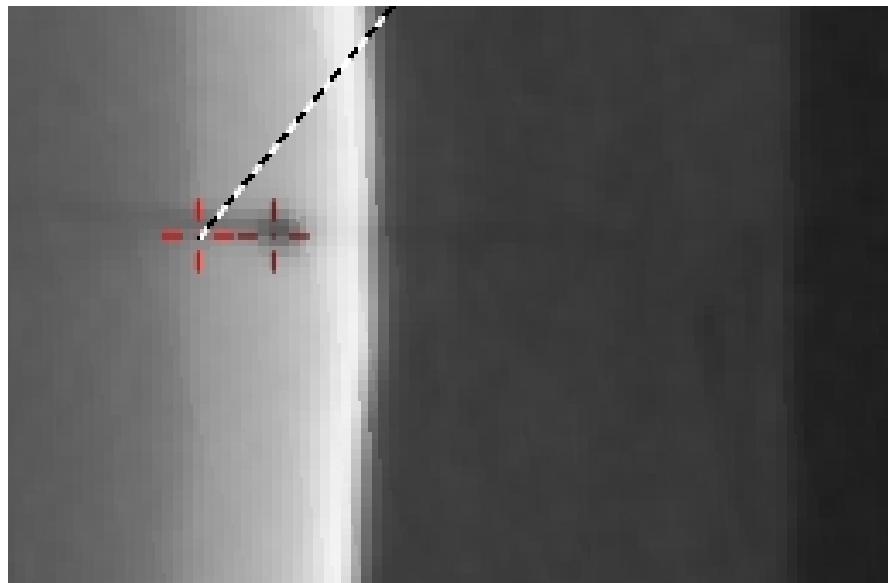
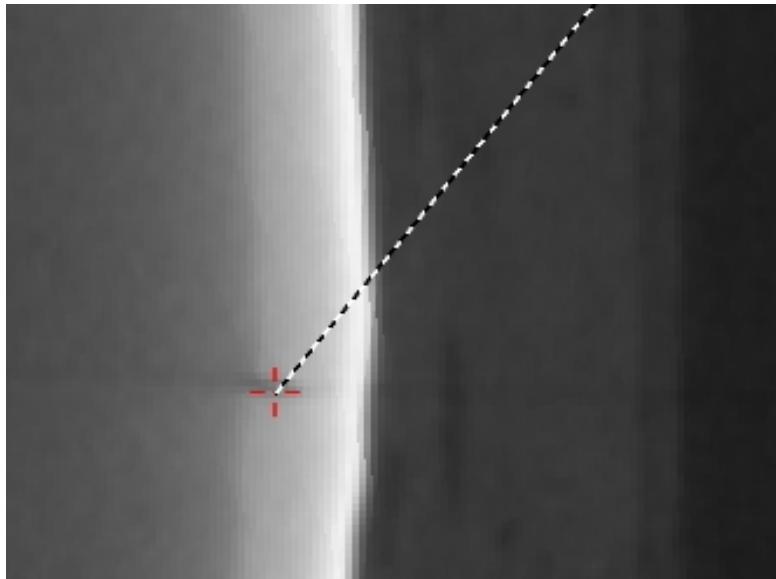
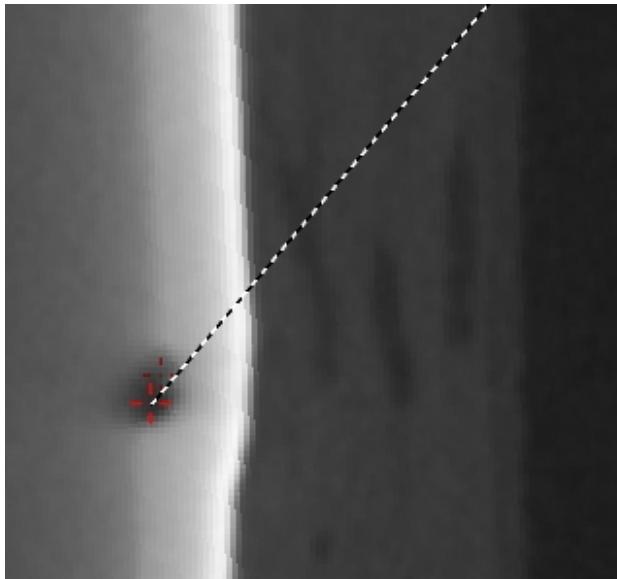
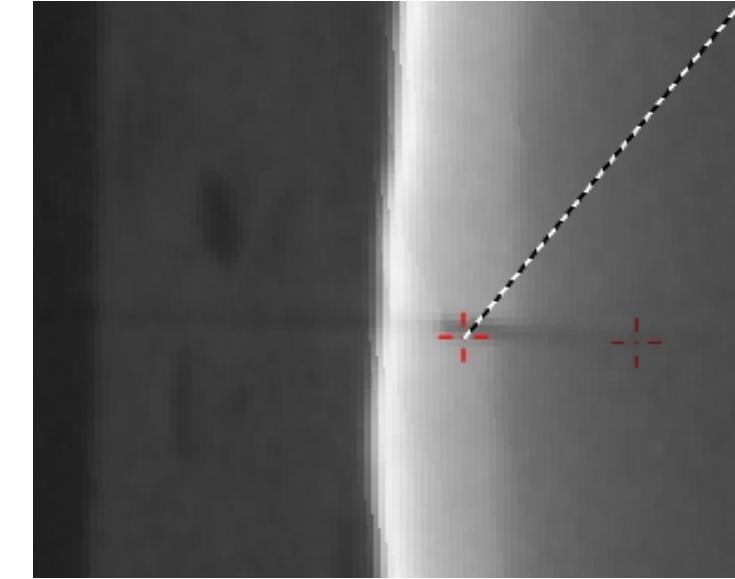
Results: COPV-6

- Poor weld penetration depth
- Possibly culprit of leaking during testing

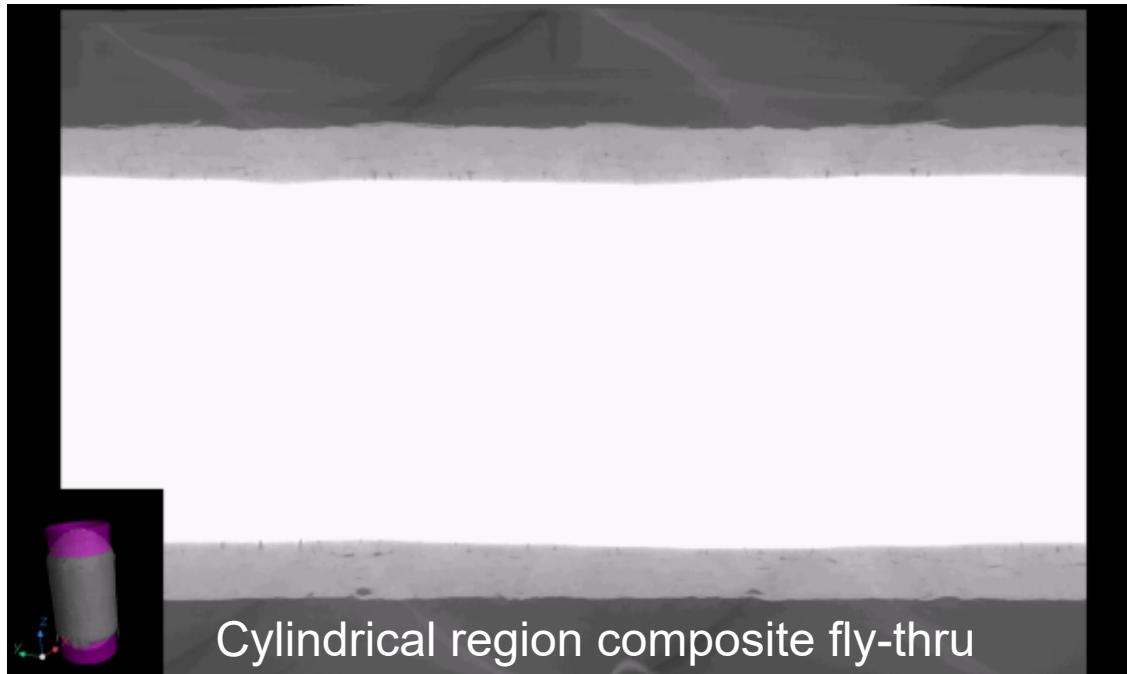
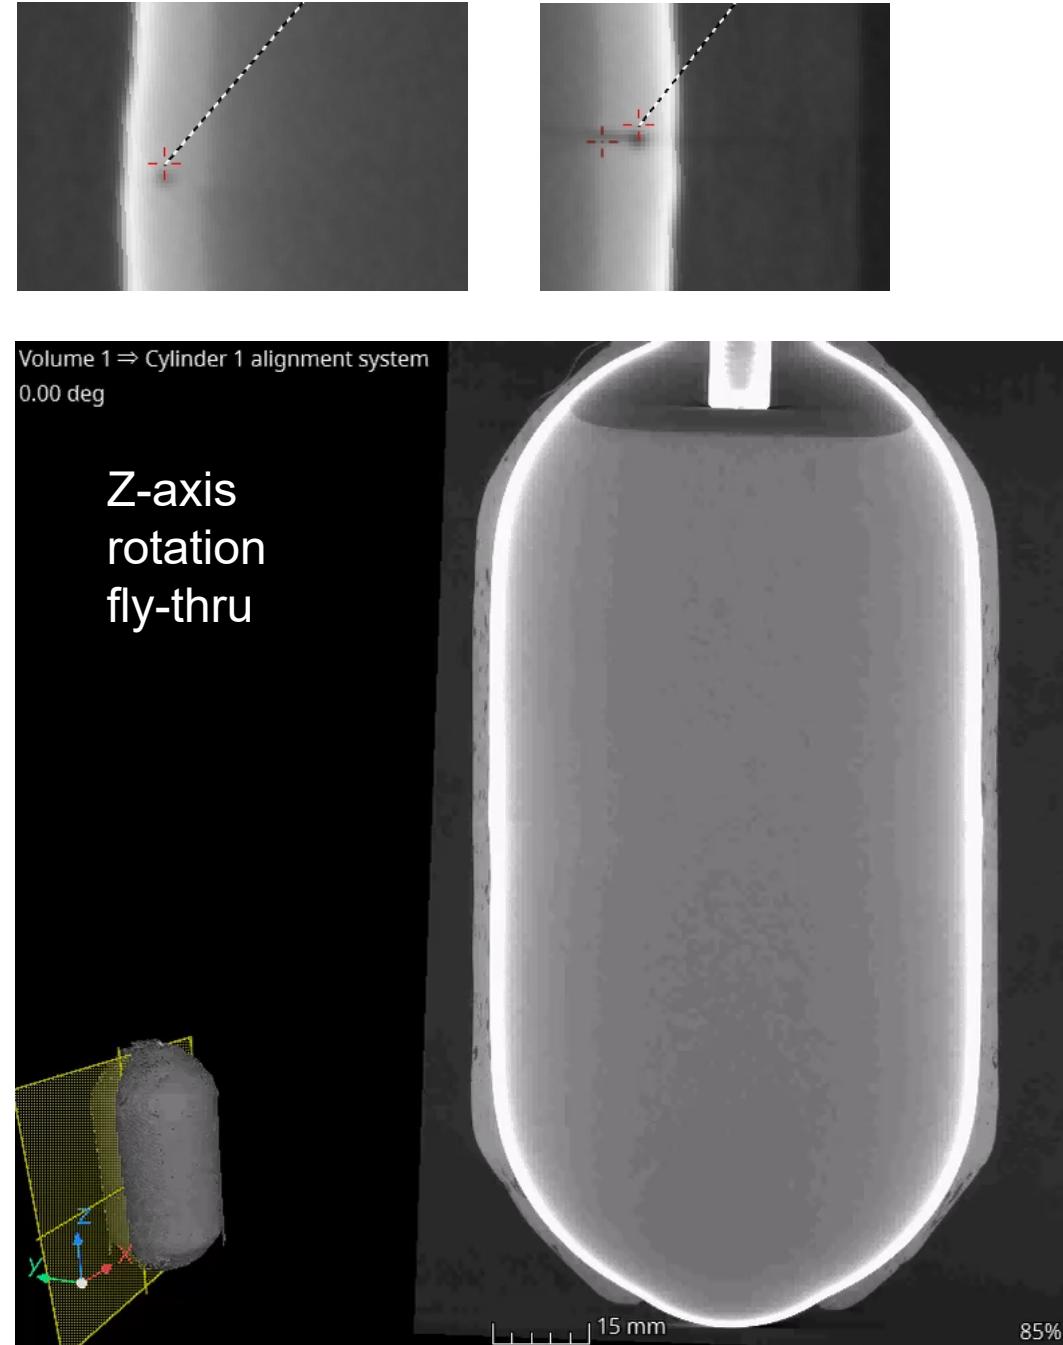
Results: COPV-6

- Some embedded porosity in the weld seam of the liner
- Composite quality poorest near transition from cylinder to sphere
 - Fly-thru videos

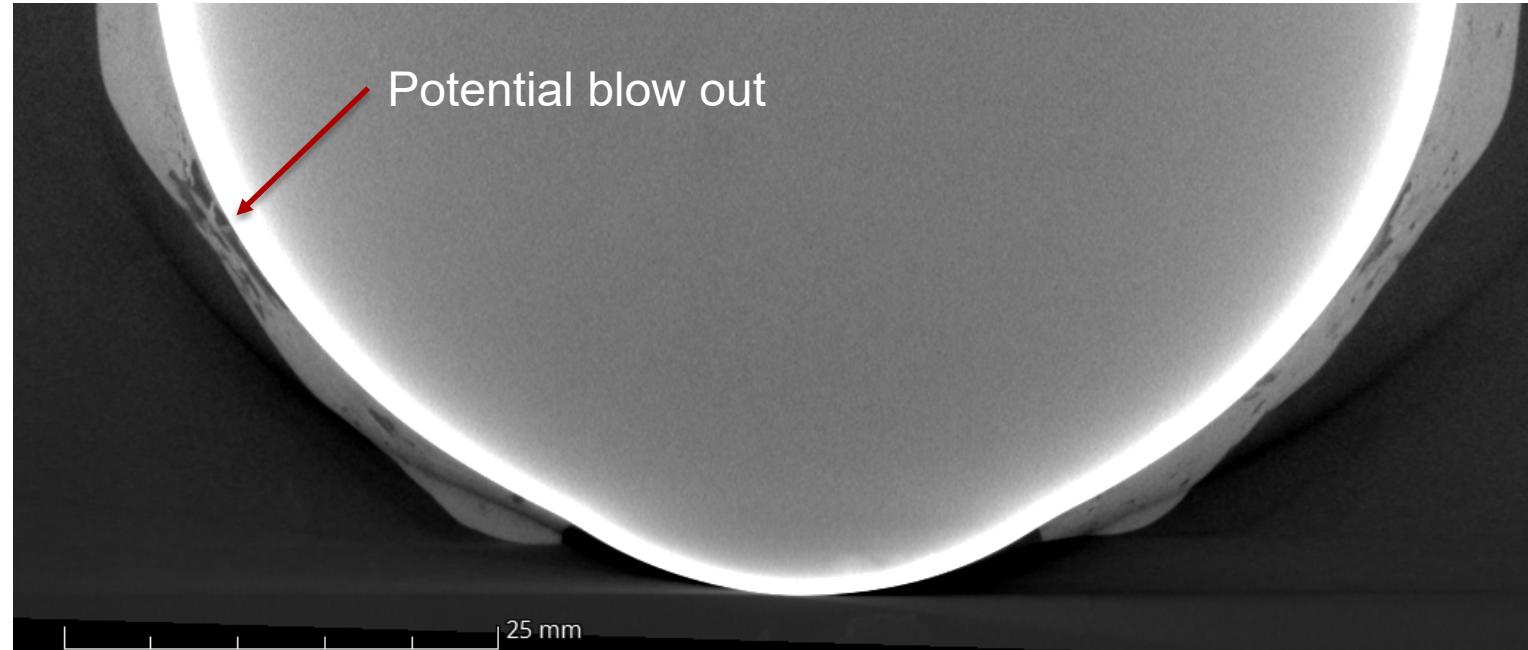
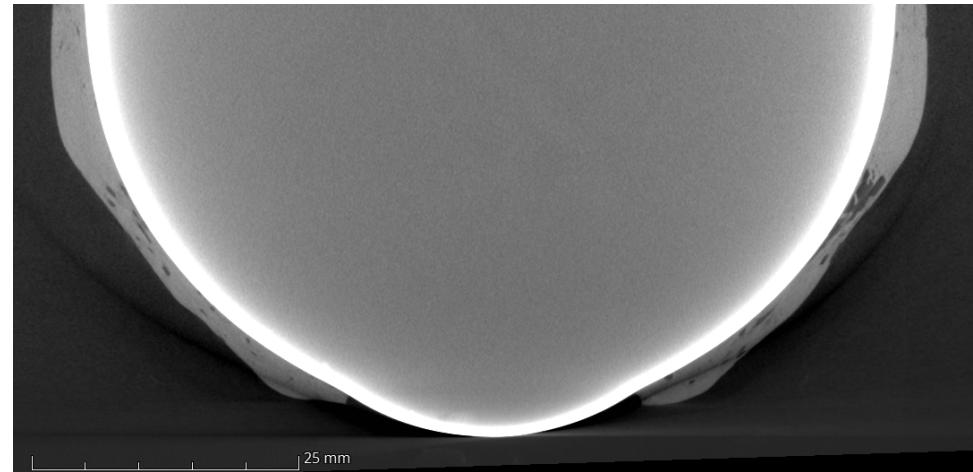
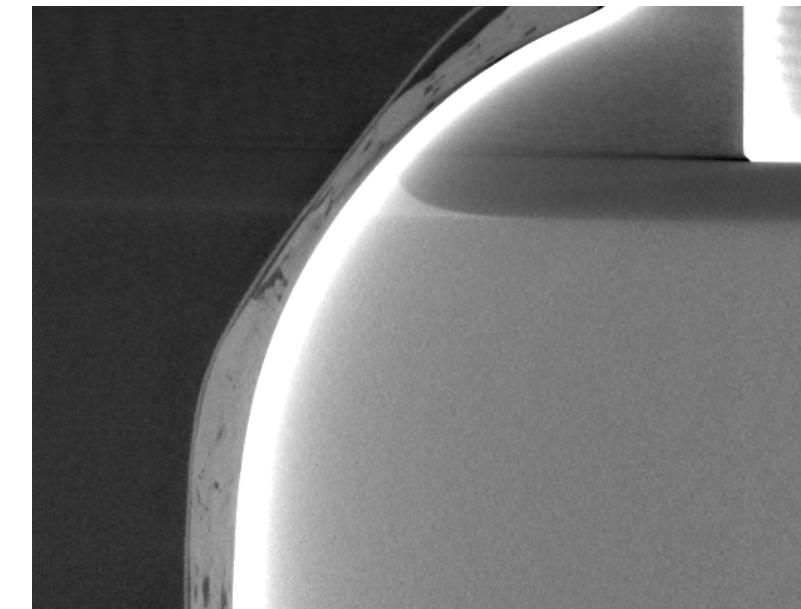
Results: COPV-6

- Composite overwrap quality degrades significantly around the transition from cylinder to sphere
 - Creates weak points for bursting if composite is not well bonded to liner
 - Potential blow out of composite

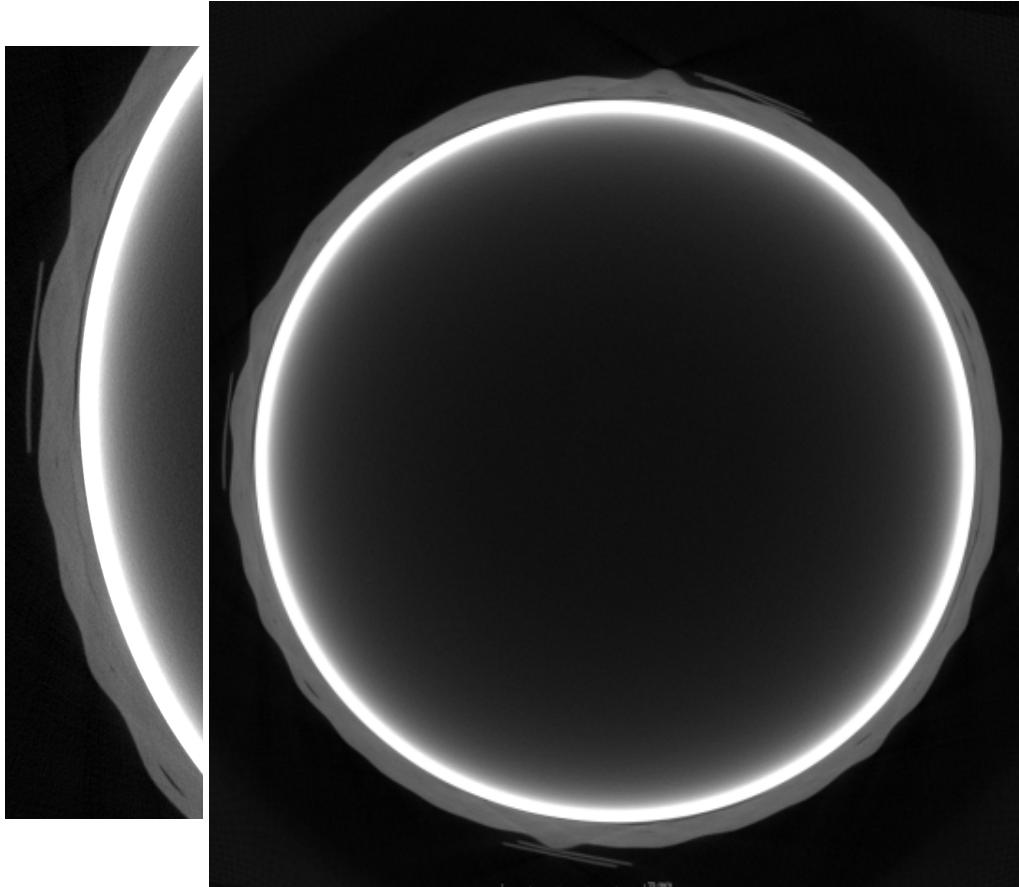
- Pre-UT frequent thin cracks in composite region

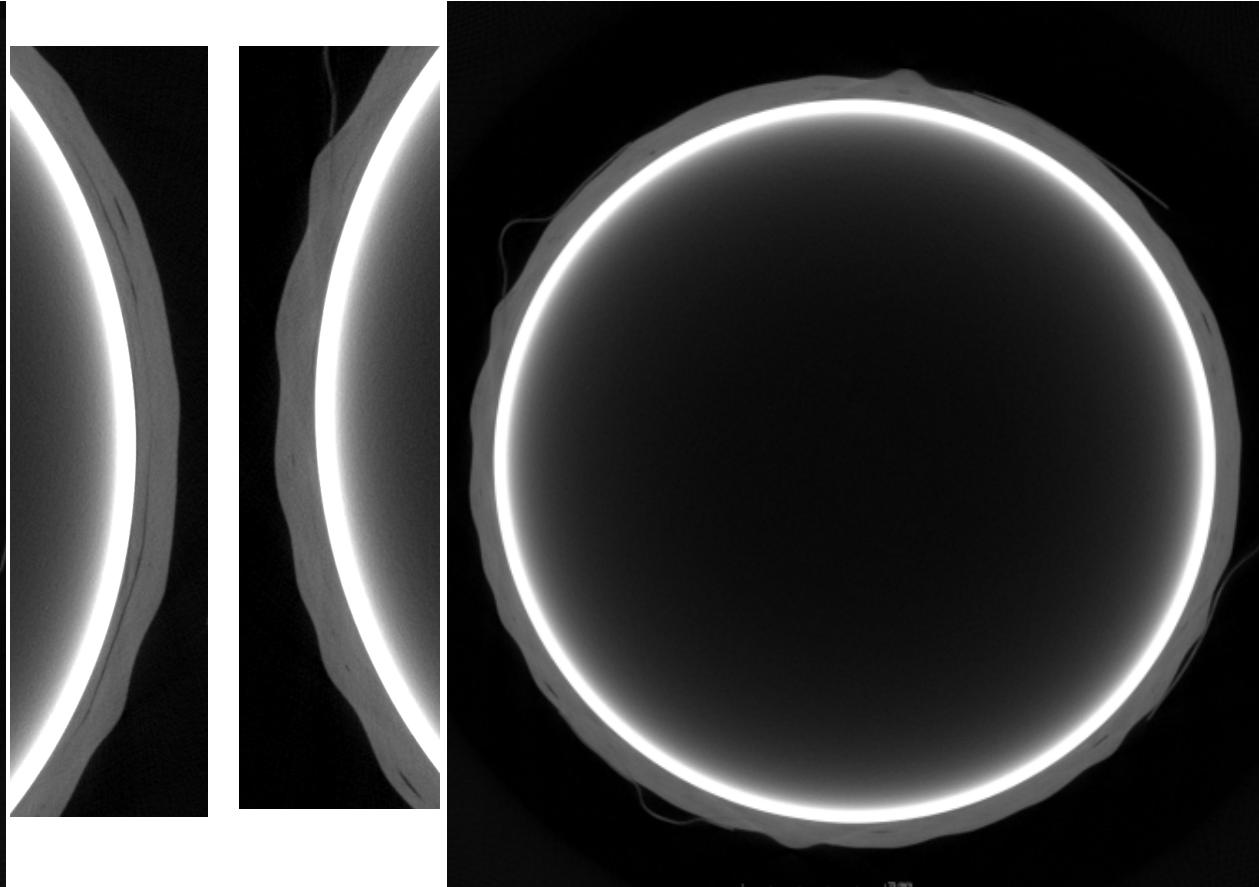
- Post-UT apparent closing of thin cracks
