Developing Technologies for Composite Overwrapped Pressure Vessels (COPV)

Comparing Traditional Inspections to Advanced 3-D Rendering Techniques

John Miers, PhD.

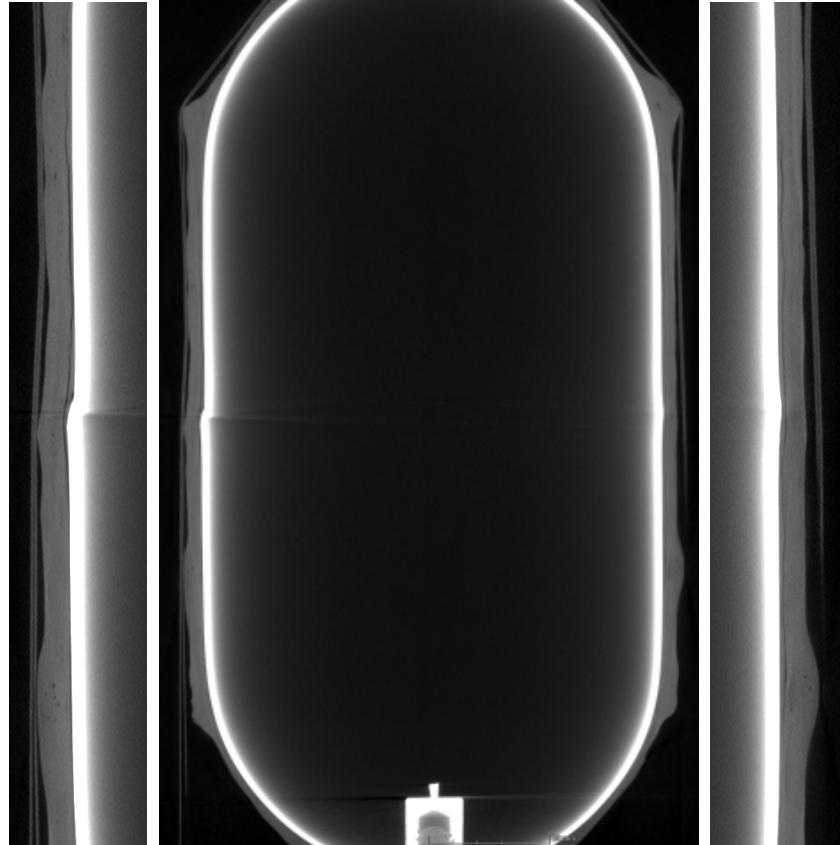
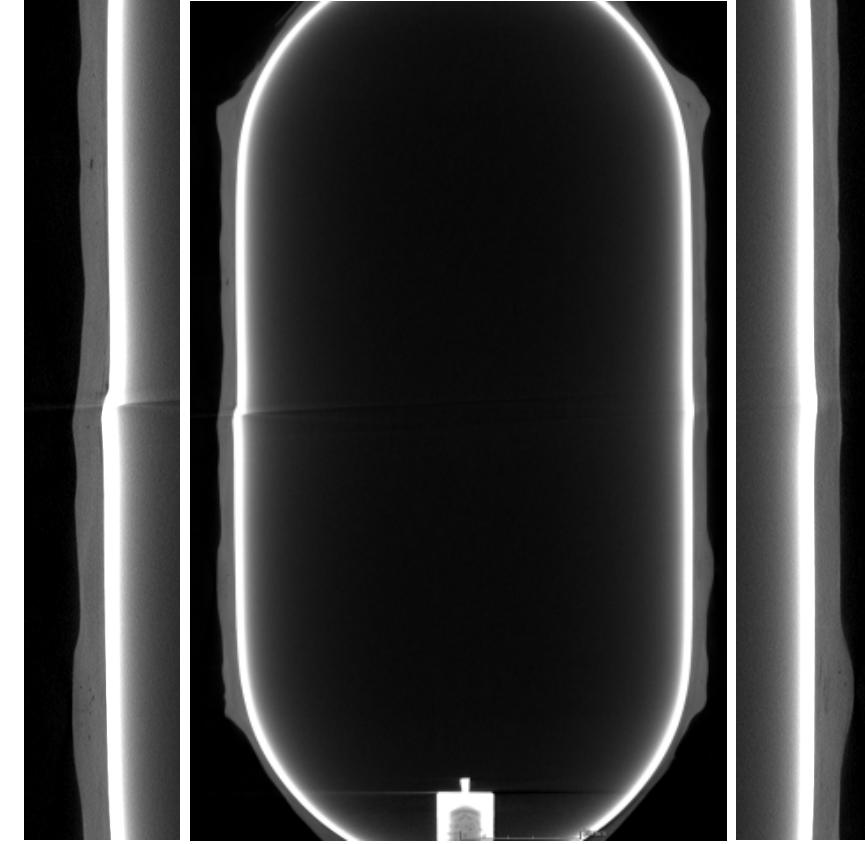
Results: COPV-7

- Pre-UT frequent thin cracks in composite region
- Post-UT apparent closing of thin cracks

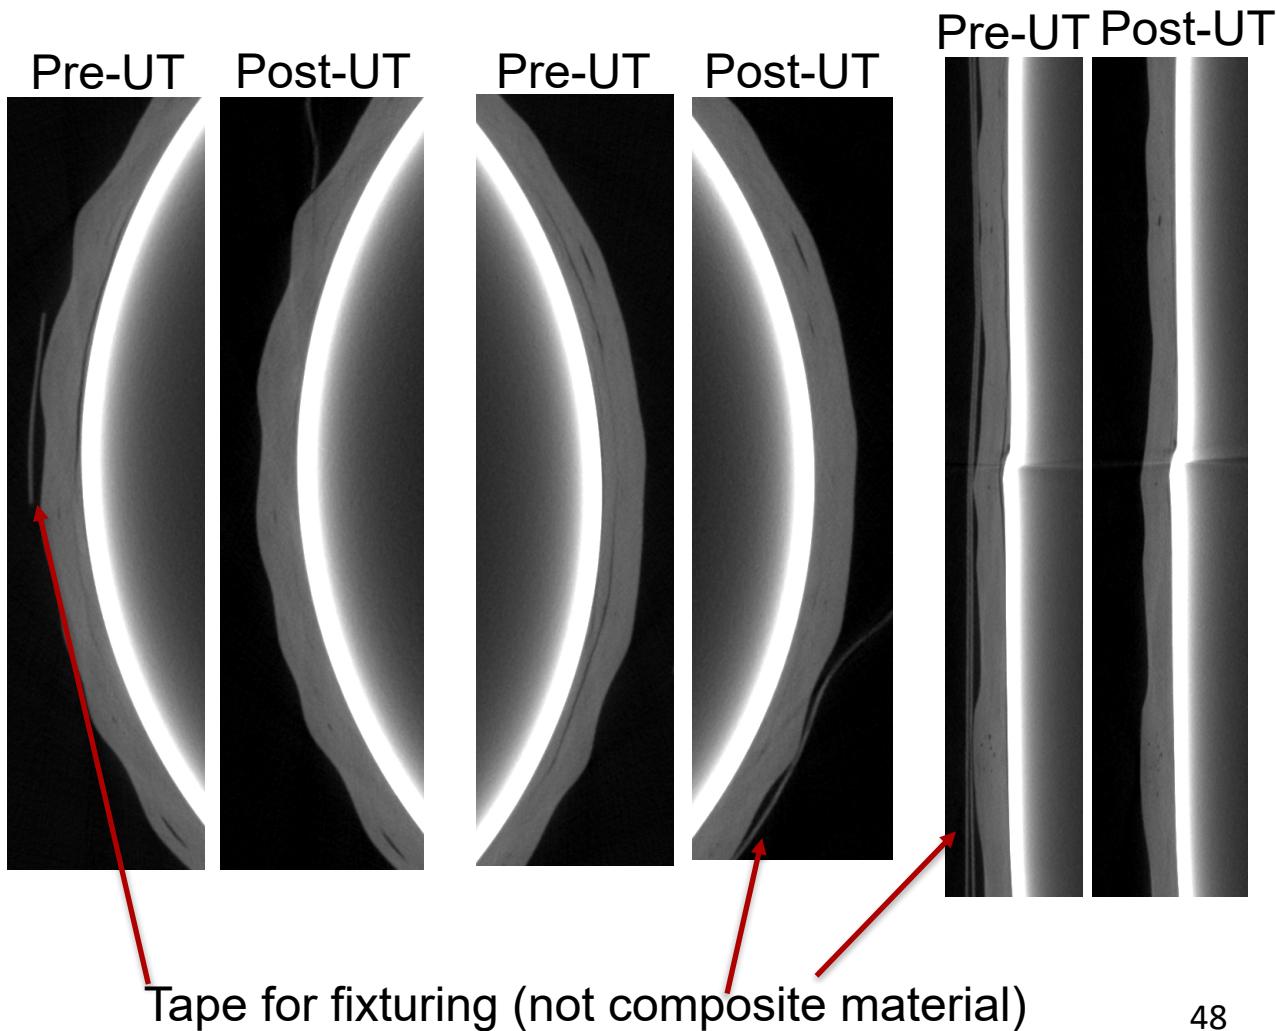
Results: COPV-7

- Think cracks between composite and liner seen in pre-UT scans
 - Not apparent in post-UT scans
 - Possible shrinkage of composite towards the liner
- Thin cracks mid composite in pre-UT scan
 - Cracks diminish in contrast in post-UT scan
 - Either a function of scan quality or partial closing of cracks
- Large cracks (pores?) unchanged

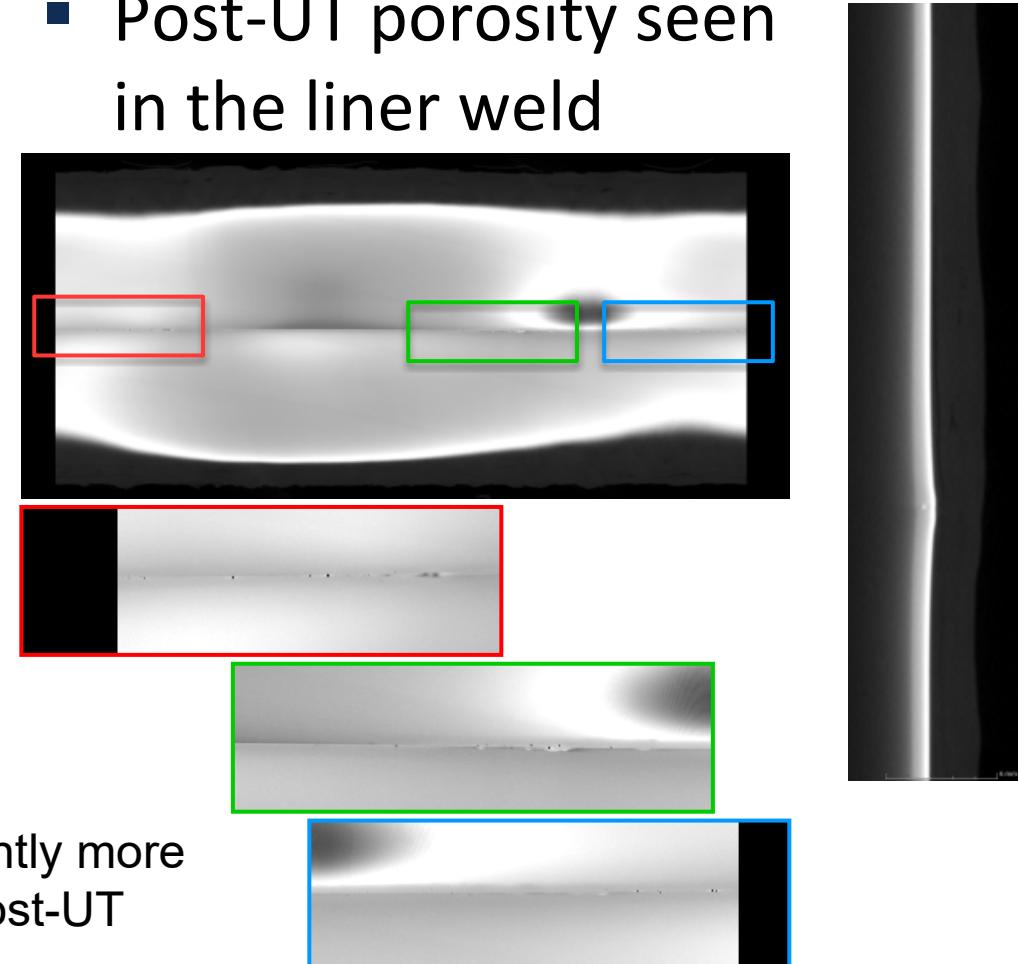
Results: COPV-7

- Pre-UT porosity seen in the liner weld

- Post-UT porosity seen in the liner weld

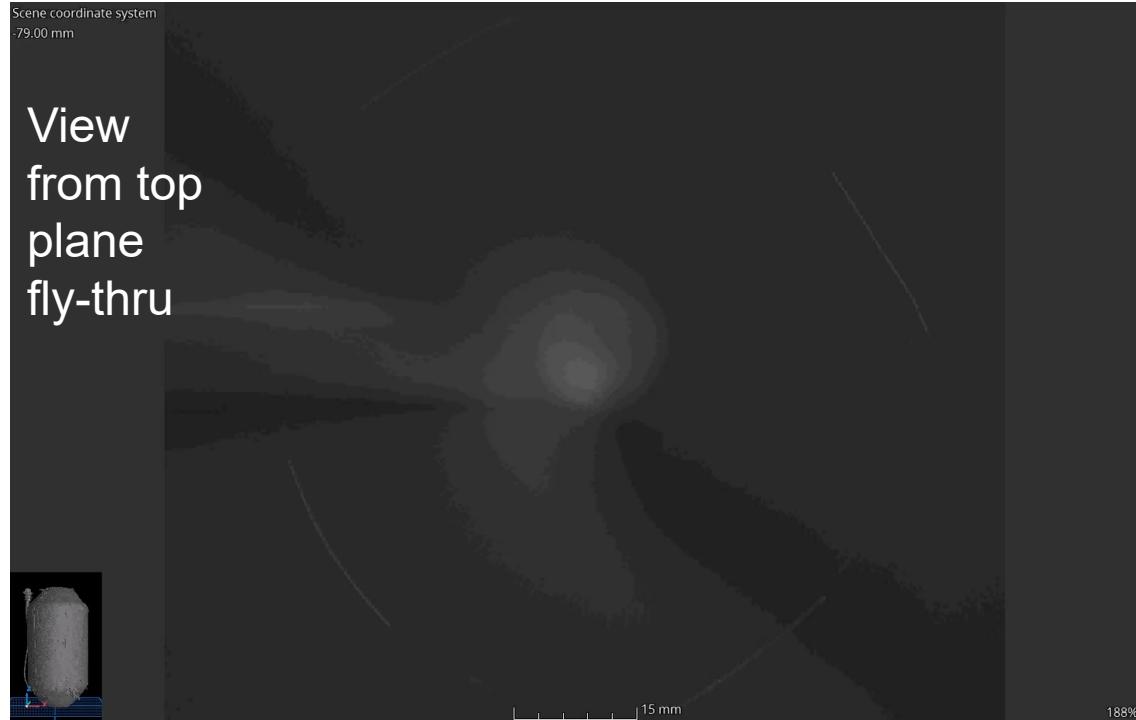
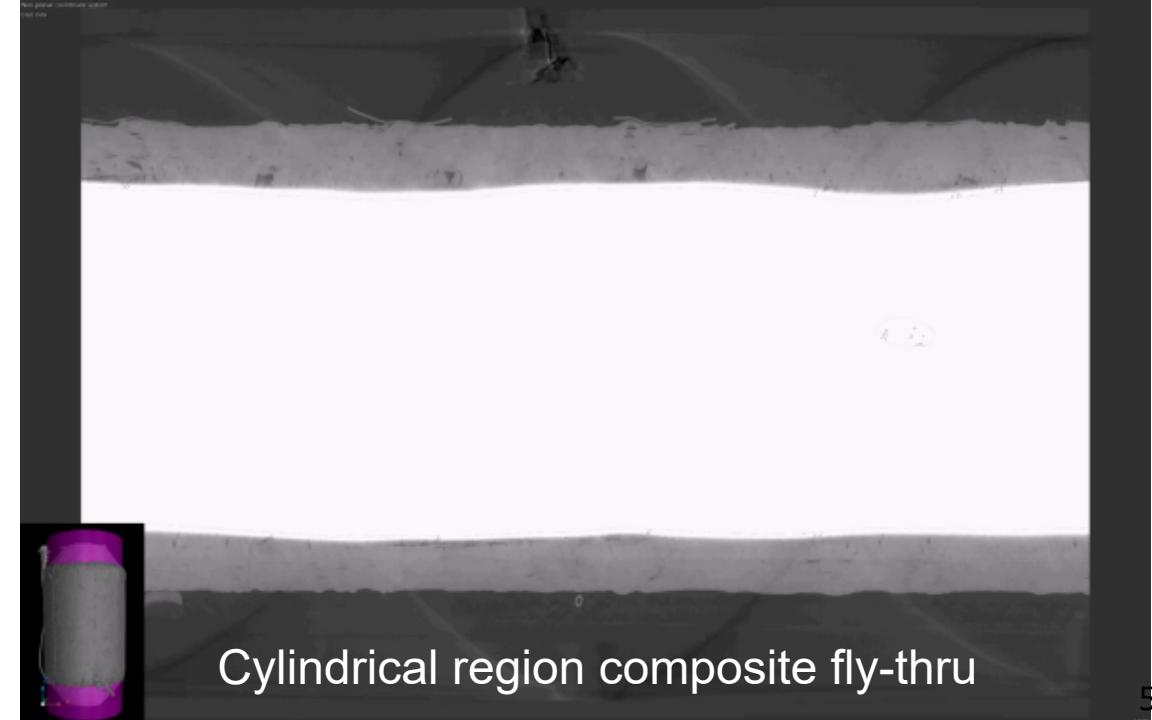
Results: COPV-8

- Vacuum Debulked sample
- Fly-thru videos
- Poor composite quality at cylinder to sphere transition

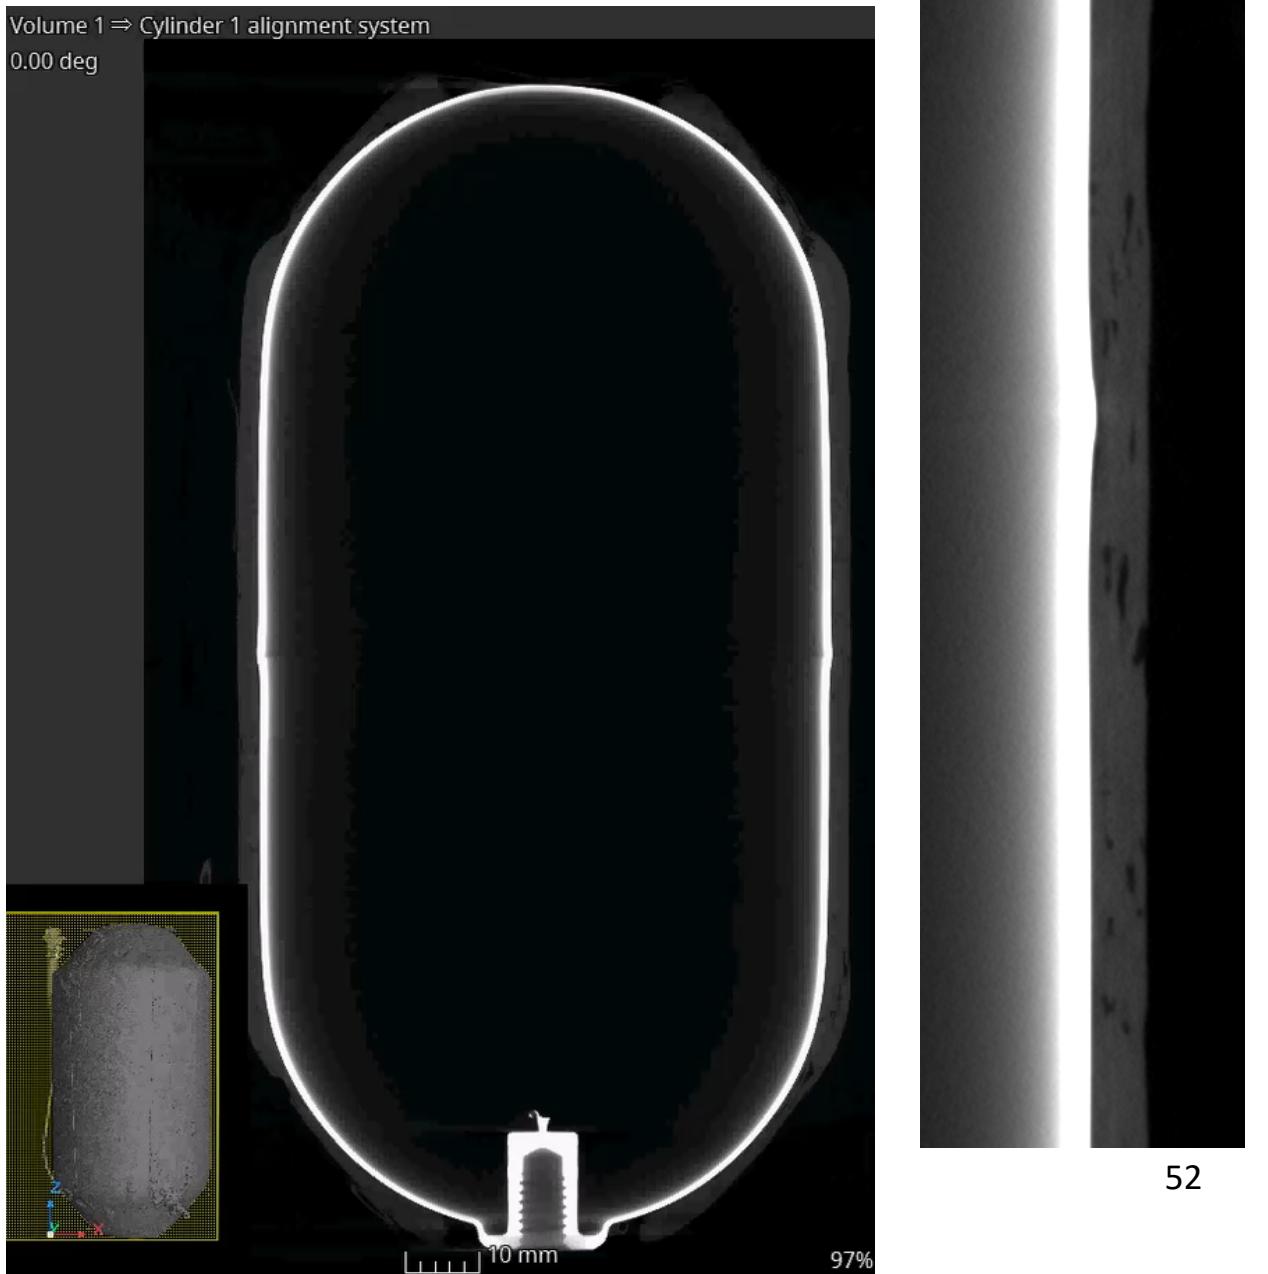
Results: COPV-8

- Composite is filled with voids/pores
- Regions of bad composite quality at transition from cylinder to sphere
- Cracking in composite near the nozzle

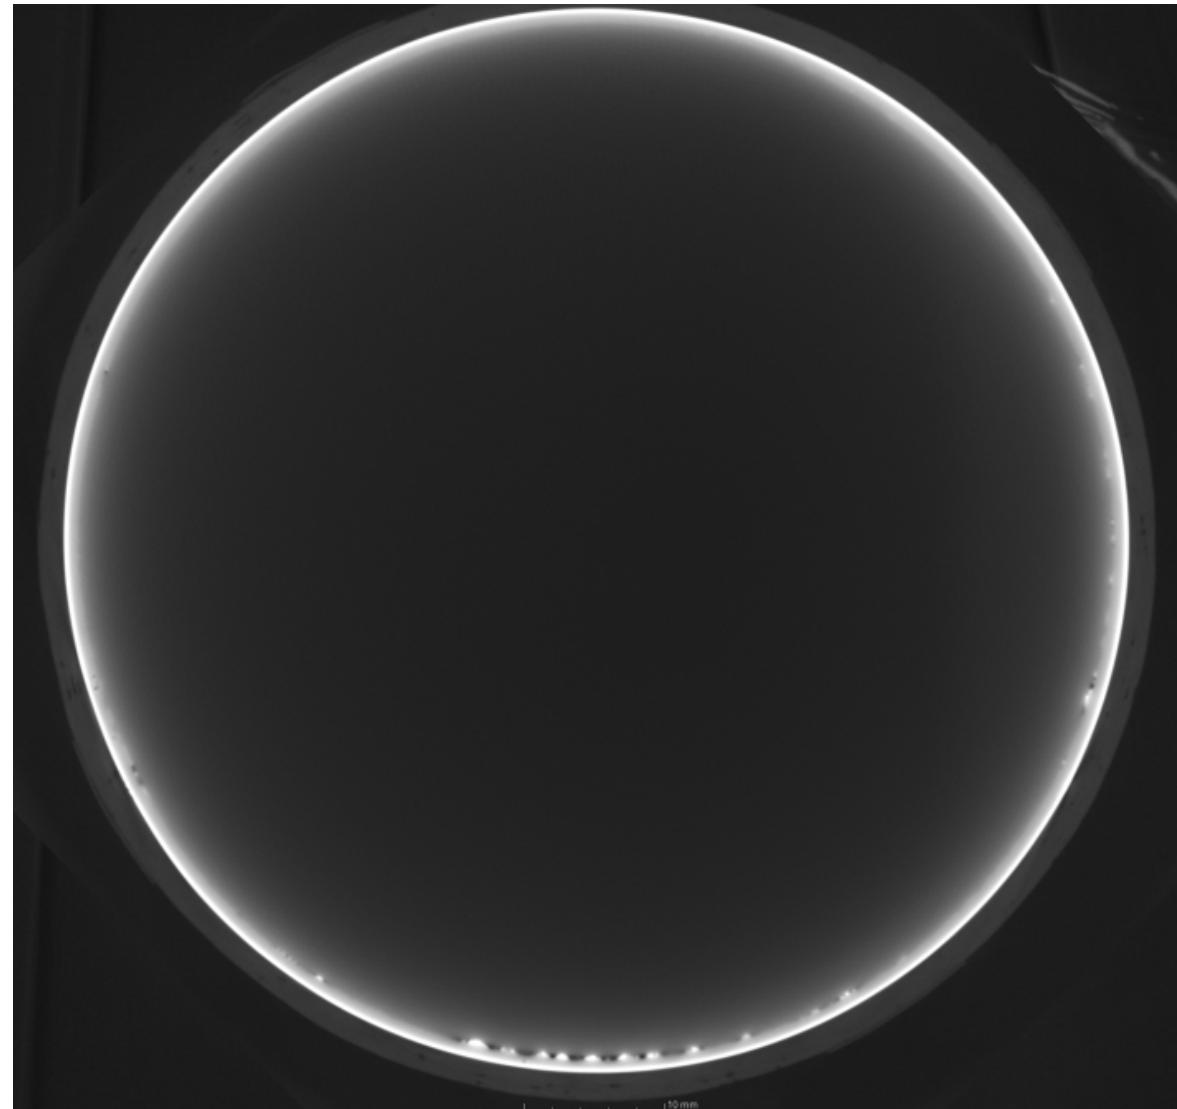
Results: COPV-8

- Weld quality concerns
- Likely locations to seed failure
