2024 Annual Site Inspection and Monitoring Report

Uranium Mill Tailings Radiation Control Act Title I Disposal Sites

MARCH 2025

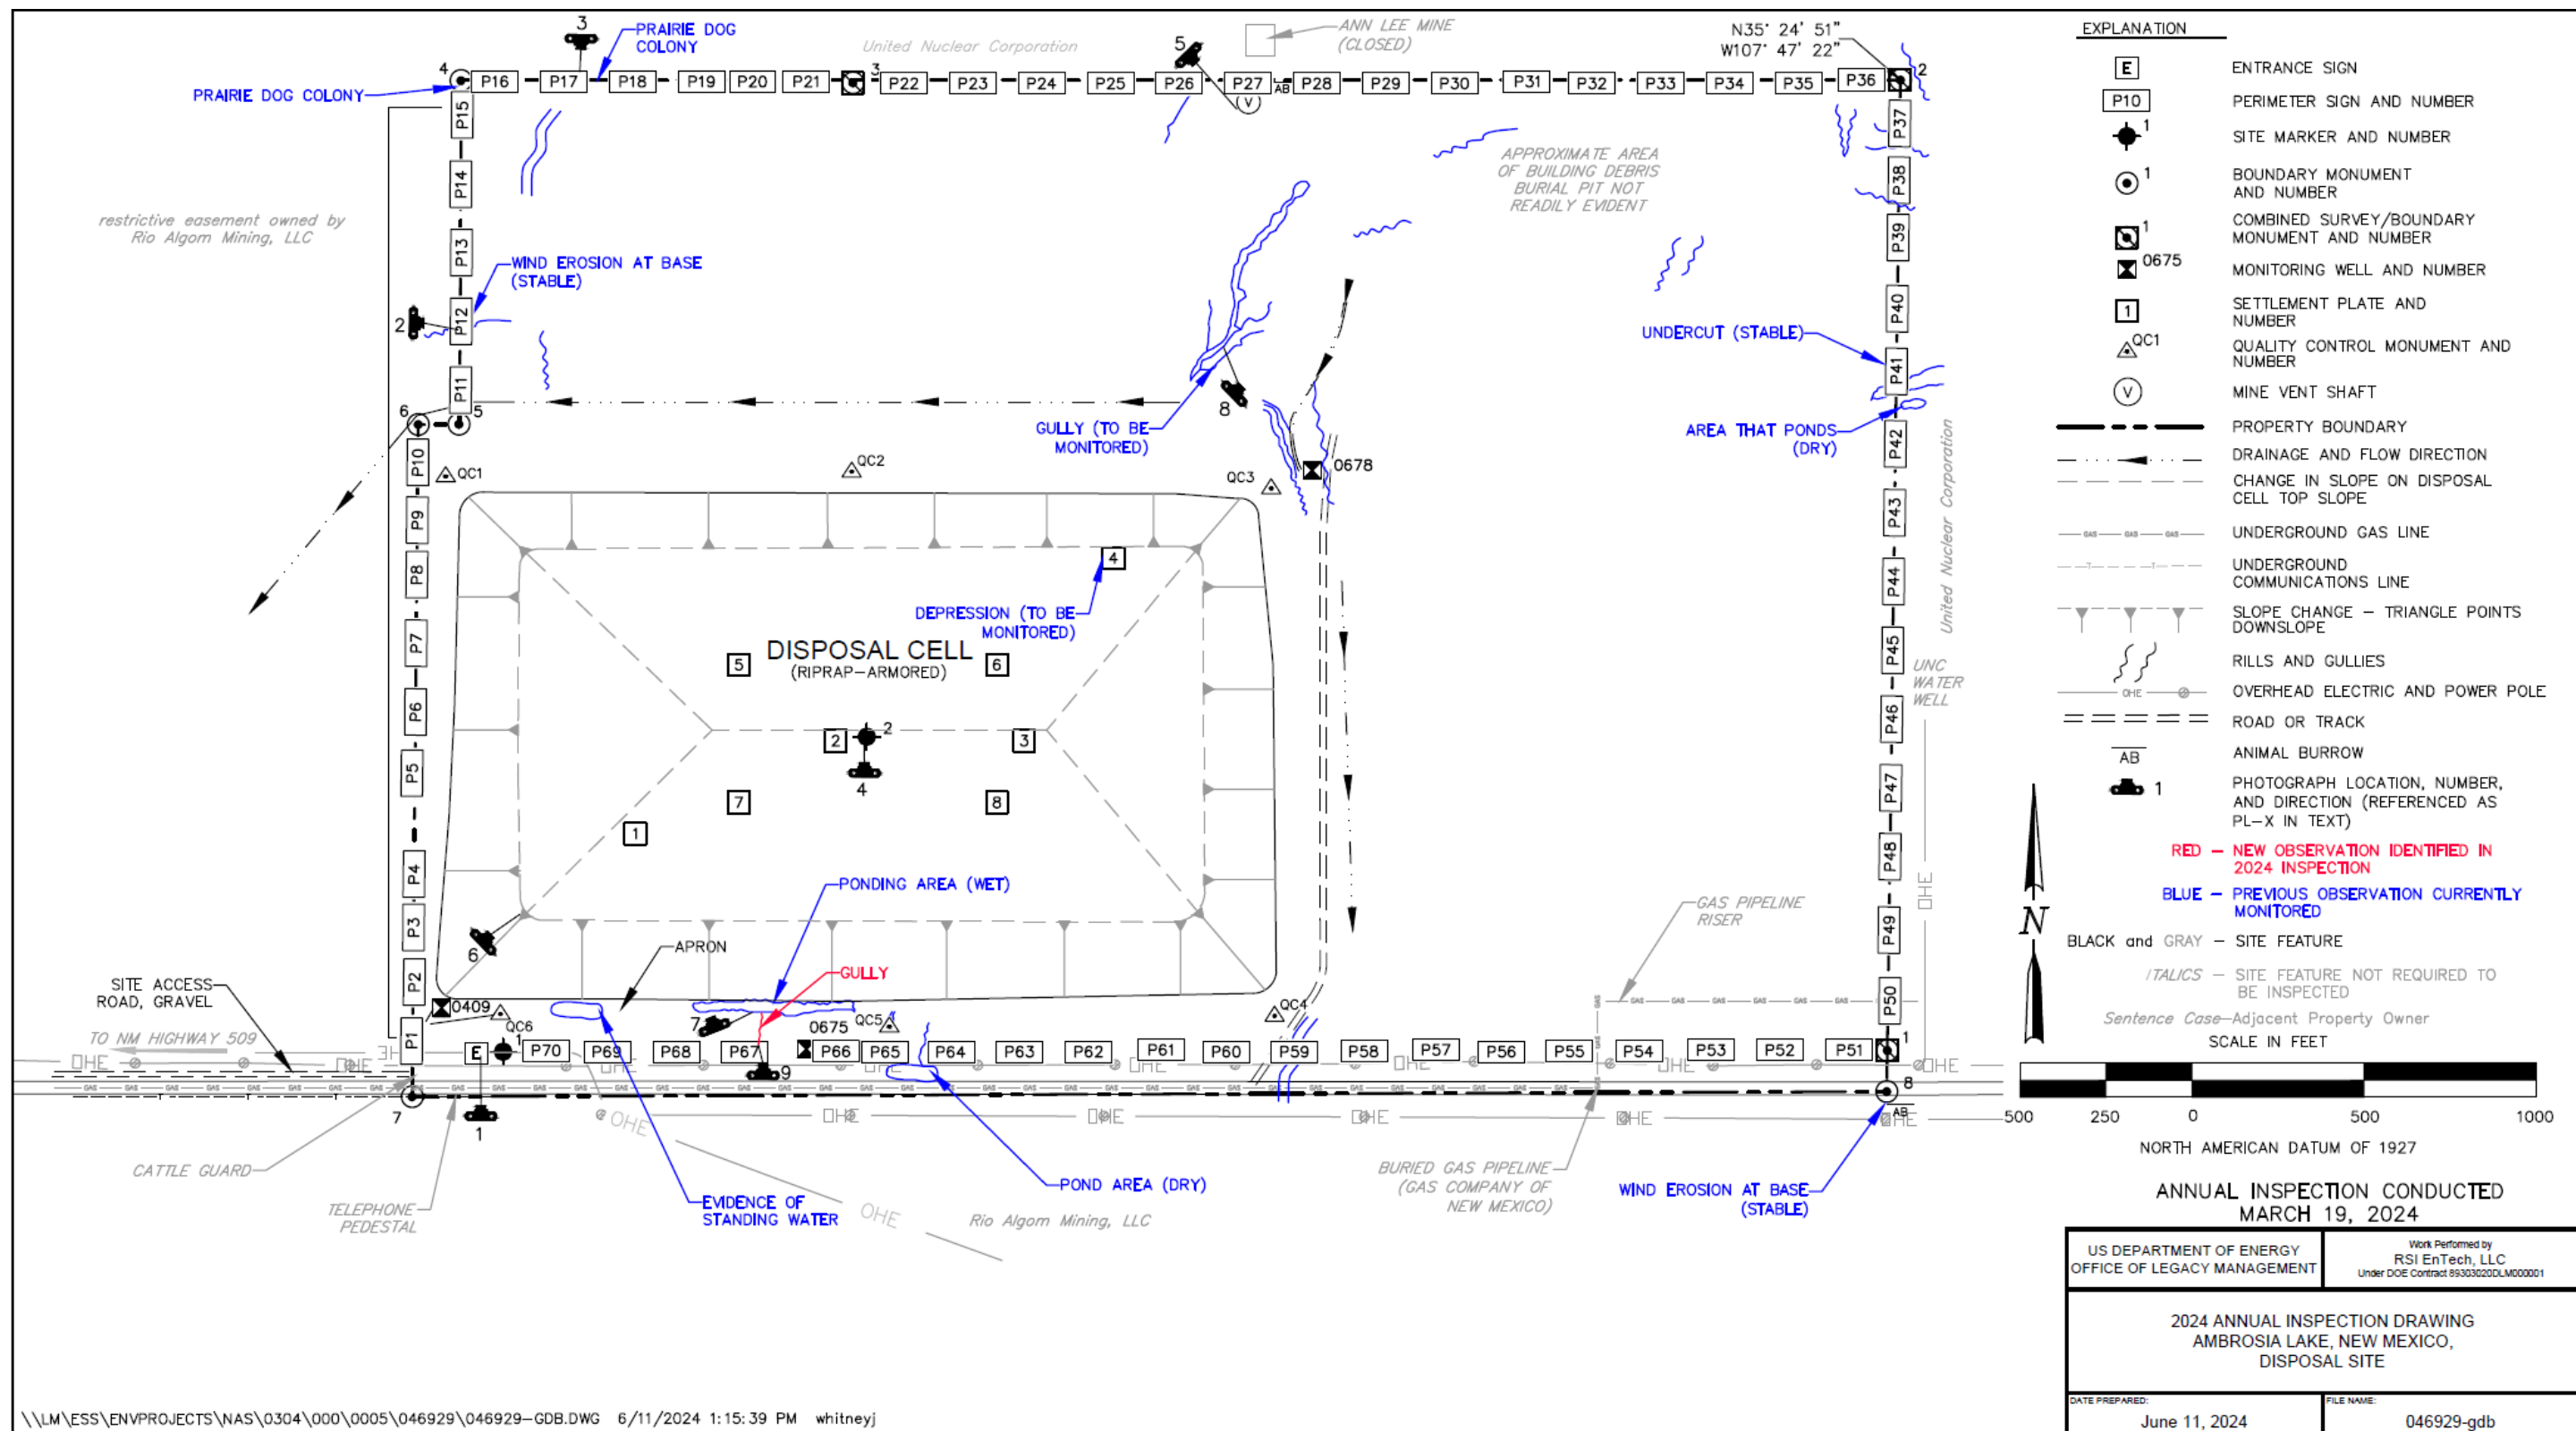
Figure 1-1. 2024 Annual Inspection Drawing for the Ambrosia Lake, New Mexico, Disposal Site

The site has two granite site markers. Site marker SMK-1 is just inside the site entrance, and site marker SMK-2 (PL-4) is on the top slope of the disposal cell. No maintenance needs were identified.

Three combined survey and boundary monuments and five additional boundary monuments delineate the property corners and boundary. Steel T-posts were installed next to boundary monuments to help inspectors locate them. At boundary monument BM-2, a new erosional gully has developed since the 2022 inspection. The boundary monument is stable, but monitoring will continue. Erosion has occurred around the base of boundary monument BM-8, but the monument is stable. Prairie dog colonies were observed near boundary monument BM-4 in 2021. Neither the erosion nor the colony threaten the integrity of the boundary monuments, and inspectors will continue to monitor these locations. No maintenance needs were identified.

A mine vent shaft associated with an abandoned underground mine is within the site boundary in the northern portion of the site (PL-5). Inspectors monitor the condition of the vent to ensure that the closure remains secure. The vent has a spot-welded cover and a casing that rises approximately 3 feet (ft) above the ground. The vent was secure at the time of the inspection. No maintenance needs were identified.

The disposal cell, completed in 1994, occupies 91 acres and is armored with basalt riprap to control erosion and deter animal and human intrusion. The top slope showed no evidence of cracking and there was no indication of riprap degradation. A shallow depression around settlement plate SP-4, near the northeast corner of the disposal cell cover, was first noted during the 1997 inspection and continued to grow in depth and area in subsequent years. The depression was repaired in August 2005. Continual visual observations since the 2017 annual inspection indicate that minor additional settlement has occurred since the depression was repaired. During the 2024 annual inspection, the settlement was shallow enough that it was determined not to have

Annual weeds and perennial grasses are sporadically growing on top of the disposal cell (PL-6). In accordance with the LTSP, deep-rooted shrubs are to be removed from the disposal cell cover. No deep-rooted shrubs were noted during the inspection. Weed control is performed as necessary, and the need for weed control will be evaluated again during the next annual inspection.

The basalt riprap-covered side slopes and apron showed no evidence of erosion, settling, slumping, or cracking. Standing water is occasionally observed in a portion of the south apron, and the area was wet during the 2024 inspection (PL-7). An additional ponding area, which was dry, exists south of the current standing water area near the apron and closer to the access road. These locations are in a topographic low spot along the base of the disposal cell, and stormwater runoff collects in these areas. During the 2022 inspection, rilling and erosion were observed on the south side slope near aerial survey quality control monument QC-5. During the 2024 inspection, these features seemed to be stable. Inspectors will continue to monitor this area. No maintenance needs were identified.

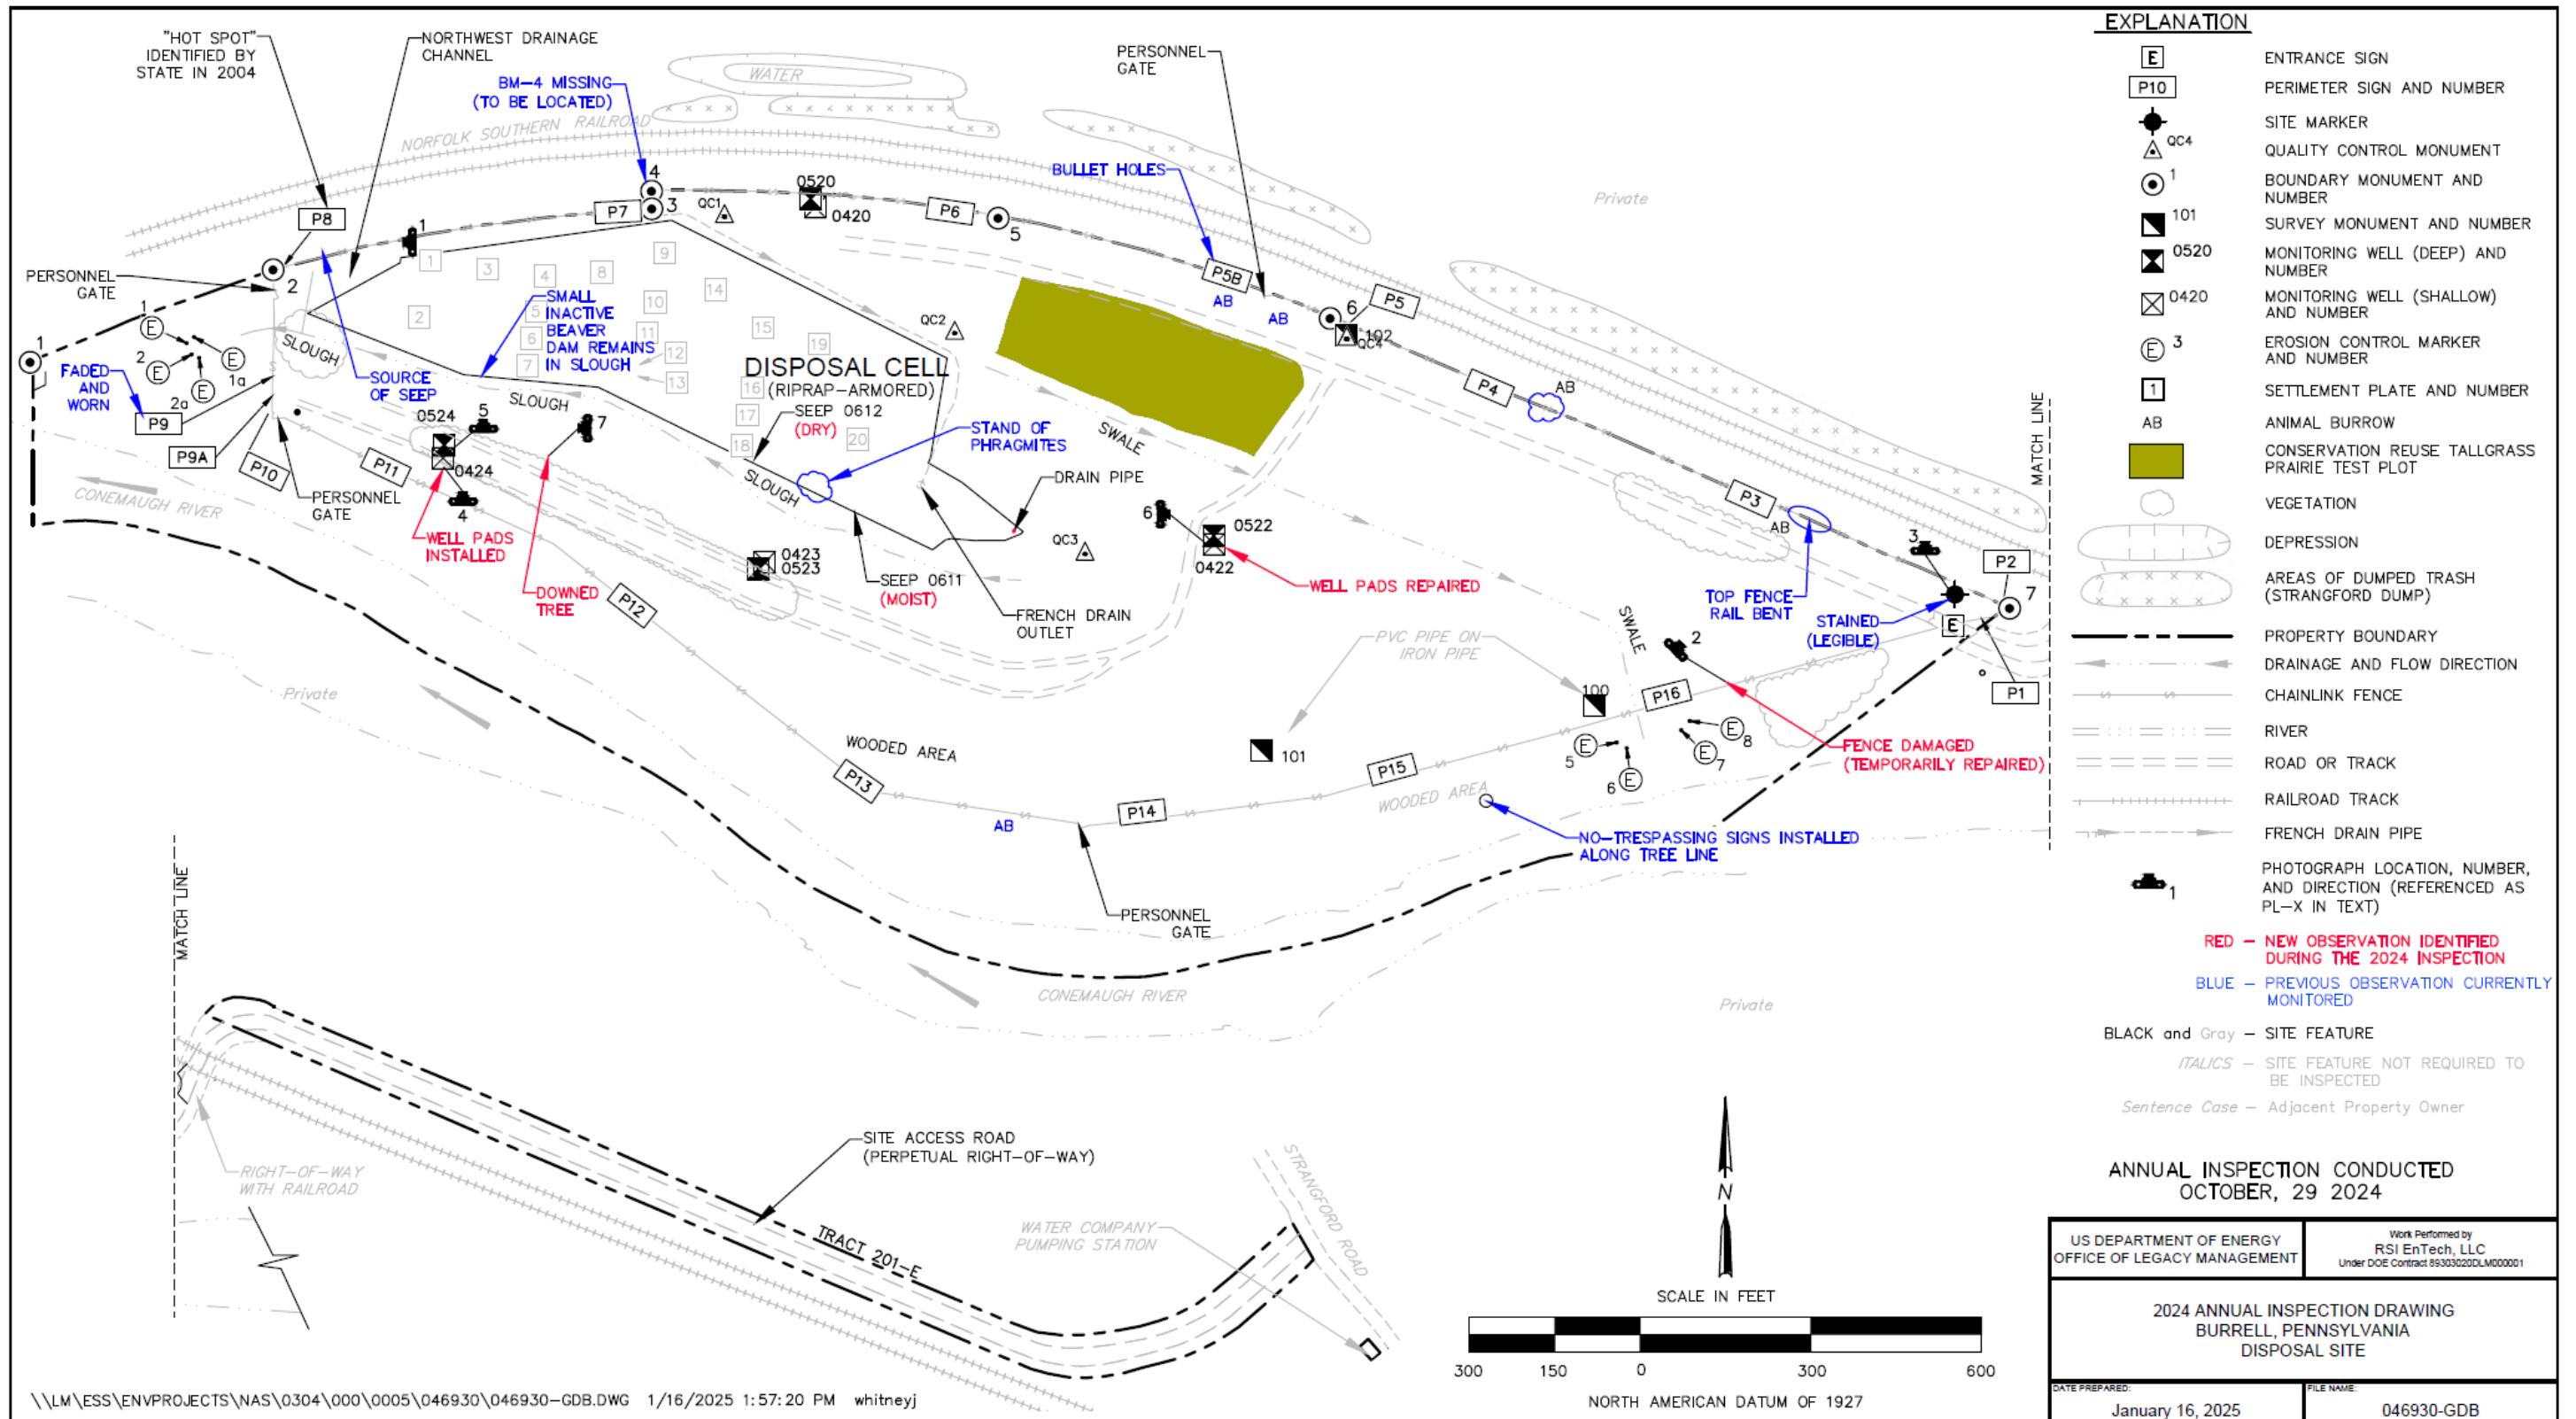
Figure 2-1. 2024 Annual Inspection Drawing for the Burrell, Pennsylvania, Disposal Site

A chainlink security fence encloses the disposal cell and drainage features. The site herbicide subcontractor keeps the fence line clear of vegetation, which should prolong the life of the security fence (PL-1). In 2023, trees felled by strong winds damaged the fence, compromising its integrity. Repairs were completed following the 2023 inspection. The upper rail of the fence along the southern boundary is bent in a few areas, but the fence remains serviceable, and repairs

are not required at this time. A large tree fell on the fence in 2024. Temporary repairs were made to the fence (PL-2). DOE plans to wait until summer 2025 to make permanent repairs. This decision was based on the observed adequacy of the temporary repairs and the late time of year. If winter and spring storms further damage the fence, repairs can be made all at once.

The site has one granite site marker just inside the main entrance gate. The concrete pad is cracked but remains functional. The surface of the site marker is stained but remains legible (PL-3). No maintenance needs were identified.

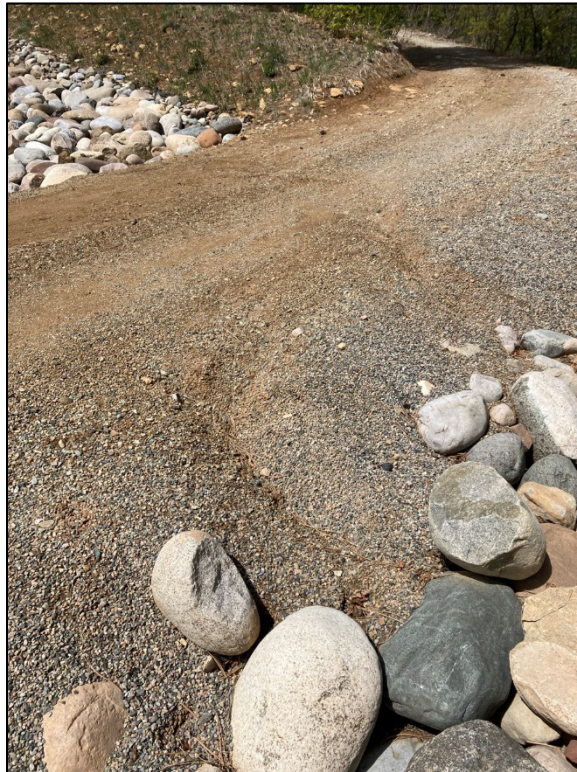
PL-1. Access Road Erosion

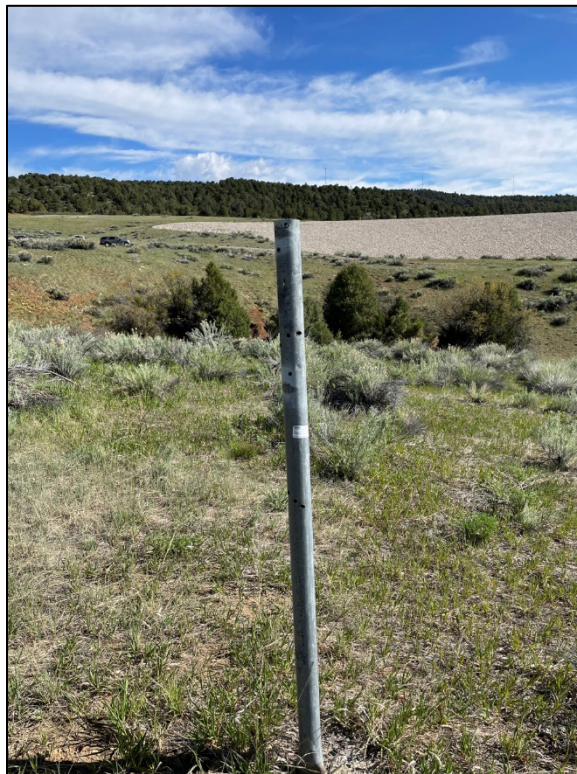
PL-2. Perimeter Sign P1 Missing

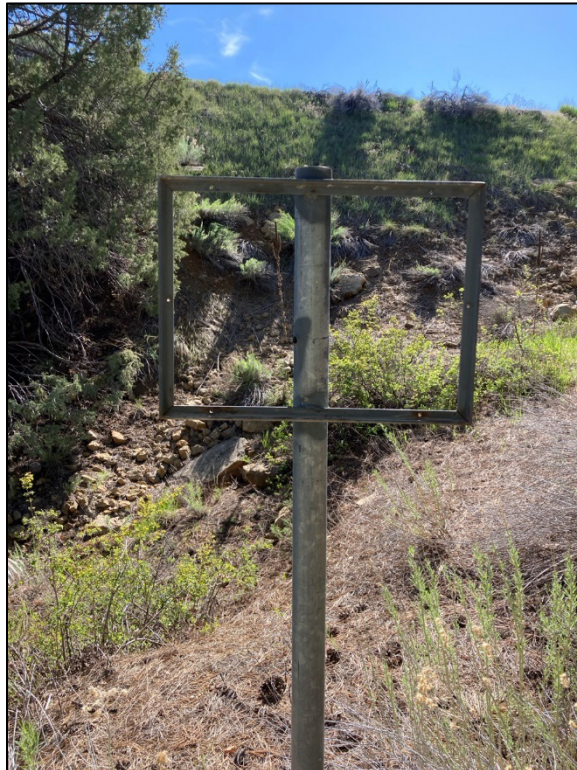
PL-3. Perimeter Sign P82 Missing

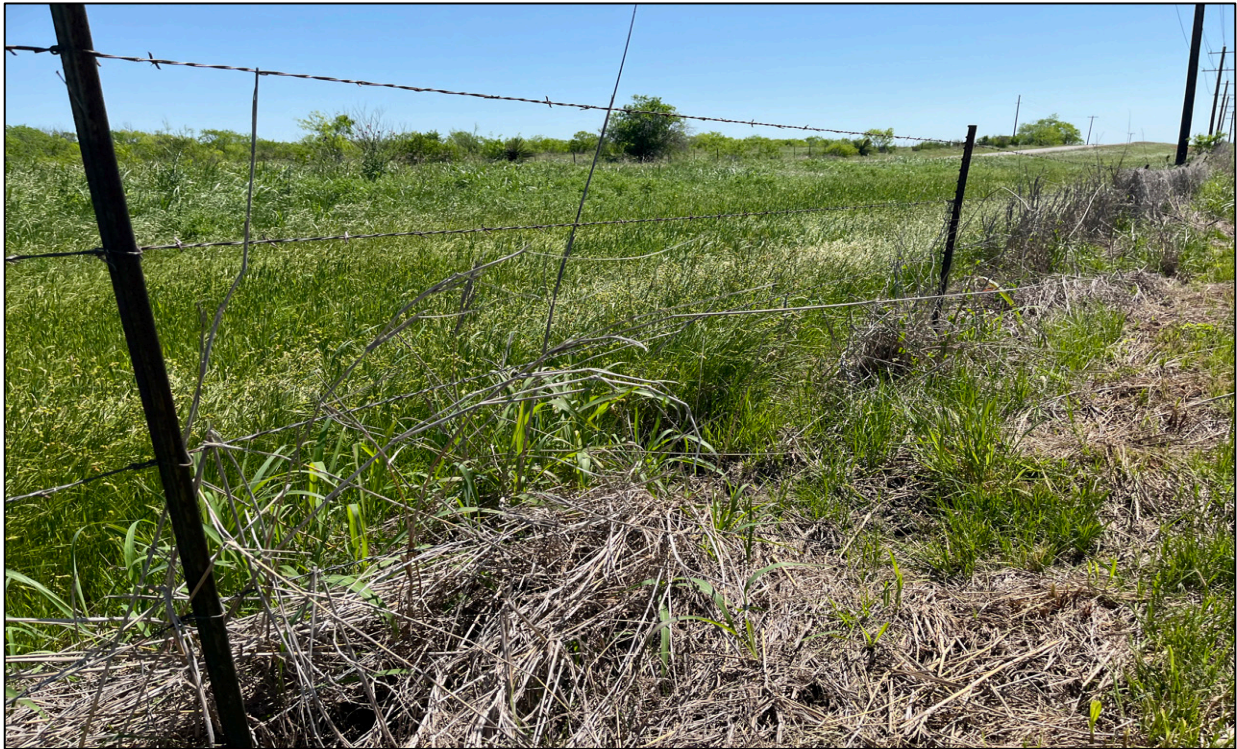
PL-1. Damaged Fence Line

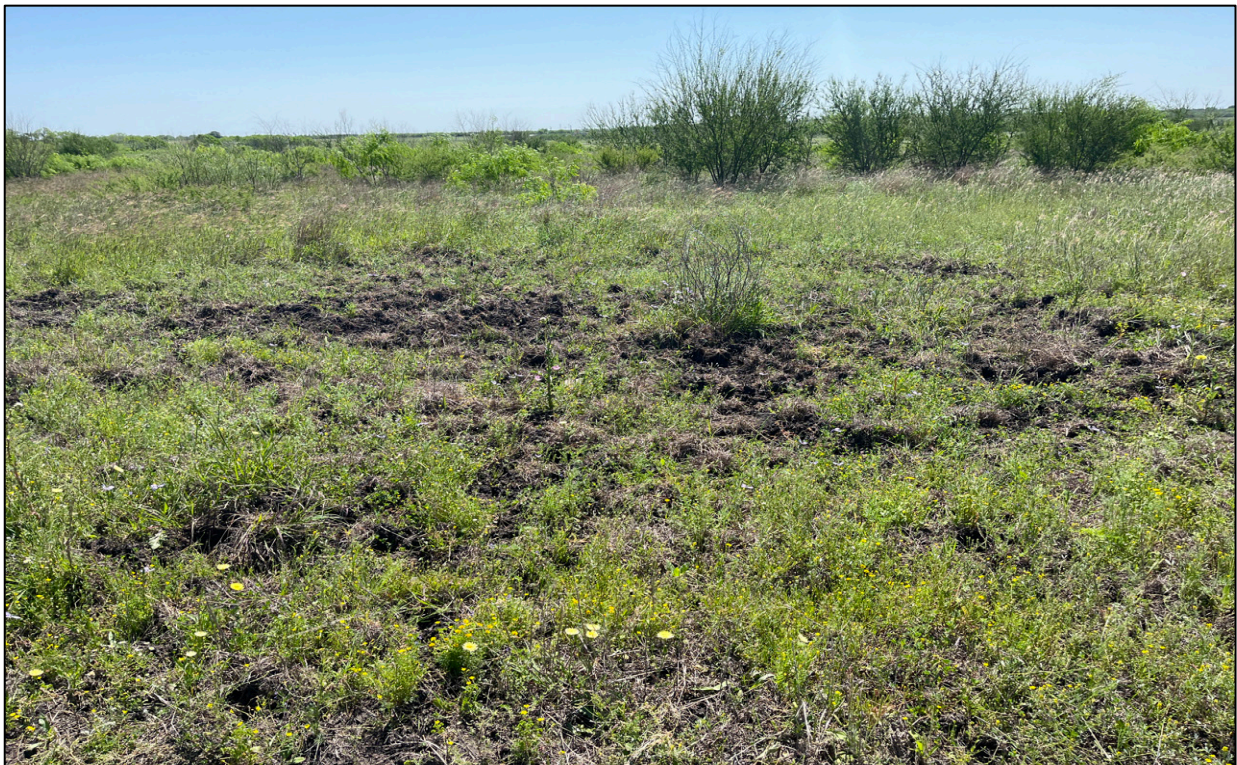
PL-2. Hog Rooting in Southeast Outlying Area

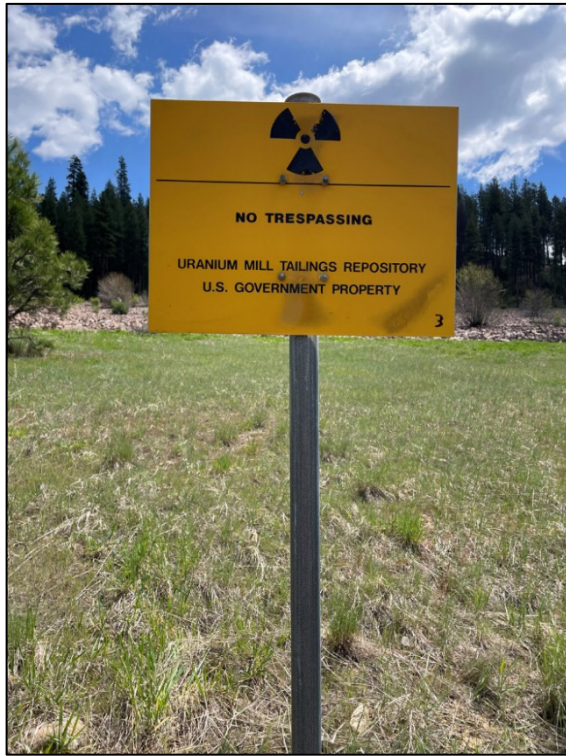
PL-1. Replaced Perimeter Sign P3

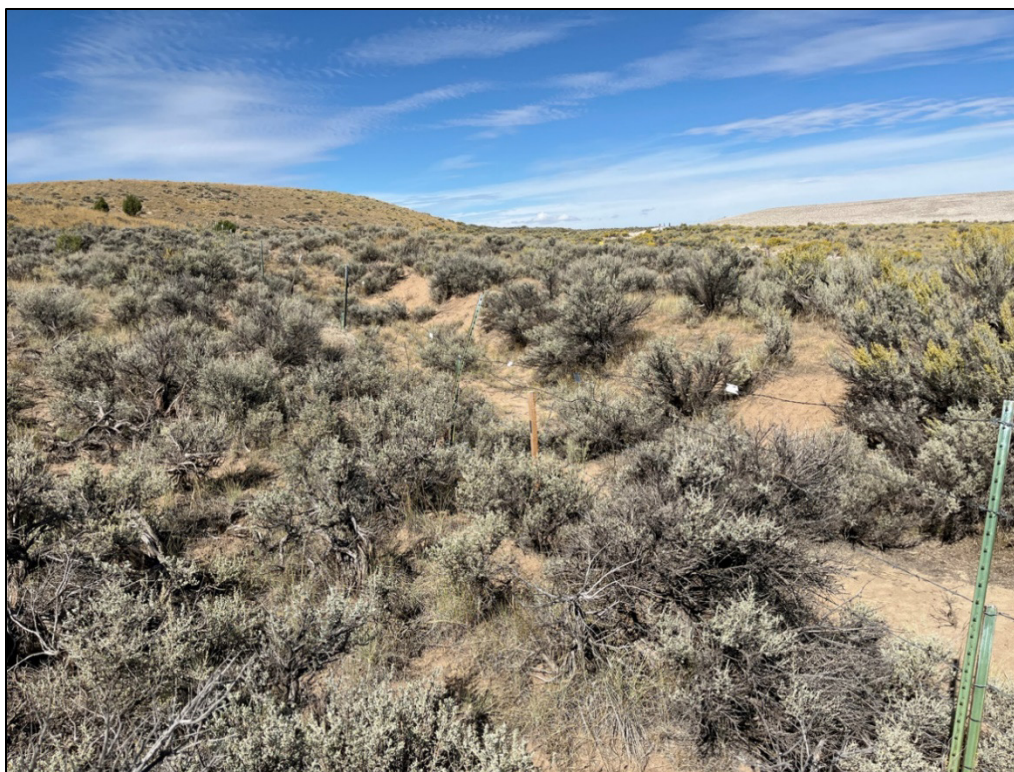
PL-2. Fence Damage

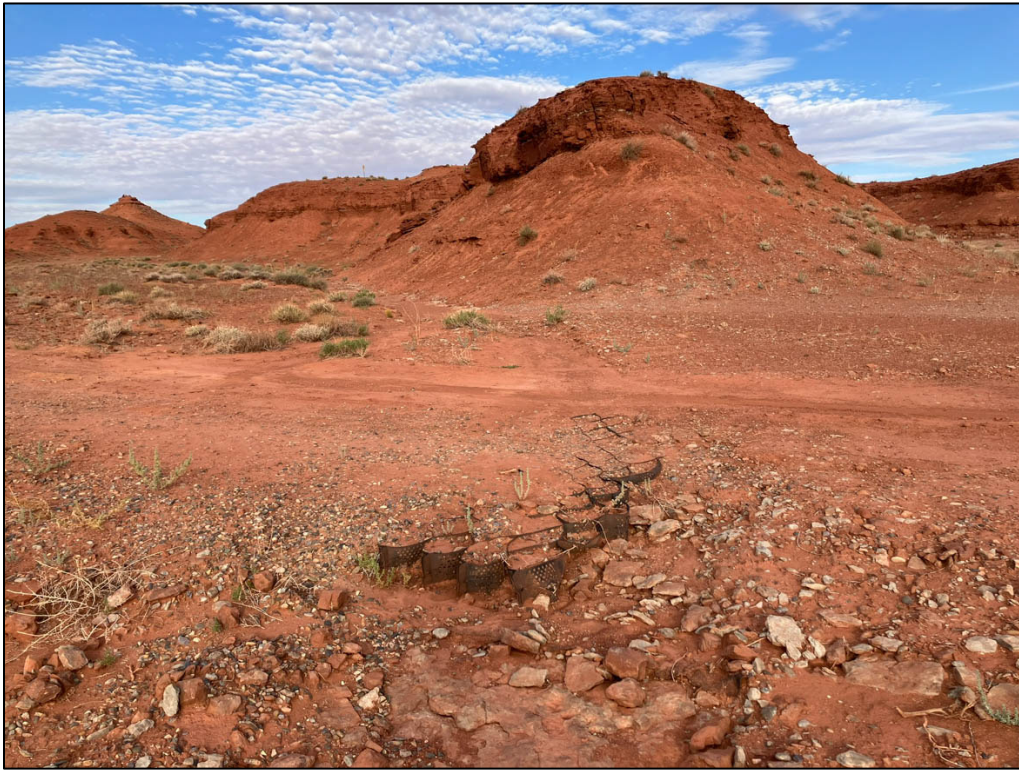
PL-1. Minor Road Erosion at Armored Drainage; Geocell Exposed

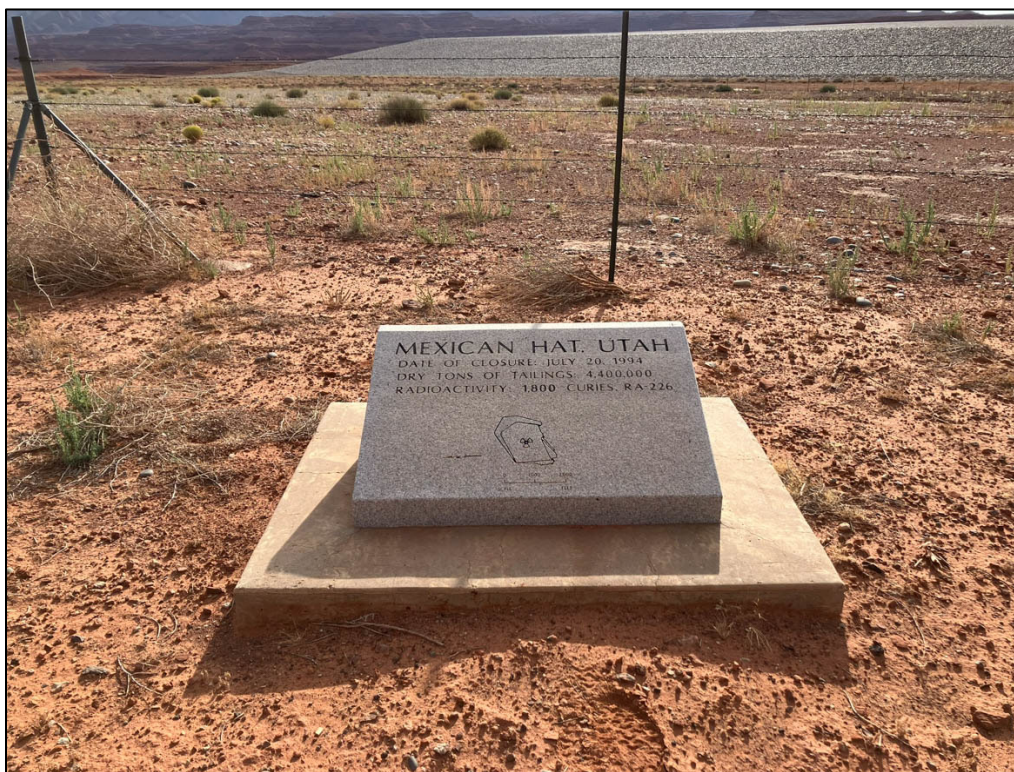
PL-7. Site Marker SMK-1 with Minor Cracks in Concrete Base

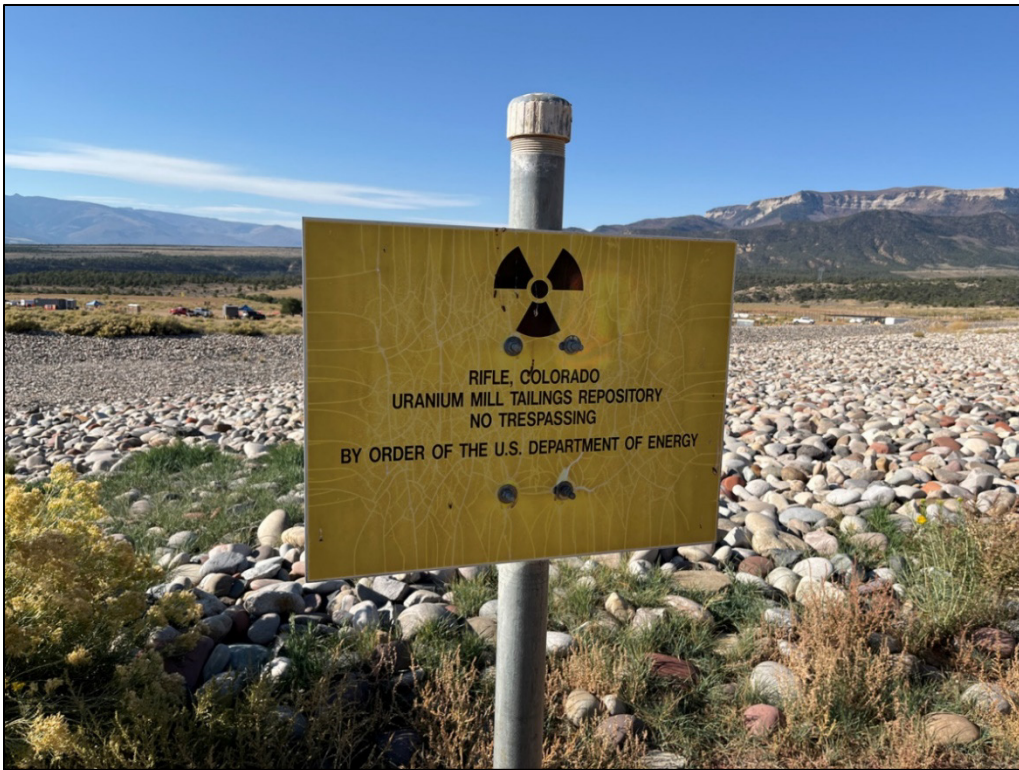
PL-2. Perimeter Sign P12, Cracked but Legible

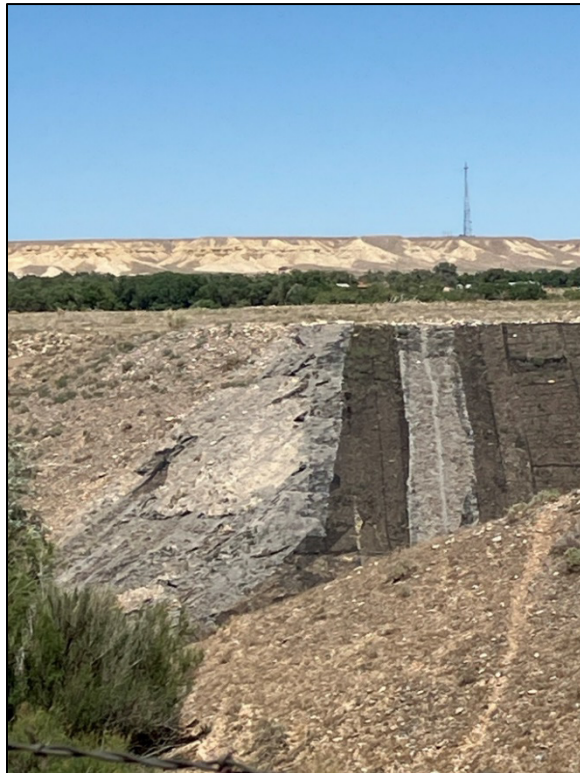
PL-13. Deteriorated Fabric in Outflow Channel

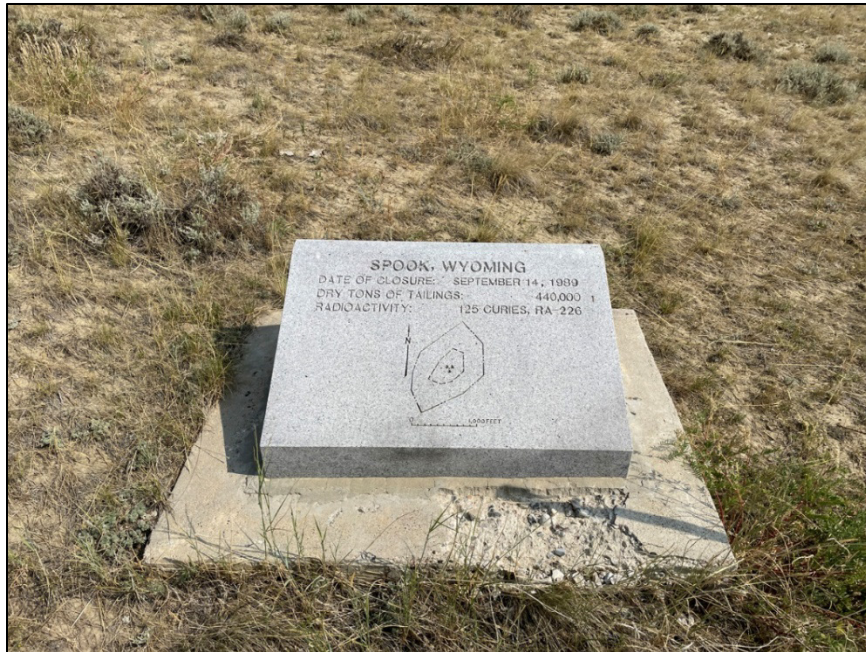
PL-2. Spalling on Base of Site Marker SMK-1
