| Project Title/Work Order Rotary Mode Core Sample System Availability Improvement | | EDT No. <i>603048</i> |

This document provides a priority listing of hardware and administrative changes that are recommended for improving the availability of the Rotary Mode Core Sample System (RMCSS).

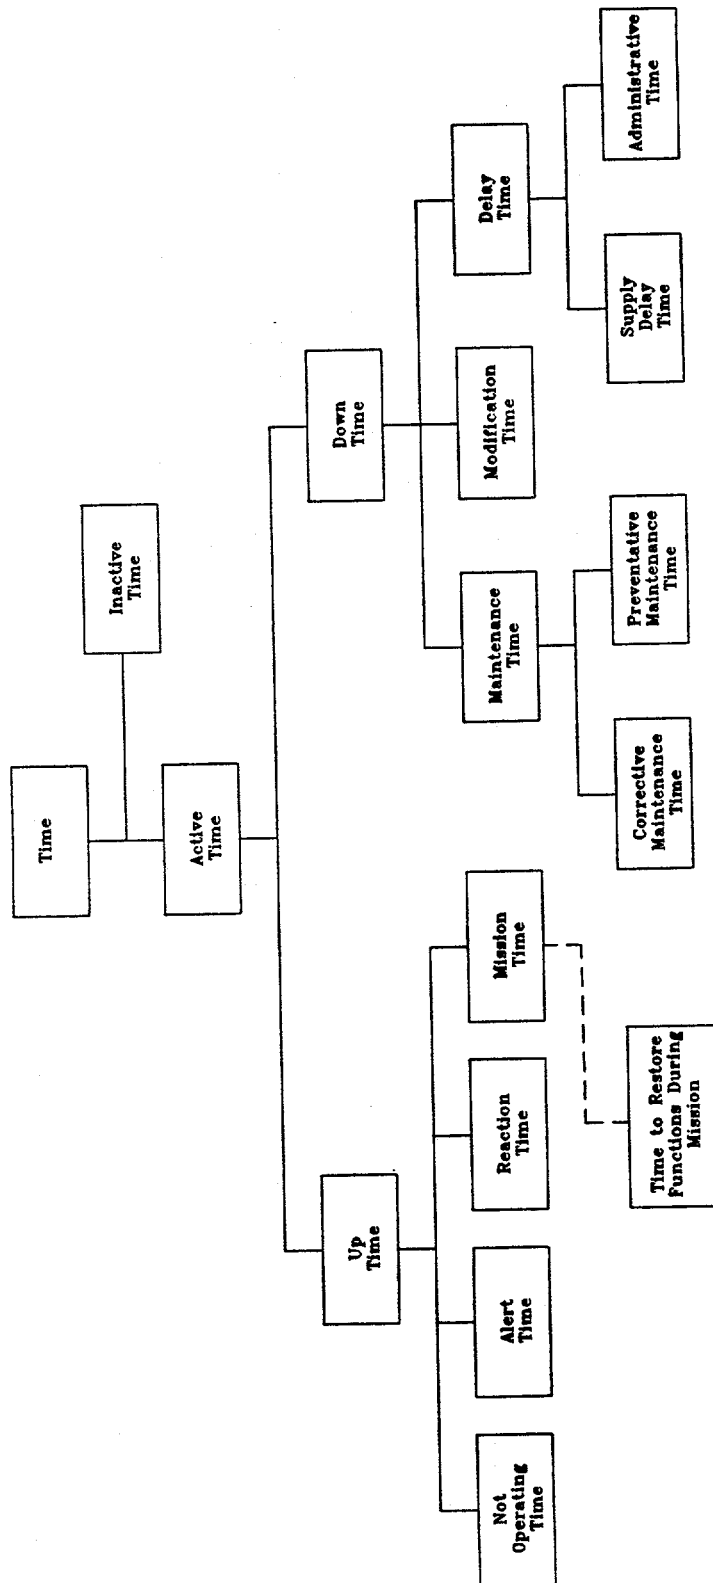
Figure 1-1. Time Relationships.

From the above, availability will be increased if MTBF is increased (reliability improved), MTTR is decreased (maintainability improved), and MISC is decreased. MISC includes activities such as waiting for replacement parts, waiting for paperwork, waiting for support personnel, and waiting for management decisions. The items that need to be considered in making up the three elements shown above are illustrated in Figure 1-1.

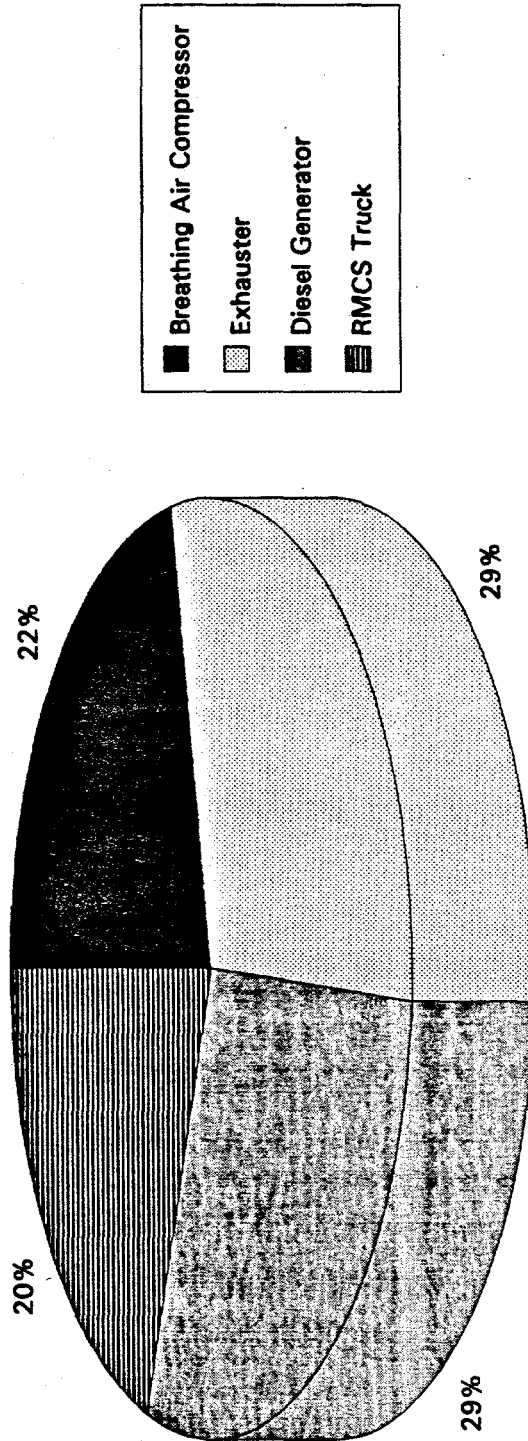
RMCSS PIC LOG
October 21 - February 1

79 Total Days of Failure

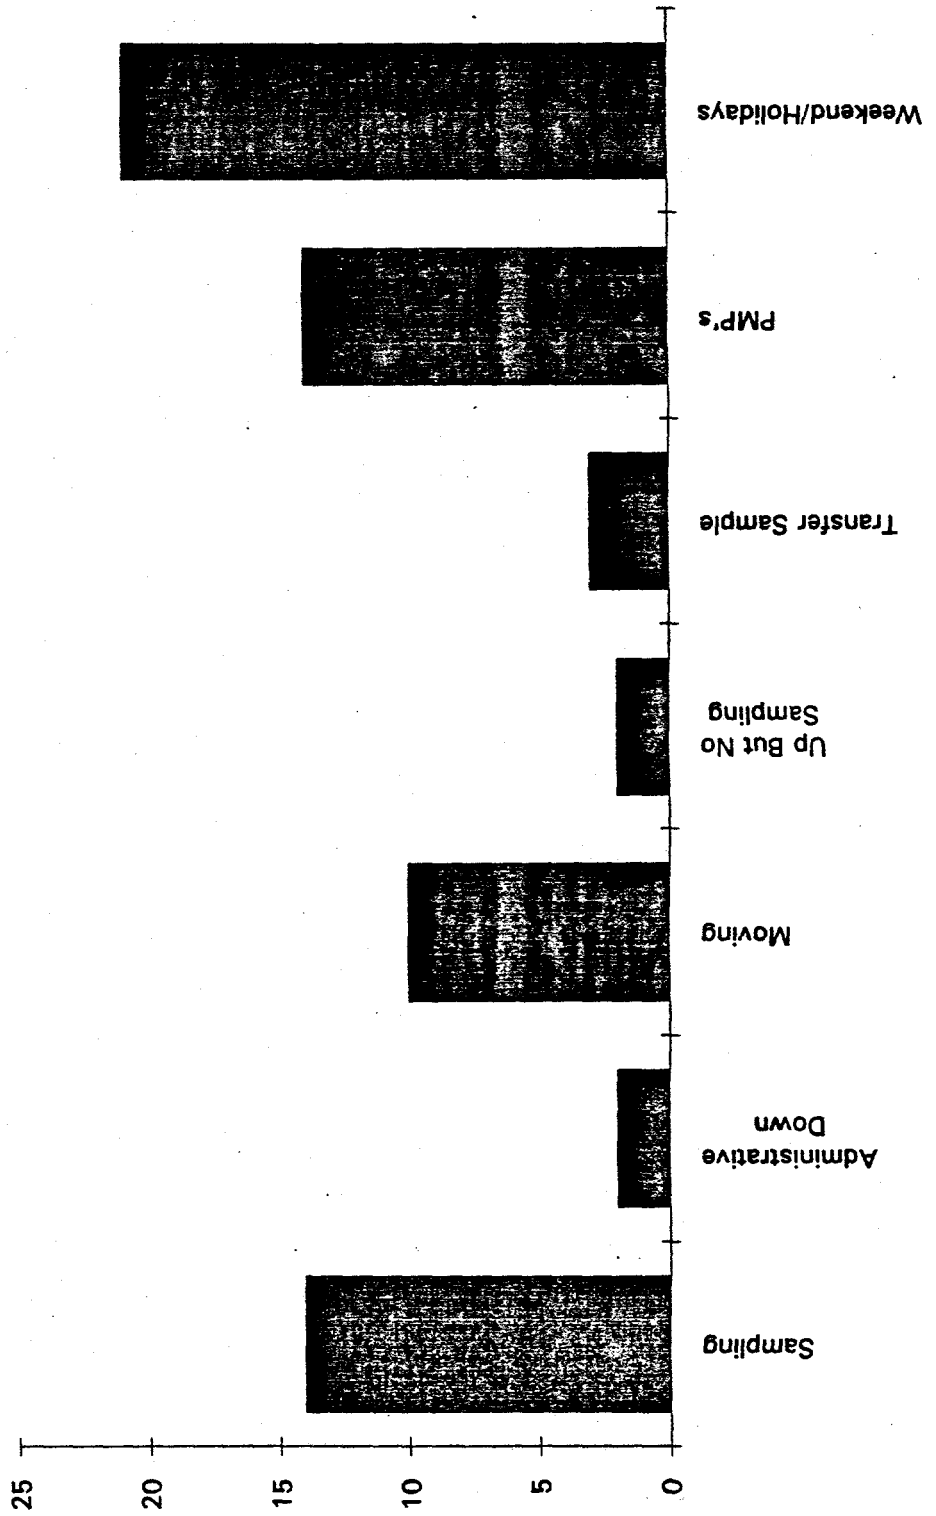
"Up Time" Usage (In Days)

** "Up Time" = 66 Total Days of 103 Day Period

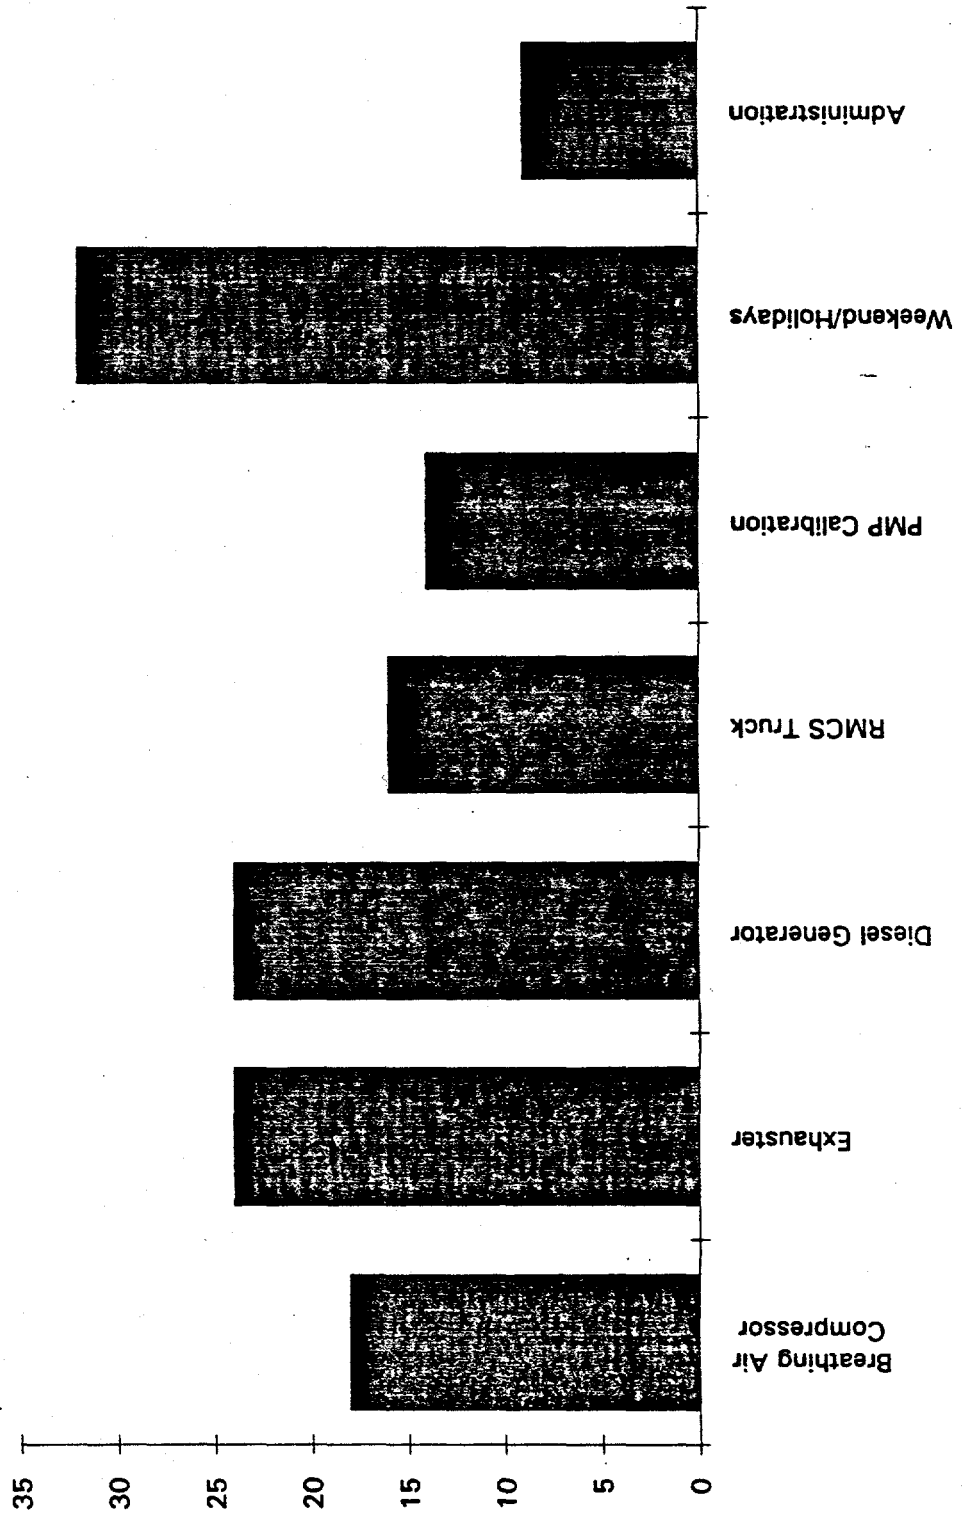
Total Down Time (In Days)

**** Multiple units were down at the same time. Period had 103 days.**
