Field Demonstration Project Using Clean Coal Technology By-Products

11th International Symposium on Use and Management of
Coal Combustion By-Products

FIELD DEMONSTRATION PROJECT USING CLEAN
COAL TECHNOLOGY BY-PRODUCTS

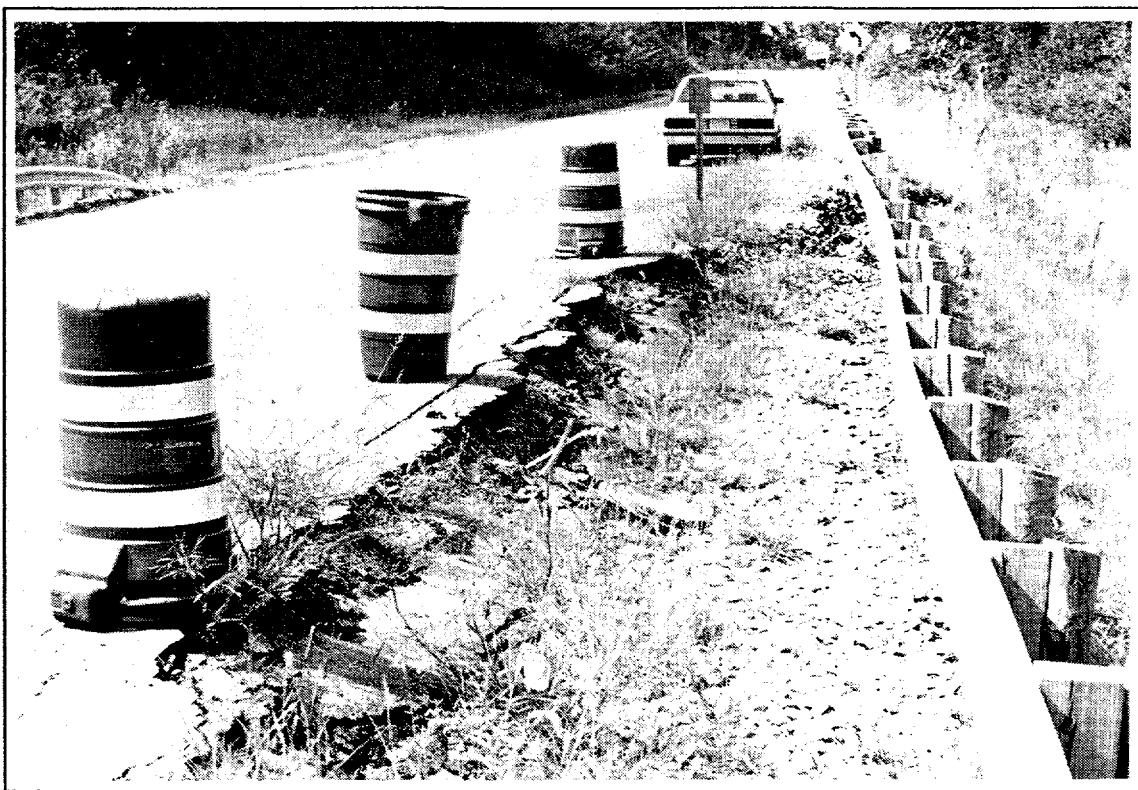
By early 1989, it became apparent that the highway was again slipping. In that summer, ODOT engineers, realizing that the pile-supported retaining wall had failed to prevent the road surface from settling, ordered a more comprehensive repair. The excavation of the piles revealed how dramatic the embankment movement was. The base of the piles, which was eight meters below grade, had moved approximately two meters down slope for an equivalent angle of rotation of almost 20 degrees. The piles were removed and the embankment material was excavated to a depth of 13 meters below the road surface and replaced with select fill. The slope was brought back to its original condition (2:1 slope). Two drains were installed at the top of the embankment, to intercept a layer of water that was detected during the excavation process. These drains are still active, particularly after periods of heavy rainfall or snow melt (Newhart, 1994).

Figure 2. Landslide in the Northbound Shoulder of State Highway 541 West of Coshocton, Ohio

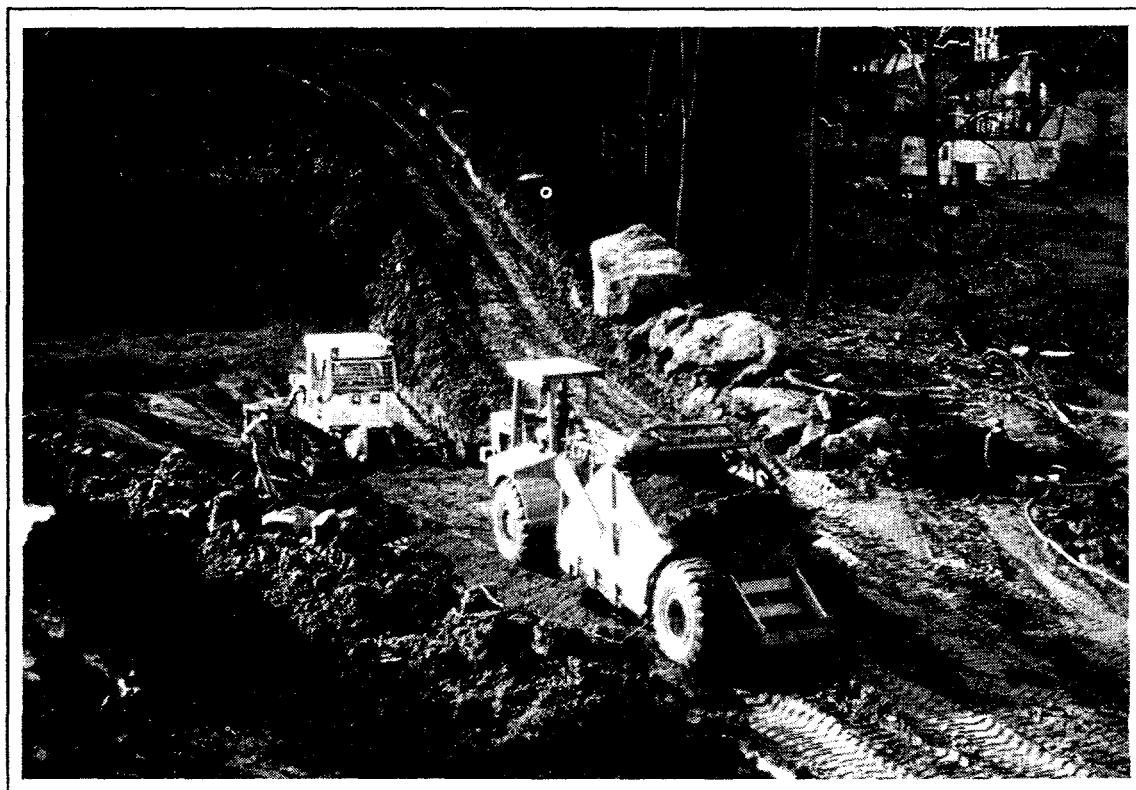
Figure 3. Construction of the FGD Buttress

retaining layer will likely find an alternate path, as the permeability of this material is often as low as 9.1×10^{-10} cm/sec (Bigham et al., 1992). Once the geotextile was in place, the crew began placing the dry FGD by-product, which had been stockpiled on site. Self loading scrapers, as shown in Figure 3, delivered the material to the excavation as bulldozers spread it evenly over an area 12 meters wide by 30 meters long. The first lift of approximately 60 cm, was placed and rolled at the end of the first day. The next morning, as the scrapers were delivering the FGD by-product for subsequent lifts, the drivers noticed that the vehicles were not leaving tire tracks on the surface. The Tidd ash was already strong enough that by the next morning, 40 metric ton scrapers could move freely over it without any noticeable settlement (Newhart, 1994). The FGD buttress was built up until the end of November, when approximately 4 to 5 meters of the material had been placed. It should be noted that there were no stringent controls on the depth of the lifts or on the quantity of water added. The amount of water added in the field far exceed the optimum water content as determined in the laboratory (Bigham et al., 1992). ODOT field personnel adjusted the size of the lifts and the amount of water added to suit the prevailing conditions. The important point to be addressed here is the material has a wide workable range and does not have to be treated with laboratory precision to yield excellent strength properties. Atop the FGD, the original embankment material was replaced throughout December in controlled lifts that ultimately totaled 3 to 4 meters.

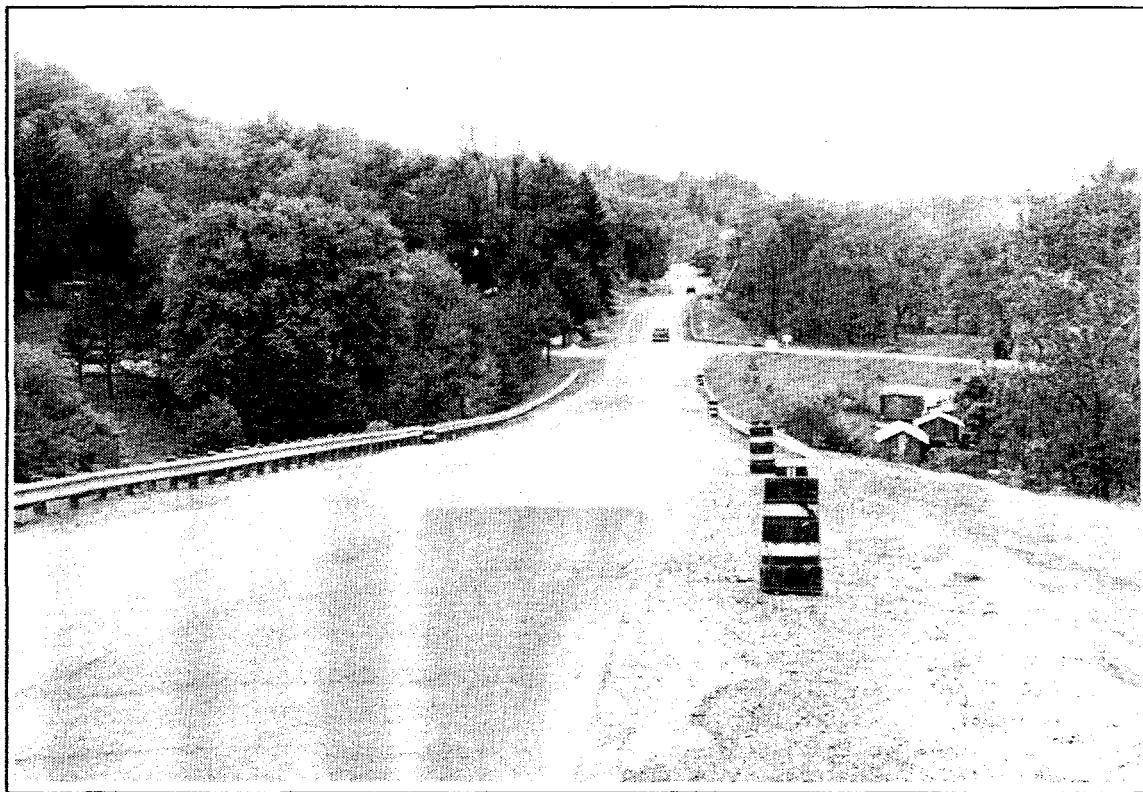
Figure 4. Completed Reconstruction of the SR 541 Embankment

To bring the embankment from this level up the final 5 meters, a grayish-brown clay shale was hauled from a borrow area two miles west of the construction site. This material has strength properties significantly higher than the original embankment material (Appendix). The base course of the repaired area was brought back to original grade in early February and the FGD by-product was mixed with aggregate to form a temporary wearing course which is shown in Figure 4. The road opened to traffic in March 1994.

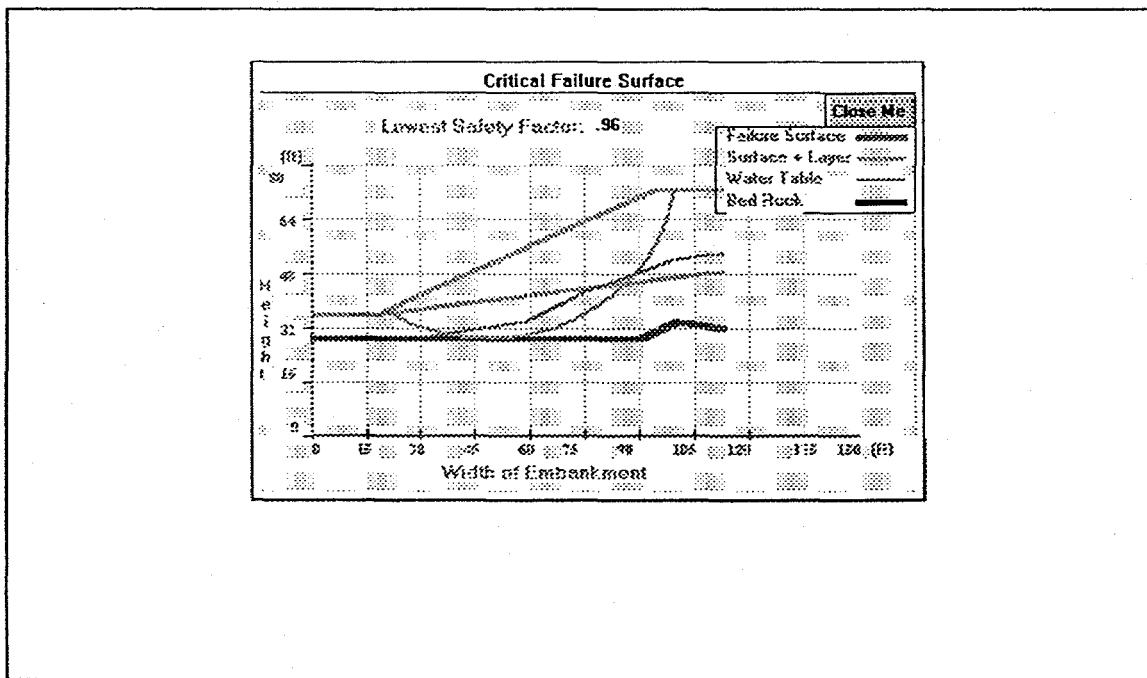
The failure of the SR 541 slope can most likely be attributed to an increase over time of the amount of water present in the embankment soils. Loss of soil strength that can be attributed to the absorption of water and the development of increased pore water pressure has been shown to be a likely cause of slope instability. Slope stability analyses were performed on the embankment profile at conditions just before the slip occurred. The material properties used in the analysis are presented in Table 1. The computer program PC STABL (Lovell, 1988) was used to perform the appropriate calculations. In its normal analytical mode, PC STABL generates a series of potential failure surfaces, each with a calculated factor of safety after all of the necessary geometric and soil data are input. However, the program also allows the user to specify a particular failure surface from which a corresponding factor of safety can be calculated. This proved to be useful when comparing the factors of safety for similar failure surfaces before and after the installation of the FGD sections. Furthermore, as the program allows for heterogeneous soils systems, anisotropic soil strength properties, excess pore water pressure due to shear, and static ground water tables, actual field conditions usually do not need to be oversimplified, (Kim, 1994).

Figure 5 shows the most critical failure surface with respect to the original embankment configuration and the estimated location of the water table. This computed failure surface, with a calculated factor of safety of 0.96 (failure is imminent when the factor of safety approaches 1.0), is nearly identical to the one that actually occurred.

Figure 5. SR 541 Embankment, critical failure surfaces.

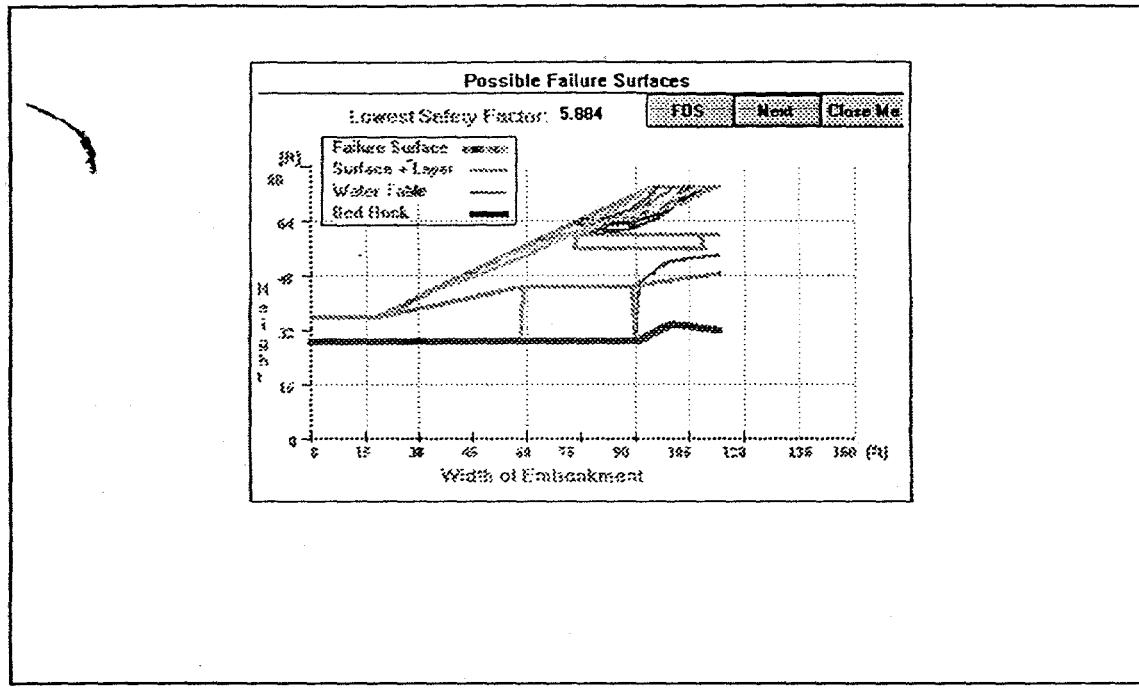
In a second analysis, the weak soil near the base of the slide was replaced by compacted FGD ash. The water table in this calculation was left at its original elevation assumed for the failed section discussed in the previous paragraph, but was quickly lowered once it made contact with the drainage material adjacent to the FGD by-product buttress. Water not intercepted by the filter is assumed to go around the buttress and exit at either the eastern or western edges of the slope. The program is limited to two-dimensional analysis, therefore the water table was simply lowered to the bottom edge of the buttress and maintained at that elevation. Figures 6 and 7 depict the profile of the embankment with the FGD by-product layers included. In Figure 6 the critical surface has been forced out of the FGD and as a result is a much shallower circle with a calculated minimum factor of safety of nearly ten. In Figure 7 the original failure surface shown in Figure 4 was specified for the reconstructed embankment and a new Factor of Safety was calculated which clearly much greater than as likely failure surfaces are now forced out of the FGD by-product.

Figure 6. SR 541 Embankment with FGD By-product, critical failure surfaces.

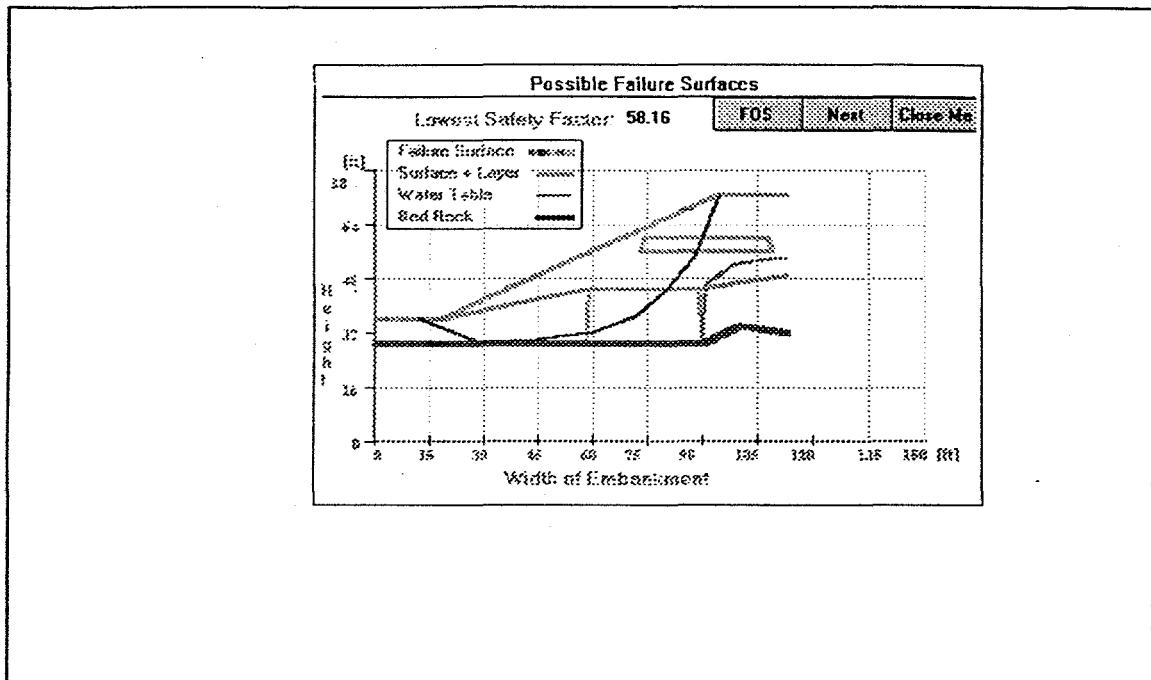
Figure 7. Factor of Safety for Failure Surface Passing Through FGD Buttress
