ENGINEERING DATA TRANSMITTAL

1998 FFTF Annual System Assessment Reports

Abstract: The health of FFTF systems was assessed assuming a continued facility standby condition. The review was accomplished in accordance with the guidelines of FFTF-EI-083, "Plant Evaluation Program." The attached document includes an executive summary of the significant conclusions and assessment reports for each system evaluated.

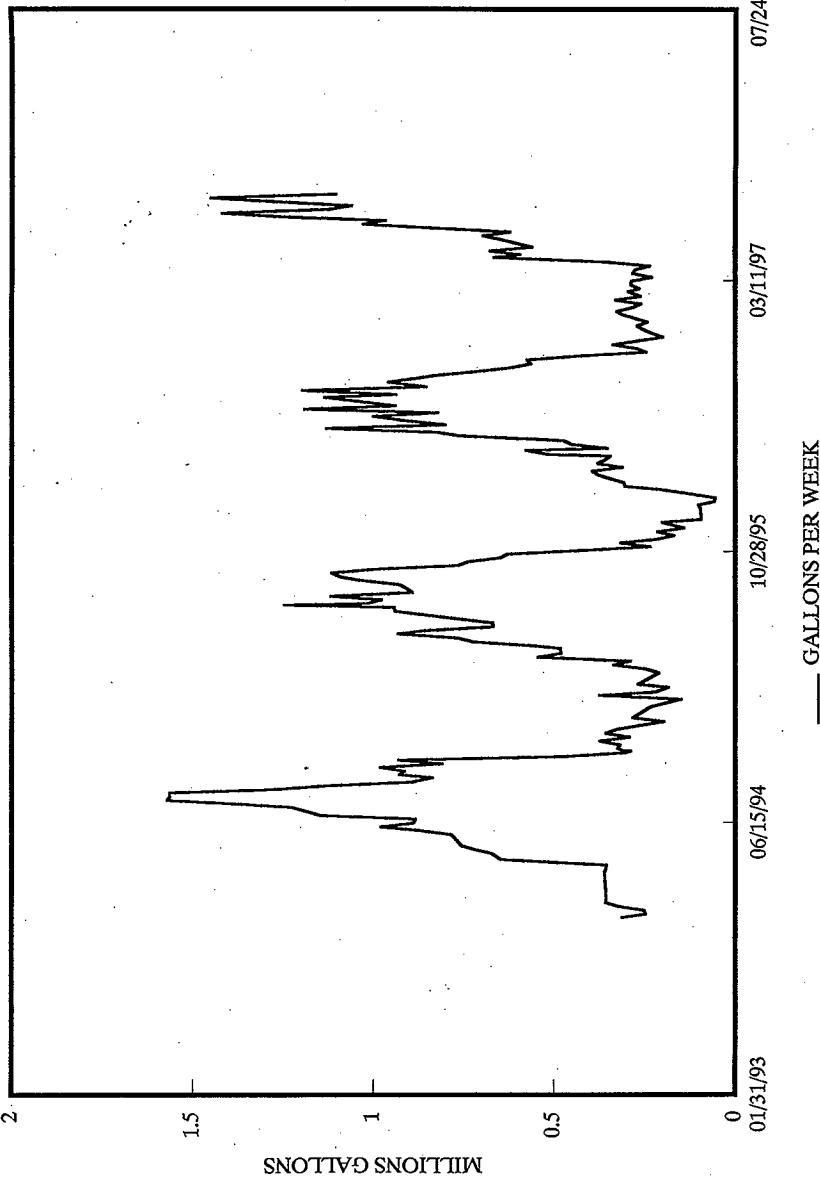
400 AREA WATER DEMAND
GALLONS PER WEEK 01/94 to 08/97

See the attached graph of 400 area water demand 01/94 to 08/97.

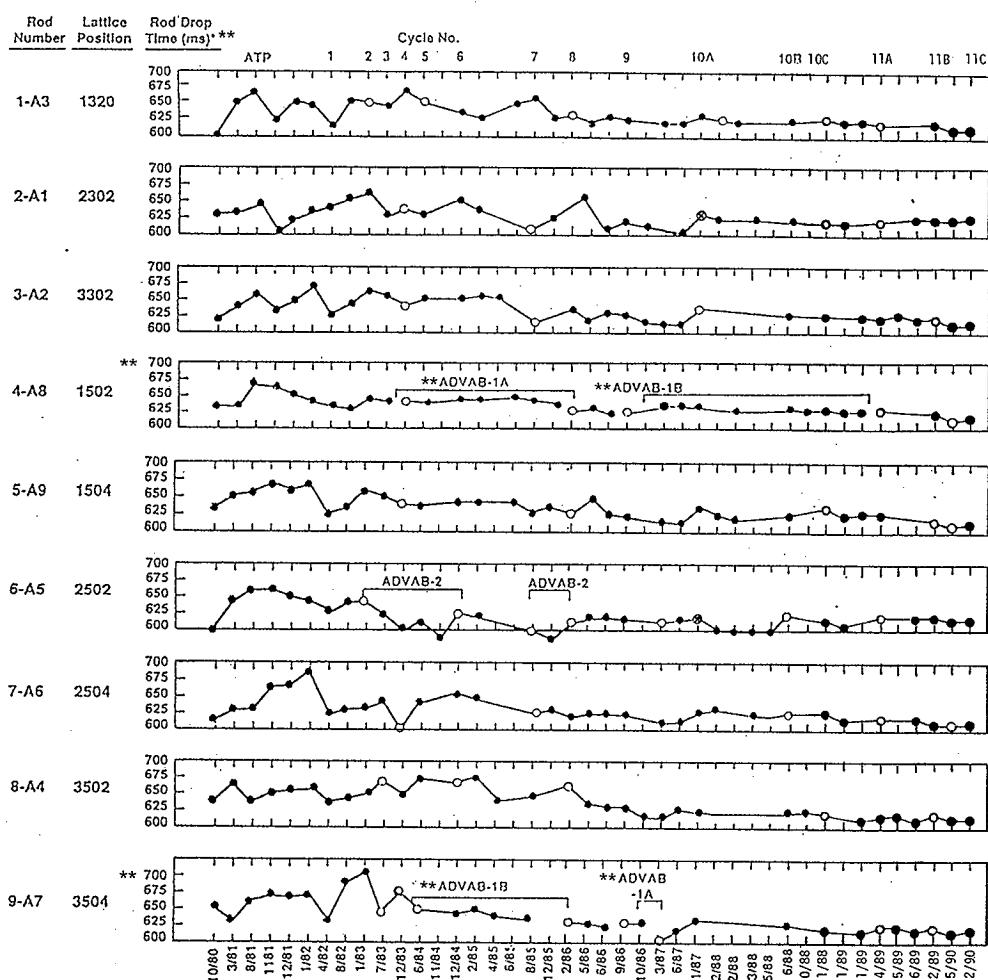
Figure 1 Control Rod Insertion Time.

- Tech Specs Limit is 836 ms.
- Indicates Control Rod Replacement.
- ◊ Indicates Control Rod Exchange.

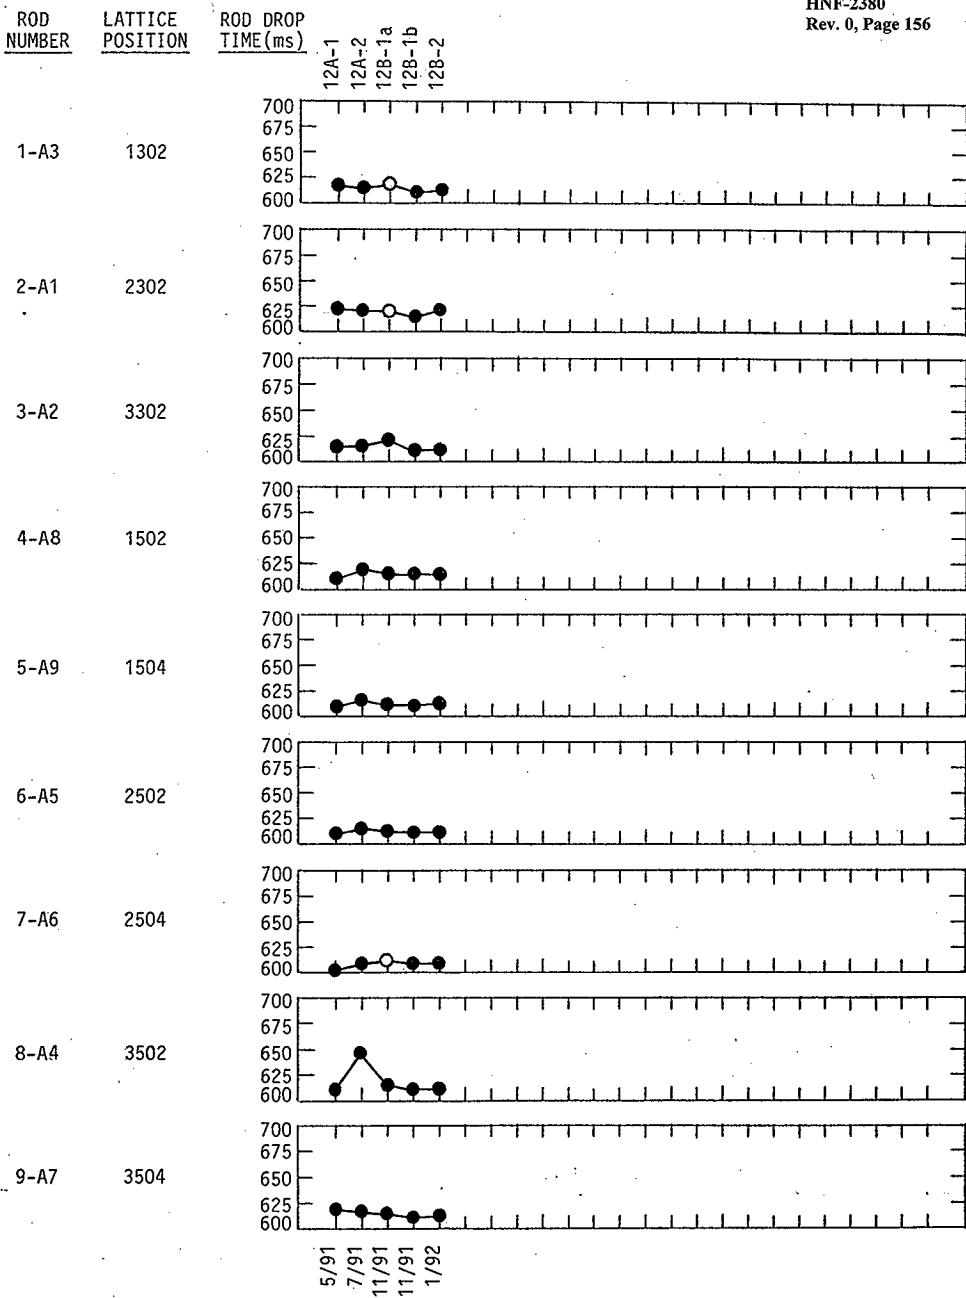
FIGURE 1 (Cont'd)

CONTROL ROD INSERTION TIMES
