# **WHC Significant Lessons Learned 1993-1995**

Date Published  
February 1996

**Westinghouse  
Hanford Company**

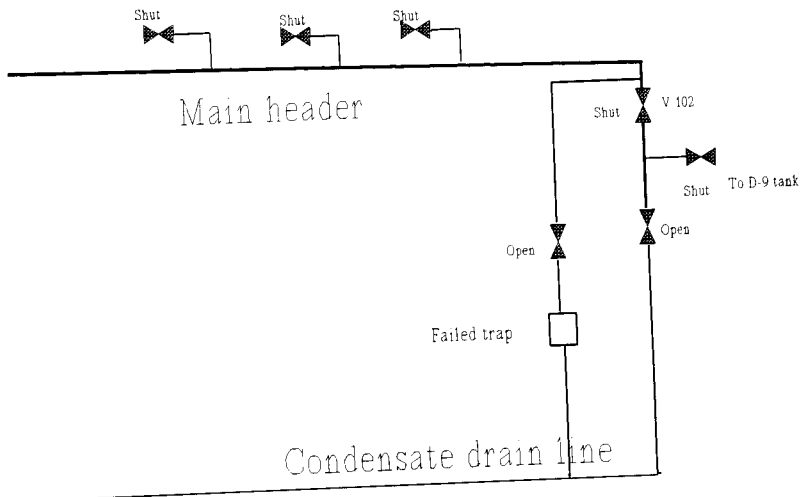
Steam System Schematic

CONDENSATION INDUCED WATER HAMMER STRIKES AGAIN

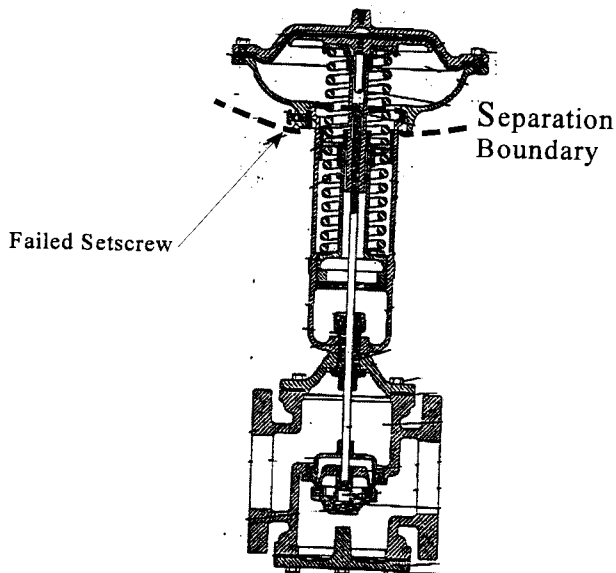
**TEMPERATURE CONTROL VALVE FAILS DURING REFURBISHMENT**
