Document #: SD-TD-TRP-005

POST DELIVERY TEST REPORT FOR THE LDUA OPTICAL  
ALIGNMENT SYS

## Post Delivery Test Report for the Light Duty Utility Arm Optical Alignment System (OAS)

Allan F. Pardini

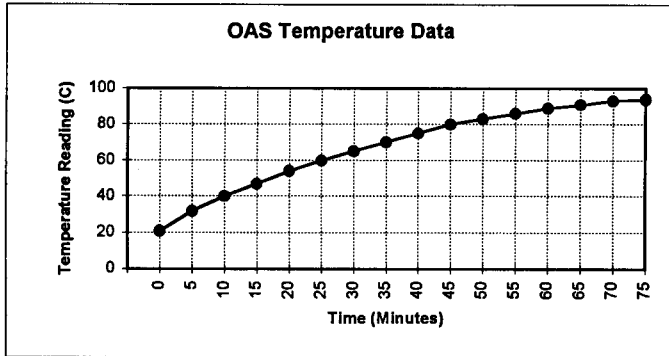
**FIGURE 2 OAS TEMPERATURE DATA**

Exception #3: In procedure step #14, during the temperature test, the line lasers stopped working. This occurred when the temperature rose to around 70 °C. All other systems (dot lasers, proximity lasers, and camera) functioned normally at the maximum temperature of 94 °C. It has been noted that the line lasers are not mandatory for OAS alignment during LDUA operations. Therefore this exception is resolved in that the line lasers do not need to be available for LDUA alignment. In all actuality, during the alignment process, the lighting system will be used very sparingly and only one or two sets of lights (2 light pairs) will be on for short durations of time. The OAS will not get nearly as hot as during this test, therefore the line lasers will probably be available for riser alignment if needed. The line lasers function normally after they have cooled down.

The temperature test in step #14 provided verification that the maximum external temperature of the protected enclosure was below the autoignition temperature of the flammable gas within the waste tank. The gas of concern in Hanford's waste tanks has been hydrogen which has an autoignition temperature of 520 °C. Figure 2 is a graphical display of the temperature rise of the OAS end effector until the temperature stabilized. The maximum temperature reached during the test was 94 °C. This value is far below the autoignition temperature of hydrogen.

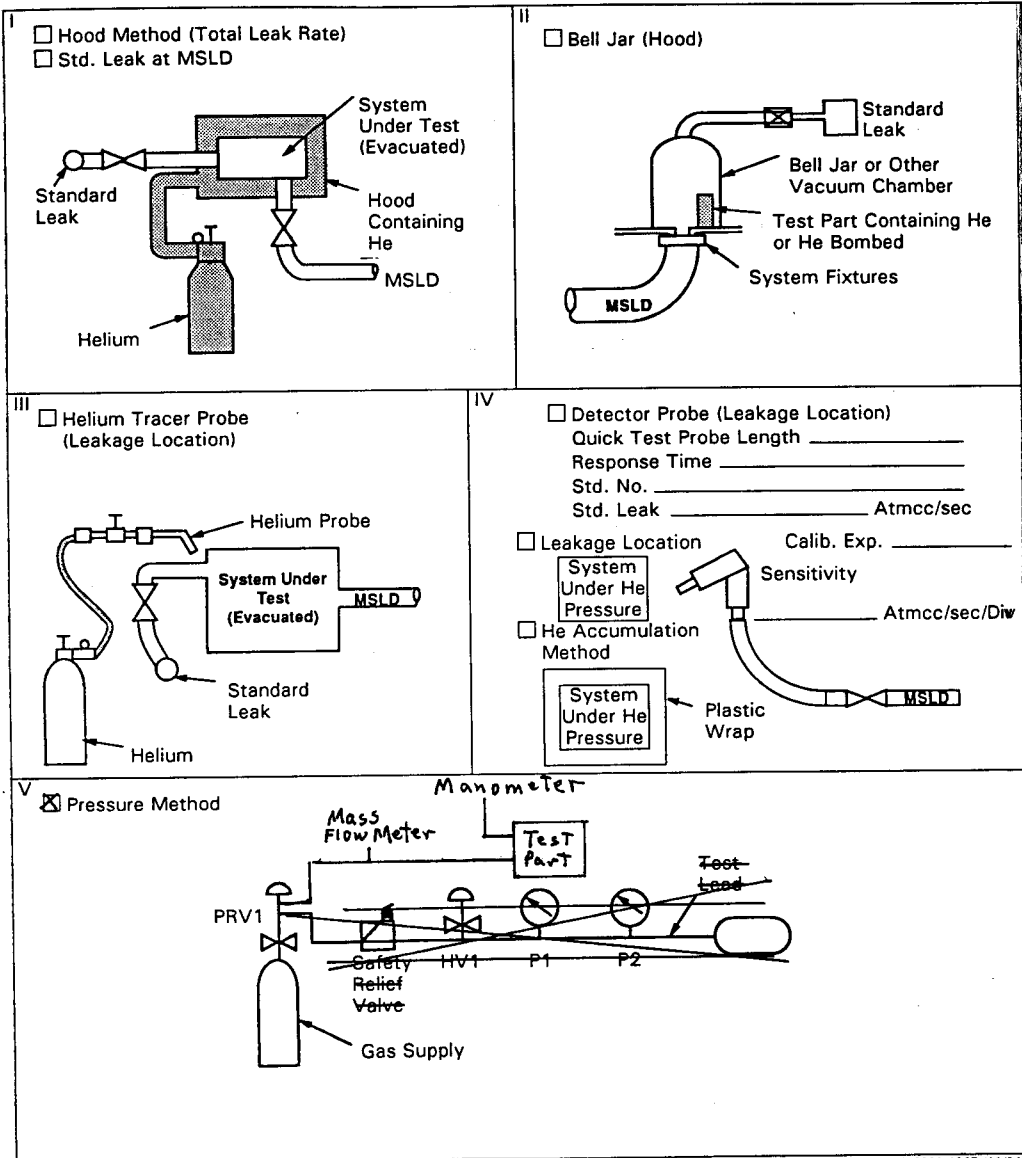
4-1-96

LUDA, Optical Alignment System (OAS)Manometer 534-28-09-005 Exp. 3-12-99 0-10 in. H<sub>2</sub>O

Positive and Negative Pressure Test of 7 in. H<sub>2</sub>O appeared  
to cause no damage.

end of the OAS. The LDUA team may consider it acceptable to use a high temperature sealant and seal the lower o-ring joint at a later time. This will still allow the OAS to be separated at the mid point joint for maintenance purposes.
