ANALYSIS OF COMPOSITE TUBE CRACKING IN RECOVERY BOILER FLOORS *

J. R. Keiser, B. Taljat, X.-L. Wang, P. J. Maziasz,
 C. R. Hubbard, and R. W. Swindeman
 Oak Ridge National Laboratory
 Oak Ridge, Tennessee

D. L. Singbeil and R. Prescott
 Pulp and Paper Research Institute of Canada
 Vancouver, British Columbia

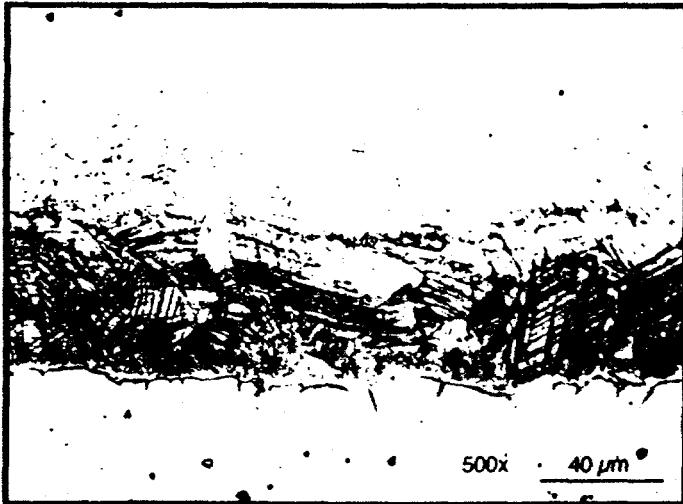
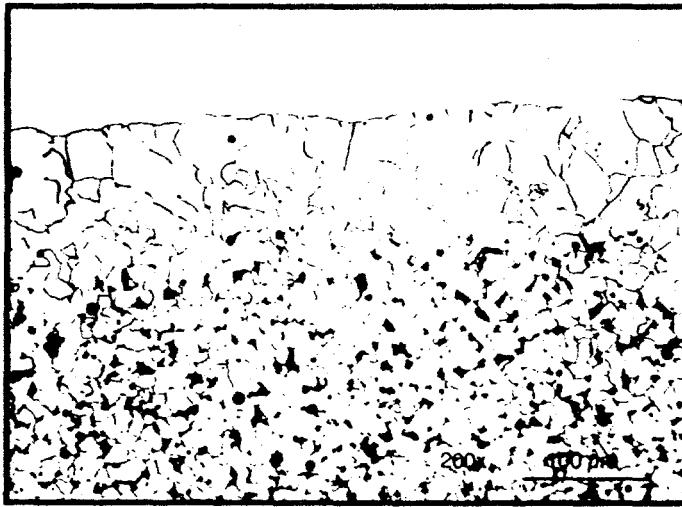
The stainless steel/carbon steel interfaces on all of the samples showed a characteristic pattern with an 80-100 μm thick decarburized zone in the carbon steel adjacent to the stainless steel/carbon steel interface along with a region in the stainless steel adjacent to the interface containing a high concentration of precipitates. Micrographs of these two areas are shown in Fig. 1.

Fig. 1. Micrographs of 304L/SA210 composite tube near the stainless steel/carbon steel interface showing a) carbide precipitates in stainless steel (aqua regia etch) and b) decarburized region in carbon steel (2% nital etch).

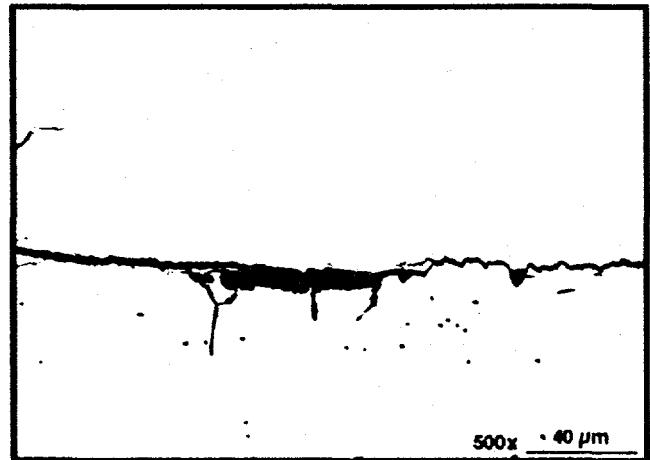
Fig. 6. Micrograph showing cracks in cross section of sample from panel in Fig. 5. Note intergranular attack in the carbon steel.

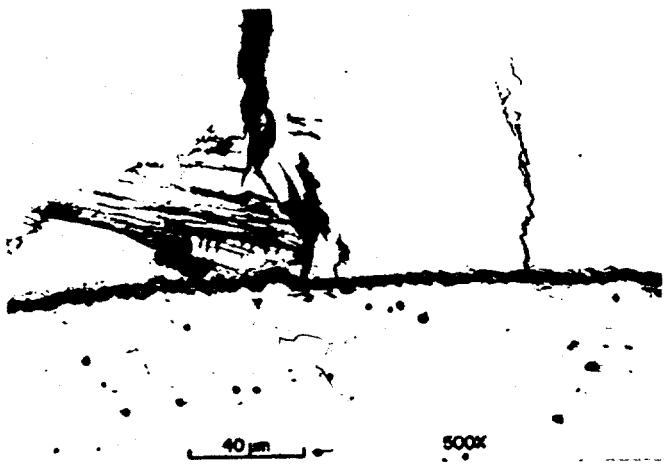
Fig. 8. Micrograph showing cracks in cross section of sample from tube in Fig. 7. Note intergranular attack in the carbon steel.

The intergranular cracks in the carbon steel, while not extensions of existing transgranular cracks in the stainless steel, should be viewed with some concern. Apparently another cracking mode, possibly caustic stress corrosion cracking, can be active in the region beneath the cracks that parallel the interface. Chemical

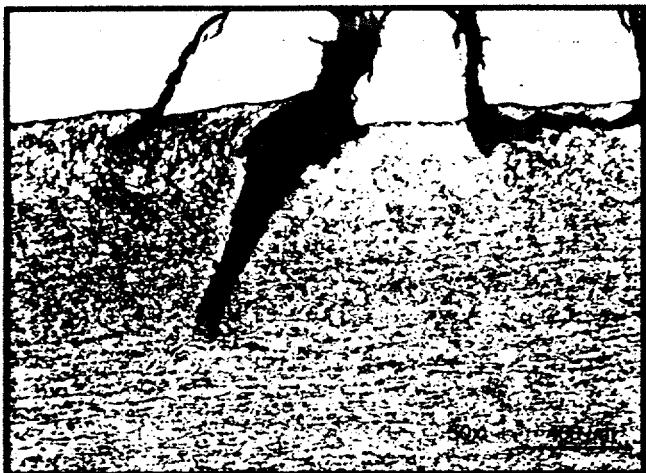
analyses of the corrosion product in the intergranular cracks showed low levels of sulfur and chlorine and appreciable amounts of oxygen. There is also reason to be concerned about the pitting that is sometimes observed in the carbon steel; an extreme example of pitting, in this case for a smelt spout opening tube from an European mill, is shown in Fig. 9. In this tube, the corrosion pits extend approximately 0.8 mm into the carbon steel.

Fig. 9. Micrograph showing severe corrosion pitting in carbon steel of composite tube from Scandinavian boiler.

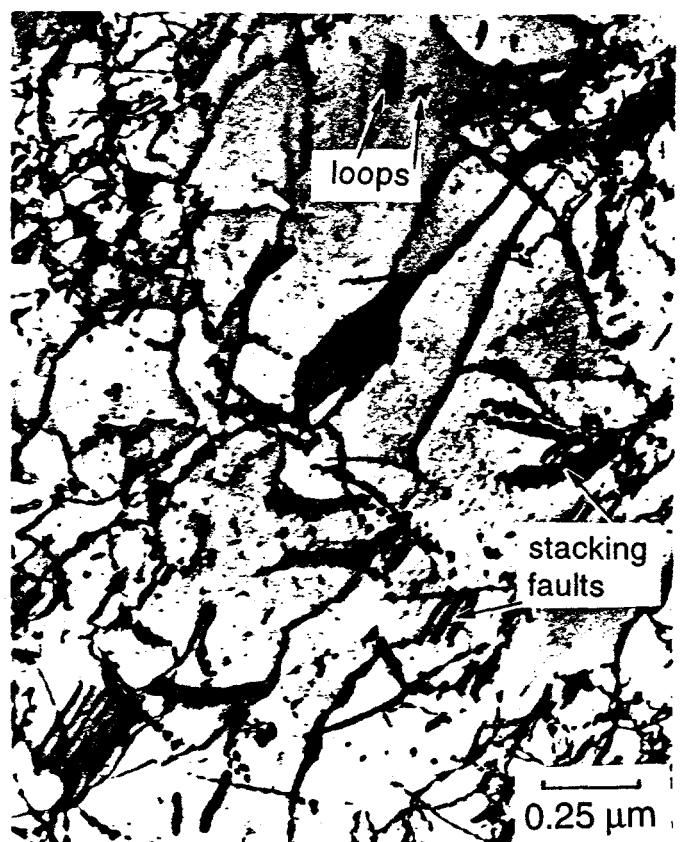
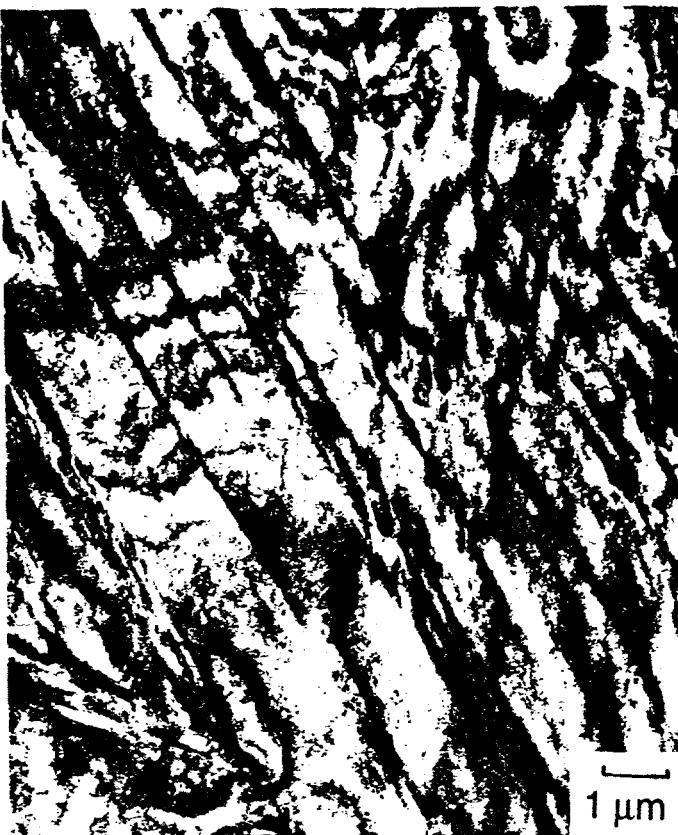
Fig. 12. Dislocation structure in sample taken from cracked tube in smelt spout opening of Scandinavian boiler after extended operation.

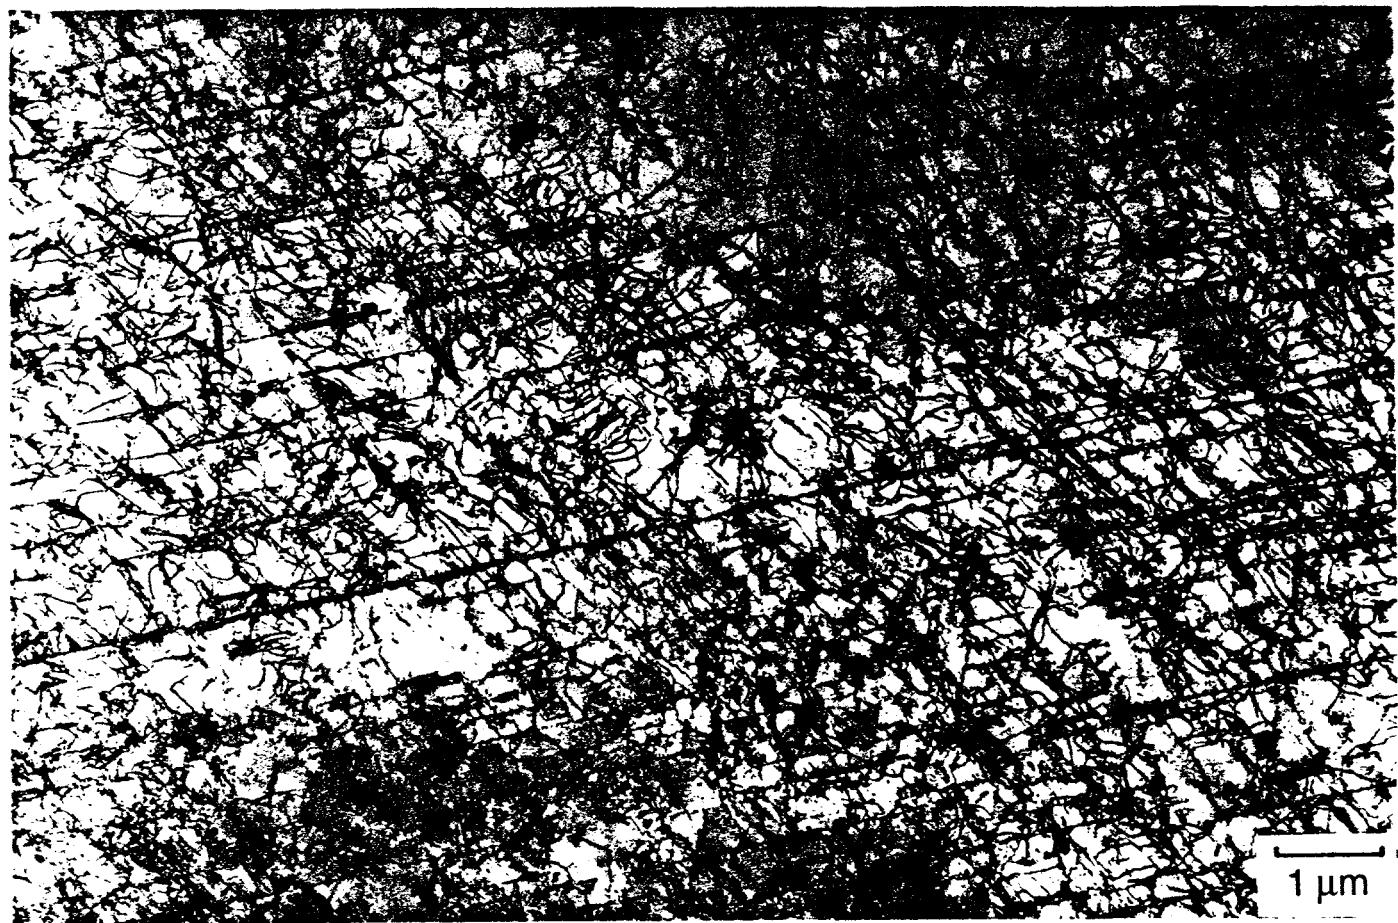
Fig. 13. Dislocation structure in sample taken from cracked floor tube of North American boiler after 18 months of operation.

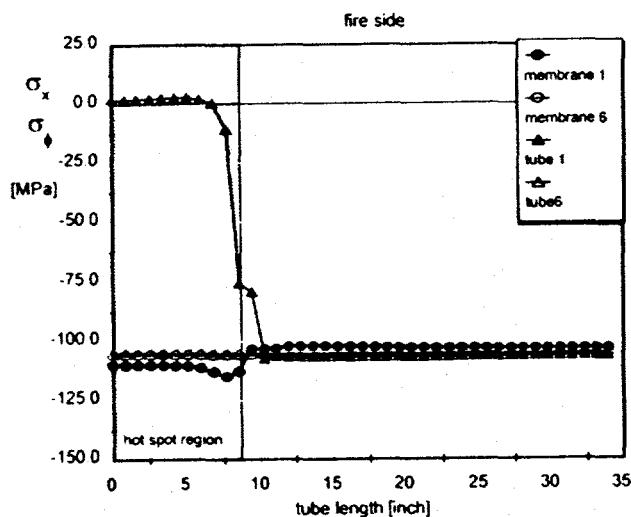
Fig. 18. Tangential stresses developed as the result of a crown hot spot in a 304L/SA210 composite tube panel for a tube and membrane in the hot spot (#1) and a tube and membrane away from the hot spot (#6).
