SNAP 10A-PSM-1 TEST RESULTS

By
R.M. OLIVA

CONTRACT: AT(11-1)-GEN-8
ISSUED: JUL 15 1964

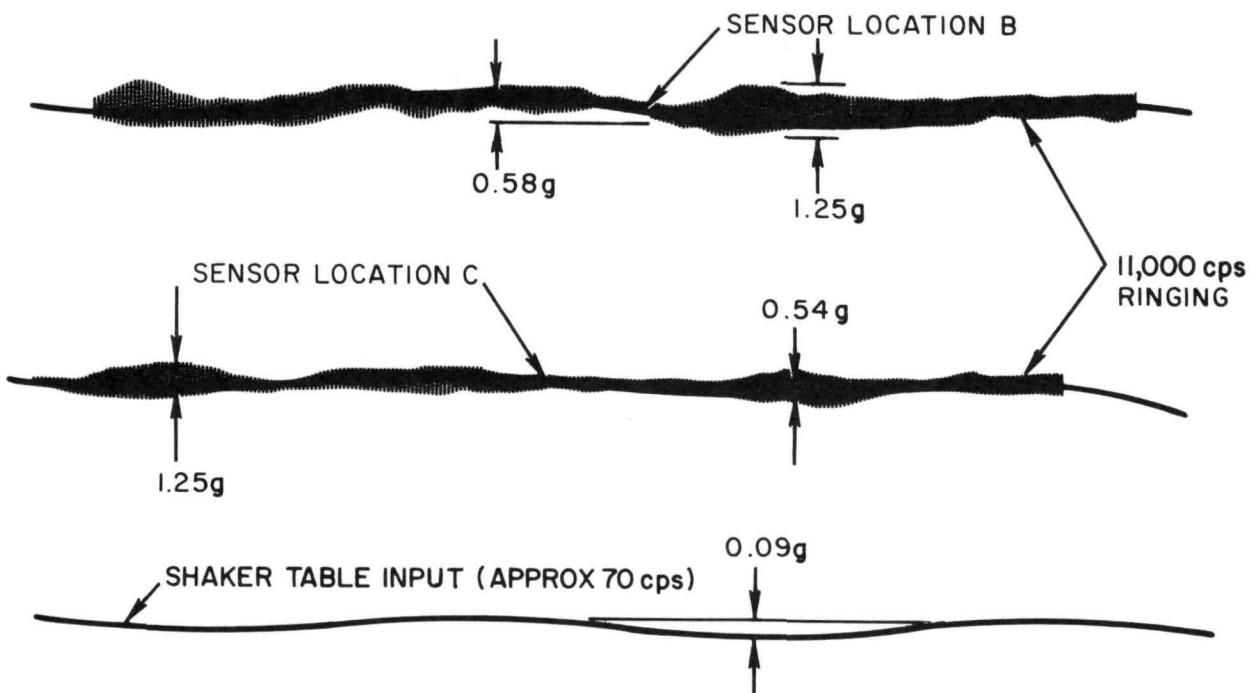
While all sensors on the lower ring of the shield displayed readings of the same order of magnitude, these same readings were not in agreement with other locations observed on the shield. The effect of whatever malfunction had occurred, therefore, could be pinpointed to the general area of the shield lower ring. To get a better look at what was occurring at the lower ring locations, a run was made at high recorder speed for more efficient analysis of the output trace. It was observed that the fundamental response of the shield was still in good agreement with the reactor and converter shell response monitor points, 7 and 126. However, a 11,000 cps ringing was superimposed on the fundamental curve; the ringing pattern repeating itself on each cycle. Figure 4 reproduces a portion of the record showing the high-frequency shield-ring response.

Usually, the source of high-frequency response from low-frequency input, as noted on the shield, is the result of loose parts hammering or rattling in or on a structure. At this point in the test, it was deduced that somehow the lithium hydride mass in the shield had become loose and was bouncing on the steel support straps which in turn dumped the ringing response into the shield housing at the lower ring. Because internal shield damage was almost a certainty, the unit was replaced with a dummy. Prior to removal, one lateral test run was made on the vehicle to check the system for lateral first fundamental mode frequency and to gather data on magnification factors at various vehicle locations. The test was intended not to rule out the need for shield removal but rather to obtain the noted data with the actual shield still in place.

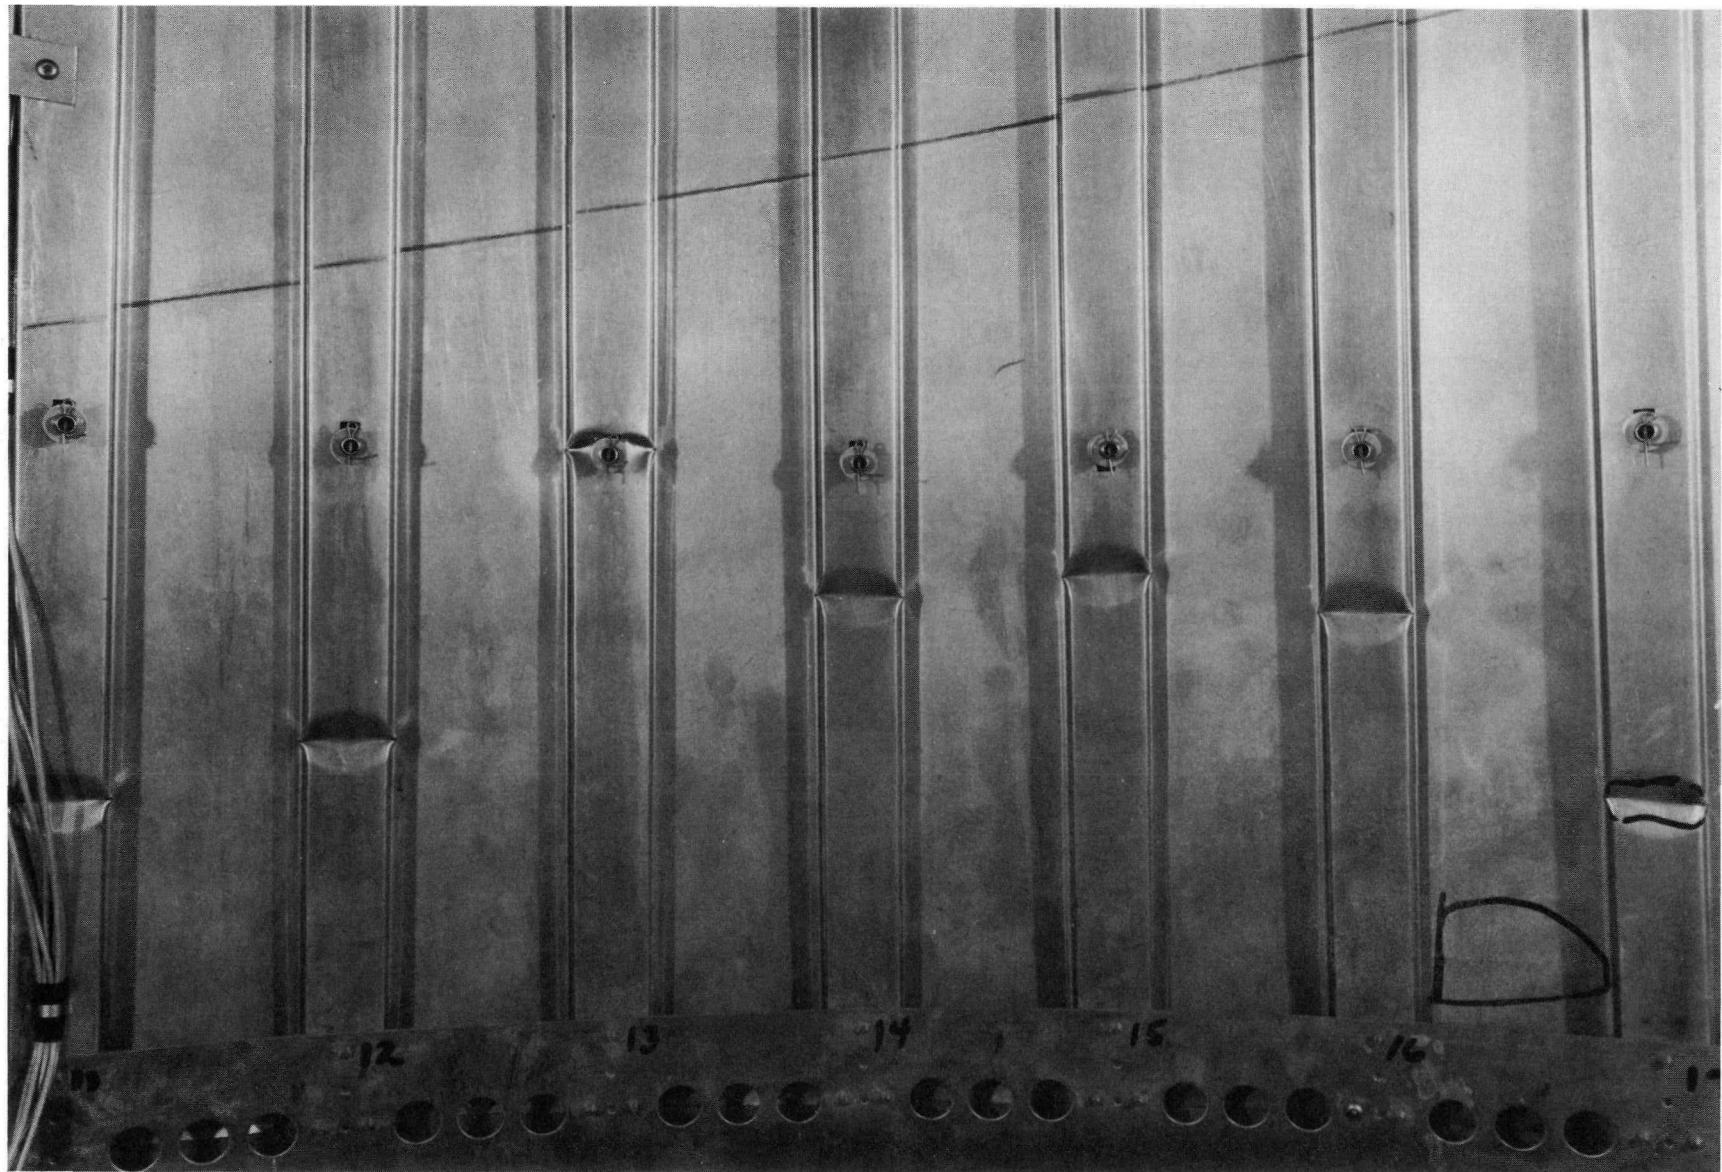
Figure 6. Damaged Converter Structure (Part 1)

Using the same sensor locations as in the 50% run and the same monitoring locations and techniques, a 100% run was started. Because the first fundamental natural frequency of the 30,000-lb vibration shaker and the large slip table as a combined system occurs between 7 and 10 cps, testing in the normal attitude was started at 12 cps and scanned at a constant octave sweep rate, which normally would require 25 min for a 5 to 3000-cps sweep. At 38 cps or 5.2 min later, testing was stopped and damage noted. Severe buckling of all converter shell corrugations had occurred near the base of the shell structure and the damage was too extensive to permit continuation of testing Figures (6, 7, and 8).

Testing was stopped at 38 cps, not because damage had been detected, but because the instrument being used to record test results had run out of paper. Until this occurred, there had been no indication of vehicle failure, at least visually. Evaluation of the test record revealed that vehicle center of gravity response limitations had been exceeded. The inadvertent overloading

of the test specimen was traced to the meter used for visually monitoring the most important response location, (No. 7) noted on Figure 3. During testing, this meter failed to give a reading. It was discovered that a small piece of metal casting had fallen into the meter needle mechanism preventing needle motion. The metal particle inside the meter case had been overlooked by the manufacturer.

Repair of the damaged structure was effected; but, because of the structural changes, the remainder of the original test plan was cancelled. The vehicle was then utilized as a test bed for special vibration and acoustic studies.

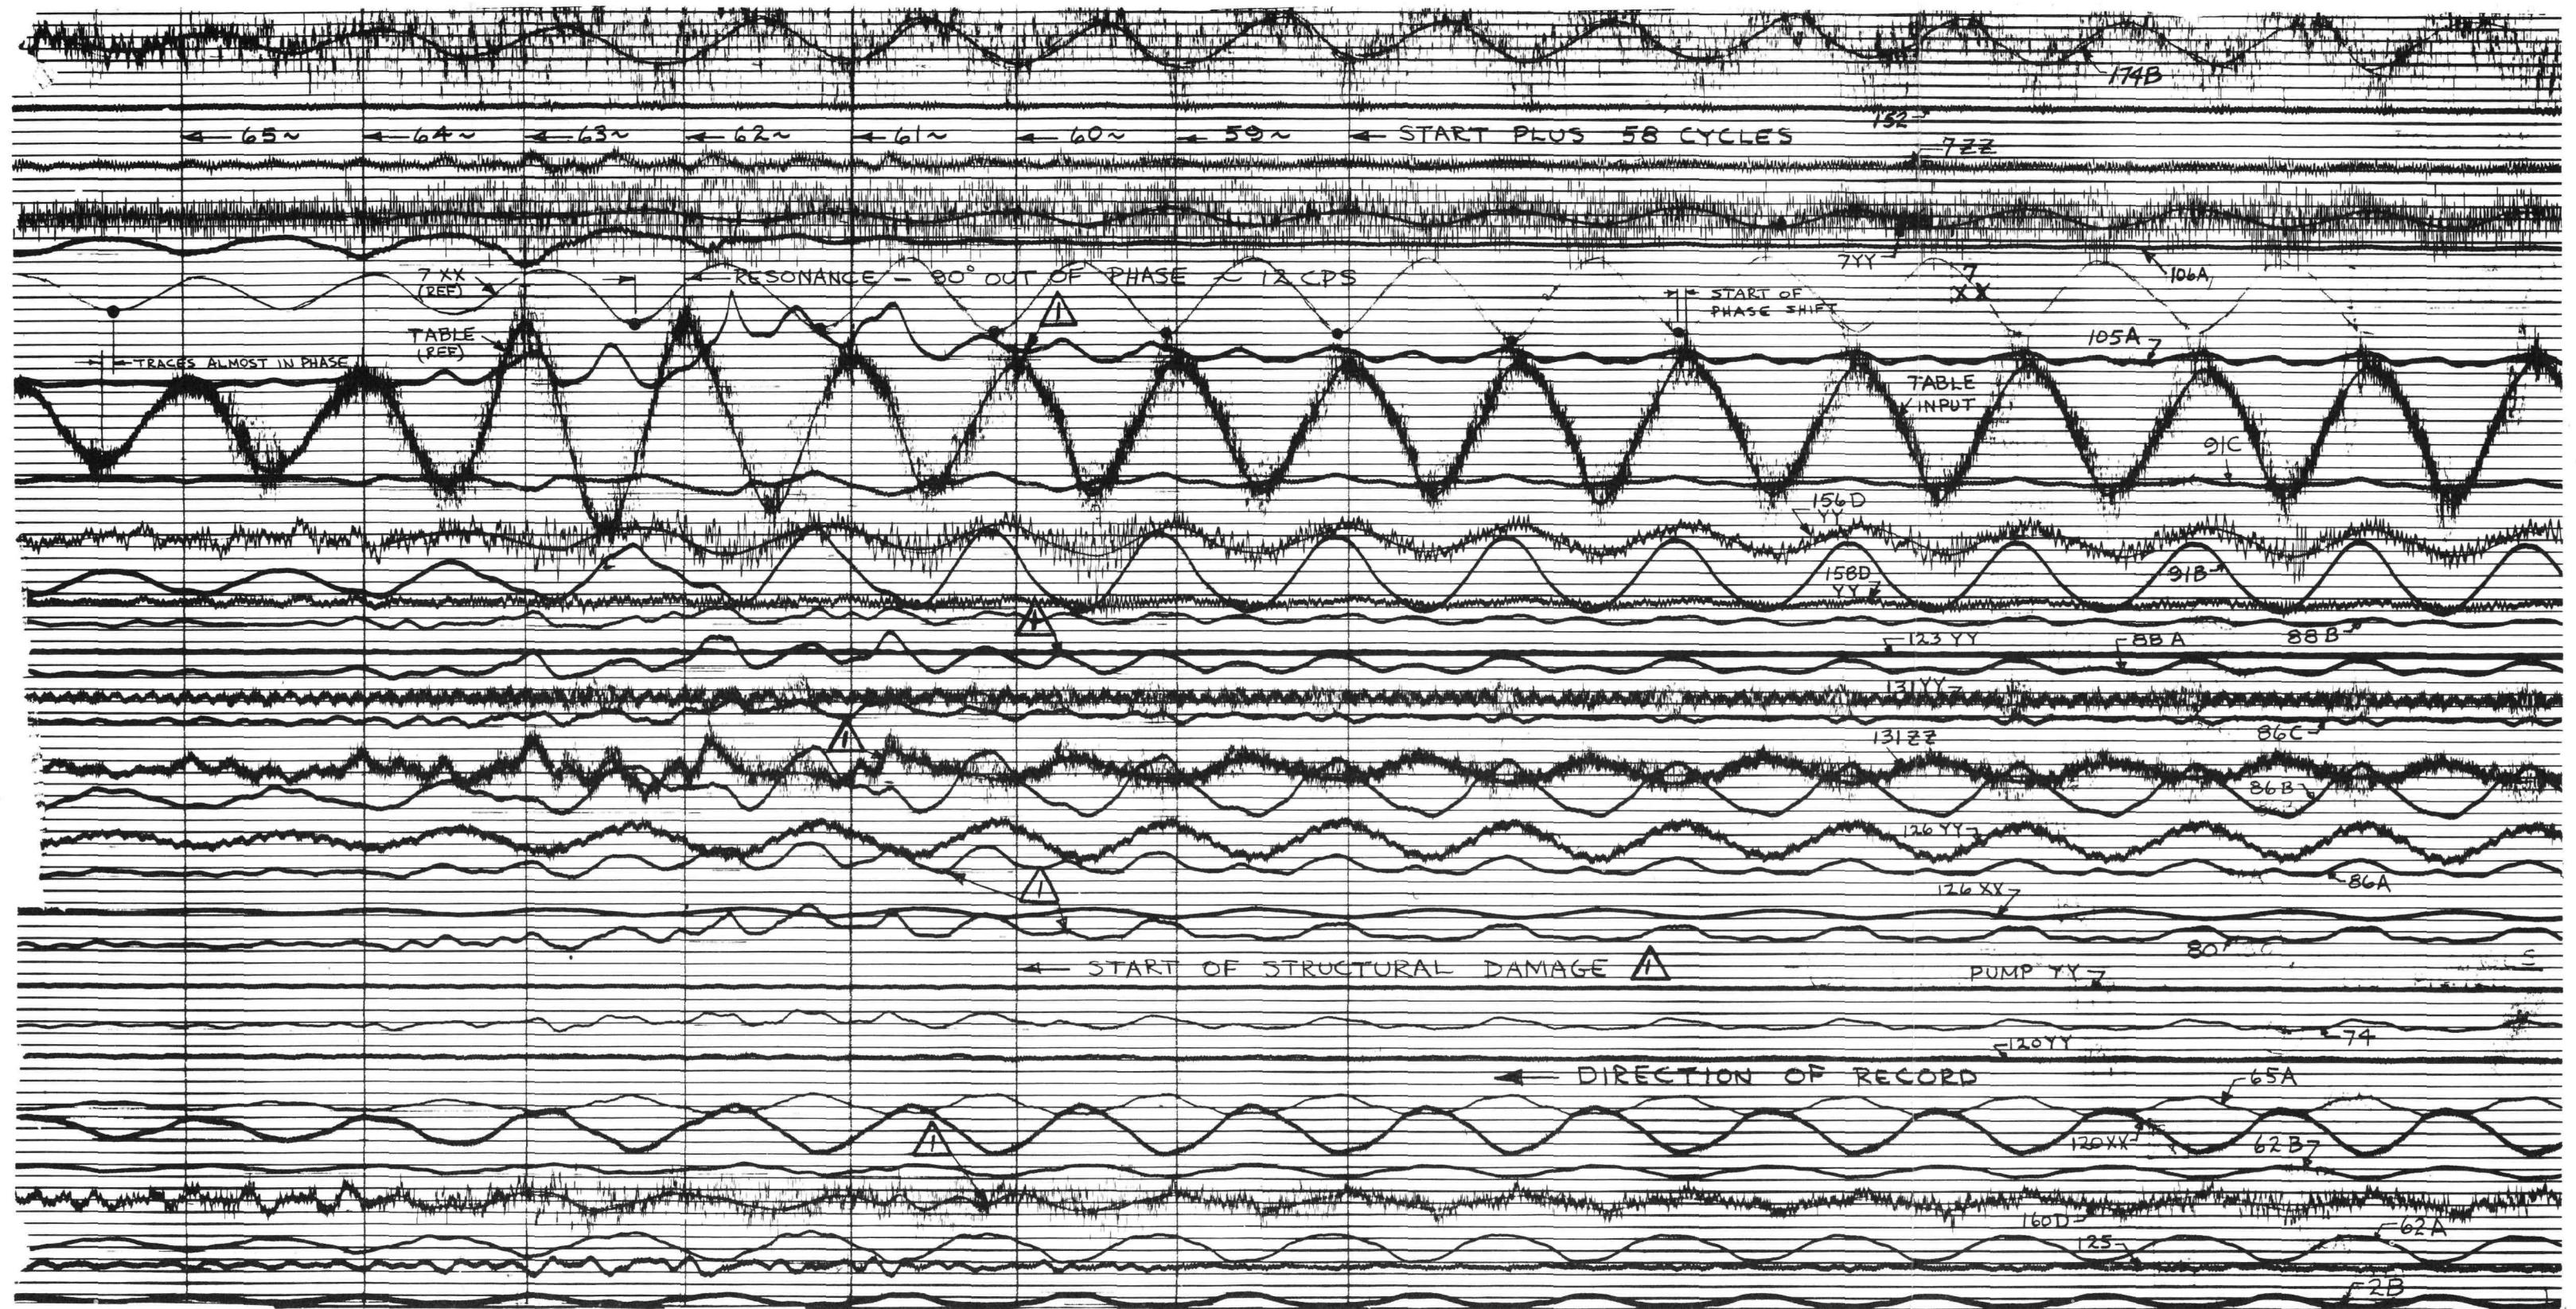
Figure 9. Oscillogram Record of S10A-PSM-1 Failure

Initial failure started exactly 5 sec after the data recording device was turned on. The recorder was started when the input to the vehicle base ring

reached 1.33 g at a frequency of \sim 12 cps, and 60 cycles later the test recorder indicated an occurring failure. Figure 9 reproduces the test run record during structural failure. At 60 cycles discontinuities appeared on most traces and indicated structural damage. The resulting damage was sufficient to drop the vehicle's first fundamental natural frequency from 17 to 12 cps. The upsurge in table input was caused by the fairly constant table input suddenly applied at this new resonance. The equally abrupt drop-off of both table input and vehicle response after resonance was due to rapid passing out of resonance (<4 cycles). Table 18 presents fundamental magnification values at the start of test recording and at various noted points before, during, and after failure. Ringing on various traces is not included in the values shown in the table; their contribution to the total trace can be seen in Figure 9. Table 19 tabulates strain gage data for the test run.

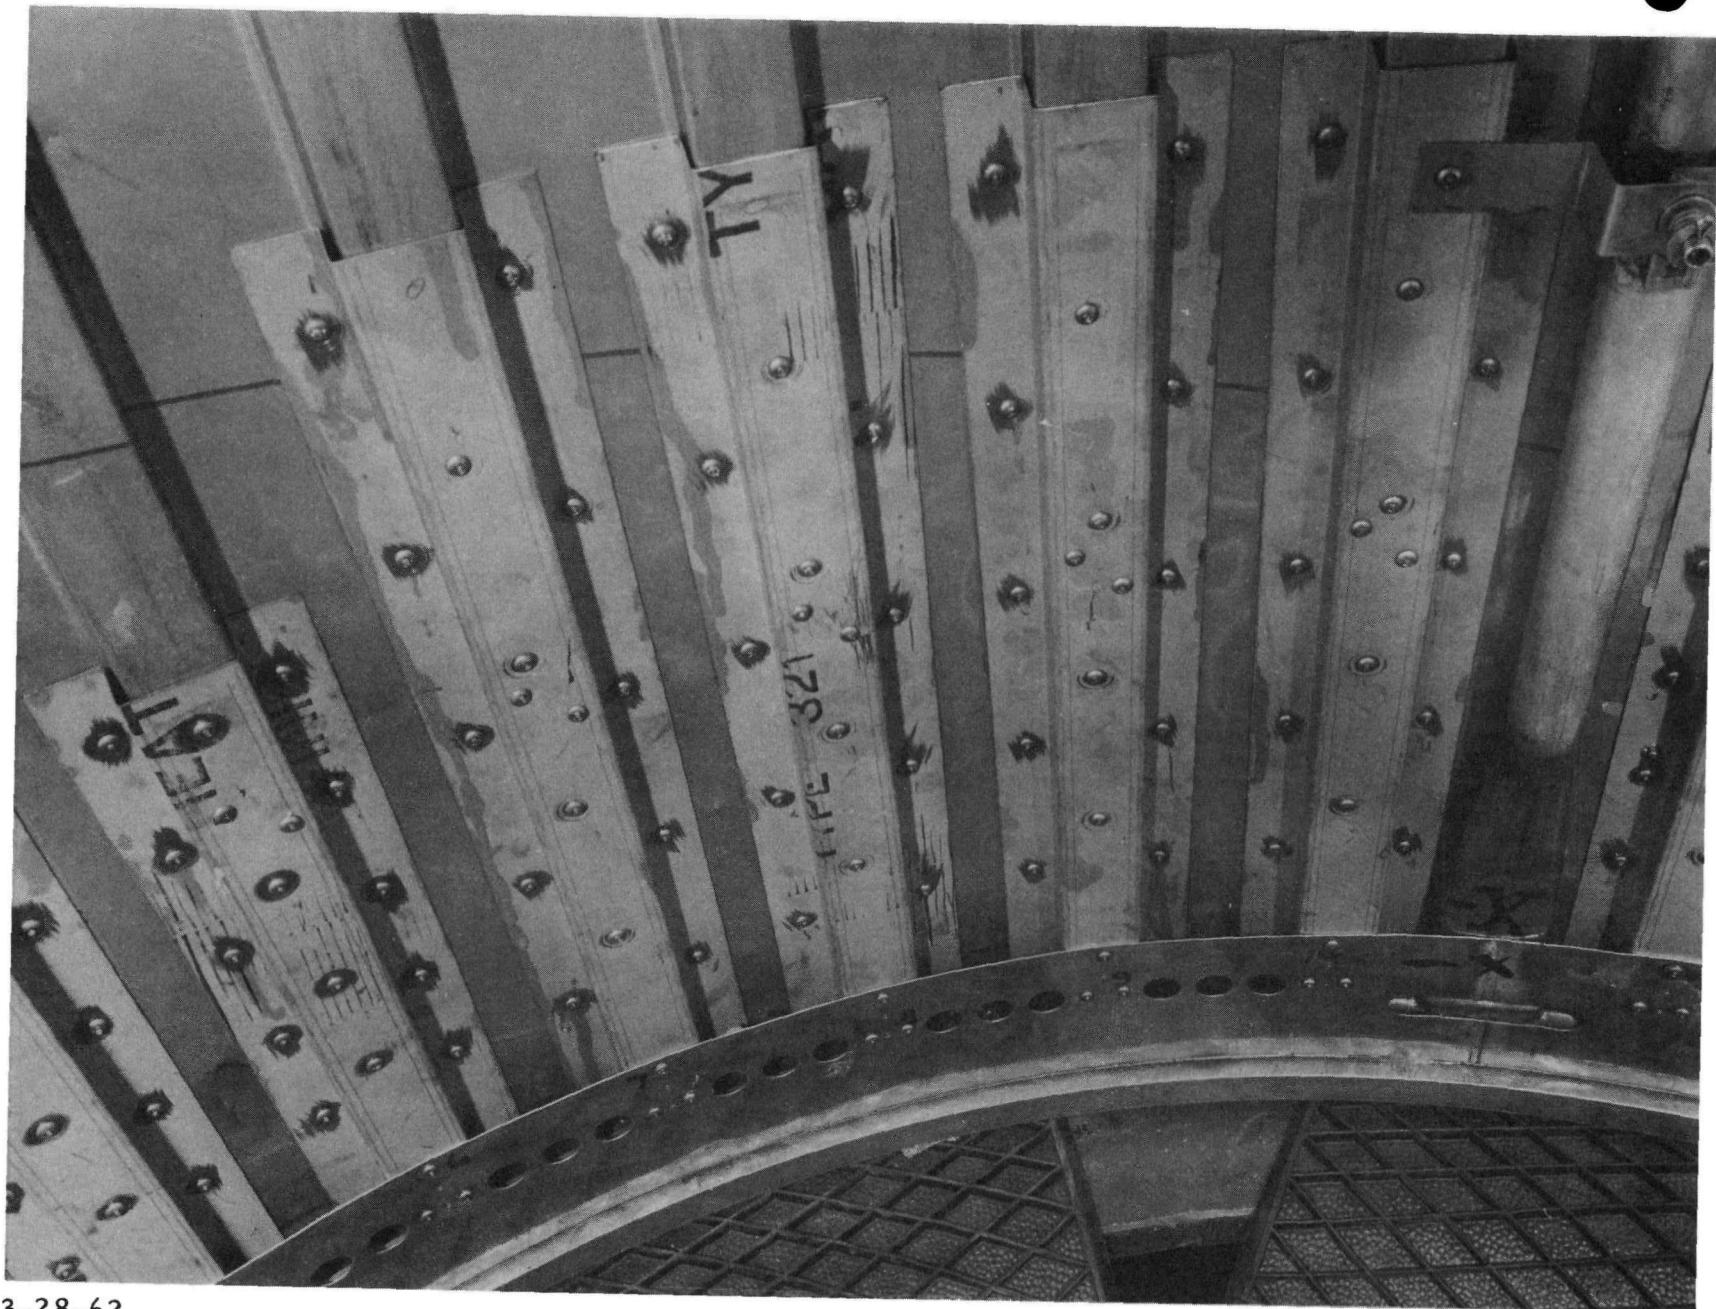
Figure 10. Repair of Damaged Corrugations

No damage to the structure was observed during testing. The cracked portions of the repaired structure were closely observed during testing, and no propagation of the cracks was noted.
