BNWL-CC-1401

CORROSION EVALUATION OF
N REACTOR PRESSURE TUBE 1756

Surface and Coolant Chemistry Section

CHEMISTRY AND CHEMICAL ENGINEERING DEPARTMENT

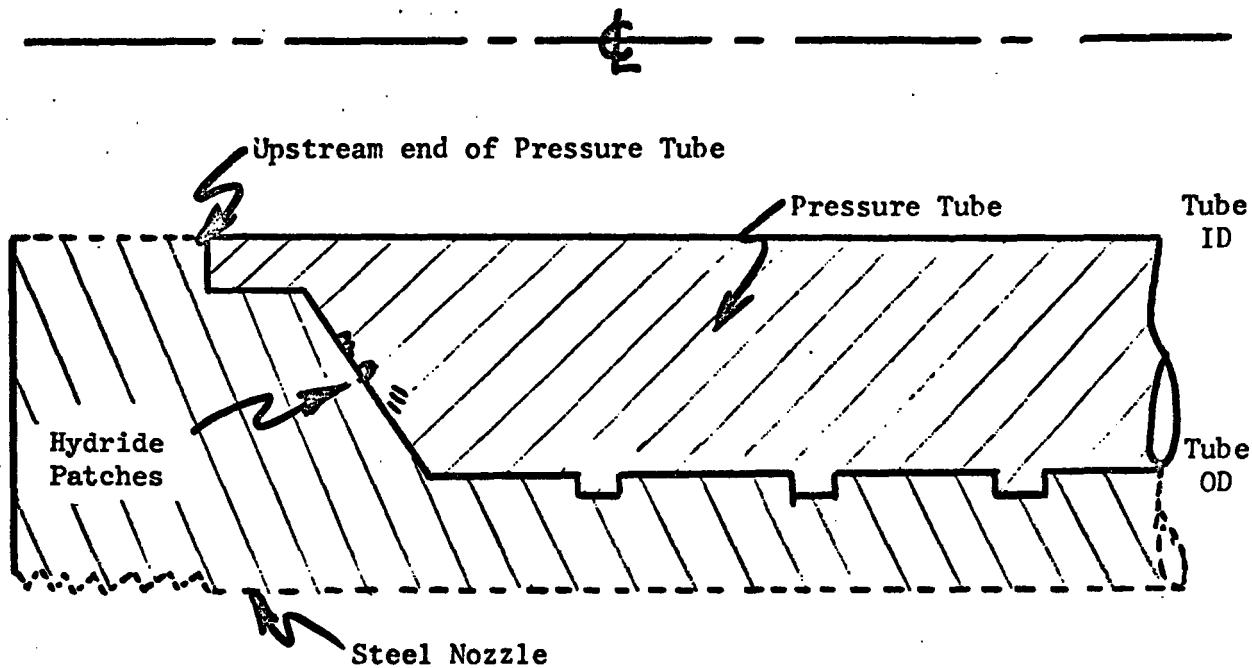
FIGURE 9.

A complete longitudinal metallographic traverse for hydriding was made on the three-inch long front and rear rolled joint sections of the pressure tube. One small area containing three patches of hydride needles was found on the upstream tip of the upstream rolled joint; no other patches of hydriding were found. The largest of the three hydride patches is shown in Figure 9.

The cause of the three small patches of hydride found in the rolled joint area (Figure 9) cannot be clearly explained and is another

item which should be more thoroughly investigated during future tube examination. Possible explanations are (1) the hydride platelets were present before installation, (2) mechanical damage during rolling of the tube into the nozzle allowed corrosion hydrogen to enter at this point, or (3) the hydriding is somehow associated with the contact with the steel nozzle. Small, localized patches of hydride platelets were found by Lerrick in Zircaloy-2 samples in contact with carbon steel in the N Reactor Graphite Cooling System.⁽¹⁰⁾ These Zr-2 samples were rods screwed into threads on a carbon steel cap so that most of the sample protruded into the water coolant stream. The hydride platelets were found on the threads furthest from the water and deepest into the steel cap.

a. Schematic of Rolled Joint Area Containing Hydrides.

b. Largest Patch of Hydride Needles, 500X.

Localized Hydrides in Upstream Rolled Joint Section

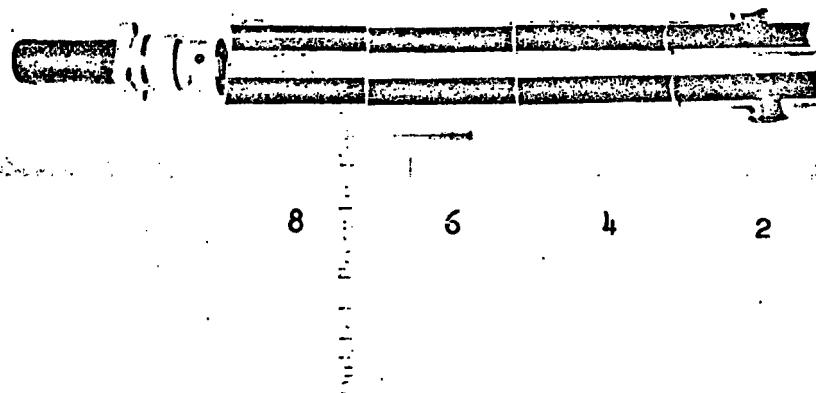
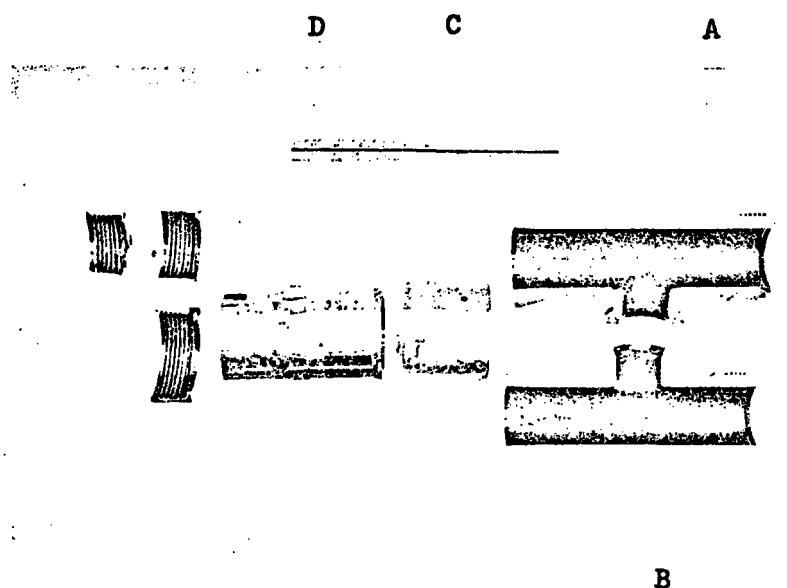
FIGURE 13.

Both front and rear nozzles were cut into 11- to 14-inch long sections and each section was then split longitudinally for examination. Photographs of the split nozzles are shown in Figure 13. Each section is labeled in Figure 13 for identification in subsequent figures. The inside diameters of both nozzles were covered with thousands of broad, shallow pits 1 to 2 mils deep. In many cases these pits had joined to form long shallow lines of attacked area. They tended to be oriented in the direction of metal flow from fabrication. Several more severe pits were also found, mostly associated with areas where fuel spacer feet had been in contact with the nozzles. Figures 14 through 16 show closeup views of the nozzle sections and magnified views of a few of the more severely corroded areas. Measurements on cross sections through the three deepest pits, shown in Figure 17, gave pit sizes of 0.02 in. deep by 0.06 in. wide for one pit; 0.026 in. deep by 0.145 in. wide for another pit, and 0.002 in. deep by 0.0675 in. wide for the third pit. Most of the pitting is attributed to exposure to oxygenated, filtered water which was passed through the reactor for about a six week period before reactor startup. This water is typically quite corrosive to steel.

Both nozzles had tightly adherent, dull-black, uniformly-thick oxides. The oxides in the pitted areas looked very similar to the oxides at the non-corroded area; indicating that the pitting corrosion which occurred during exposure to semitreated water before startup was no longer active.

N-Reactor Nozzles and Identification.

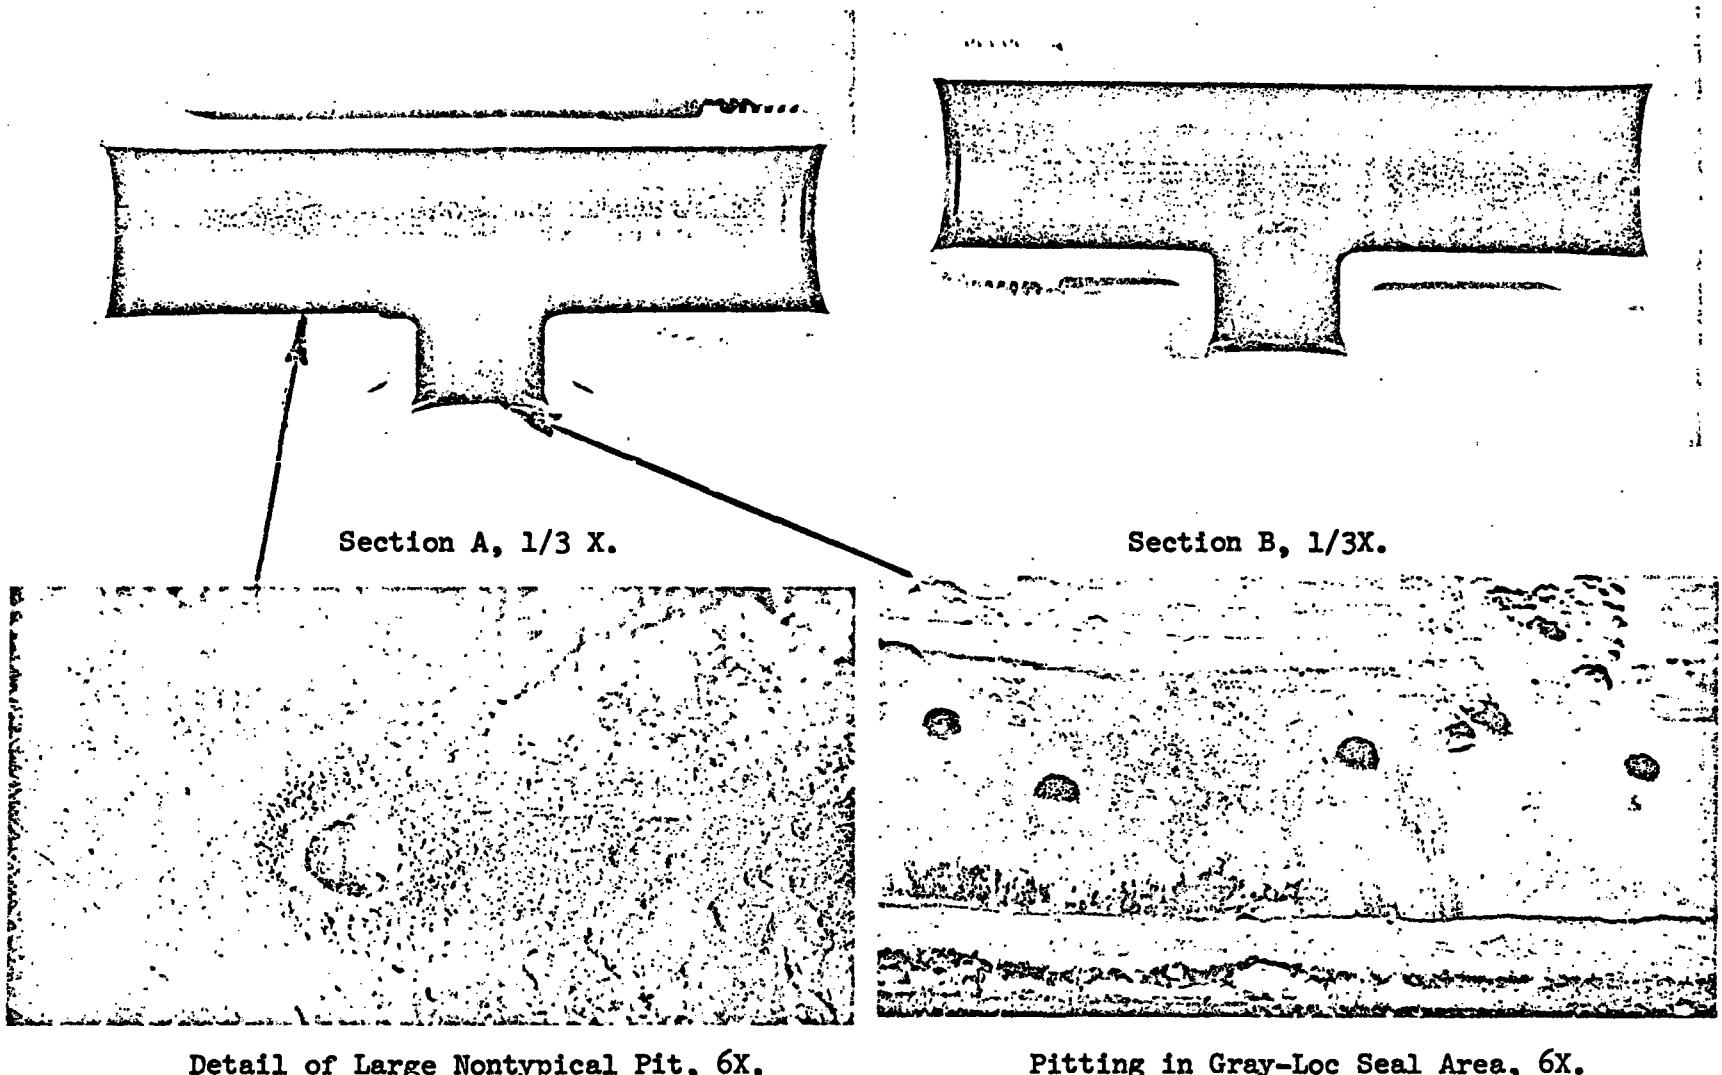
Detail of Large Nontypical Pit, 6X.

Pitting in Gray-Loc Seal Area, 6X.

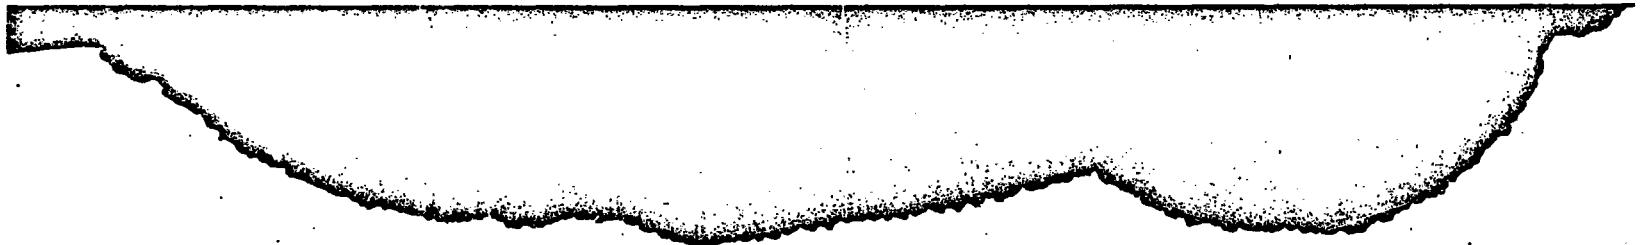
Mosaic of Pit in Outlet Nozzle, Section 2.

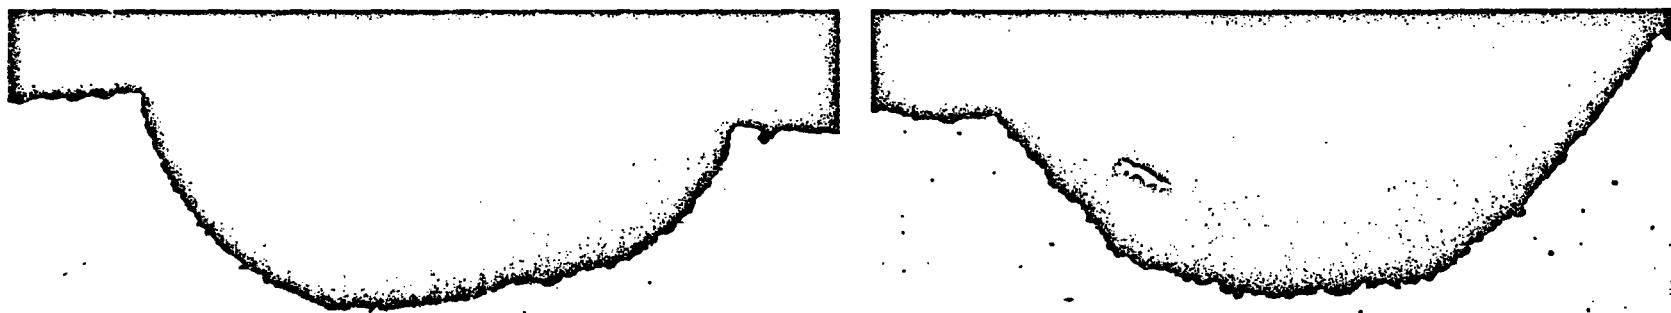
Pit in Inlet Nozzle, Section A.

Pit in Outlet Nozzle, Section 3.

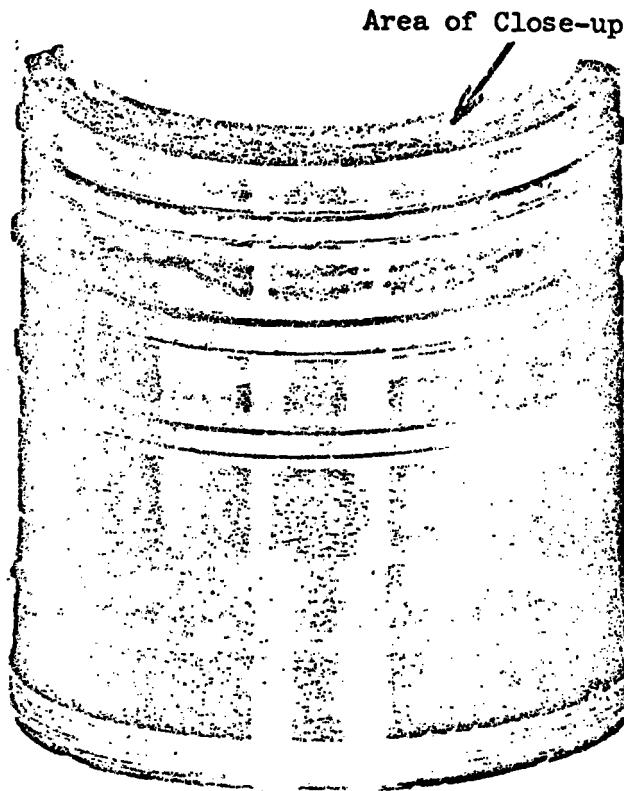
FIGURE 19.

The steel surfaces of the nozzle in contact with the Zircaloy-2 in the rolled joints had shiny interference films indicating very little corrosion. The films were slightly darker on the rolled joint on the downstream nozzle than on the upstream nozzle. A continuous circumferential line of pits in both nozzles was found at the crevice area where the end of the Zr-2 butted against the nozzle. The pitting appeared to be slightly worse on the front rolled joint junction than on the rear rolled joint junction. A typical area of pitting is shown in Figure 19; maximum pit diameter was about 30 mils. There were no indications of leakage past the grooves in the rolled joint but the center groove on the rear rolled joint was rusty colored, indicating that moisture had been present. The lack of rusting on the grooves on either side of the center groove indicates that the moisture came through the weep hole drain collection system. Whether or not the source of the moisture in the drain system was from leakage of another tube connected to the system or some other source is unknown.

a. Macro of Rolled Joint, 3/4X.

b. Close-up of Pitting at Steel-Zr-2 Junction, 10X.
