ANL-6632
Metals, Ceramics,
and Materials
(TID-4500, 26th Ed.)
AEC Research and
Development Report

NONDESTRUCTIVE TESTS OF COMPONENTS
OF EBR-I, CORE IV

October 1963

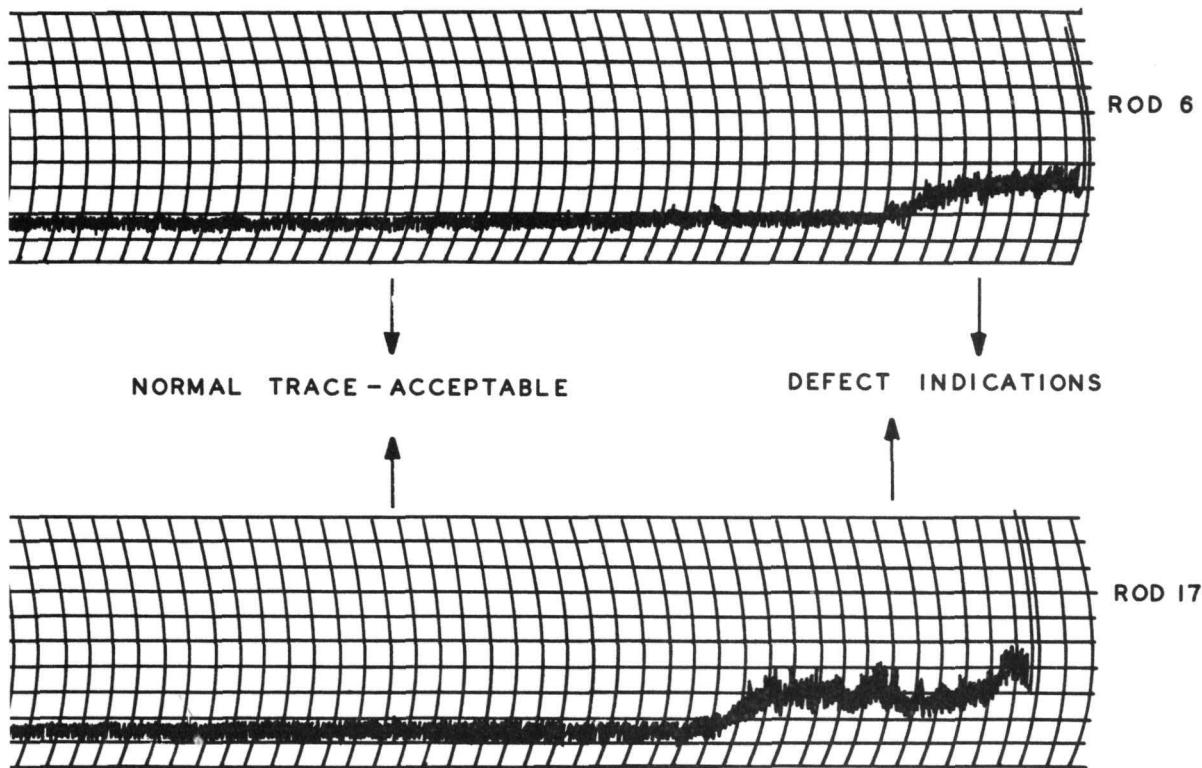
Figure 4. Pen recordings of void areas detected in Rods Nos. 6 and 17 of Zircaloy-2 rod stock

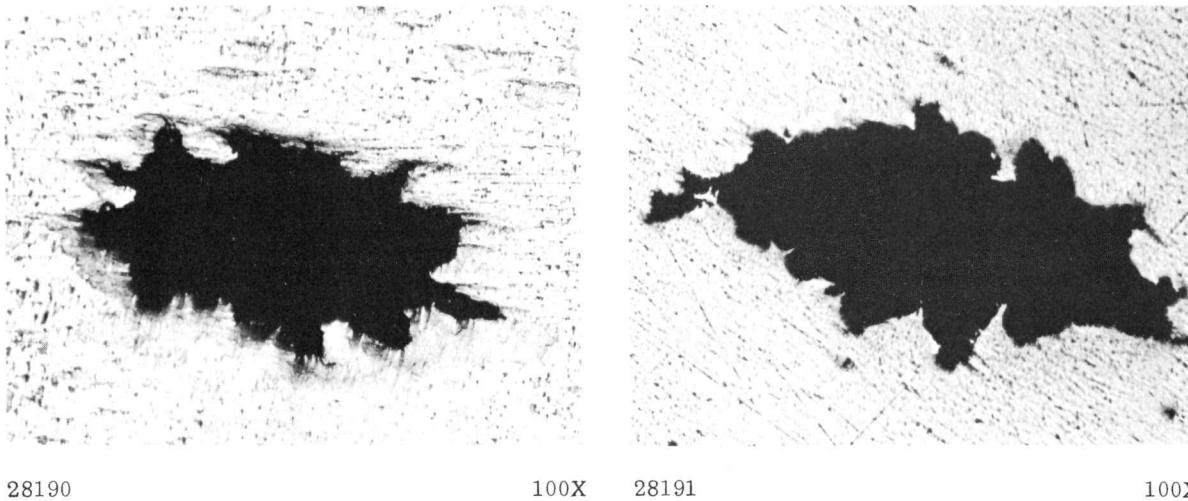
Subsequent metallographic examination of transverse sections from defect areas revealed void areas (see Figure 5) which tended to be greater in diameter at the ends of the rods. The voids ranged in diameter from 22 to 52 mils.

Figure 5. Transverse sections of void areas detected in Zircaloy-2 Rods Nos. 6 and 17

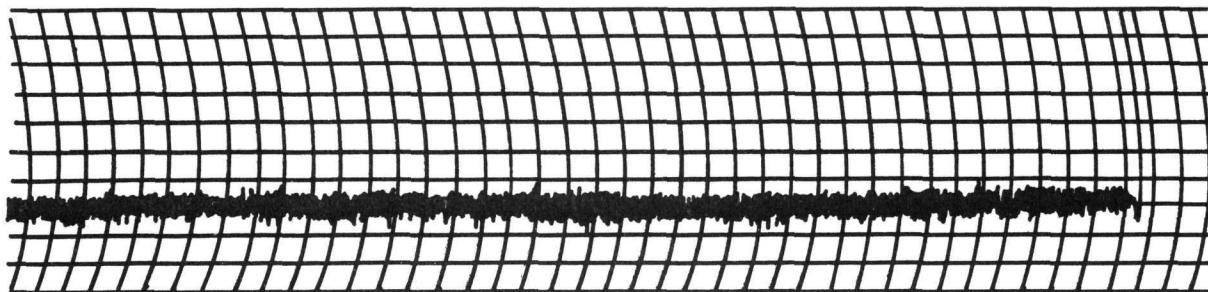
No difficulties were encountered in this test until one batch of zirconium stock produced wide, as well as normal, base-line fluctuations on the pen recordings. An example of such a pen recording is shown in Figure 7. Metallographic examination of rods exhibiting normal and wide base-line fluctuations revealed a great difference in microstructure, as shown in Figure 8. The large particles in rod EO are thought to be a result of improper annealing or quenching processes. X-ray diffraction studies on samples from rod EO were unsuccessful in determining the exact nature of these particles. Although a definite zirconium pattern could be seen, other lines were weak and diffuse.

Figure 7. Typical pen recording of zirconium stock with abnormal microstructure

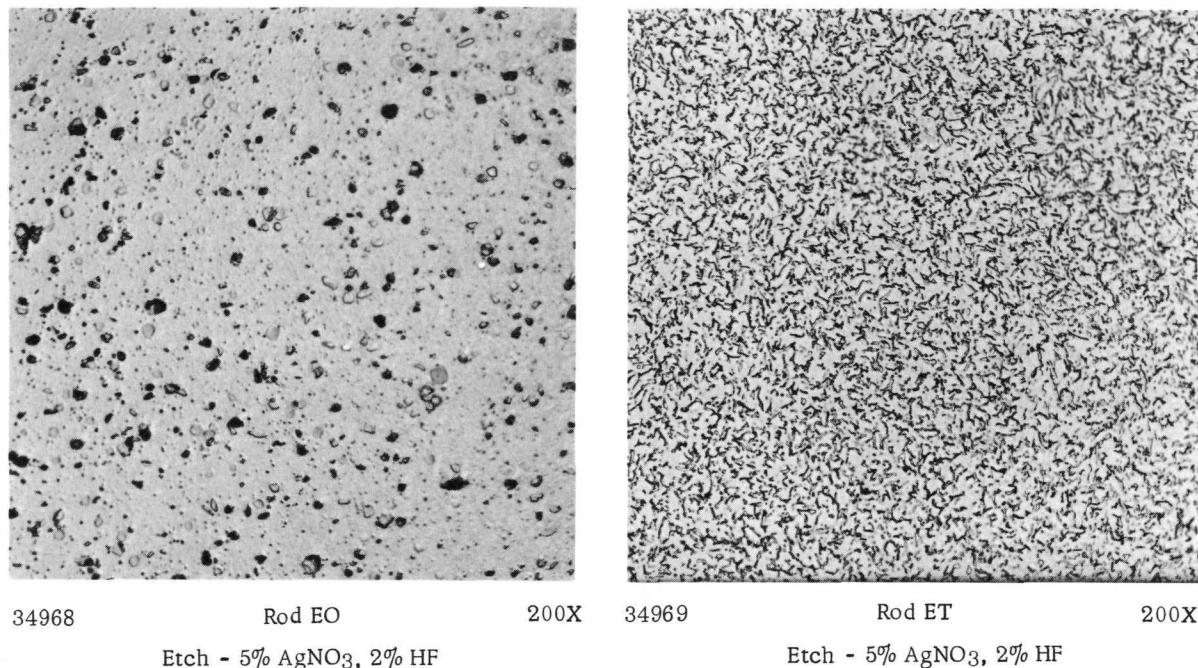
Figure 8. Transverse sections of zirconium rods EO and ET. Rod EO contains large particles while ET is normal stock.

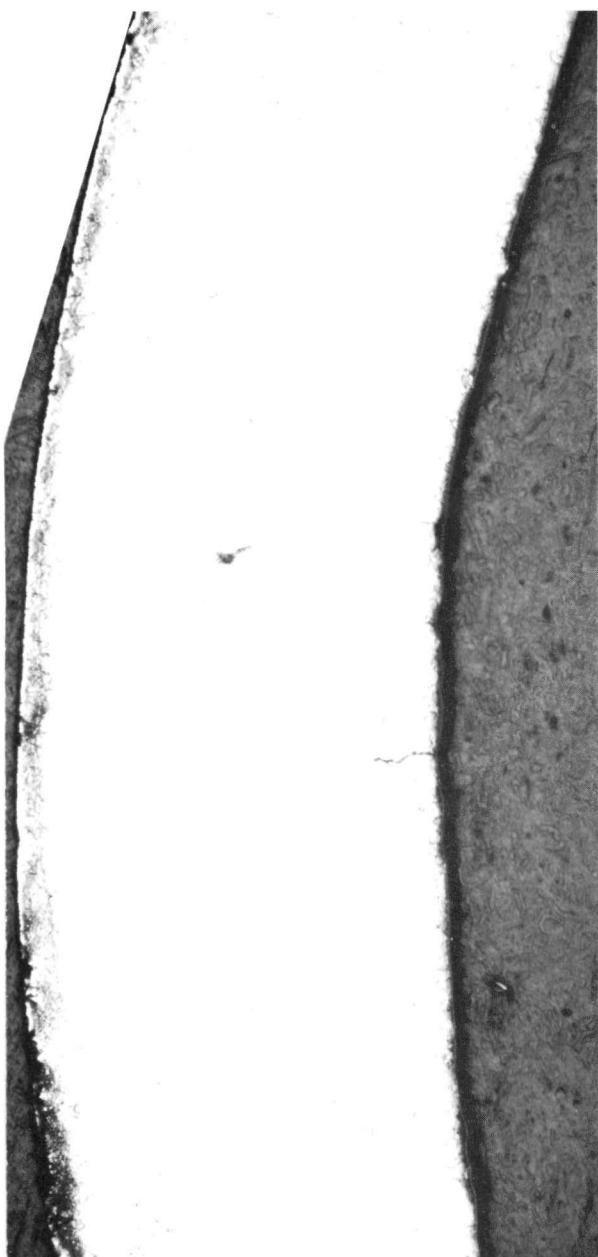
30499

Figure 9. A typical small crack on the inner circumference detected by the eddy current test equipment.

were or whether they were in fact deleterious. Transverse sections showed defects of this type running parallel to the tube wall as well as normal to it, and at all angles in between.

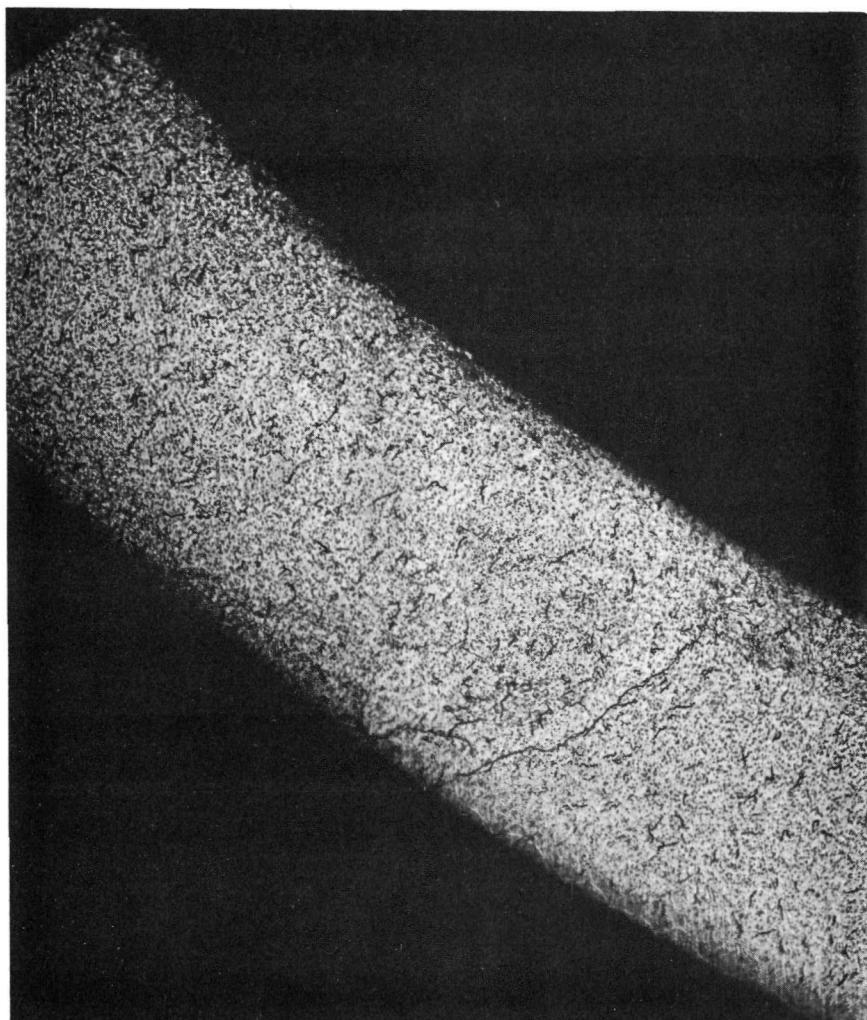
30500

Figure 10. A defect in the wall detected by the eddy current test equipment.

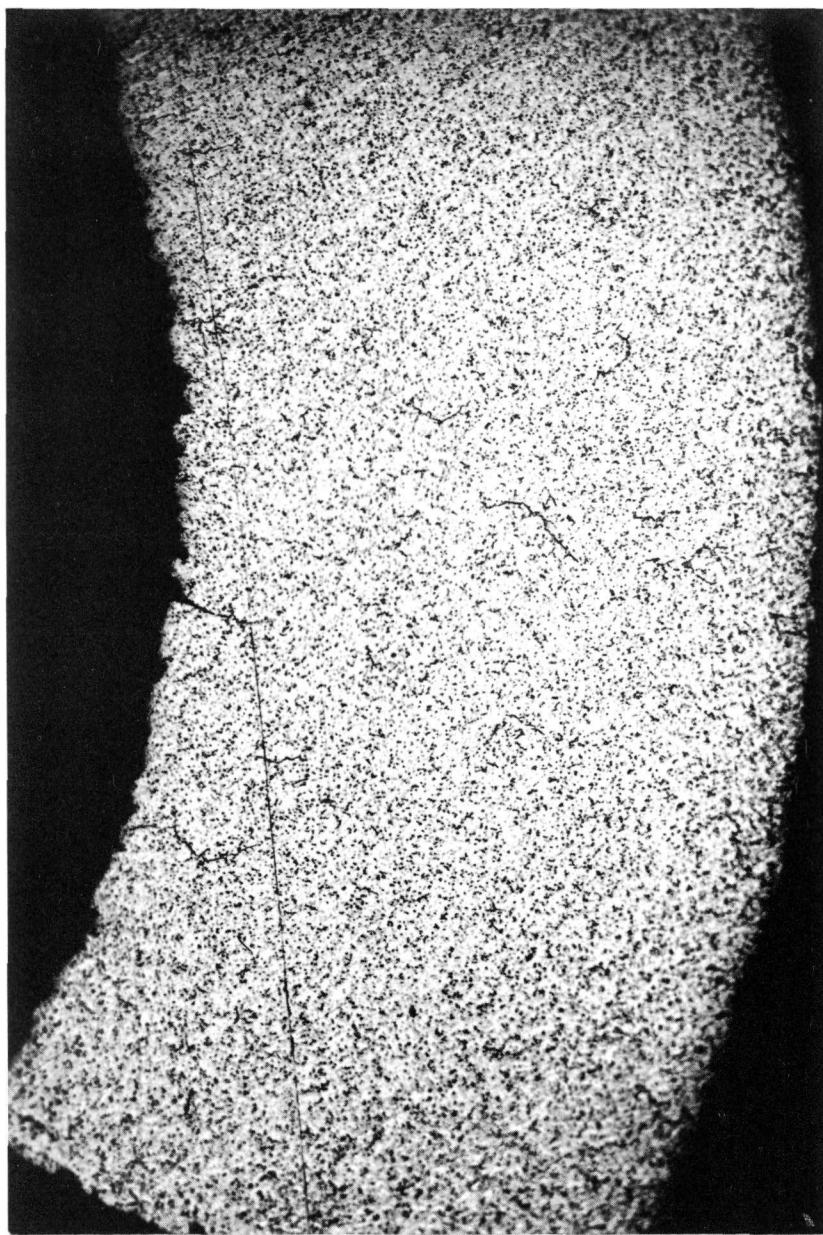
34157

Figure 11. Defects located in the 0.080-in. Zircaloy-2 thermocouple tubing by the eddy current test equipment. This figure shows a small transverse crack starting from the ID.

The fabrication process which was used to produce these tubes generally caused defects of the type shown in Figure 11. The lengths of these defects which were examined metallographically always were between $\frac{1}{16}$ in. and $\frac{1}{8}$ in. Occasionally other defects were encountered, such as the inclusions in Figure 12 and the very shallow surface lap in Figure 13. These were judged to be less serious than the radial cracks and were certainly easier to detect. They were more or less automatically eliminated once the lower limit on crack depth was set.

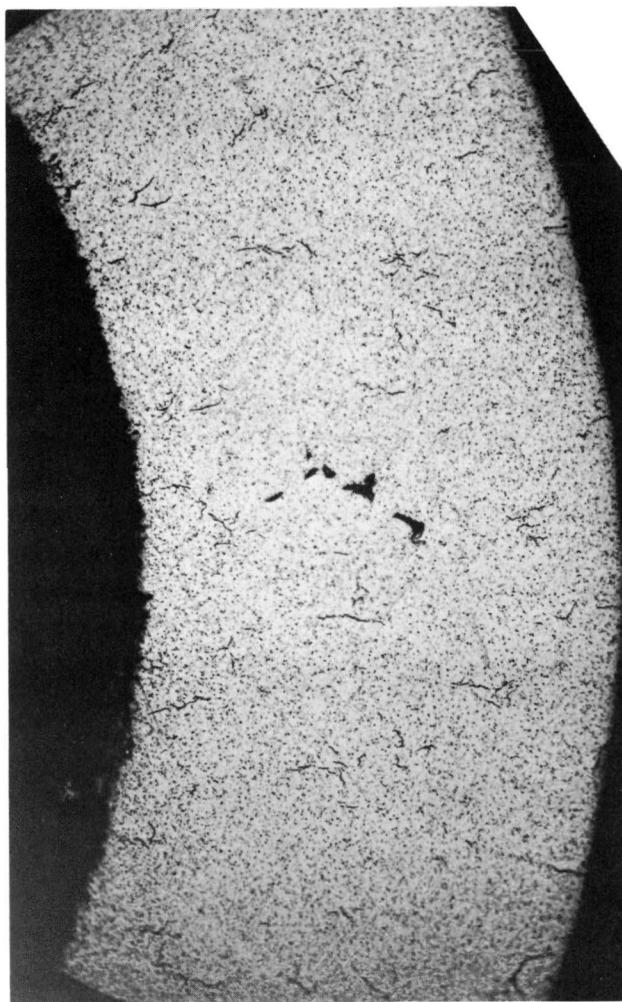
34147

Figure 12. Defects located in the 0.080-in. Zircaloy-2 thermocouple tubing by the eddy current test equipment. This figure shows wall inclusions.

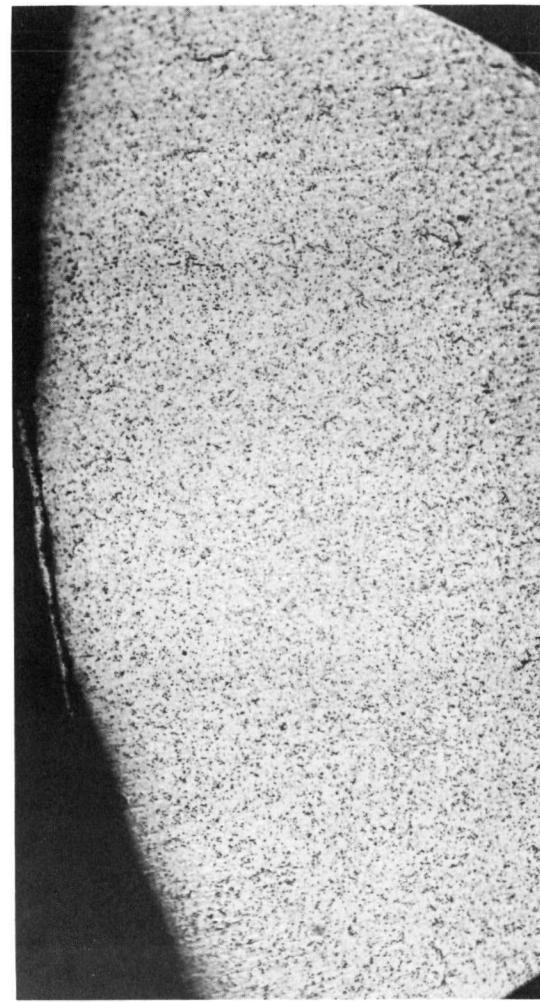
34155

Figure 13. Defects located in the 0.080-in. Zircaloy-2 thermocouple tubing by the eddy current test equipment. This figure shows a shallow surface lap.

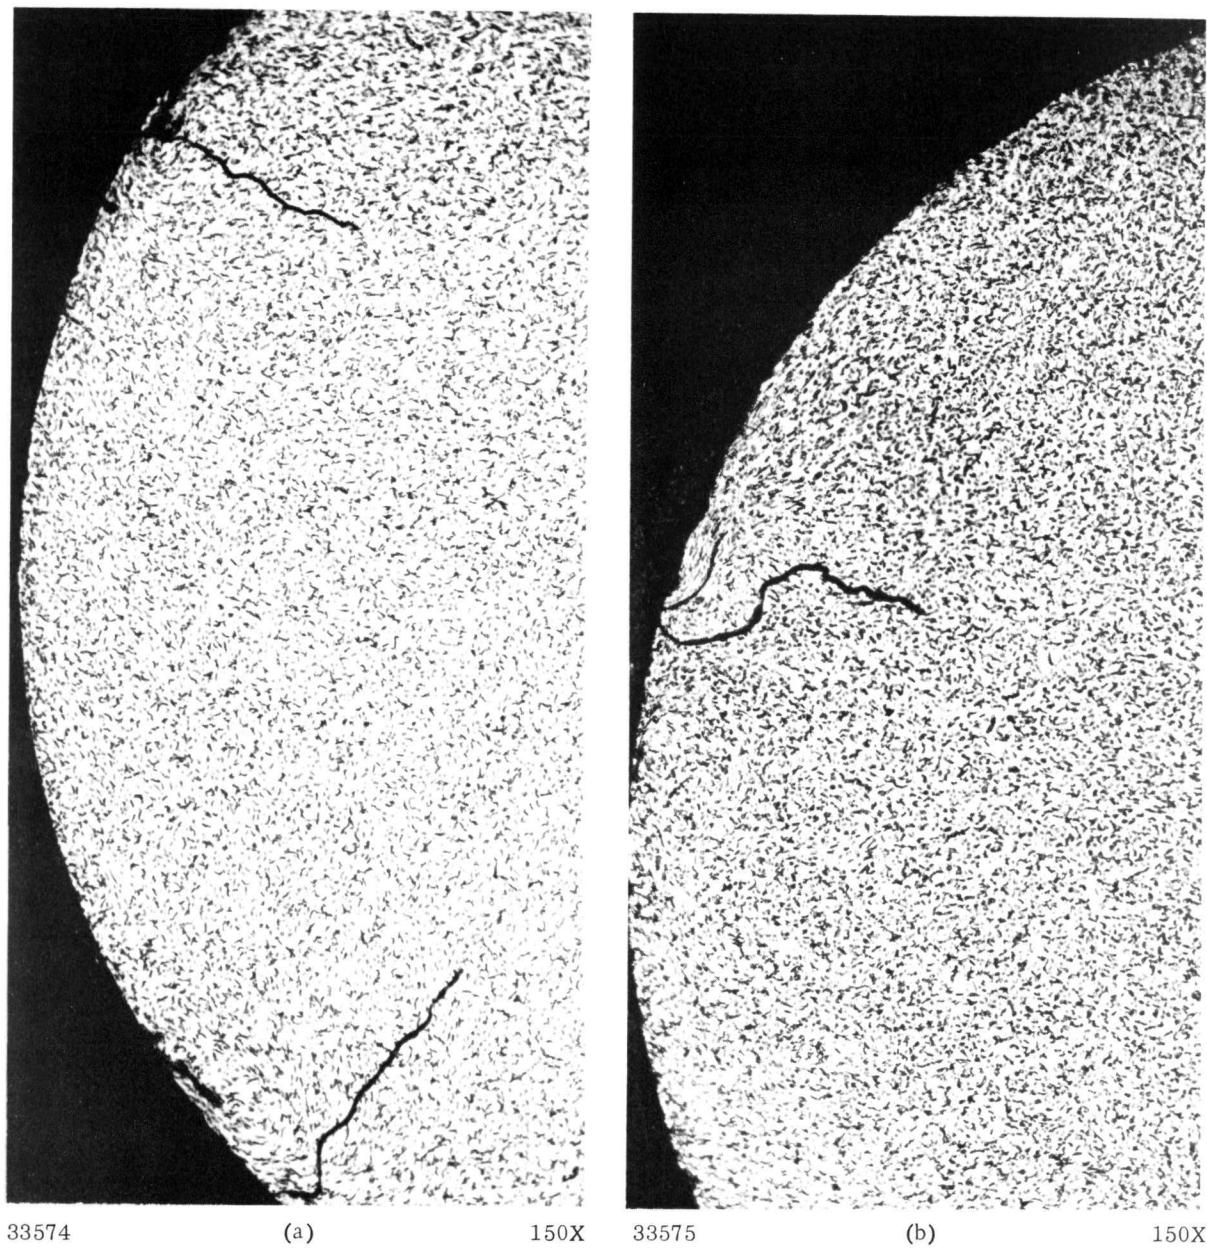
Figure 14. Transverse sections showing cracks in zirconium wire located by the nondestructive test equipment.

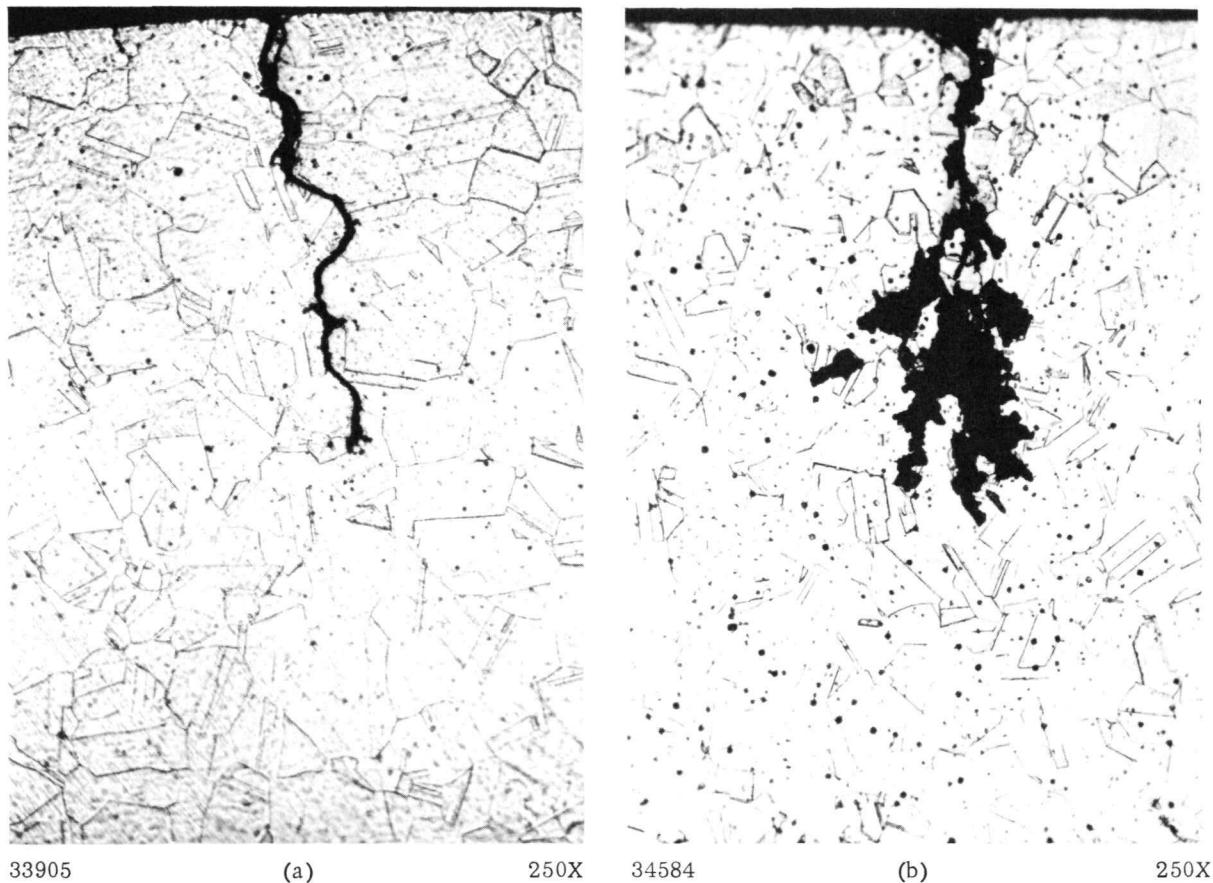
Figure 15. Transverse cracks discovered by the eddy current test system in stainless steel tubing which was to be used for components of the EBR-I Mark-IV breeding gain experiments.

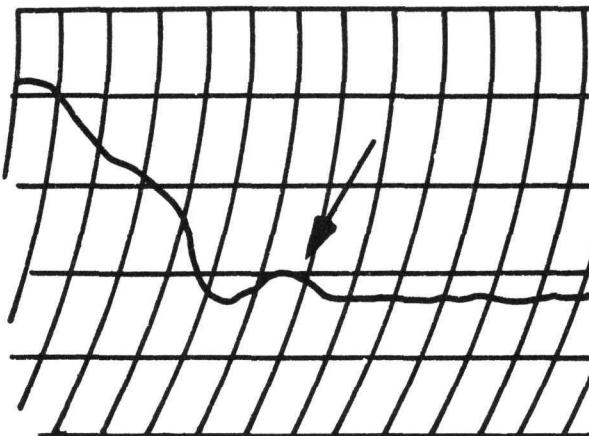
The eddy current test trace (see Figure 17a) for blanket element No. 748 indicated a large void at the top of the upper blanket slug. On removing part of the jacket in this location a number of closely spaced voids were found, as shown in Figure 17b. Figure 18a shows that the NaK easily pulled away from the slug and the jacket, as this element had not

Figure 17a. Defect shown by the recording of the eddy current test obtained before Rod No. 748 was stripped.

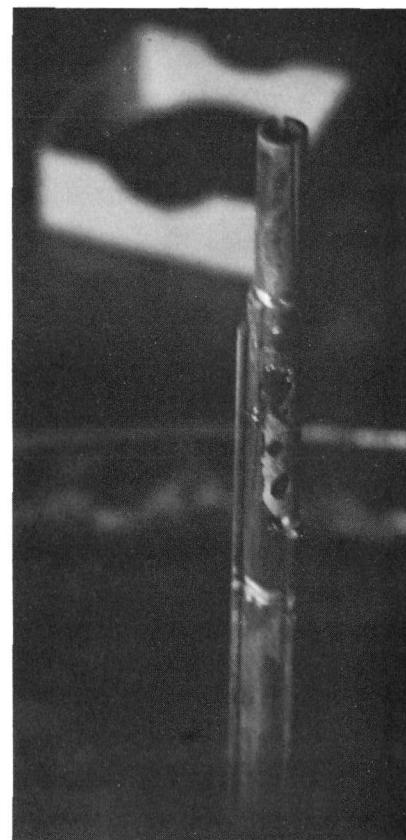
32866

Figure 17b. Appearance of the slug portion on stripping. Note the voids in the frozen NaK sticking to the slug.

been heat treated and no wetting is evident. Note also that the end of the slug has only a thin layer of NaK. Before heat treatment the ends of the slugs could easily be located on the eddy current test trace by the large signal developed at this point, as shown in Figure 18b. Evidence that the space between the chamfered ends of adjacent slugs was filled with NaK was given by the ridge of frozen NaK that can be seen on the jacket at the bottom of Figure 19.

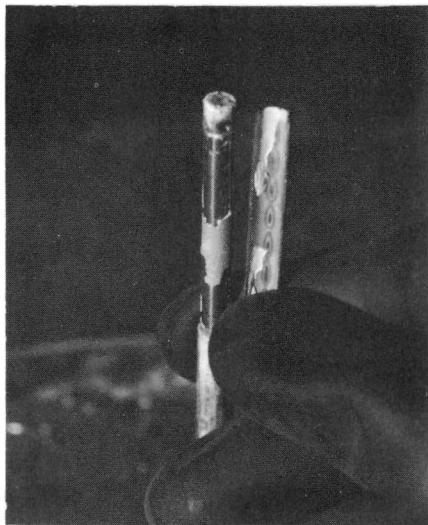
32852

Figure 18a. Appearance of one-half of the Zircaloy-2 jacket immediately after stripping. Weld areas are seen on the jacket.

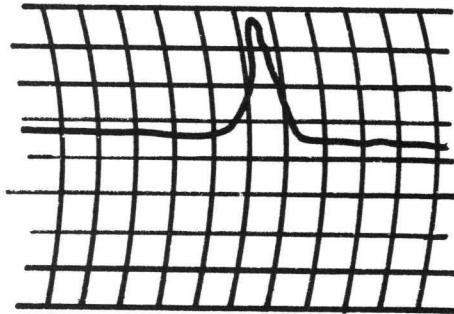
Figure 18b. Top of the second uranium slug of Rod No. 748.

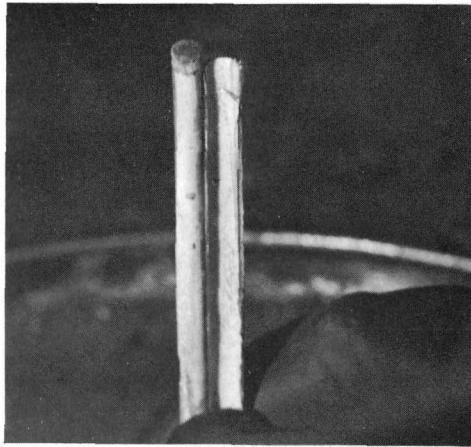
32833

It was evident from Figure 20a that the NaK level in blanket element No. 709 was below the top of the upper slug. An indication of the low NaK level was given on the trace shown in Figure 20b. The dotted line in the figure indicates the trace for a correct NaK level. This element had been heat treated, and the NaK appears to have wet both the uranium slugs and the jacket tubing. The small voids in a vertical line in Figure 20a were directly underneath the rib wire and were not detected by the eddy current instrument.

Figure 20a. Rod No. 709. Note the absence of NaK near the top of the slug and on the Zircaloy-2 jacket.

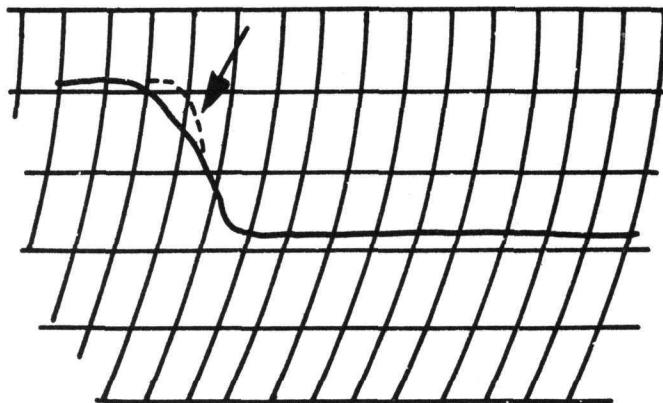
Figure 20b. Part of the trace obtained on testing Rod No. 709. Low level of NaK could be noticed by the deviation of the trace from the dotted line which indicates normal level.

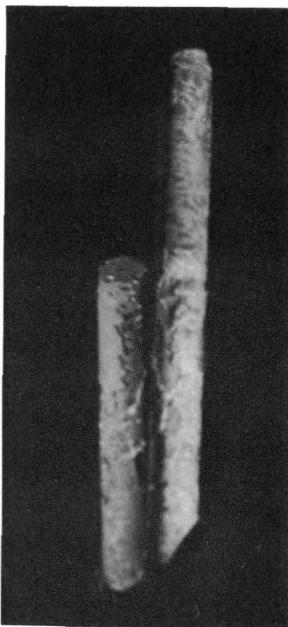
Figure 21a

The upper end of the fourth or bottom slug of blanket element No. 709 appeared to have an area of poor wetting, for most of the NaK had pulled away with the jacket, as shown in Figure 21a. This corresponds with position A of the trace shown in Figure 21b. A similar condition appeared at the bottom of the same slug shown at the top of Figure 22, corresponding to position B of the trace in Figure 21b.

The appearance of the top portion of the fourth slug soon after stripping. Note the presence of voids near the top.

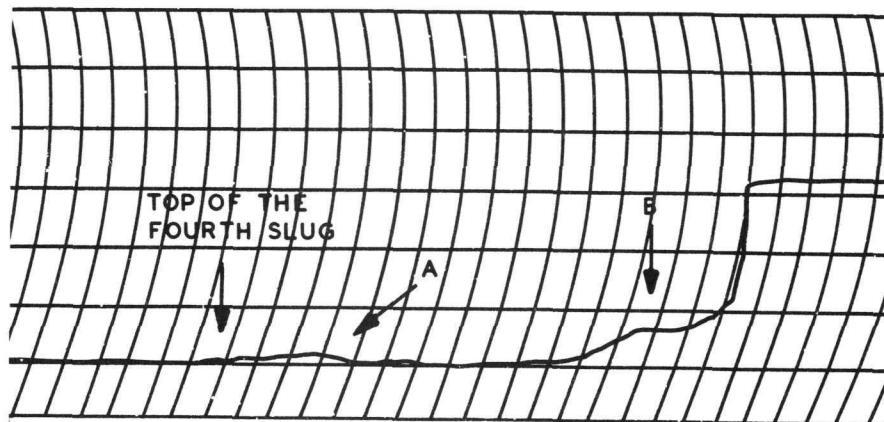
Figure 21b

Part of the trace obtained in testing Rod No. 709 before stripping.

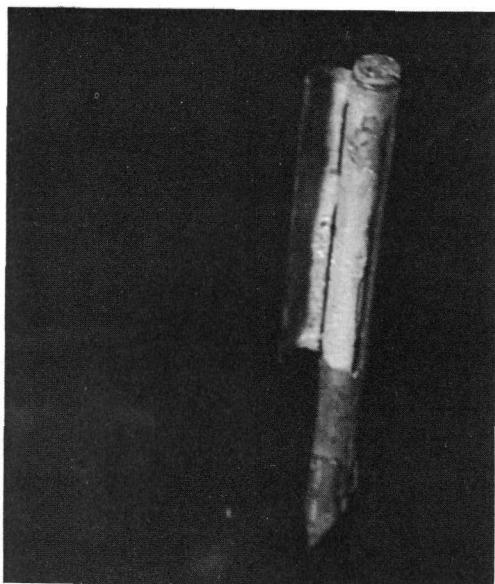
Figure 22

Appearance of the bottom portion of the fourth slug along with partly opened jacket. The slug is upside down. Note the presence of voids at the end near the top of the picture.

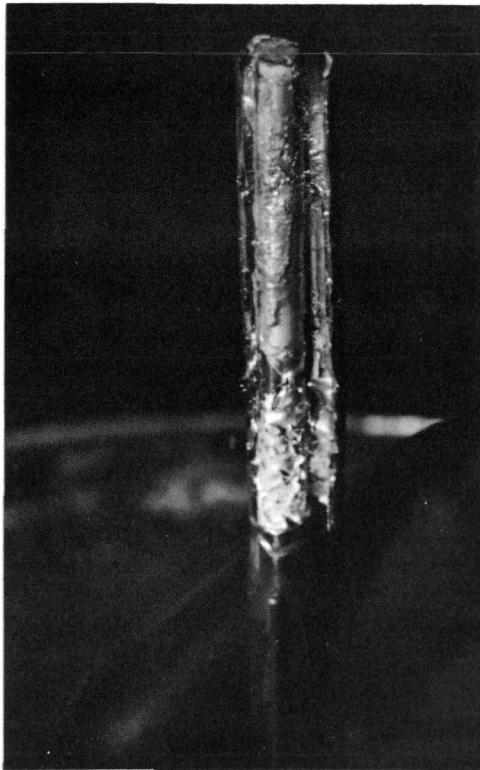
32846

Figure 23a. Appearance of Rod No. 715 on stripping the bottom portion. Note the appearance of NaK.

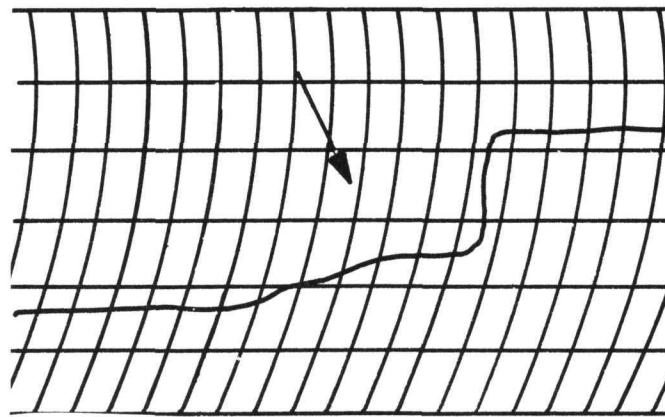
Figure 23b. Bottom portion of the trace obtained on testing Rod No. 715 before stripping. Note the deviation of the trace line.

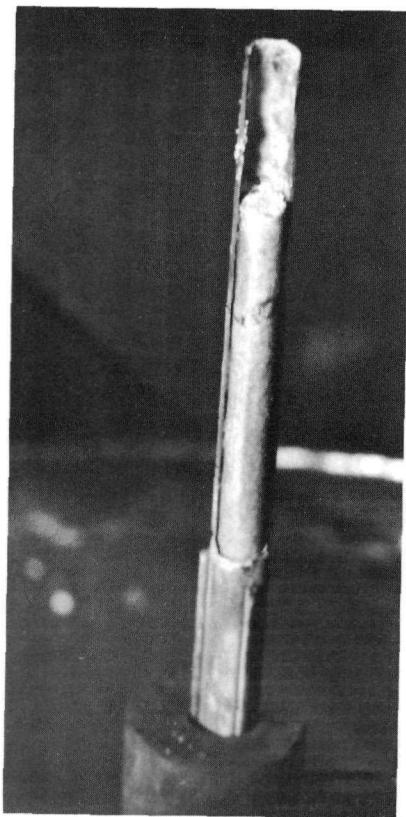
Figure 24a was typical of the slug ends in the heat treated elements. A dense layer of NaK remained on the end after removing the adjacent slug. The trace in Figure 24b shows a slight indication where one slug ends and another begins. This may be compared with Figure 18b, which was the trace of the element that had not been heat treated.

Appearance of Rod No. 715 after stripping one side of the jacket on the second slug from the bottom. Note the presence of NaK at the junction.

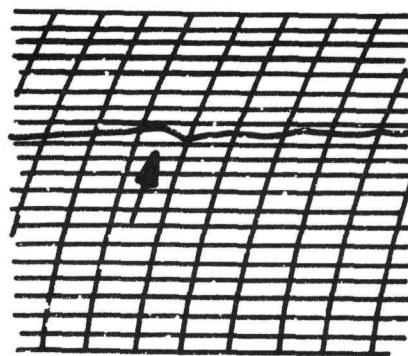
Figure 24b

Indication where one slug ends and another begins.

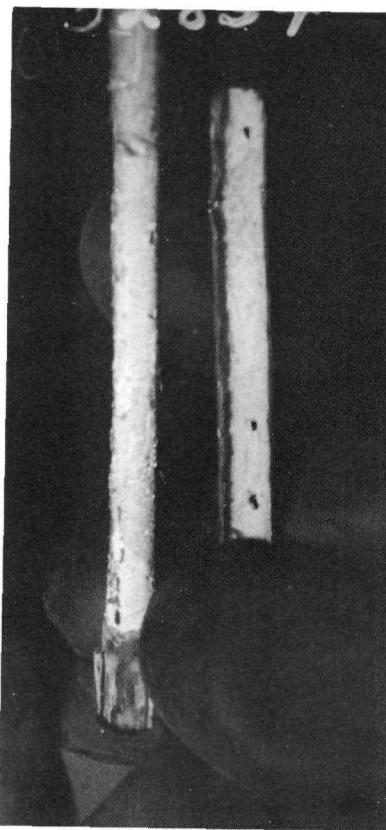
The three voids in a vertical line on the jacket in Figure 25a were approximately $\frac{1}{16}$ in. in diameter and represent the limit of sensitivity of the eddy current test, as was shown by the trace in Figure 25b.

The appearance of the top slug portion soon after stripping. Note voids on the frozen NaK of the jacket.

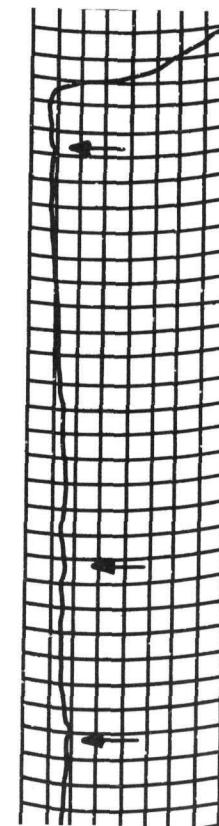
Figure 25b

Part of the trace obtained on testing Rod No. 854 before stripping. The voids indicated by the trace represent the limit of sensitivity of the instrument.
