SNAP I
DYNAMIC MERCURY LOOP TESTS
OF SELECTED MATERIALS

MND-P-2128

January 1957-June 1959

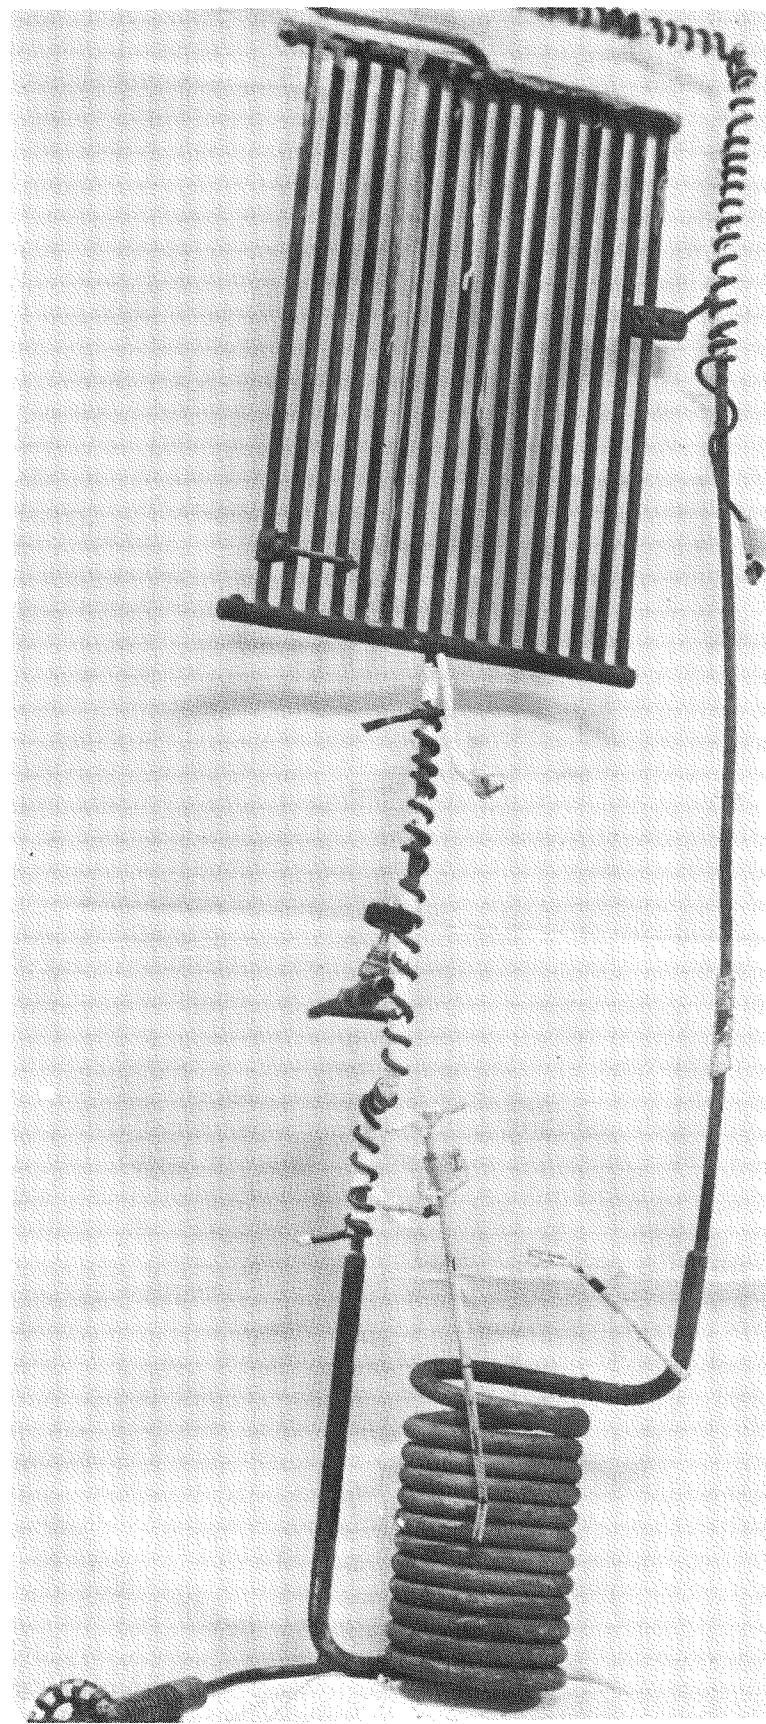
Fig. 3. Croloy-5 Si Loop After Test

The entire exterior of the loop was covered with a dark adherent oxide film as shown in Fig. 3. The boiler coil and superheat area in particular were severely oxidized as was expected because they were in contact with atmospheric oxygen during the test. Thirty-eight metallographic samples, including one from each condenser tube and one from each turn of the coil, were prepared for examination. The corrosion consisted chiefly of pitting in the various areas and the depth of penetration was tabulated from measurements of these pits with the micrometer eyepiece of a metallograph. Eighteen specimens from the condenser averaged penetration depths of 2.0 mils, 5 specimens from the superheater averaged 3.2 mils, and 14 specimens from the boiler averaged 2.4 mils. The greatest depth found was 3.5 mils which was in the superheater. The evidence indicates that the superheater exhibited the greatest amount of corrosion. This was particularly true of the area just after the boiler which contained "wet" mercury vapor and was one of the hottest sections of the loop. The attack was of a general pitting type with precipitation of the metallic oxides throughout the loop and an eventual return of these oxides to the boiler by entrainment of the oxide particles in the vapor or liquid mercury.

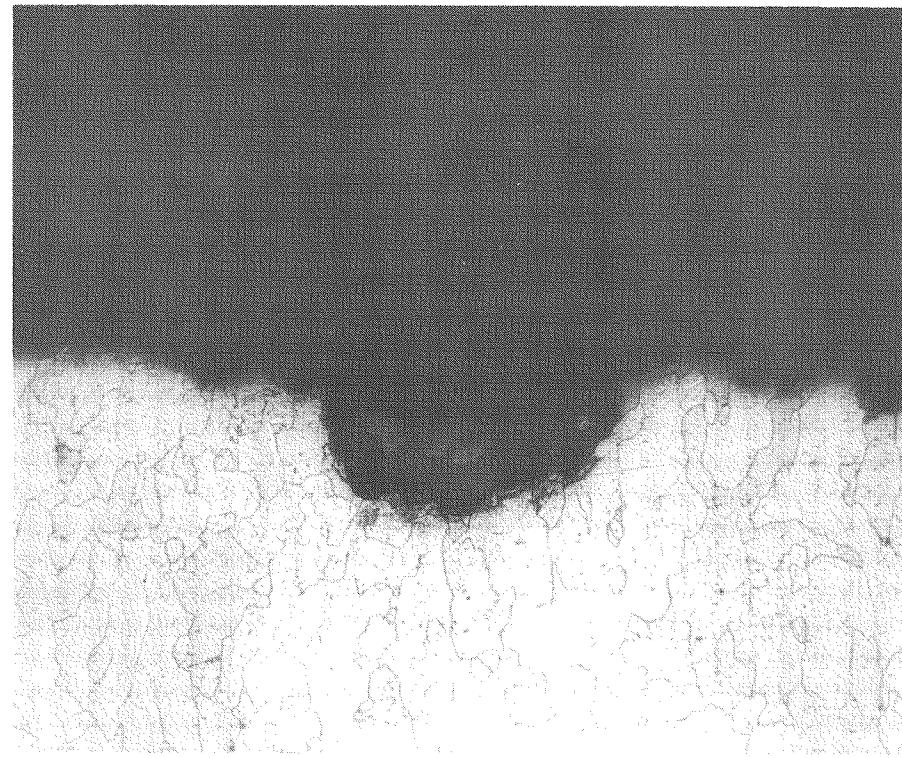
Fig. 6. Croloy-5 Si Loop--Pitting in the Condenser Tube No. 2

The condenser showed various degrees of pitting which averaged 2.0 mils in depth. Several specimens had indications of concentrated attack in single large pits and general corrosion elsewhere. These are shown in Figs. 6, 7 and 8.

(Exposed to mercury at 1000° F) 250X

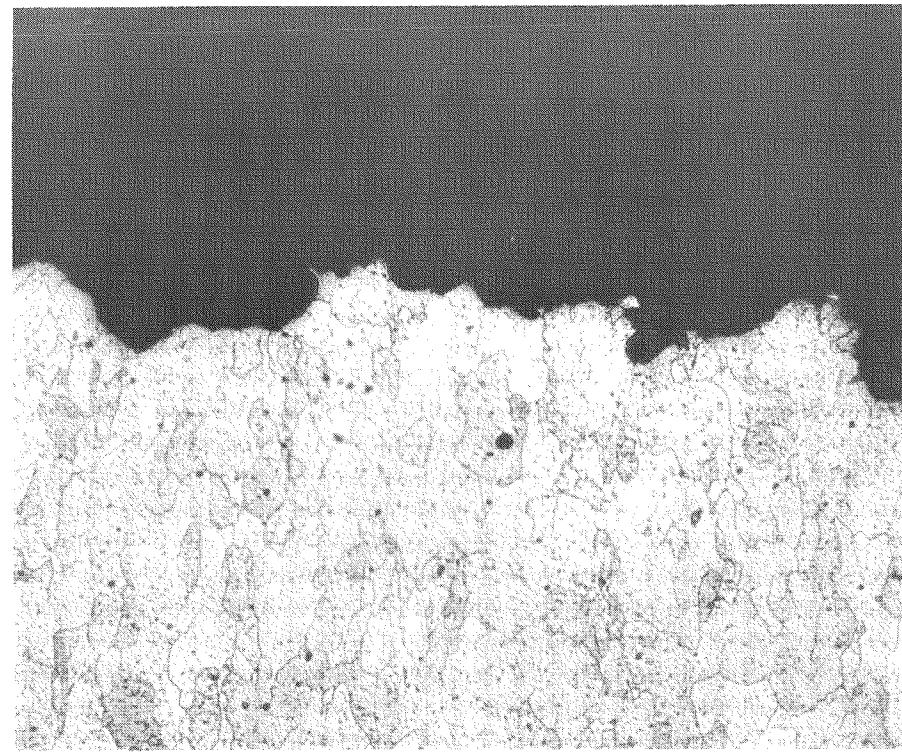
Fig. 7. Croloy-5 Si Loop--Pitting in Condenser Tube No. 7

(Exposed to mercury at 1000° F) 250X

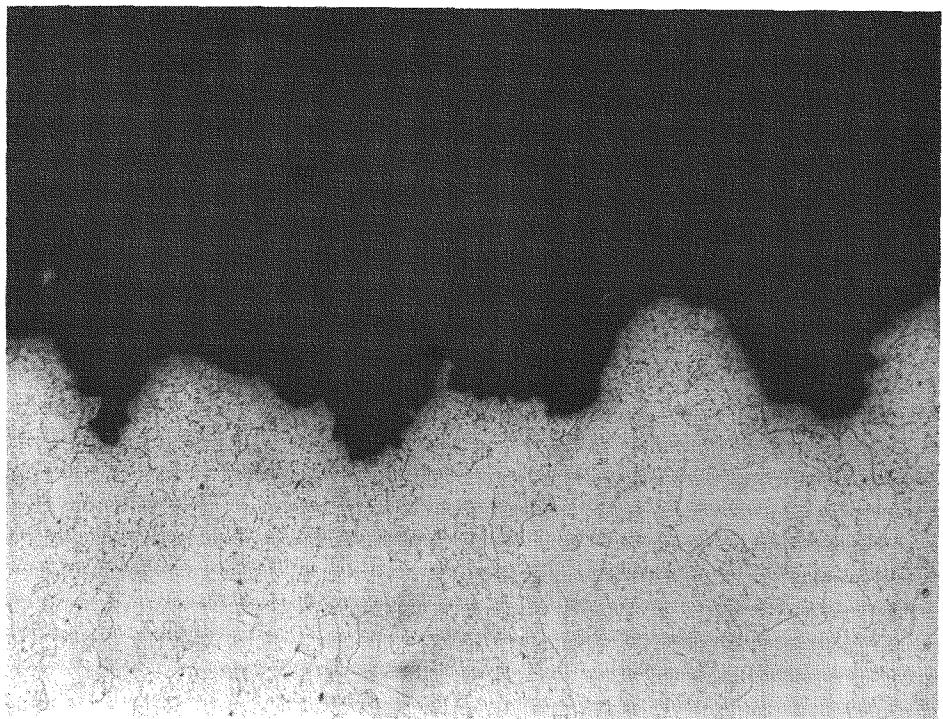
Fig. 8. Croloy-5 Si Loop--Pitting in Condenser Tube No. 12.

(Exposed to mercury at 1000° F) 250X

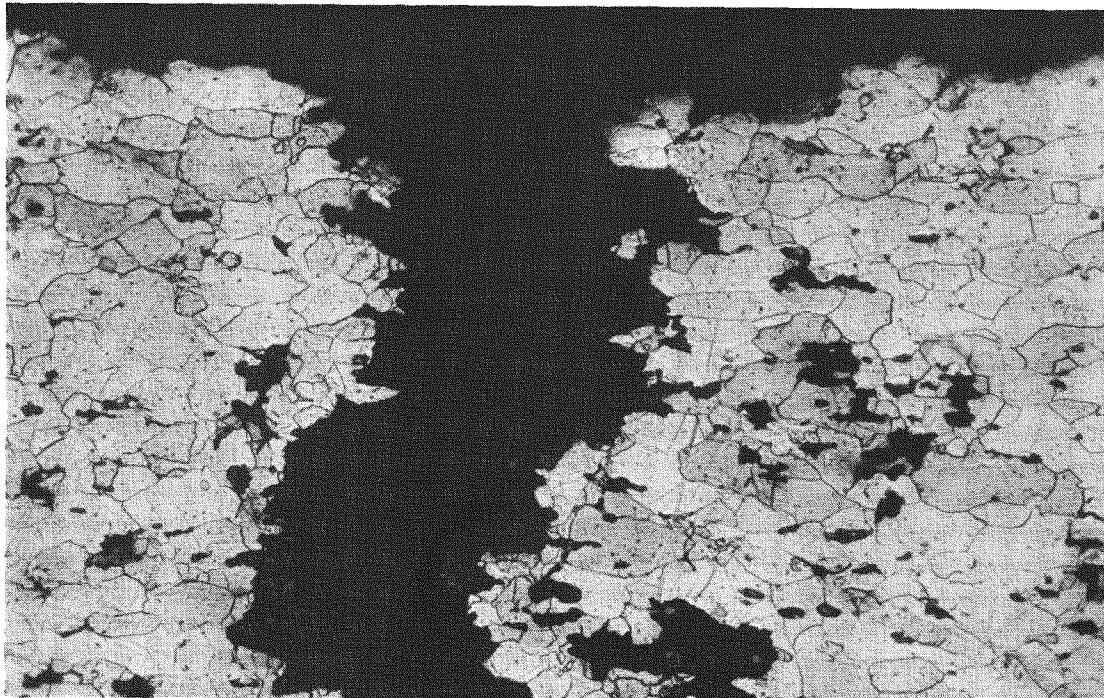
Fig. 9. Croloy-5 Ti Loop--Boiler Coil Perforation

This loop operated continuously for 150 hours at design conditions until a rupture occurred in the boiler outlet. The loop was then drained and disassembled for visual, optical and metallographic examination. The same trend corrosionwise as that found in the Croloy-5 Si was noted in this loop. All samples taken from the areas subjected to the higher temperatures showed a greater depth of penetration than the specimens removed from the relatively cooler areas. The external appearance of this loop duplicated that noted with the Croloy-5 Si loop.

(Exposed to mercury at 1050° F) 250X

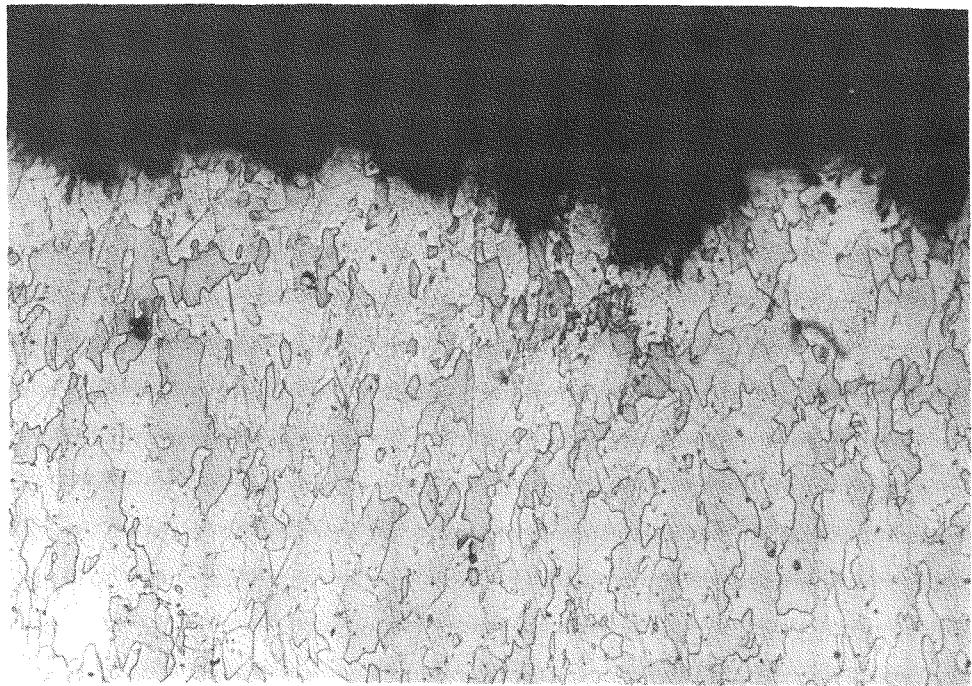
Fig. 10. Croloy-5 Ti Loop--Pitting in Condenser Tube No. 7

(Exposed to mercury at 1000° F) 250X

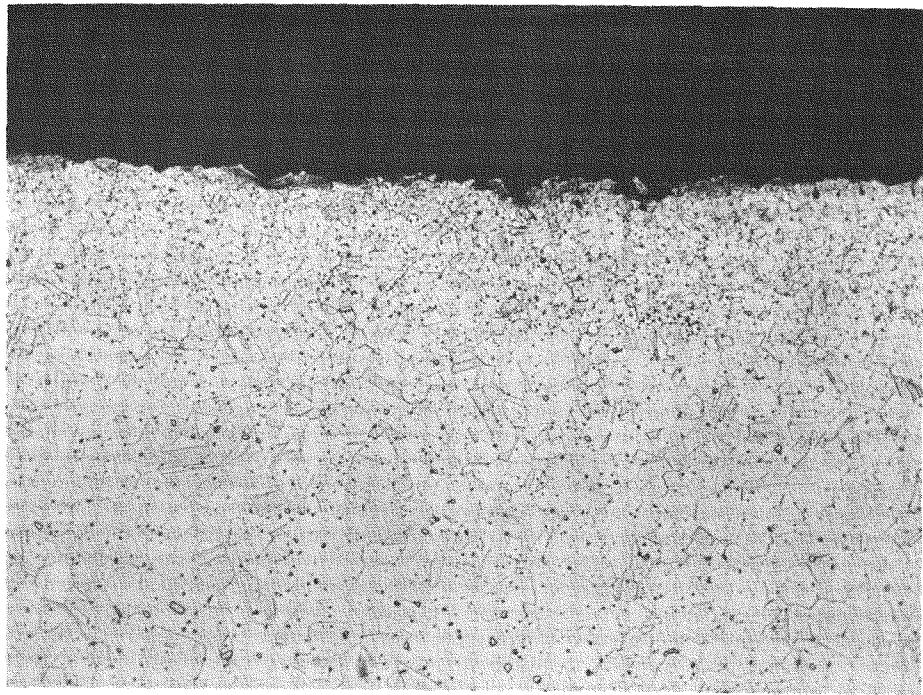
Fig. 14. Carpenter 20 Cb Loop--Tube Structure Adjacent to the Melted Area

The superheater section was reworked by installing specially wound alundum cores with sufficient power density to maintain superheat. The loop was again tested and sections of the superheat section broke down. It was found that the wire in the superheater was arcing to the coil with subsequent melting at these points.

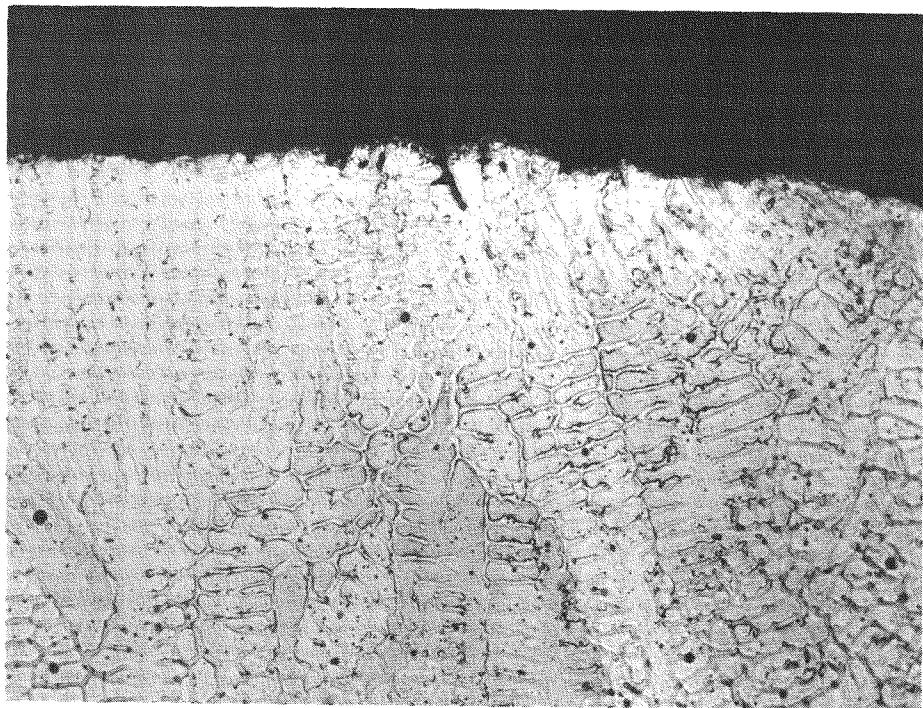
Fig. 15. Carpenter 20 Cb Loop--Melted Area of Tube Where Arcing Occurred

It must be noted that care should be taken to prevent the boiler coil from shifting and thereby touching the Globar heating elements. This results in arcing through the tubing.

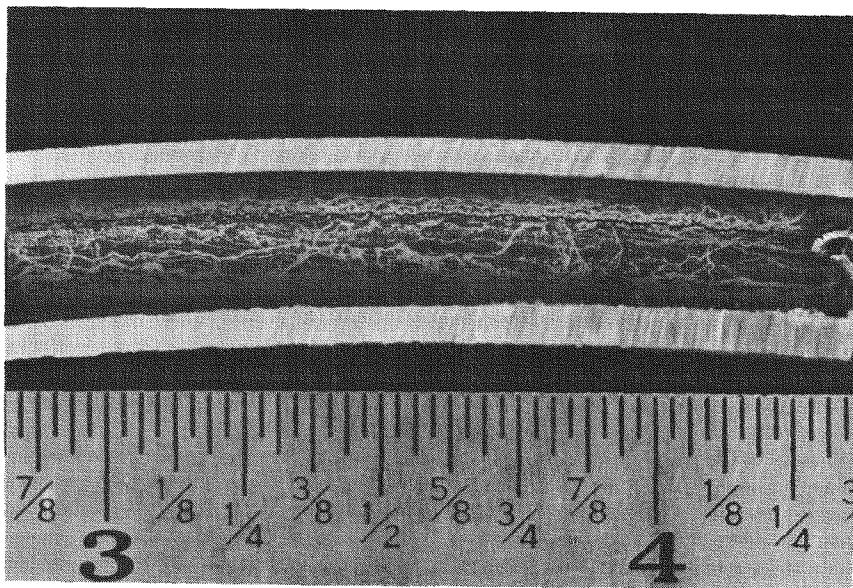
Fig. 20. Type 347 Stainless Steel Boiler--Two Coils from Top (hot) End--Inside Surface of Stainless Tube

Failure of the Type 347 stainless steel loop occurred when the outlet leg of the boiler ruptured. A four-inch long section of the tube just outside the top coil was expanded around the point of rupture. The loop had operated over periods of 8, 8, 135 and 175 hours for a total of 326 hours before the failure. Metallographic sections were taken from the top, middle and bottom loops of the coil as well as from the ruptured area. There was no attack at the bottom of the boiler coil as shown in Figs. 16 and 17. About half way up the coil where the temperature was some 700 or 800° F higher and liquid mercury was converted to vapor, some corrosion occurred as shown in Figs. 18 and 19. Farther up the tube near the top, where the temperature was about 1350° F and dryer mercury vapor was in contact with the tube, the general attack noted in the middle coil is not present. However, there is a continuous crack running longitudinally along the tube as shown in Figs. 20 and 21. Figure 22 is an enlargement of the crack shown in Fig. 21.

(Note longitudinal crack; exposed to mercury vapor at 1350° F)

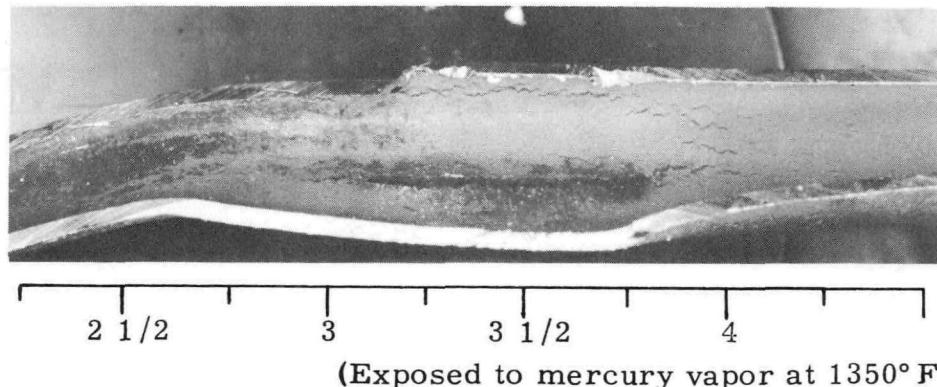
Fig. 23. Type 347 Stainless Steel--Inside Surface of Tube at Rupture
on the Exit Leg

The ruptured area is shown in Fig. 23. The numerous cracks that appear in the photograph are attributed to the overall expansion of the tubing just prior to its rupturing. Figure 24 shows a transverse section through the rupture. The continuous crack in the upper boiler area was attributed to the severe cold work of the tubing. The crack was located along the outer wall of the tube where the greatest amount of cold work occurred. It appears that this area which was cold worked extensively was susceptible to mercury corrosion.

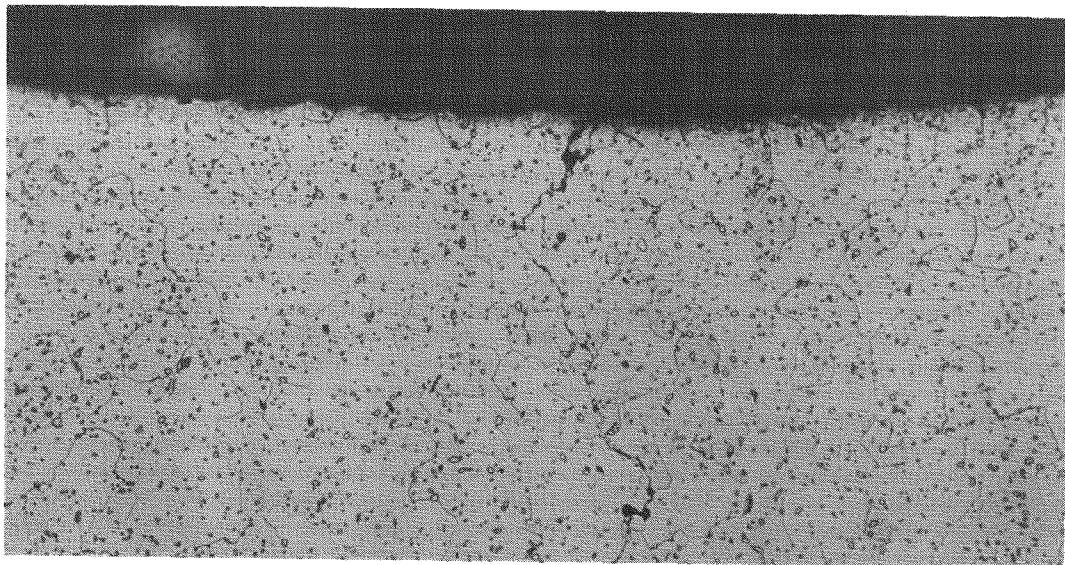
Fig. 25. Type 446 Stainless Steel Boiler, (exposed to Mercury at 1050° F)

(Note partial sealing of crack)

This loop did not fail. It was shut down after operating periods of 8, 8 and 125 hours due to multiple leaks in the Swagelok fittings which could not be controlled. Examination of the boiler coil after disassembly revealed the transgranular cracks shown in Figs. 25 and 26. Some of the cracks, which occurred only on the inner wall of the tubing, appear to be partially healed. This indicates that the cracks probably originated during fabrication of the tubing. The subsequent bending of the tubing, aided by the embrittlement due to the sigma phase, may have reopened some of these cracks.

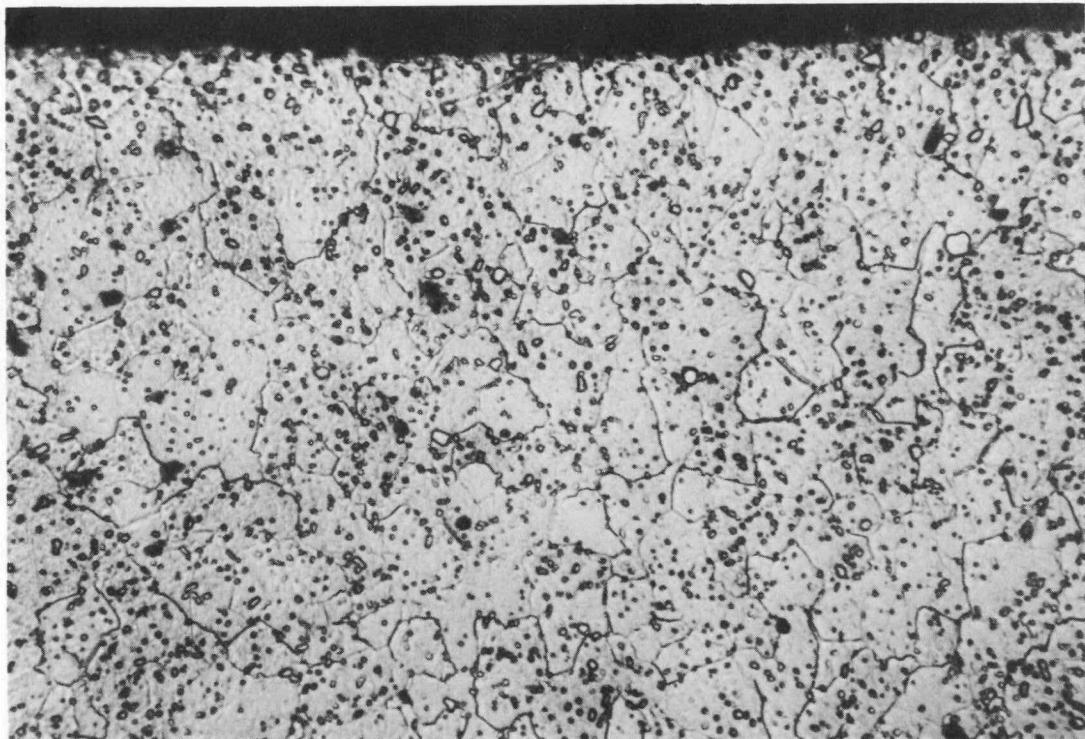
Fig. 27. Type 446 Stainless Steel--Unused Tubing from Same Lot as Loop

Metallographic sections of the unbent portions of tubing from the same lot showed sigma phase, but no cracks were found (see Fig. 27). The fact that cracks were not found is not conclusive proof that none were there. It is difficult to say what role, if any, mercury played in producing or enlarging these cracks. However, it is notable that, in general, the mercury did not attack the metal.

(Note presence of sigma phase)

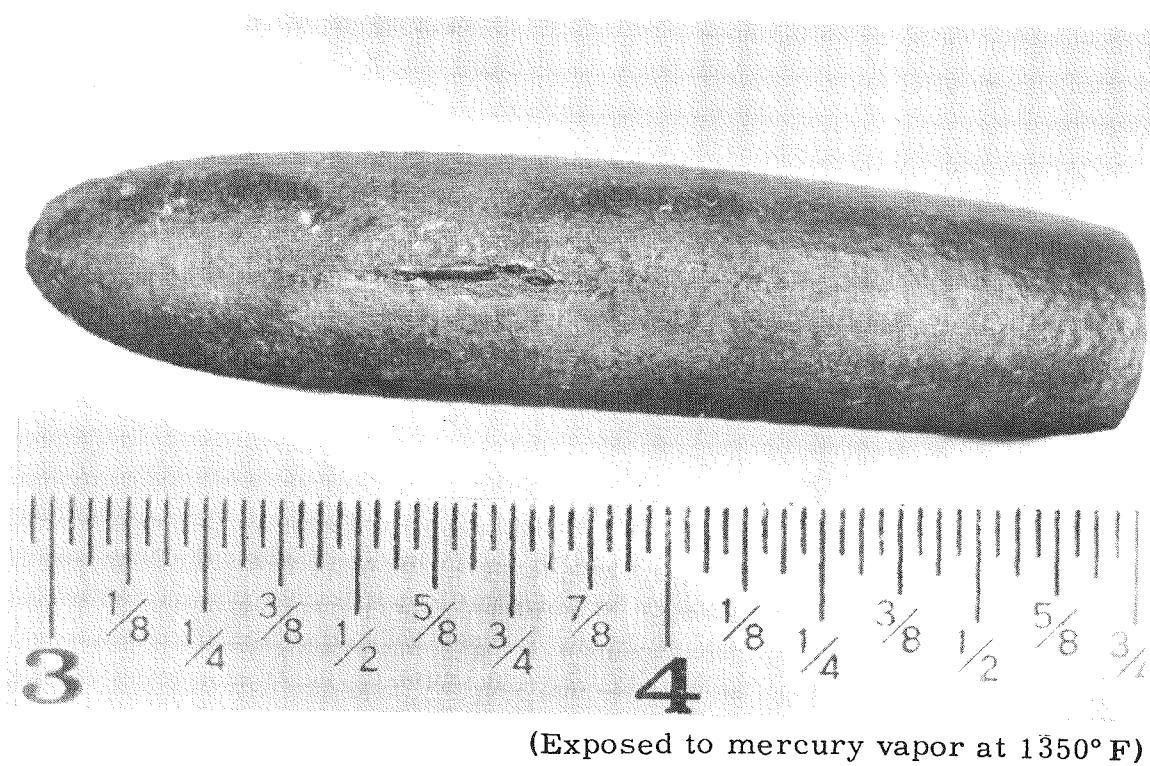
Fig. 28. Type 347 Stainless Steel Clad Niobium Boiler--Point of Rupture Two Coils from Top (Hot) End

The niobium boiler ruptured after 50 hours, two coils below the top. Figure 28 shows the outside of the Type 347 stainless steel clad at the rupture point. Figure 29 shows the perforated niobium tube with the stainless steel clad removed. A transverse section of the rupture area, Fig. 30, shows some of the remaining corrosion products between the tubes. The probable cause of failure was atmospheric oxidation from outside the tubing--not mercury corrosion. The argon blanket normally maintained in the furnace was somehow reduced in depth, exposing the upper loops of the boiler coil to atmospheric oxygen. Figure 28 shows that considerable external oxidation occurred. An imperfection in the stainless steel clad perforated, allowing oxygen to contact the niobium with resultant oxidation and the deposition of the reaction products. Examination of the as-received material showed that the stainless steel clad was weld-drawn tubing rather than seamless tubing. The failure occurred along this seam.

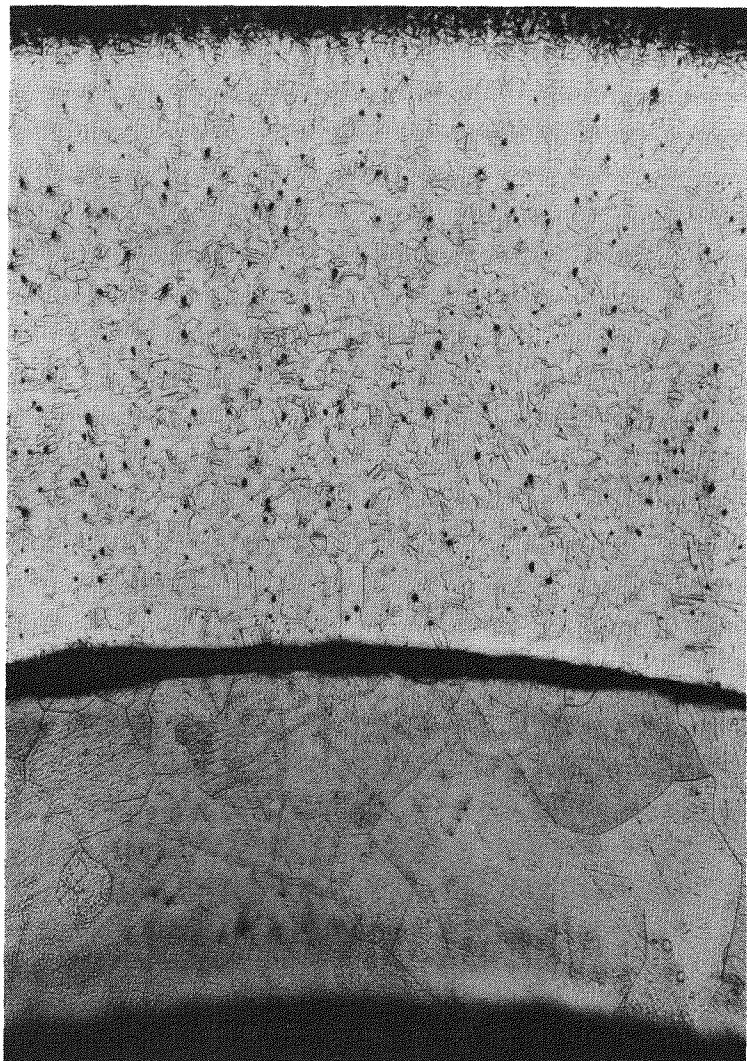
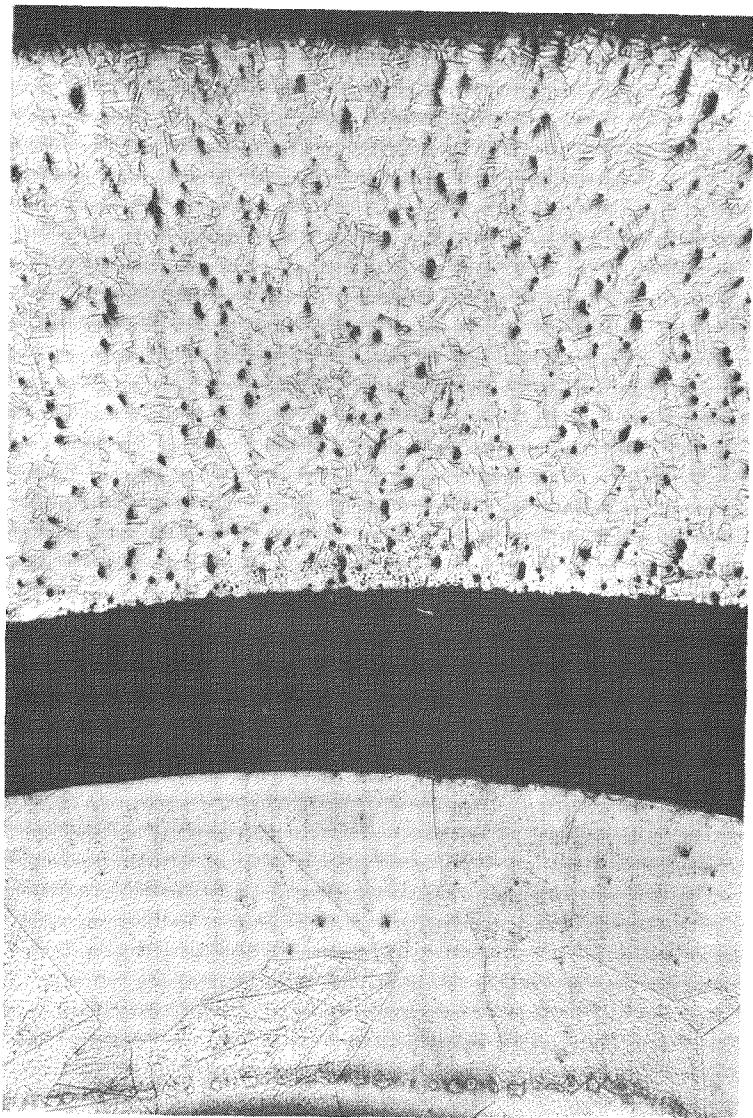
During the period of this test (50 hours), mercury had little effect corrosionwise on the niobium. Figures 31 and 32 show this. The dark areas in the photomicrographs are the mounting resin. The bimetal tubes separated when the metallographic sections were cut. The dark trace just inside the surface of the niobium which contacted mercury was made by the etchant.

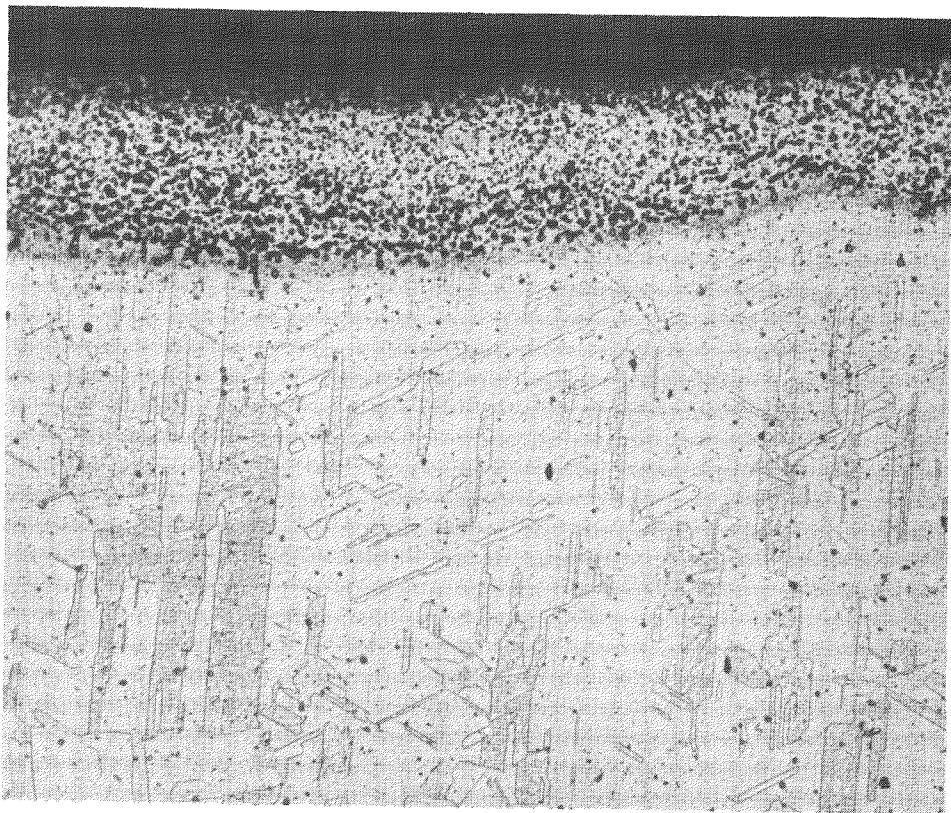
Fig. 33. Type 347 Stainless Steel Loop--Hot Leg Immediately Beyond Boiler Outlet, Temperature 1350° F

After completing the niobium boiler coil test, the Type 347 stainless steel loop was disassembled for examination. Metallographic sections were taken from the hot and cold legs and the condenser. Figure 33 is a cross section of the tubing in the hot leg just beyond the boiler coil rupture. It is obvious that a reaction has occurred. The mercury has penetrated the tubing to an average depth of six to seven mils with a maximum penetration of about 20 mils in isolated areas. A spectrographic analysis of the corroded area shows a depletion of nickel. The entire hot leg through the first loop in the condenser coil suffered the same penetration. A short section of the hot leg was cut longitudinally and flattened in a vise. Mercury droplets were squeezed from the penetrated layer as shown in Fig. 34. The entire corroded area was permeated with mercury.

No corrosion was expected in the hot leg because the tubing was exposed to dry mercury vapor, i.e., there were, supposedly, no condensed droplets present. Generally, it was postulated that the most severe corrosion would occur in the boiler in the area of the interface. The area of the rupture did not show a general attack like that just beyond the rupture. This indicates that the failure was probably due to an imperfection in the tubing.

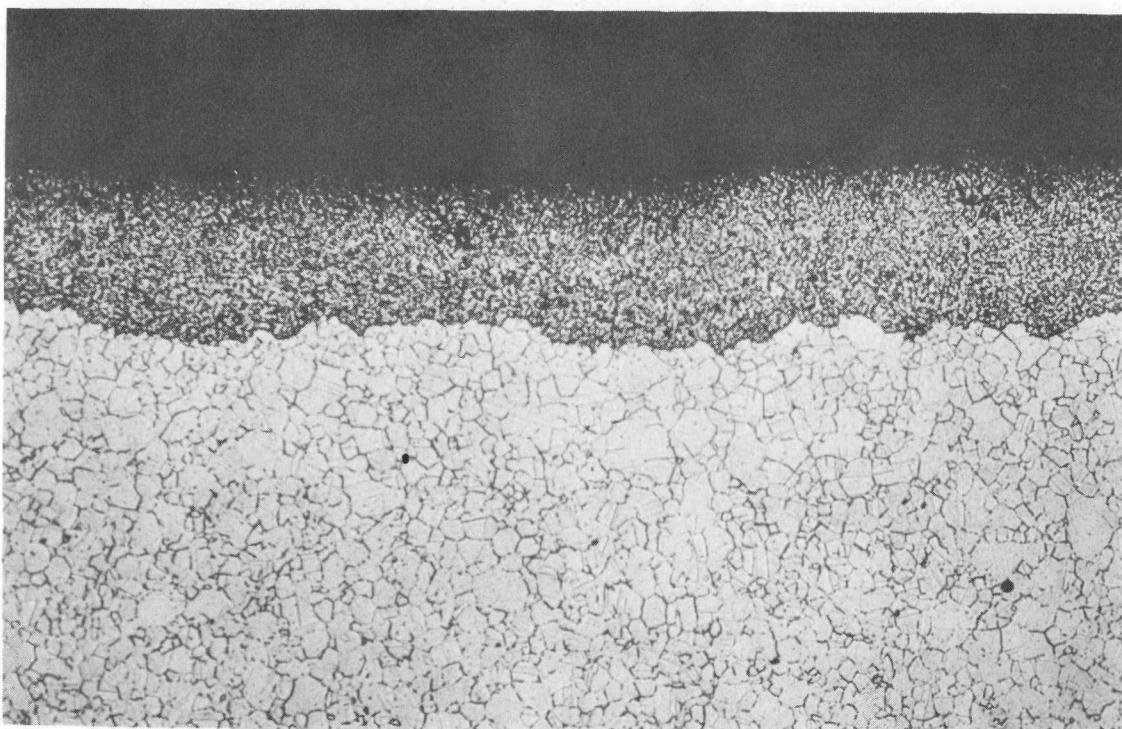
Fig. 36. Type 347 Stainless Steel Condenser at Area Shown in Fig. 34

The condenser coil is shown in Fig. 35. A metallographic section from the top condenser coil, Fig. 36, shows the continuation of the attack noted in Fig. 33. Farther down the coil the metal is unattacked. Figure 37 shows the middle of the coil, and Fig. 38 pictures the bottom of the coil where the temperature was about 350° F. The remainder of the cold leg was also unaffected.

(Note penetration of the tubing by mercury)

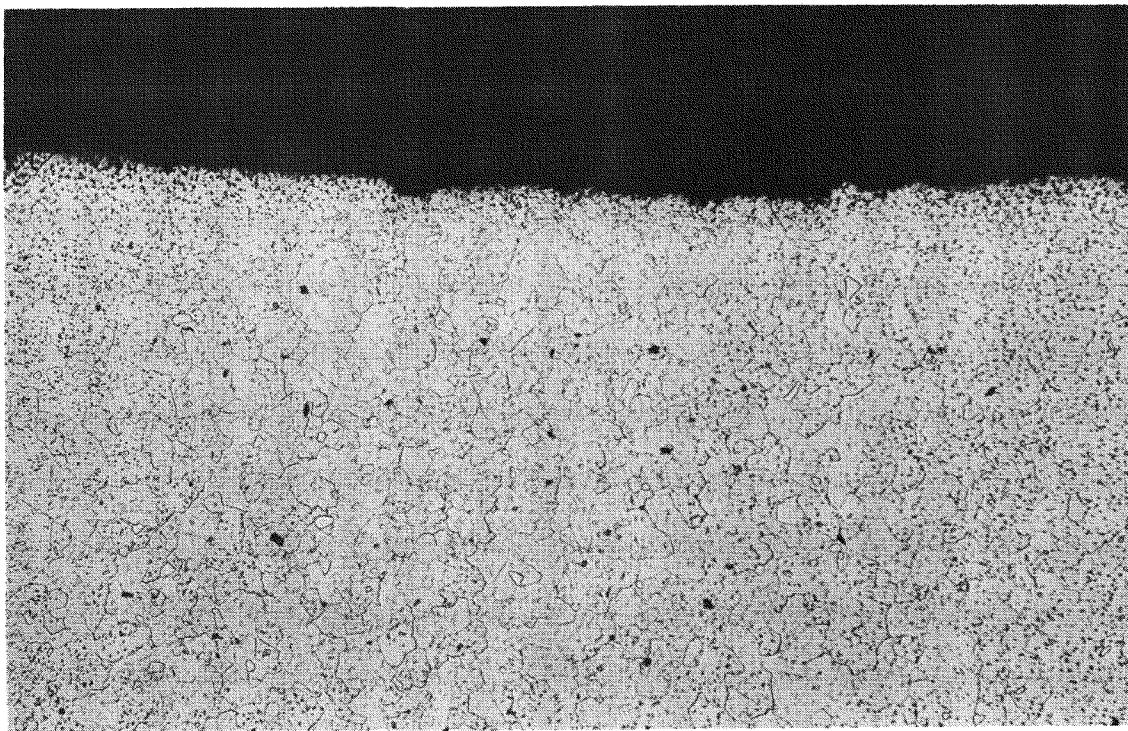
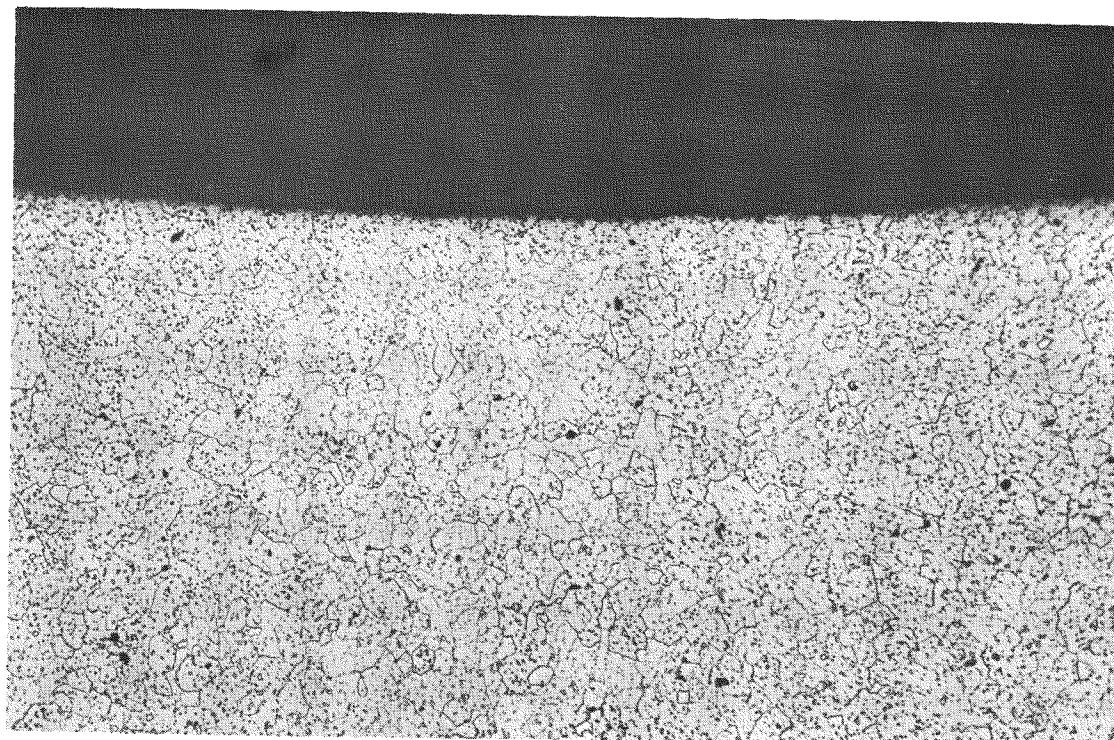
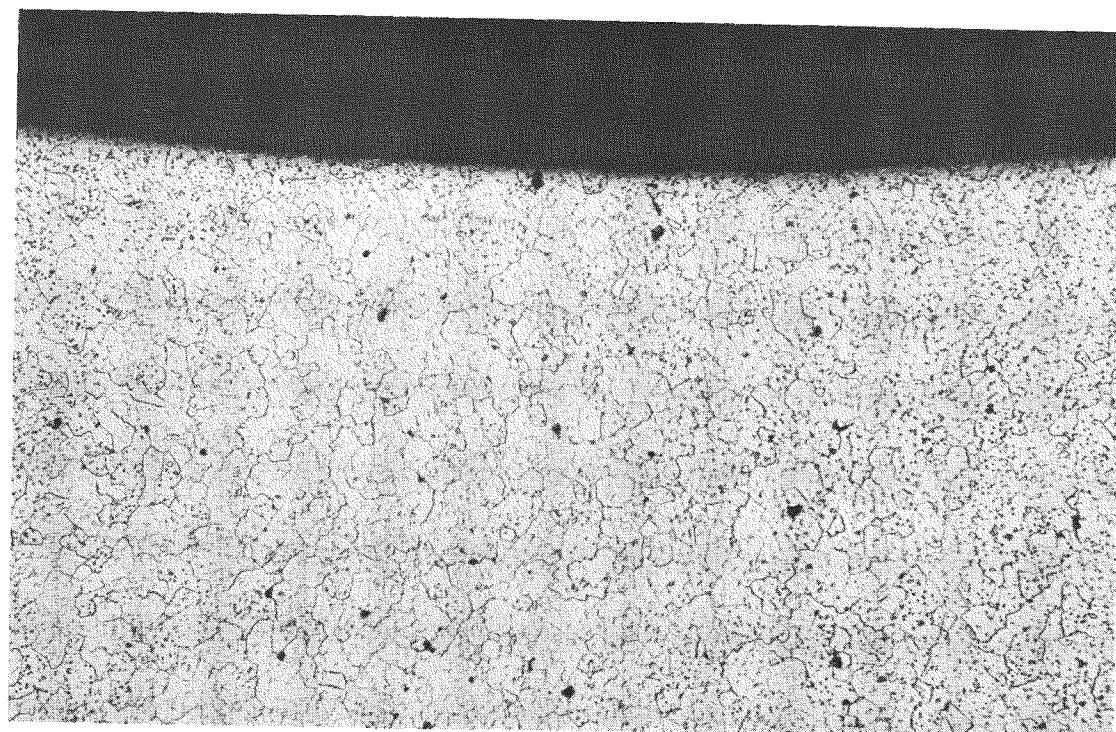
The entire Type 446 stainless steel loop was apparently unaffected by the mercury. The top, middle and bottom of the condenser coil, shown in Figs. 39, 40 and 41, show no signs of attack, as was previously noted in the discussion of the Type 446 boiler coil. It should be noted that the material was very brittle. A longitudinally cut section shattered when an attempt was made to flatten it in a vise.
