CORROSION OF CURRENT-COLLECTOR MATERIALS IN LI-ION CELLS

Jeffrey Braithwaite, Ganesan Nagasubramanian,
Angelo Gonzales, Samuel Lucero, Wendy Cieslak

Sandia National Laboratories
Albuquerque, NM 87185-0340

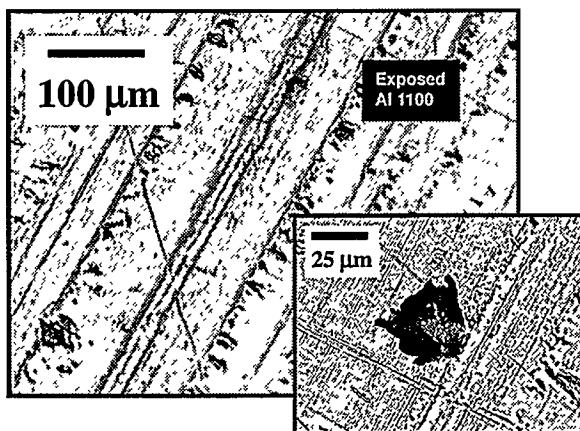
During electrical cycling, the aluminum current collector undergoes a form of pitting corrosion. After several days of cycling (40 LEO cycles), some general attack of the aluminum surface was visible in that an almost electropolished appearance existed, but more importantly, some scattered pitting had initiated (compare Figure 4 and Figure 5). With continued cycling, the pit density increased, as shown in Figure 6 for 690 LEO cycles in the PC:DEC electrolyte. Cycling in the EC:DMC electrolyte resulted in a higher pit density, as shown in Figure 7 for 150 LEO cycles. Curiously, what optically looked like pits after extended cycling in both electrolytes are actually mounds. Based on cross-sectional SEM examination of the foil (as in Figure 8), these mounds appear to be filled in pits. XPS and Auger analyses are presently being performed to help understand this phenomenon. Initial results indicate that the mounds contain both Al^0 and Al_2O_3 . Because of the primarily anodic conditions during LEO cycling, the existence of metallic aluminum implies that the mounds are electrically isolated from the foil. Two possible explanations are that 1) corrosion undermined the initial pit and caused the metal to bulge and break away, or 2) metal was redeposited on poorly conductive corrosion products during the discharge portion of the LEO cycle during which cathodic conditions exist (open circuit voltage for Al is between 3.2 and 3.6 V).

Figure 5. Photographs of the Al surface after 40 LEO cycles in PC:DEC electrolyte

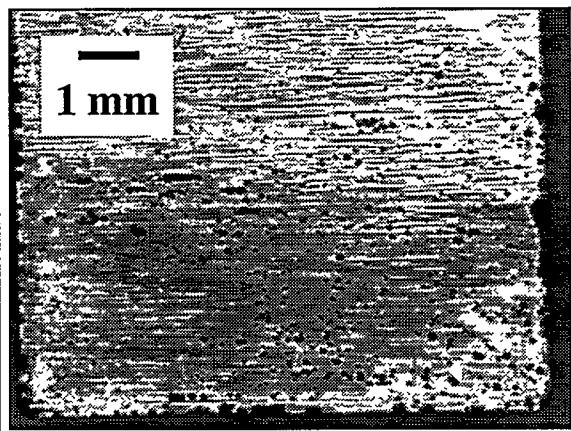
Figure 6. Photograph of an Al surface after 690 LEO cycles in PC:DEC electrolyte

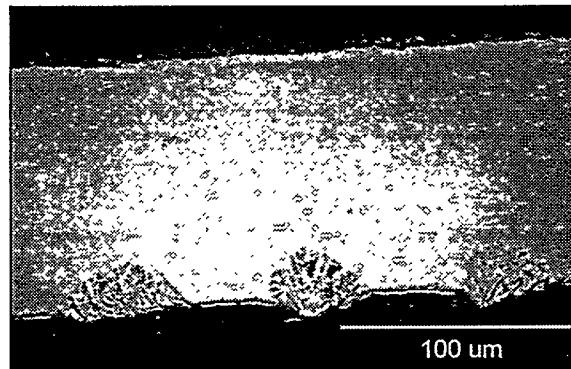
Figure 8. SEM cross-section of Al foil after 150 cycles in EC:DMC electrolyte

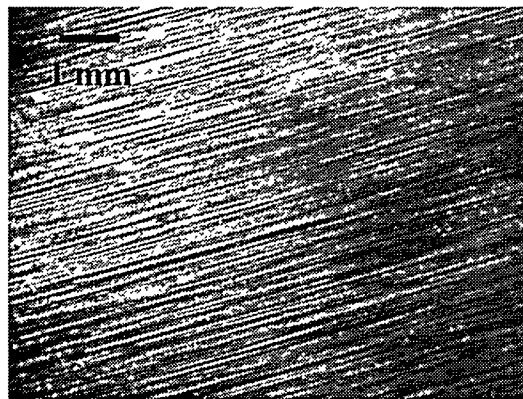
Figure 15. Al substrate after polymerized C coating removed after 445 cycles

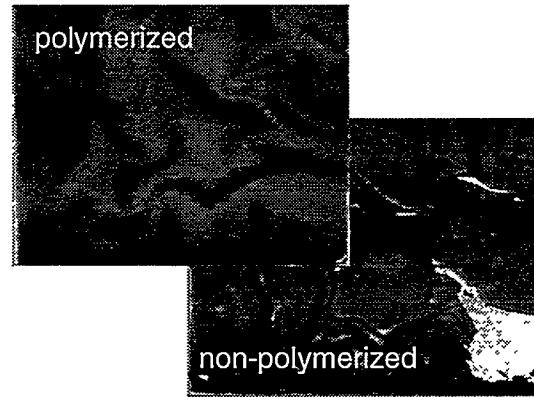
- The fluoro-carbon based coatings improve corrosion resistance. Figure 14 is a Bode phase plot showing that the uncoated electrode has a single dominant process (represented with a single capacitive/resistive combination and thus one pseudo-time constant), whereas the two coated electrodes show two processes: the non-polymerized with two overlapping time constants, and the polymerized with two distinct time constants. Quantitative modeling of the EIS data is thus a necessary activity to determine the pitting resistance portion of the total EIS resistance. Results indicate that pitting resistance can increase by close to one order of magnitude for coated electrodes. The corresponding increase in resistance was confirmed by a lack of pitting observed on one of the samples (Figure 15) after 445 LEO cycles in the PC:DEC electrolyte. Although not substantiated with surface analysis, a possible reason that these coatings improve the corrosion resistance of aluminum is that much of the active pit area becomes sealed. However, some interaction (swelling and delamination) did occur between the electrolyte and both coatings (Figure 16). As such, the ability to provide long-term protection is unknown.

Figure 16. Polymerized and non-polymerized coatings after 445 LEO cycles

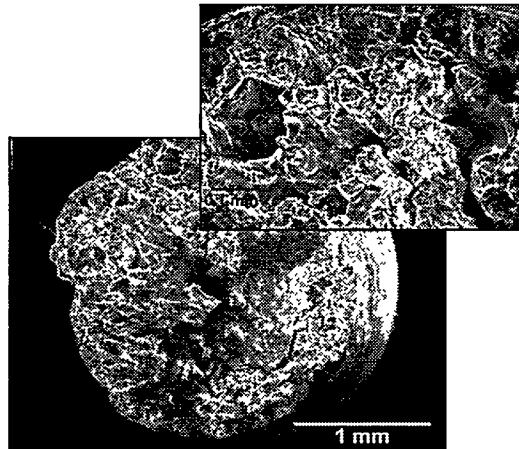
CERT revealed intergranular EAC of copper in large-grained, work-hardened material when tested at an applied voltage of 0V vs. Li/Li⁺ (Figure 18). Lack of either of the two metallurgical factors was sufficient to eliminate EAC susceptibility in these tests. For example, the very ductile behavior of fine-grained, work-hardened material under the same electrochemical conditions is shown in Figure 19. The susceptibility conditions are consistent with those observed for Ni in Li/SOCl₂ cells [1], implying that the Cu EAC phenomenon is mechanistically similar, that is, Li-induced EAC.

Figure 18. SEM photograph of the brittle fracture surface of coarse-grained, work-hardened copper

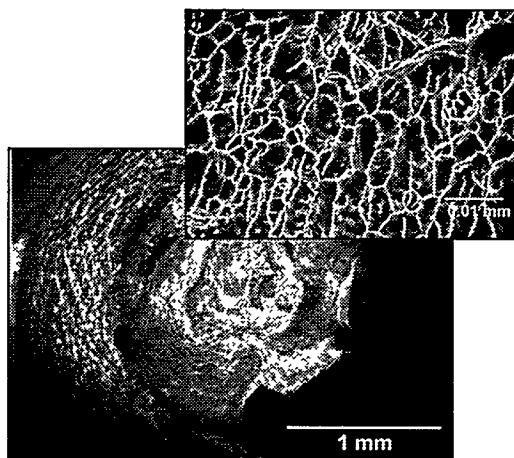
Figure 19. SEM photograph of the ductile fracture surface of fine-grained, work-hardened copper

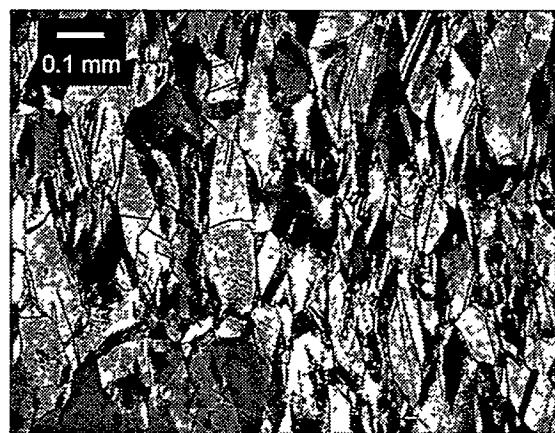
Because the conditions of CERT are so severe, intergranular cracking occurred despite an unfavorable orientation of the grains that were longitudinally elongated in the rod (Figure 20). An important effort to complete in the future will be to characterize the range of actual conditions that cause a susceptibility using u-bend samples of varying orientation and stress levels under various simulating cell environments. To date, EAC from the limited u-bend tests completed or from actual foil from commercial cells has not been observed.

Figure 20. Longitudinal cross-sectioned copper tensile bar that had brittle behavior
