**Masonry Infill Performance During the
Northridge Earthquake**

March 8, 1996

**For Presentation at the
1996 North American Masonry Conference
South Bend, Indiana**

by Roger D. Flanagan¹, Richard M. Bennett², Samy A. Adham³, William L. Fischer⁴

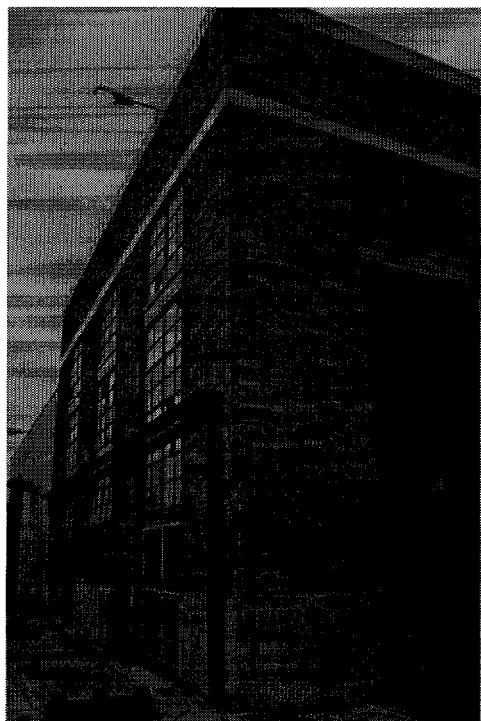
Figure 1: Sepulveda VA Hospital
Building 40

Building 40 at the Sepulveda VA hospital is a one story steam plant building with a reinforced concrete frame, Figure 1. Records at the base showed peak accelerations of 0.75g in the east-west direction, 0.94g in the north-south direction, and 0.45g in the vertical direction. This building was constructed in 1955. It appeared well designed, but some construction deficiencies were apparent. Concrete had spalled off of one concrete column near the base revealing about 15" of vertical reinforcing, Figure 2. No ties were present in this length, despite plans calling for #3 ties at 10". There was also a corner of the infill that had been damaged revealing the grout core, Figure 3. One place was observed in which there was a large void in the grout leaving some reinforcing with no grout around it. Nevertheless, this building survived the large ground shaking to which it was subjected. The building had visible damage at numerous locations but did not suffer collapse. Therefore, life safety was achieved and the building still has limited use. However, it will eventually be replaced. The infills had a positive beneficial effect on the performance of this structure.

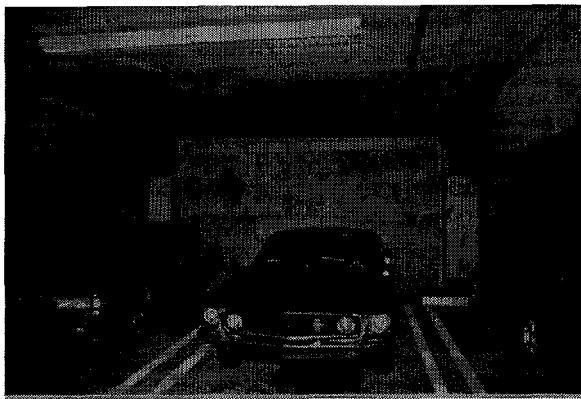
Several parking garages in the northern Los Angeles area were observed which had reinforced concrete frames with concrete masonry infills. In one instance, these were separated from the concrete frame by a $\frac{1}{2}$ "-1" joint filled with styrofoam, Figures 4-5. Obviously the intent was to isolate the infill from the frame, so that there would be no interaction. Isolating the infill leads to other problems. The infill must be adequately anchored out-of-plane, as arching cannot develop. If the gap is not large enough, the columns will engage the infill, and it will interact with the structure (Flanagan, 1994). Yanev and McNiven (1985) observed in dynamic testing that the buffeting that occurs when the frame engages the infill quickly destroys the infill. They tried using foam rubber as a filler in the gap to minimize the impact effects, but it had minimal effect. Thus, in designing isolated infills, the out-of-plane anchorage and the provision of a sufficient gap ($\frac{1}{2}$ " may be inadequate since it only allows for approximately 0.5% drift) need to be considered.

Figure 4: Parking Garage

Figure 5: Isolated Panel

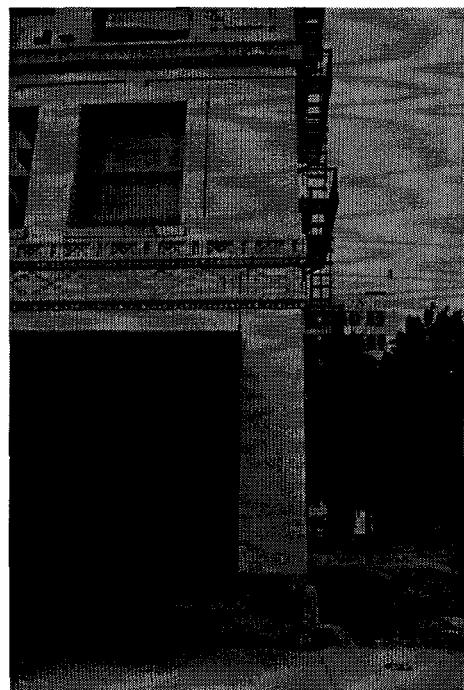
Several buildings in downtown Los Angeles had a primary lateral load resisting system of unreinforced infills. These buildings were constructed early in the 1900s and typically had clay brick or clay tile infills.. One notable example is the City Hall building which has steel framing with unreinforced clay tile infills. Ground motions in the downtown area were in the range of 0.15-0.20g during the Northridge earthquake. This is typical of the level of excitation expected in many of the large moderate seismic zones in the eastern and central United States. Damage was noted in many of the infills, primarily consisting of diagonal cracking or cracking along the infill boundary. Figures 8-9 show damage near building corners. Diagonal cracks are shown in Figures 10-11.

Figure 8: Los Angeles Building

Figure 9: Pasadena Building

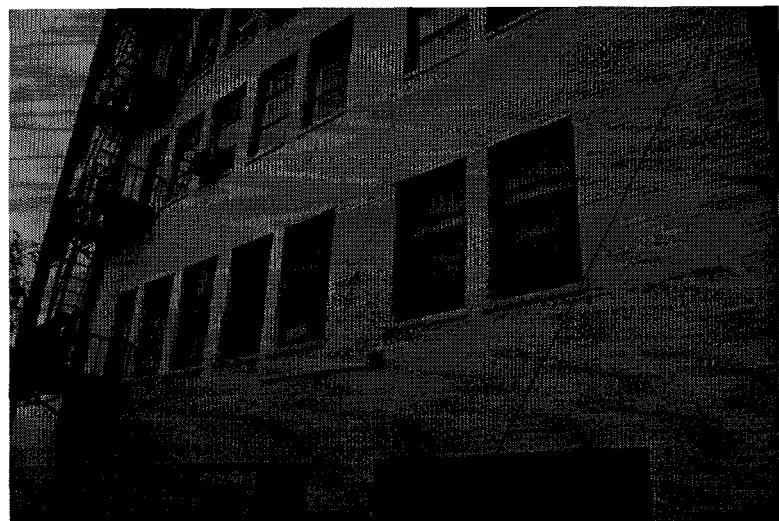
Figure 10: Pomona Building

Figure 11: Pasadena Building
