Y/EN-5493

**Evaluation and Analysis of the Performance of  
Masonry Infills During the Northridge  
Earthquake**

**Final Report for Submission  
to the National Science Foundation  
Grant No. CMS-9416262**

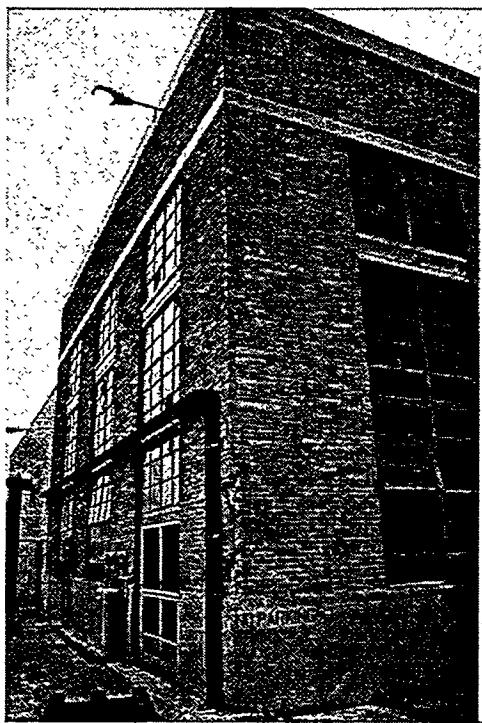
Figure 2.1: Sepulveda VA Hospital  
Building 40

Building 40 at the Sepulveda VA hospital is a one story steam plant building with a reinforced concrete frame, Figure 2.1. Records at the base showed peak accelerations of 0.75g in the east-west direction, 0.94g in the north-south direction, and 0.45g in the vertical direction. This building was constructed in 1955. It appeared well designed, but some construction deficiencies were apparent. Concrete had spalled off of one concrete column near the base revealing about 15" of vertical reinforcing, Figure 2.2. No ties were present in this length, despite plans calling for #3 ties at 10". There was also a corner of the infill that had been damaged revealing the grout core, Figure 2.3. One place was observed in which there was a large void in the grout leaving some reinforcing with no grout around it. Nevertheless, this building survived the large ground shaking to which it was subjected. The building had visible damage at numerous locations but did not suffer collapse. Therefore, life safety was achieved and the building still has limited use. However, it will eventually be replaced. The infills had a positive beneficial effect on the performance of this structure.

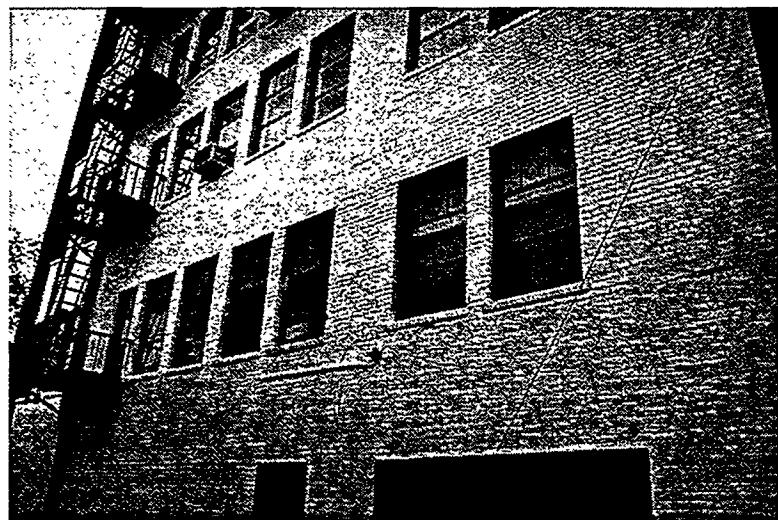
Figure 2.10: Pomona Building

Several buildings in downtown Los Angeles had a primary lateral load resisting system of unreinforced infills. These buildings were constructed early in the 1900s and typically had clay brick or clay tile infills. One notable example is the City Hall building which has steel framing with unreinforced clay tile infills. Ground motions in the downtown area were in the range of 0.15-0.20g during the Northridge earthquake. This is typical of the level of excitation expected in many of the large moderate seismic zones in the eastern and central United States. Damage was noted in many of the infills, primarily consisting of diagonal cracking or cracking along the infill boundary. Figures 2.8-2.9 show damage near building corners. Diagonal cracks are shown in Figures 2.10-2.11.

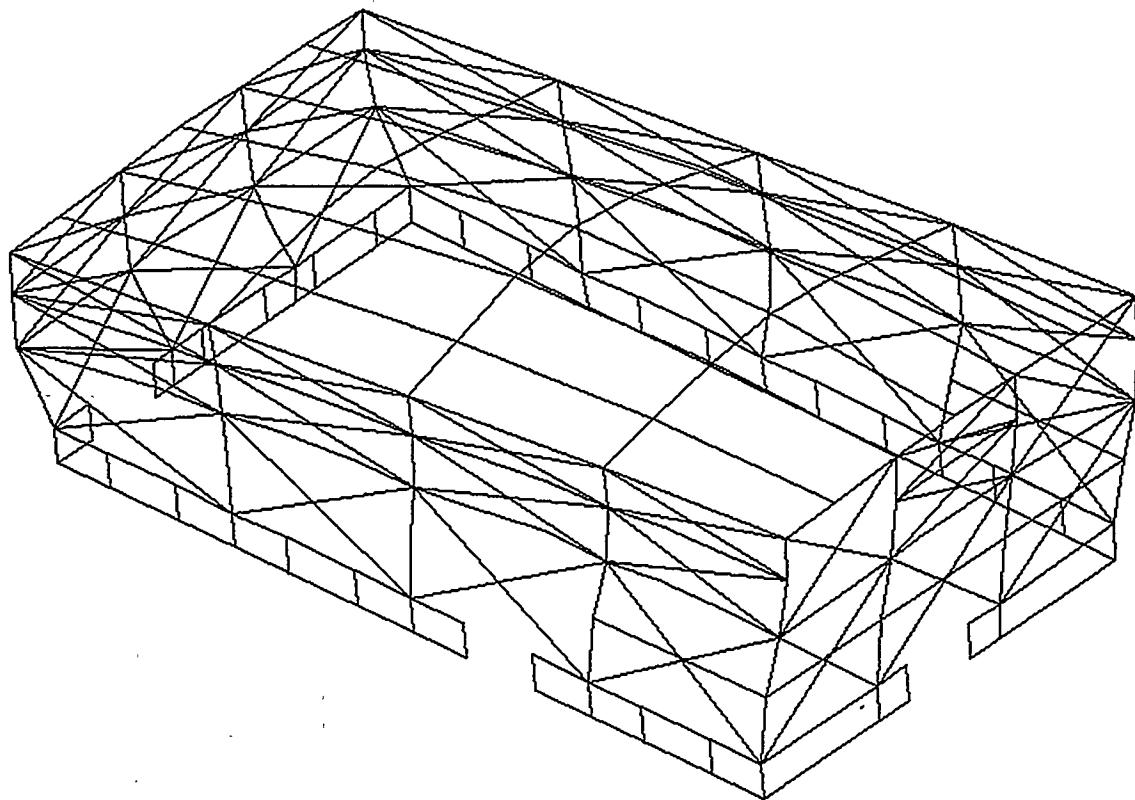
Figure 4.5 Deformed Shape of Building 40

The results can also be viewed in terms of strut/infill behavior. There is a band of solid infills around the top of the structure, which adds a significant amount of stiffness. The drift in these infills was on the order of 0.1-0.2", with C generally being 4. Possibly some minor cracking would exist in these infills. Drifts at the middle level varied between 0.4-0.8". Thus, these infills were reaching their capacity, and corner crushing was starting to occur. As expected, the largest drifts were in the lowest level, with the drift on the east side being approximately 4.1". All of the lower level infills had reached their capacity, and with the large drifts that some experienced, quite visible damage would be expected.

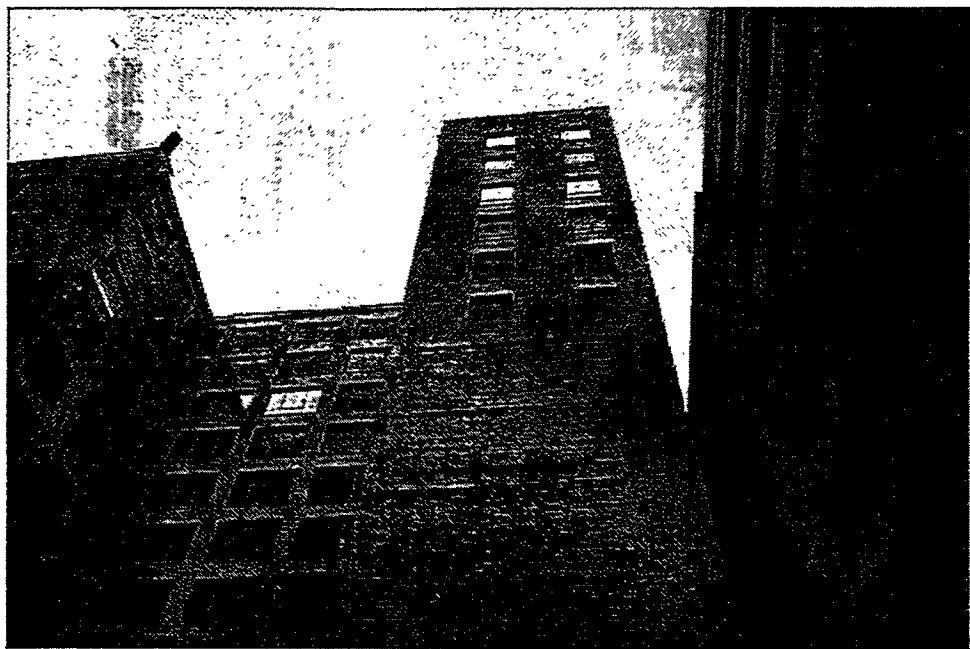
Figure 5.3 Damage to Los Angeles Building

The investigators did not have access to the interior of the building to observe any damage as the result of the Northridge earthquake. The exterior of the building showed some minor damage. Primarily this was vertical cracking on the back side at the southwest side. Some minor diagonal cracking was also observed in these infills. Figures 2.8 and 5.3 show some of the damage to the structure. Note the cracking in the lower infills in Figure 5.3.

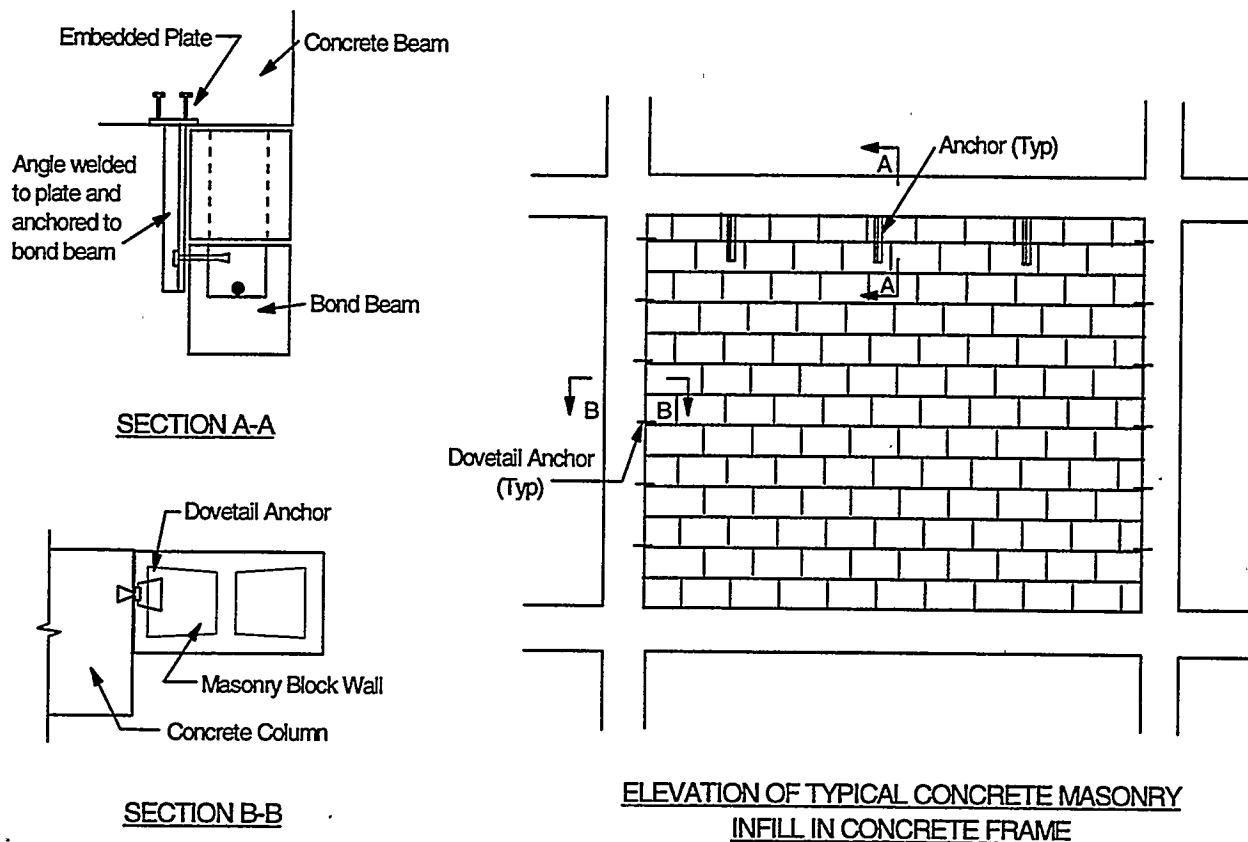
Figure 6.1 Typical Infill Construction

The researchers have observed the construction of tightly fitted infills that used some details that added to the expense of the structure without adding any beneficial behavior, and in some cases detrimental behavior. Figure 6.1 shows a typical infill construction. The infill was anchored to the columns using dovetail anchors. Presumably this is done to anchor the panel against out-of-plane

motions. The primary out-of-plane resisting mechanism is arching, for which the anchors do not contribute. The anchors can lead to premature in-plane cracking, which can reduce the panel capacity. It is therefore recommended that these anchors be eliminated. A similar situation exists at the top of the infill. For example, Figure 6.1 illustrates a steel plate embedded into the underside of the concrete floor slab, an angle field welded to the plate after completion of the masonry wall, and an anchor installed to anchor the wall to the frame. As with the side anchors, this does little to enhance the out-of-plane stability of the wall. The anchors can also lead to localized failures of the infill under in-plane loading, which can cause a premature out-of-plane failure, or a partial height infill and premature shear failures of the columns. Again, it is recommended that these anchors be eliminated. A tightly constructed infill has in general a large factor of safety against out-of-plane loads due to arching, and can add to the in-plane stiffness and strength.
