## Air Drop Test of Shielded Radioactive Material Containers

**SAND75-0276**  
Unlimited Release  
Printed September 1975

Ivan G. Waddoups  
System Studies and Engineering Division 1741  
Sandia Laboratories  
Albuquerque, New Mexico  
87113

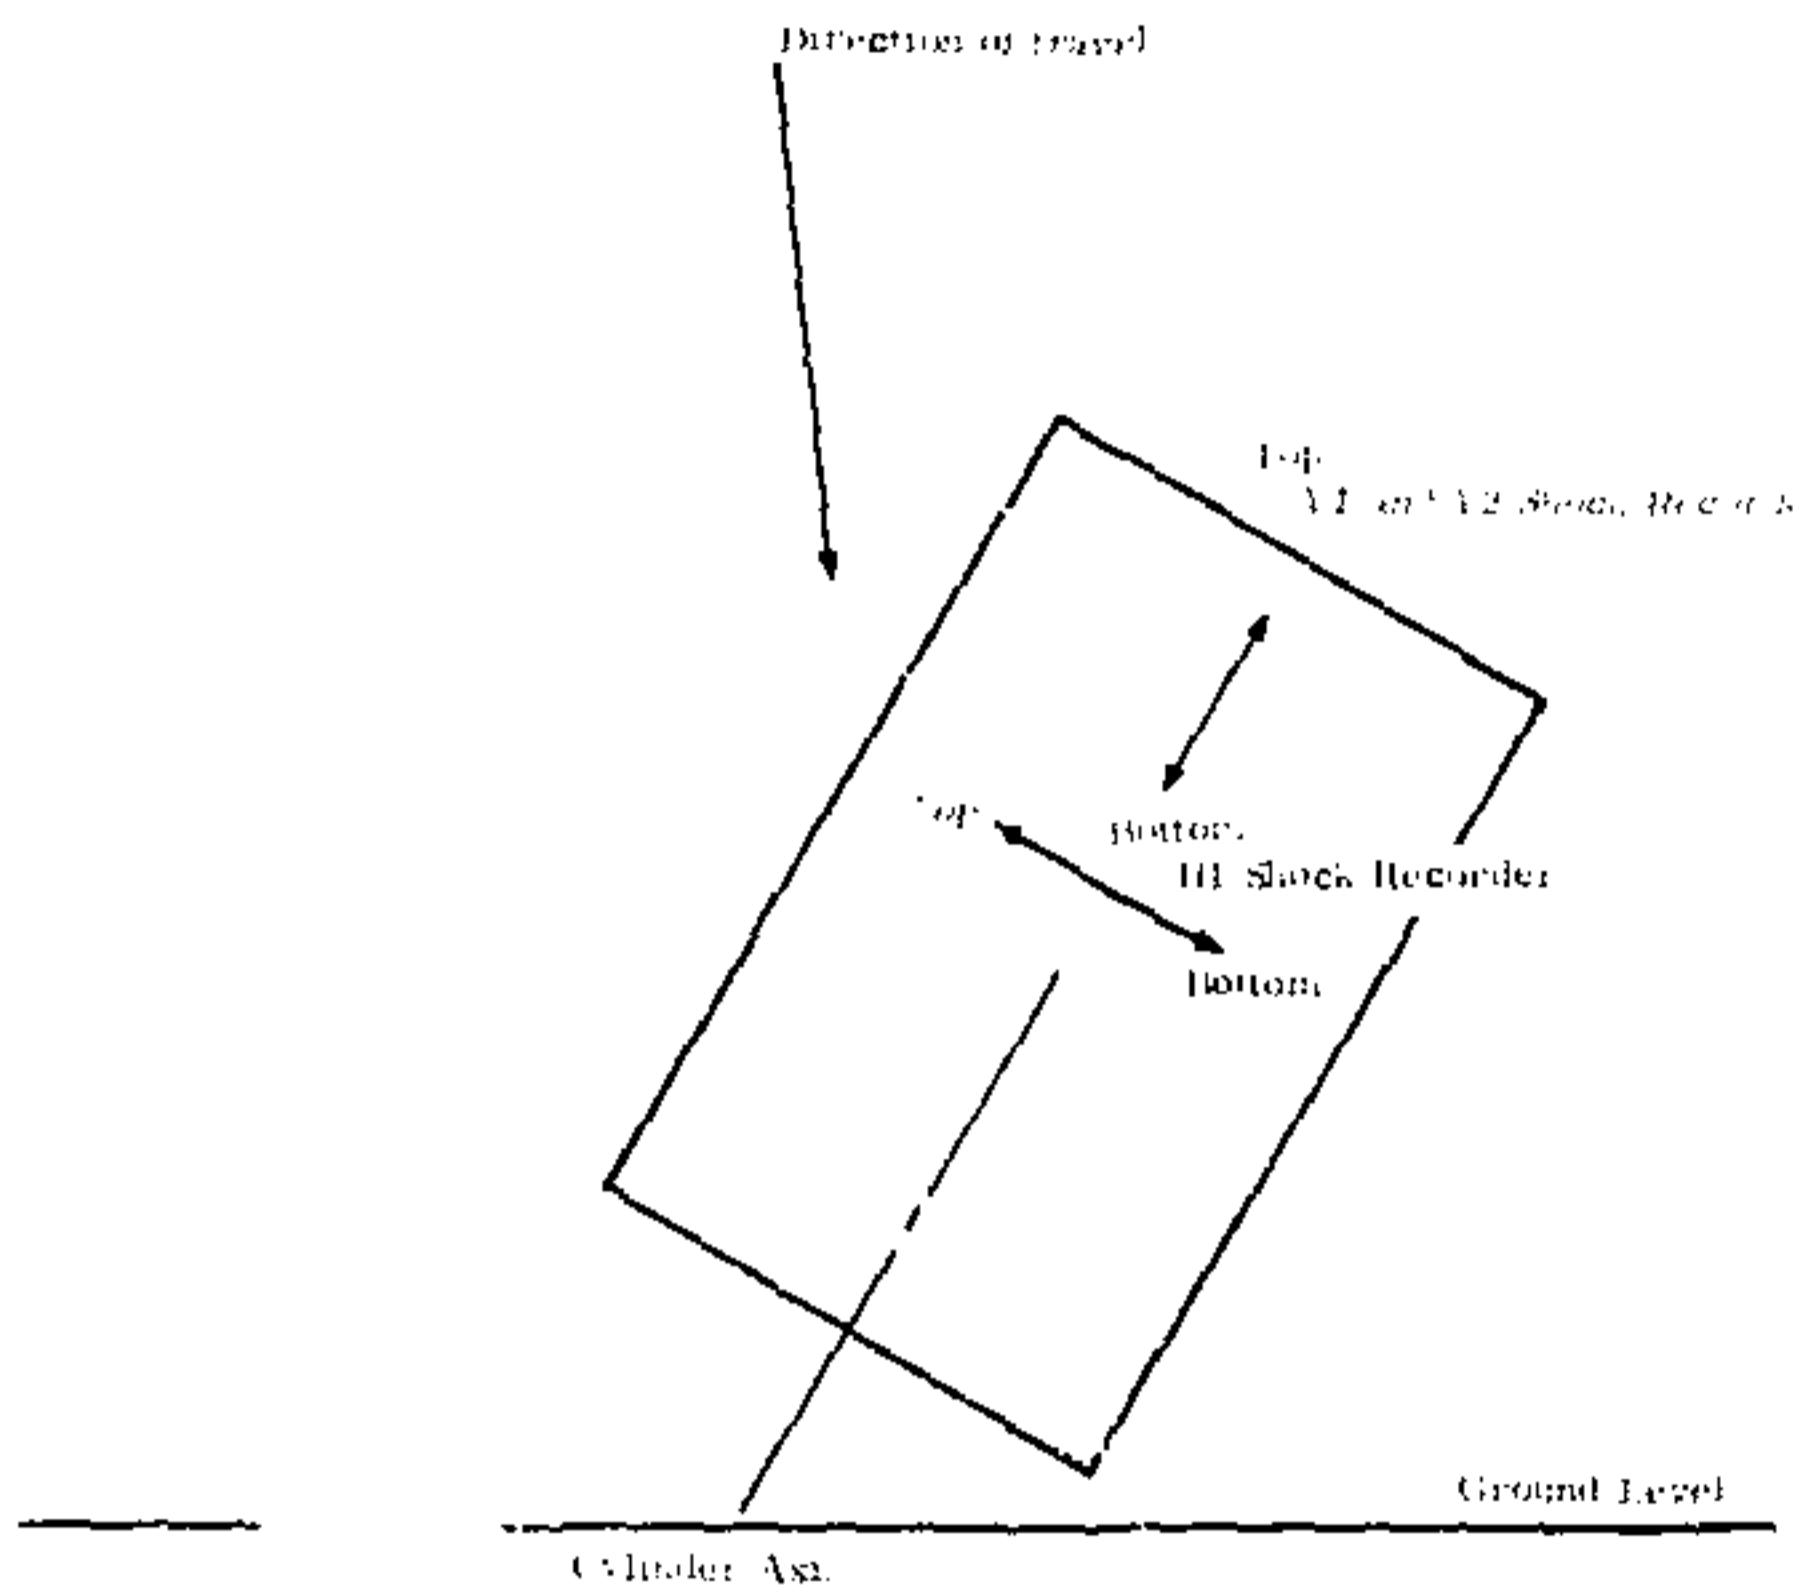
a. Orientation of Shock Recorders and the ODS-1 on Impact

Three Celeseco Model A-12 passive shock recorders were attached to the cask prior to testing to obtain an indication of the deceleration forces. These devices are rather crude and are only accurate to within +100 percent or -50 percent of the actual environment. Two recorders (V1 and V2) were positioned to measure accelerations along the cylindrical axis and the other (V3) was perpendicular to both this axis and the trunnion center line, as shown in Figure 6. Table III shows the acceleration levels measured. These levels are determined by the extent of deformation occurring in two deformable plastic filaments which are located between each end of a spring-loaded seismic mass and a viewing window.

<u>Shock Recorder</u>	<u>Top</u>	<u>Bottom</u>
V1	400 g's	> 600 g's
V2	400 g's	> 800 g's
B1	> 800 g's	> 800 g's
