**GREENHOUSE**

SCIENTIFIC DIRECTOR'S REPORT  
ANNEX 3.5

THE EFFECTS OF ATOMIC WEAPONS ON GLAZING AND  
WINDOW CONSTRUCTION

by  
WALTON C. CLARK  
of  
PUBLIC BUILDINGS SERVICE

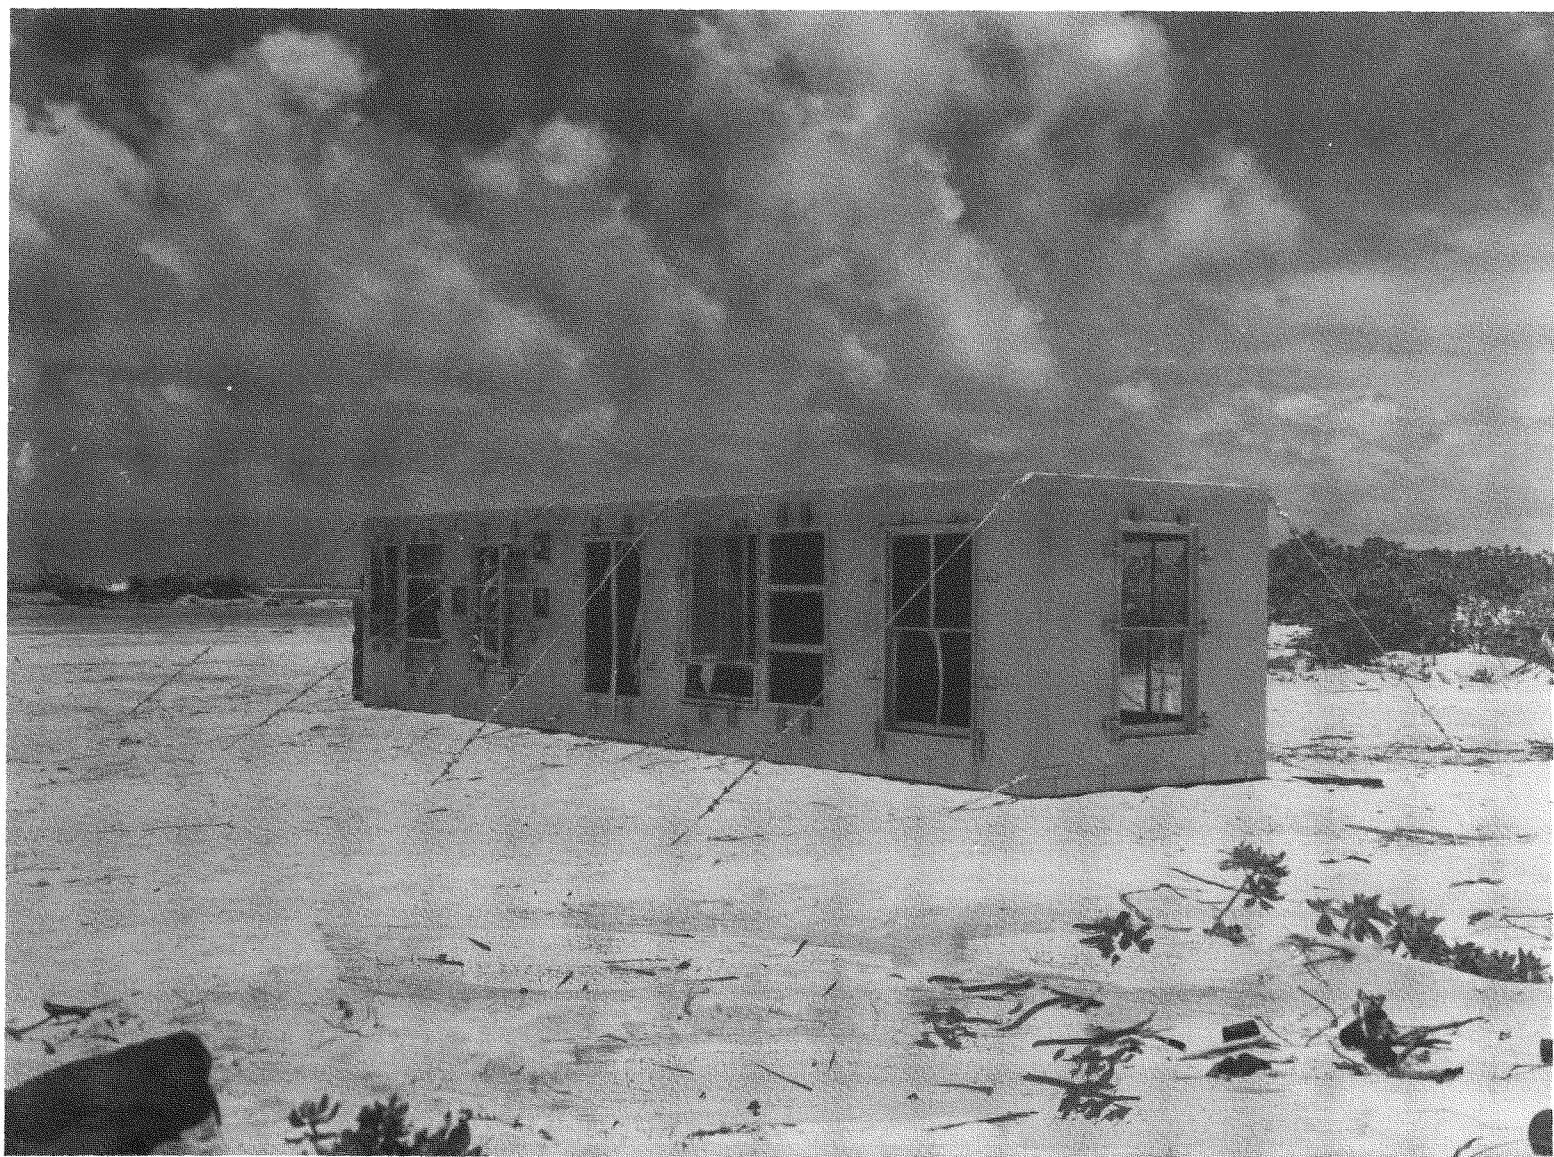
FIG. 3.2 Front of the Building after the Blast

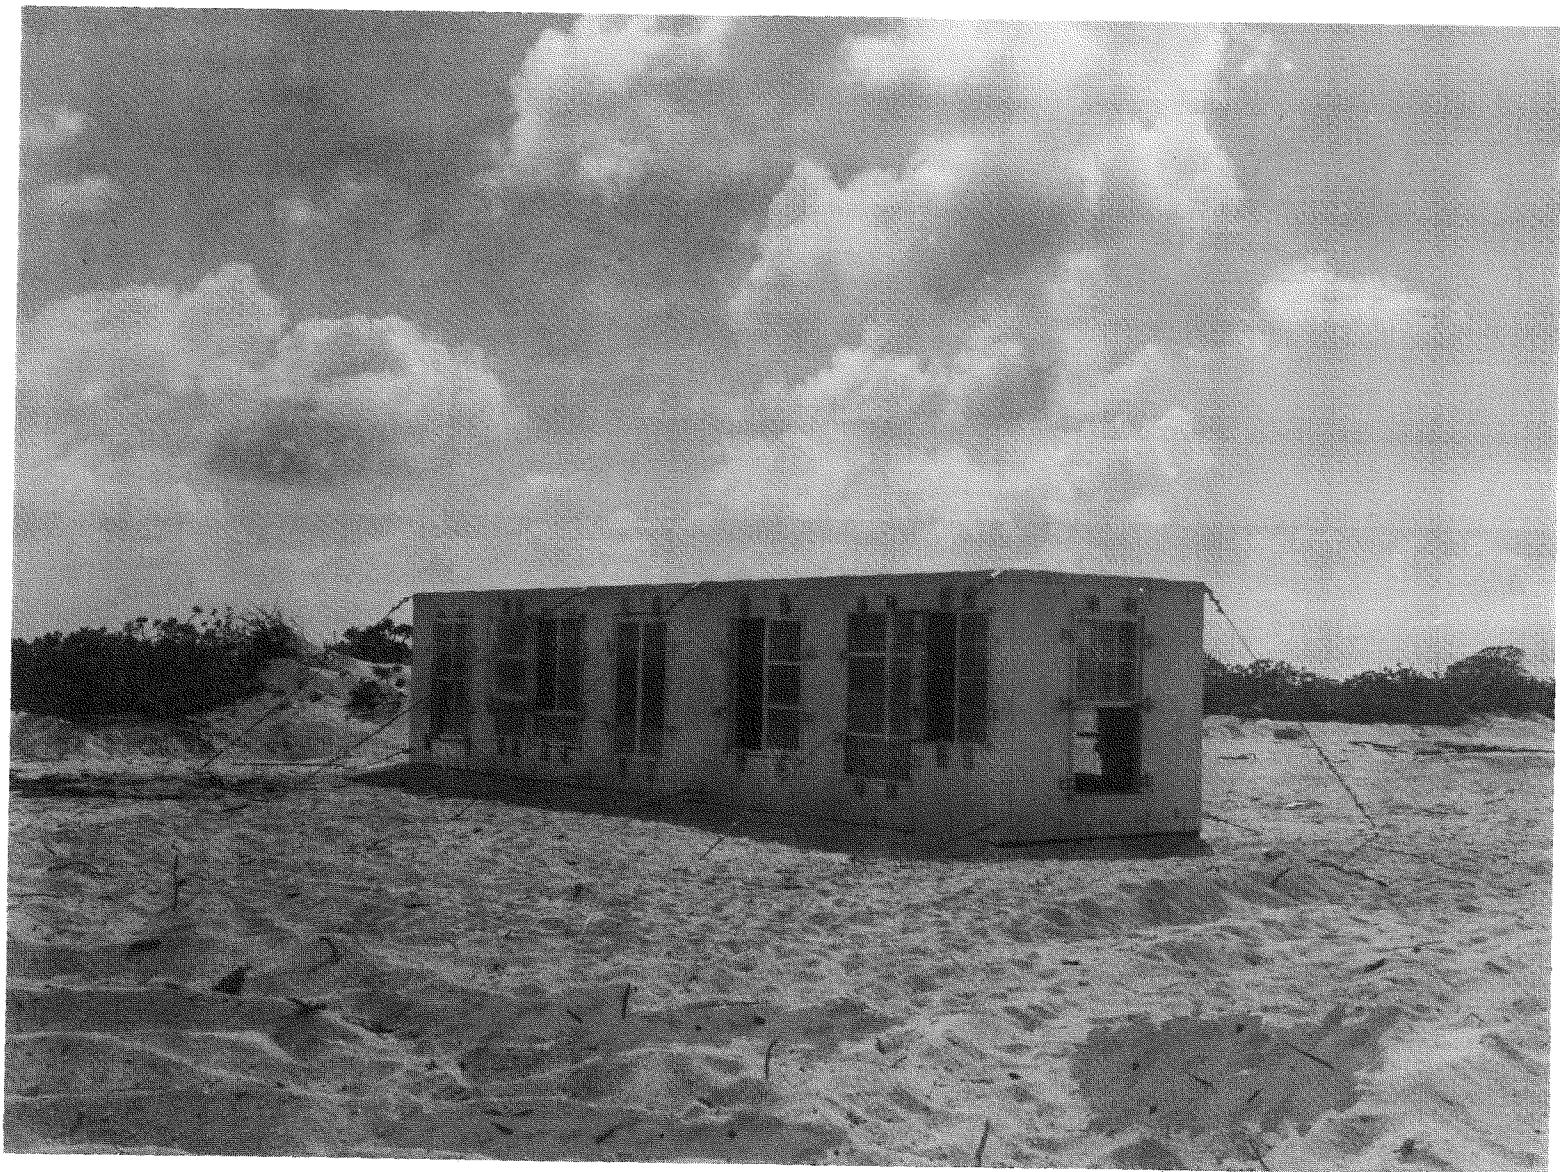
FIG. 3.4 Rear of the Building after the Blast

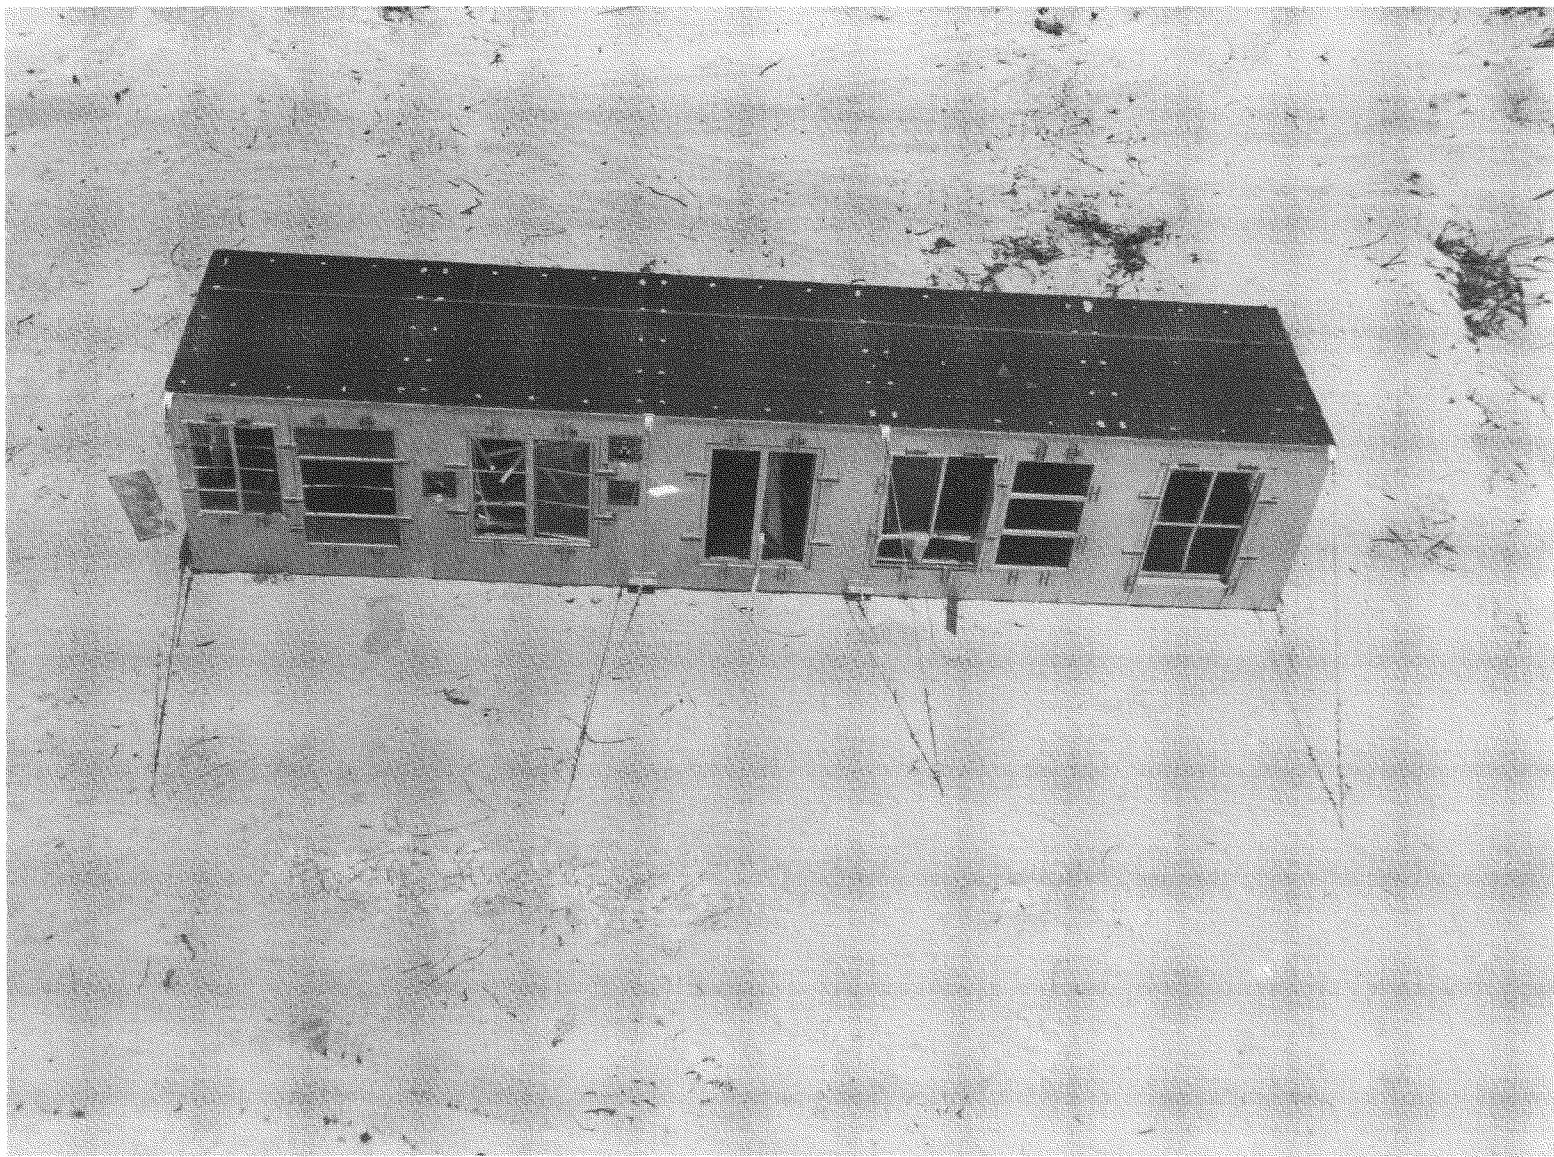
FIG. 3.5 Front of the Building after the Blast from the Air

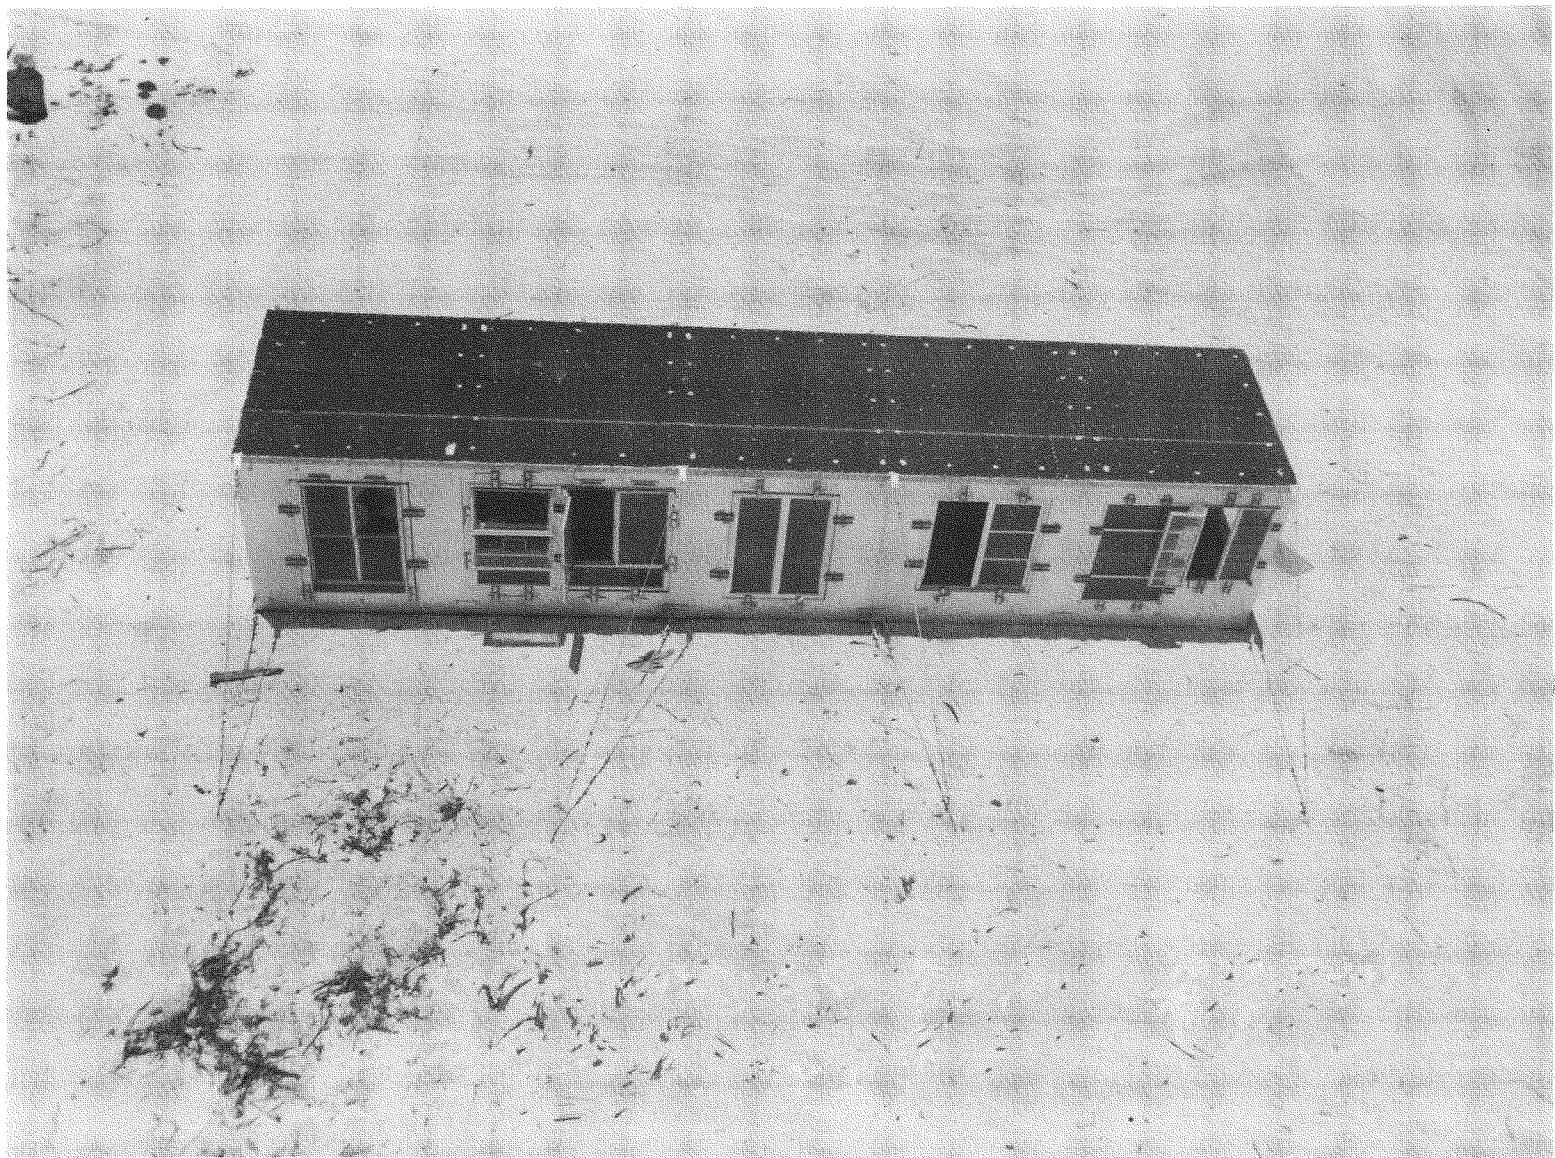
FIG. 3.6 Rear of the Building after the Blast from the Air

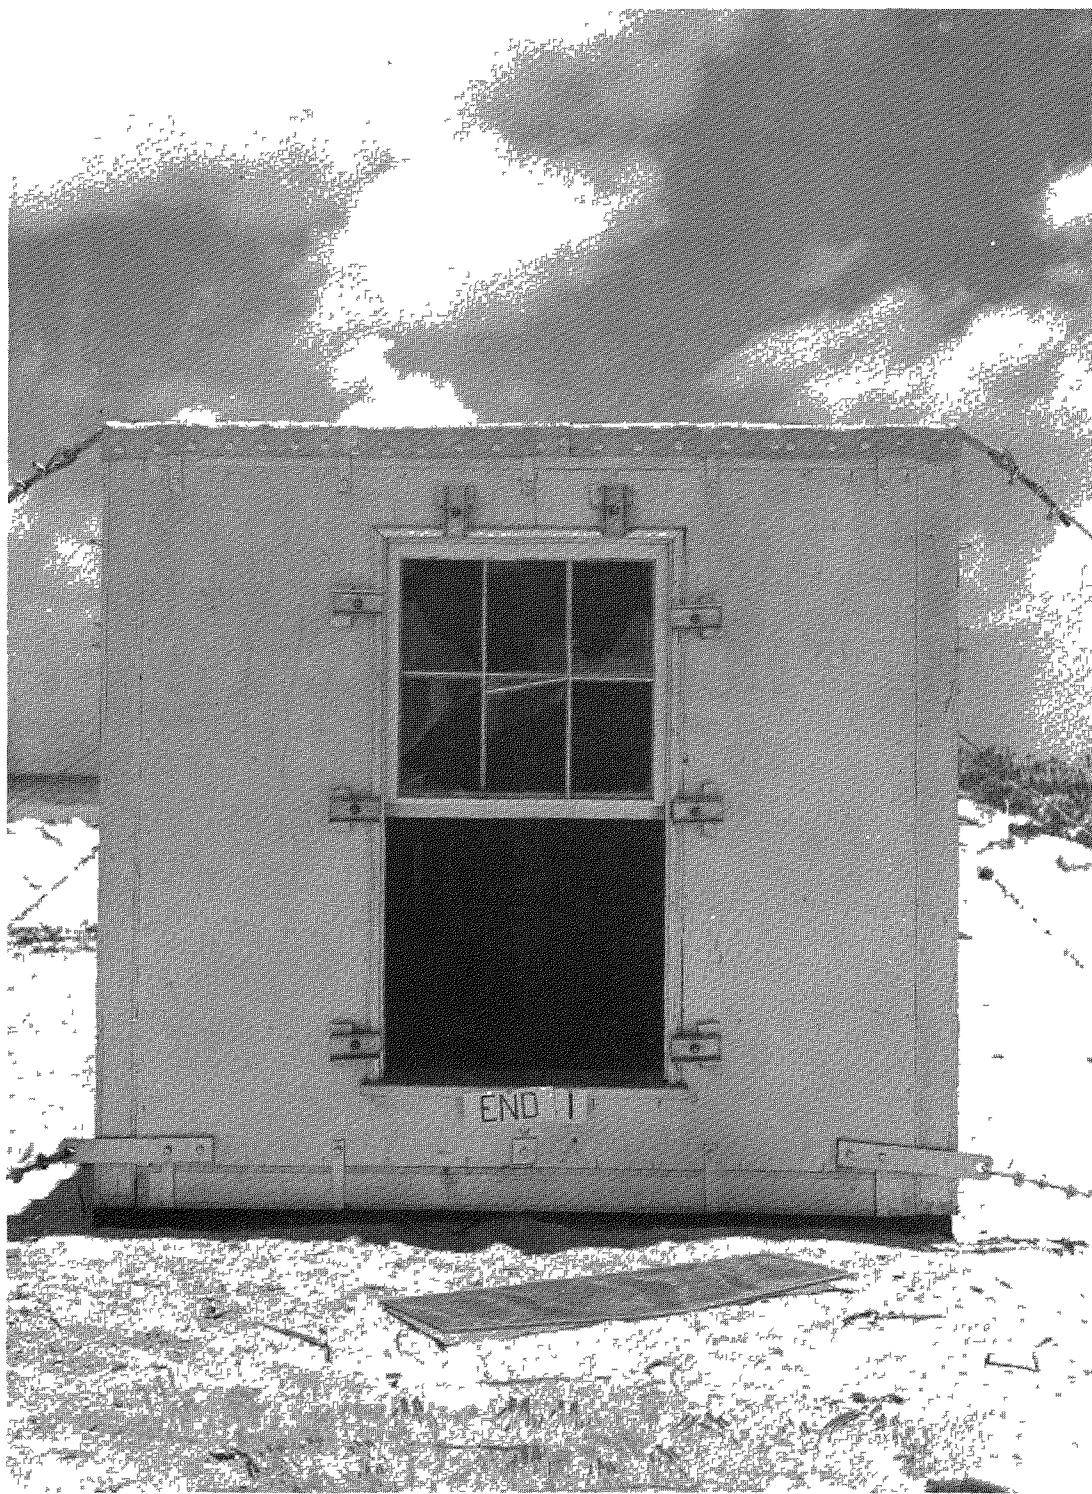
FIG. 3.8 Outside of Double-hung Wooden Window 1 after the Blast. The aluminum wire insect screen on the ground was blown through the opening below the raised sash in the end of the building. The screen was originally installed on the casement window 2 on the front of the building.

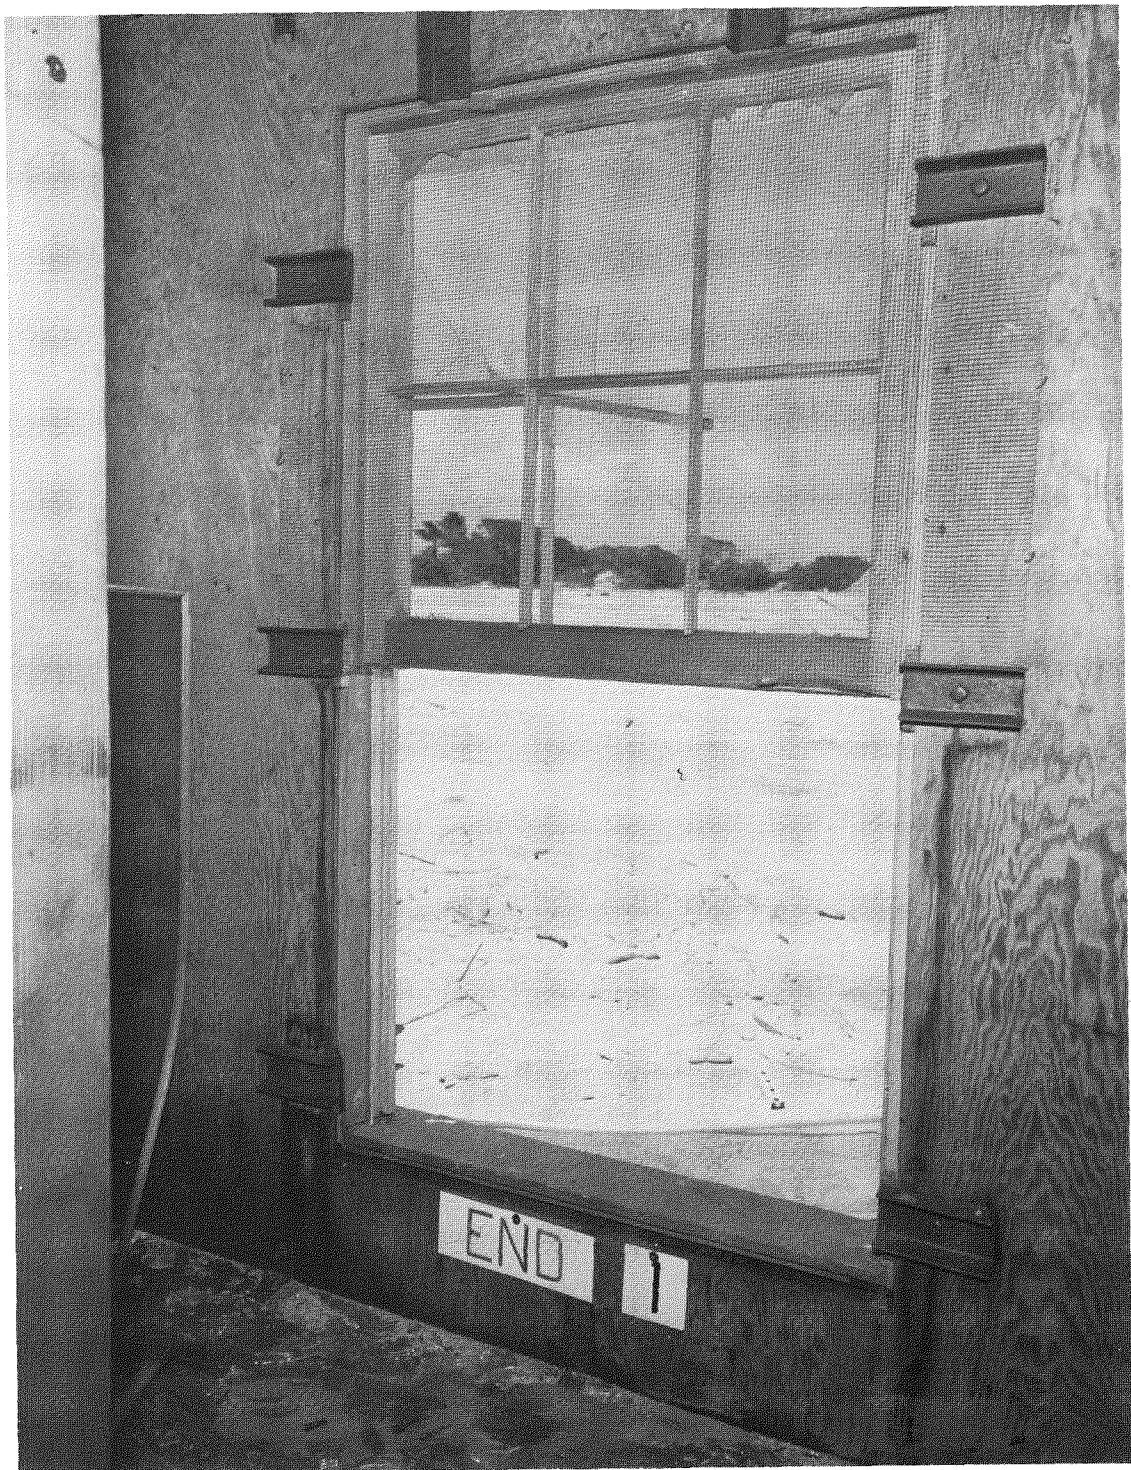
FIG. 3.10 Inside of Double-hung Wooden Window 1 after the Blast. The  $\frac{1}{4}$  in. mesh wire netting was undamaged. All the glass fragments and pieces of muntins torn loose from the sash were blown outward, apparently by the expanding air within the room after the shock front passed, before the pieces could fall vertically. This debris was on the sand outside the building about 4 ft from the face of the wall.

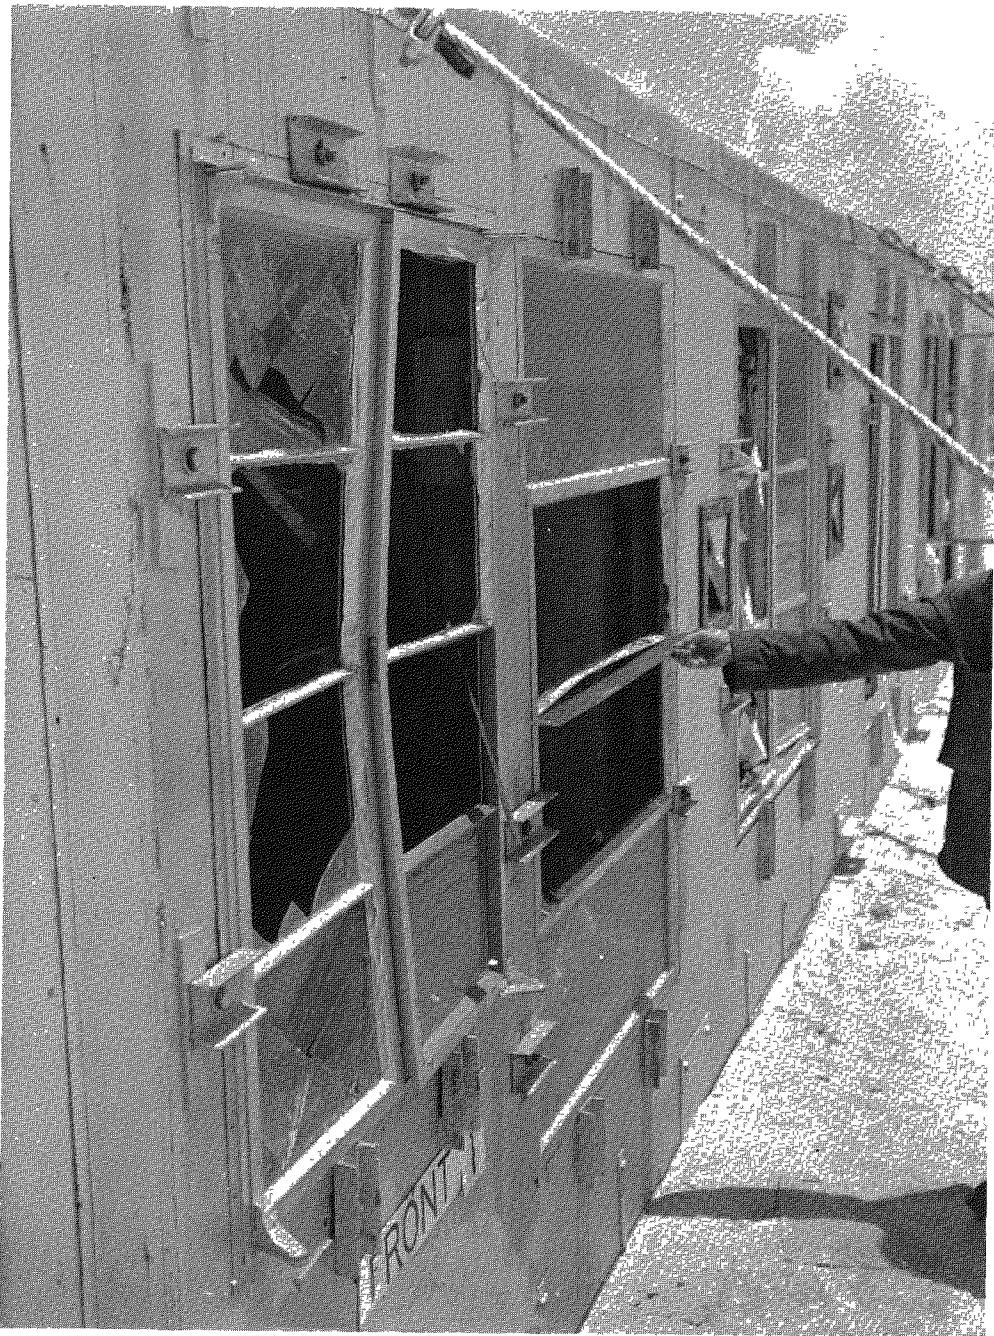
Steel architectural projected window 3 had plate glass in the upper section, two panes of safety glass in the ventilator section (separated by a lightweight muntin), and a piece of wire glass in the lower section. All glass pieces were approximately 16 by 40 in. The upper and lower panes were not damaged although the safety glass in the ventilator was destroyed when the muntin was bent inward by the blast. Wire glass only  $11\frac{1}{4}$  by  $15\frac{7}{16}$  in. was blown out of a lightweight aluminum casement adjacent to the steel window when the aluminum muntin bent inward. Glass mounted in a flexible frame is likely to be broken if the frame is distorted by the blast, whereas the same size pane may be undamaged if installed in a more rigid frame.

FIG. 3.12 Outside of Casement Window 2 and Architectural Projected Window 3 after the Blast. On the right-hand sash, the upper wire glass pane was blown out, as well as the double-strength glass in the second opening, and the  $1/10$  in. plastic in the third opening. The  $1/8$  in. thick plastic in the fourth opening was undamaged. The center meeting rail was bent approximately 2 in. out of line. The upper and lower panes on window 3 were undamaged, and the two sections of safety glass in the ventilator were broken in a large number of fragments less than  $1/2$  in. square. The plastic, however, held these fragments together in one sheet. The lower piece of safety glass fell between the lower pane of the window and the wire screen on the inside. The upper sheet of safety glass fell to the ground and can be seen in the shadow of the man's hand.

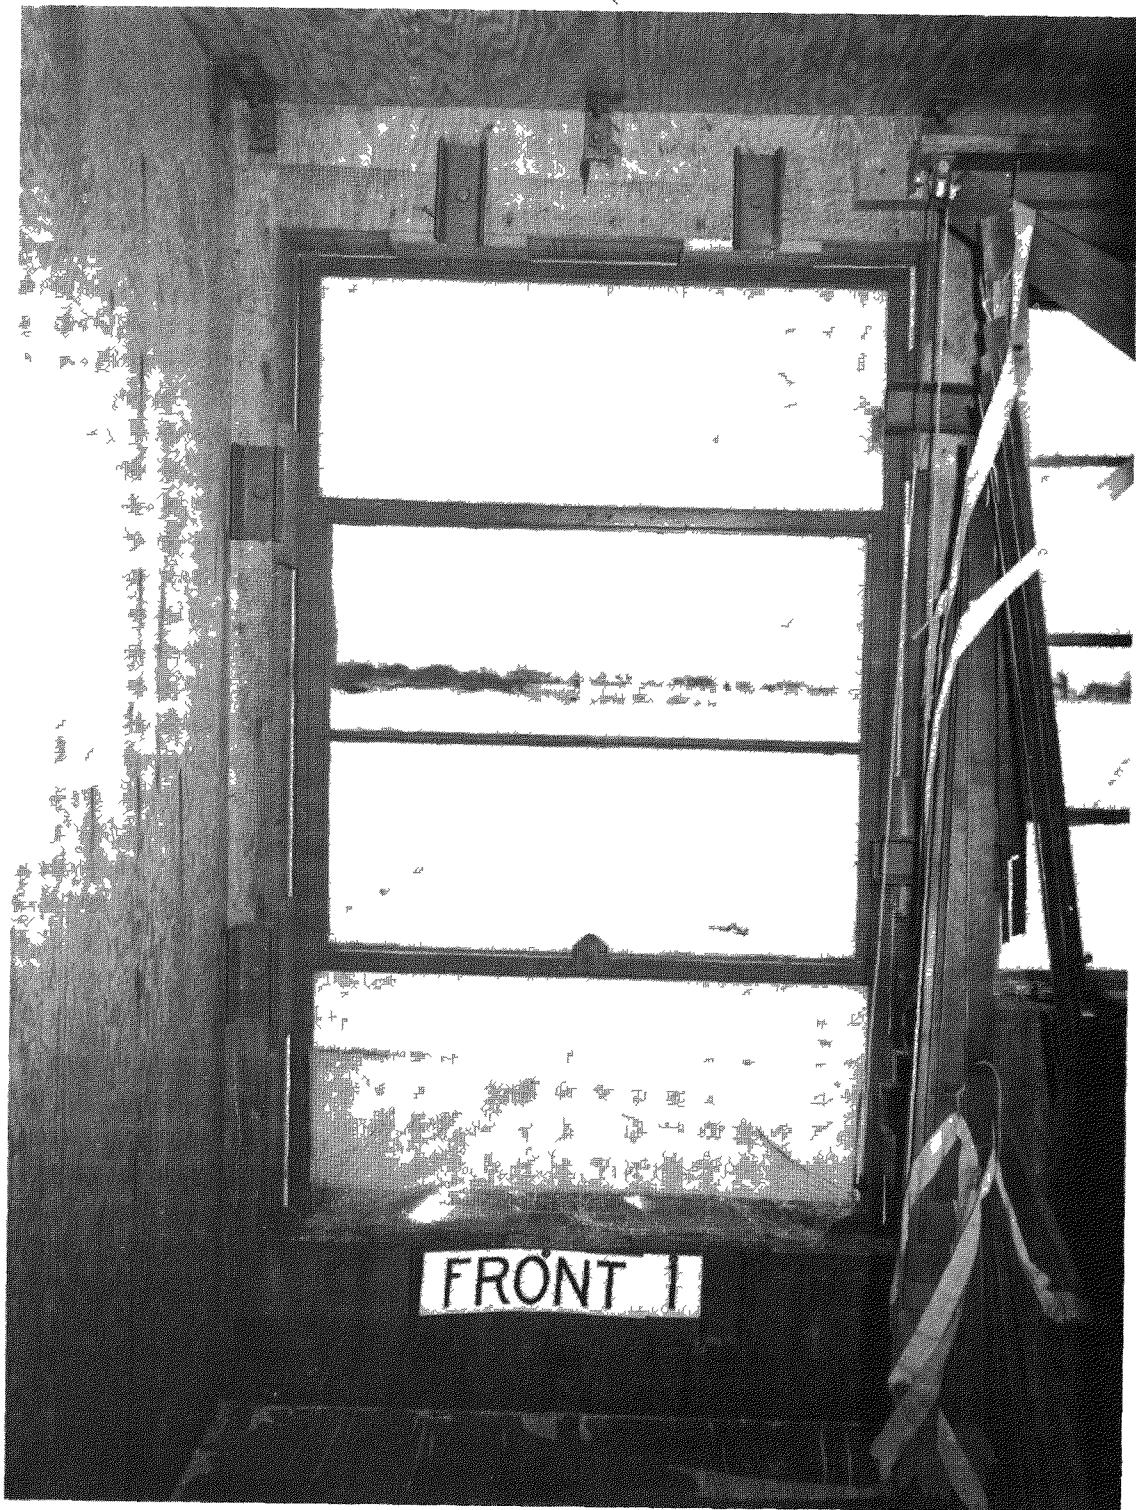
FIG 3 14 Inside of Architectural Projected Window 3 after the Blast The  $\frac{1}{4}$  in mesh wire netting is intact, and the lower section of the crushed safety glass dropped to a position between the wire netting and the wire glass pane, which was unbroken

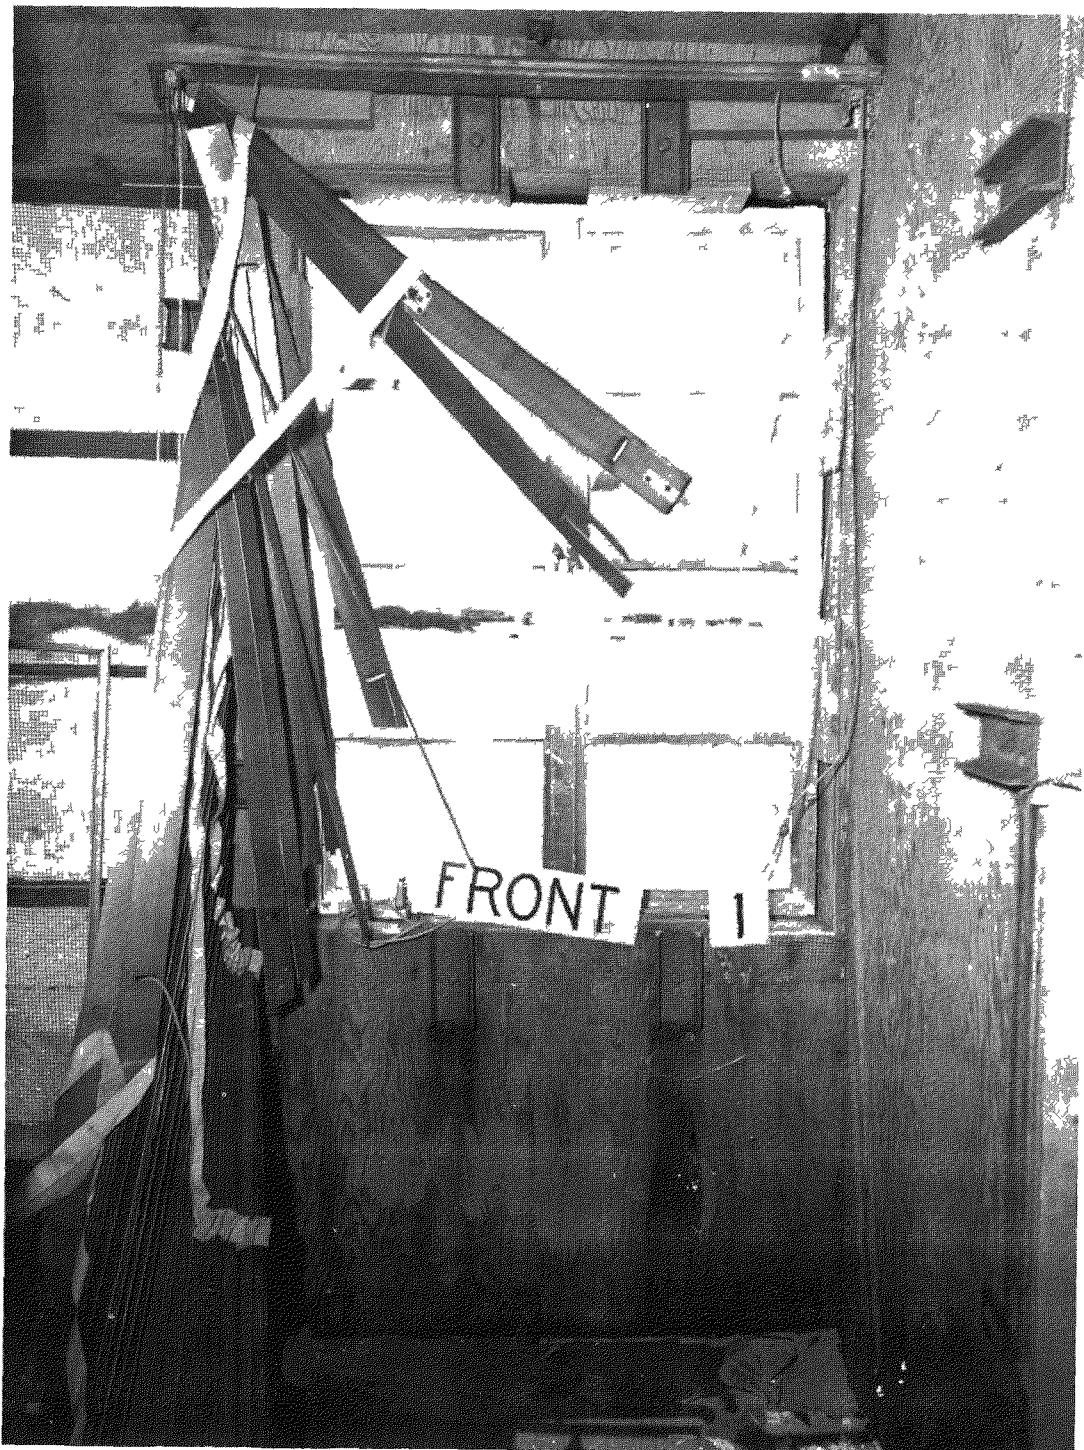
FIG 316 Inside of Casement Window 2 after the Blast The Venetian blind was completely wrecked, one side being torn from the wall, and the supporting cords broken off so that it was hanging by the connections on the left side only Below the window sill the fragments of the 1/10 in plastic which were mounted on the wall after the blast can be seen faintly The plastic was broken in only about eight pieces, which fell to the floor near the center of the room

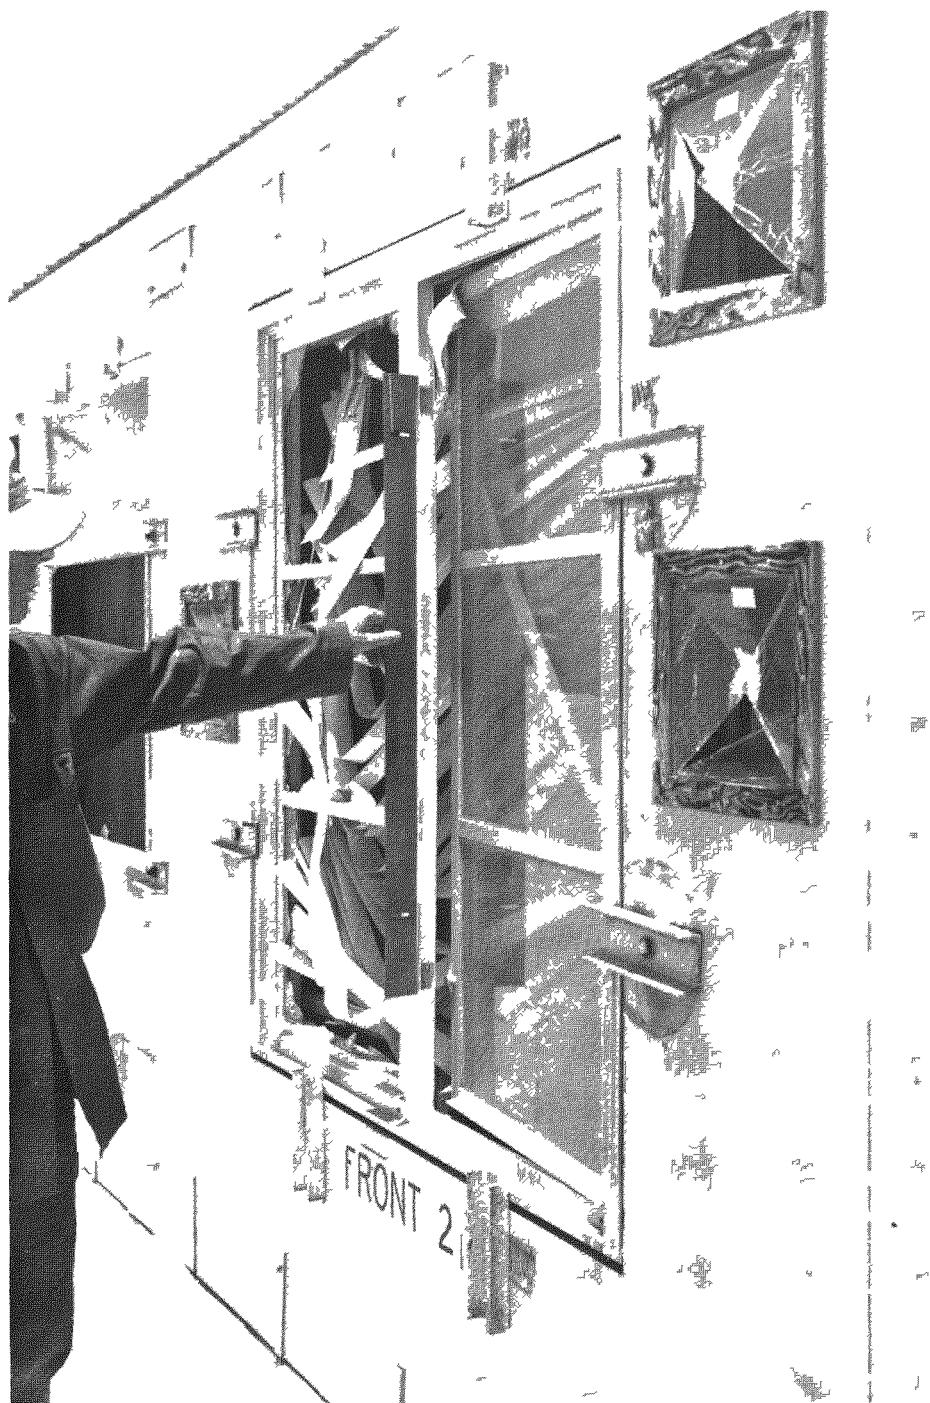
FIG 3 18 Outside of Inswing Casement Window 4 after the Blast All glass was broken out of the left-hand sash, and the right-hand sash was undamaged except for the broken catches which allowed the sash to swing inward with the blast After the shock front passed this sash was partially closed, probably by the negative wind, trapping some slats of the blind between the sash and the frame The center meeting rail of this window was deflected about  $\frac{1}{2}$  in The outer glasses in the three 12 in square openings surrounding this window were broken along the diagonal lines and forced in Later some of the triangular sections were pushed outward

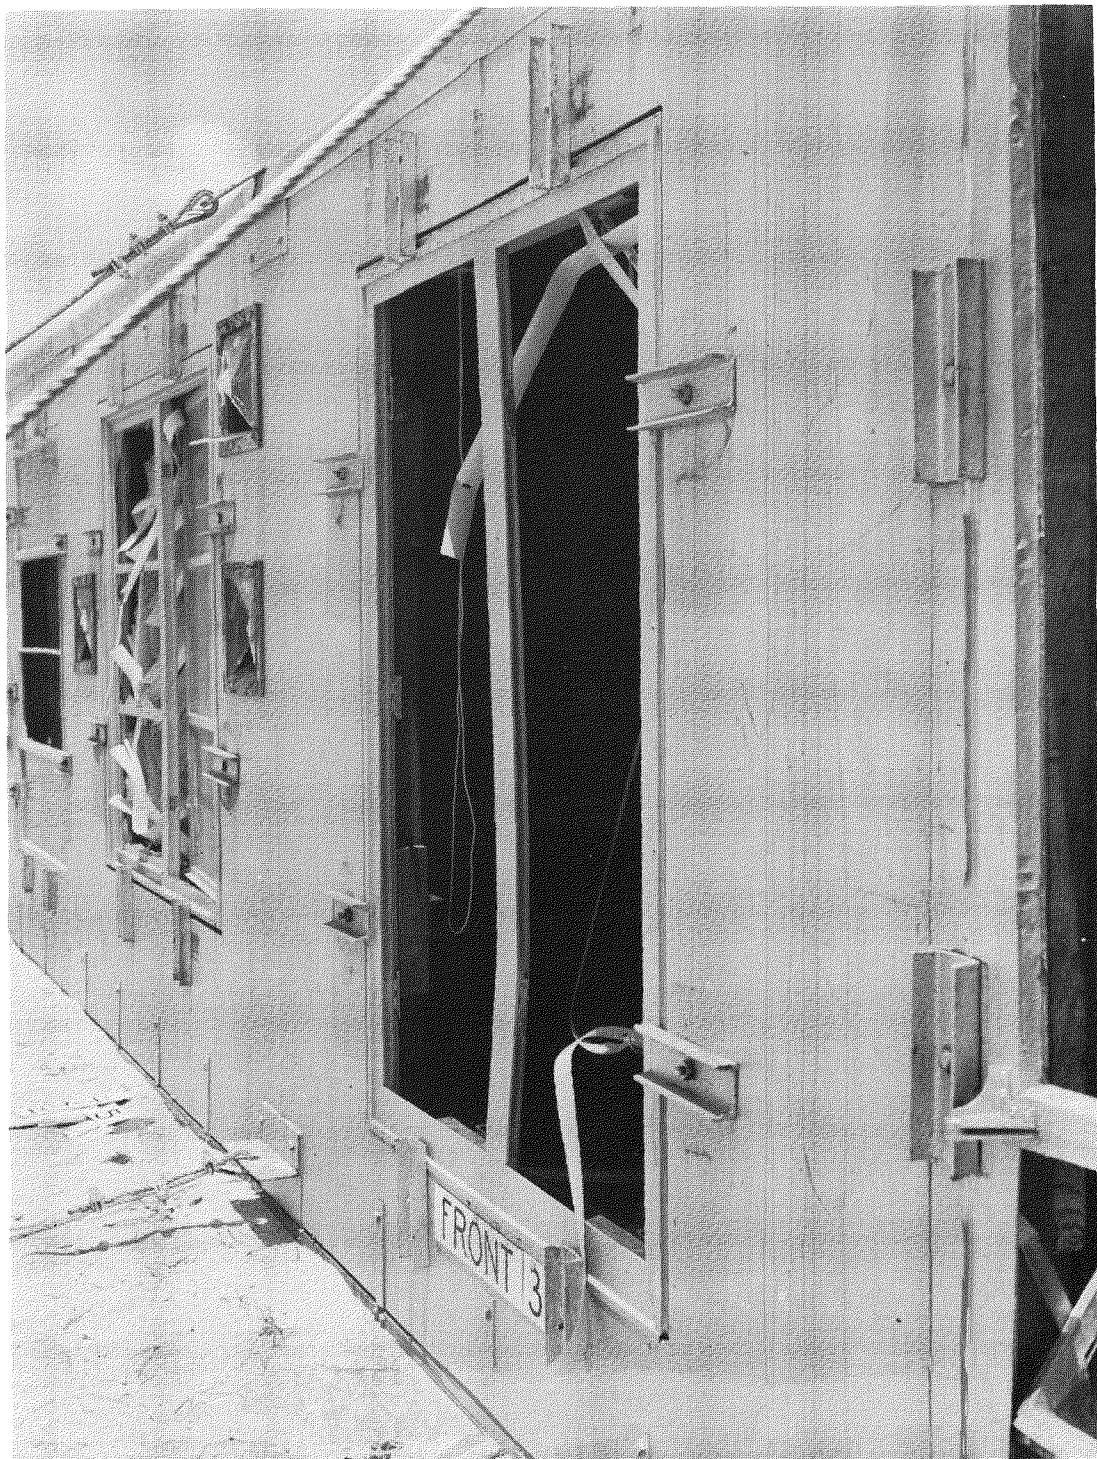
FIG. 3.22 Outside of Casement Window 5 after the Blast. The left-hand sash of this window was broken from the hinges and thrown across the room. The tempered glass in this sash was not broken. The locks on the right-hand sash were torn loose, and the wire glass was broken out of the frame. The center meeting rail was deflected about  $1\frac{1}{2}$  in. out of line.

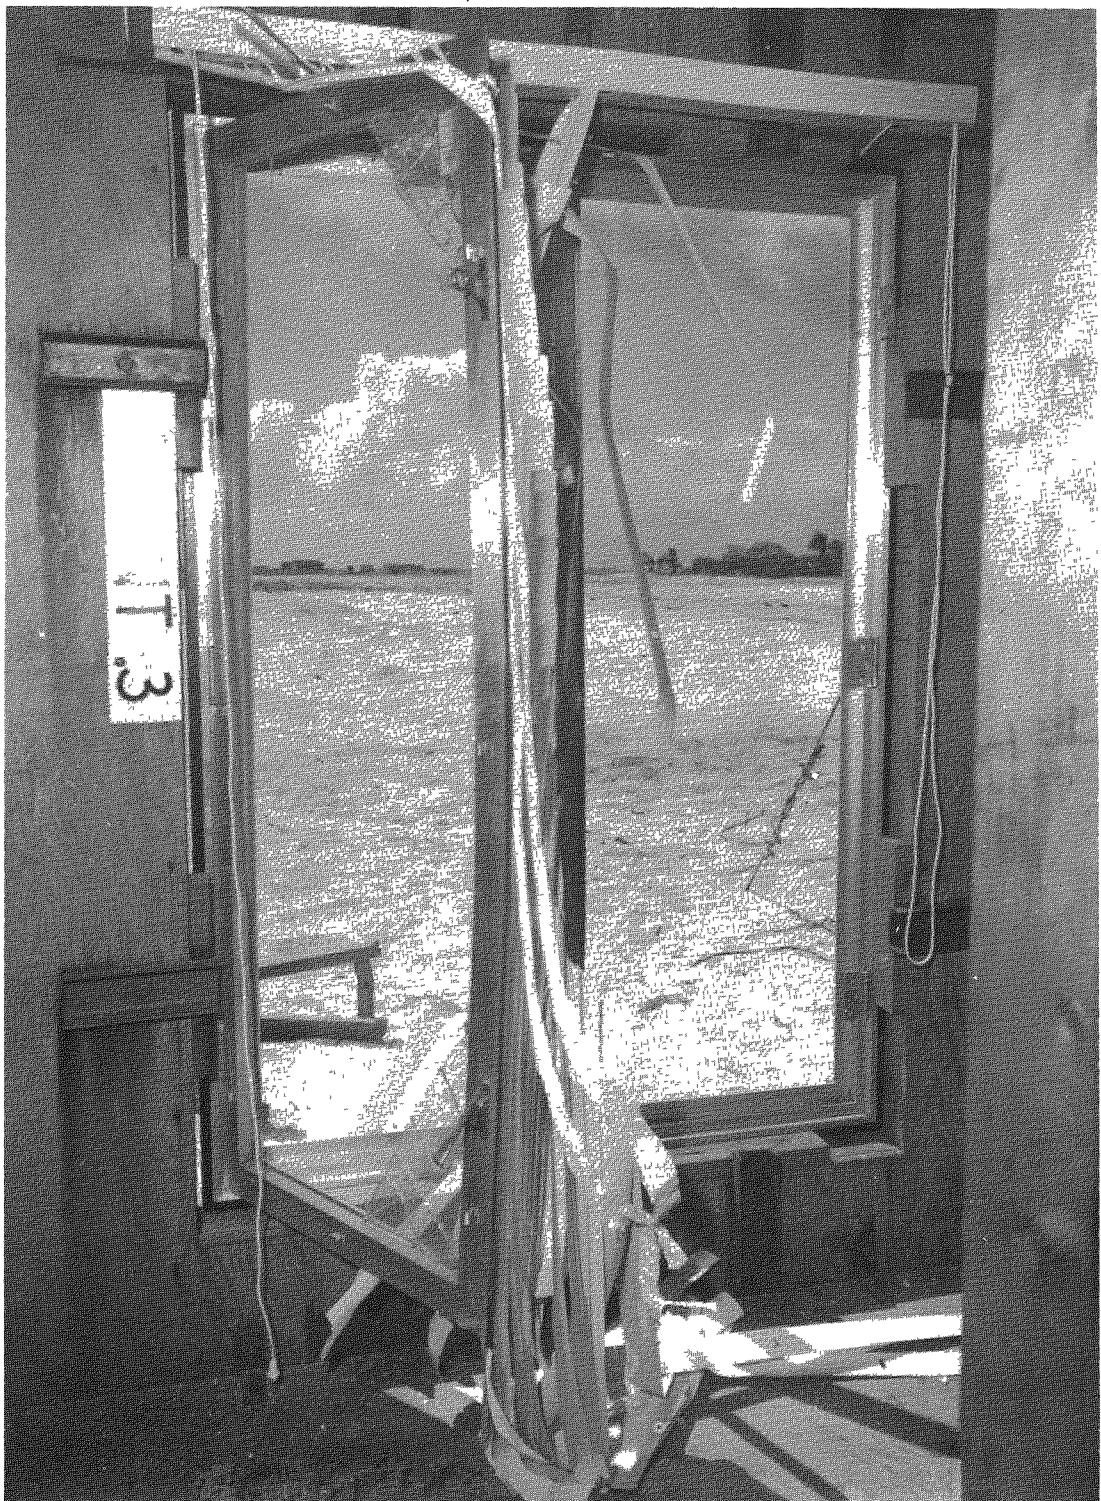
FIG. 3.24 Inside of Window 5 after the Blast. The Venetian blind was completely wrecked. Some of the glass fragments of the wire glass section were imbedded in the partition running perpendicular to the front wall just beyond the limit of the picture on the left side.

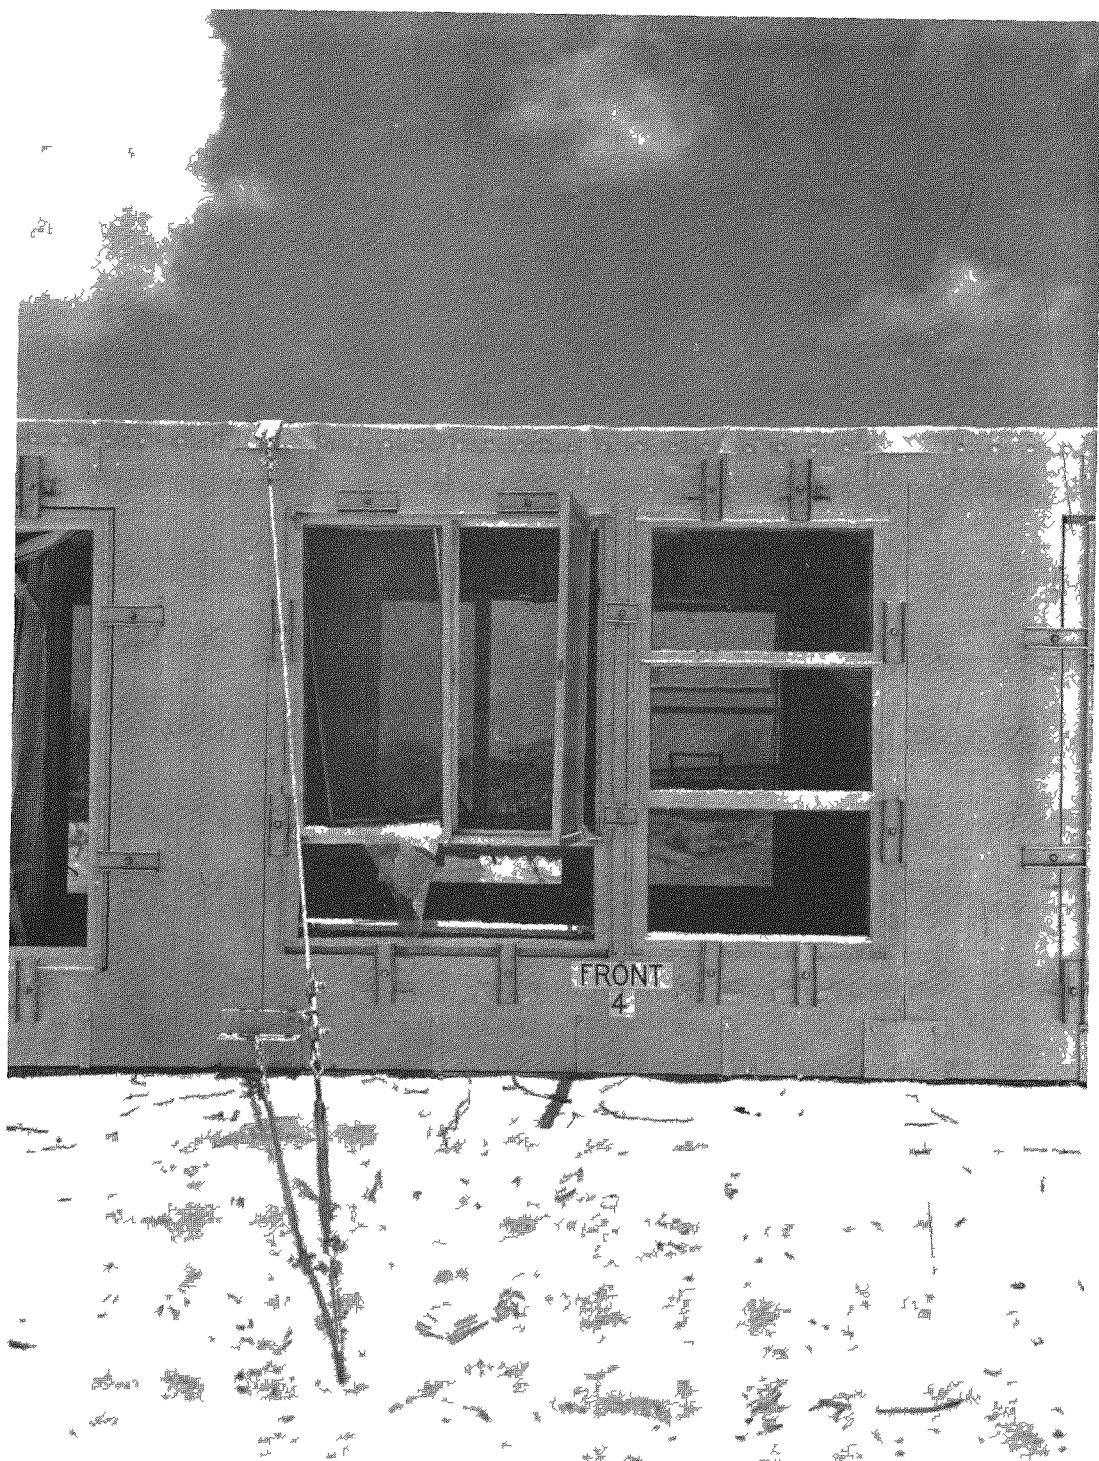
FIG 326 Outside of Casement Window 6 and Canopy Window 7 after the Blast. The safety glass in the right-hand sash of the casement was shattered and fell to the sill as shown in the photograph. The right-hand sash of the casement was undamaged and the glass in the hopper vent was broken out. All glass was broken out of window 7, however, the frame was undamaged.
