**GREENHOUSE**

SCIENTIFIC DIRECTOR'S REPORT  
ANNEX 3.5

THE EFFECTS OF ATOMIC WEAPONS ON GLAZING AND  
WINDOW CONSTRUCTION

by  
WALTON C. CLARK  
of  
PUBLIC BUILDINGS SERVICE

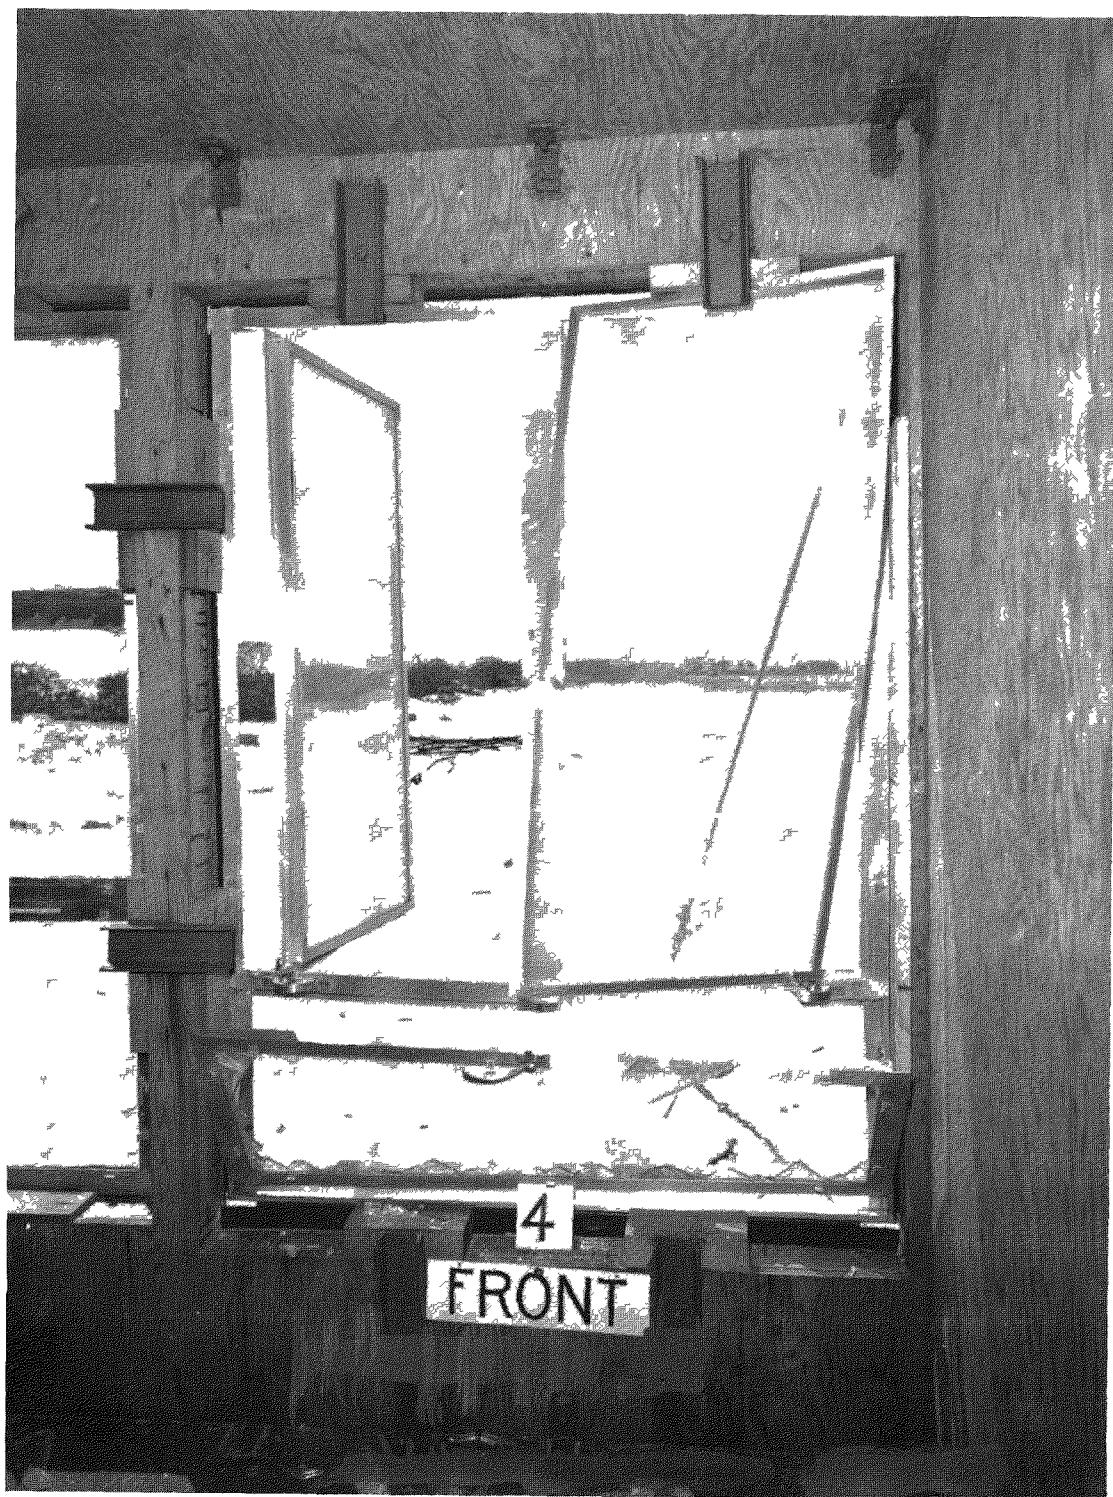
FIG 328 Inside of Casement Window 6 after the Blast. The left-hand sash of the window was opened outward perpendicular to the wall before the blast and was undamaged. The latch on the hopper vent was broken as the sash was forced open.

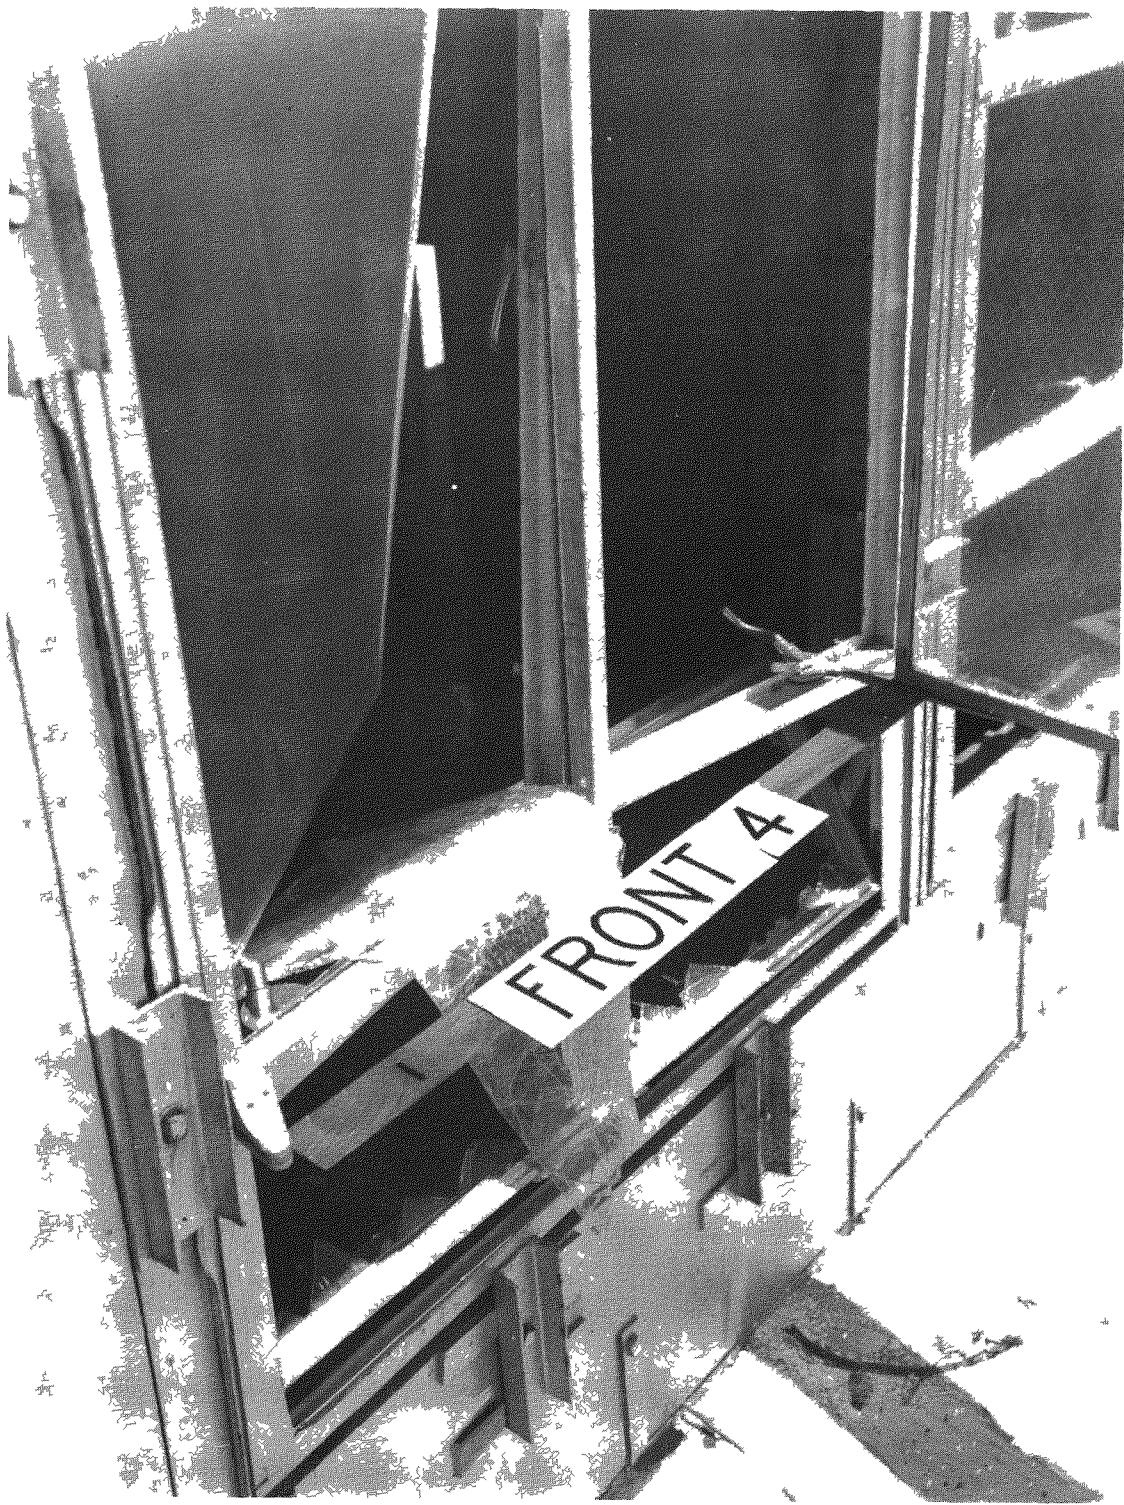
FIG 330 Close-up of Casement Window 6 after the Blast. The insect screen was partially torn from the frame, and no trash was deposited on the outer surface by the positive wind. The bottom rail of the casement opening was bent about 2 in out of line

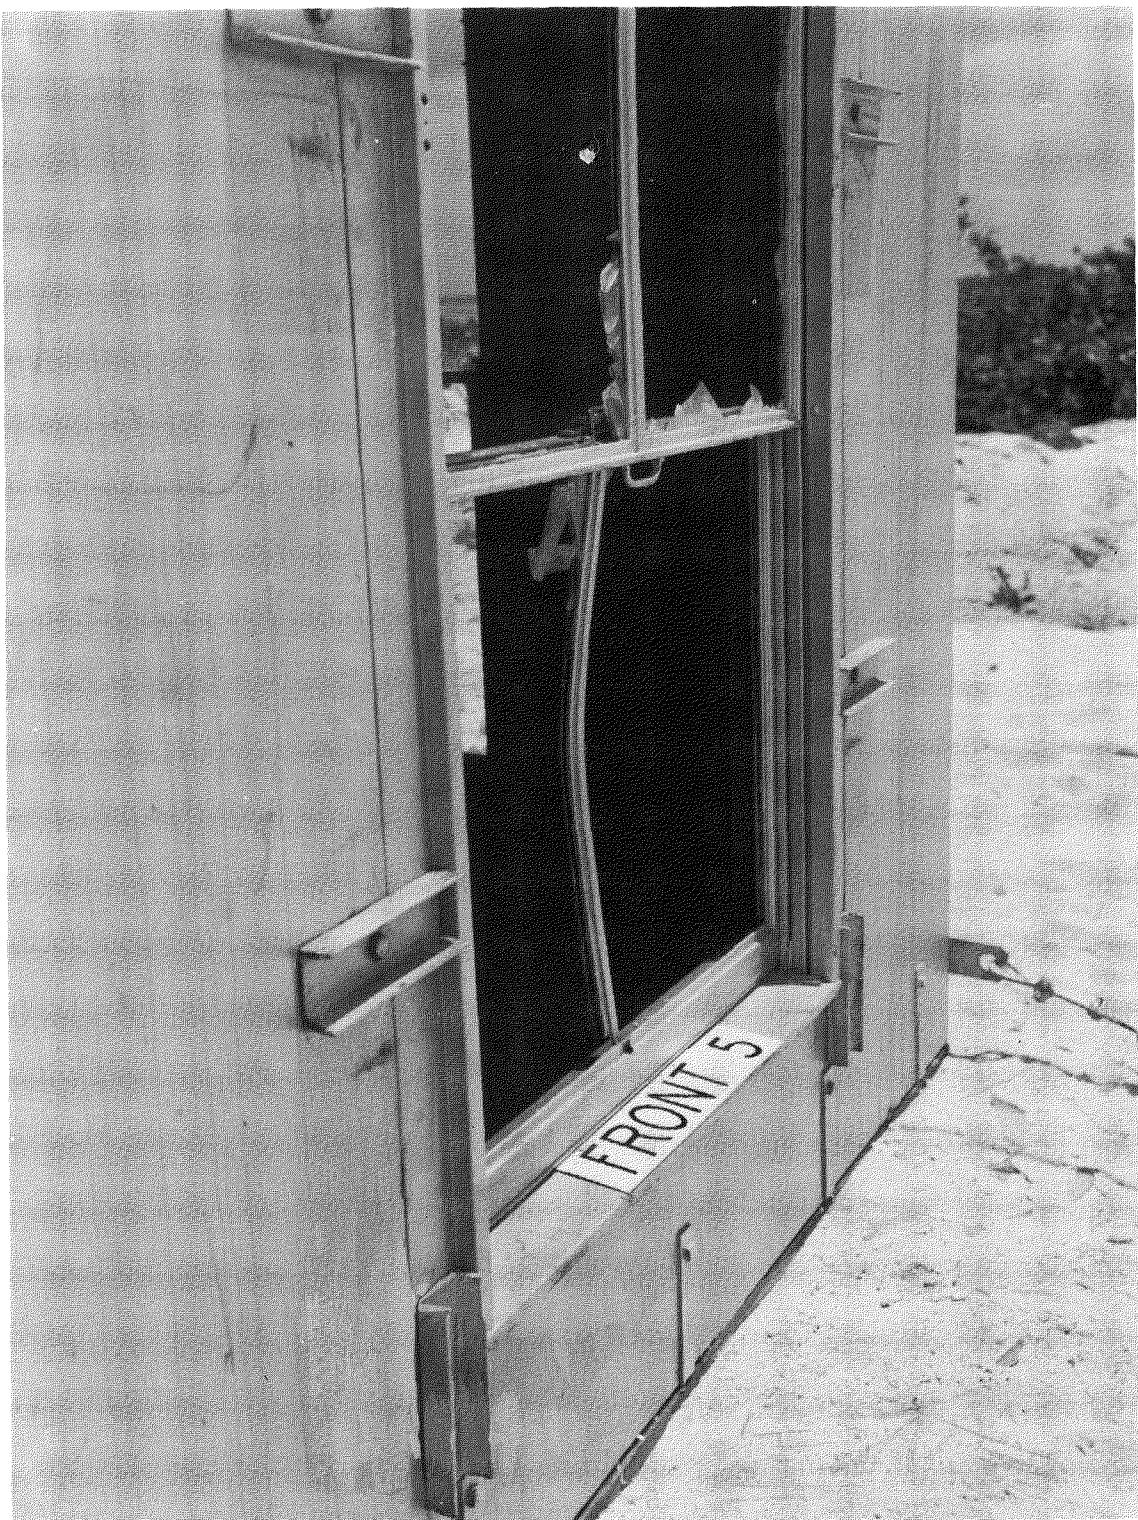
FIG. 3.32 Outside of Double-hung Window 8 after the Blast. All panes of glass were blown from the frame and the lower muntin was torn loose from the bottom rail of the sash.

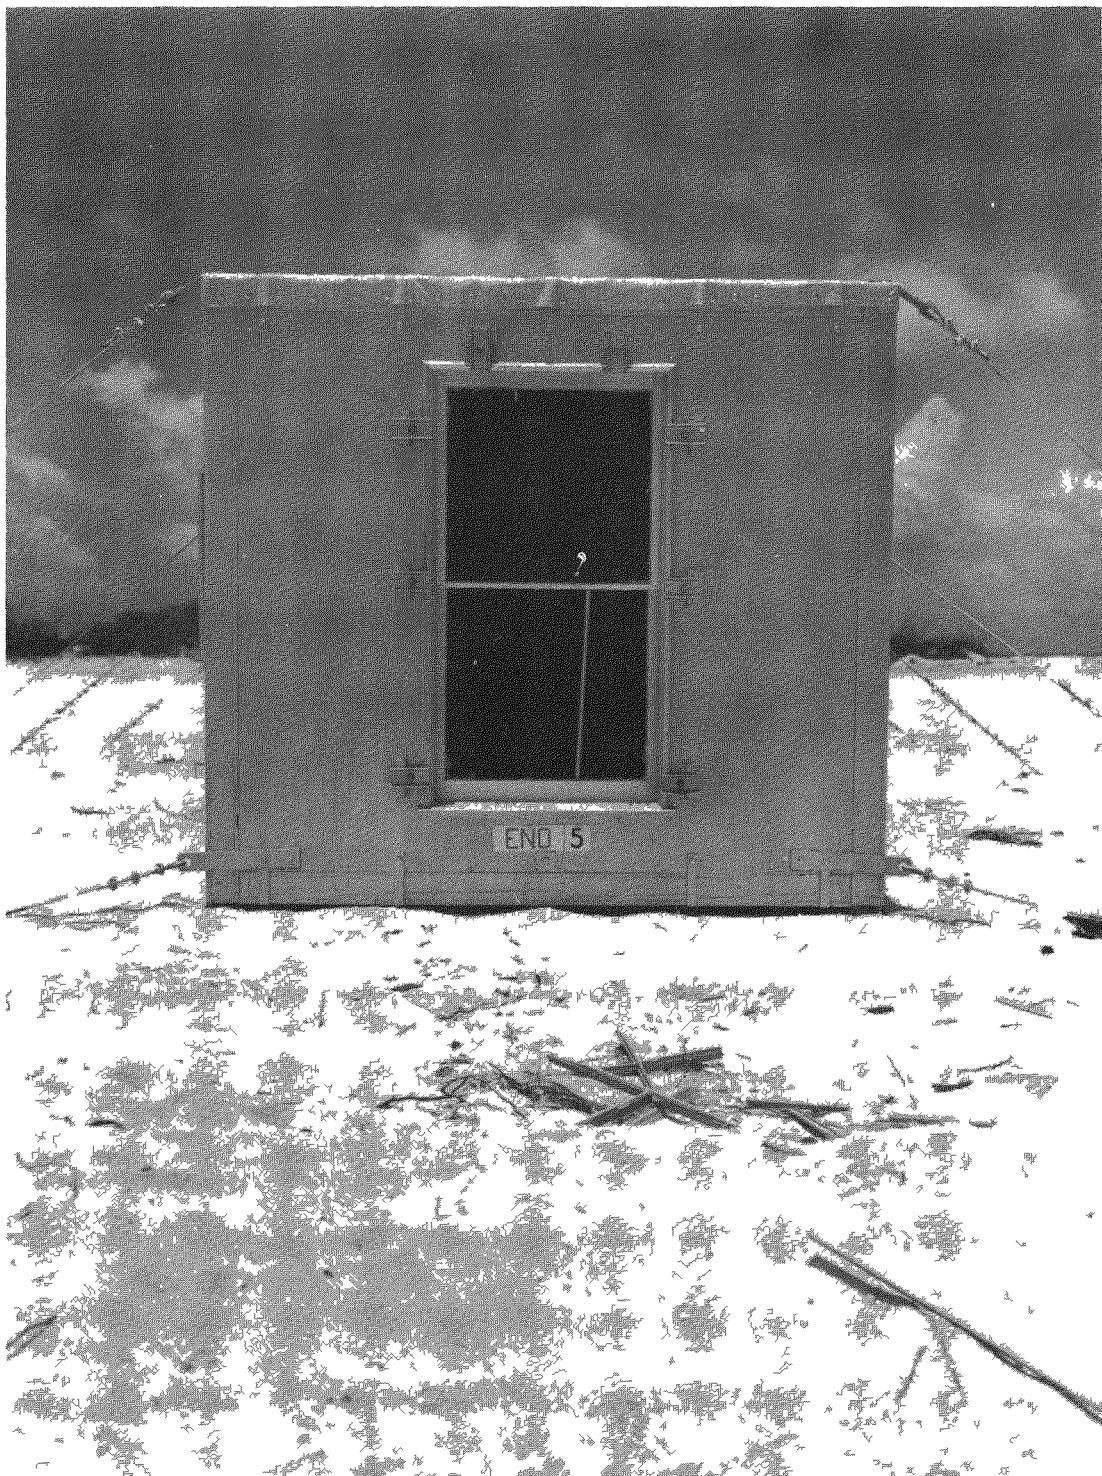
FIG 334 Outside of Double-hung Window 9 after the Blast. The debris in the foreground was about 6 ft from the building and was composed of glass fragments and muntins that apparently were blown outward by the expansion of the air after the shock wave had passed and before gravity could pull the fragments down to the window sill

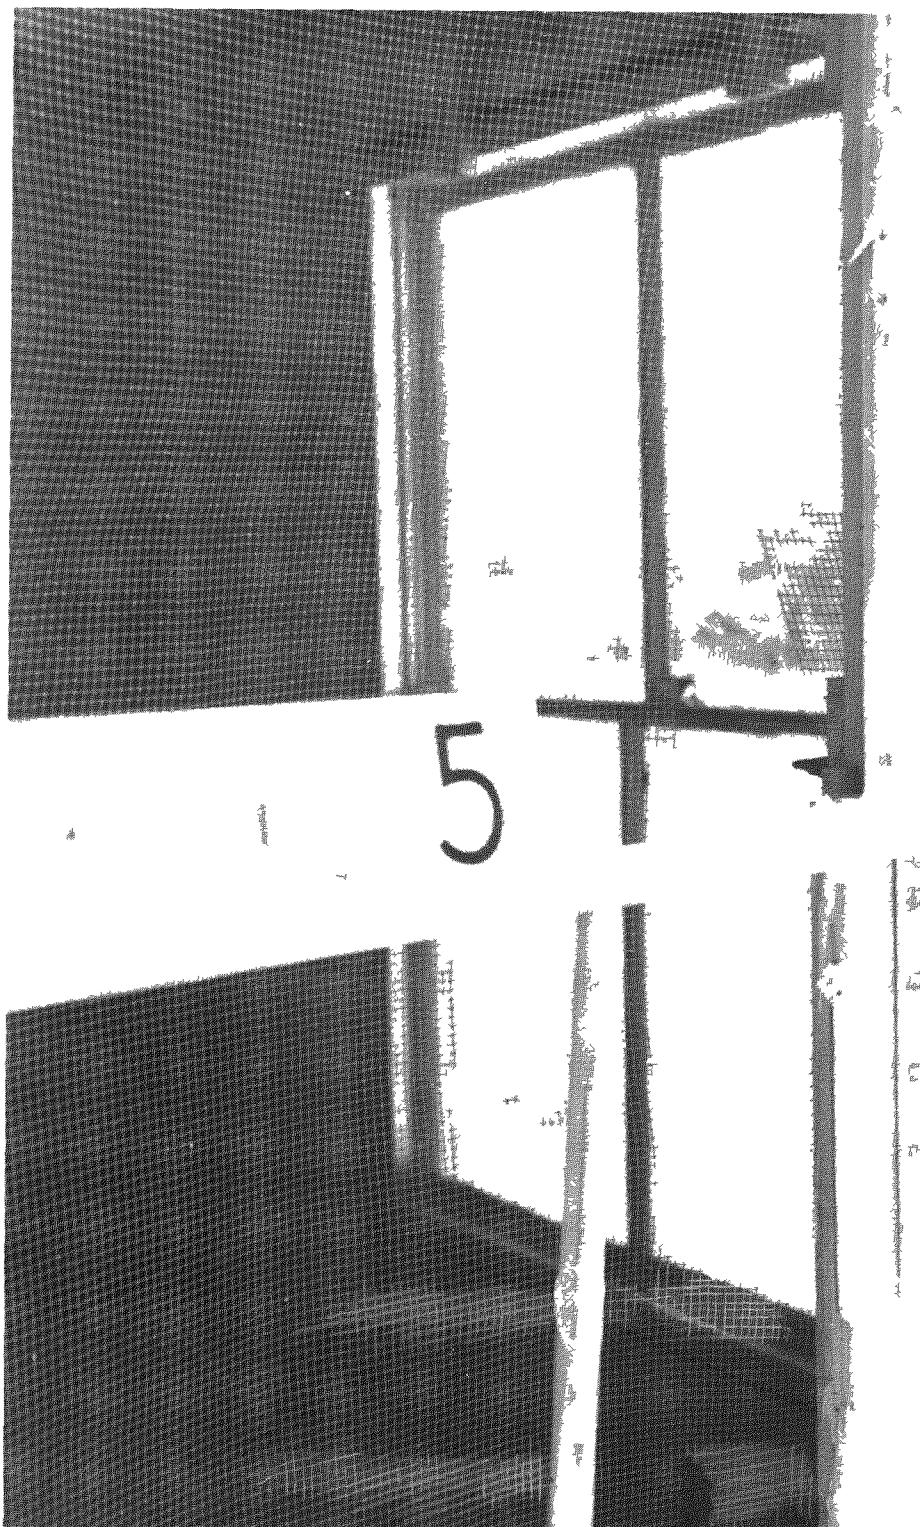
FIG 335 A Close-up of Outside of Window 9 after the Blast The wire screen was bent inward by the blast and split along one side

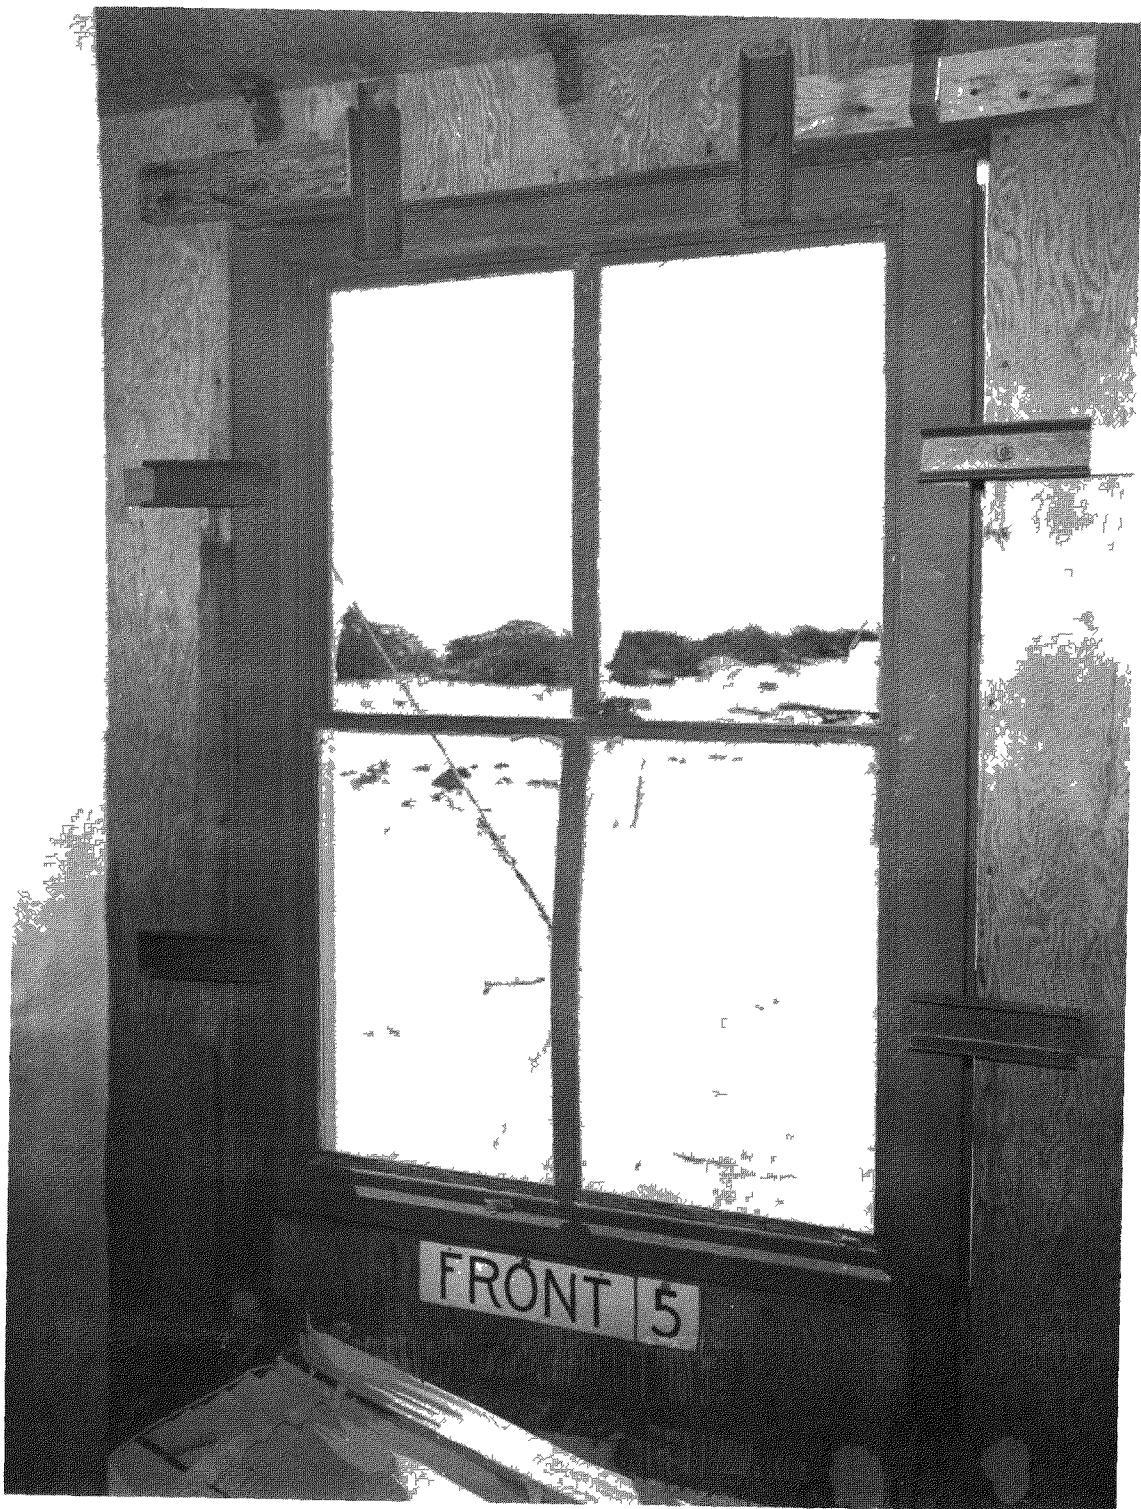
FIG 3.36 Inside of Double-hung Window 8 after the Blast. The Venetian blind mounted over the window opening was torn loose from the brackets at the top and fell to the floor. Glass was scattered over the entire room, and the Venetian blind apparently offered little resistance to the flying fragments.

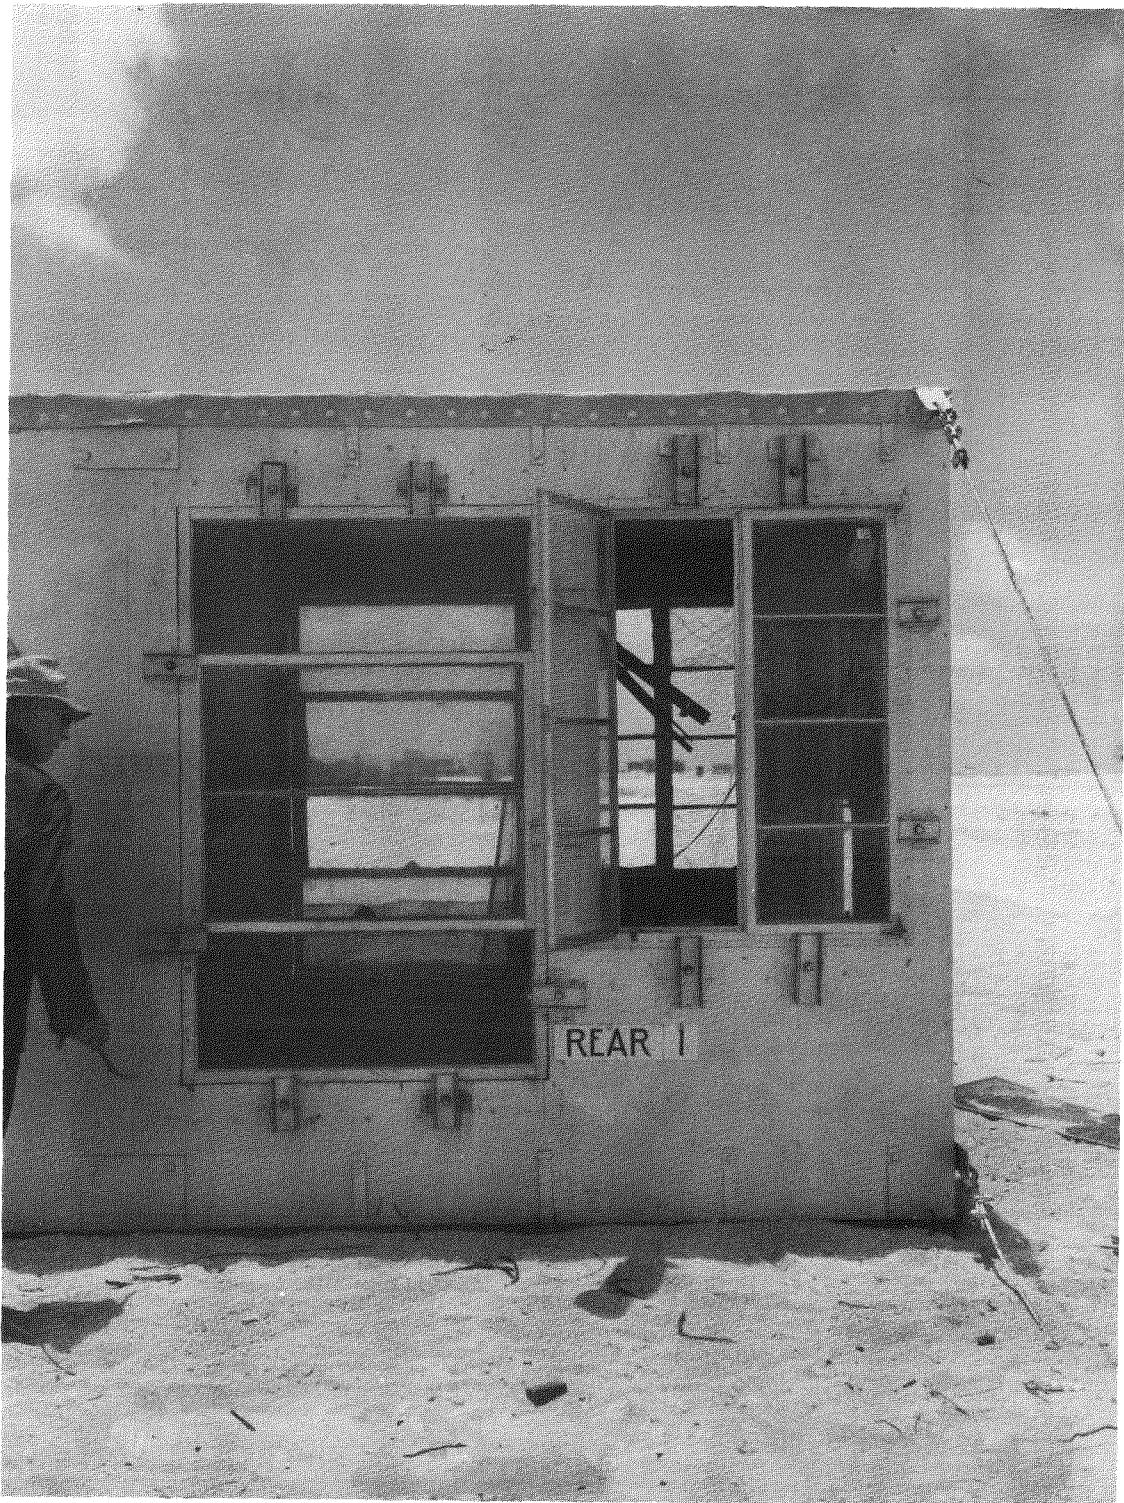
FIG. 3.38 Outside of Casement Window 10 and Architectural Projected Window 11 after the Blast. There was no damage to either of these windows except that the operator on the open sash of the casement was broken and the center meeting rail was bent inward slightly.

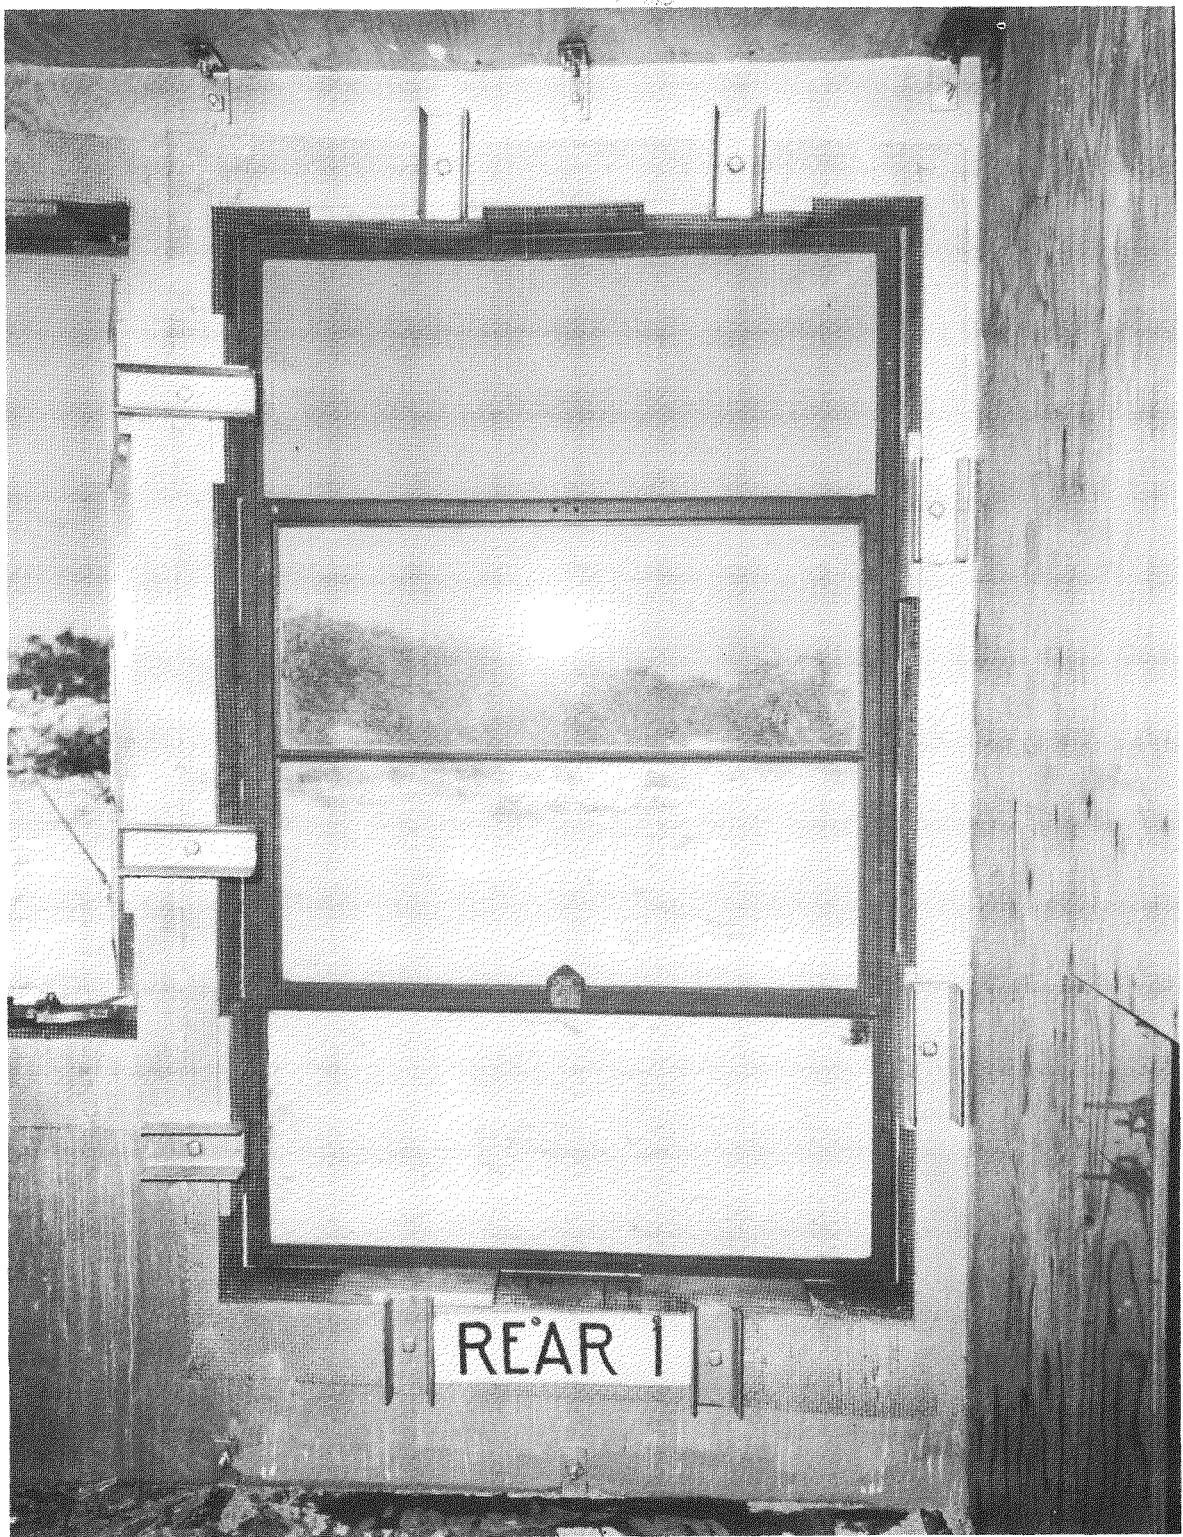
FIG. 3.42 Inside of Window 11 after the Blast. There was no apparent damage to this unit.

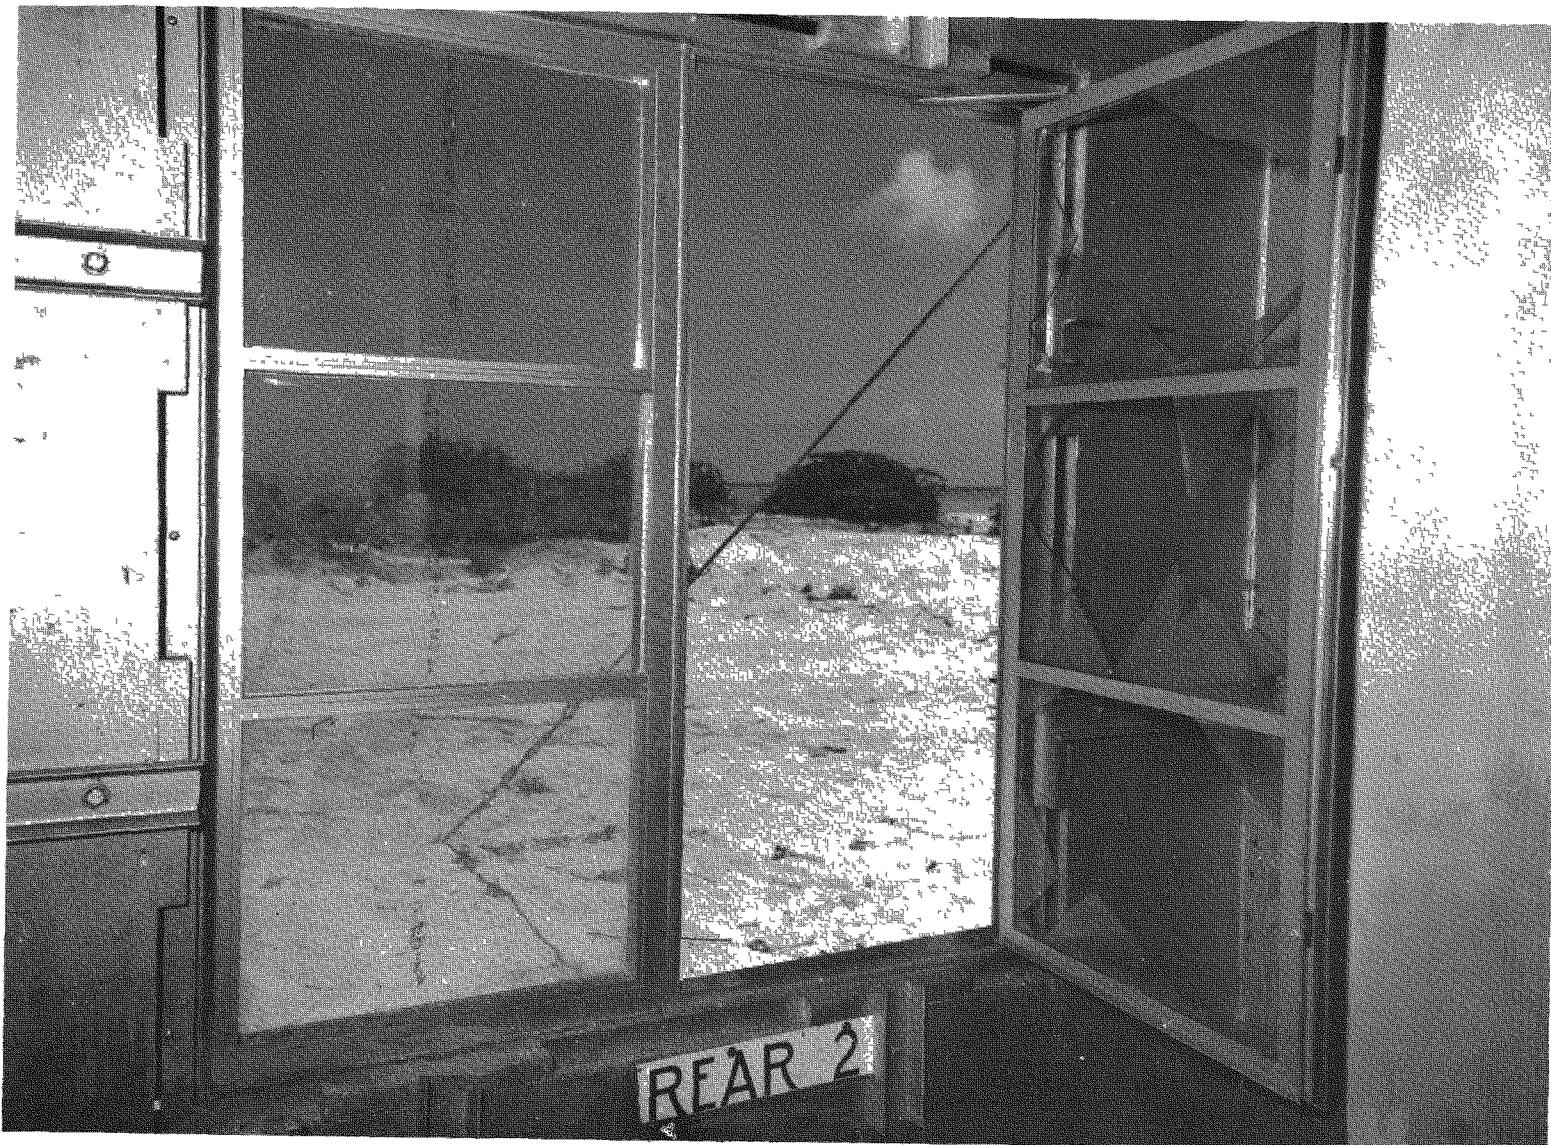
FIG. 3.44 Inside of Window 12 after the Blast. Possibly either the shock wave or the expansion of the air within the building after the shock wave passed slammed the open sash of this window shut with such violence that all the glass was broken and the fragments fell to the ground outside of the building. The negative wind blowing against this free-swinging sash evidently returned it to its original position.

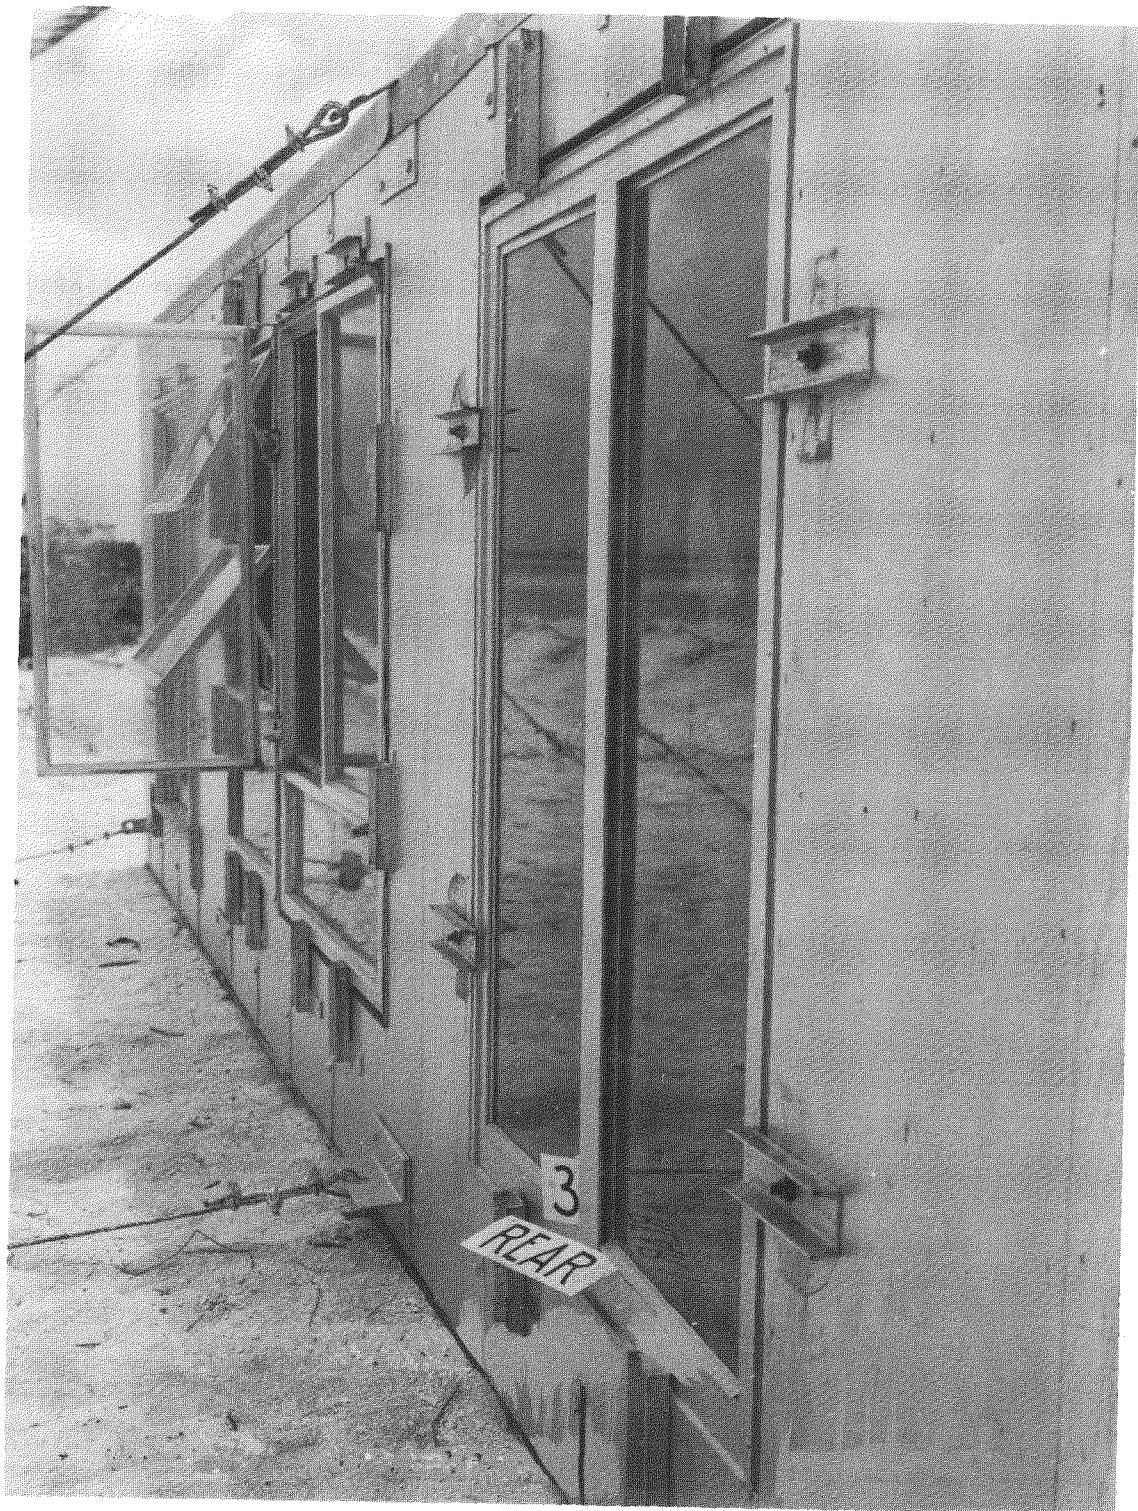
FIG. 3.46 Outside of Casement Window 13 after the Blast. The pressure of the shock wave apparently forced both sashes of this casement inward against the latches approximately  $\frac{1}{2}$  in. There was, however, no breakage of the glass.

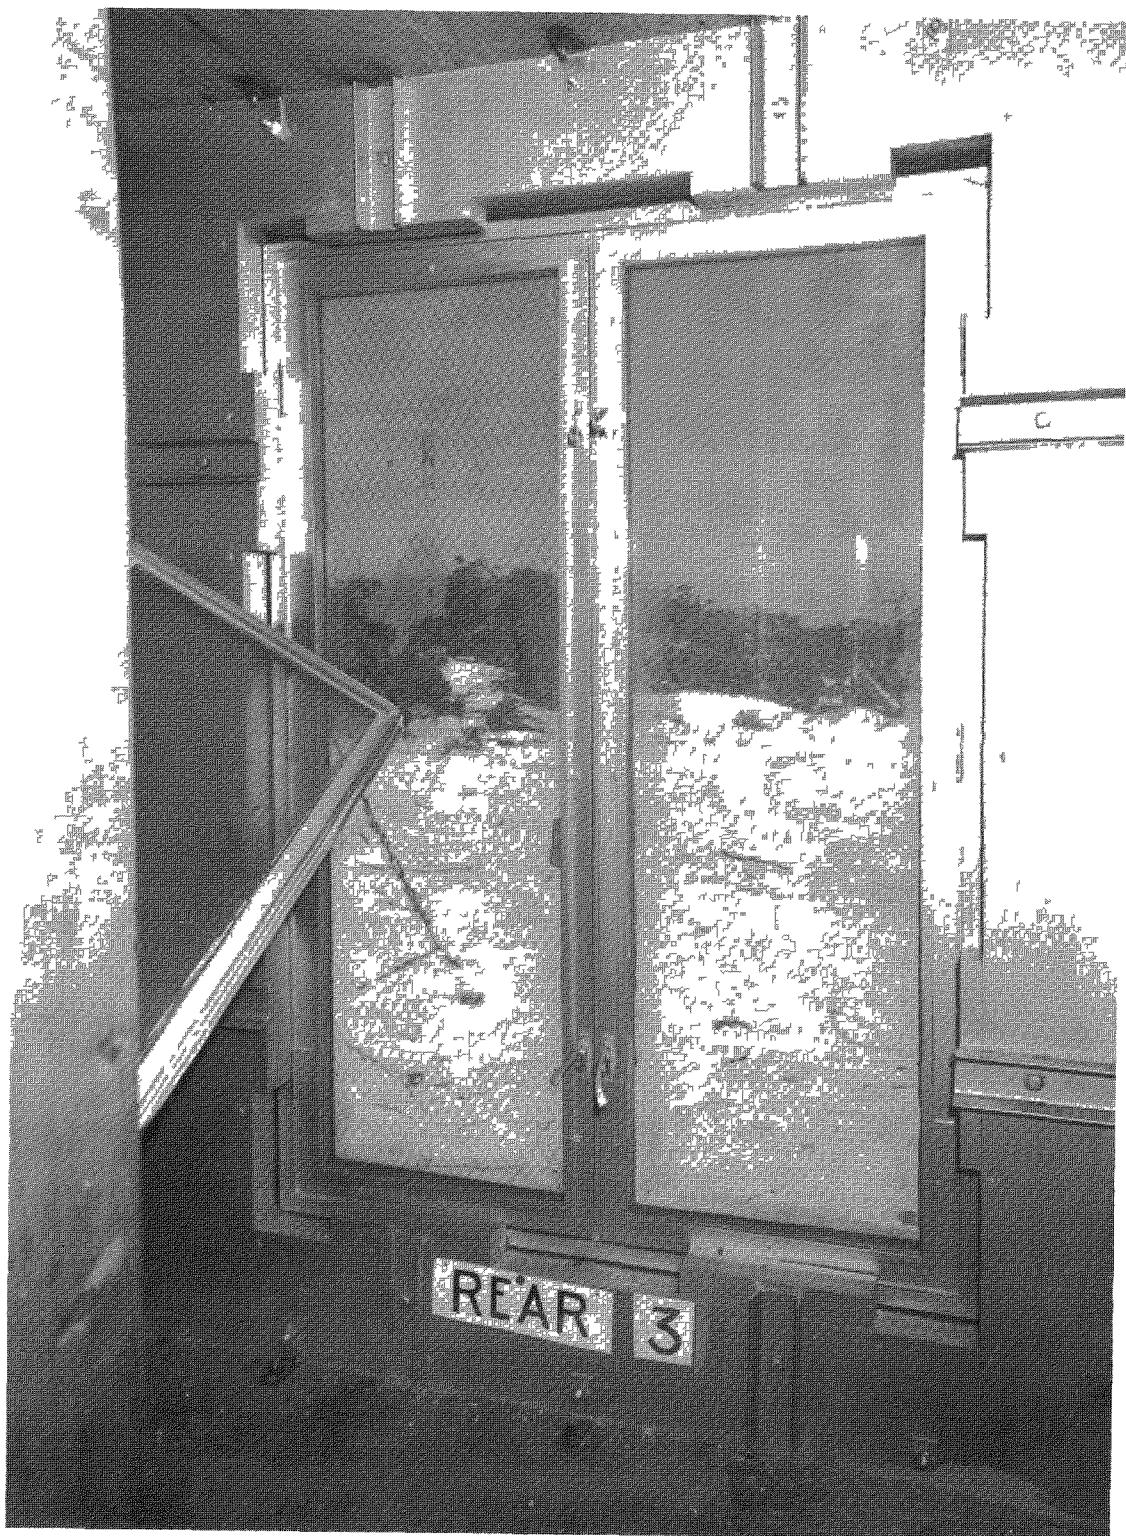
FIG 348 Inside of Casement Window 13 after the Blast. The sash on the extreme left with only the corner showing is the one which was torn from the frame of window 5 on the front of the building

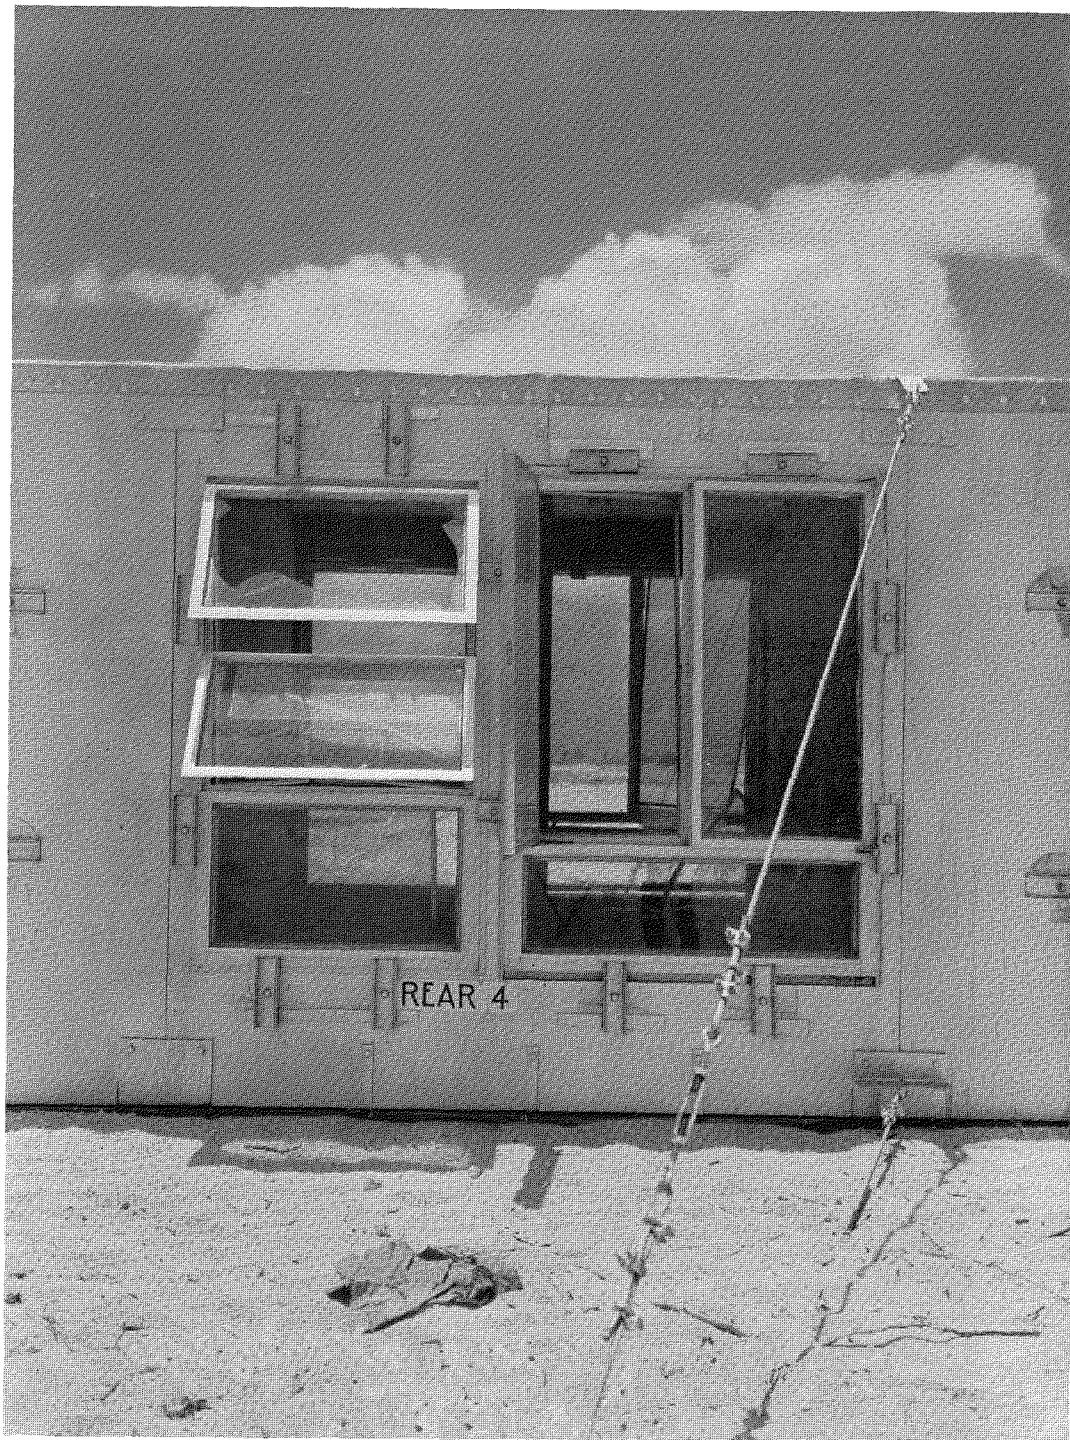
FIG. 3.50 Outside of Windows 14 and 15 after the Blast. Window 14 was undamaged. The upper glass in window 15 was blown in. The expanding air in the room following the blast apparently tore the catch loose, which locked the two upper ventilators in place and opened the window, as shown in the photograph. The insect screen over the opening in window 14 was covered with fine debris which was probably picked up by the negative wind and deposited on the outside surface of the screen.

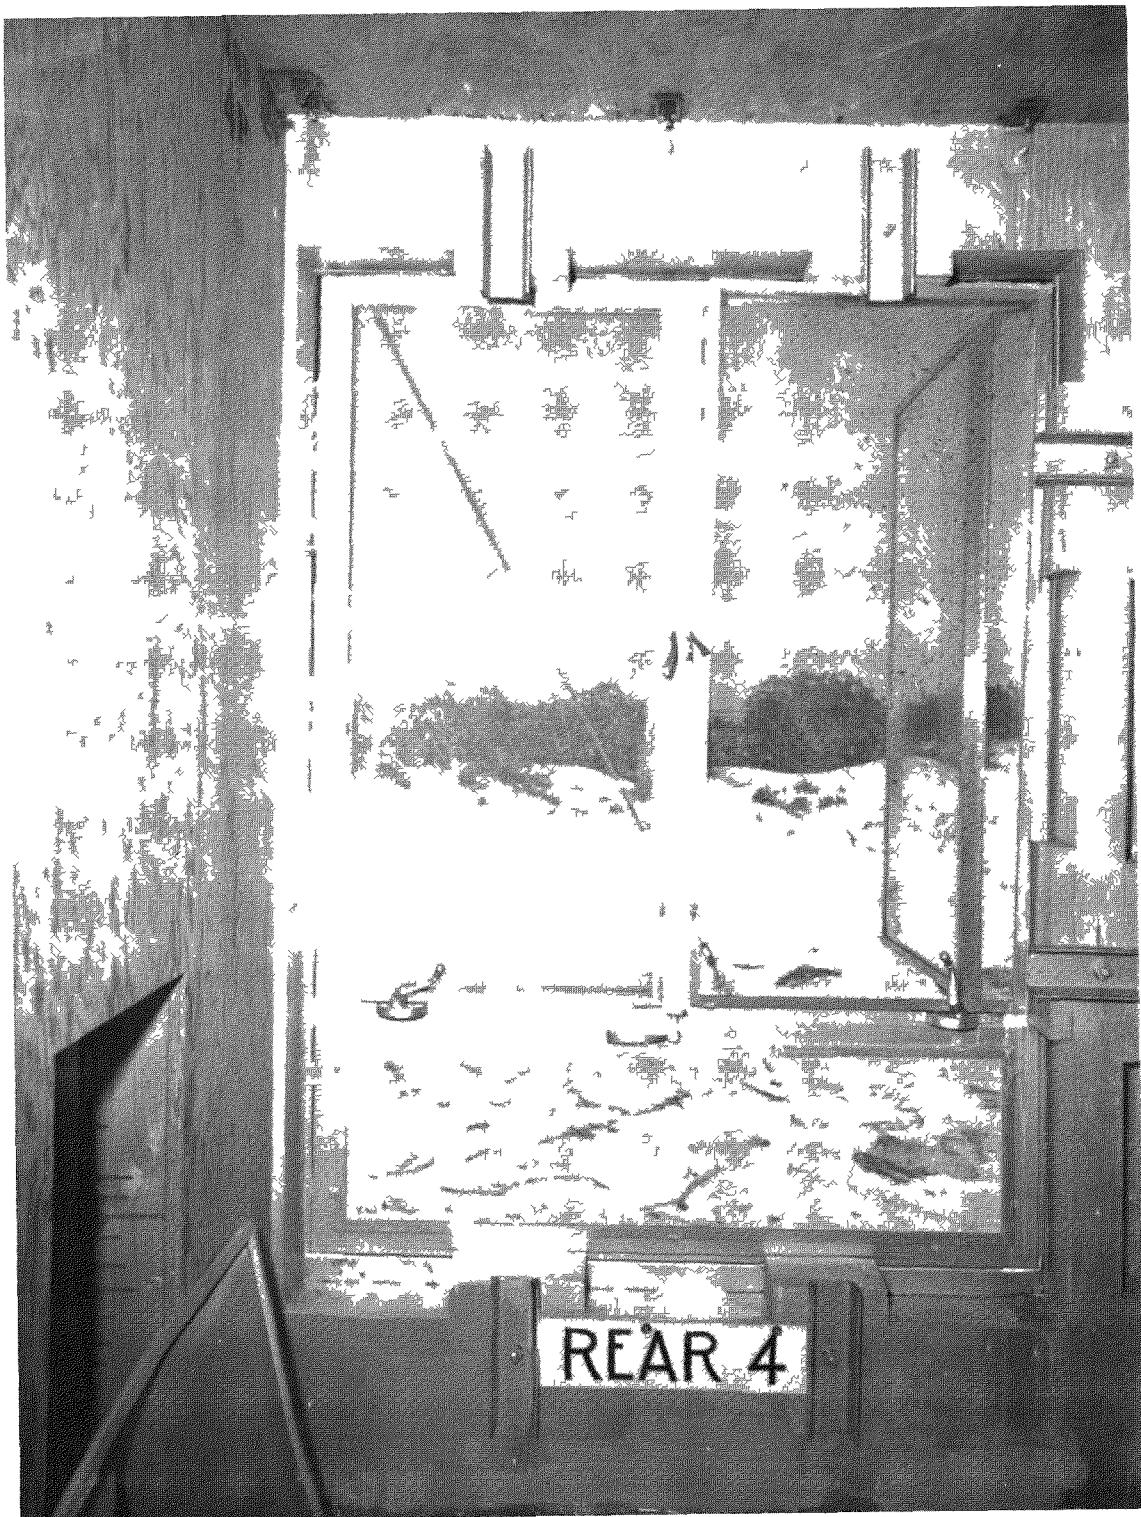
FIG 352 Inside of Window 14 after the Blast Debris on the outside of the insect screen is visible, as previously noted
