**GREENHOUSE**

SCIENTIFIC DIRECTOR'S REPORT  
ANNEX 3.5

THE EFFECTS OF ATOMIC WEAPONS ON GLAZING AND  
WINDOW CONSTRUCTION

by  
WALTON C. CLARK  
of  
PUBLIC BUILDINGS SERVICE

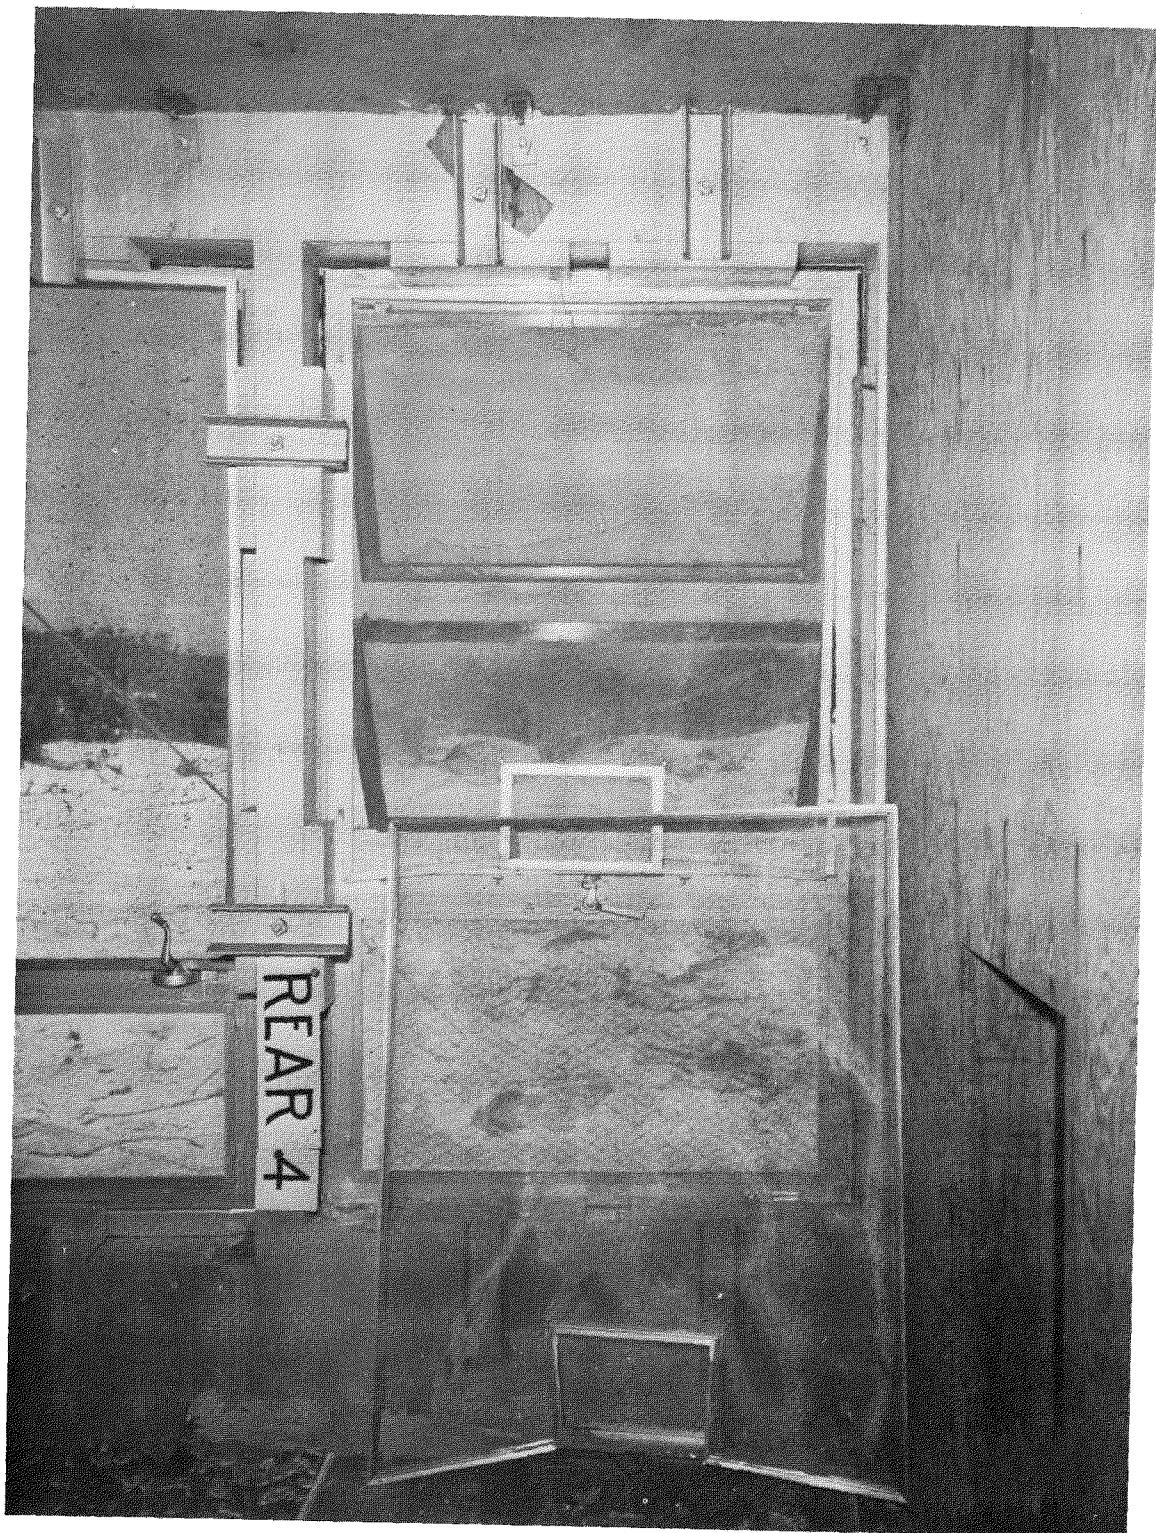
FIG. 3.54 Inside of Window 15 after the Blast. The insect screen mounted on the window was torn loose from the frame and dropped to the floor.

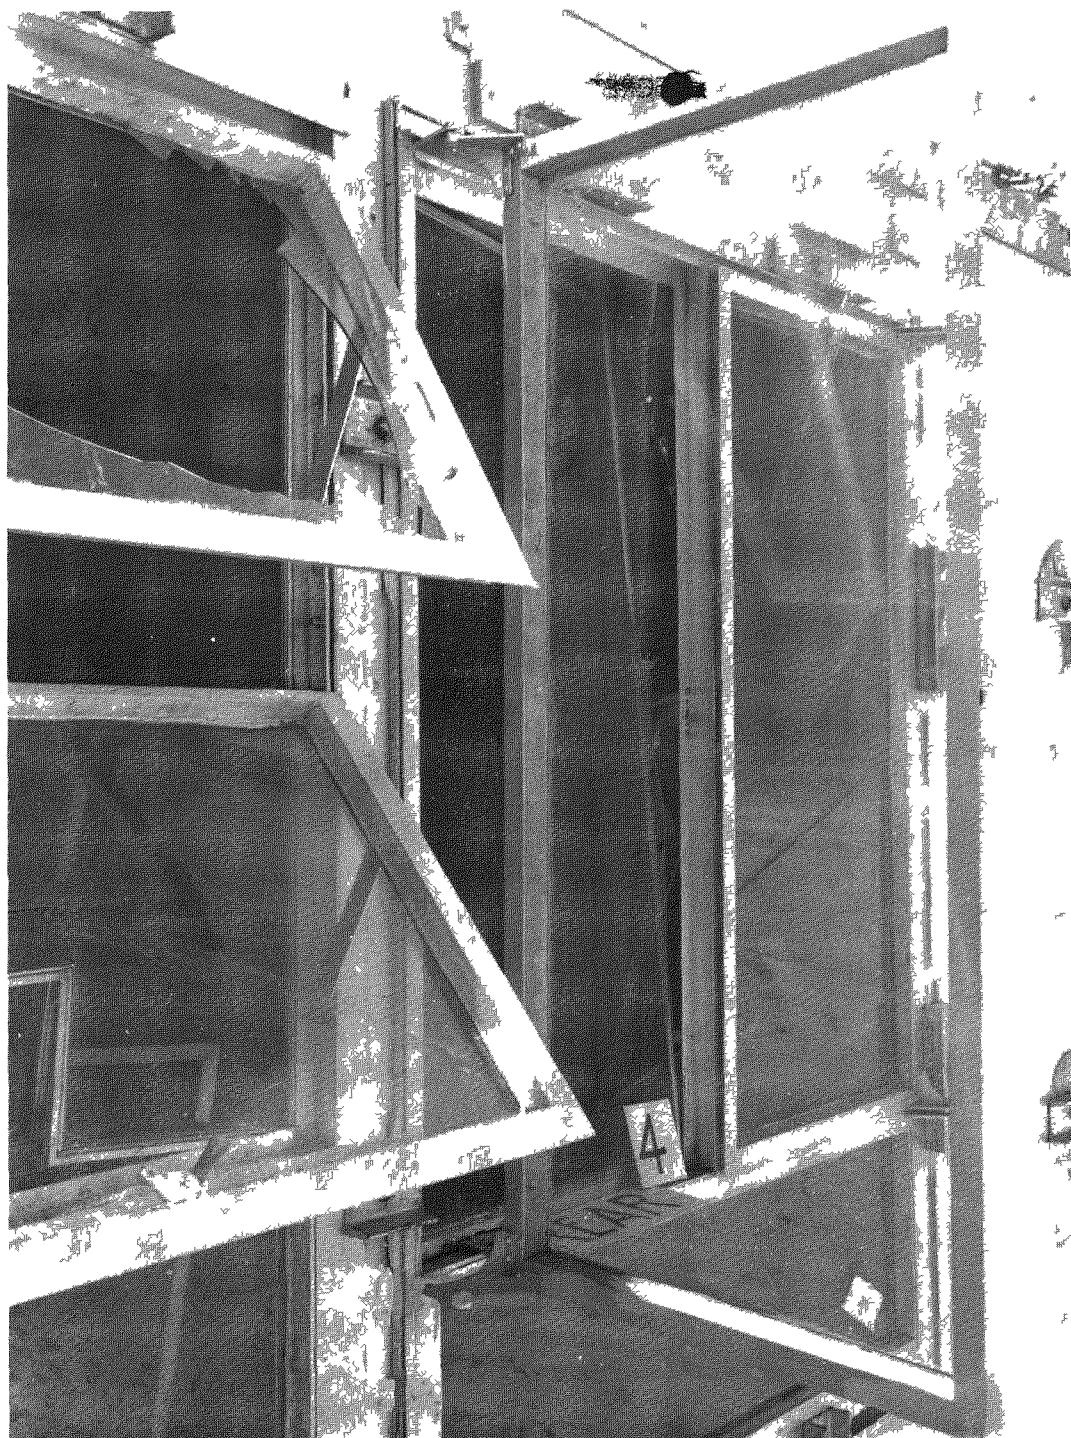
FIG 355 A Close-up of the Outside of Windows 14 and 15 after the Blast. The right-hand sash of the casement was sprung outward about  $\frac{1}{2}$  in., possibly due to the expanding air in the structure after the shock wave passed. Apparently the outward pressure of the expanding air also broke the catch on the middle ventilator section of the canopy window and both upper and middle sections moved outward together, as they are connected by a vertical bar so that a movement in one sash causes a corresponding motion in the other sash.

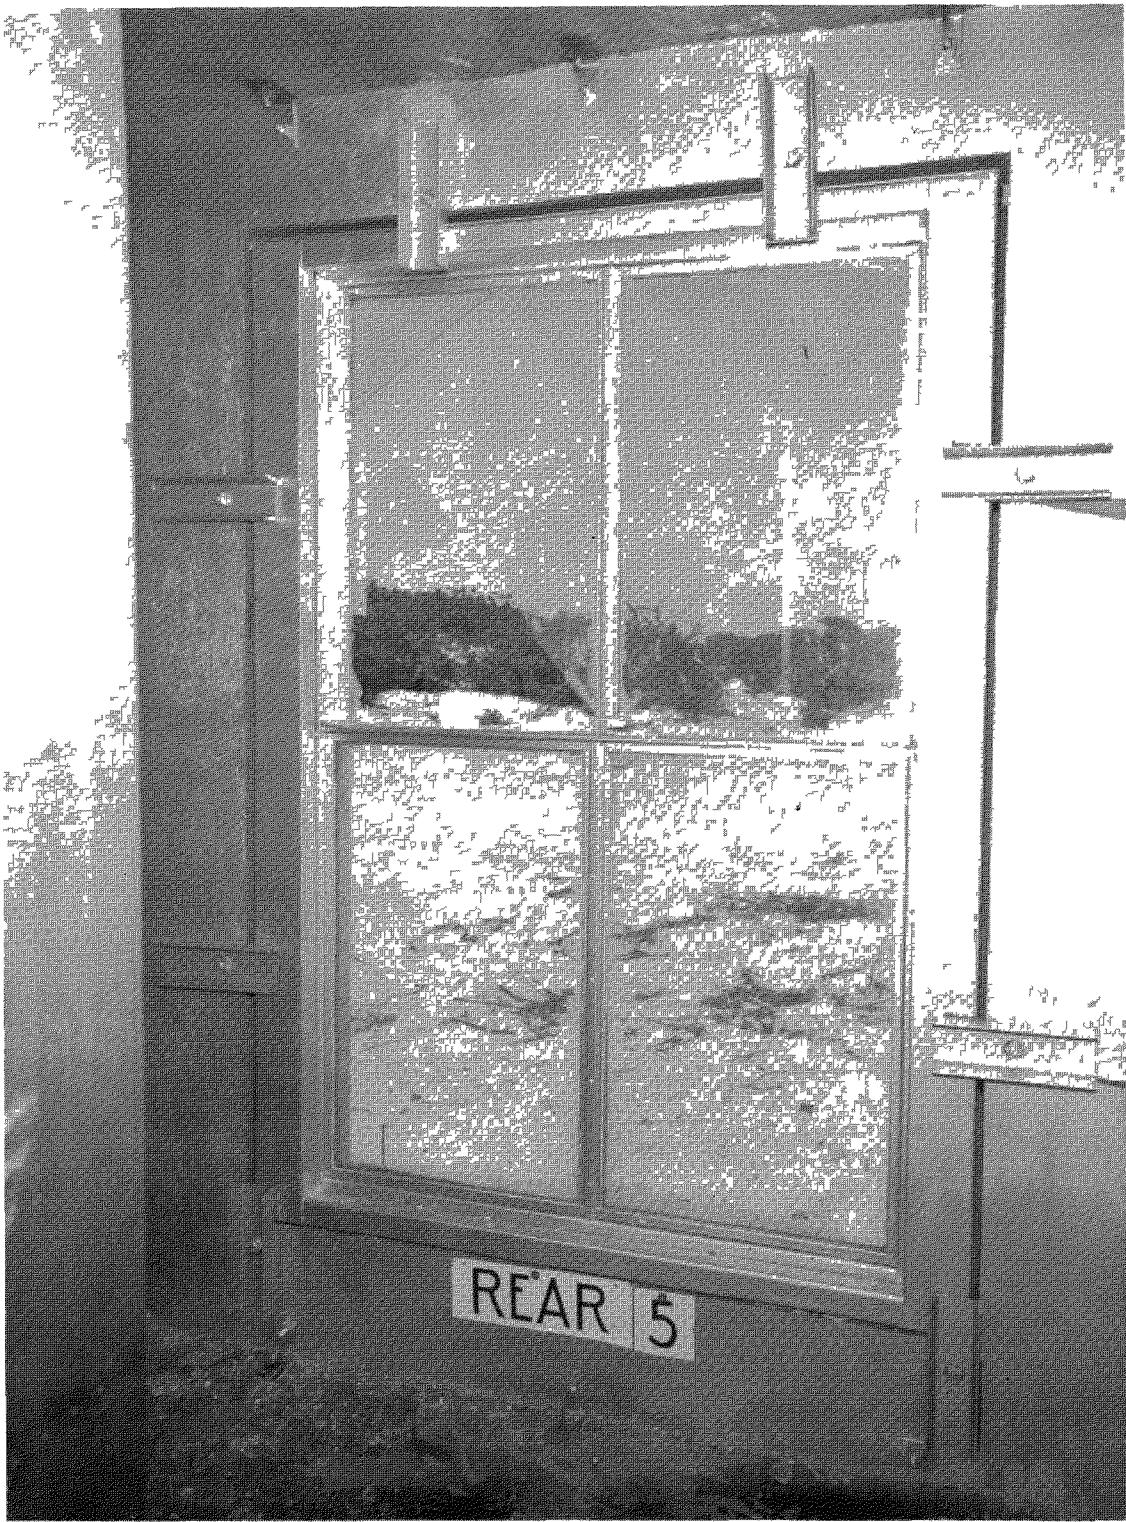
FIG 358 Inside of Window 16 after the Blast. The double-strength glass in the upper sash was forced inward, and the fragments fell inside of the building. The other three panes of  $\frac{1}{4}$  in glass were unbroken.
