Nondestructive Evaluation (NDE) of Composite-to-Metal Bond Interface of a Wind  
Turbine Blade Using An Acousto-Ultrasonic Technique.

John H. Gieske and Mark A Rumsey

Sandia National Laboratories

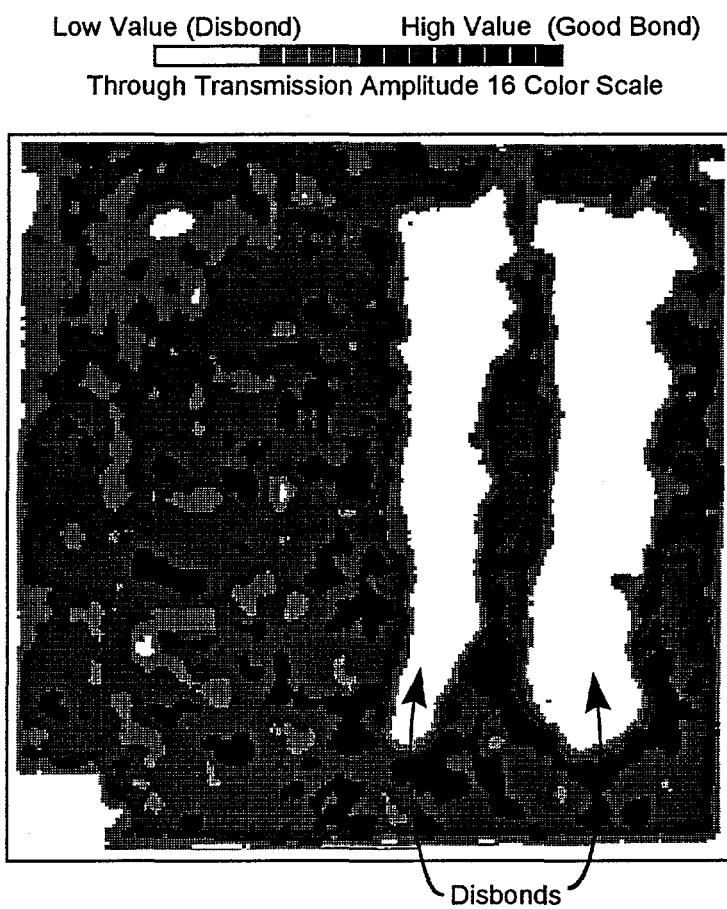
Figure 3. C-scan image of the through transmission amplitude for a 305 mm square test sample of the composite bond and steel insert where 2 disbonds were constructed into the adhesive interface.

As an example, Figure 3 shows the ultrasonic C-scan results obtained with a TT technique for a 305 mm square test sample that had two strips of disbonds purposely manufactured into the test piece that consisted of the structural components of the fiberglass composite bonded to a steel plate. Adequate C-scan images of the same disbond areas could not be obtained with the pulse-echo or pitch-catch techniques. The results of Figure 3 were obtained with an automated ultrasonic data acquisition and display system using a water bath to couple the ultrasonic energy between the transducers and the test piece. However, water immersion techniques will not be appropriate for wind turbine blade examinations. In addition, the blade will be installed in a fixture or wind turbine where the inside surface of the turbine blade will not be accessible for application of an ultrasonic transducer for the TT technique. For these reasons, an acousto-ultrasonic (AU) inspection technique was developed. The AU technique would approximate the detection capability of the TT technique as near as possible.

The AU technique was implemented using the test sample of Figure 3 by attaching the receiver transducer to the bottom side of the steel plate of the sample. The detection of the two strip disbonds was observed by an abrupt loss of signal recorded at the stationary receiver as the transmitter passed over the disbonds. This test demonstrated the capability of the AU technique to simulate the TT examination and it could be used in a similar way to assess and identify certain areas of damage and disbonds at the metal insert of a full-scale turbine blade.

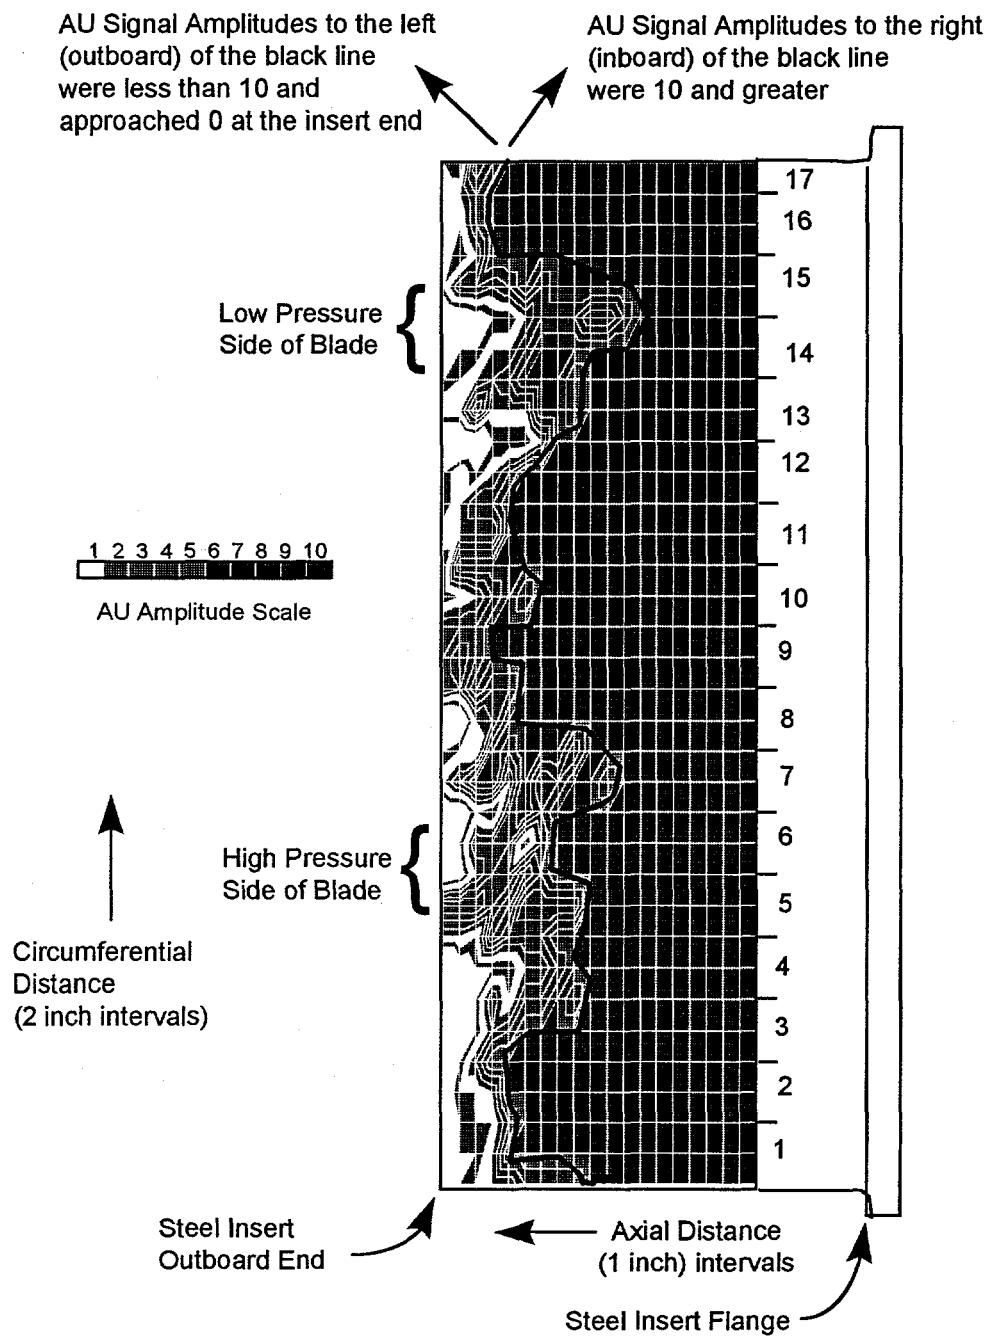
Figure 6. Contour plot of the amplitude levels of acousto-ultrasonic signals taken around the root bond area at a steel insert of a wind turbine blade.

A color contour plot of the tabular data was made by entering the AU data into a Microsoft Excel spreadsheet. Figure 6 displays an equivalent gray scale mapping of the AU data over the steel insert area of the blade. The AU data in Figure 6 indicated that some damage was present at this stage in the fatigue cycle schedule near the high and low pressure sides of the blade as referenced in the sketch of Figure 5. Maximum loading occurs at the outboard end of the steel insert during the fatigue test and during the normal operation of the blade in these two areas. After the AU examination was performed, the blade was fatigue tested to failure. It is noted that the failure of the blade was expected and it did occur in these two areas of the blade.

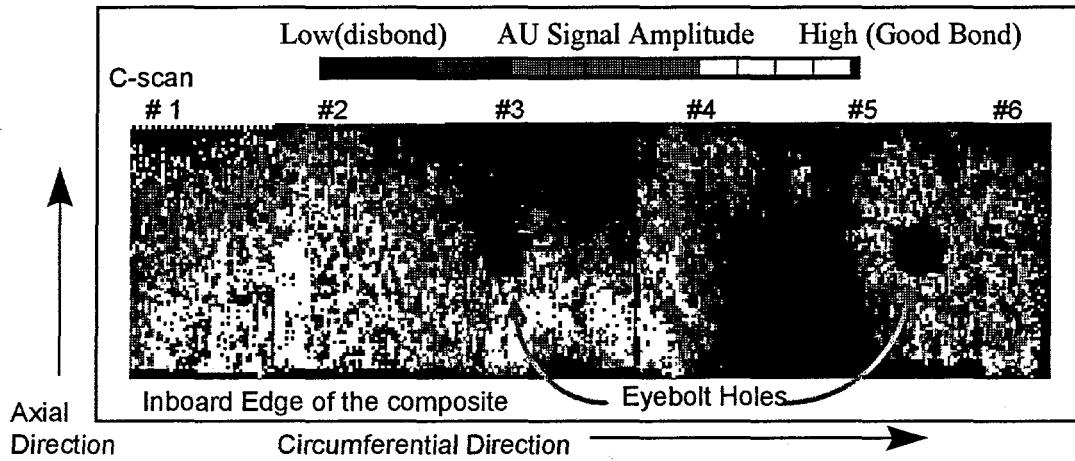
(a) Acousto-ultrasonic Amplitude C-scan Image of Entire Root Bond Area of the Steel Insert

Figure 7(a) displays a montage of the 6 C-scan images collected around the entire circumference of the blade. The C-scan images of Figure 7(a) were rendered in a simple gray scale since the normal 16 color scale could not be reproduced in this publication. Some detail of the AU signal variations is therefore lost but an assessment of the disbonded area is clearly indicated in the gray scale images. The area of Figure 7(a) shown in black where a low AU signal amplitude was recorded indicated the area of disbond.

Figure 7. C-scan image (a) of the AU signal amplitude taken over the root bond area compared with a photograph (b) of the same area after the composite skin was removed from the steel insert of a wind turbine blade.

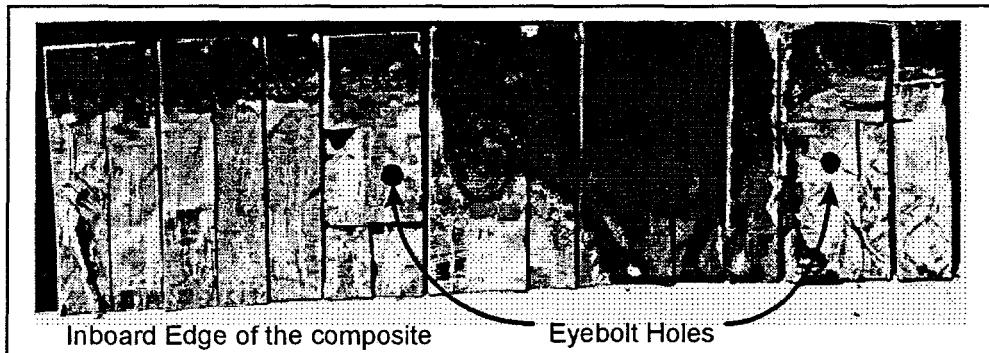
(b) Photograph of Pieces of the Composite Removed from the Steel Insert Root Bond Area in Sections Placed Together in the Same Orientation as the above C-scan Image

Figure 7(b) shows the corresponding visual examination of the bond interface of this blade by cutting the segments of the composite and removing them from the steel insert. The removed pieces of the composite were the reassembled with the metal-to-composite bond interface facing outward. A photograph of the reassembled pieces is shown in Figure 7(b) where the bond failure is shown in black due to a dark metal oxide present on the adhesive surface of the failed area. A comparison of Figures 7(a) and 7(b) shows that the AU data correlated well with the disbond visually observed after removing the composite with the exception of two small areas. The area to the right of center in Figure 7(a) indicated an area of low AU signal but not completely disbonded. It is possible that the composite was held in compression against the metal surface so that a so-called kissing bond existed in this small area. Also, the area just above the left eyebolt hole in Figure 7(a) is shown in black because the metal path to the receiver was obstructed by the eyebolt hole. This area does not show a disbond in Figure 7(b).

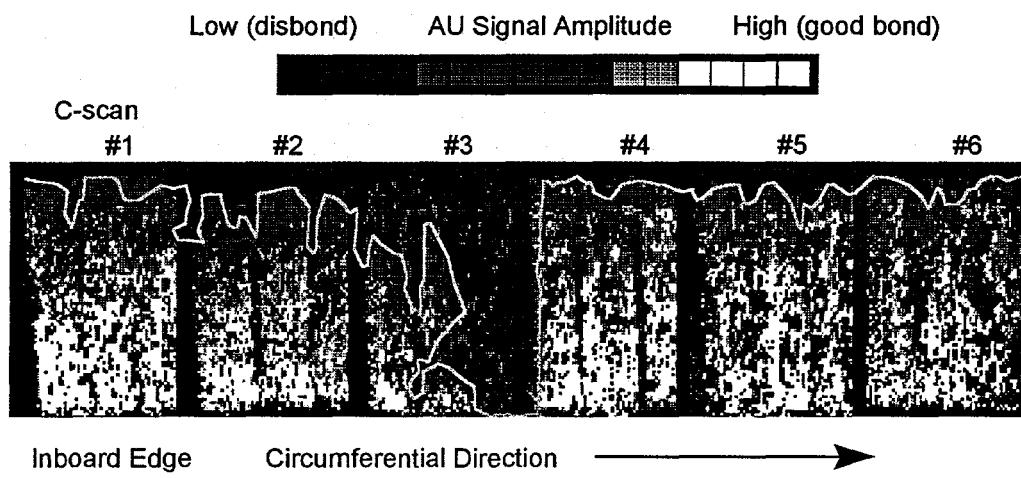
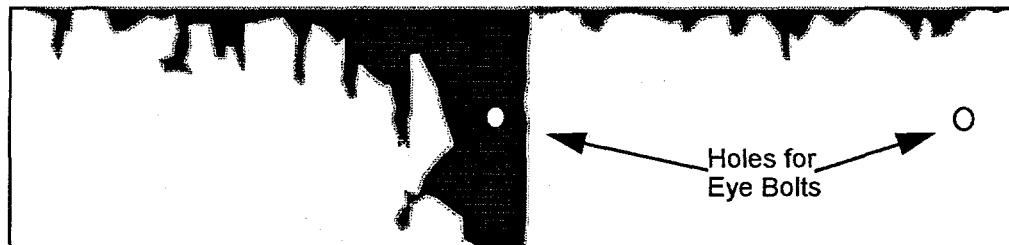
Figure 8 . C-scan image (a) and processed data (b) of the AU signal amplitude taken over the root bond area at the steel insert of a wind turbine blade.

The steel insert area of a third blade was also examined with the PC data acquisition and display system. A manufacturing defect was suspected in this blade but the location and extent of the defect was not known. Figure 8(a) shows the montage of the 6 C-scans of the AU signal amplitude. The AU signal amplitude data was processed so that a black color was assigned to signal amplitudes below a given threshold value. The result is shown in Figure 8(b). The area of the defect is then clearly indicated in Figure 8(b) by the area in black. After the AU examination was made, a partial removal of the composite skin at the area of C-scan number 3 showed that a large void existed in one of the layers in the composite and the void area correlated well with the C-scan image number 3.
