ITR-1449

OPERATION
PLUMB BOB

Project 30.2

RESPONSE OF DUAL-PURPOSE REINFORCED-
CONCRETE MASS SHELTER

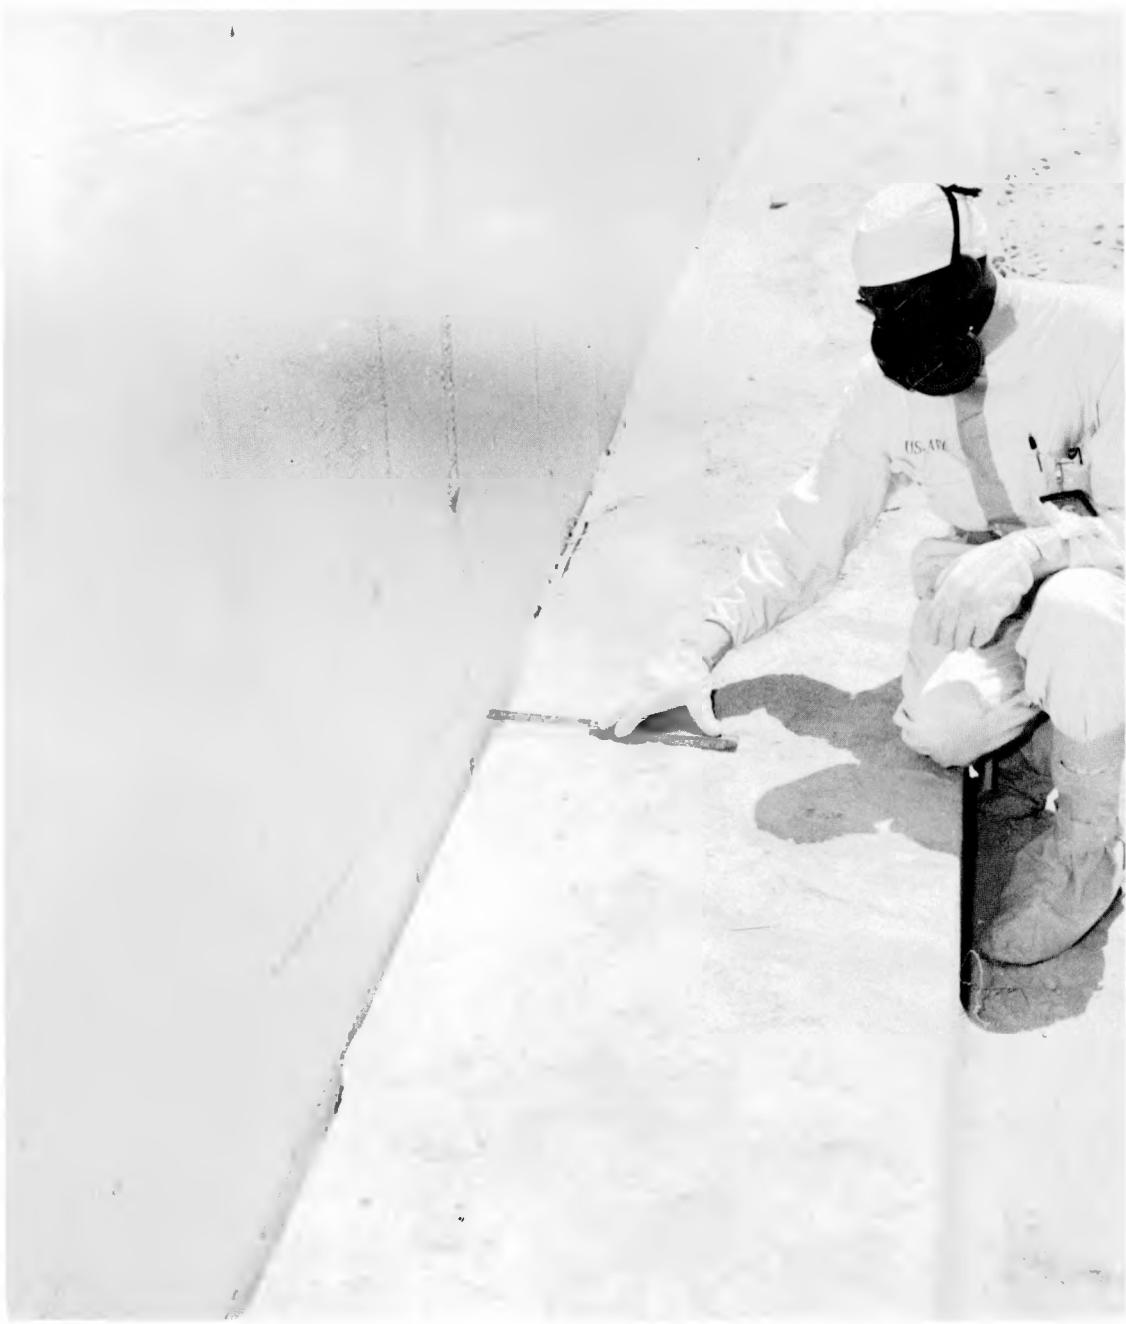
Fig. 3.2-Open joint between ramp slab and wall of main garage structure (postshot).

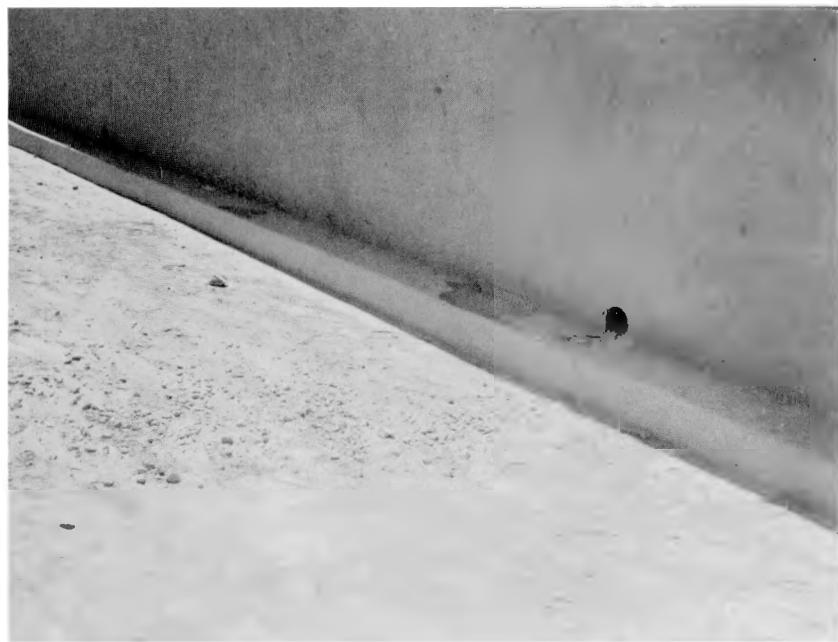
Fig. 3.3-Gravel backfill at weepers (postshot).

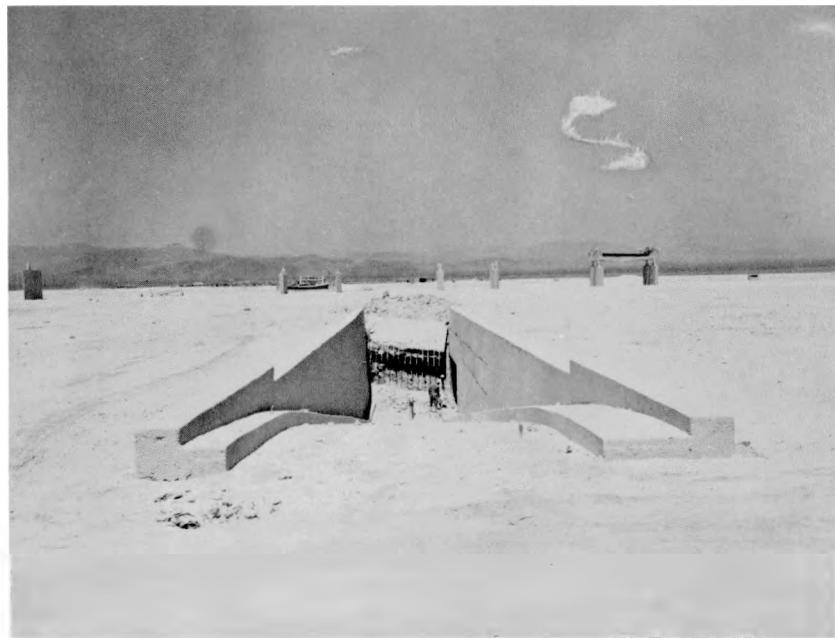
The end wall of the ramp was the only area badly damaged (Figs. 3.4 and 3.5). The top 8 ft of the end wall was broken off as a single unit on a nearly horizontal plane at the top of the splice of the vertical steel. It tipped into the backfill and slipped over the lower section until it wedged tightly between the garage wall and the longitudinal wall of the ramp. It was torn loose on a diagonal through the corner at its junction with the longitudinal retaining wall. In its final position, the top was displaced approximately 5 ft 6 in. into the earth backfill, which was pushed up and mounded. It is estimated that it may have been displaced approximately 8 ft before sliding back. The concrete cover had split off most of the lower section, and the bars had separated at the splice apparently without having developed their yield strength. Near the middle of the panel where the concrete had not split, three bars failed in tension and had fractured after necking down at the top of the splice (Fig. 3.6).

Fig. 3.4-View of ramp looking toward damaged end wall (postshot).

The only substantial damage noted in connection with this project was to the retaining walls at the end of the ramp where damage was expected (see Sec. 1.4). The loading on this wall was about 6 to 7 times the nominal design pressure, and a very low or negative surcharge could be expected on the backfill behind the wall because of high turbulence. The turbulence and diffraction patterns in this region are not well defined. Measurements made for this project indicate additional shock-tube and wind-tunnel data may be desirable.

There is evidence that the upper several feet of backfill behind the wall was not compacted in accordance with the specifications at the time of detonation because of excavation and backfill for an instrumentation trench after original backfilling had been completed. Such a condition would mean that a greater deflection would be required before developing the maximum passive resistance of the soil.

With the given orientation, the high pressures and damage experienced by the end wall can be avoided by use of a through type ramp where such a layout is not prohibited by other factors.

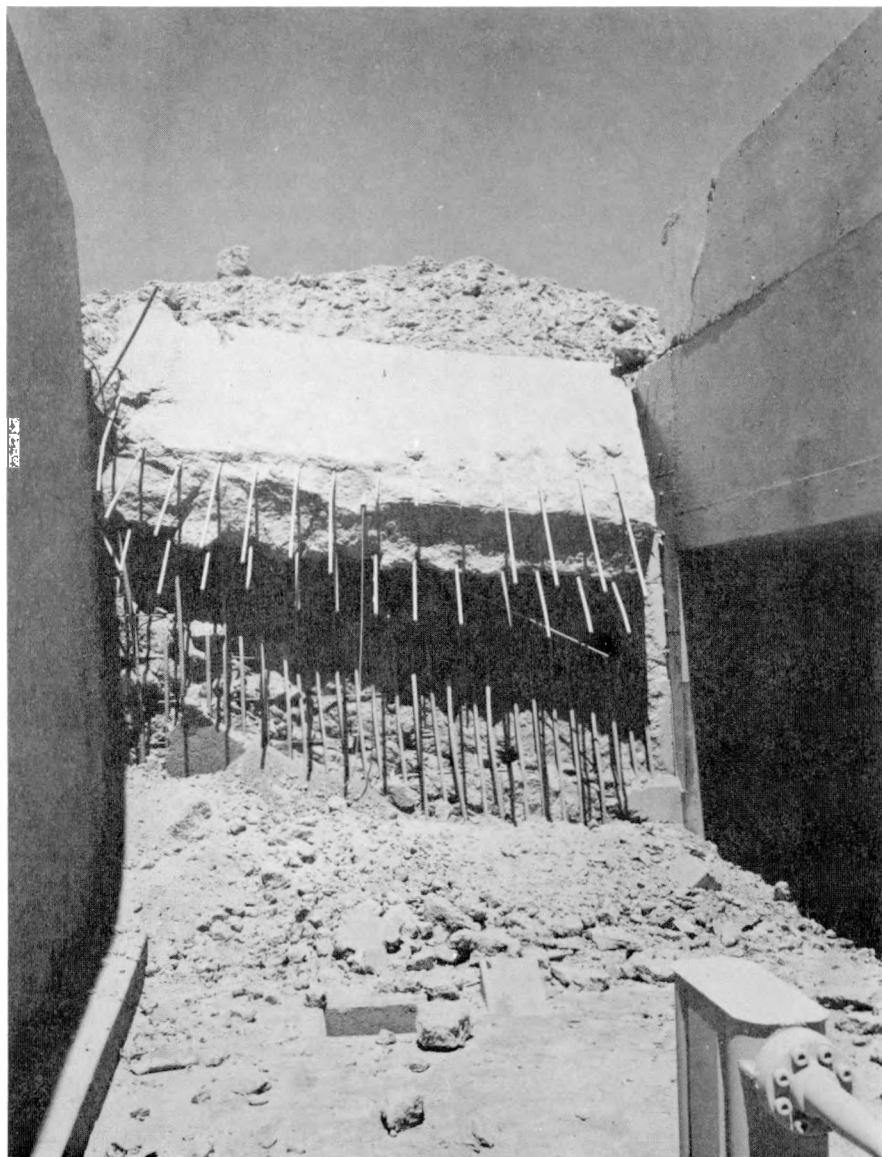
Fig. 3.5—Close-up of damaged end wall (postshot).

The end corner of the 1 ft 3 in. parapet wall at the lower end of the ramp was cracked as shown in Fig. 3.5.

Because of its orientation and high pressure loading, the wall was expected to deflect into the backfill by yielding of the reinforcement, but the concrete and reinforcement were expected to remain banded together, although the concrete would be badly cracked. The complete separation of the top half of the end wall from the bottom, disintegration of the bottom portion into loose rubble, separations along the planes of the reinforcement, and failure of the splices without yielding of the steel can be attributed to the poor adhesive quality of the concrete in place. However, the mode of failure also may have been influenced by the rapid blast loading and the probability that the strength of normal splices under such load may be much lower than under static loading. Laboratory data to verify splice efficiencies under dynamic loading would be highly desirable. The ductility of

actual shelter-garage structure would have alternate vehicular and personnel entrances and exits. For this reason, the design strength of the retaining walls need not be increased. However, the brittle type failure is undesirable, and the problem should be studied further in an effort to modify the details to produce a more ductile retaining-wall structure.

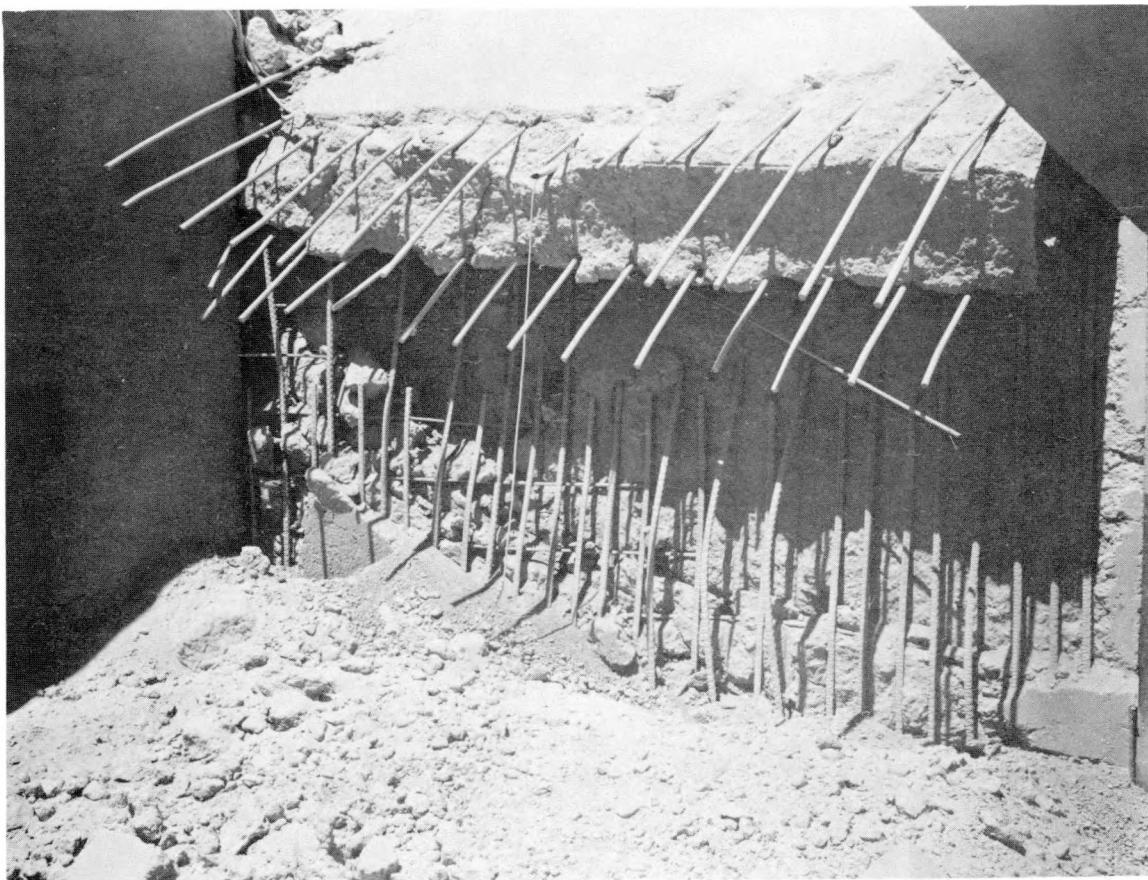
Fig. 3.6-Detail of failure showing fractured bars (postshot).

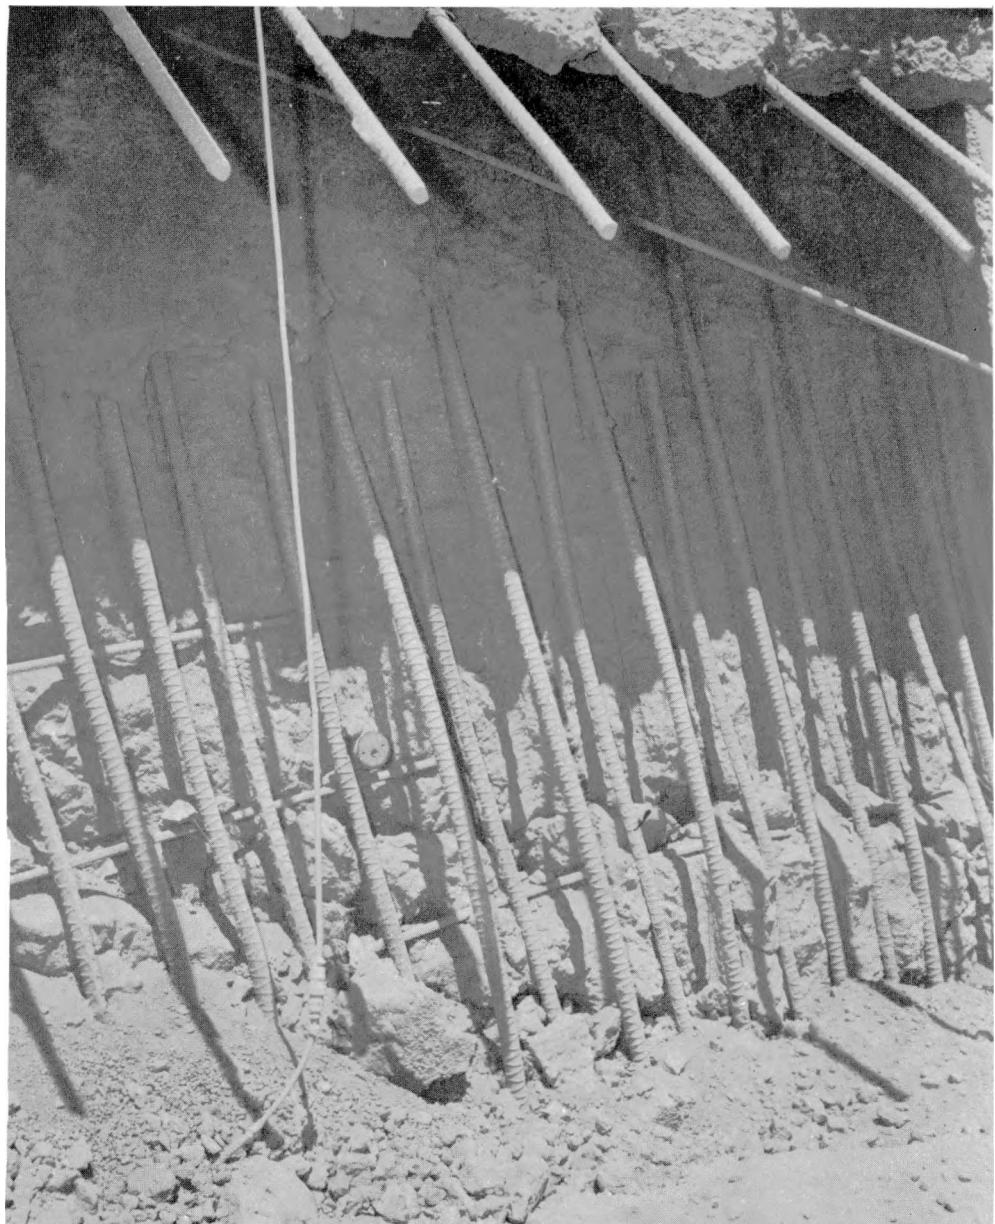
The bars in the lower section were bent away from the displaced concrete; the cover was deposited at the base (Fig. 3.7). The remaining concrete behind the bars was reduced to rubble, varying in size from 6 in. to 3 ft in diameter. Fractures, including the one at the

Fig. 3.7-Detail of lower portion of wall (postshot).

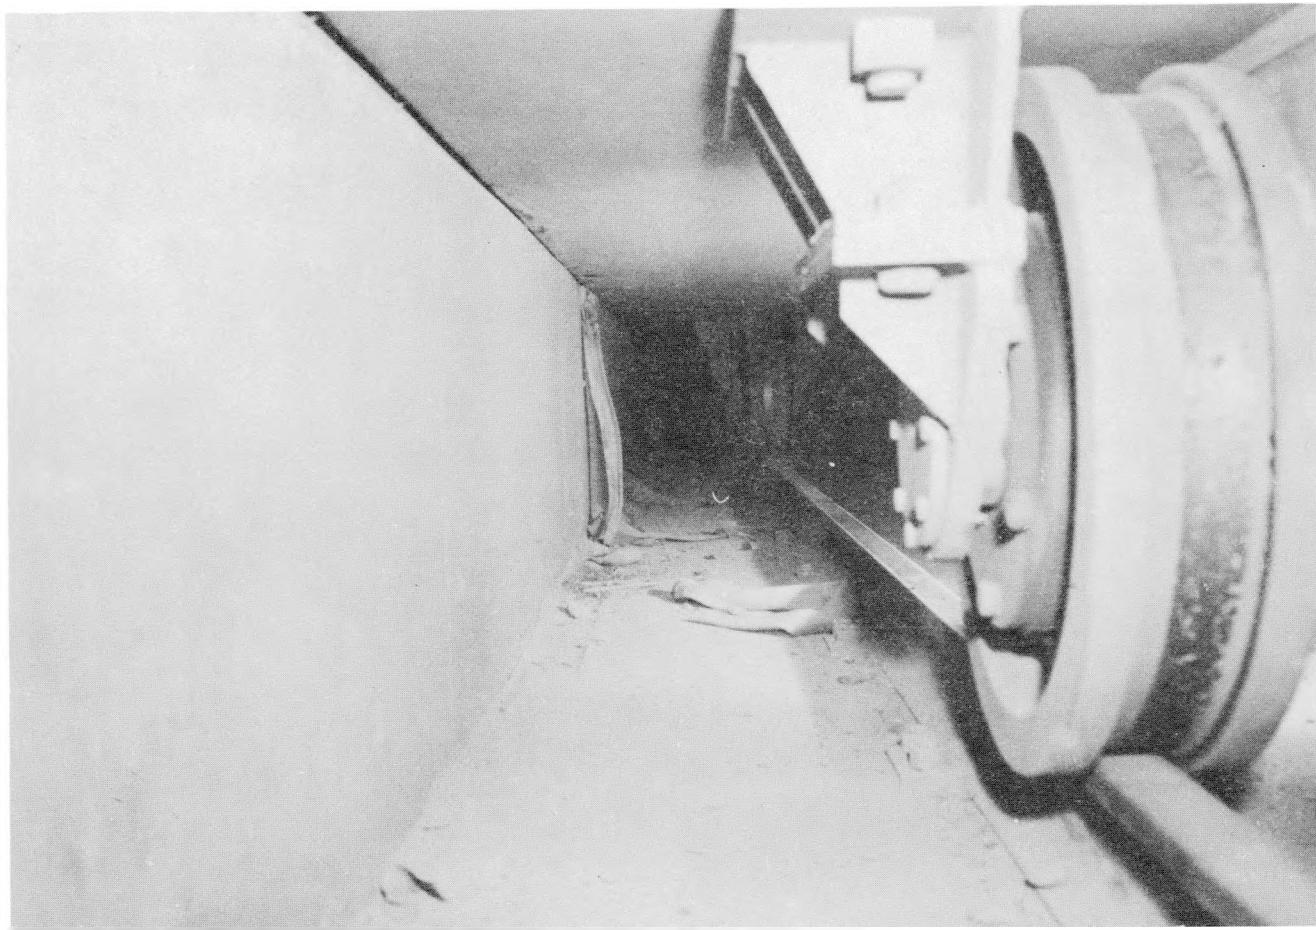
Fig. 3.10-Wheel assembly and rails, door partly open (postshot).

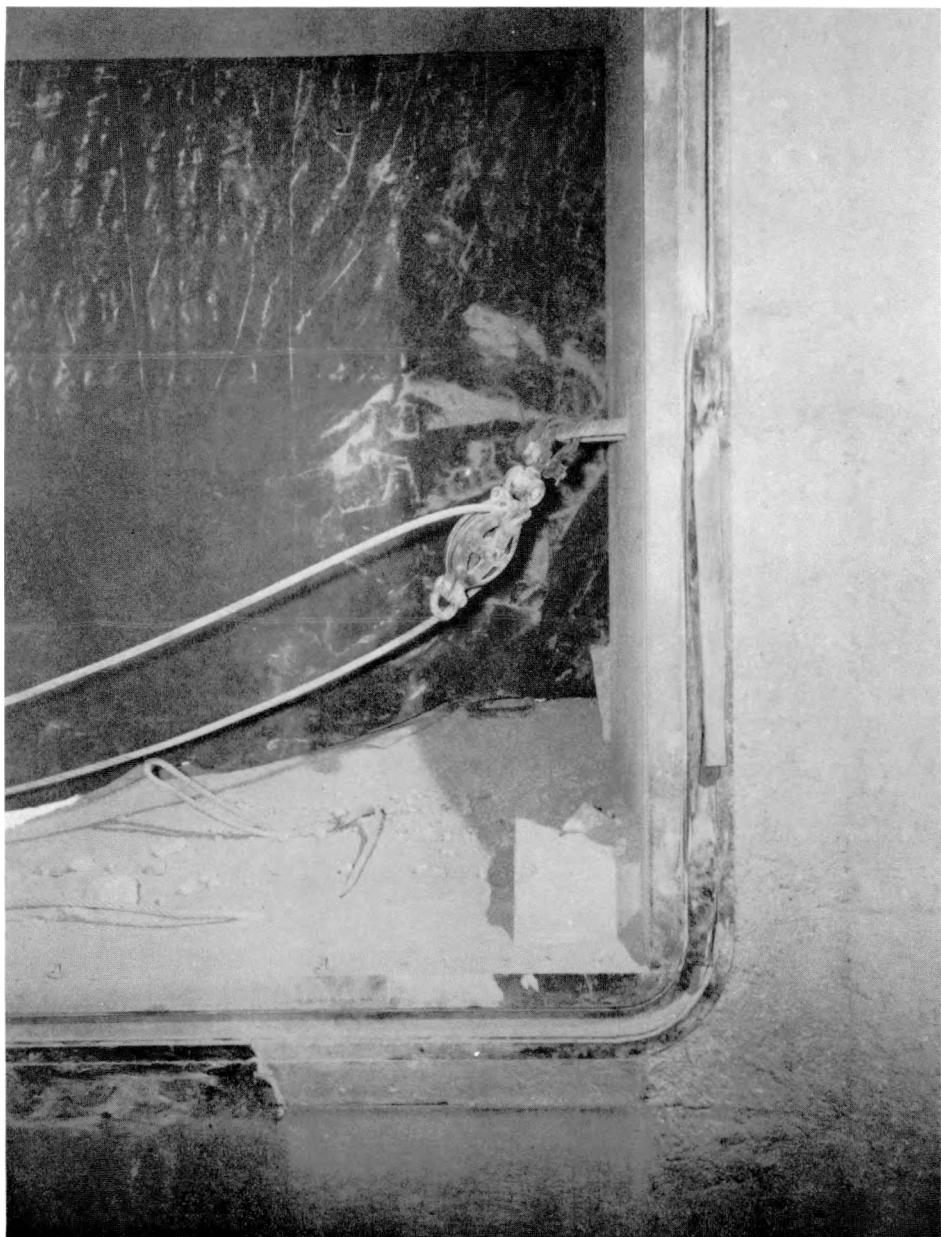
The pneumatic gasket around the door frame was blown in and torn apart by the blast pressure (Fig. 3.11). The gasket had a slow leak prior to the shot, and a compressed-air cylinder was installed outside in the doorway recess to maintain the air pressure. The cylinder and air hose were sandbagged and were not damaged by the blast. No information is available regarding the condition of the gasket at shot time.

**Fig. 3.11-Damaged gasket at lower corner
of door opening (postshot).**

Because the as-built clearances between the door and frame were as high as 13/16 in., more than three times that shown on the plans, the pneumatic seal would have been ineffective even in good working condition. To prevent excessive infiltration of the blast pressures, clearances at the base were reduced prior to the shot by 3 x 3 x 3/8 angles; one leg was inserted vertically into the opening and the other bolted to the frame. Although it is not known if the compressed-air cylinder placed prior to the test was adequate to maintain pressure in the gasket up to shot time, the blast pressures entered the joint and forced the gasket toward the interior of the shelter, stripping and tearing it along its entire length.

1. The pneumatic seal should be replaced with a rigid mechanically operated seal adequate to resist the maximum peak pressures in the region of the door.
2. Additional study should be given to the mechanical equipment, space, maintenance, and operating requirements in actual garage shelters for vehicular doors of the type proof tested.
3. Further laboratory tests and studies in connection with the reflected pressures and air flow in the ramp are desirable.
