for presentation 2⁺
the AIAA / ASME 1997 Spring Meeting
Wind Energy Jan 6 - 9 1997 Rowan University

A.G. Beattie
Department 9742
Sandia National Laboratories
Albuquerque NM, 87185-0615

Abstract

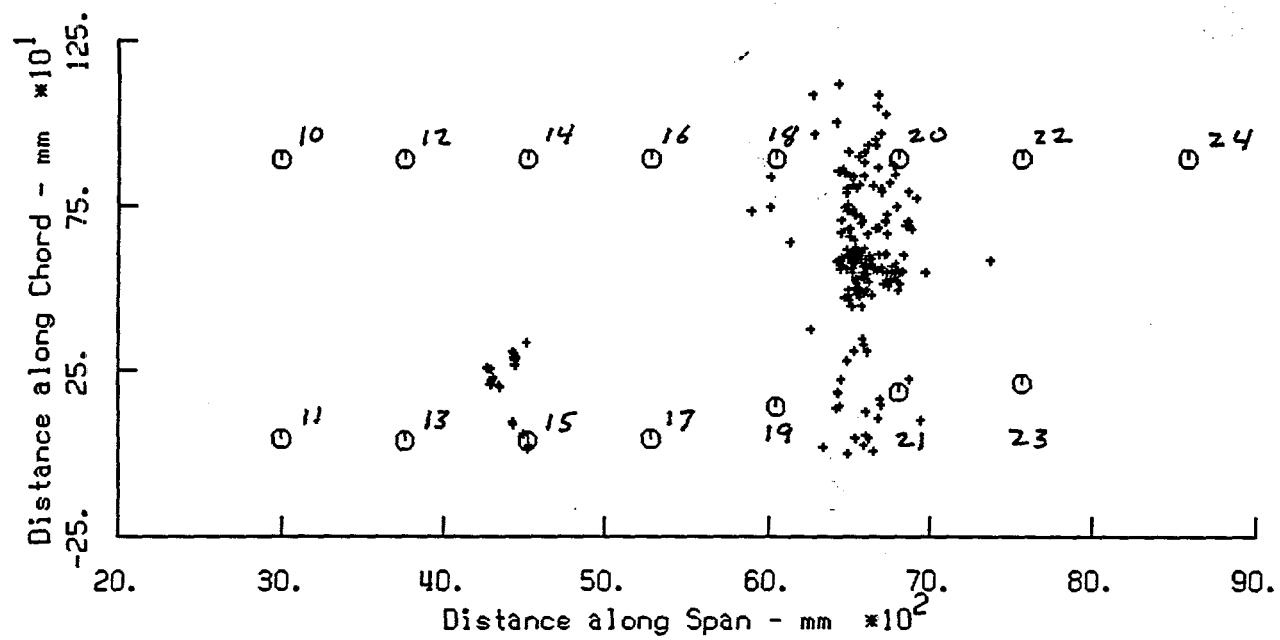
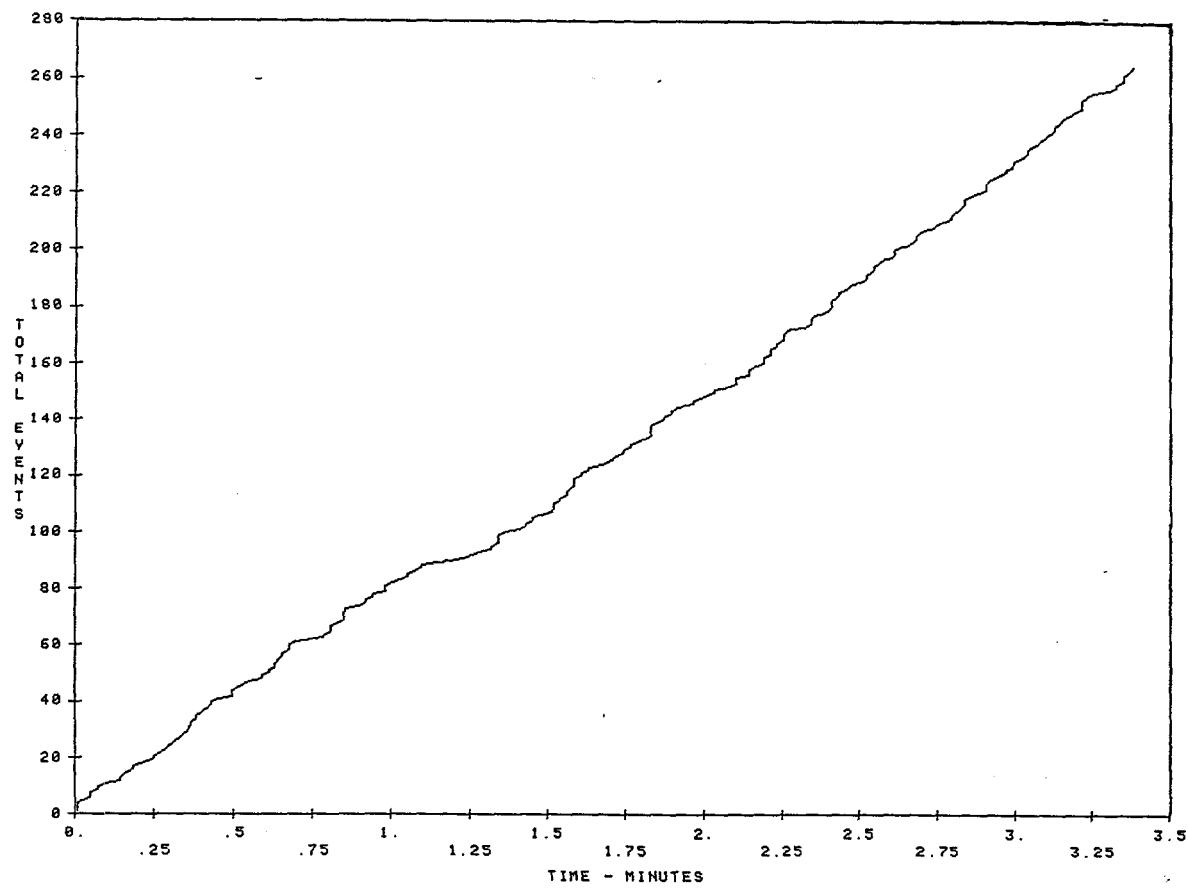
Figure 3. Event Locations and Events as a function of time for Stage 1

The acoustic emission system was set up and run for about 3.4 minutes without the voltage controlled gate. While the purpose of this brief run was to determine the overall data rate, the data set can also be used to find the initial rate of locatable sources and plot those sources. The data set was filtered to remove all sources which appeared to occur at times other than at the peak load. Figure 3 shows the location of these sources and the sum of the number of located sources as a function of time. It is quite apparent from this data that damage in the 18,19,21,20 rectangle started at the first cycle which reached full load. The other oil can region, which occurred in the rectangle 12,13,15,14 showed no sign of locatable emission during this short run. No located emissions were seen in the root area covered by sensors 1 through 9.

The steady occurrence of locatable emission at the peak load of almost every cycle as shown in figure 3 strongly indicates that the peak test load of 9535 lbs. exceeded the strength of this blade design in the region of rectangle 18,19,21,20.

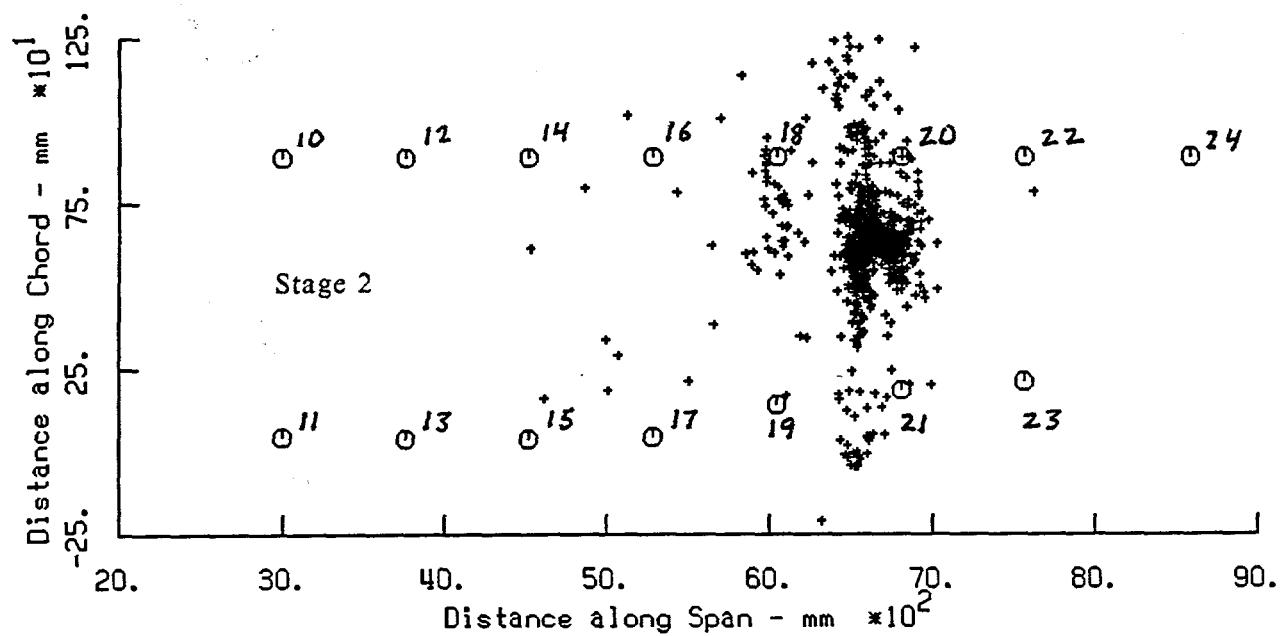
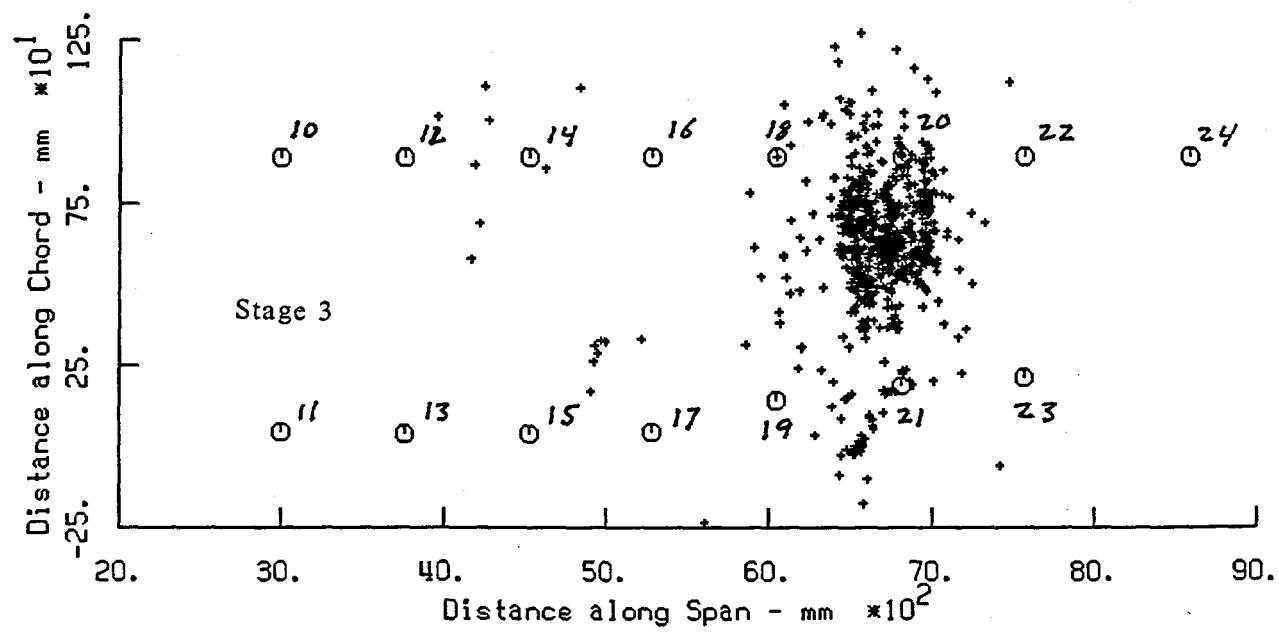
Figure 4. Event Locations for Stage 2 and Stage 3

Most of the located emissions in this fatigue test occurred in stages 2 and 3. Figure 4 shows the located emissions in these test stages. Again most of the emissions appear to come from the oil can distortions in rectangle 18,19,21,20. Figure 5 shows the sum of the located sources as a function of time. Thirty-two minutes into the stage 2, there was an order of magnitude decrease in the rate of locatable emissions. A similar behavior is seen in stage 3 (the step between 20 and 28 minutes occurred when the loading was temporarily stopped) Notice that the temporary halt in loading did not change the event rate. The event rate did decrease at 78 minutes. A lower rate then continued, with some fluctuations, to 268 minutes. The rate again declined and ceased entirely at 549 minutes. The overall acoustic emission rate from the blade remained constant for the 23 hours of stage 3 but no events occurred where the acoustic burst excited sensors at all four corners of a rectangle within a 350 microsecond window for the last 14 hours of this

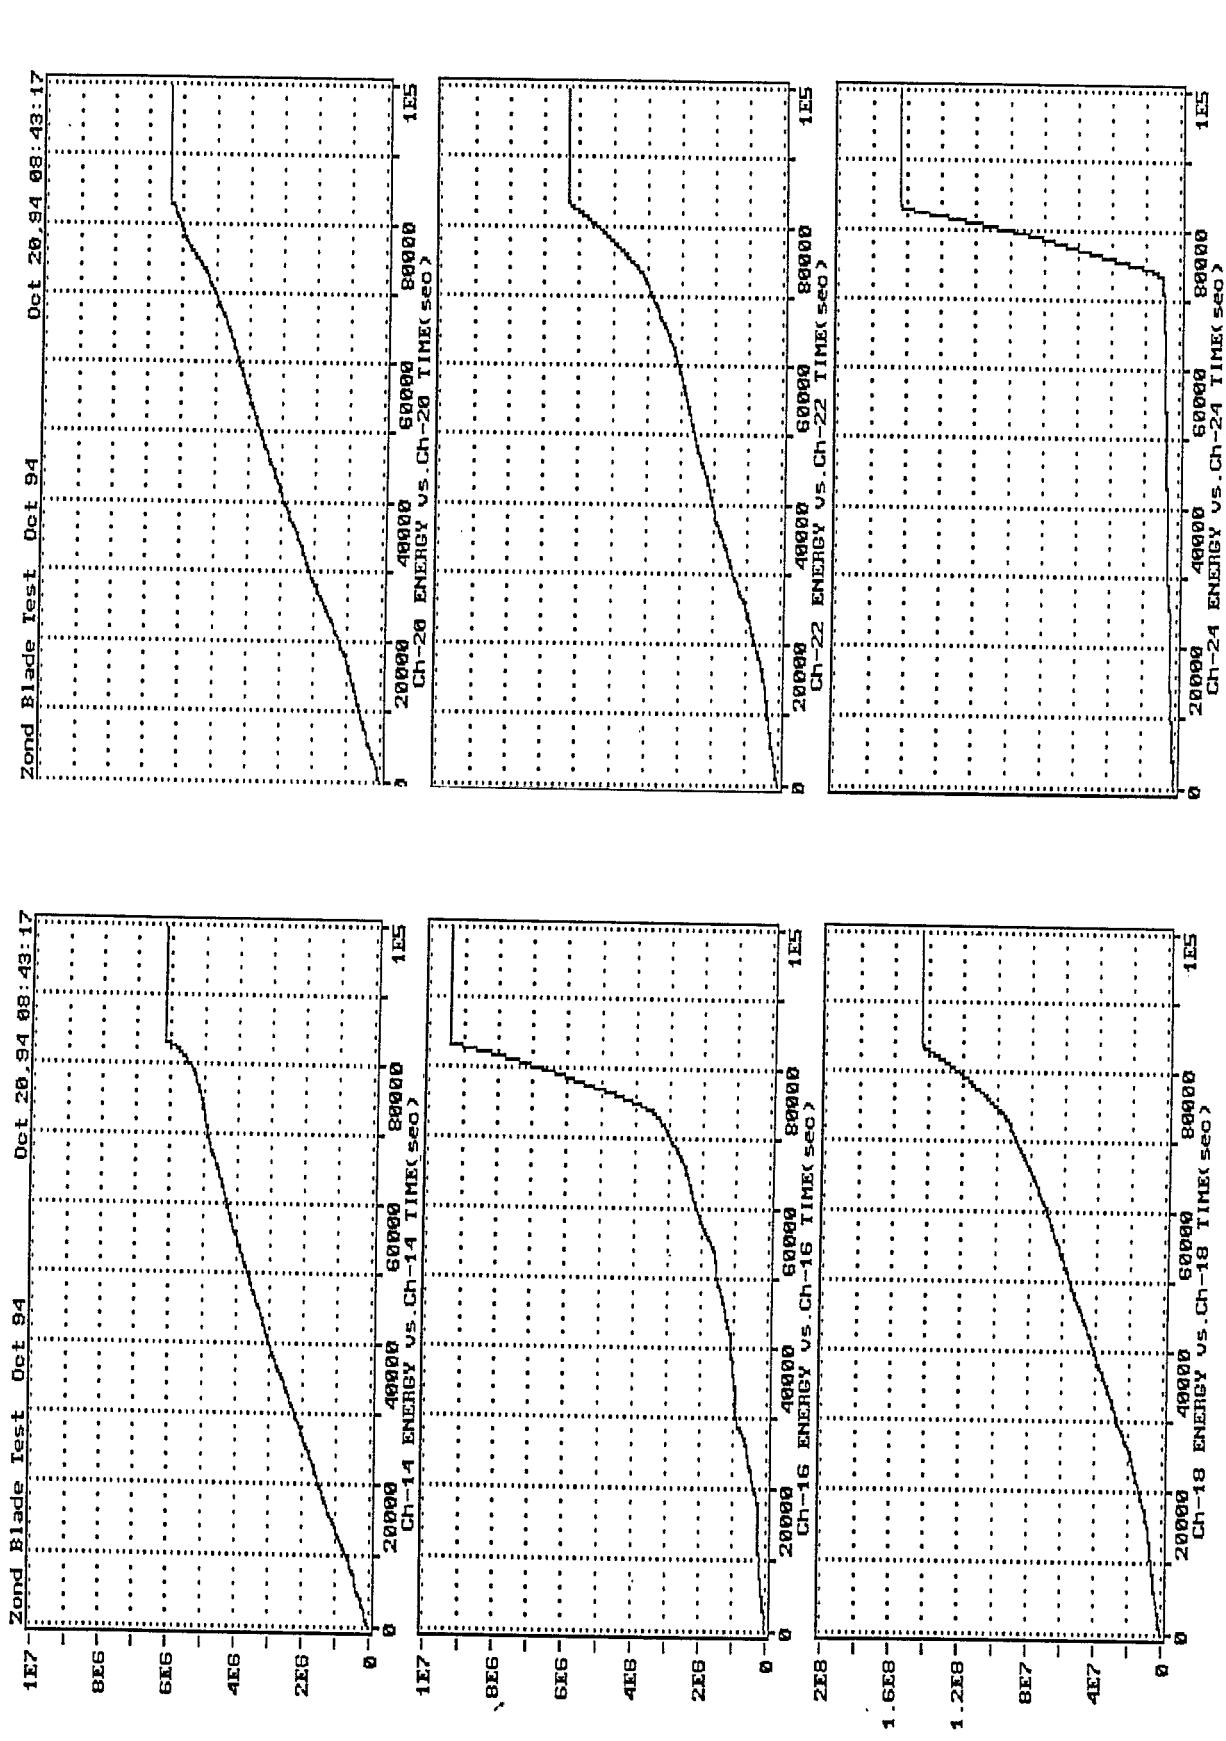
Figure 6. Total "energy" as a function of time for the leading edge sensors.

Another way to examine the acoustic emission data is to plot hits from each sensor individually. Figure 6 shows totalized plots of the "energy" (actually the signal strength for each emission burst) as a function of time for sensors on top of the spar. Note that there are no significant changes in slope in any of these curves at 78 minutes (4680 seconds), 268 minutes (16,000 seconds) or 549 minutes (33,000 seconds). Thus the rates of located events have no correlation with acoustic emission rates seen at the individual sensors. Also notice that there was an increase in the "energy" rate around 72000 seconds (20 hours) for all sensors except 20. Closer examination showed that except for sensors 20, 21 and 24, there was an increase in the average "energy" per burst after 20 hours. Sensors 20 and 21 are located near the region where maximum damage occurred. There was very little sound material left in the skin in rectangle 18,19,21,20 by this point in the test. It is probable that this region weakened, transferring more load to the surrounding regions. This should increase the damage and lead to more acoustic energy being produced in each burst. Sensor 24 is a different case. Here the separation from sensor 22 (60 inches) is far enough so that the attenuation would allow few, if any, signals to excite both sensors. The increase here was much larger, proportionally, than that seen in other sensors. The sensor was positioned to try to detect any damage occurring near the loading point on the blade and such damage is probably what is being seen. The average "energy" per burst decreased for sensor 24 beyond the 20 hour point which reinforces the assumption that this is a different mechanism from that seen in the other sensors.

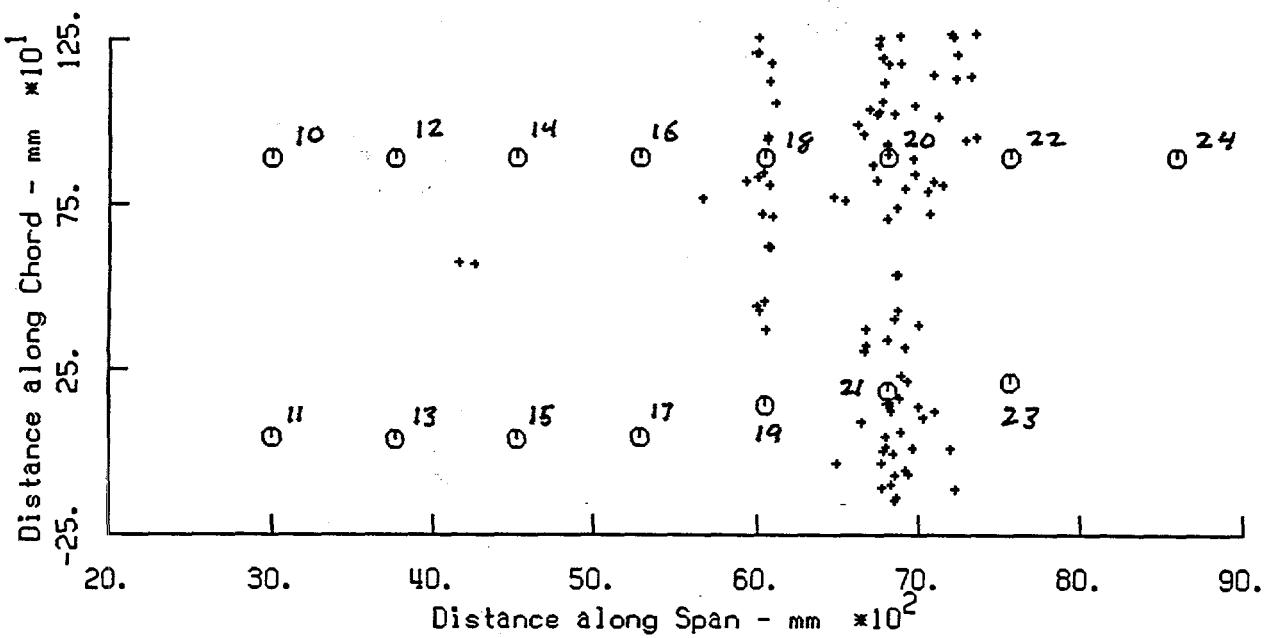
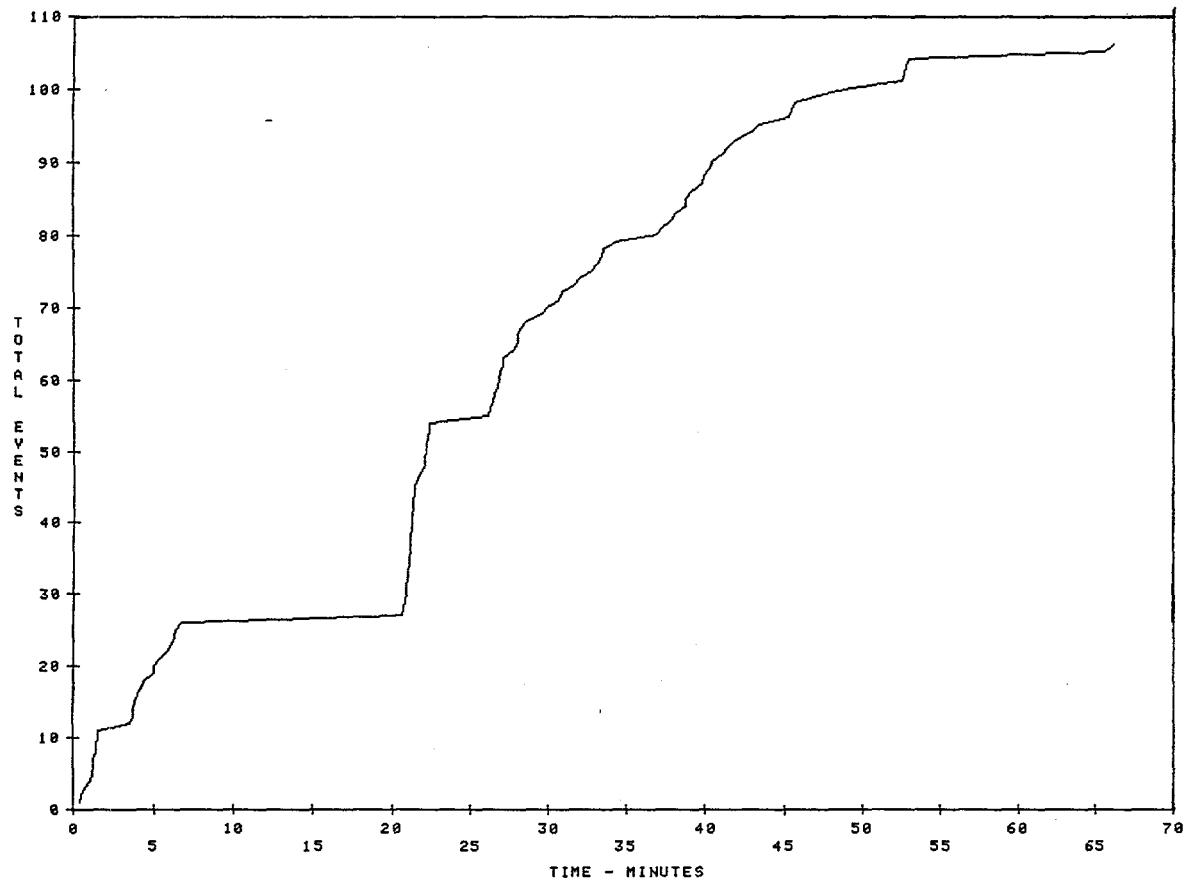
Figure 7. Event Locations and Events as a function of time for Stage 4

Stage 4 covered less than an hour of testing time. There were several halts during the test. The test was terminated at 66 minutes when the blade failed. A halt at 53 minutes was taken just after the skin ripped and separated from the top of the front spar. The test was restarted at 64 minutes and lasted about two minutes when the top skin buckled and ripped from the front spar toward the rear spar. Sensor 20 was just about over the rip and the failure broke the silicone rubber bond and launched sensor 20 skyward.

Figure 7 shows the map of located events for this stage and the located events as a function of time. There were not a large number of events located during this stage. The reason is not the lack of emission, but rather the gross damage in the skin which increased the acoustic attenuation, and the separation of the skin from the spar which interrupted the acoustic path to the rear sensors. These mechanisms prevented the acoustic bursts generated by even very energetic events from triggering all four sensors in a rectangle.

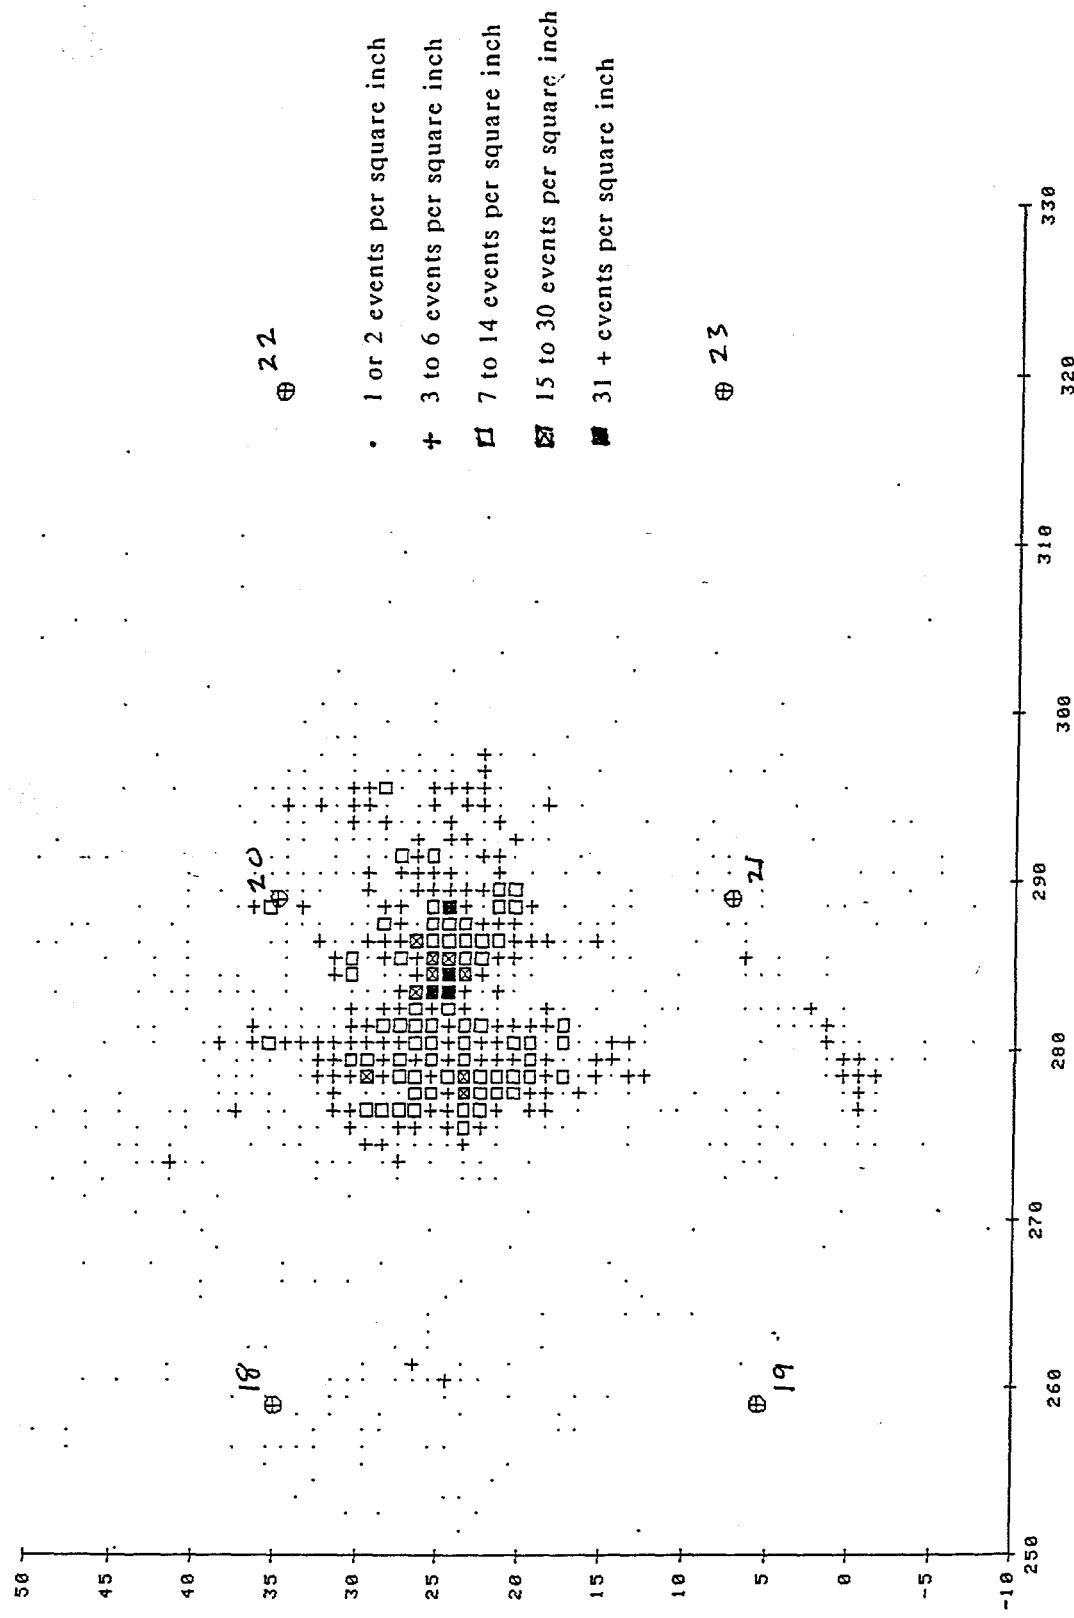
Figure 8. Density of Located Events for the Entire Test.

The location data from all four stages was combined. Figure 8 shows this data plotted in the critical rectangle 18,19,23,22. The symbols on the plot indicate the number of located events per square inch. The highest density is right in the middle of the region showing oil can deformation. Visual observation of this area before the stage 4 run indicated extensive damage. The final failure of the blade also occurred very close to the area of maximum density of located events.

One should note that the highest density of located events is not along the line between sensor 18 and 20 where the initial tear in the skin along the spar took place. The tear effectively prevented any acoustic signals from being transmitted to sensors 19 and

From this table one can see that the center of the damaged area is between sensors 20 and 21 and part way back toward sensors 18 and 19. This corresponds very well with figure 8.

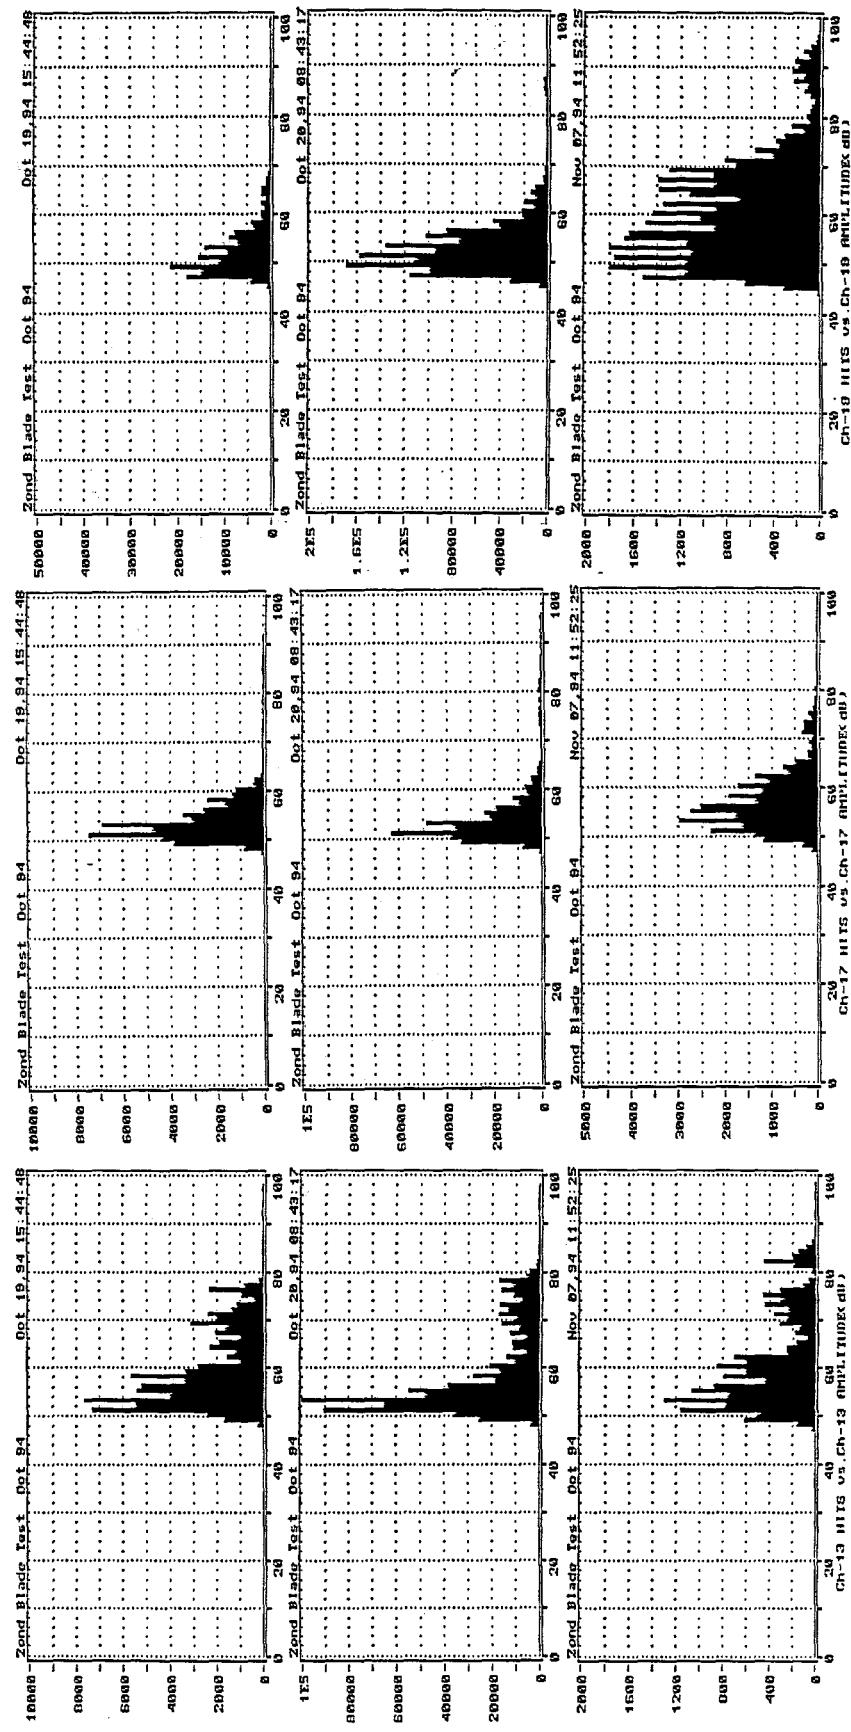
Figure 9. Peak amplitude distributions from Stages 2 (top), 3 (middle) and 4 (bottom) for sensors 13, 17 and 19.

Another way to look for damage is to look at the peak amplitude distributions for different sensors. For a given sensor and material, a higher peak amplitude usually indicates greater damage. (Note that the peak amplitude is measured on a logarithmic scale such that 20 dB corresponds to one order of magnitude). Figure 9 shows the peak amplitude distributions from sensors 13, 17 and 19 for stages 2, 3 and 4. The top graph is stage 2, the middle, stage 3, and the bottom is stage 4. For Stage 1, except for sensor 21, there was essentially no emission with peak amplitudes at or above 80 dB. In stage 3, all sensors but 13 have shown a few hits above 80 dB but they are still in a distinct minority. In stage 4, there are far fewer hits on each sensor but some of the distributions have changed. Sensor 19 now has a distinct peak around 90 dB while 17 is still lacking any signals above 80 dB. This agrees with all of the previous data which indicates failure between sensors 19 and 21. However, we now see peaks with amplitudes above 80 dB for sensor 13. These peaks were not seen in data from sensors 11, 17 nor from sensors 10, 12, 14, and 16. There are few located emissions near the rear spar in this region. The most plausible explanation for this data is that new damage occurred during stage 4 behind the rear spar between sensors 13 and 15. The damaged region would be far enough behind the spar that the attenuation prevents the detection of the signals at sensors 12 and 14.
