ANL-6048
Metallurgy and Ceramics
(TID-4500, 15th Ed.)
AEC Research and
Development Report

EXAMINATION OF JACKETED URANIUM SLUGS FROM THE
LOS ALAMOS FAST REACTOR "CLEMENTINE"

S. H. Paine, W. F. Murphy and F. L. Brown

Final Report of Metallurgy Division Program 6.1.5

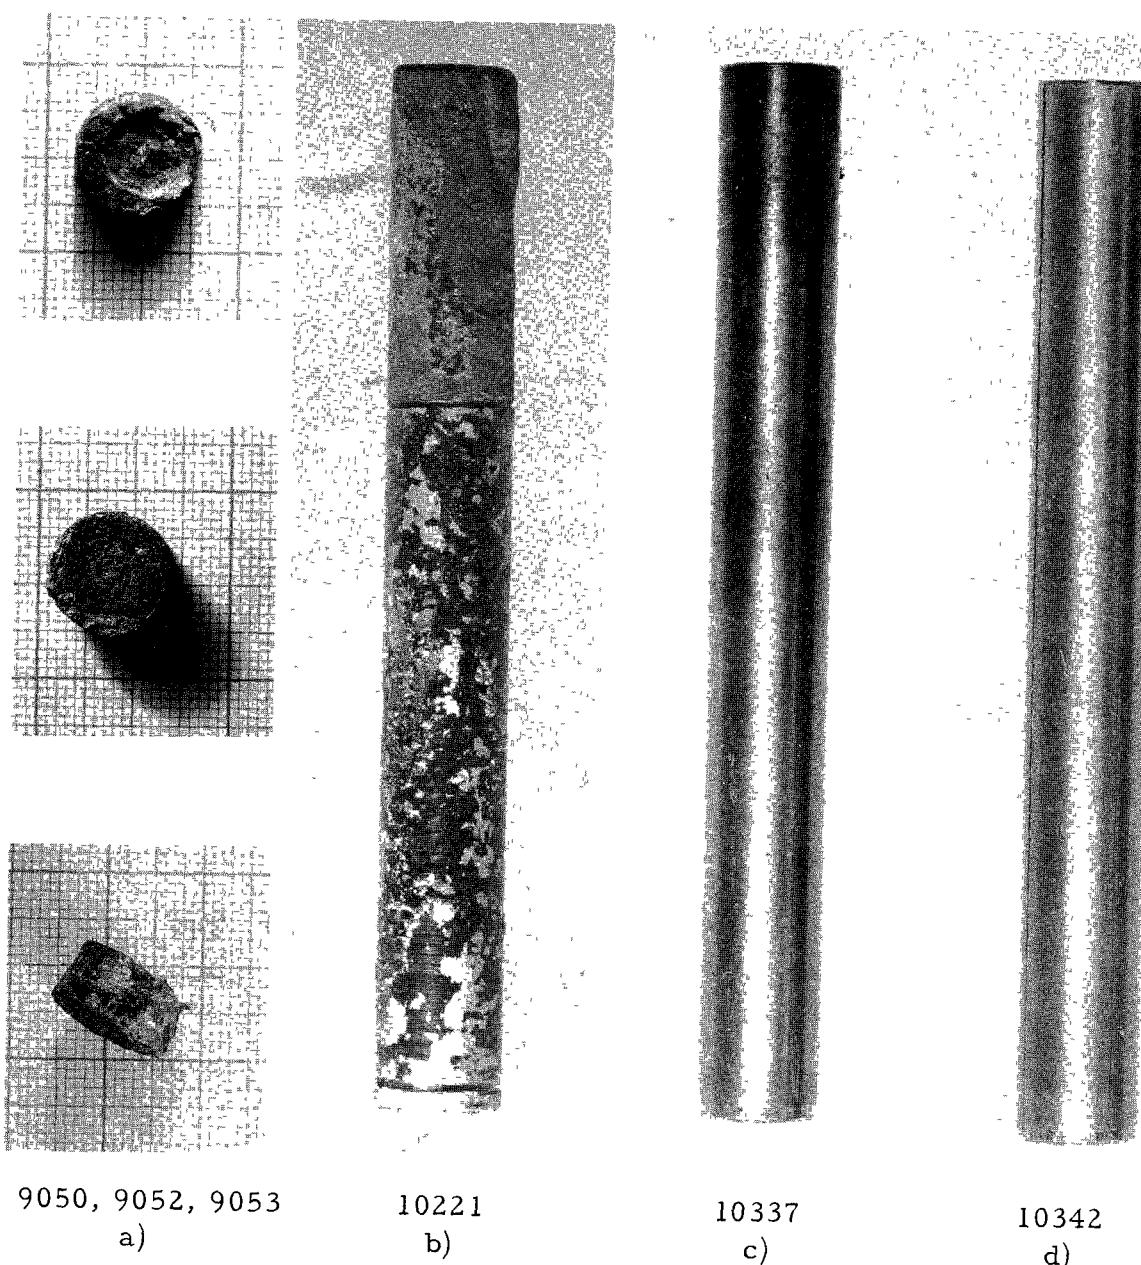
The overall appearances of the decanned slugs and of the small uranium filler plug from the ruptured slug are shown in Figure 2. The appearances of surface details are seen better in Figure 3. The core of the failed slug was covered with bumps and erosion. It had been silver-plated before assembly, whereas the other two cores were unplated. In Figures 3-b and 3-c may be seen the small bumps on the surfaces of the latter slugs which were associated with the out-of-roundness of their respective cans, noted above. Careful measurements (Table I) showed these irregularities to be the only ones present on the surfaces of the cores. They had the same general appearance as the smaller surface bumps on the ruptured slug, except for the absence of silver plating, but equipment was not available whereby they could be studied more critically.

Two regions of damage on the ruptured slug core appeared characteristically different. 1) The end in the vicinity of the jacket rupture had no large bumps, was heavily eroded and had a dull gray, oxidized appearance (Figure 2-b). The small filler plug had a similar appearance. It was also noted that, on this piece, the surface closest to the weld had considerable more erosion than the surface in contact with the main core slug (Figure 2-a). 2) At positions remote from the rupture the damage took the form of many discrete bumps between which could be seen tool marks originally left on the core surface by the machining operation.

Figure 2. Appearances of Uranium Slugs after Removal of Cans (1X).
a) Three views of end filler from Slug 141 (ruptured).
b), c), d) Main cylinders from Slugs 141, 205 and 236, respectively.

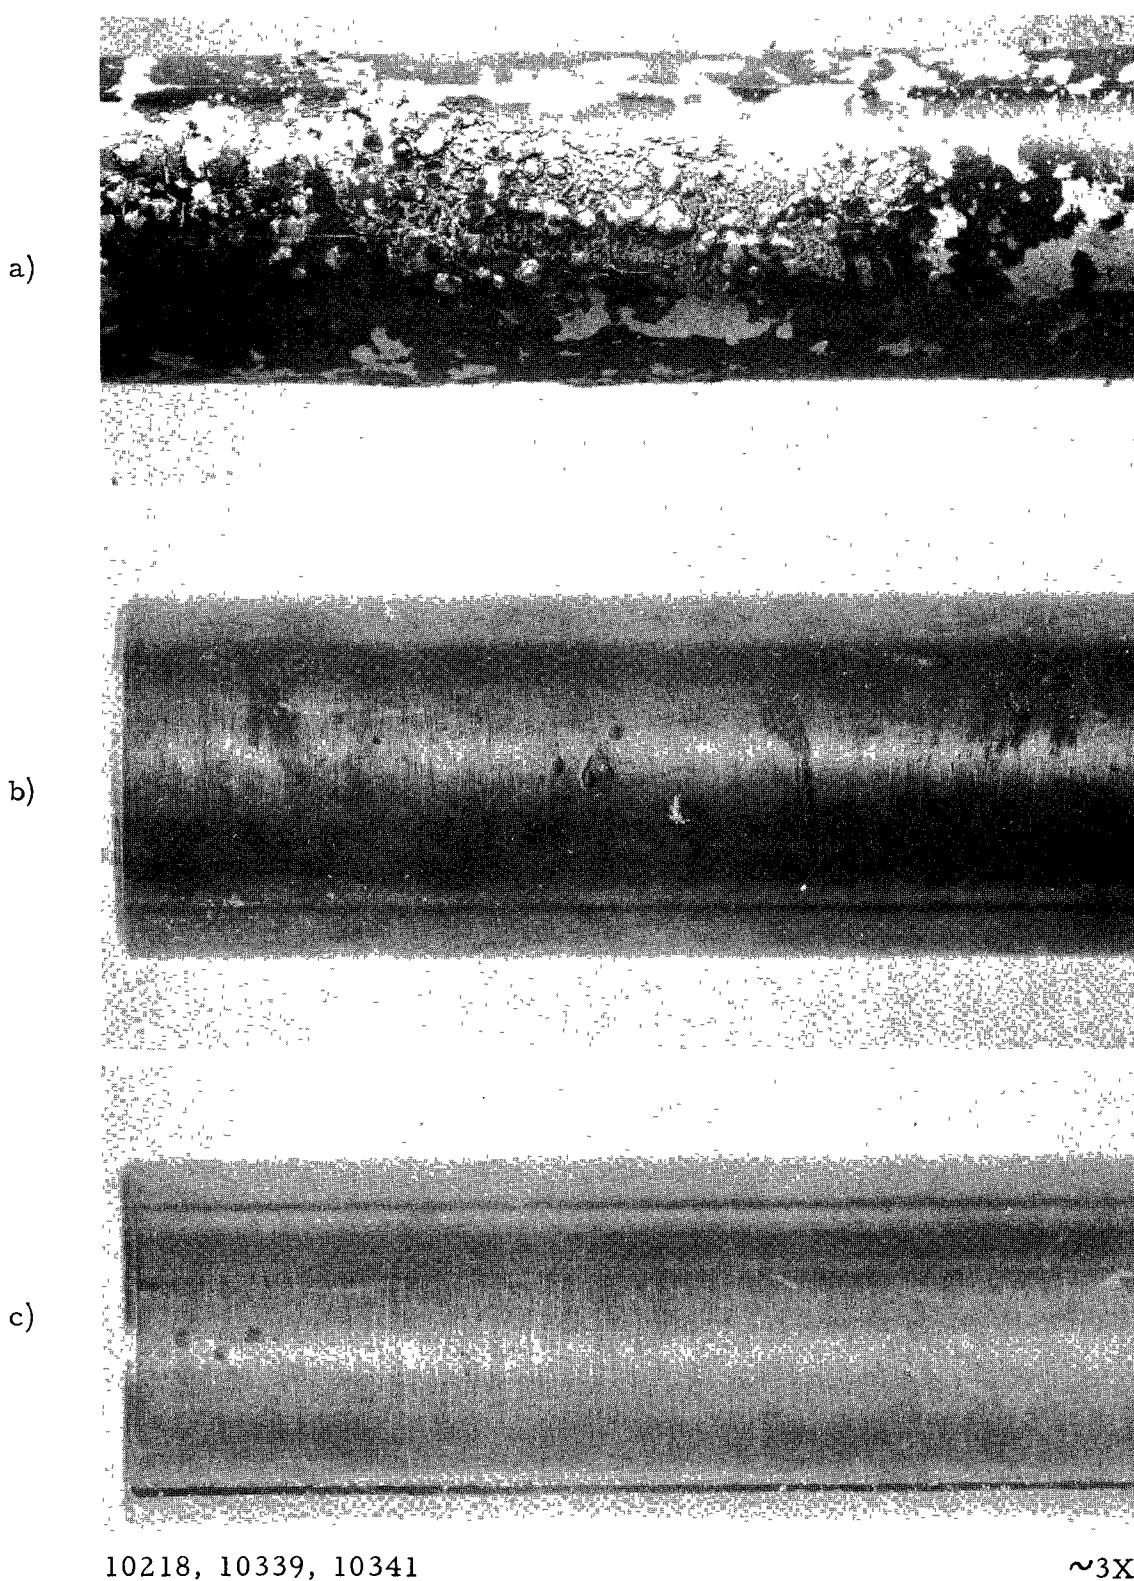
Figure 3. Enlarged Views of Stripped Slugs. a) Profuse bumping of ruptured Slug 141. b) c) The only irregularities noted on Slugs 205 and 236.

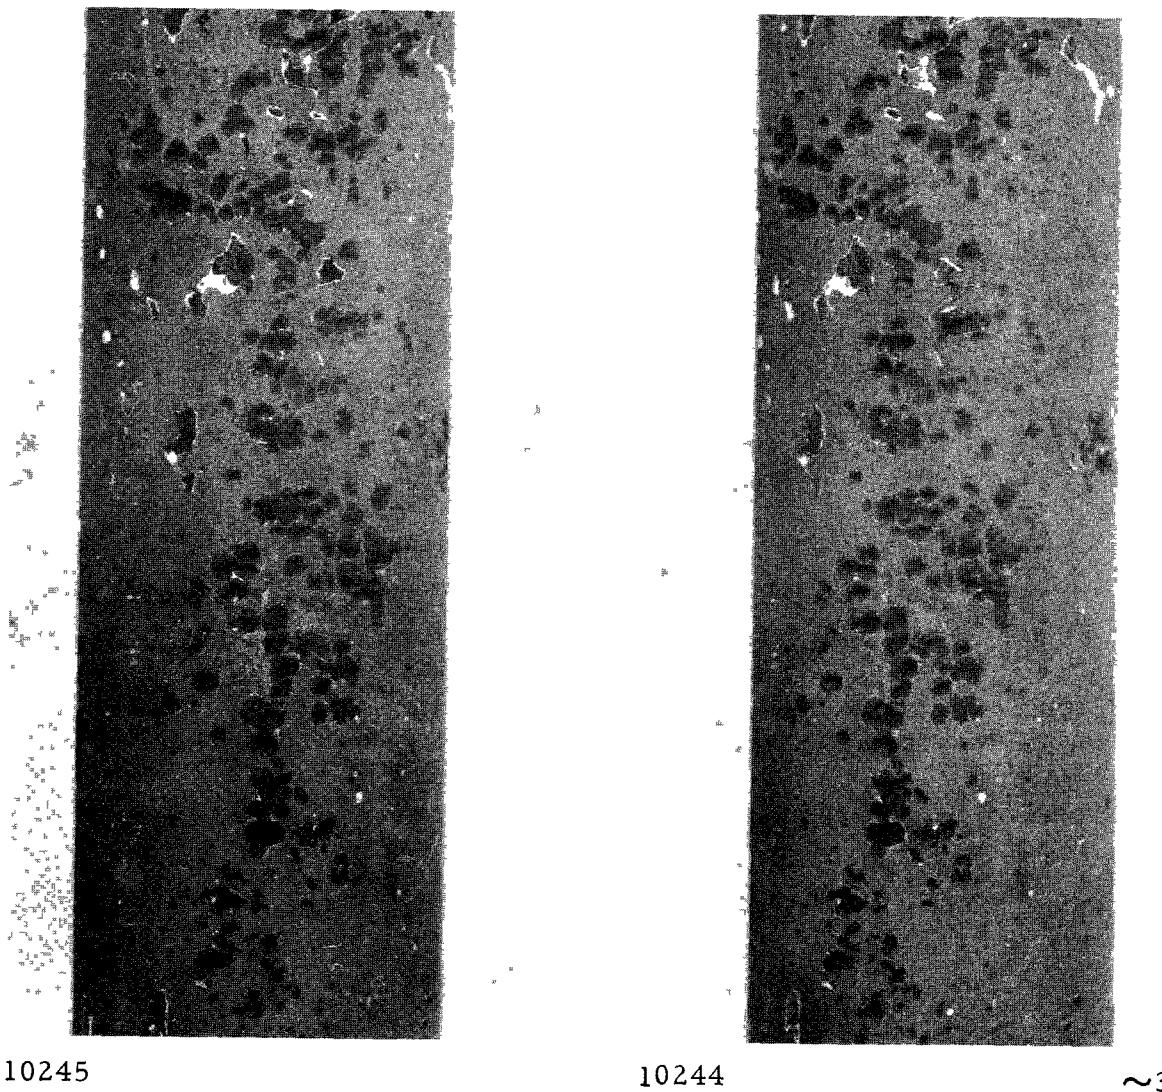
The core of the ruptured slug was next pickled in 50% aqueous nitric acid for a total of ten minutes. The silver plating and raised bumps were attacked and removed quite rapidly, leaving a matte metallic surface in which pits occupied the positions of all the bumps. Pickling was stopped before the reaction went to an end. Figure 4 shows the appearance of the slug after it was washed and dried. The stereo permits seeing in three dimensions the pits and residual nonmetallic gray material contained by them. A cross section through one of the pits is seen in Figure 7. The grain structure of the uranium is coarse and typical of gamma extruded

Figure 4. Stereomicrograph of the Core of Ruptured Slug 141 after Acid Pickling.

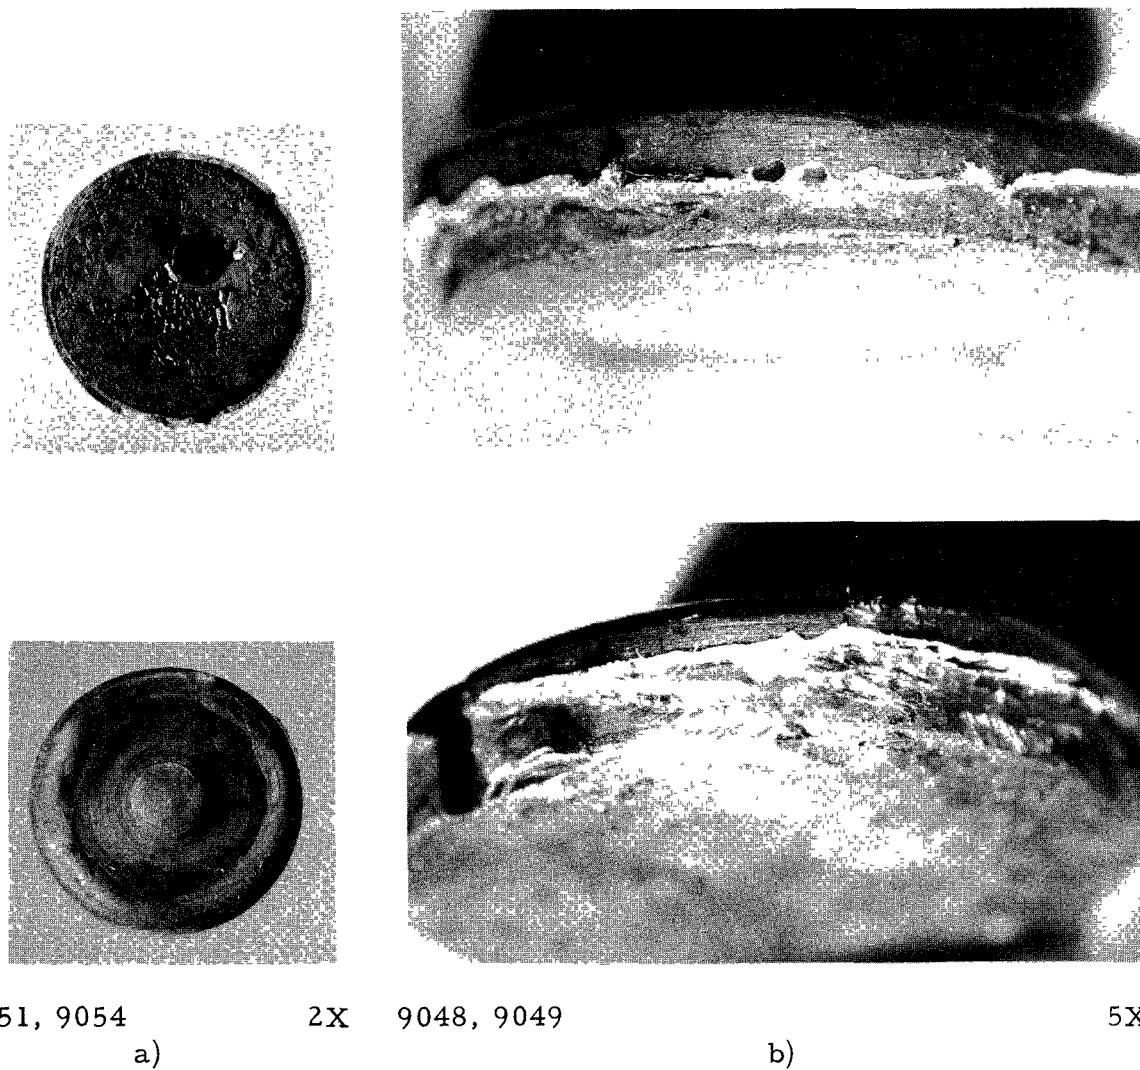
Steel in all cans and end plugs proved to be ferromagnetic. The appearance of the end cap removed from the ruptured slug is recorded in Figure 5. Its inner surface was covered with a coating of crud, some of it black and vitreous, and some similar to that on the filler plug. The glassy black material proved to be insoluble in aqua regia, and analysis indicated that it contained appreciable amounts of barium and manganese.

Figure 5. Views of End Cap from Ruptured Slug 141. a) As removed from slug, showing inner vitreous deposit, and small blowhole in outer weld. b) After peeling can back to weld line, showing blowholes and "flakes" along same.

The welded closure of the end (Figure 5-a) seemed visually sound, except for a hint of a surface pit where the arc had been struck. However, it was prepared for further study by carefully peeling back the small ring of attached can material so that the line of fusion all around the end cap could be examined more critically for points of leakage. Two blowholes were found adjacent to each other; one of these extended through the thickness of the can (0.020 in.) and had apparently formed a leak from outside to inside. The inner surface of the hole was discolored (Figure 5-b) and the discoloration continued inside along the side of the end plug toward the uranium. Several flakes in the weld were also observed, one of which (Figure 5-b) was discolored in such a way as to suggest leakage.

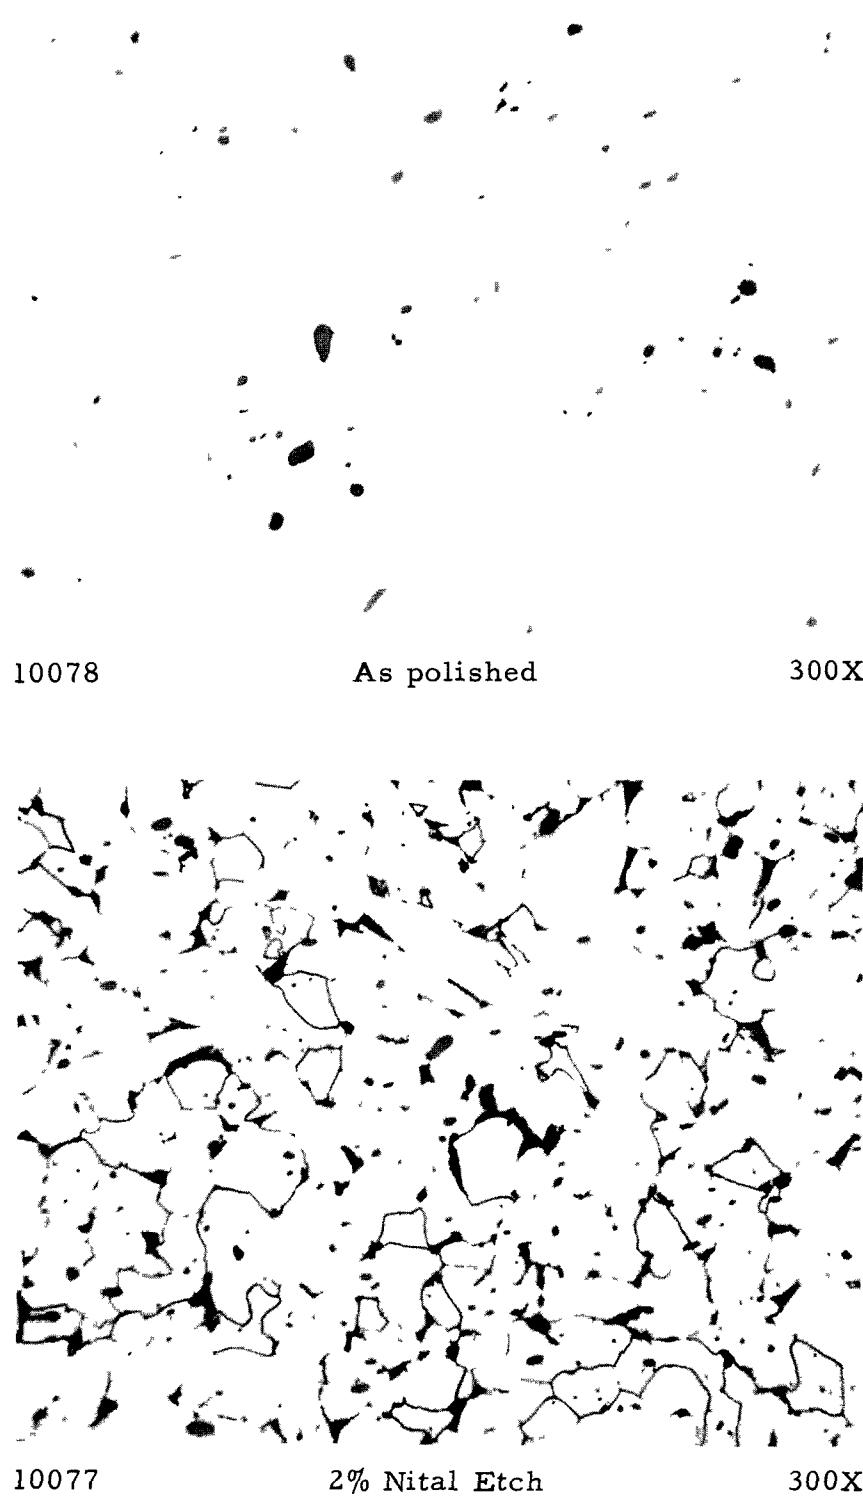
Examination of the steel can in the vicinity of the rupture showed a brittle type of fracture in this material. It was impossible to flatten out a cut section of the jacket without breaking it along the rolling direction. Hardness of the material was Rockwell 15T 88.8 to 89.9 (R_B 86-90 converted), which is considerably higher than would be expected in annealed mild steel. However, metallography confirmed its low carbon content (approximately 0.20%), as may be seen in the etched structure (Figure 6). The presence of many manganese sulphide inclusions in the structure labeled it as free-machining steel, and an analyzed sulphur content of 0.175% confirmed this point.

Figure 6. Photomicrographs of Steel Can from Ruptured Slug 141

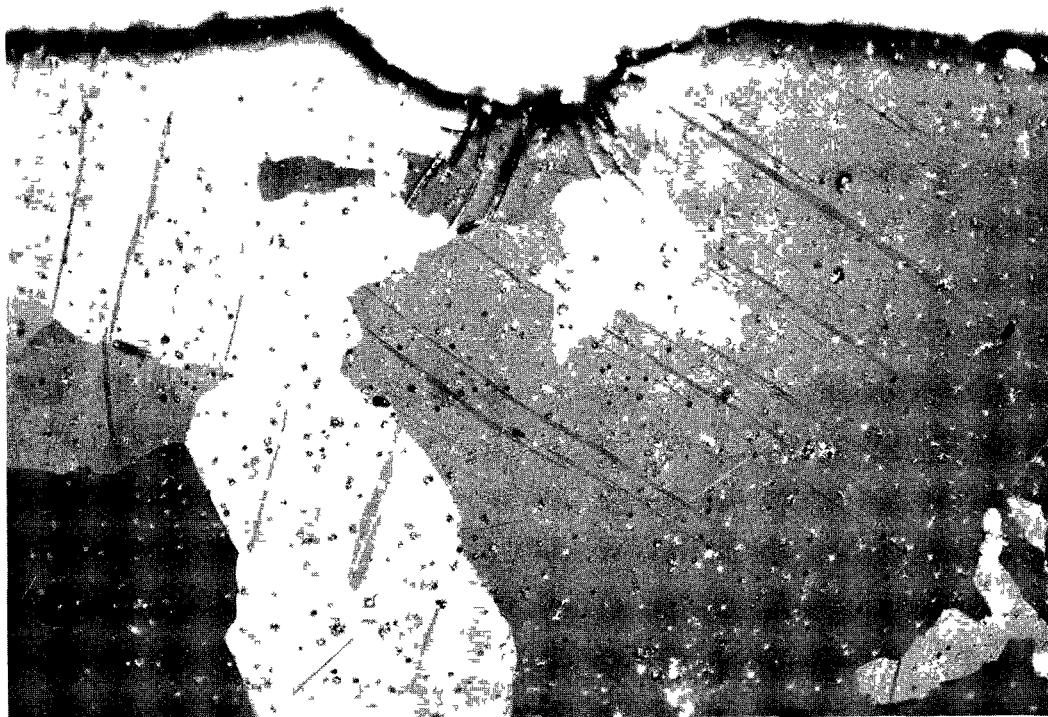
material. It is of interest to note that the corrosive attack which formed this pit was transgranular, with preferential action in certain definite directions in the grains.

Figure 7. Photomicrograph of Uranium Core of Ruptured Slug 141, Showing Gamma-extruded Structure and a Surface Pit
