OAK RIDGE NATIONAL LABORATORY

DATE: June 3, 1958

SUBJECT: Metallographic Examination of Components and
Coupons from HRP In-Pile Loop L-2-19

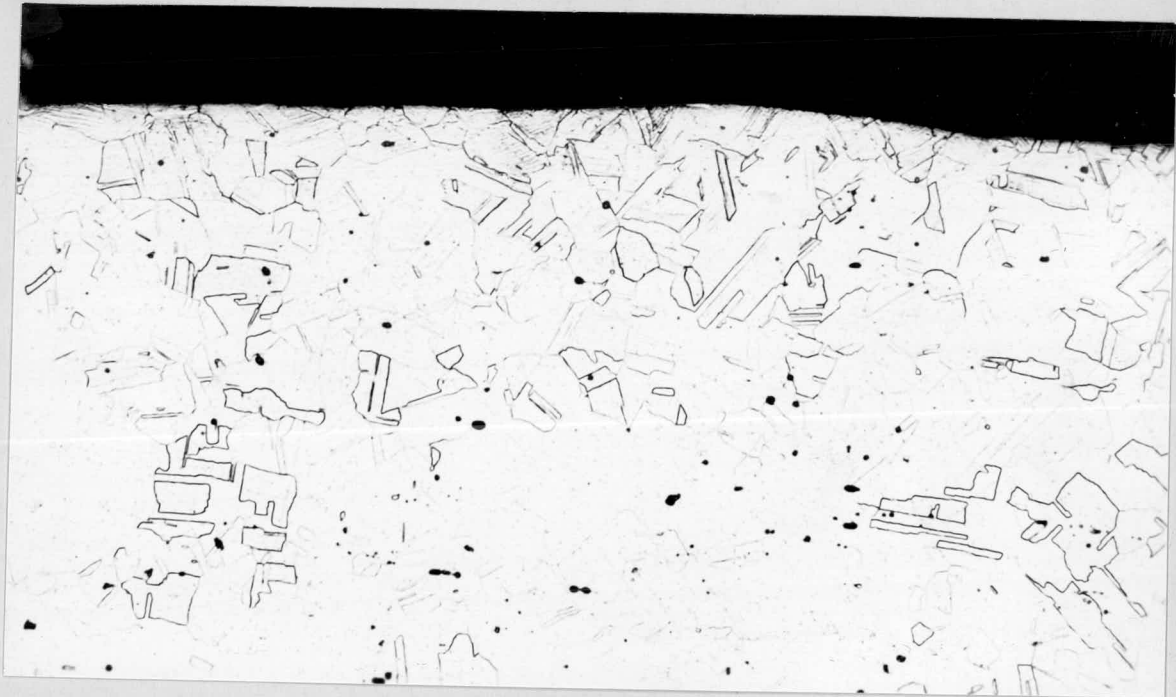
Fig. 1
Core Cap

Examination of a section from the nose of the core cap revealed no evidence of corrosive attack (Fig. 1).

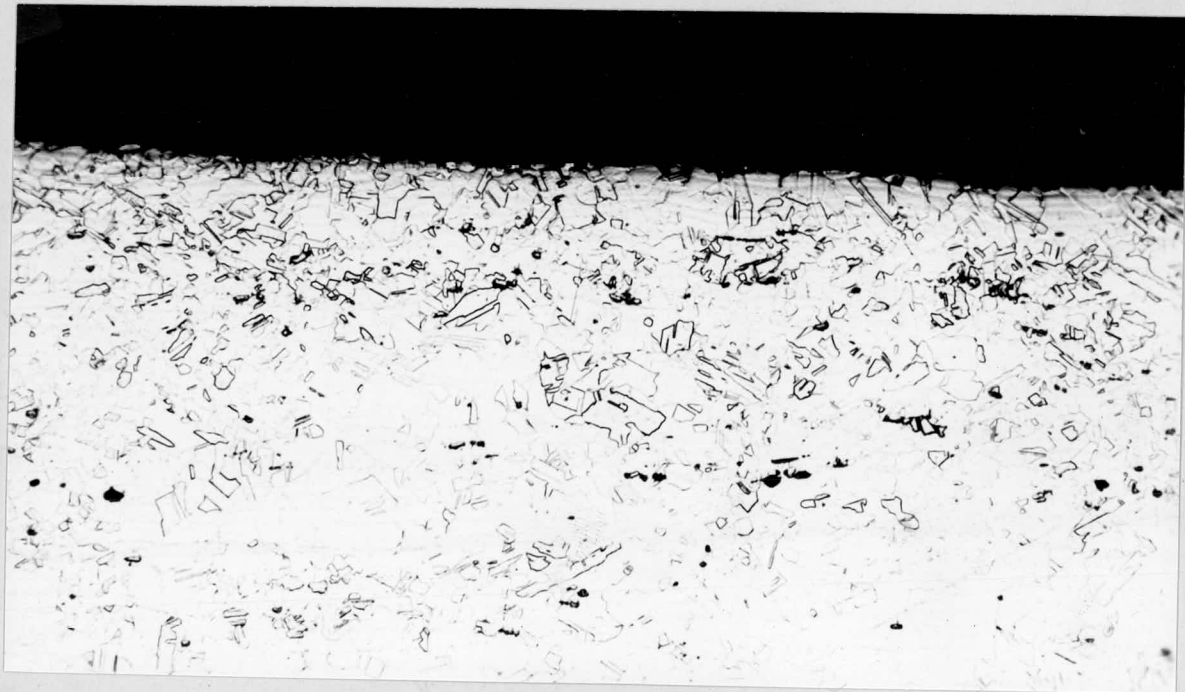
Fig. 2
Pressurizer - Liquid Phase

The surfaces of sections from the loop pressurizer body showed slight general corrosive attack at the grain boundaries on areas exposed to the vapor phase of the fuel solution (Fig. 2). Sections exposed to the fuel solution proper showed only slight general surface roughening (Fig. 3). Of particular interest is the absence of surface scale on sections from the vapor phase of the pressurizer and the peculiar "needlelike" oxide on surfaces below the liquid level.

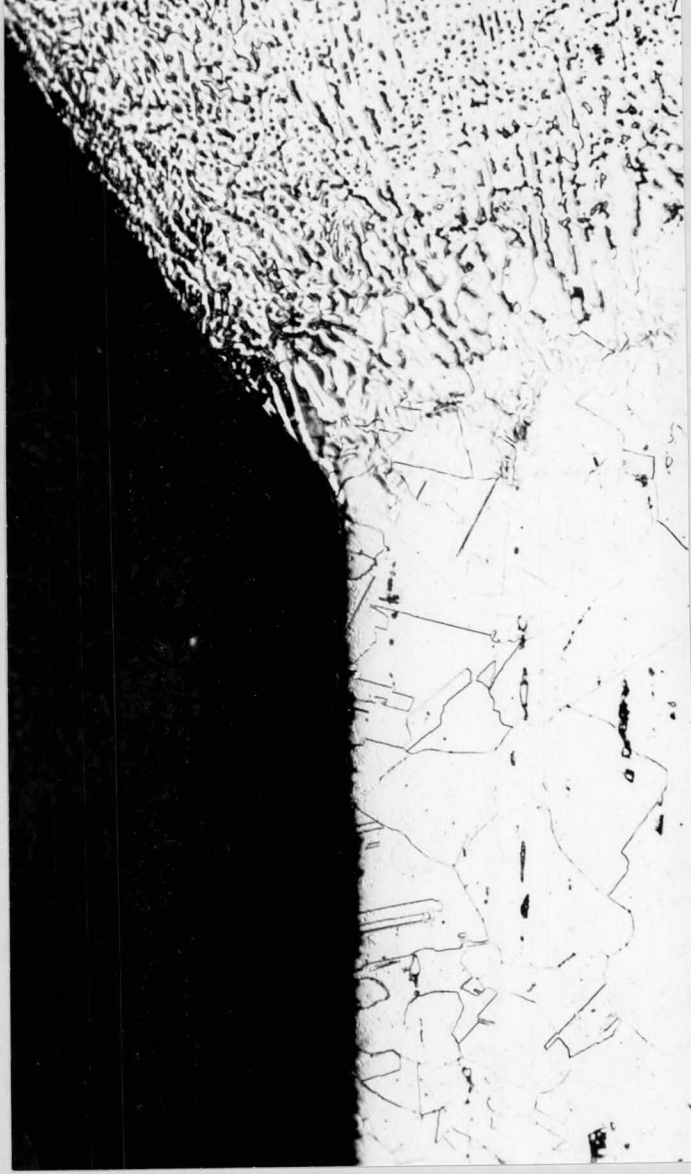
Fig. 4
Pump Outlet

A section of the loop piping at the pump outlet showed no evidence of corrosive attack or oxide scale formation (Fig. 4).

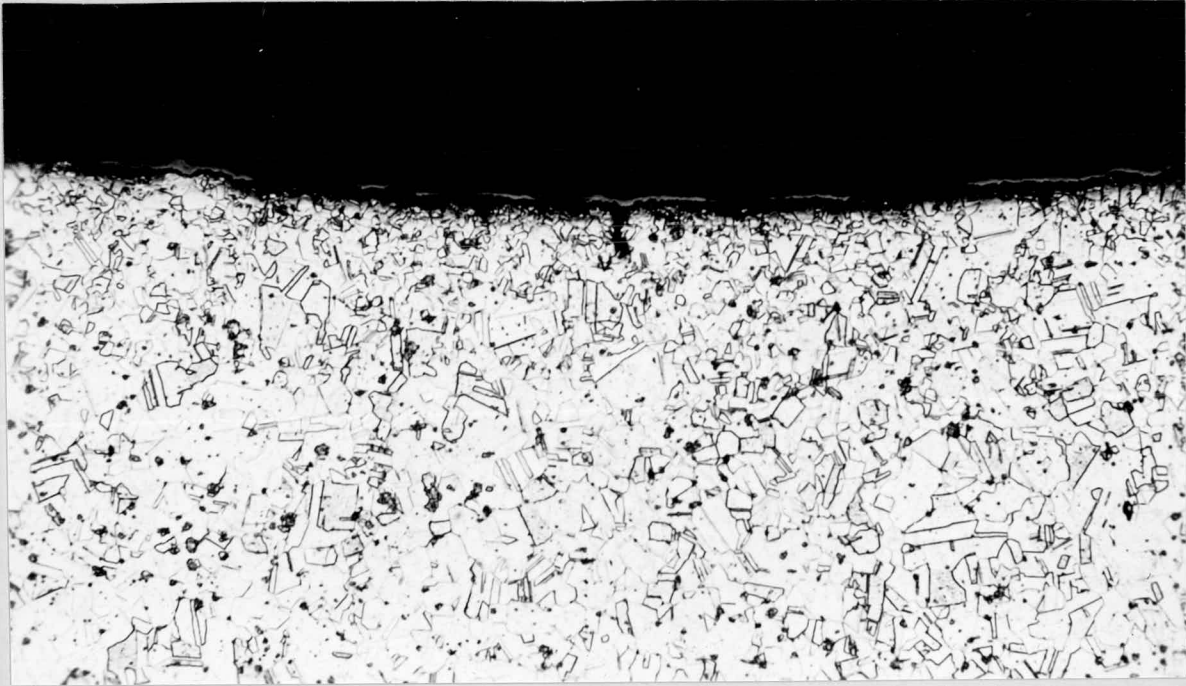
Fig. 5
Pressurizer Heater Line

Sections from the pressurizer heater lines showed evidence of radial cracking such as noted in previous loops. A thin oxide scale formation on all interior surfaces with only slight general surface roughening was noted (Fig. 5).

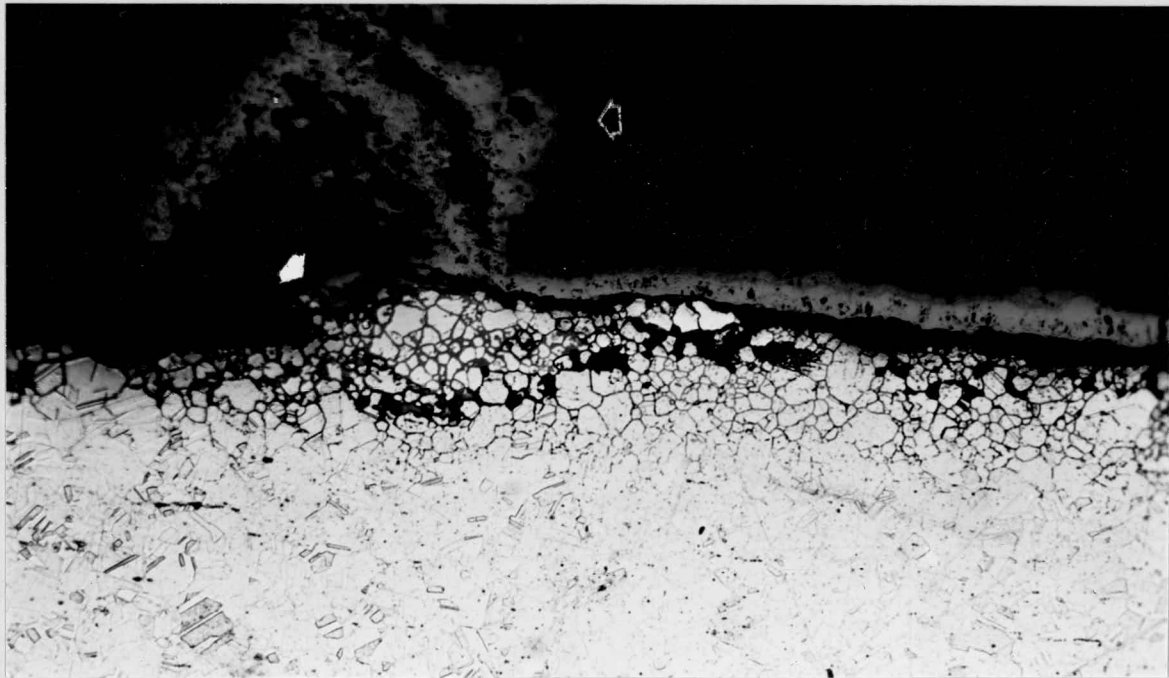
Fig. 6
Sampler Line Capillary Tubing

Sections from the sampler line capillary tubing showed rather severe intergranular attack to a depth of 3-4 mils in the region within 1/4" of the pump outlet piping junction (Fig. 6). The interior surface of the capillary tubing was covered with a heavy (1 - 1-1/2 mil) oxide scale. The line itself appeared to be plugged by an oxide "wall" in the region of heaviest intergranular attack. The oxide "plug" is shown by the "open" arrow and an area showing a peculiar intergranular oxide formation of the capillary tubing material is indicated by the solid arrow. Sections slightly (<1/8") beyond this oxide "plug" showed only slight general surface

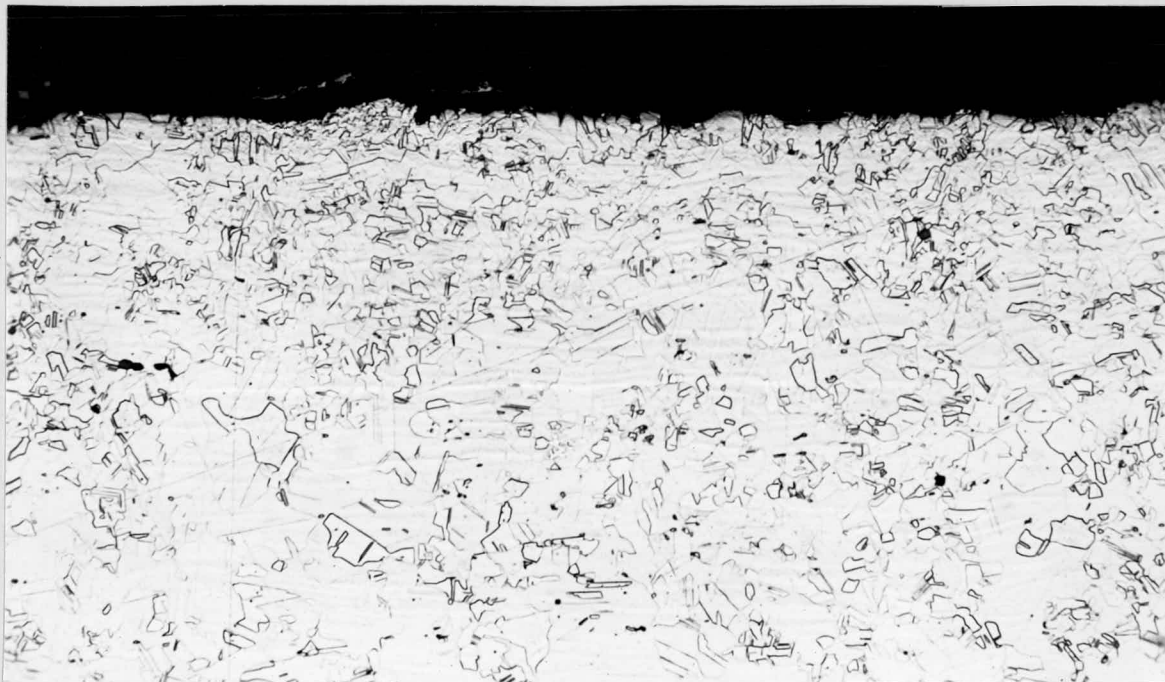
Fig. 7
Sampler Line Capillary Tubing

roughening (Fig. 7). Large spherical oxide deposits were also found inside the tubing (Fig. 8). It will be noted that they appear to consist of a lighter-colored, porous inner sphere coated with a darker, more dense outer scale.

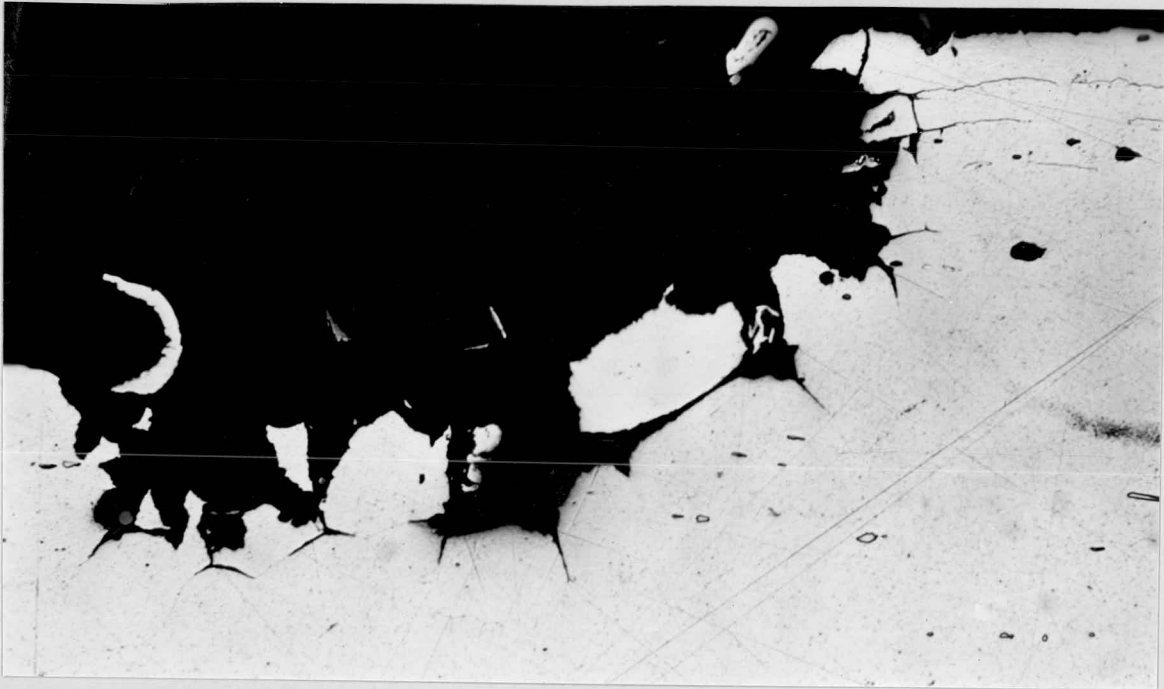
Fig. 9
Impeller Shaft

Sections from both the impeller shaft and the thermal barrier showed heavy corrosive attack in a rather restricted region. Maximum depth of attack noted on the impeller shaft is estimated at 12 mils, and occurred in an abrupt manner toward one end of the shaft (Fig. 9). Sections from the thermal barrier also showed a similar type of attack in the most heavily corroded region (Fig. 10); however, the transition region between this area and areas showing no attack was characterized by a pitting type of attack such as shown in Fig. 11.

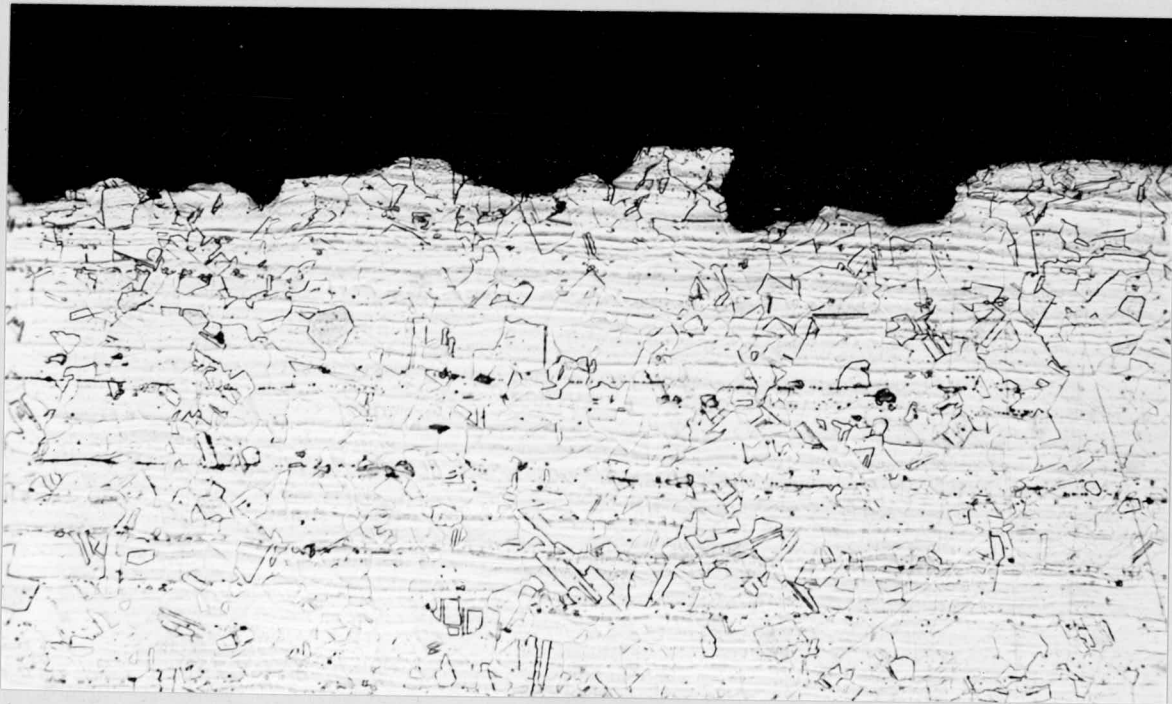
Fig. 12
Coupon SA-1607

As would be expected from the weight loss data, corrosive attack on the 347 S. S. coupons varied from a heavy pitting type of attack on coupon SA-1607 (Fig. 12) to only slight general surface roughening on coupon SA-1620 (Fig. 13).

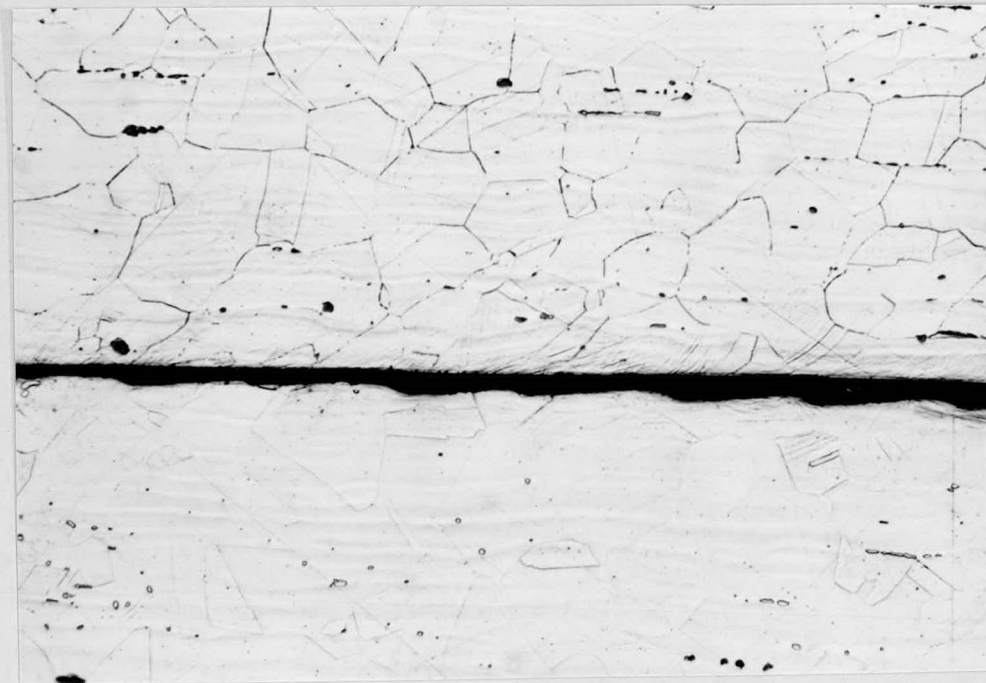
Fig. 14
Coupons SMS-1 and SMA-4

Examination of the 304L S.S. coupons revealed no evidence of localized attack for either the annealed or the sensitized specimens. The typical appearance of two of these specimens is shown in Fig. 14.

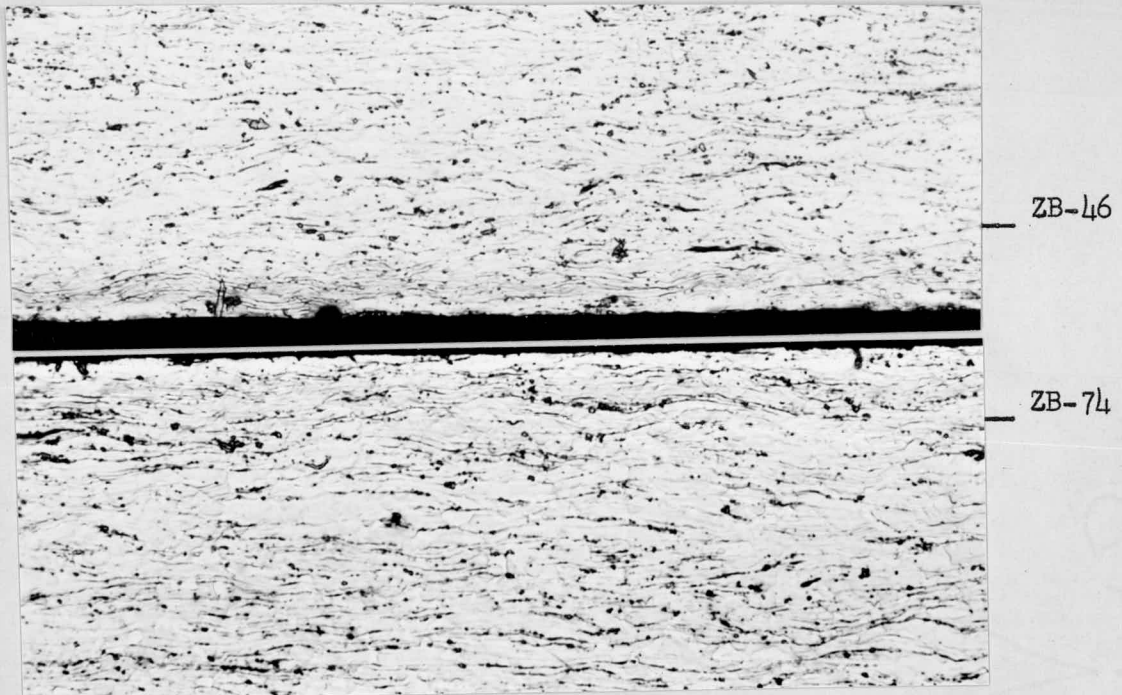
Fig. 15
Coupons ZB-46 and ZB-74

Coupons of the zircaloy-2 and zirconium types showed no evidence of localized attack. Typical examples of the surfaces of these coupons are shown in Figs. 15, 16, and 17.

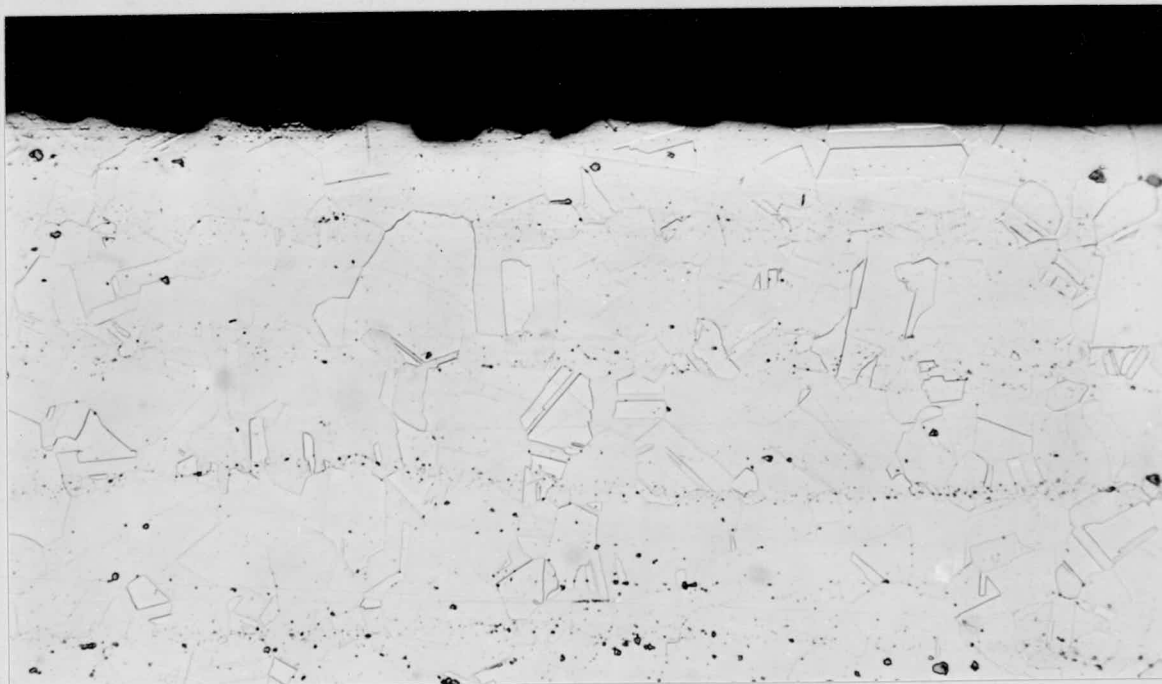
Fig. 18
Coupon LN-2

All surfaces of the Ti-110AT specimens were smooth and even with no evidence of corrosive attack. The submitted incoloy specimen showed slight general corrosive attack near the center of the coupon (Fig. 18).

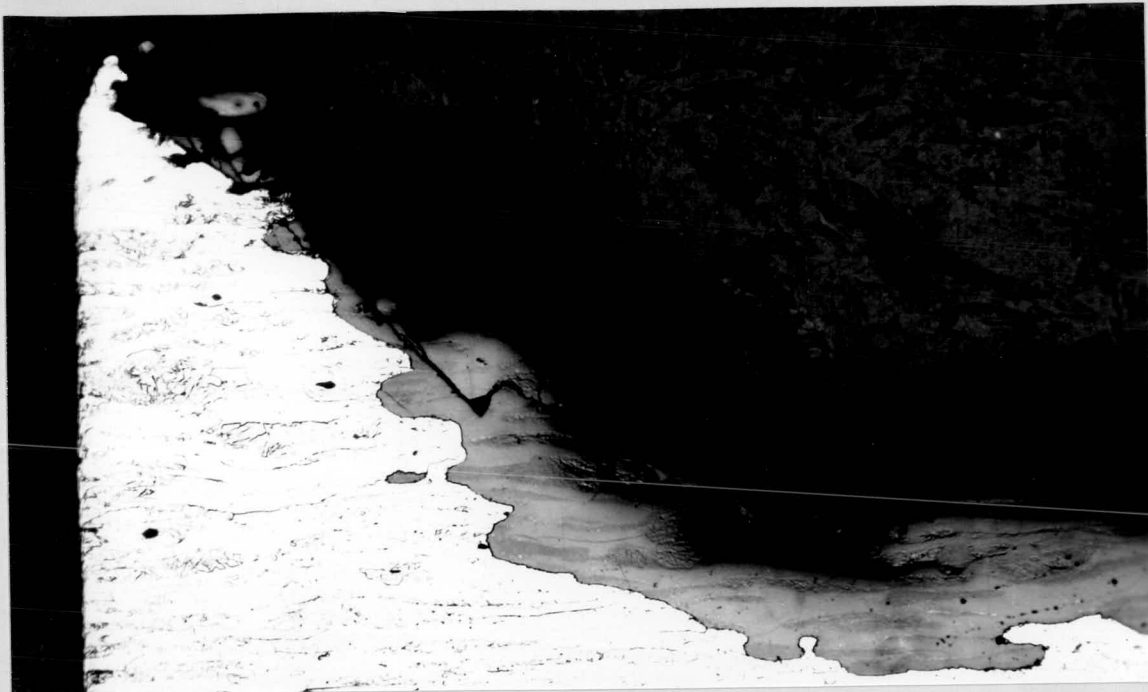
Fig. 19
Stress Specimen SL-20 (End)

All 430L S.S. stress corrosion specimens exhibited severe localized corrosive attack at both ends and beneath the fulcrum of the specimen. A typical example of this attack is shown in Fig. 19, at the end of specimen SL-20. Maximum depth of attack was 13 mils and was characterized by a heavy scale formation on all corroded areas. Attack at the fulcrum of the specimens was of a similar nature but much less intense (2 mils maximum). Strangely, the compression face opposite the heavily corroded ends of the specimen also showed a similar, but less intense, type of corrosive attack. This was not true of the tension face opposite the fulcrum or at the exposed ends of the specimen. Except for these areas of localized attack, the remaining surfaces of the coupons were smooth and even with no evidence of corrosive attack (Fig. 20).

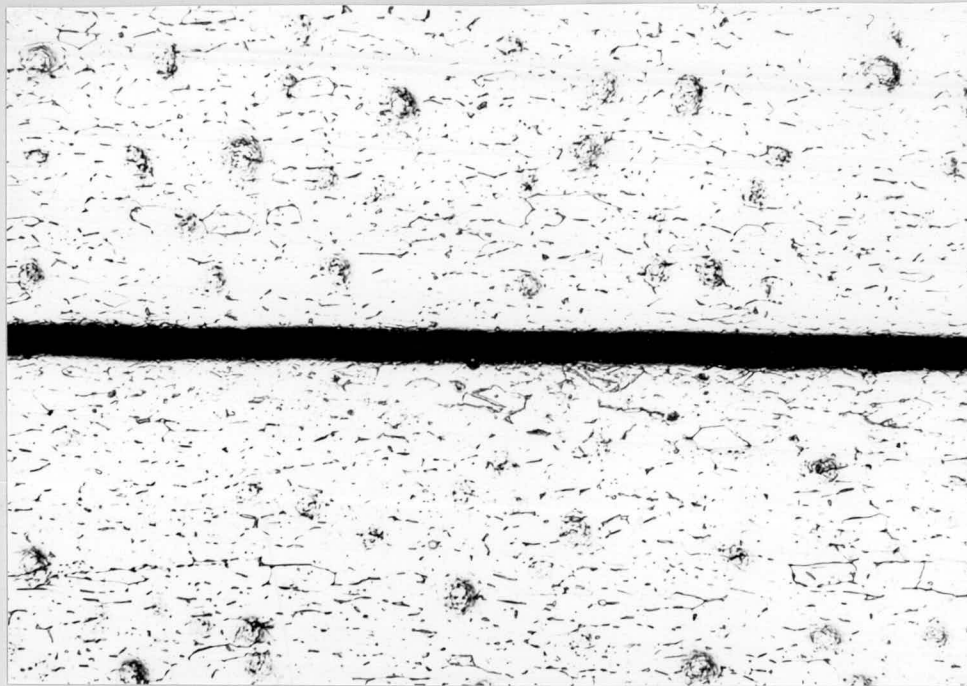
Fig. 21
Typical Ti-110AT Stress Specimen

All surfaces of the Ti-110AT stress corrosion specimens were smooth and even, showing no evidence of corrosive attack (Fig. 21).

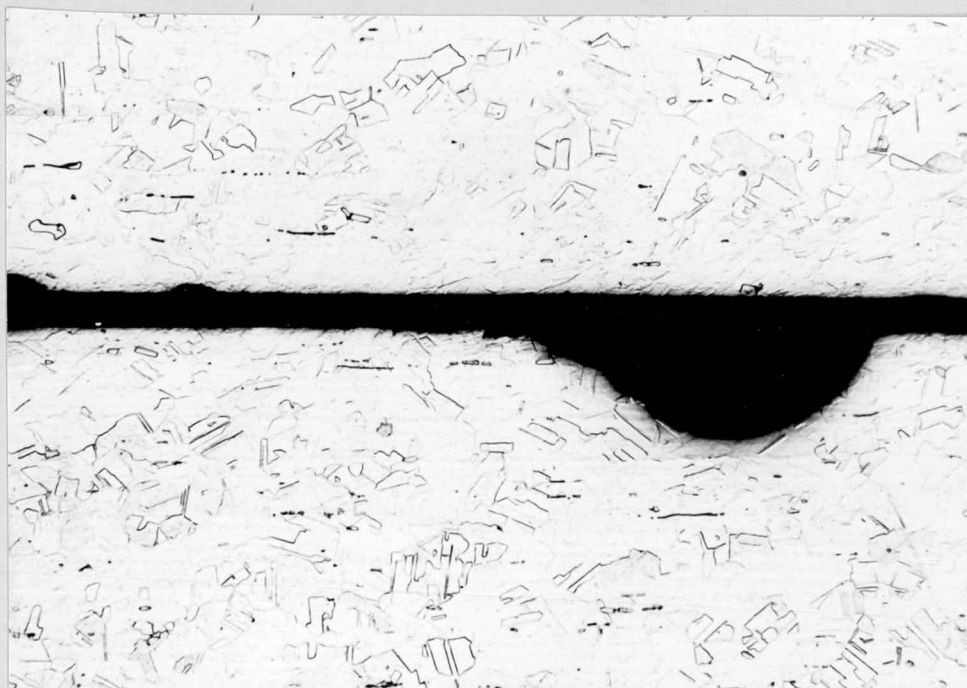
Fig. 22
Coupons SS-111 and SS-115

Corrosion coupons from the in-pile autoclave L53Z-111 showed long "canal-like" pits, however, metallographic examination of these specimens revealed no abnormal structure which could account for such a type of attack.

Coupon No.	Mat'l	Wt. Loss	Thickness - In.			Surface Appearance
			End	Center	End	
SS-111	347 S.S.	8.2	.062	.061	.062	Numerous canal like pits approximately 1/2 mil deep.
SS-113	"	8.6	.059	.058	.058	Numerous canal like pits approximately 3 mils deep.
SS-115	"	5.0	.061	.061	.060	No evidence of attack.
