OAK RIDGE NATIONAL LABORATORY

SUBJECT: Metallographic Examination of Components
and Coupons from HRP In-Pile Loop L-2-17 - Part I

Intra-Laboratory Correspondence
OAK RIDGE NATIONAL LABORATORY
Solid State Division

Metallographic examination of representative components and coupons from HRP in-pile loop L-2-17 has been requested. This loop operated for a total of 1136.8 hours at 300°C in beam hole HB-2 of the LITR. A complete report of fabrication, operation, and post-irradiation observations will be issued in the near future.

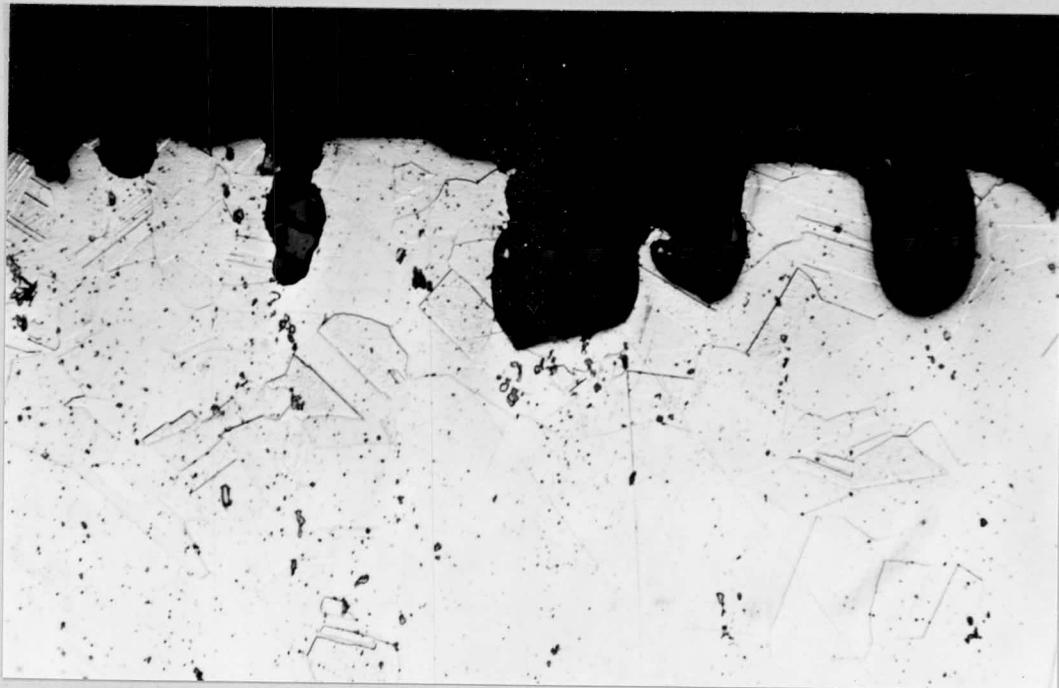
Fig. 1
Core Cap

Examination of sections from the core cap revealed severe pitting attack to a depth of over $\frac{1}{4}$ mils at the nose of the cap (Fig. 1). Both depth and frequency of attack was significantly less ($1\frac{1}{2}$ mil) near the core-cap to body weld (Fig. 2).

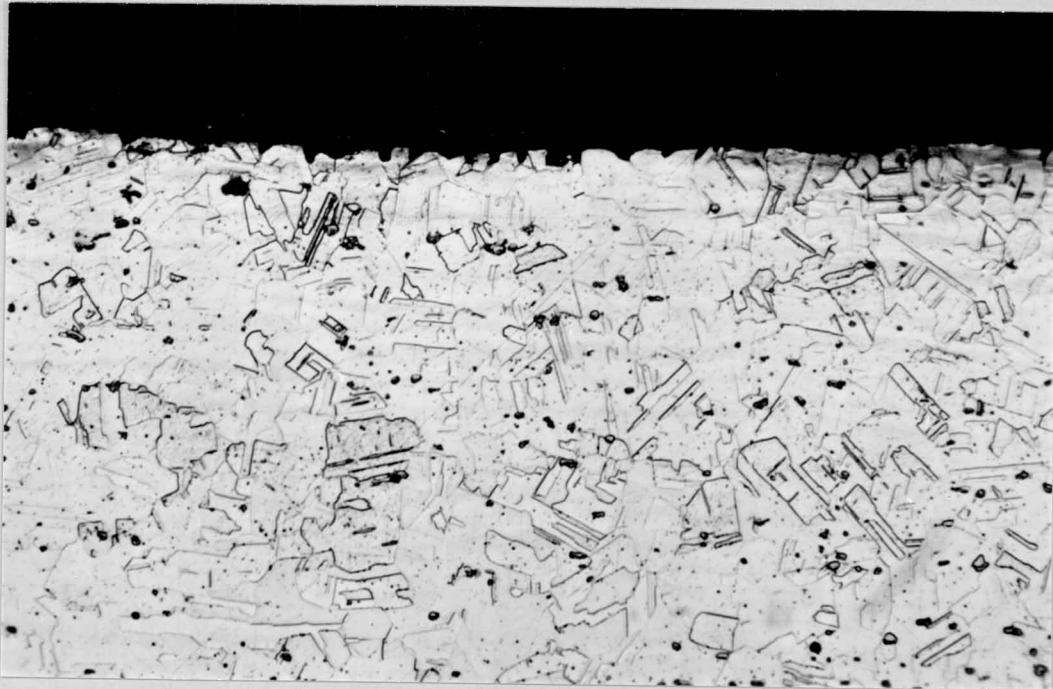
Fig. 3
Pressurizer-Vapor Phase

Corrosive attack upon sections from the pressurizer was similar to that noted in previous loops. Slight corrosive penetration was evident on sections exposed to the vapor phase of the fuel solution (Fig. 3) while areas below the fuel solution level showed only slight evidence of surface roughening (Fig. 4).

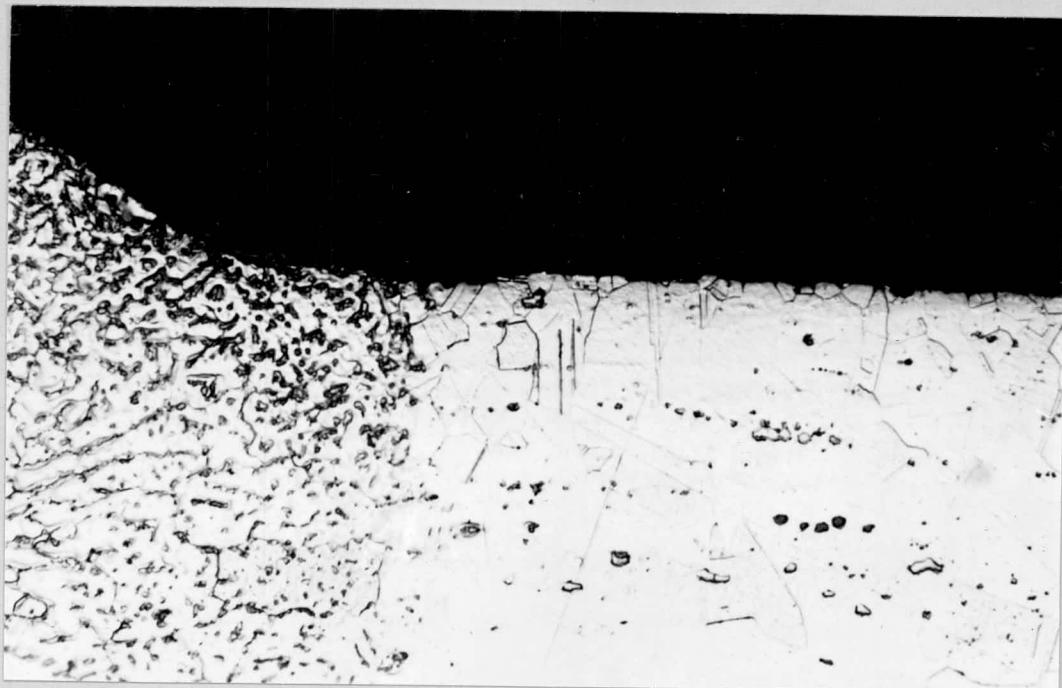
Fig. 5
Pump Outlet Piping

A section from the loop piping at the pump outlet showed slight corrosive penetration at the grain boundaries (Fig. 5) with some evidence of a $\frac{1}{4}$ mil scale on the base metal surface.

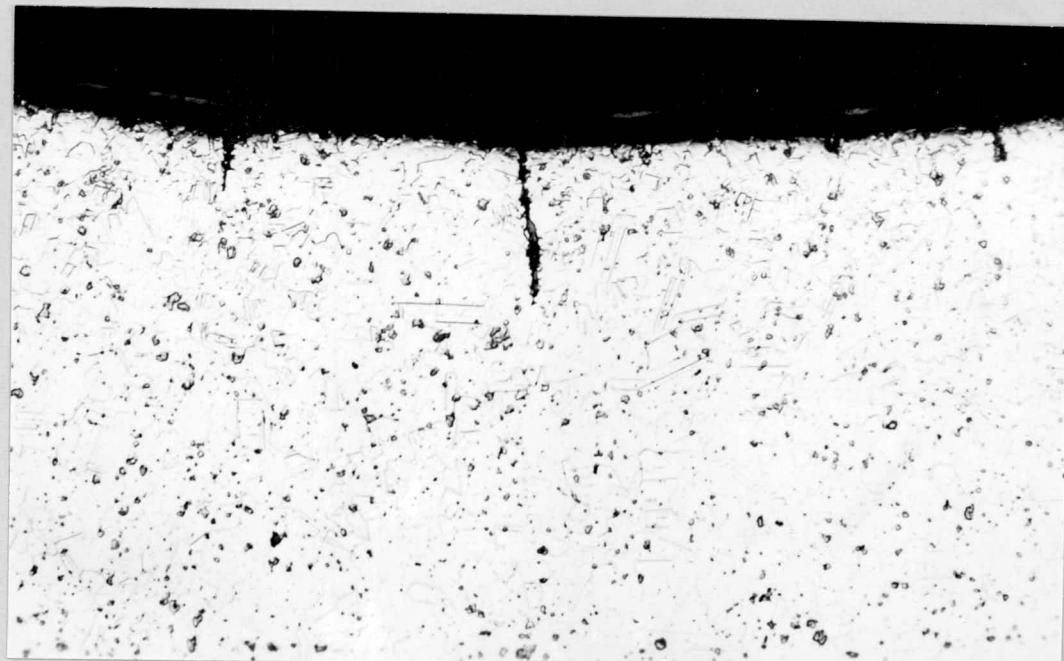
Fig. 6
Typical Pressurizer Heater Line

All sections from the pressurizer heater lines revealed evidence of numerous transgranular cracks extending radially from the interior surface to a maximum depth of $3\frac{1}{2}$ mils (Fig. 6). The frequency and uniformity of this cracking was such that it appears to be a fabrication fault rather than stress-corrosion attack. The interior surface of the tubing was covered with a $\frac{1}{4}$ mil scale with occasional globules of oxide increasing the thickness of scale to $3\frac{1}{4}$ mils. No evidence of corrosive attack was noted.

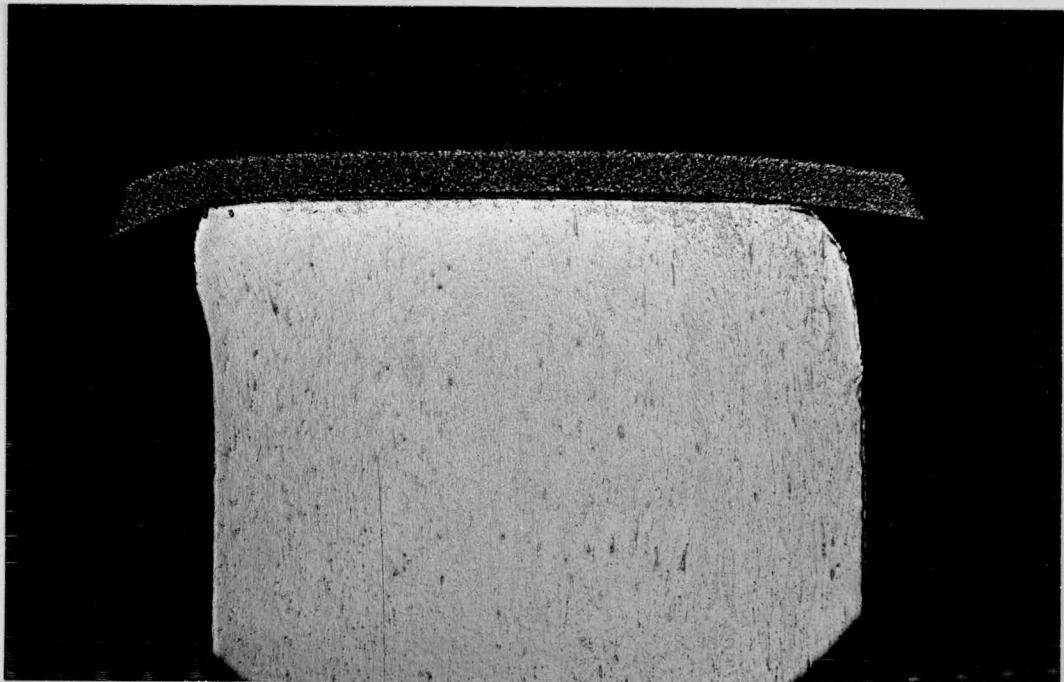
Fig. 7
Coupon ZB-119

Examination of the Zircaloy-2 coupons revealed that all the submitted specimens exhibited rather badly deformed edges. A typical example is shown in Fig. 7. This deformation might easily be mistaken for a channeling effect during visual examination but coupon thickness measurements in general do not indicate that channeling has occurred. The surfaces of the zircaloy coupons, with the exception of ZB-101, were smooth and even with

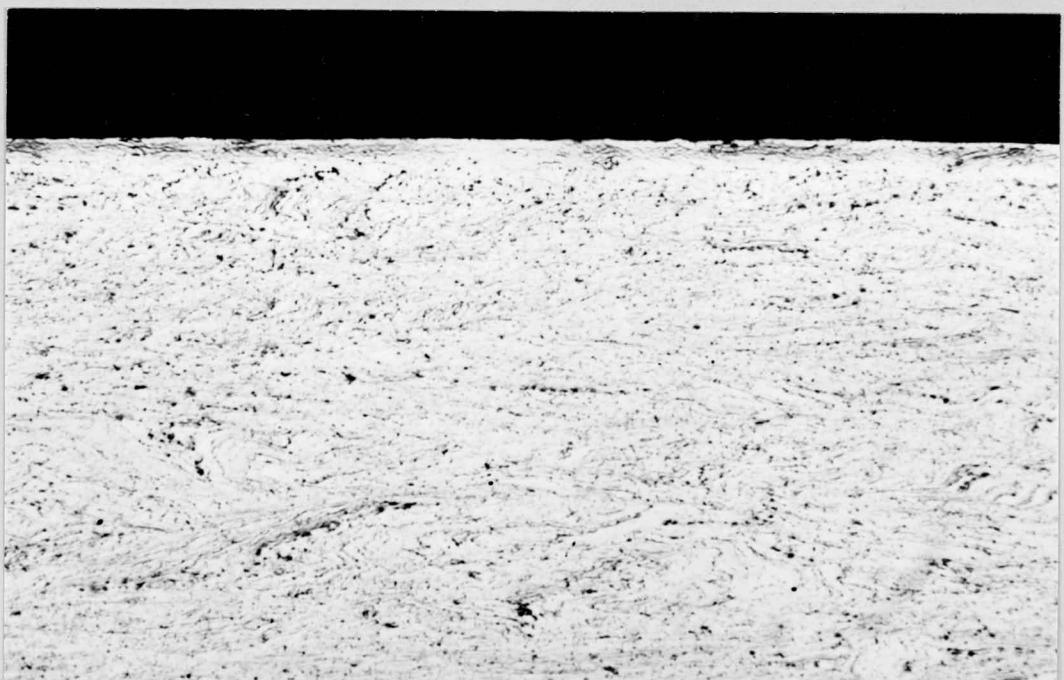
Fig. 8
Coupon ZB-106

no evidence of pitting. Figure 8, of coupon ZB-106, shows a typical appearance of the surfaces of these coupons. Coupon ZB-101, Fig. 9, showed a small area near one end of the coupon where the surface was very irregular, possibly indicating corrosive attack.

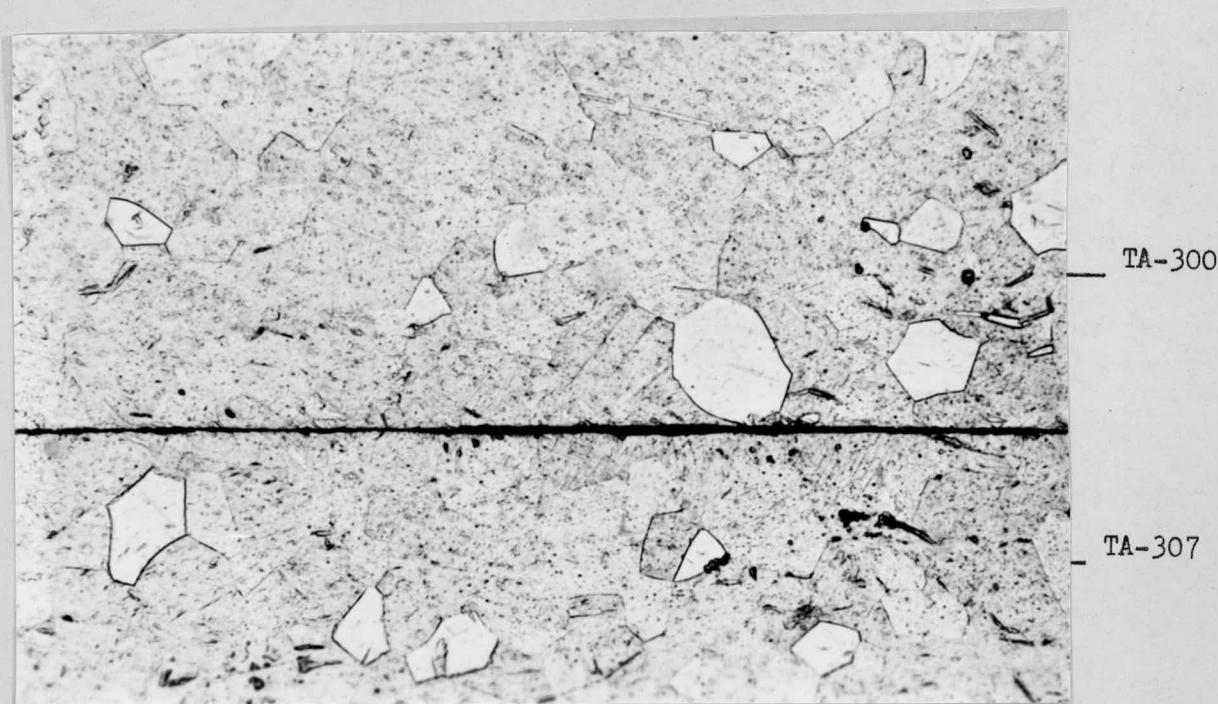
Fig. 10
Coupons TA-300 & TA-307

Surfaces of the Ti-55 and Ti-110 AT coupons were smooth and even showing no evidence of corrosive attack. Typical areas of the surfaces of these specimens are shown in Figs. 10 and 11. The surfaces of the titanium - 3% aluminum alloy coupons (Fig. 12) were very irregular although relatively smooth. Weight loss data indicates little or no corrosive attack on these specimens, thus the irregularities must be assumed to be a result of fabrication methods.

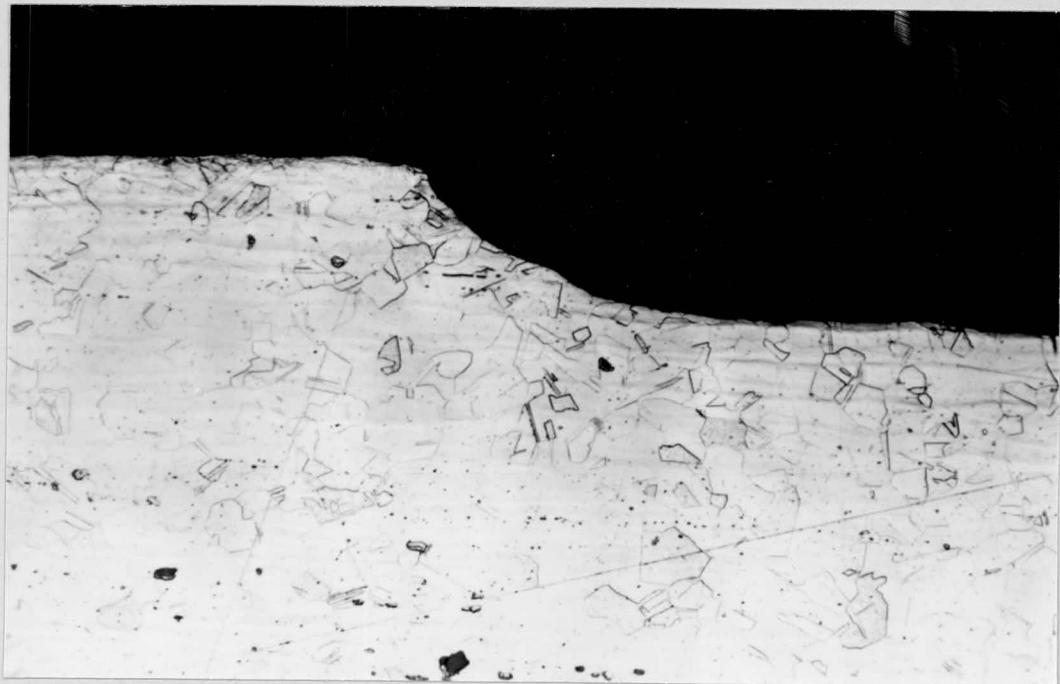
Fig. 13
Coupon SA-1506

As would be expected from the weight loss data, considerable variation in corrosive attack was noted in the examination of the 347 S.S. coupons. Coupons SA-1506, SA-1505, SA-1500 (from the core channel holder) showed corrosive attack either in the form of channeling and/or pitting (Fig. 13). The core annulus coupons generally showed evidence of a pitting type of attack (Fig. 14), while the pressurizer coupons showed only slight general surface roughening (Fig. 15).

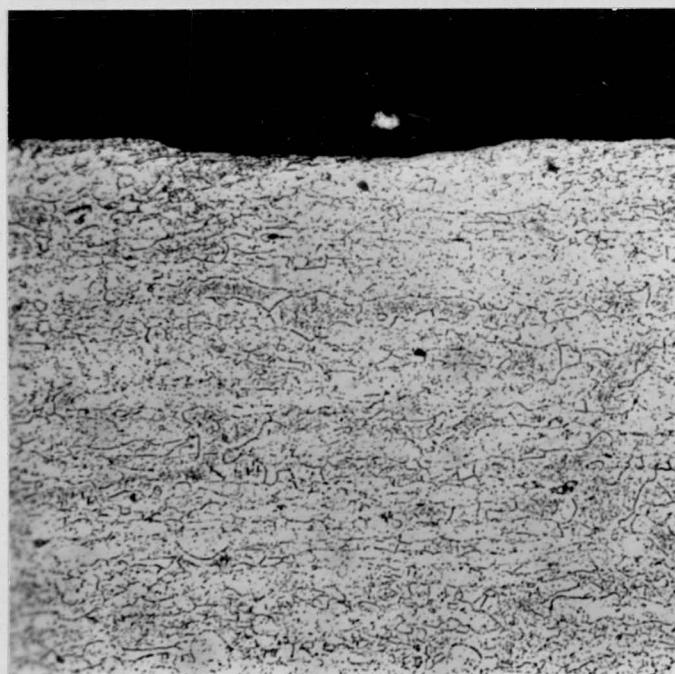
Fig. 16
Coupon SJ-1

The surfaces of coupons SJ-1, SJ-5 (430 S.S.); SL-2, and SL-6 (430 L S.S.) were slightly irregular as shown in Figs. 16 and 17, however no evidence of localized corrosive attack was noted. Surfaces of coupons SK-1 and SK-5 (431 S.S.) were smooth and even showing no evidence of corrosive attack (Fig. 18). Similarly, no evidence of corrosive attack was noted in the examination of the 17-4 PH S.S. coupons SH-1 and SH-4 (Fig. 19).
