KAPL-M-JLV-1

General Electric Company
KNOLLS ATOMIC POWER LABORATORY
Schenectady, New York

EXAMINATION OF LUMMUS CONDENSER TUBING

February 9, 1956

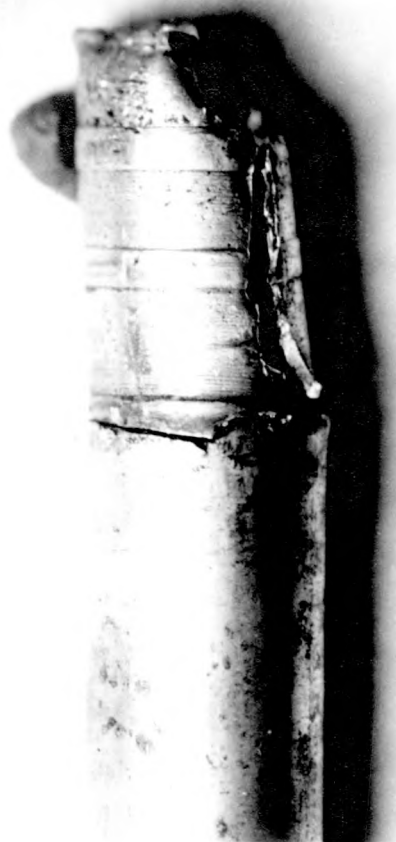
Tubes identified as #2, #3 and #4 cracked near the return water box tube sheet. Failure in tube #4 occurred circumferentially in the tube as shown in Figure 2. The short section of tubing, originally in the tube sheet, was distorted to facilitate removal. Figure 3 shows the circumferential fracture edge and secondary intergranular cracks. The grains near the cracks show many strain markings probably caused by severe cold working during expansion of the tube into the tube sheet. Figure 4 shows the tip of a longitudinal crack is preceded by an area differing in composition from the matrix. Annealing twins are present in the fine grained matrix which does not show strain markings.

Fig. 2. Condenser Tube #4. Right side expanded into tube sheet, circumferential ridges visible. Longitudinal crack and distortion caused during tube removal. Center - primary circumferential crack. Left side is tube section exposed to condensate environment. A small secondary longitudinal crack is visible 1/2" from bottom. 2 X

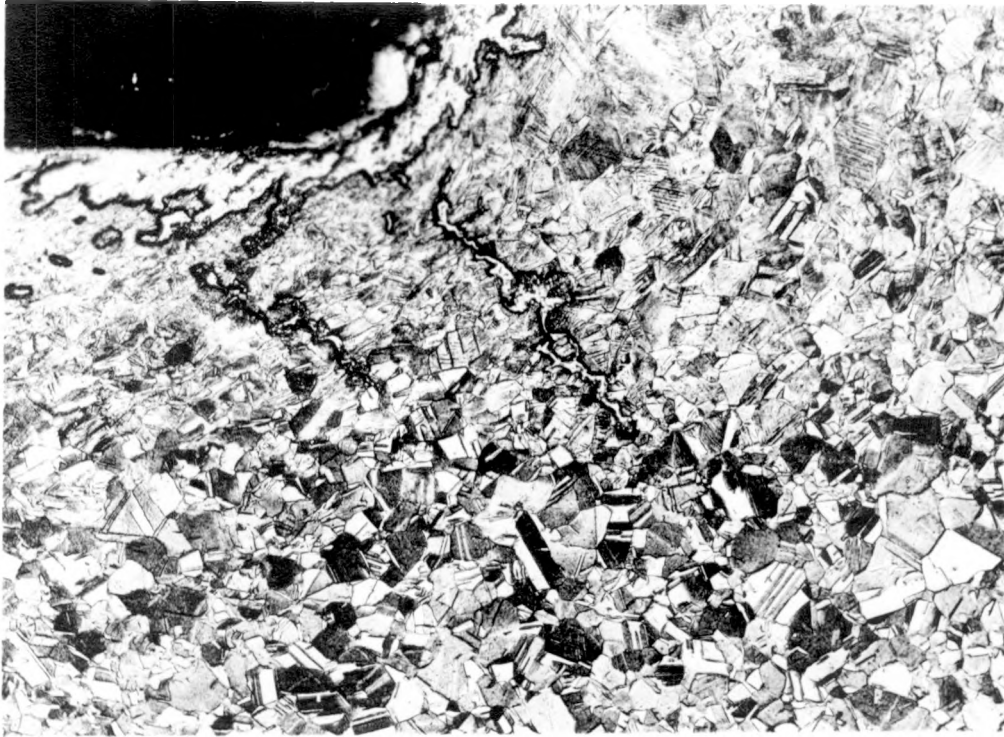
Fig. 3. Condenser Tube #4. Upper left corner is primary circumferential fracture. Cracks in upper left are longitudinal and intergranular. Strain markings are evident in grains near cracks showing effects of cold expansion into tube sheet. 250X

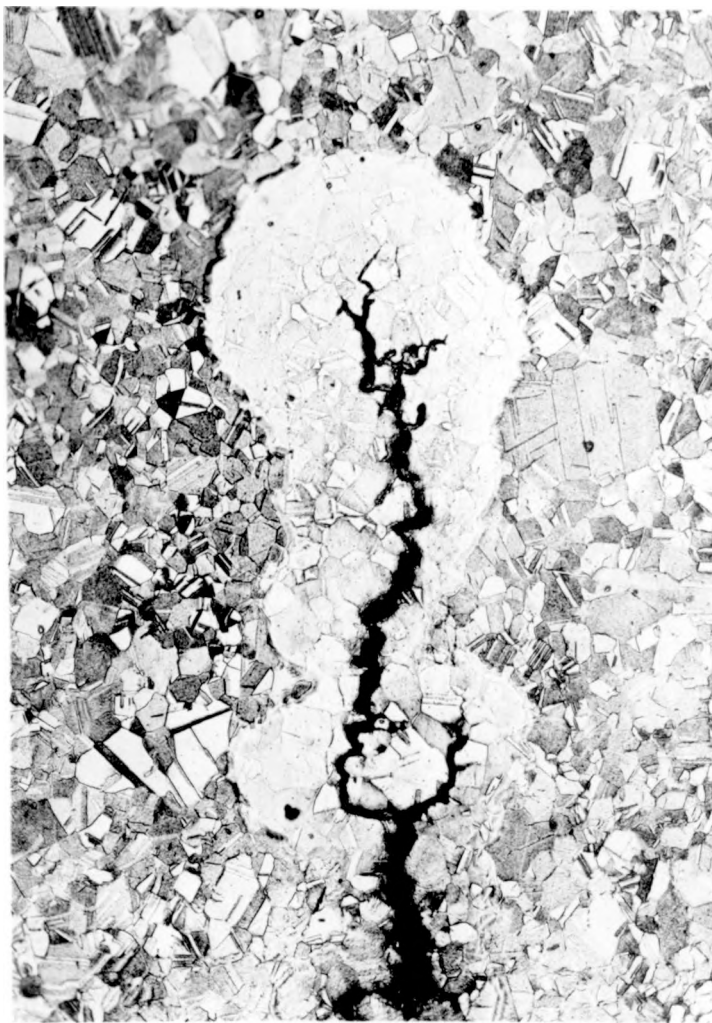
A tubular specimen taken 15" from the tube sheet was flattened to produce a maximum strain of 0.02", exposed to mercurous nitrate and cracked badly in four minutes. Figure 6 is a photomicrograph of this tube section. There is a marked resemblance of these cracks to those found in tube #1 and shown in Figure 4. A zone of amalgamation apparently is associated with the crack formation.

Fig. 4. Termination of longitudinal crack in tube #4 showing area of amalgamation around crack. 250X

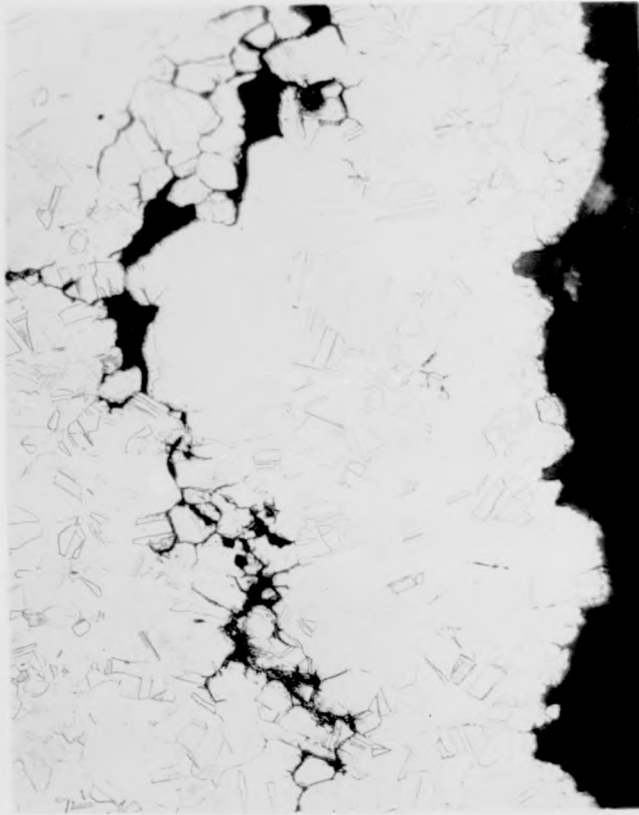
Tubes 2 and 3 show substantially the same type cracks as described for tube 4. The failure location in tube #1 differed from the other three since the leak occurred 26" from a tube sheet. The crack was circumferential and intergranular as were the others. There was very slight evidence of a composition change around the crack as shown in Figure 5.

Fig. 5. Tube #1 which failed 26" from tube sheet. Crack is intergranular. Slight evidence of amalgamation.

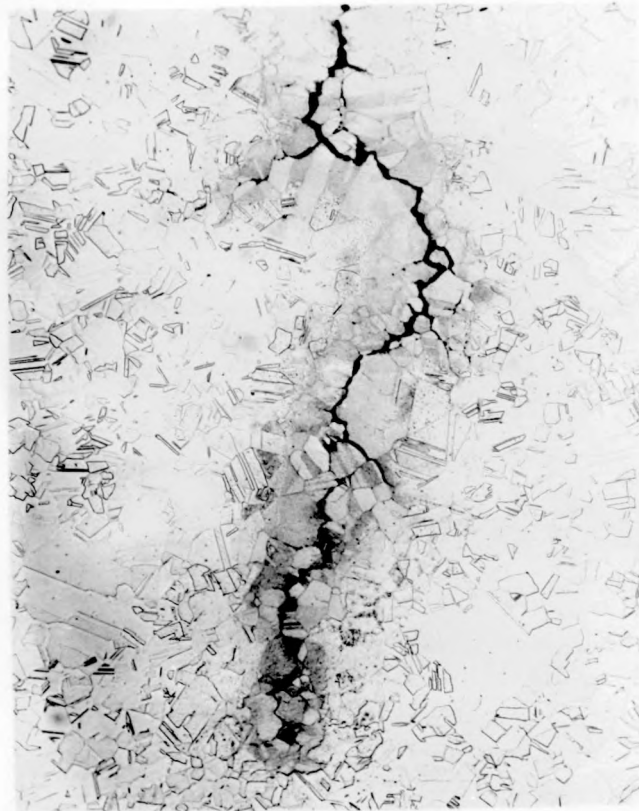
Fig. 6. Section of tube #1 flattened and cracked in mercurous nitrate.
