**Materials Design Considerations and Selection for a Large  
Rad Waste Incinerator (U)**

Westinghouse Savannah River Company

Savannah River Site

A document prepared for CORROSION 1997 at New Orleans, LA, USA from 3/9/97 - 3/14/97.

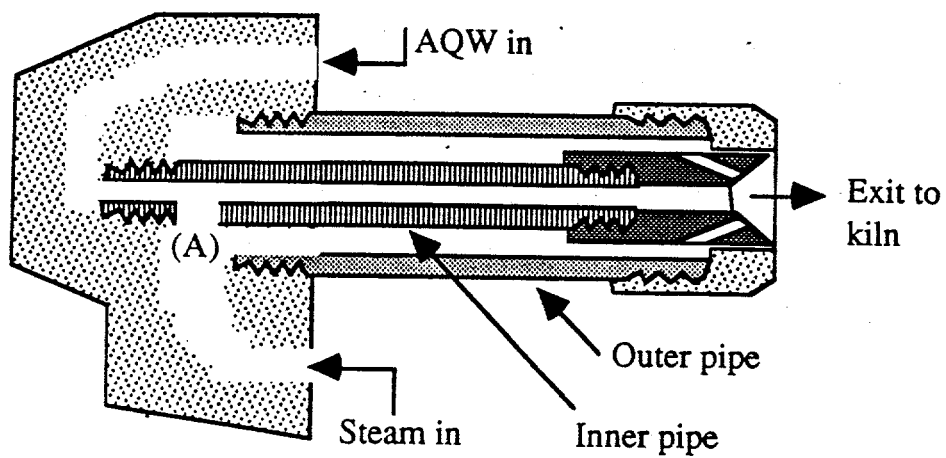
The injector gun at the kiln is constructed of a cast steel manifold, two concentric steel pipes, and a Type 303 stainless steel nozzle, Figure 3. The center pipe contains

Two kinds of failure were experienced at the injector during early trial runs. These were due to corrosion and steam erosion. Steam erosion occurred within the manifold as a consequence of wet steam and a 90° change in direction, Figure 4. In the figure, impingement was at position B on the OD of the inner pipe and a leak did occur. At the time of this failure, waste liquid pump pressure exceeded the steam pressure and acids were forced into the annular space, i.e. into the steam system. This led to corrosion in the condensate piping and failure at a nearby steam trap.

Figure 3. Injection gun arrangement. Location (A) identifies the area of steam impingement and location of the failure in the carbon steel pipe. Not to scale.

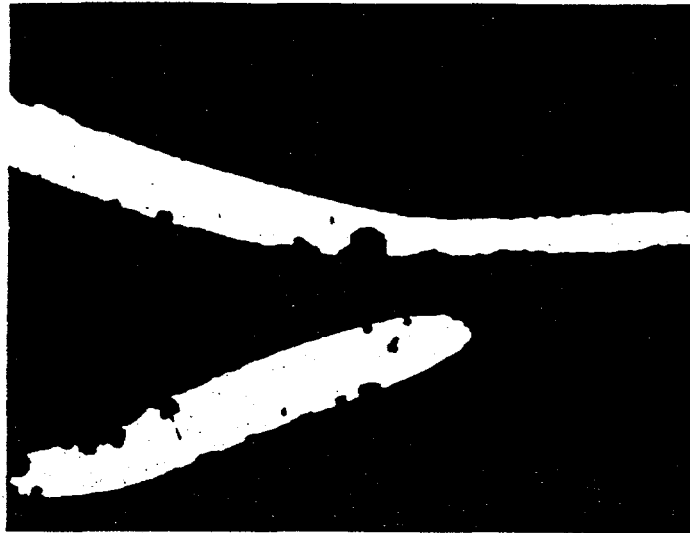
Pieces of the pre-filter wire were examined optically and in the scanning electron microscope. Wire lengths ranged from 0.32 to 5 cm (0.125 to 2 in.). Figure 6 shows an individual fiber with substantial pitting corrosion. Large round bottomed pits grew completely across the wire (Figure 7), or fracture occurred through the reduced cross sections. Deposits on the wire were primarily NaCl, KCl, and small quantities of iron oxide. The pitting is related to the high chloride environment.

Figure 6 Pitting corrosion in HEPA pre-filter wire. (0.1 mm wire, stainless steel)

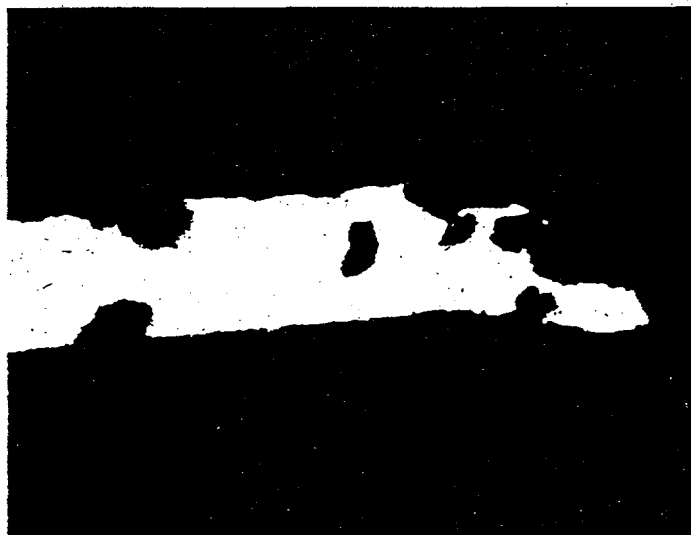
Figure 7 HEPA pre-filter wire. Note that corrosion pitting extends across the thickness of the stainless wire (0.1 mm).

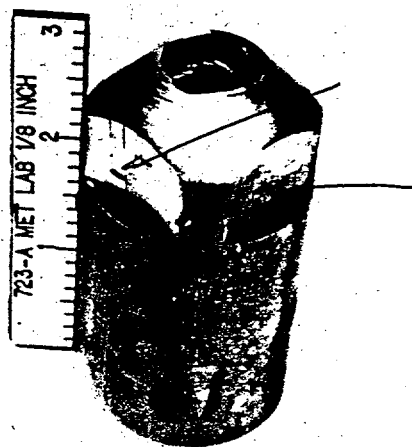
a.)

As previously mentioned, the quench tower contains several spray nozzles for reducing gas and quench liquid temperatures from 1095°C (2000°F) to less than 120°C (250°F). Several of these alloy C-276 nozzles were plugged with a black substance after the trial, and holes appeared on the outer surface of the nozzles. Sectioning revealed that severe erosion had taken place (Figure 10). There was no indication of stress corrosion cracking. Analysis of the black product by energy dispersive x-ray spectroscopy indicated high quantities of silicon and lesser amounts of potassium, calcium, chlorine and iron (Table 4). A limited amount of fly ash is contained in the recycled cooling water. Most of the elements can be accounted for based on the feed material. The iron is the result of corrosion in the system but silicon had to be part of the solid feed (clay absorbant) to the incinerator. High silicon values were also found in the blowdown system.

Figure 10. Quench spray nozzles showing through wall holes in (a). Inside appearance (b) shows channels eroded on the wall. Thinning in the channels led to the penetrations in (a)
