MONTHLY REPORT NO. 7 - FEBRUARY 1967

COMPILATION OF CURRENT TECHNICAL EXPERIENCE AT
ENRICO FERMI ATOMIC POWER PLANTAEC CONTRACT NO. AT (11-1) -865
PROJECT AGREEMENT NO. 15SPONSOR: DIVISION OF REACTOR DEVELOPMENT
AND TECHNOLOGY, UNITED STATES
ATOMIC ENERGY COMMISSION

Prepared by
ATOMIC POWER DEVELOPMENT ASSOCIATES, INC.
DETROIT, MICHIGAN
with the cooperation of
POWER REACTOR DEVELOPMENT COMPANY
AND
THE DETROIT EDISON COMPANY

Date Issued: May 1967

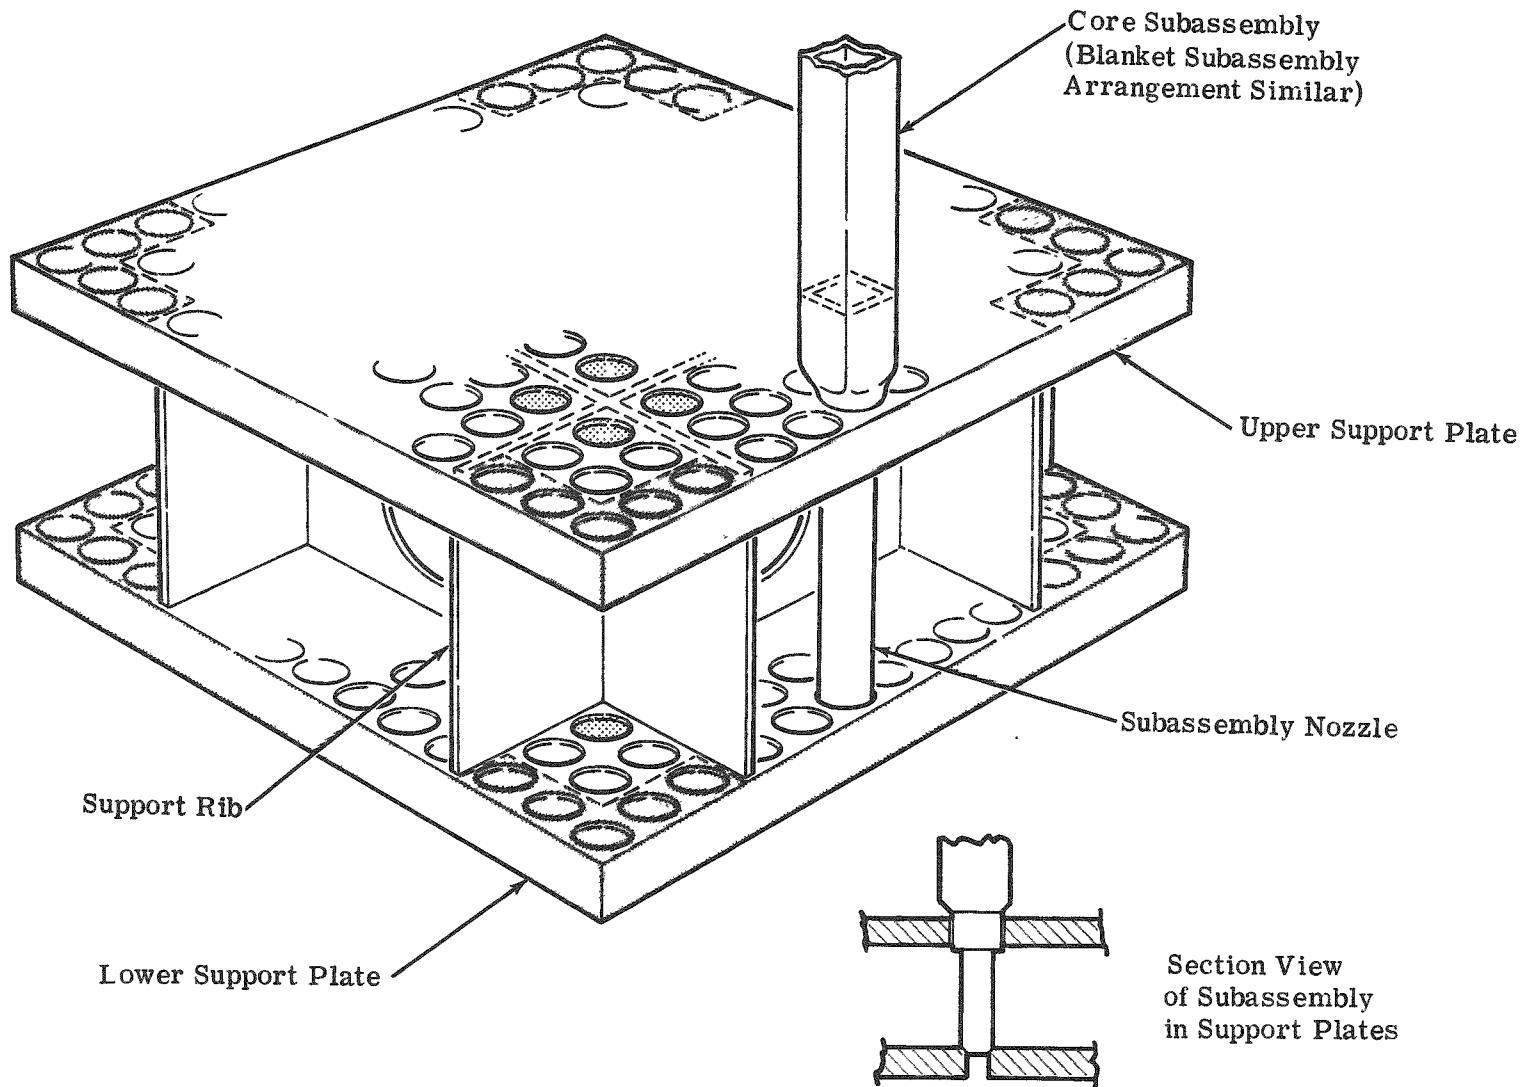
SUPPORT PLATE AND RIB STRUCTURE

A 100-pound extra pushing force was required to complete seat subassembly S-550 in position N13-P03. This was because of hang-up as the upper portion of the support nozzle entered the upper support plate. See the diagram on page 10. Subassembly S-510 had previously exhibited an interference upon insertion in this position, as reported in Section II A of report No. 6. A 150-pound extra pushing force had failed to move S-510 the final one-inch of travel.

S-510 was transferred to the cask car from the transfer rotor container. It was let down out of the cask car into the glove box (in the Fuel and Repair Building) and examined by direct vision through a viewing window. At the upper shoulder on the support nozzle a small raised gall mark 1/16-inch wide by 1/8-inch high was observed.

S-510 is at present stored in the FARB transfer tank. The galled area will be stoned smooth and the subassembly eventually returned to the reactor.

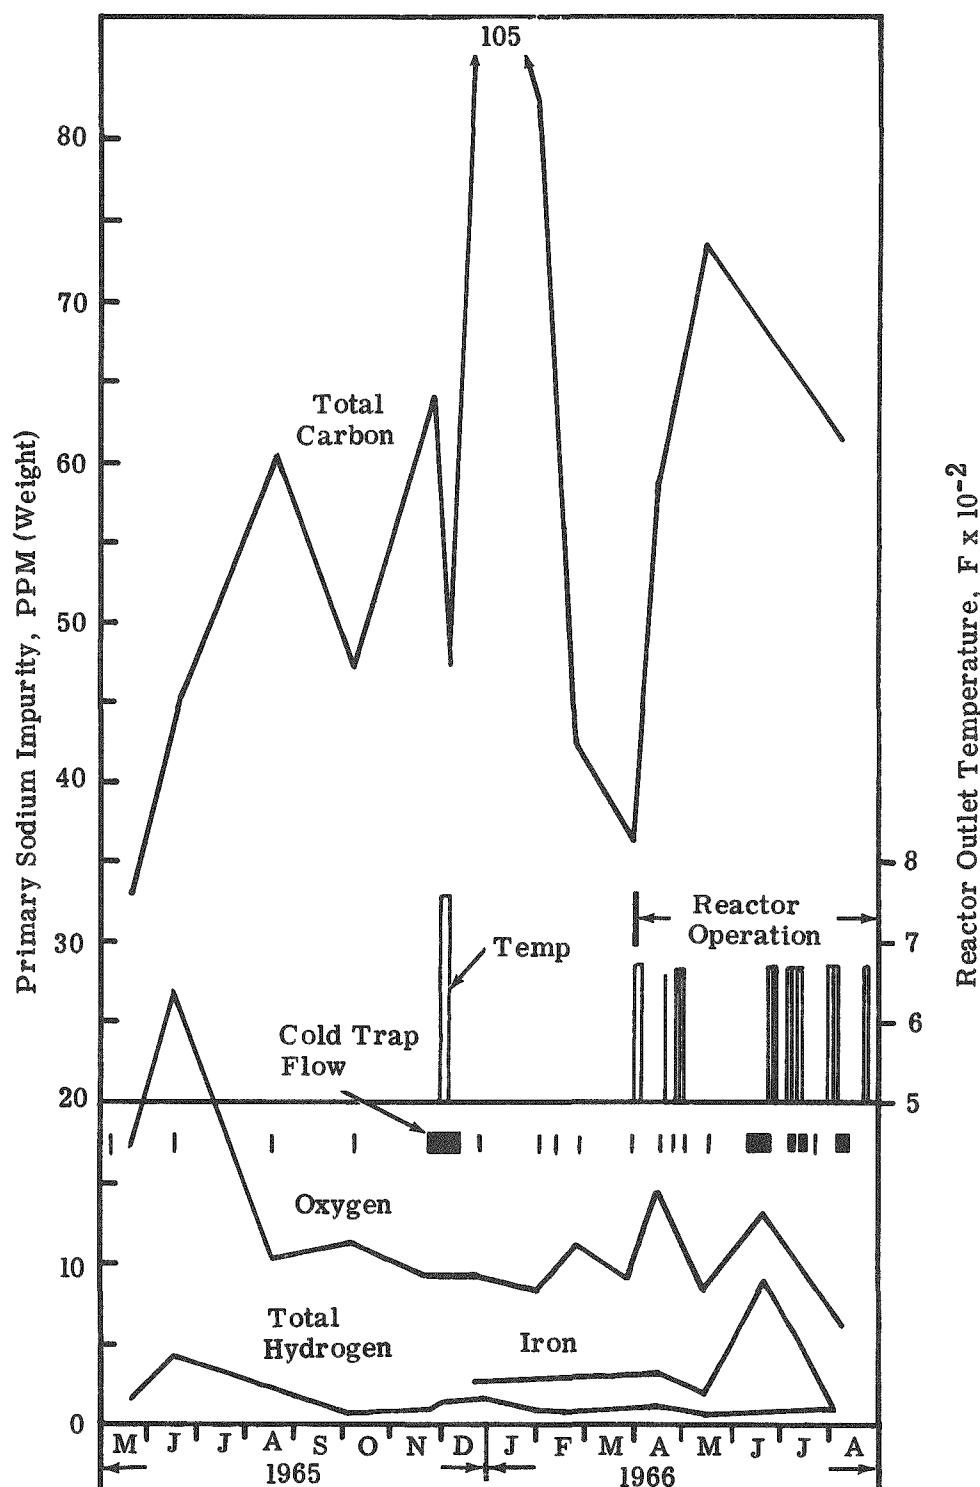
PRIMARY SODIUM IMPURITIES

The curve sheet on page 14 shows the variation of several impurities (carbon, oxygen, hydrogen and iron) in the primary sodium during the period from May 1965, through August 1966. Also shown are the periods of cold trap operation and of reactor operation and the intervals when the sodium temperature was above the normal shutdown temperature of approximately 500 F.

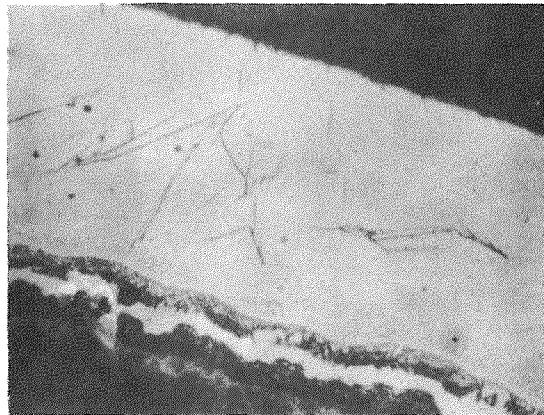
Microstructure of fuel pin No. 18699 removed from subassembly M099. Zirconium clad estimated to contain approximately 150 ppm hydrogen.

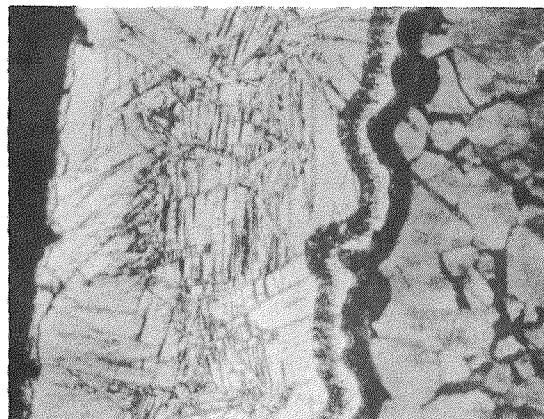
Microstructure of fuel pin No. 18692 removed from subassembly M099. Zirconium clad shows a metallographically estimated 2500 ppm hydriding, vacuum fusion analysis shows 700-900 ppm hydriding.

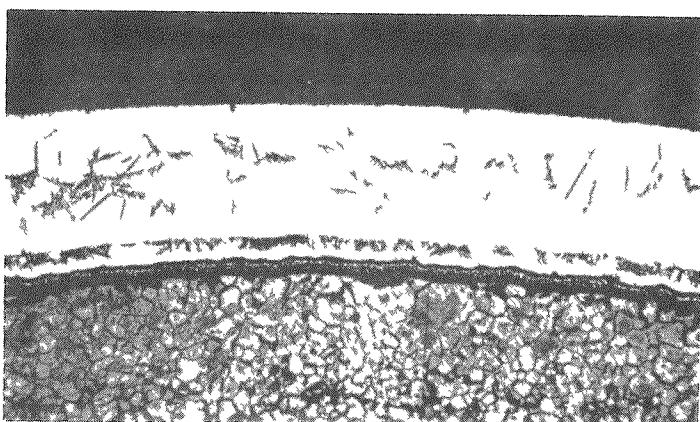
ZIRCONIUM HYDRIDING LABORATORY TESTS

Clad Contains Approximately 10,000 ppm Hydrogen
(50 percent Hydrided)

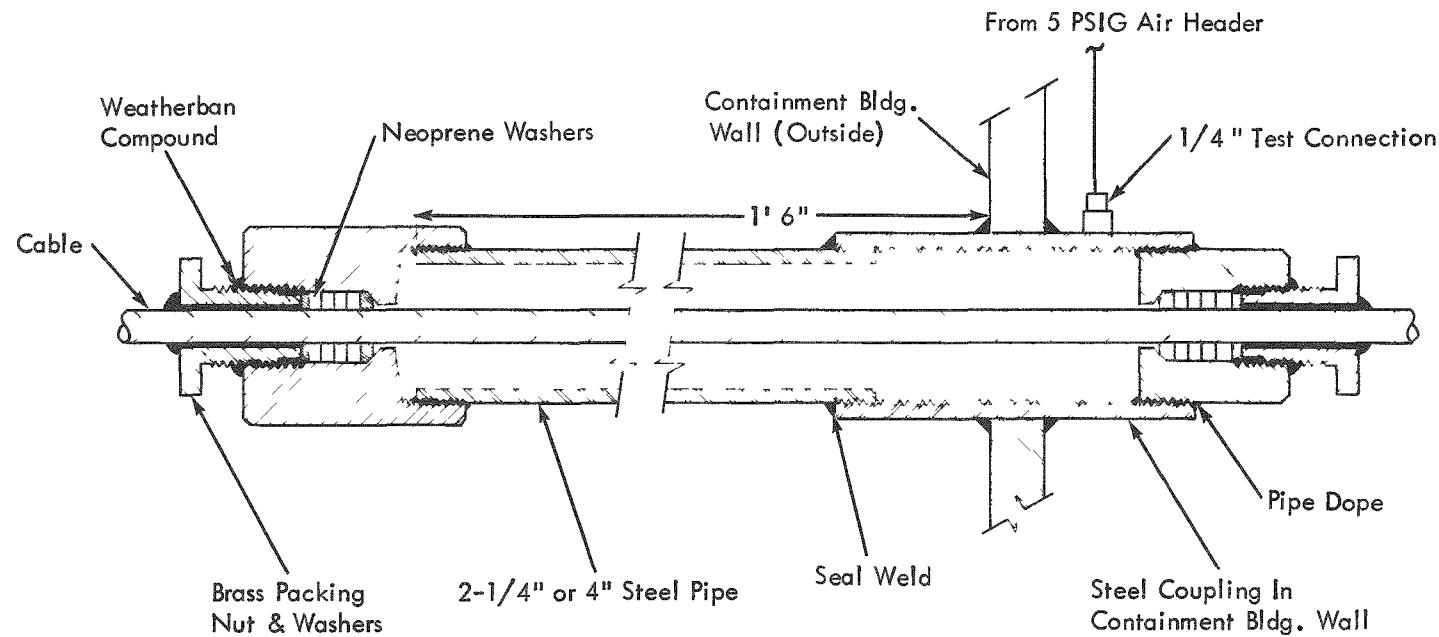
CABLE PENETRATION

Details of the penetration are shown on the drawing on page 26. The cables vary in size from 1/2-inch to 2-inches outside diameter. The cables carry circuits at 4800 V, 480 V, 120 V and instrumentation voltages ranging down to less than one volt. Air leakage out of the reactor building through the cables is prevented by using gastight cables, or in the case of lead covered cables, by potting the ends.

Over the past year or two the cable seal original neoprene packing rings have been assisted by application of a back-up mastic (trade name Weatherban), applied with a caulking gun, which remains resilient and has given improved reliability. However, during extremely cold weather the outer seal appears to lose some of its resiliency and occasional leaks have appeared. These seals were recaulked. A header system supplies 5 psi air pressure continuously to each penetration. A flowmeter in the header is checked daily for indications of increased leakage. Each month the penetrations are tested at 32 psig; the average leakage is approximately 70 CFD.

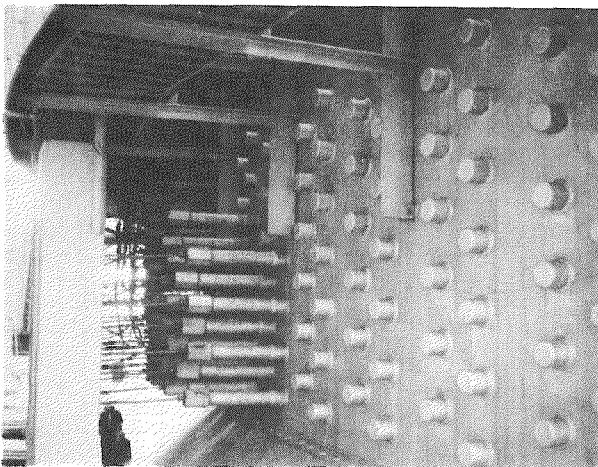
EXTERIOR VIEW OF A PORTION OF THE REACTOR BUILDING ELECTRICAL PENETRATIONS. THOSE ON THE RIGHT ARE SPARES.

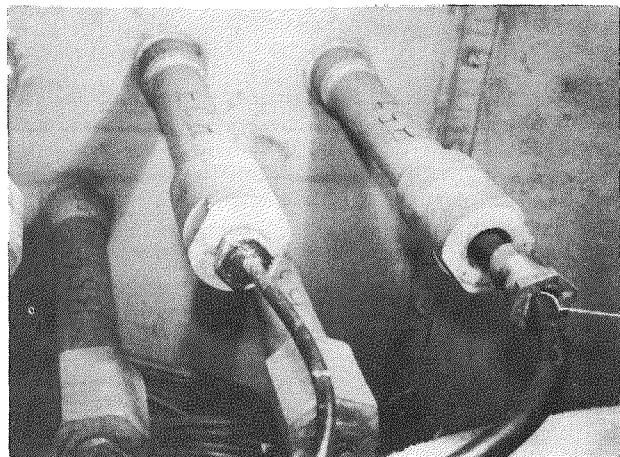
ELECTRICAL PENETRATIONS EXTENDING OUT FROM THE REACTOR BUILDING. PACKING NUT BEING INSTALLED IN THE PENETRATION ON THE RIGHT.

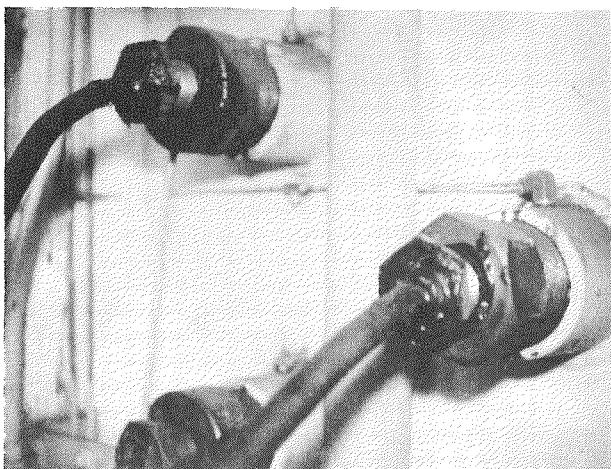
VIEW OF THE PENETRATIONS FROM INSIDE THE BUILDING. NOTE TUBING CONNECTION SUPPLYING 5 PSI AIR FOR CONTINUOUS LEAK MONITORING.
