THE ACCIDENT TO THE NRX REACTOR ON DECEMBER 12, 1952

DR - 32

W.B. LEWIS

Report DR-32

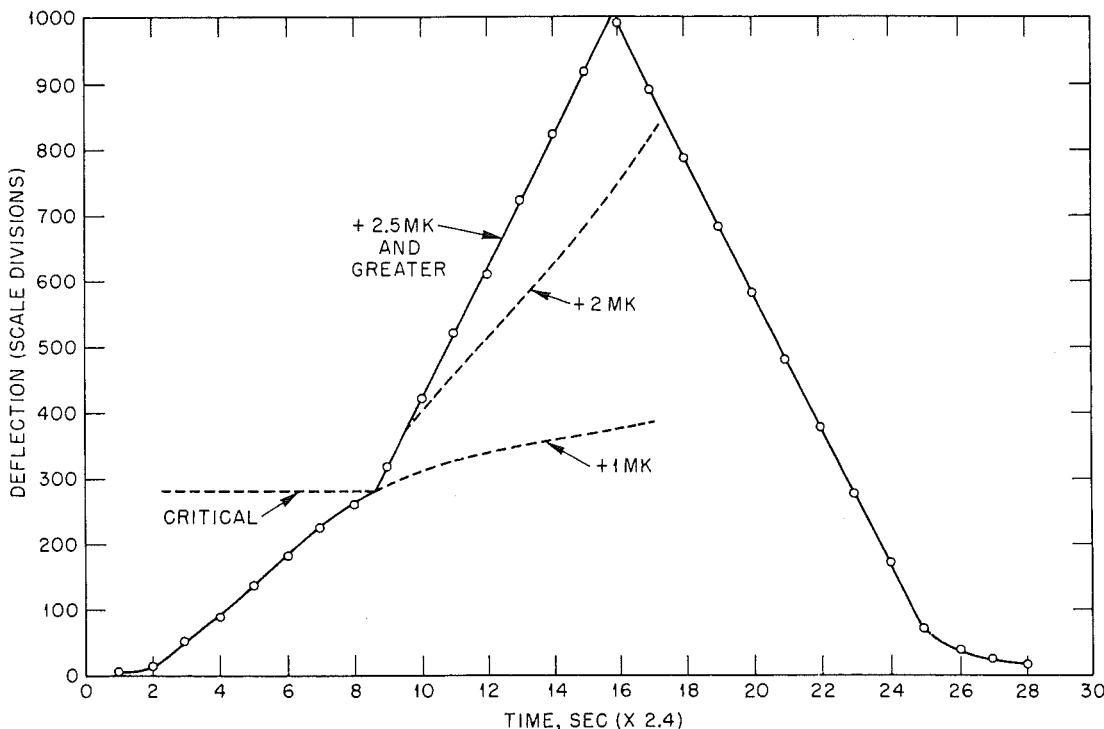
a good graph could be made of instrument reading against time. This is shown in Fig. 5.

greater, the recorder ran at its maximum rate. The estimate that the reactor power did not exceed 90 megawatts (on the scale of this instrument) is based on the observation that a sufficient overload signal would jam the indicating galvanometer and the recorder would remain at full-scale deflection. This did not occur in the incident as shown by Fig. 5.

Fig. 5—Expanded trace of power recorder during the power surge with transients from simulator superposed. (Time scale is in units of 2.4 sec., the interval between successive balancings.) —, NRX transient. ---, reactor simulator transient.
