METALLURGICAL EXAMINATION OF
GUN BARREL SCREWS

E. L. Bird
T. L. Clift

June 1996

Y-12 Development Division

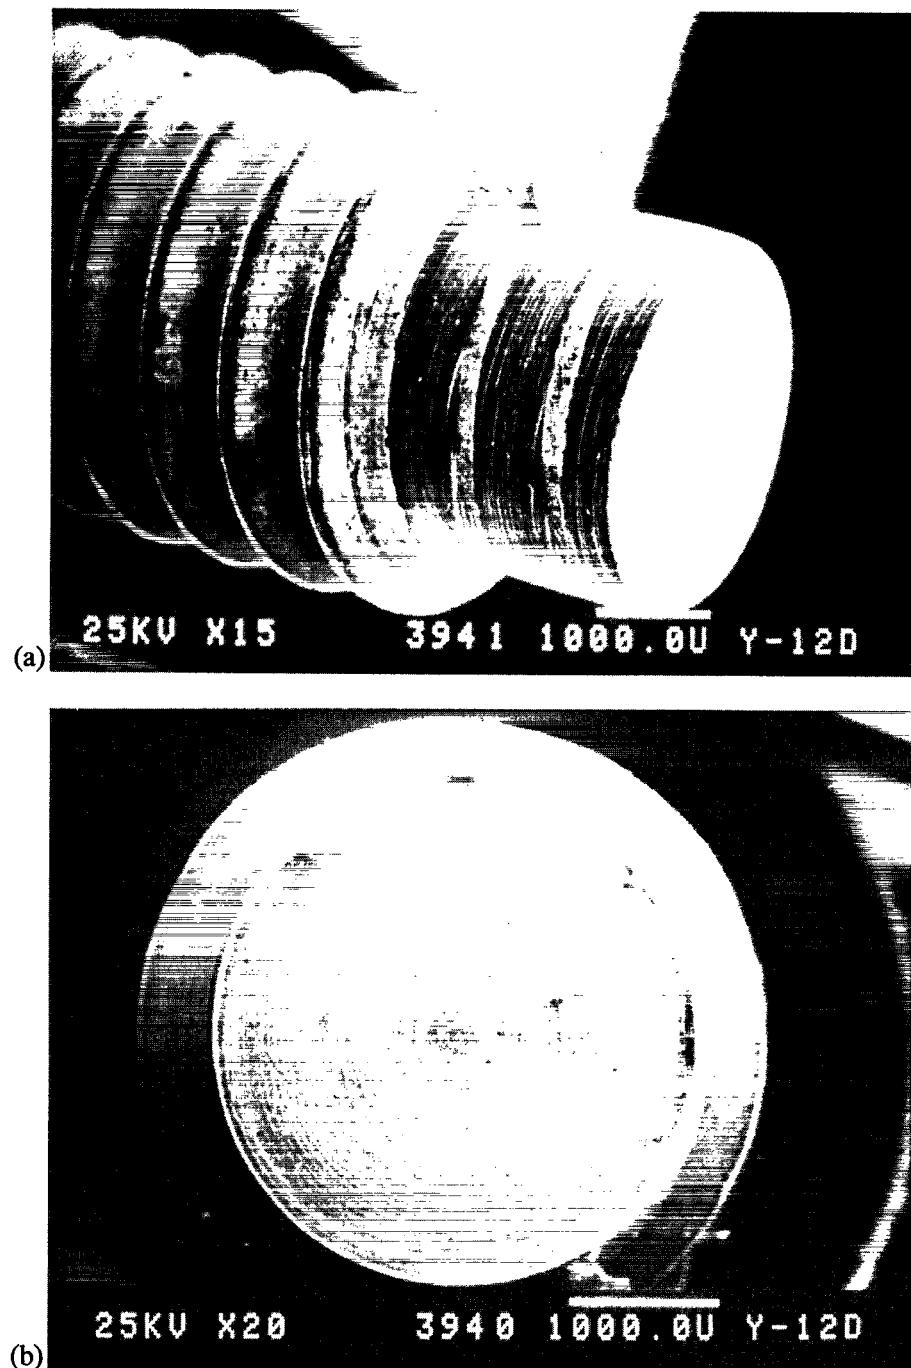
Figure 2 shows SEM photographs of the new or unfired screw for reference. Figure 3(a) is a cross section of the new screw, and Fig. 3(b) shows the microstructure near the first thread of the same screw at a higher magnification. Note the absence of any cracks in Fig. 3(a) and the presence of a tempered martensitic microstructure in Fig. 3(b).

Fig. 2. Scanning electron microscopy images of new, unfired screws
(a) 15X, (b) 20X.

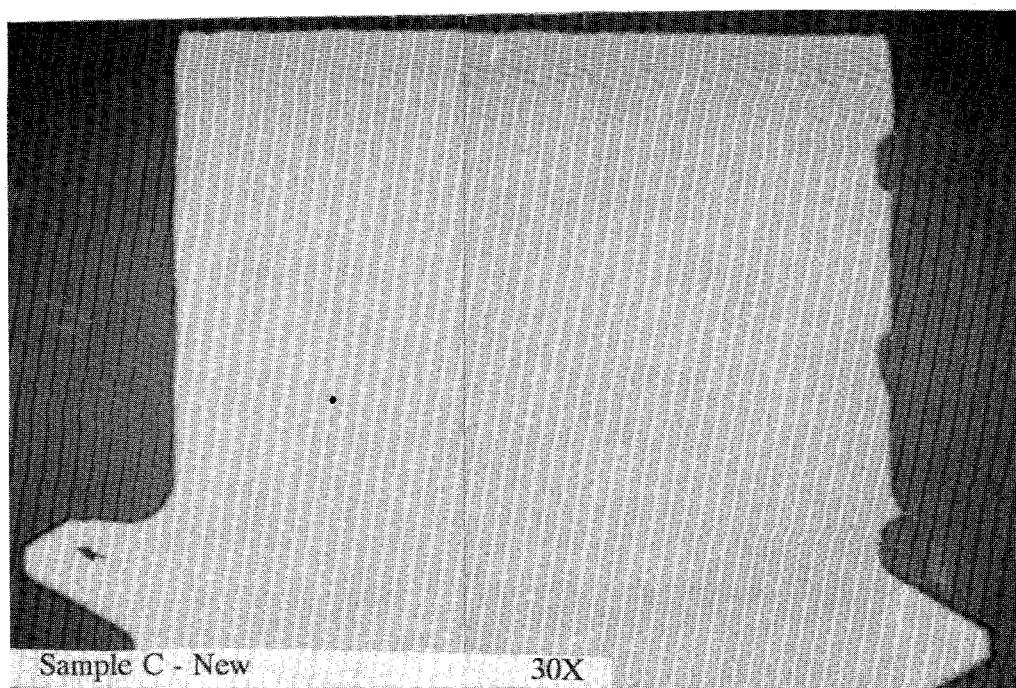
Fig. 3(a). Polished cross section of a new screw (30X).

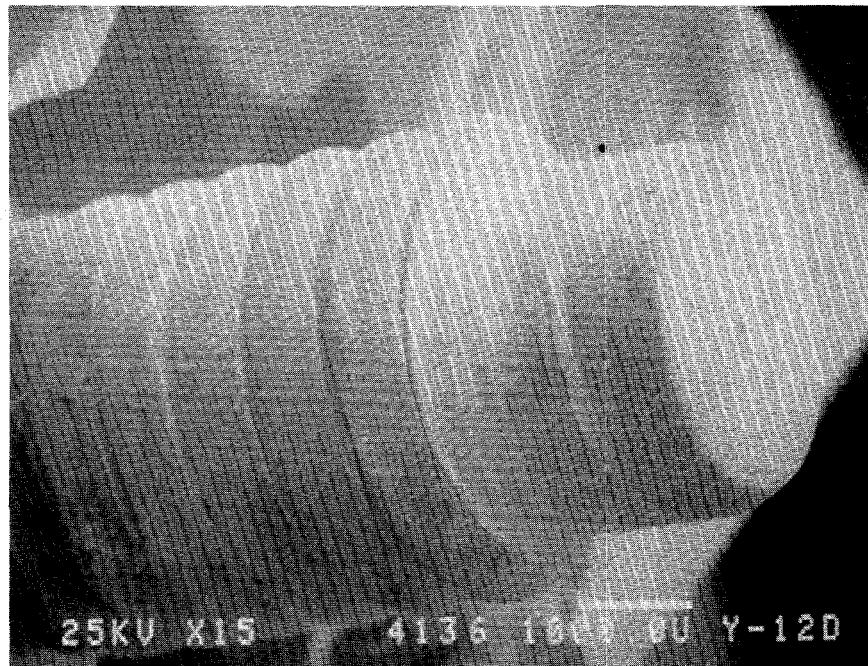
After being exposed to 100 fired rounds, the screw looks like the SEM pictures in Fig. 4. Some of the powder residue is evident in Fig. 4(b). Figure 5 shows cross sections of the screw that was polished but not etched, and one can see that small cracks are beginning to form in the upper region of the screw. The etched version of the microstructure (Fig. 6) reveals predominantly tempered martensite with a small region in the top, left corner exhibiting slight transformation.

Fig. 4(a). Scanning electron microscopy image of a screw after 100 rounds (15X).

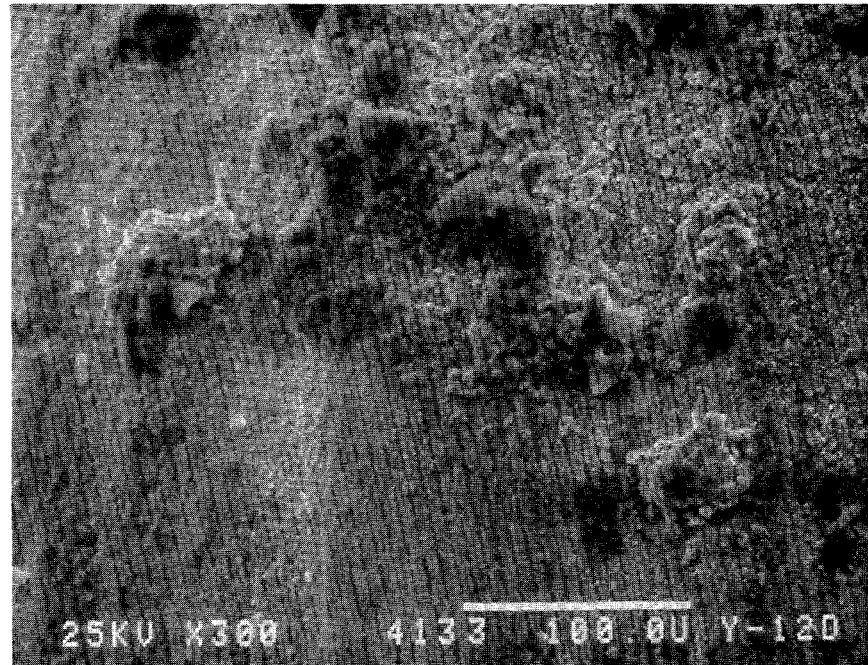
Fig. 4(b). Gunshot/powder residue on the surface of a 100-round screw (300X).

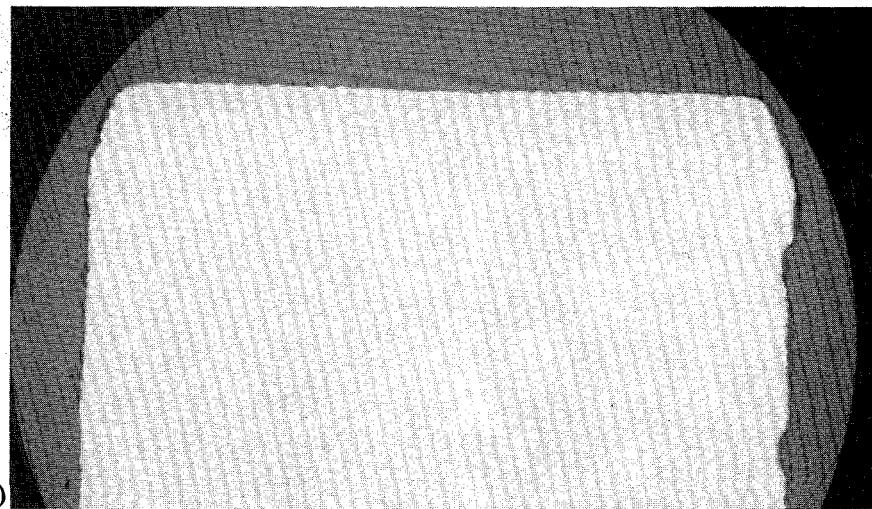
(a)

Fig. 5(a). Polished cross section of a screw after 100 rounds (30X).

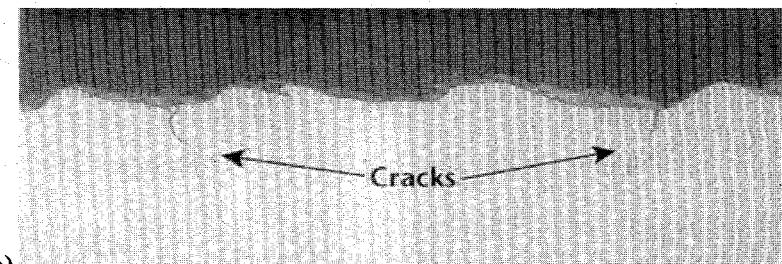
(b)

Fig. 5(b). Magnified view of top portion of Fig. 5(a) showing the presence of shallow cracks (400X).

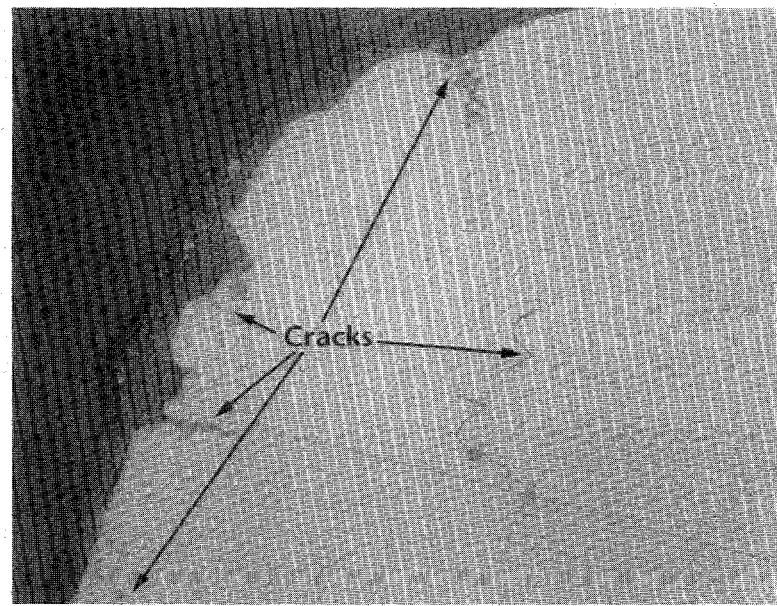
Fig. 5(c). Magnified view of the top left corner of Fig. 5(a) showing shallow cracks and areas of degradation (400X).

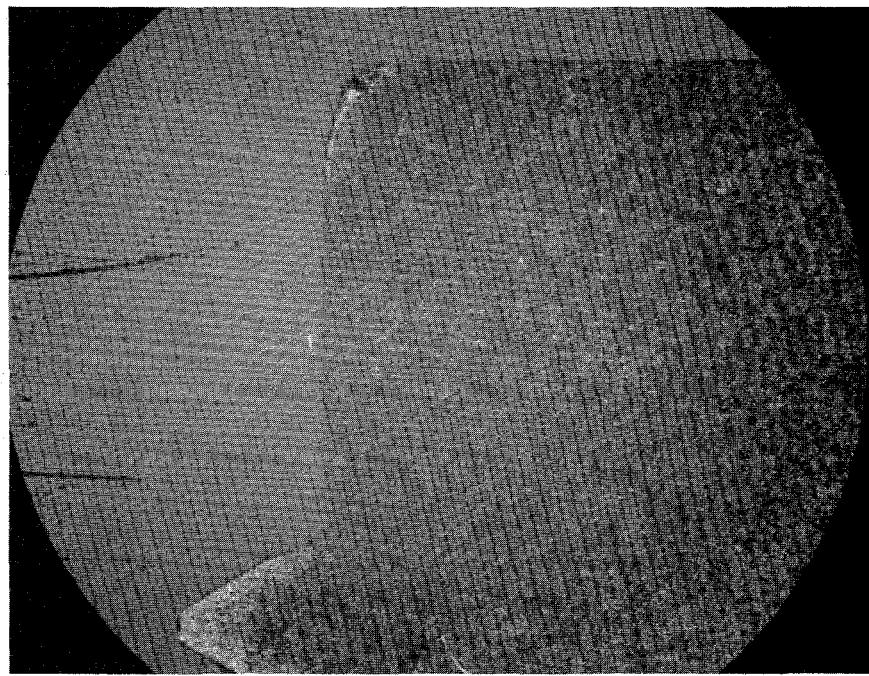
Fig. 6(a). Etched microstructure of a screw after 100 rounds
(Etch: 2% Nital, 30X).

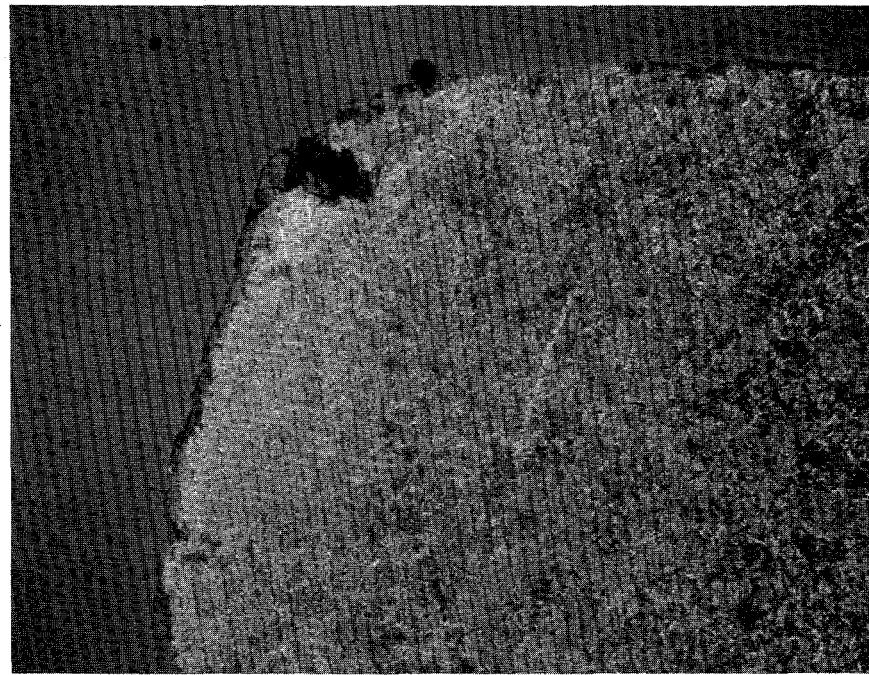
Fig. 6(b). Magnified view of top left corner of Fig. 6(a) (150X).

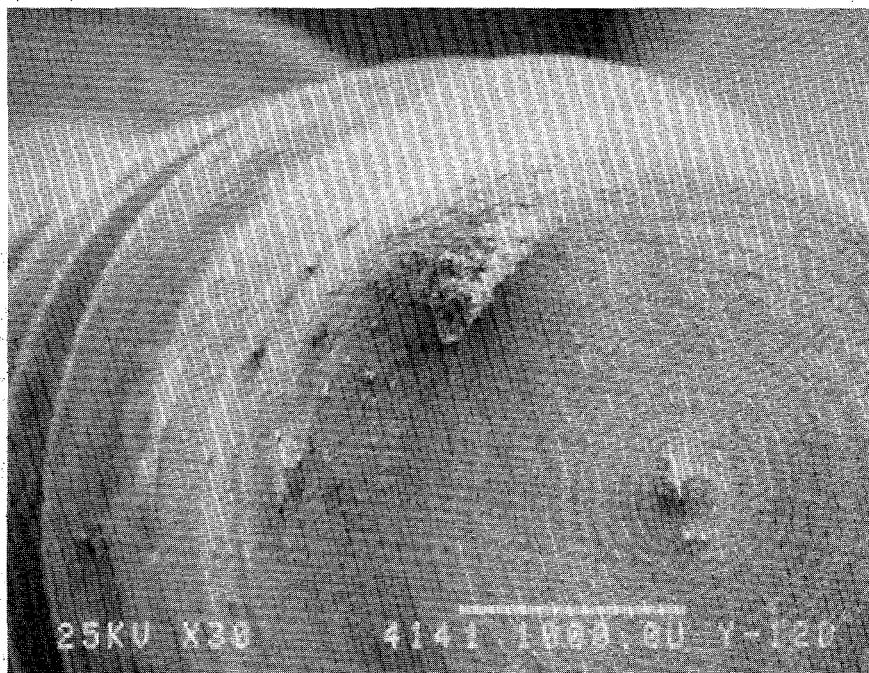
Figure 7 shows the screw that had been used in the firing of 200 rounds; the presence of cracking and wear is more pronounced. Figure 8 shows a polished, cross-sectional region that reveals

Fig. 7(a). Residue on a screw after 200 rounds (30X).

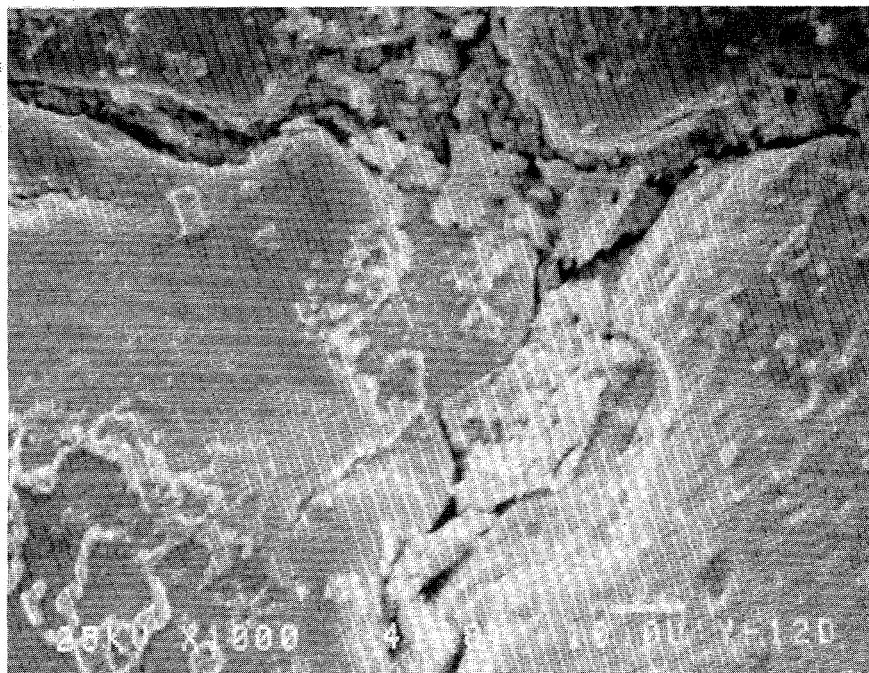
Fig. 7(b). "Mud cracks" in the residue deposited on a 200-round screw (1000X)

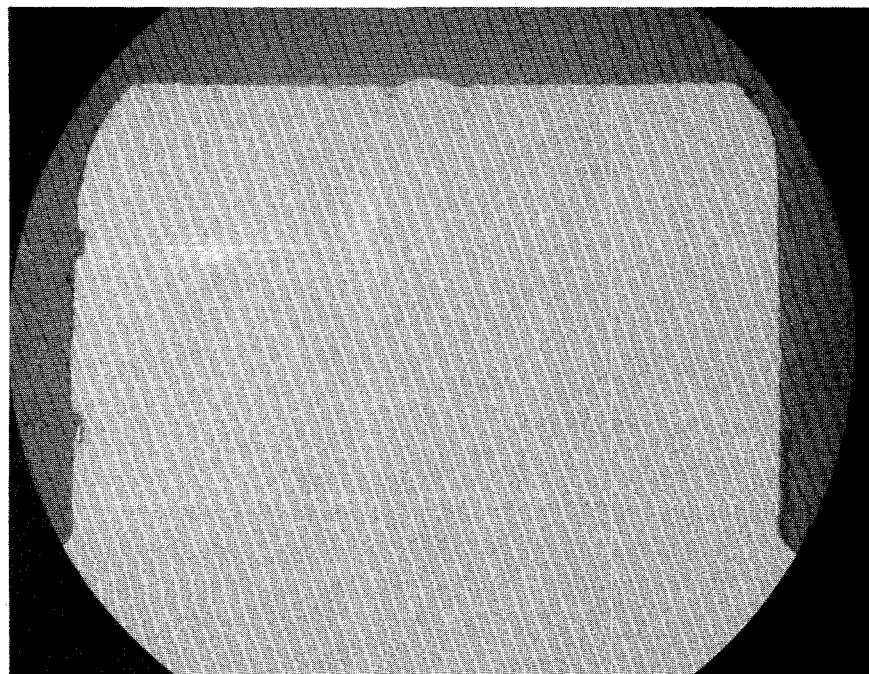
areas of intergranular cracking. Changes in the microstructure also become evident in Fig. 9 in the region on the upper left side of the photograph. This region shows up as a white, crescent-shaped region in the photograph of the microstructure. At first, this region was thought to be an area that had undergone decarburization. However, micro X-ray analysis of the carbon content in the white region was similar to that of the matrix. At higher magnification, structural transformation within the white region became more evident by the absence of acicular needles, which are present in the matrix and indicative of martensite. Microhardness testing of this region revealed a range in hardness (see Fig. 10), but, more importantly, a significant increase in hardness of approximately 670 in this white region. A slight decrease in microhardness was observed in a narrow layer between the white region and the matrix.

Fig. 8(a). Polished cross section of a screw after 200 rounds. Note the increase in the number of cracks along the top surface (30X)

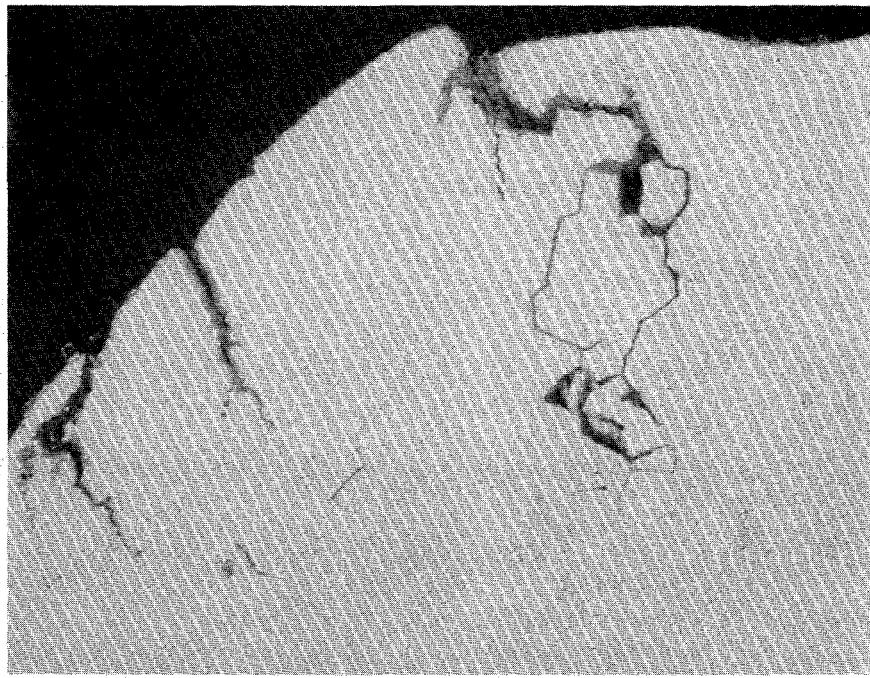
Fig. 8(b). Magnification increased for a closer look at the degree of cracking in the left upper portion of Fig. 8(a) (400X).

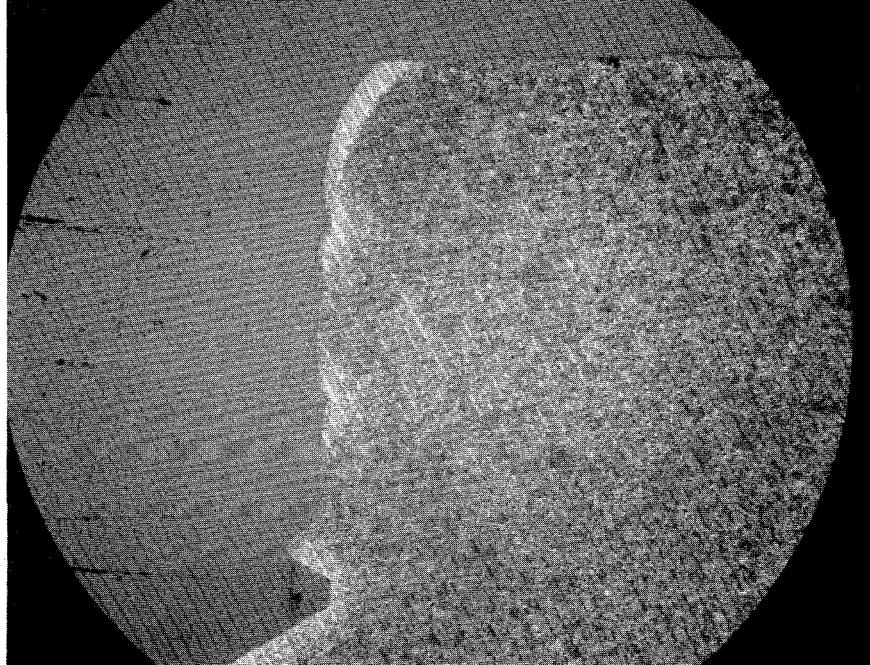
Fig. 9(a). Etched microstructure of a screw after 200 fired rounds. Note the "white layer" at the top left portion of the screw (30X).

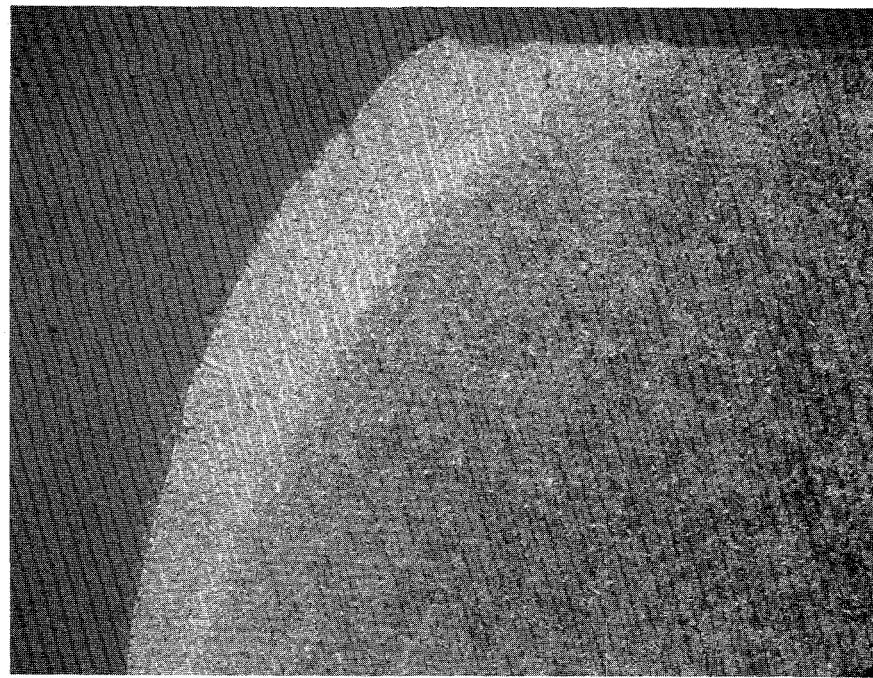
Fig. 9(b). A closer view of the white layer on the screw from 200 fired rounds (150X).

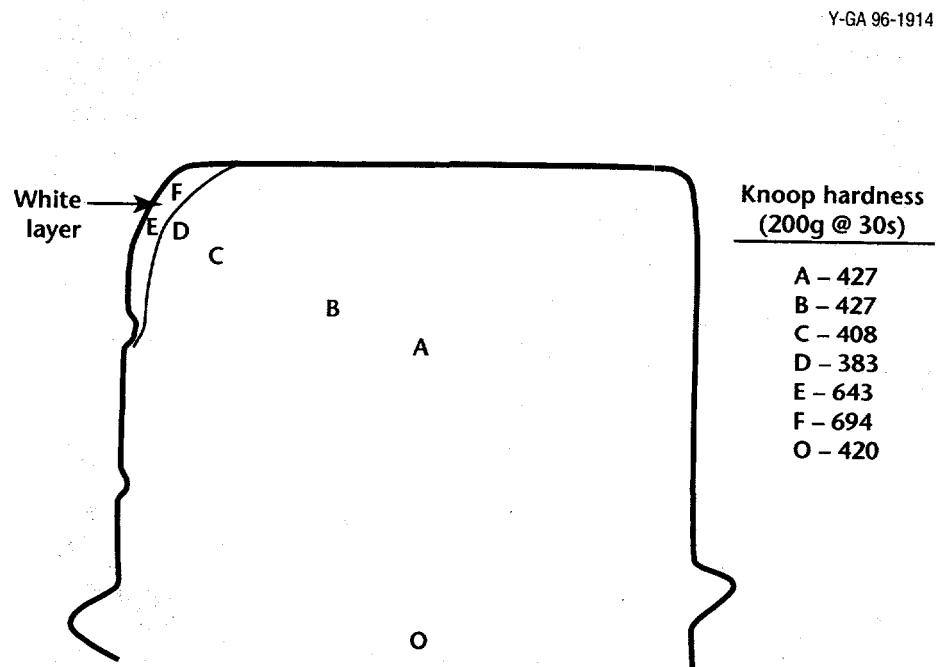
Fig. 10. Microhardness results of a screw exposed to the firing of 200 rounds.

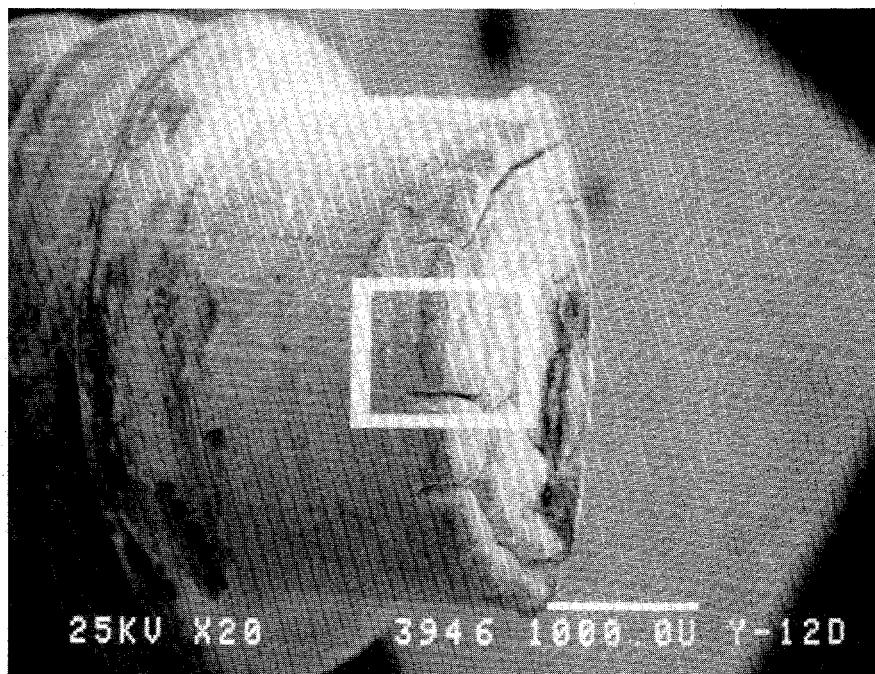
The tips of each of the two 300-round screws were heavily covered with gun powder residue and revealed large cracks on the surface, as shown in Fig. 11. Several of these cracks began to branch and propagate along the intergranular paths, as shown in Fig. 12. Changes in microstructure are more significant in these specimens as indicated by a difference in appearance marked by the presence of a zone or "white band," as seen in Fig. 13(a), in a plane between the blunt tip and the threaded portion of the screw. Microhardness values taken around the surface regions of the blunt tips of two screws exposed to 200 firings revealed a variation in hardness, as shown in Fig. 14. The residue on the surface of one of these tips was analyzed using X-ray spectra analysis, revealing several heavy elements, including lead, barium, antimony, and copper, as noted in Fig. 15.

Fig. 11(a). Scanning electron microscopy image of a screw after 300 rounds. Note the enclosed box depicting the region of heavy residue and cracking. (20X)

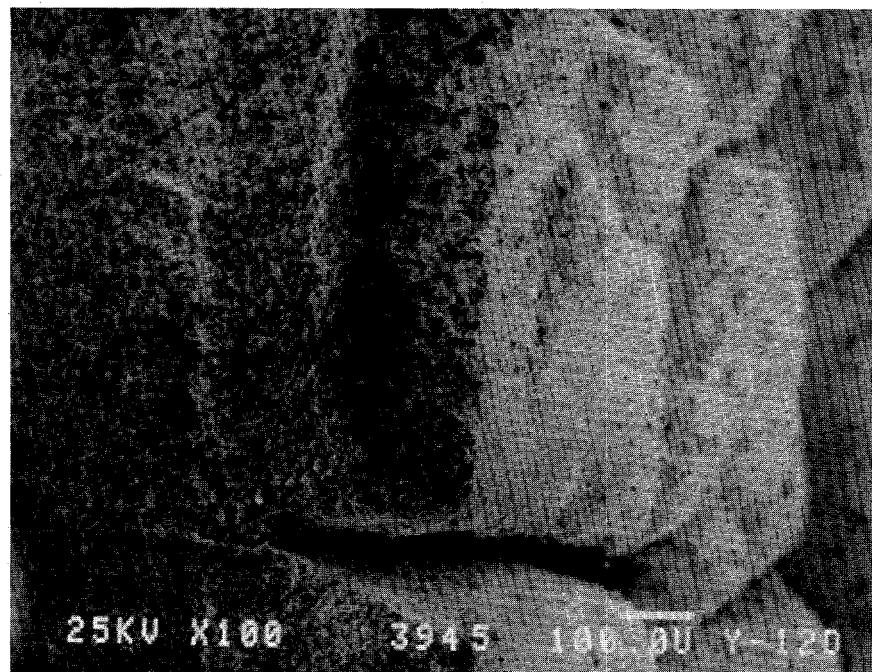
Fig. 11(b). Scanning electron microscopy image of the enhanced area from Fig. 11(a) showing cracking at higher magnification (100X).

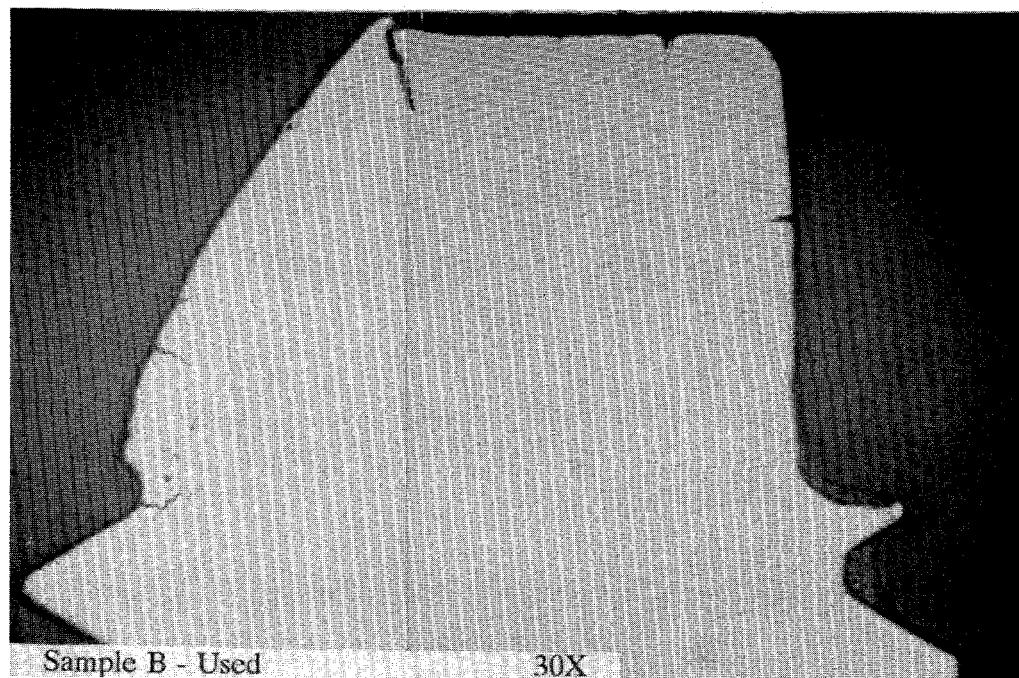
Fig. 12(a). Polished cross section of a screw after 300 rounds. Note the severity of the cracking and wear, which is predominant on the left side of the screw (30X).

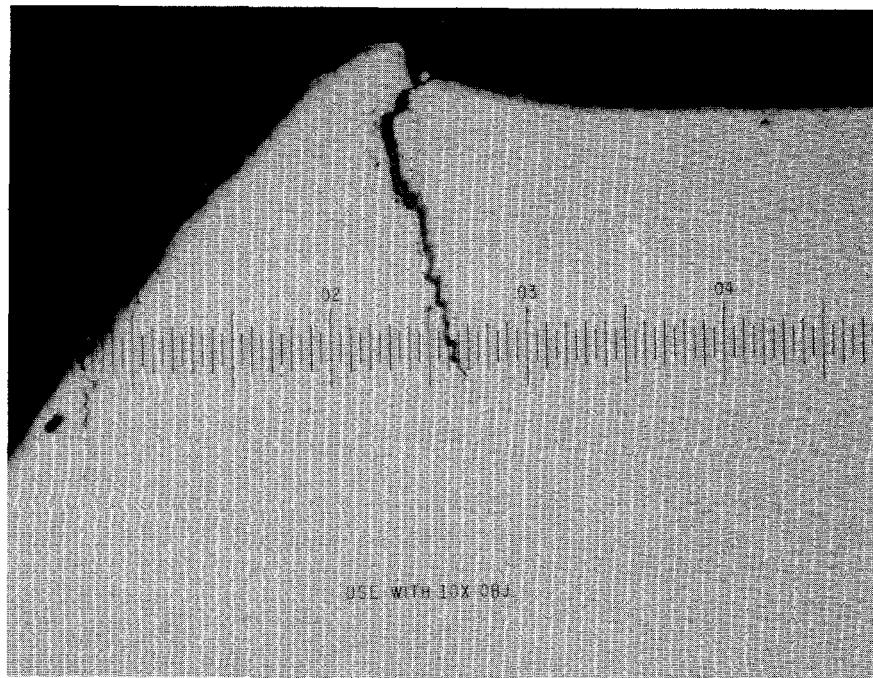
Fig. 12(b). Magnified view of Fig. 11(a), upper left corner, showing the depth of the crack (approximately 0.017 in.) and deformed metal at the crack origin (100X).

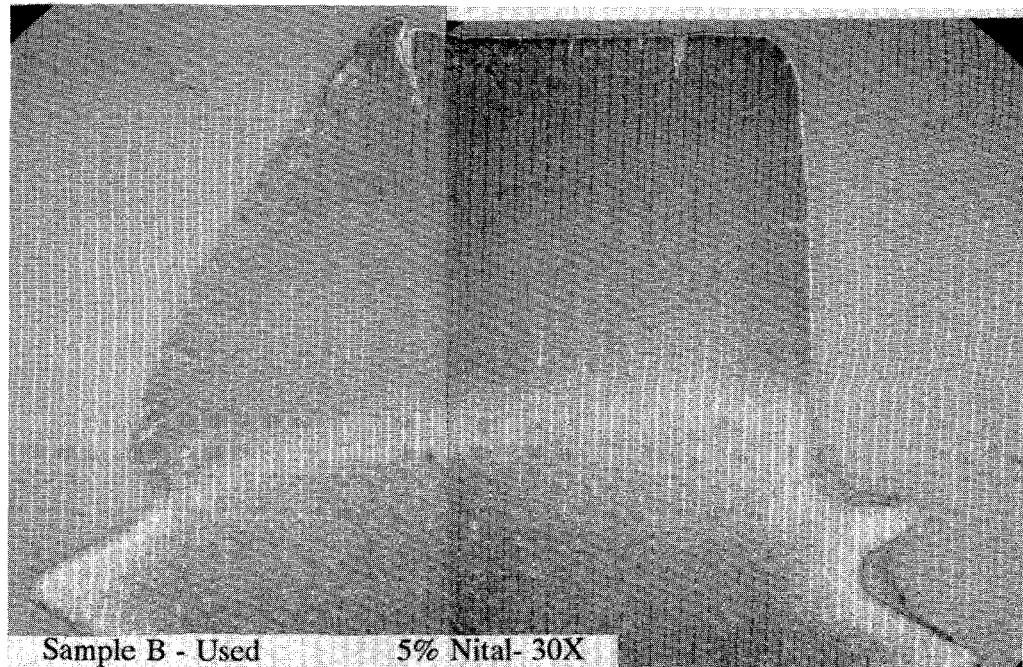
Fig. 13(a). Etched view of a screw after 300 rounds. Note the white zone or band across the screw in a plane slightly above the threaded plane and the difference in the appearance of the microstructure above and below this band. (30X)

In addition to cracking, another condition of degradation observed in the screws that had experienced the firing of 200 to 300 rounds was the formation of a structural transformation zone, as indicated by a white band within the microstructure that is different from the other microstructures. In fact, the transformation zone starts at the surface of the screw that was in direct contact with the firing of 200 blank rounds and moves deeper into the screws that experienced the firing of 300 rounds. This transformation zone, which appears whiter or lighter than the matrix when etched, is believed to have been caused by additional heating of the blunt tip of the screw. Specifically, the heat generated by the firing of the rounds created cyclic blasts of heat that led, in effect, to a combination of undertempering and overtempering of the portion of the screw exposed in the barrel. Undertempered martensite, when etched, is very white and typically very hard and brittle, much like the white crescent-shaped region of the screw exposed to 200 rounds. Overtempering leads to a decrease in hardness, which was verified when microhardness tests identified a loss in hardness in the outer regions of the 300-round specimens.

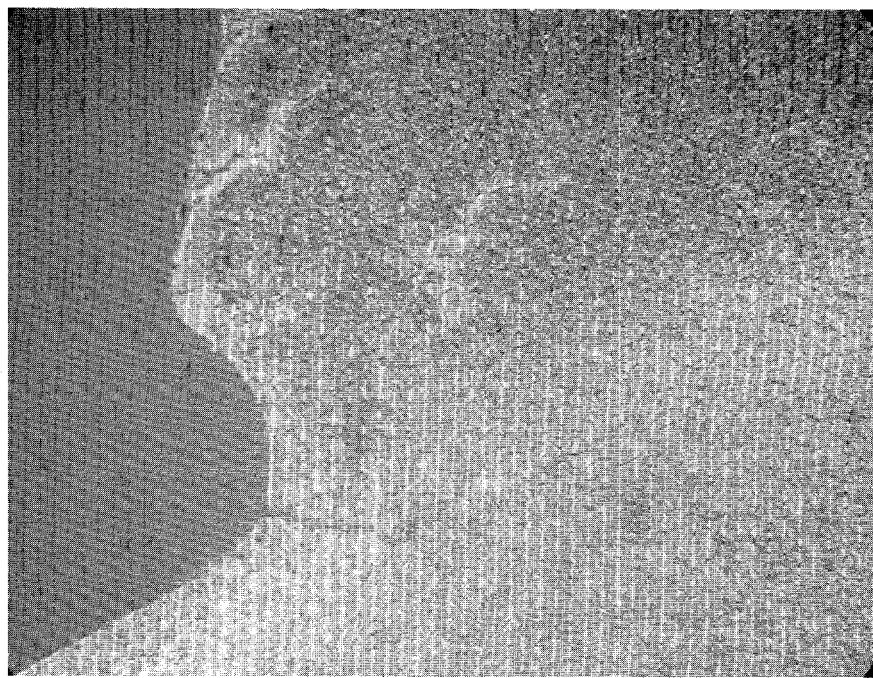
Fig. 13(b). Magnified view of the region above the top, left thread shown in the bottom left portion of Fig. 12(a). The differences in microstructure are more evident (150X).

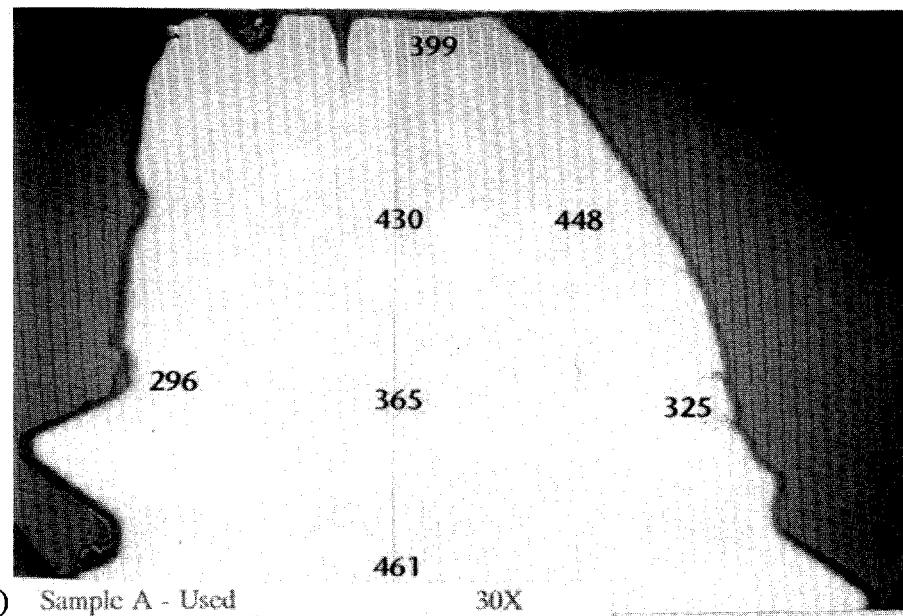
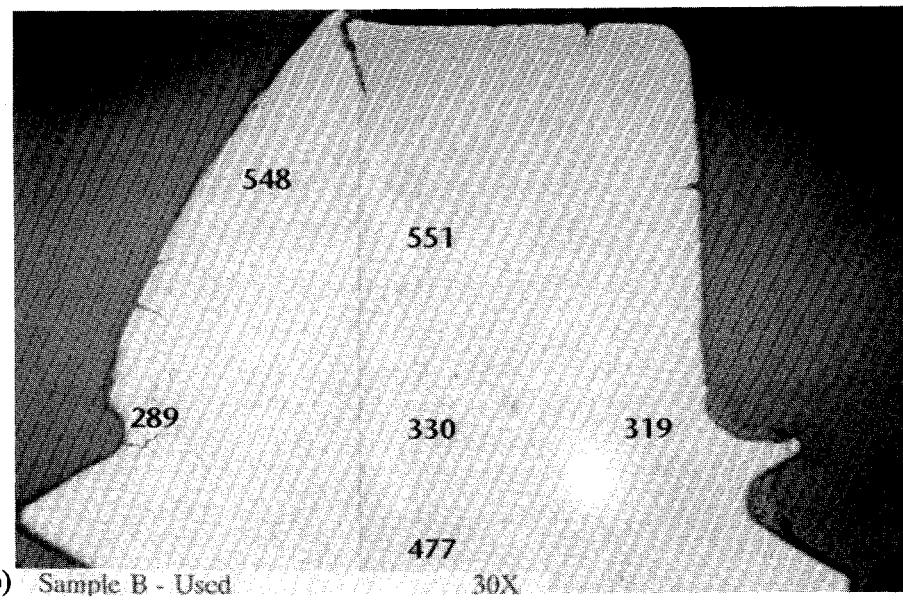
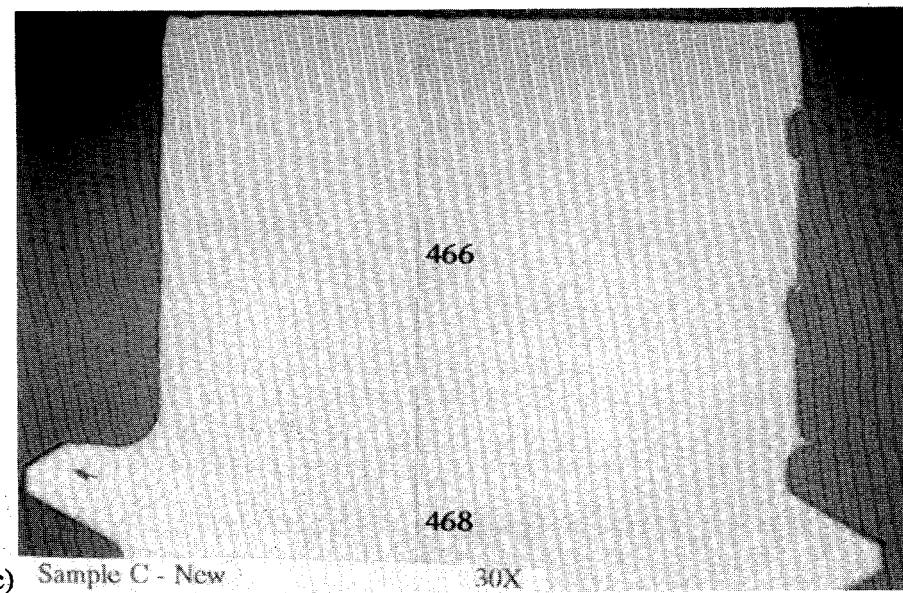
**Fig. 14. Profiles of Knoop hardness tests at a 500-g load for 15 s.
(a) and (b) 300-round screws, (c) new screw (30X).**

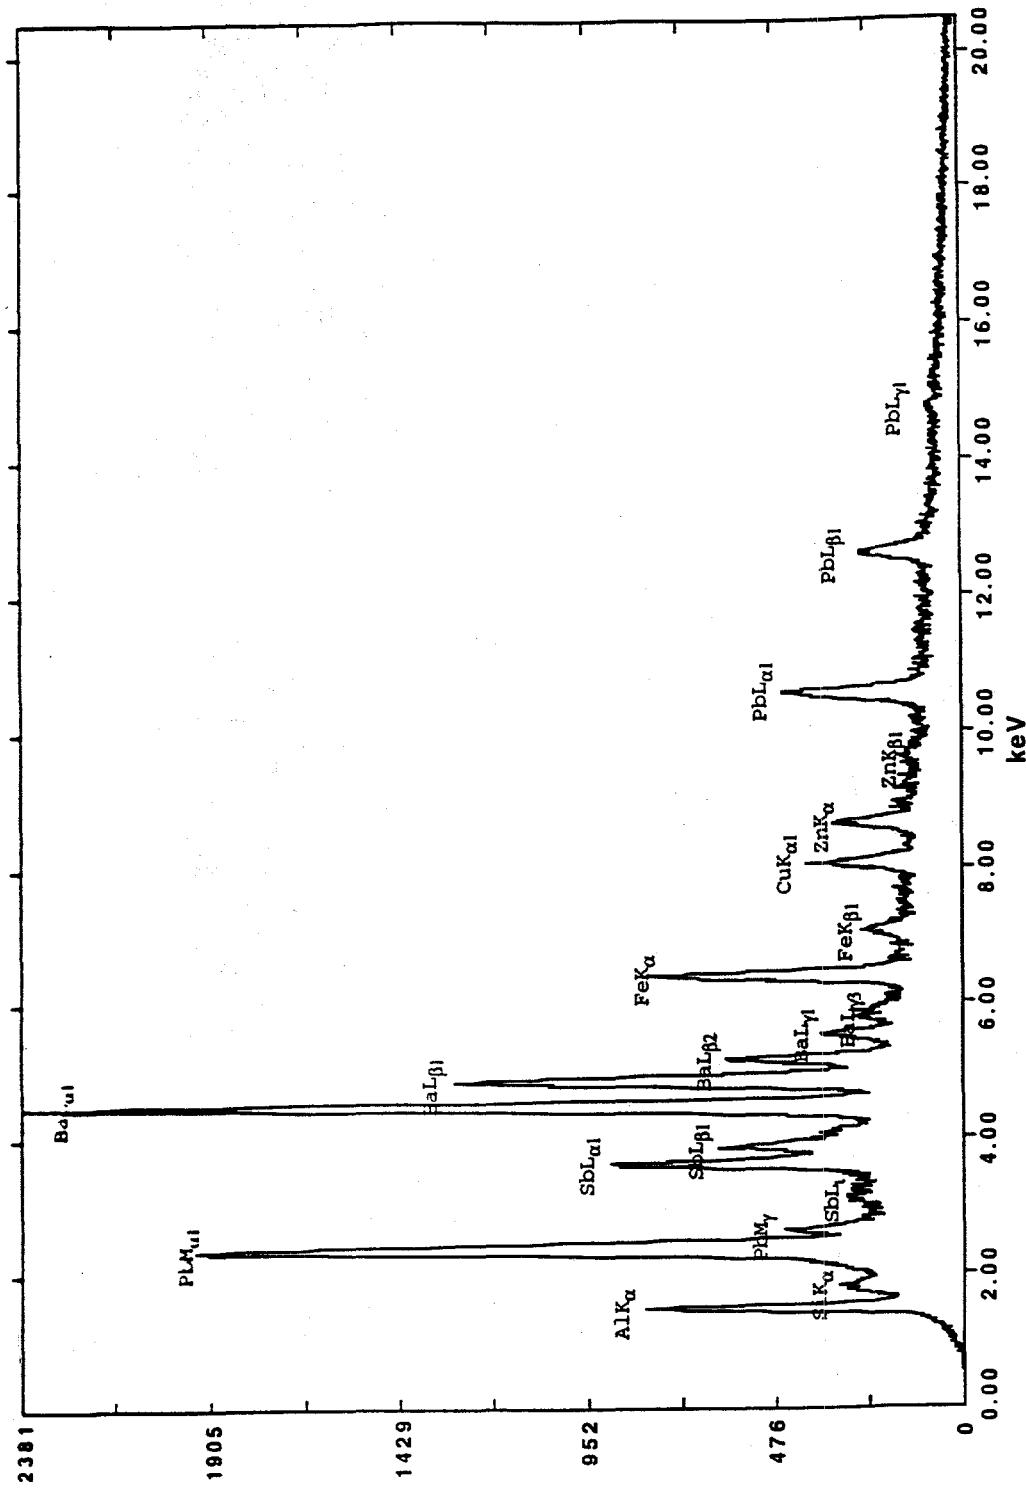
Sample A - Test fired 300 rounds. Residue on tip.

Fig. 15. Analysis of residue on the surface of screw tip after 300 fired rounds.
