SAND97-0497 • UC-704

# Characterization of the Mechanical Properties of LTCC "Green Tape"™ for the MC4352 MET

Fernando Uribe, Stephen Garrett, Saundra Monroe, Steven Burchett

## Abstract

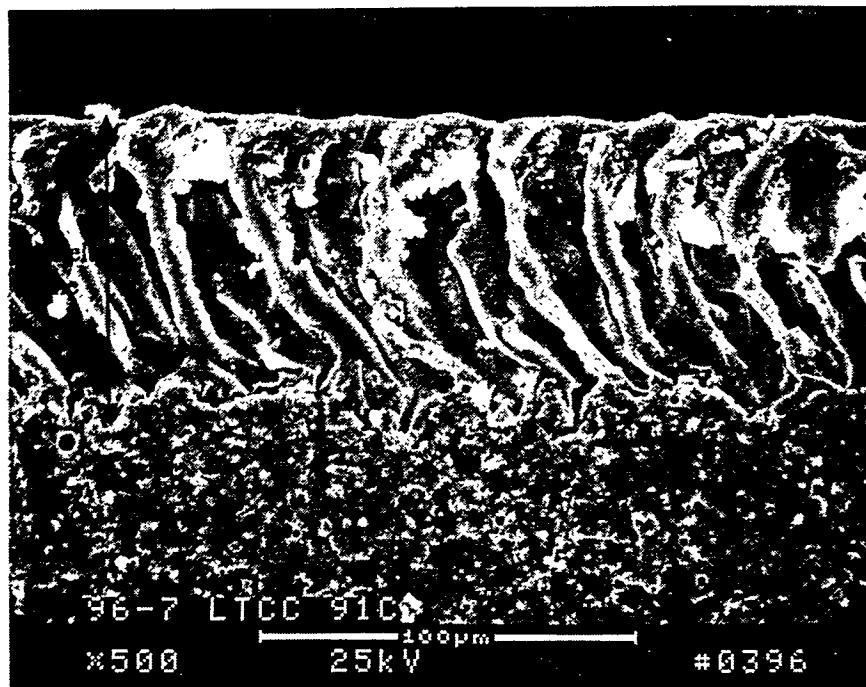
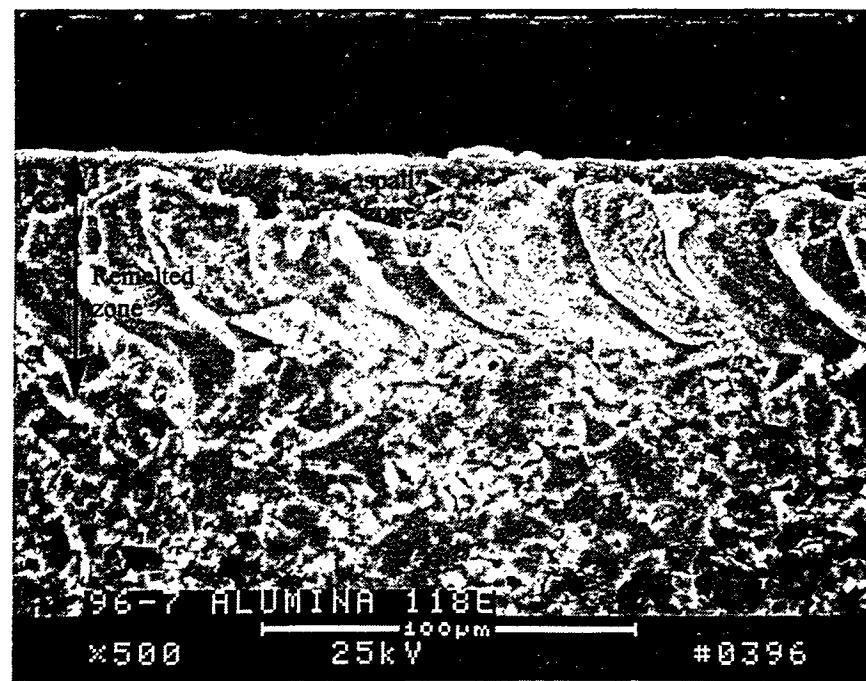
**Figure 5.** Laser entry side of bend bars shows remelt damage zone where failure originated.

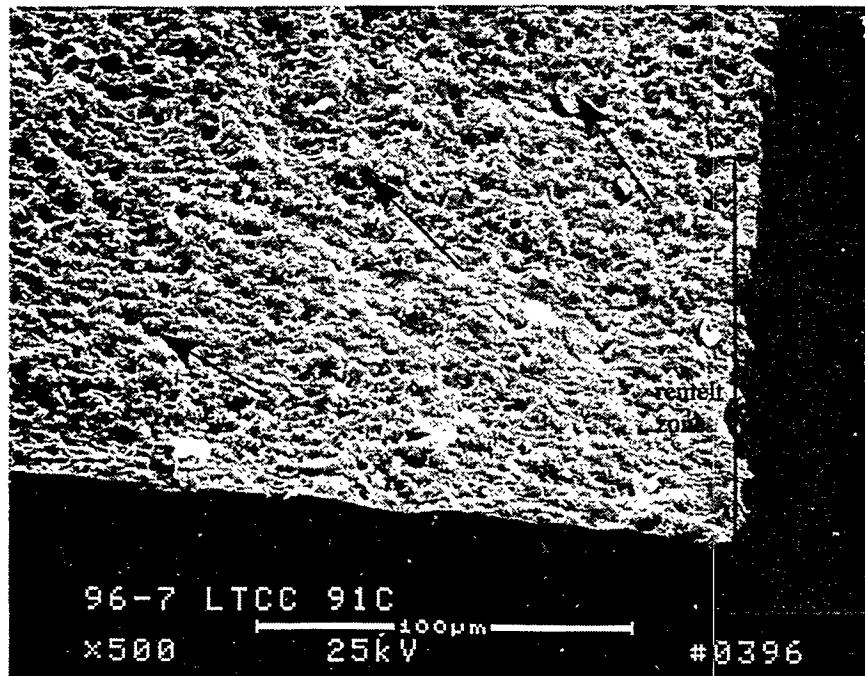
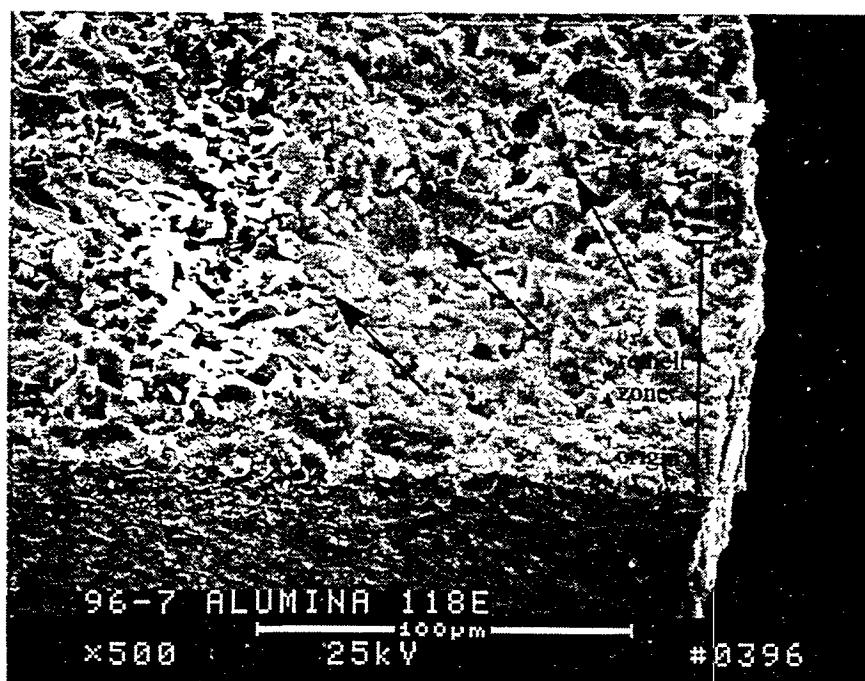
**Figure 6.** Fracture surface shows failure origin and remelt zone at origin.

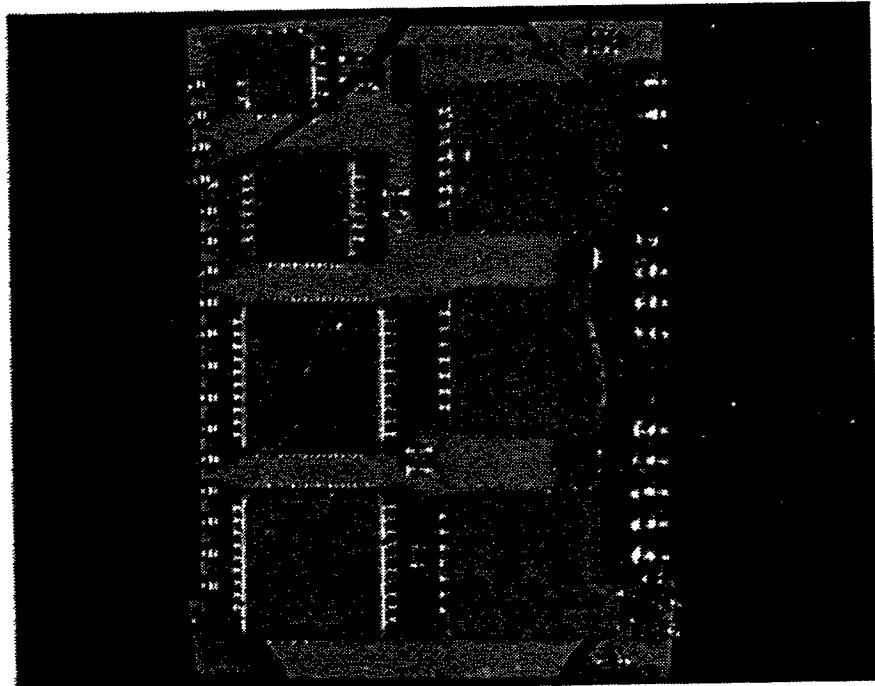
1. Fracture originated beneath a solder pad located at the corner of the LCC package on the front surface and ran through the plate thickness.
2. The fracture surface contains cantilever curl, a feature indicating that a bending load caused the failure.
3. Fracture origins are located on the substrate surface that would have been placed in tension in during the +z orientation 600-G shock test.
4. Small zones of fracture exist (Figure 10B) beneath the solder pads, which served as the failure origins for the catastrophic fracture during the 600-G level shock test.

**Figure 9A.** TV#8, front surface after fracture during 600-G level shock overtest.

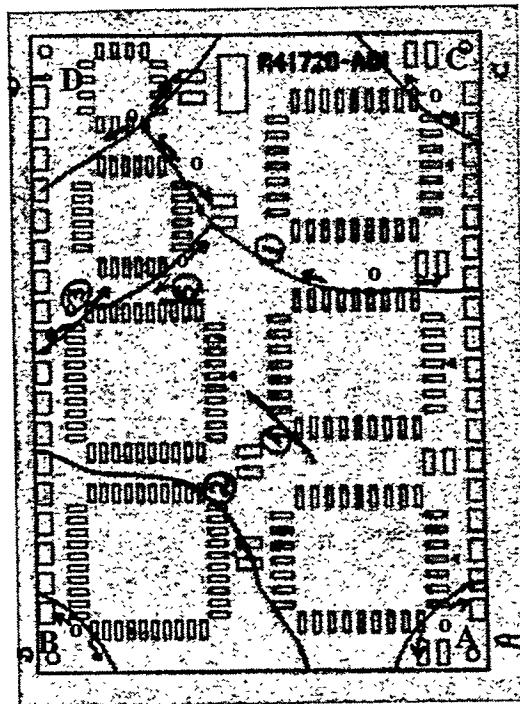
**Figure 9B.** Sketch of TV#8 shows all cracks observed in fractographic examination.

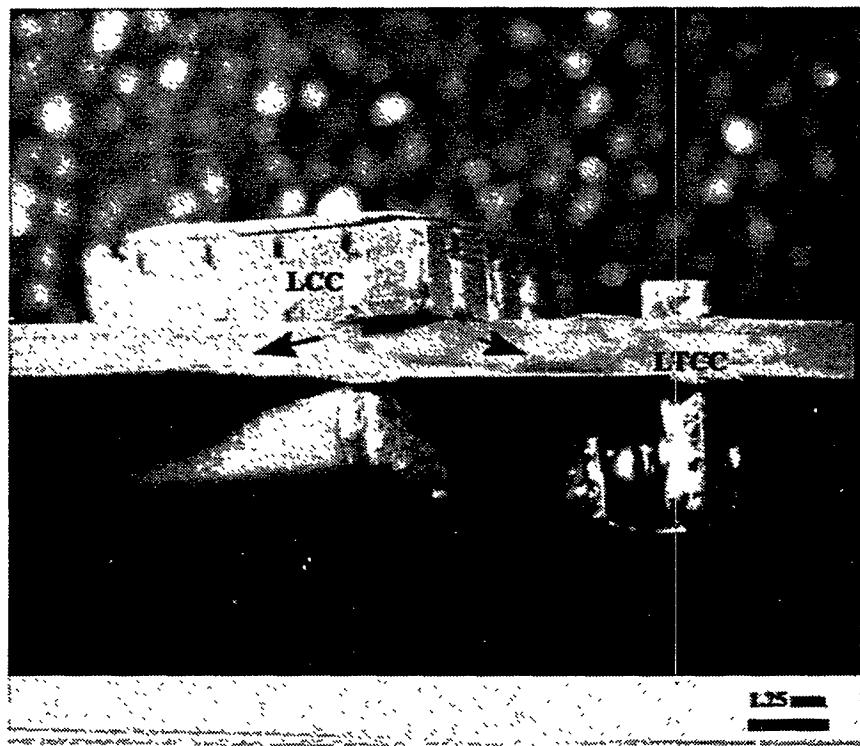
**Figure 10A.** Fracture surface of LTCC shows origins beneath LCC packages. Arrows indicate direction of crack propagation.

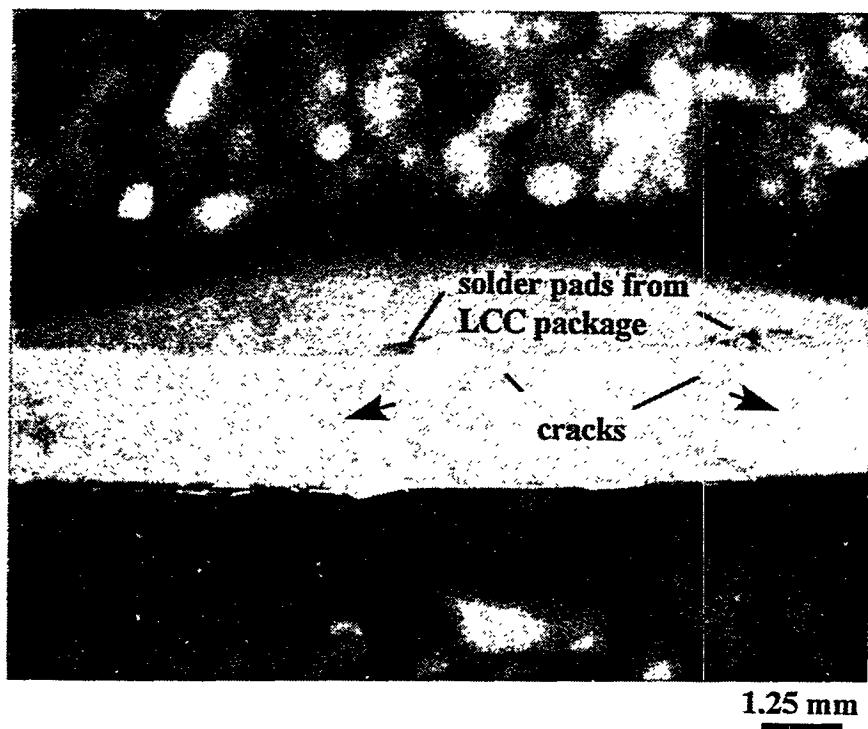
**Figure 10B.** Small cracks beneath LCC solder pads served as ultimate failure origins.

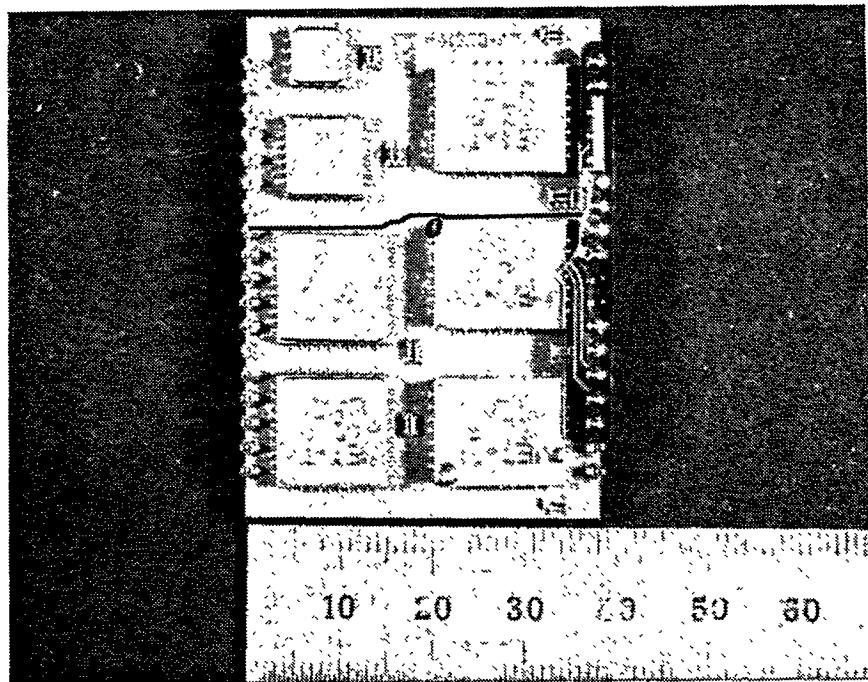
**Figure 11A.** A single mid-plane fracture caused failure in TV#24 after exposure to the long-term vibration environment. "o" marks the failure origin.

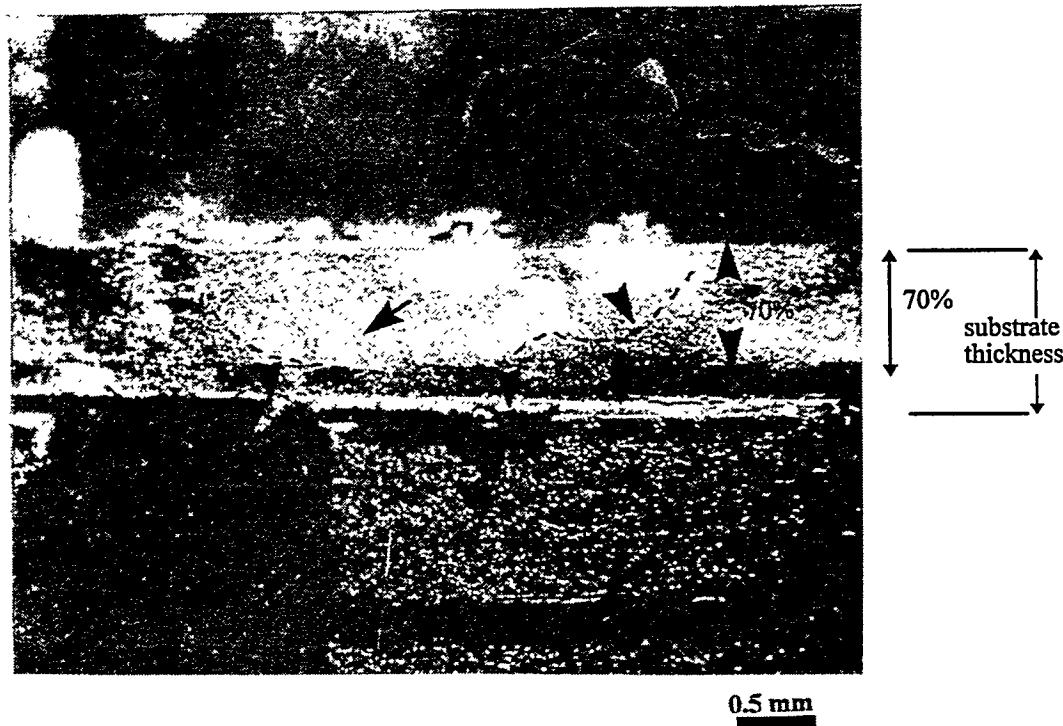
The coalesced crack extended roughly 70% through the substrate thickness as shown by arrows in Figure 11B. This crack did not intersect any conductor line until it propagated beyond 70% of the substrate thickness. Additional examination of the fracture surface revealed cantilever curl, a fracture feature typical of failure due to a bending load.

**Figure 11B.** Exposed fracture surface of TV #24 shows two bright areas on either side of "o". These small cracks extended to the position marked with a dashed line. The final failure, during long-term vibration testing, probably initiated from this very large defect.

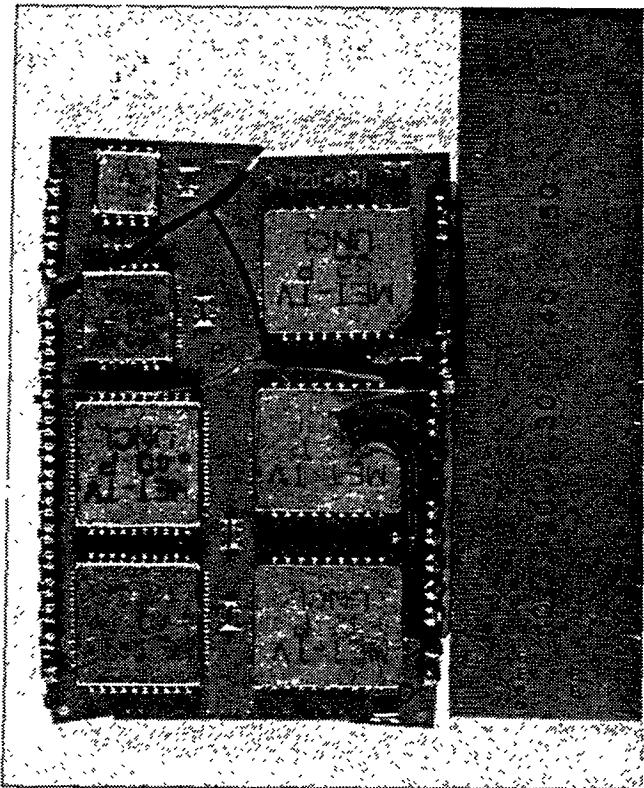
**Figure 12A.** S/N #2 shows fractured substrates after exposure to the 1250-G shock overtest level.

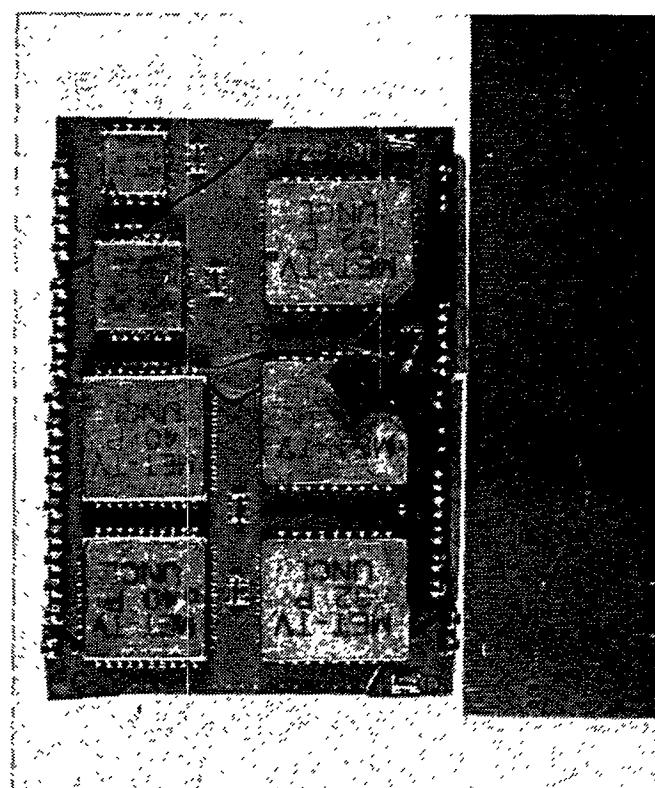
**Figure 12B.** S/N #3 fracture after exposure to 1250-G shock overtest level.

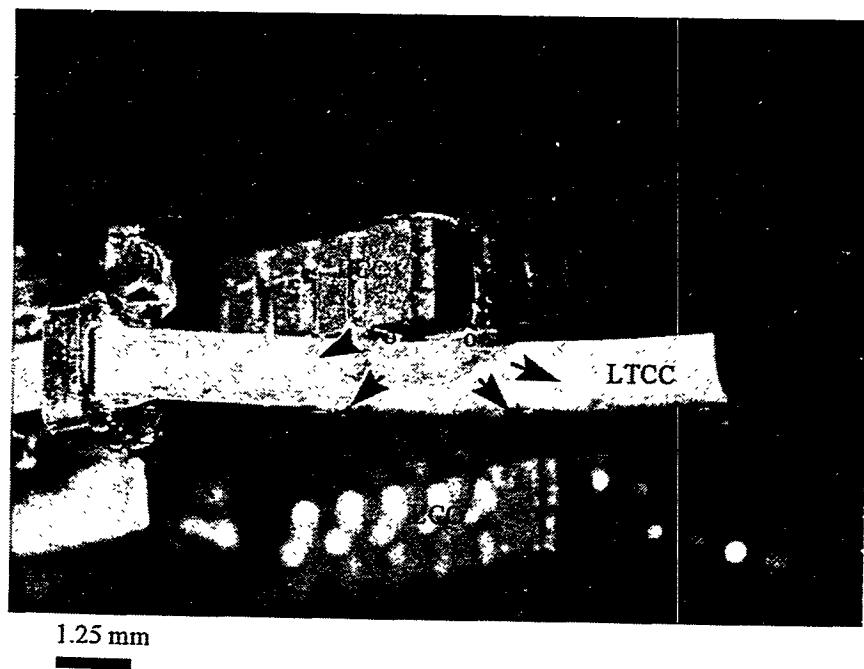
**Figure 12C.** Fracture surface of S/N #2, corner C, shows crack originated beneath the LCC at solder pads. The crack extended to the position indicated by the back of the arrows and propagated in the direction shown by arrow tips.

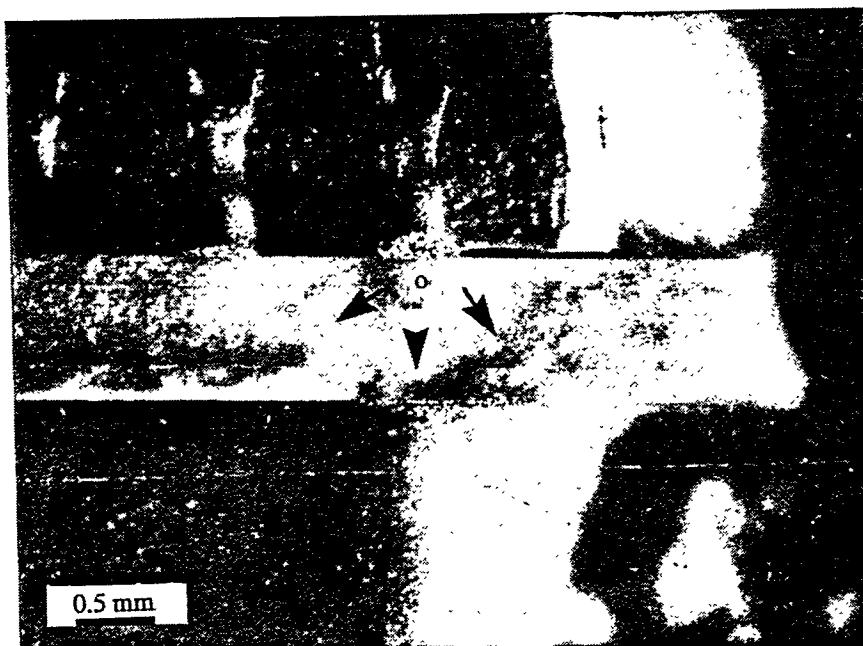
**Figure 14.** Fracture surface at corner of U4 LCC package from soldered+thermally cycled substrate. "o" marks the origin of fracture and arrows show the direction of crack propagation. No small cracks pre-existed in the intentionally fractured substrate. This is typical of all fracture surfaces examined in both the soldered only and soldered+thermally cycled substrates.

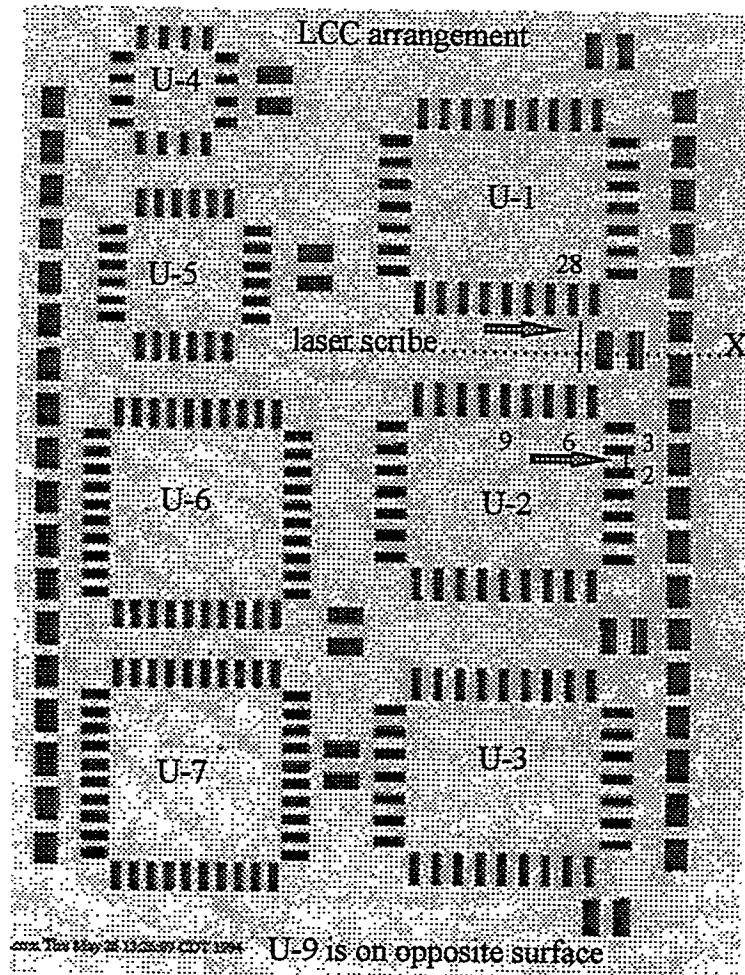
**Figure 15.** Schematic of front, arrows show locations of open electrical paths in TV#10.

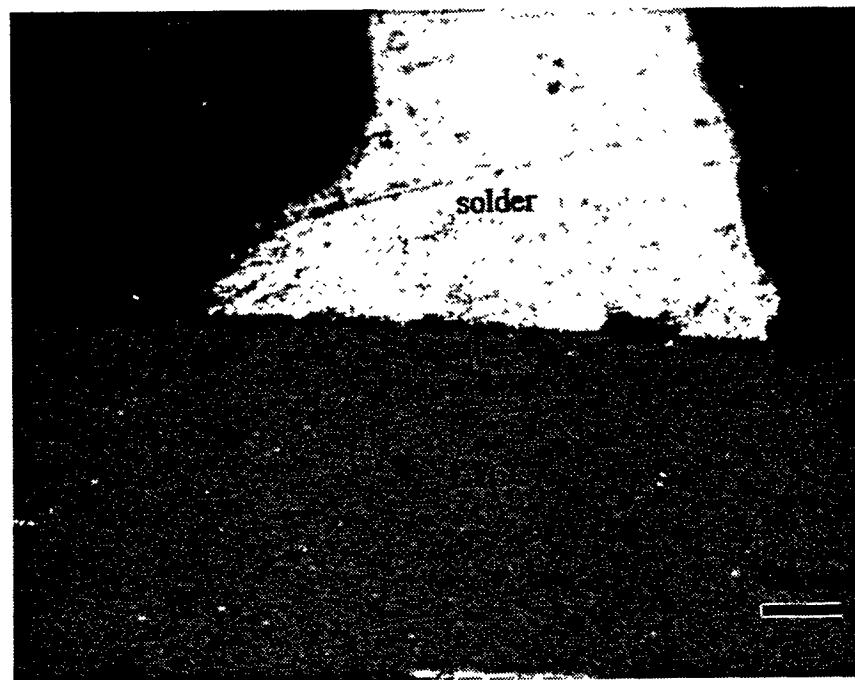
**Figure 16B.** Cross-section of solder joint at pin 6 shows gap between the LTCC and solder.

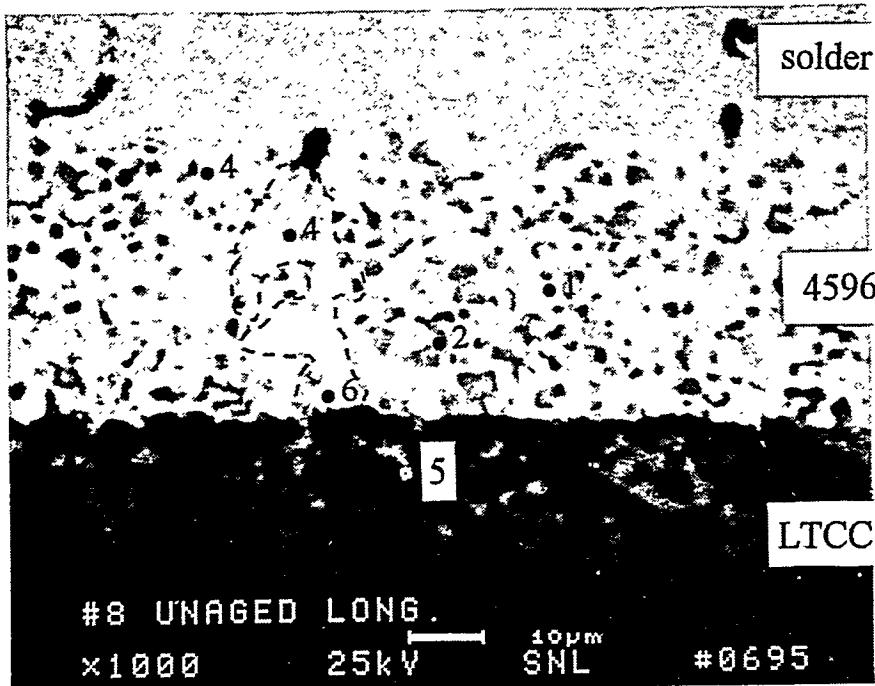
**Figure 22C.** High magnification of the interface shows solder moving to the LTCC through porosity (6) in the 4596 metallization and development of some intermetallic (4) during the solder process.

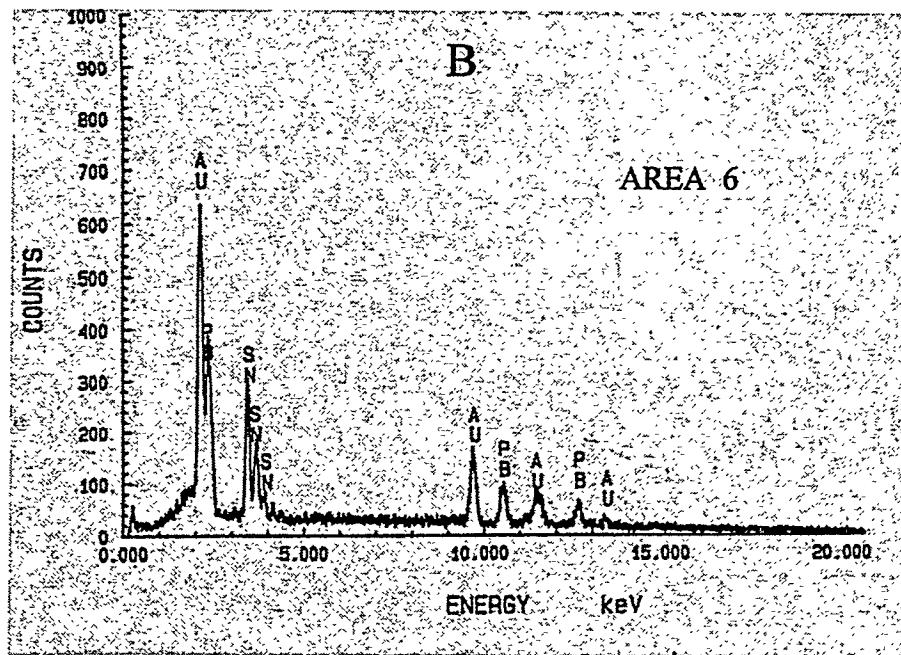
EDS spectra, shown in Figure 23B, area 6, contains Au, Sn and Pb, indicating that solder physically penetrated into the Au-Pt metallization, in some cases extending to LTCC interface. Because the penetration of the solder was not as a continuous front, this is strong evidence that excessive porosity existed in the DuPont 4596 metallization layer prior to the solder operation.

**Figure 23B.** EDS spectra shows some Pb with the intermetallic, suggesting that the 4596 metallization was sufficiently porous to allow solder to penetrate to the LTCC interface.

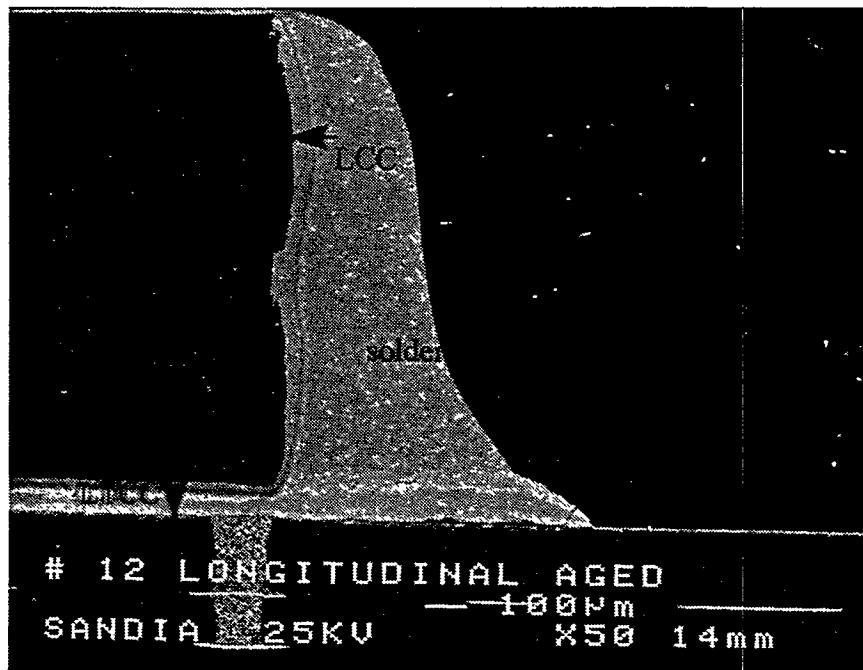
**Figure 24A.** Crack is evident in toe of solder.

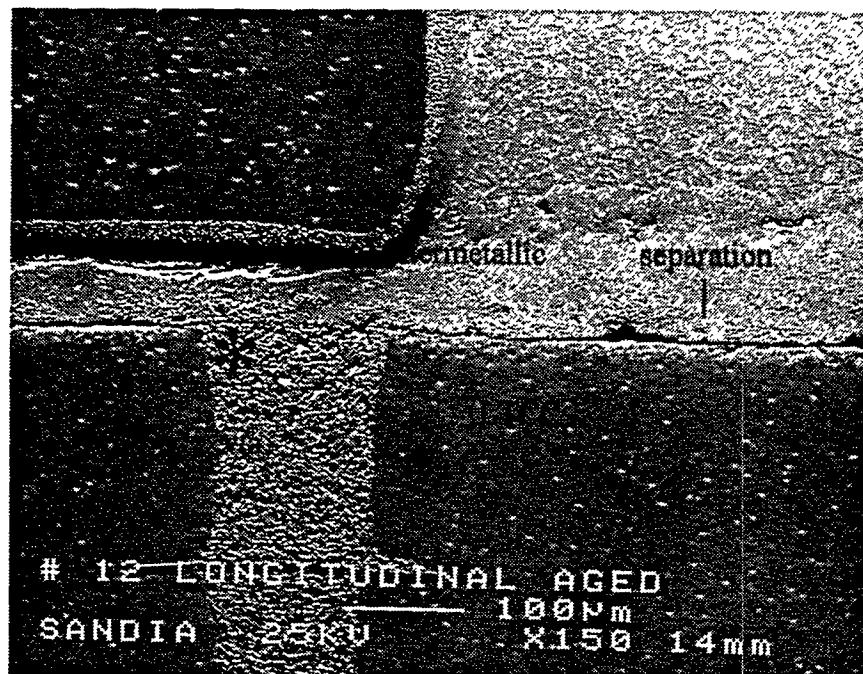
**Figure 24B.** The only continuity between the LTCC and LCC is through the via (\*).

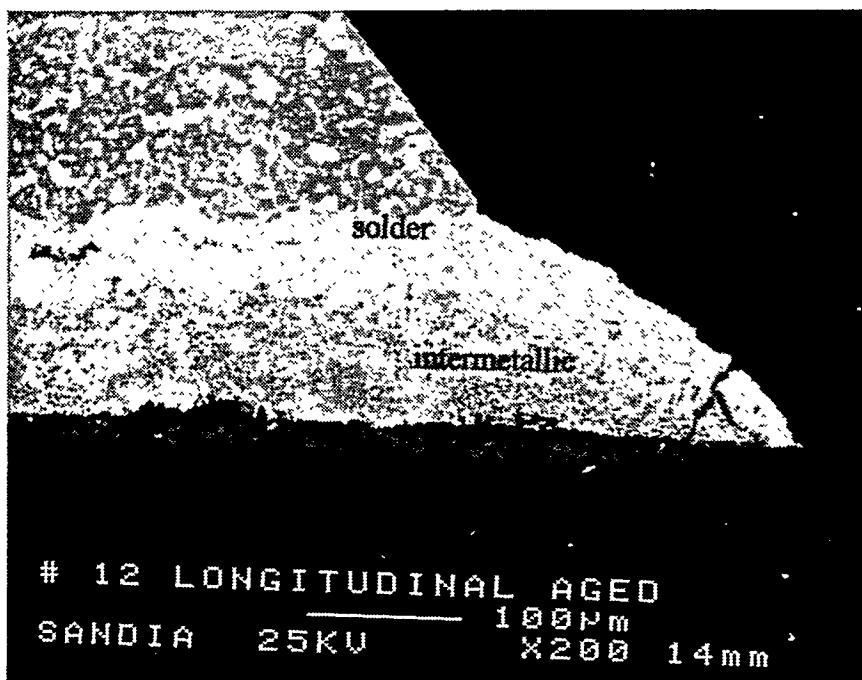
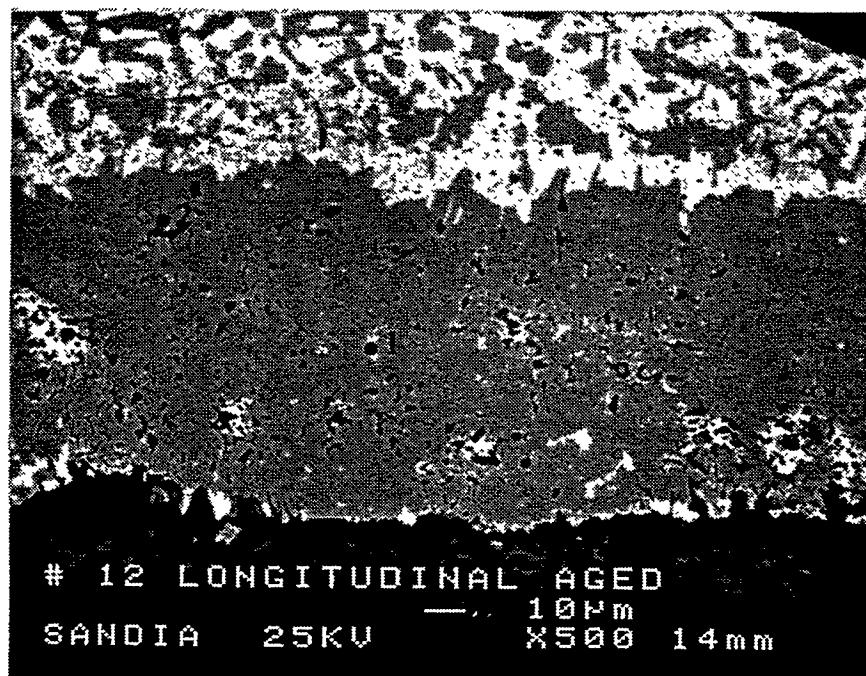
**Figure 24C and D.** Intermetallic has completely consumed the 4596 metallization.

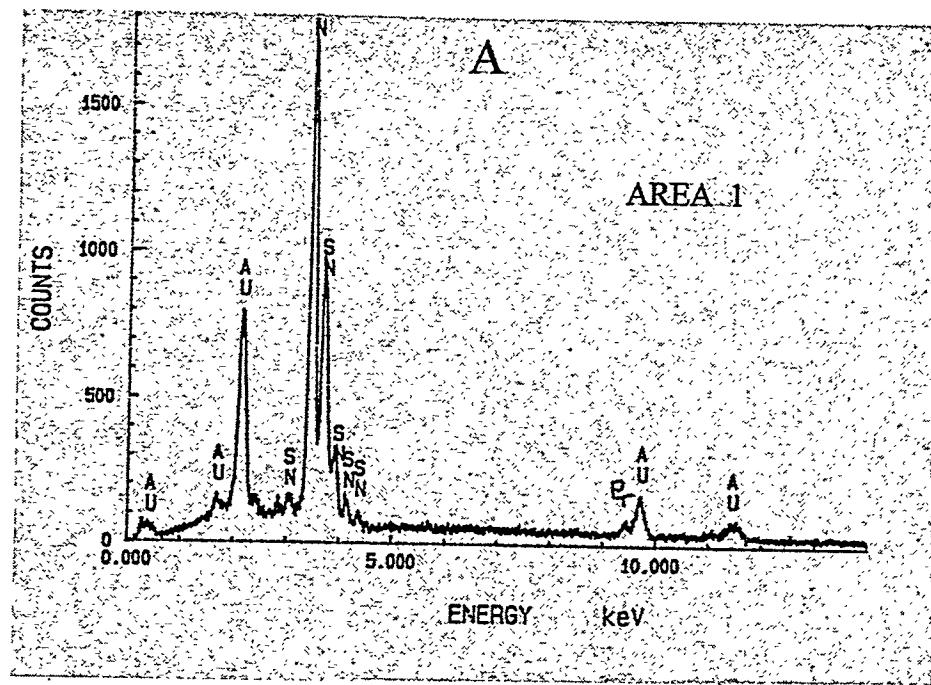
**Figure 25A.** EDS spectra of intermetallic material developed between the solder and LTCC, its formation consumed most of the 4596 metallization.

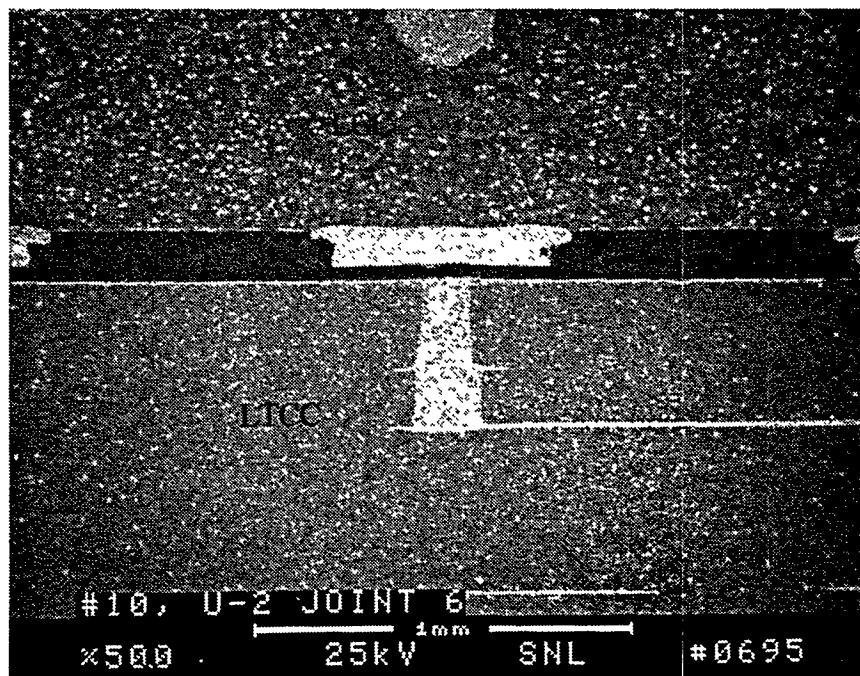
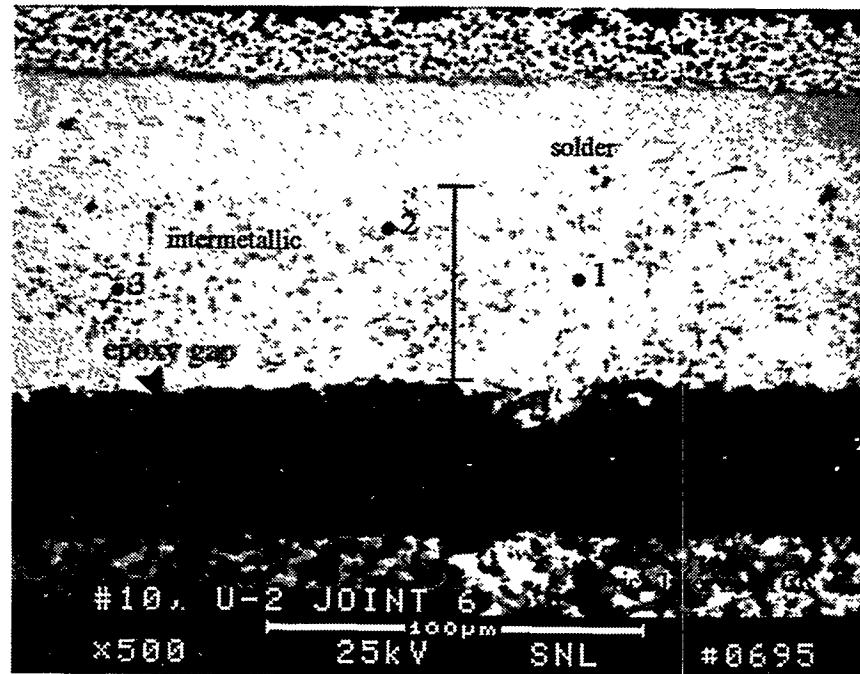
**Figure 26A and B.** TV#10, LCC package U-2. A and B are micrographs of pin 6 where the electrical open was observed.

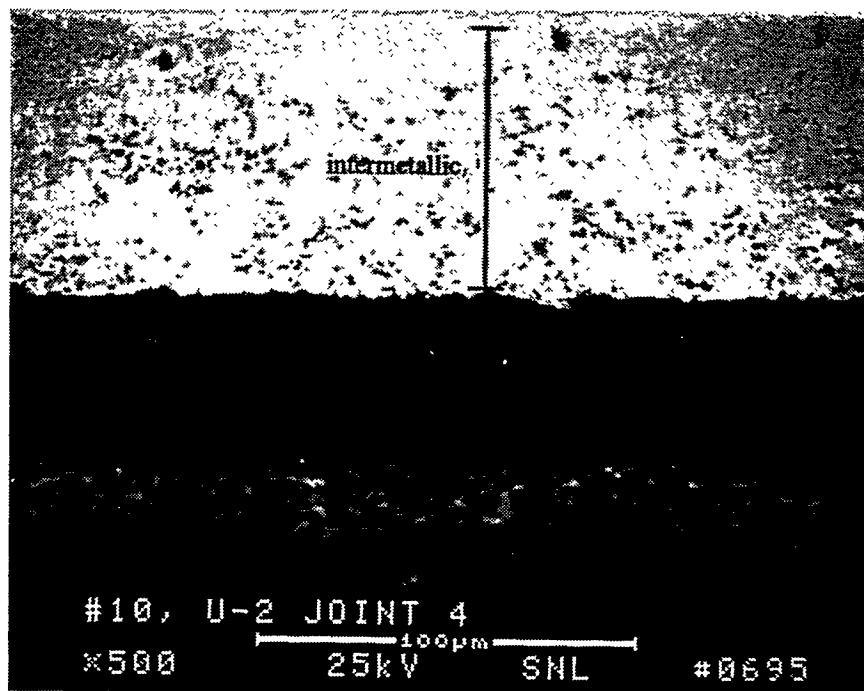
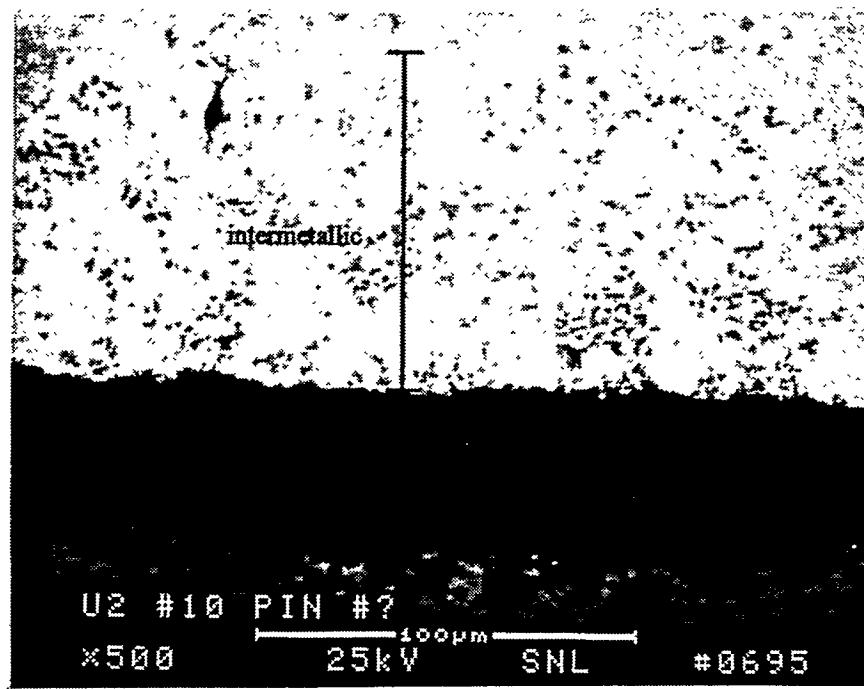
**Figure 26C and D.** C and D are cross-sections of two other pins on U-2 shows thickness of the intermetallic.
