# ENRICO FERMI ATOMIC POWER PLANT

## CURRENT EXPERIENCE SERIES

### COMPILED OF CURRENT TECHNICAL EXPERIENCE AT ENRICO FERMI ATOMIC POWER PLANT

APRIL 1968

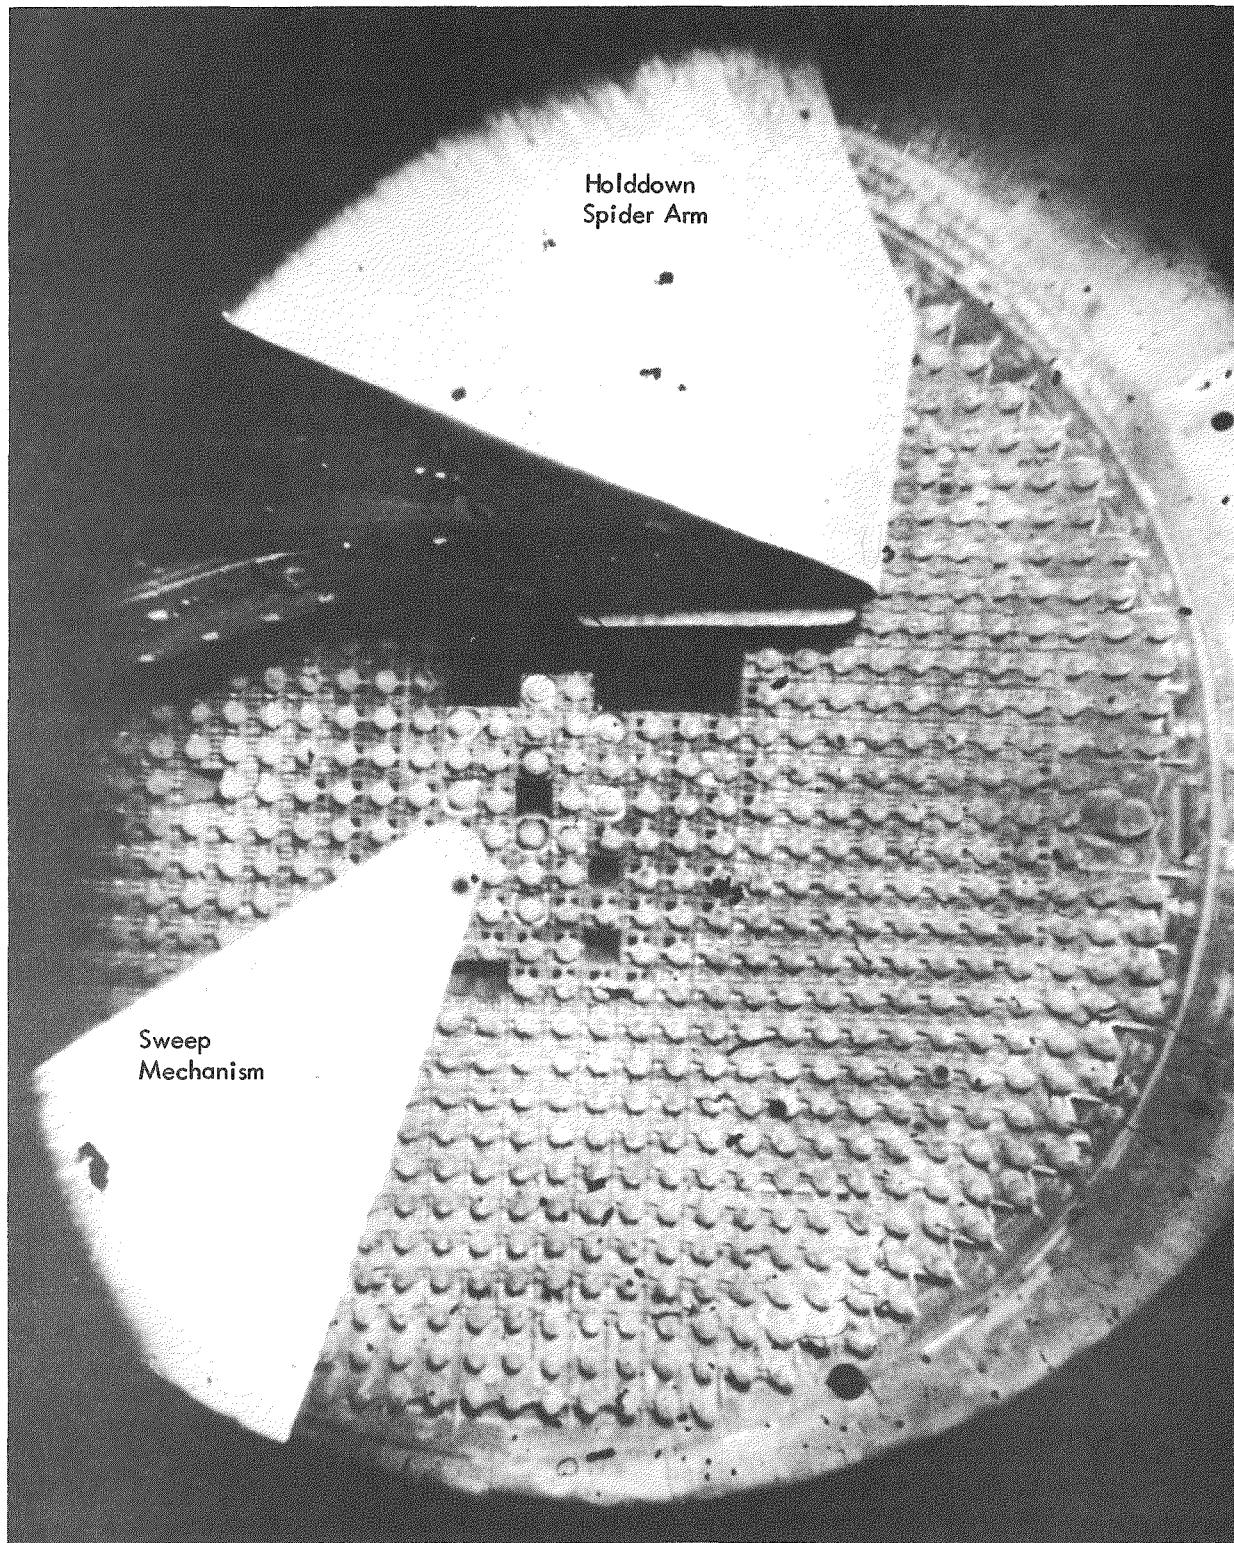
Figures 1 through 7 are representative of photographs obtained of details in the upper reactor compartment and of the support plate. There were no loose or foreign objects sighted in the upper reactor compartment, nor was there any evidence of damage except the condition of the orifice retainer spring fingers in lattice position NO7-POQ. As can be seen in Figure 7, several of the orifice retainer springs in NO7-POO appear to be bent, presumably resulting from insertion of the spherical mirror support post (see inset photograph) in this position.\* Viewing revealed no evidence of erosion of core subassembly seating surfaces due to sodium leakage around subassembly nozzles. Photographs such as shown in Figure 6 were not sharp enough to confirm this, however.

FIG. 1 REACTOR CORE AND BLANKET LATTICE

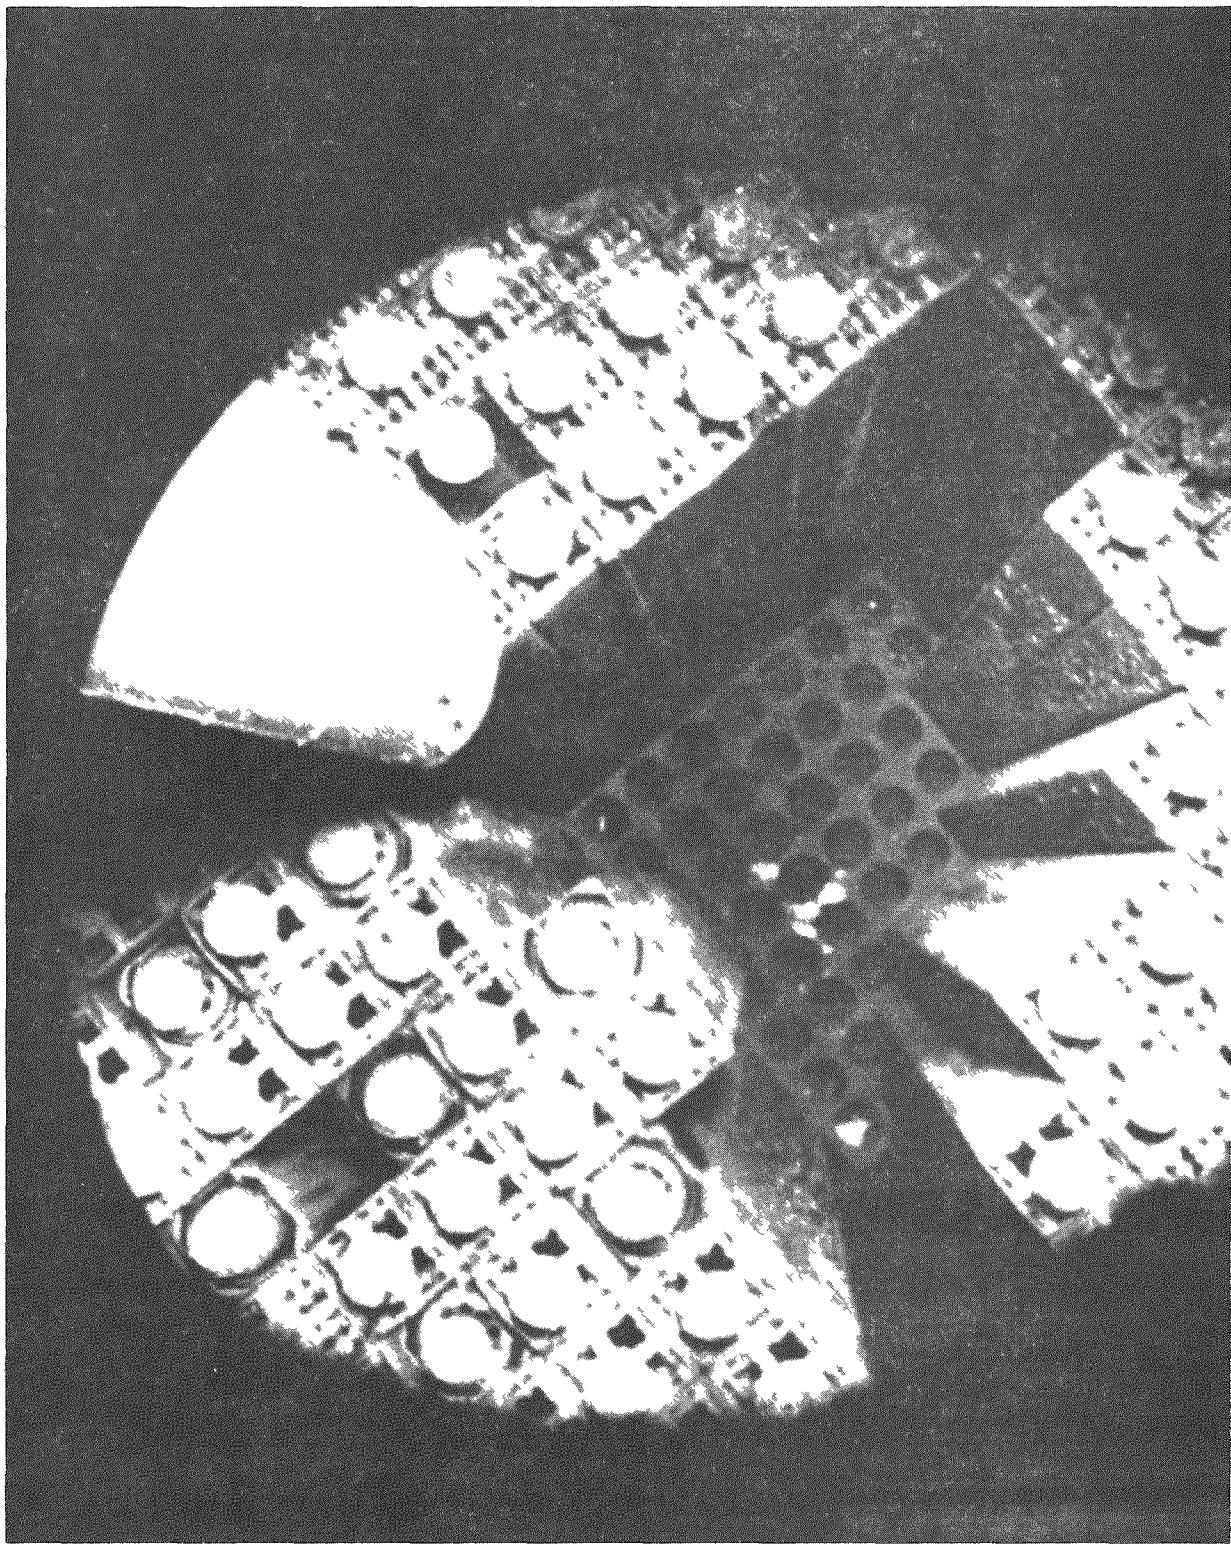
FIG. 2 CANYON IN EAST SIDE OF REACTOR CORE AND BLANKET LATTICE

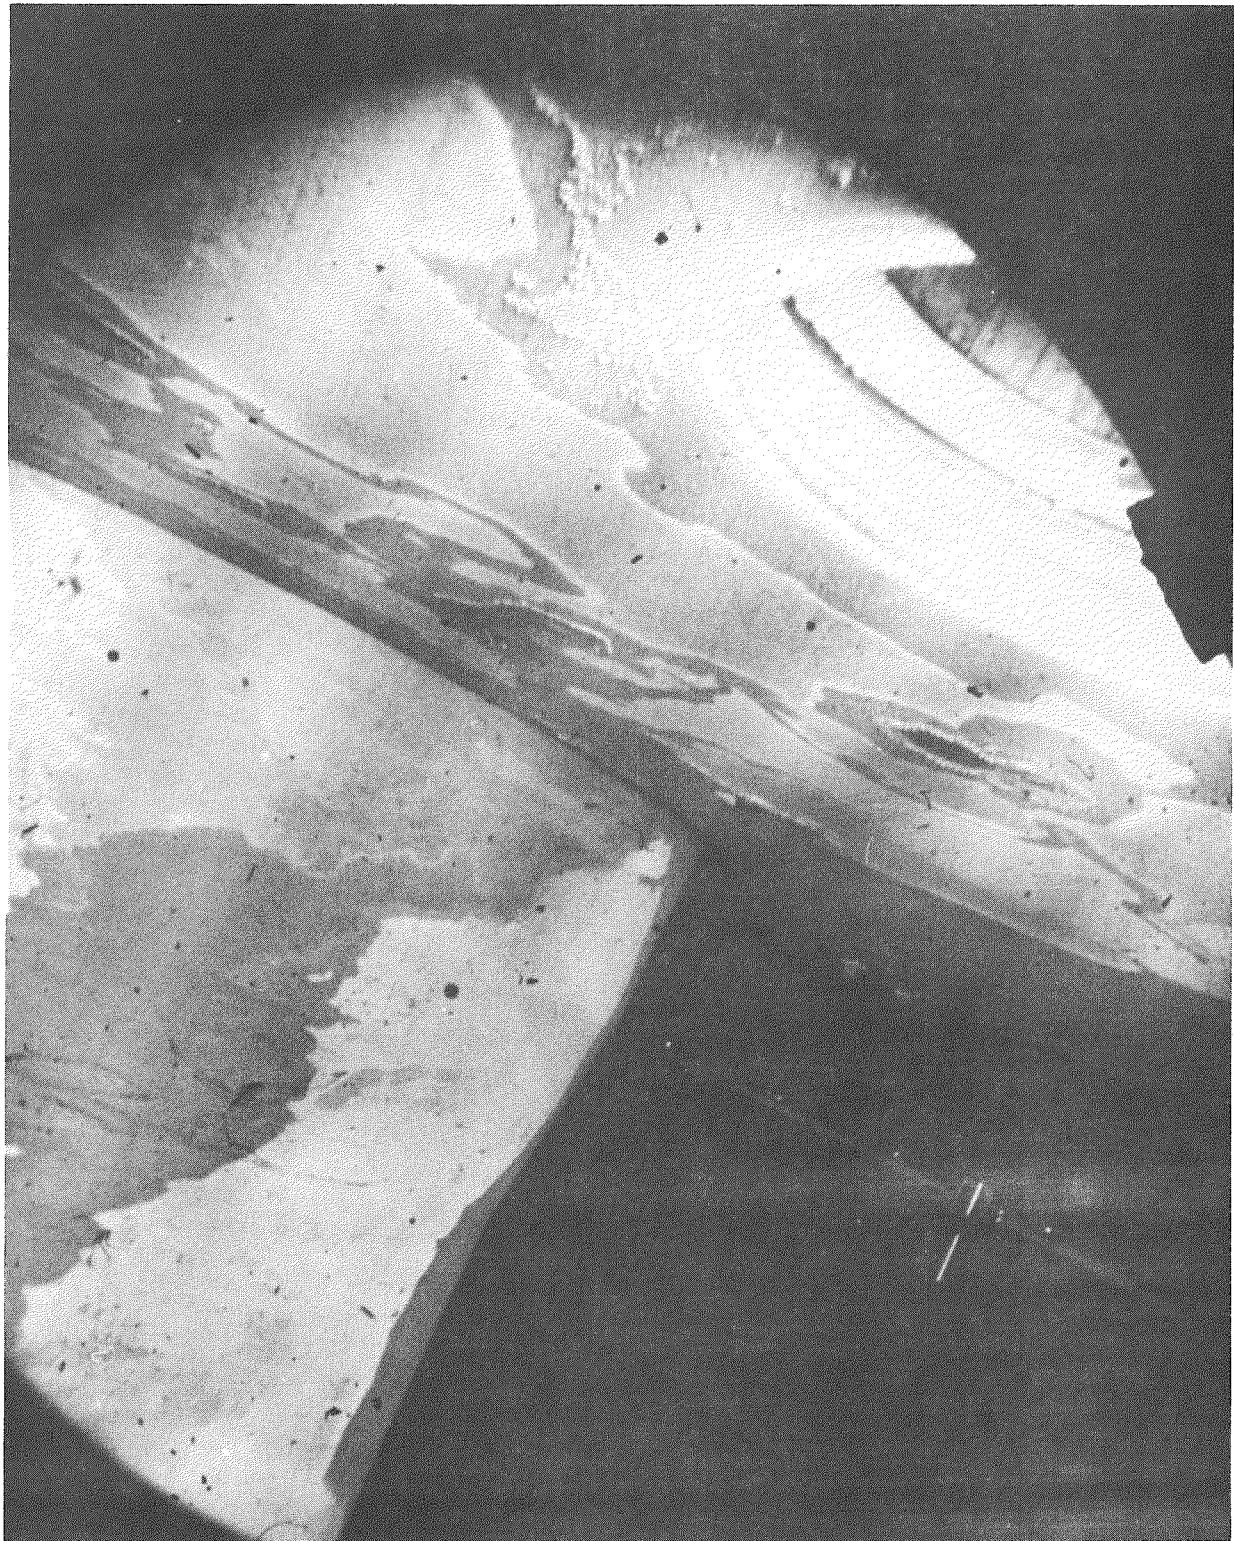
**FIG. 3 UNDERSIDE OF ROTATING SHIELD PLUG NEAR HOLD DOWN  
AND PENETRATION THROUGH ROTATING PLUG**

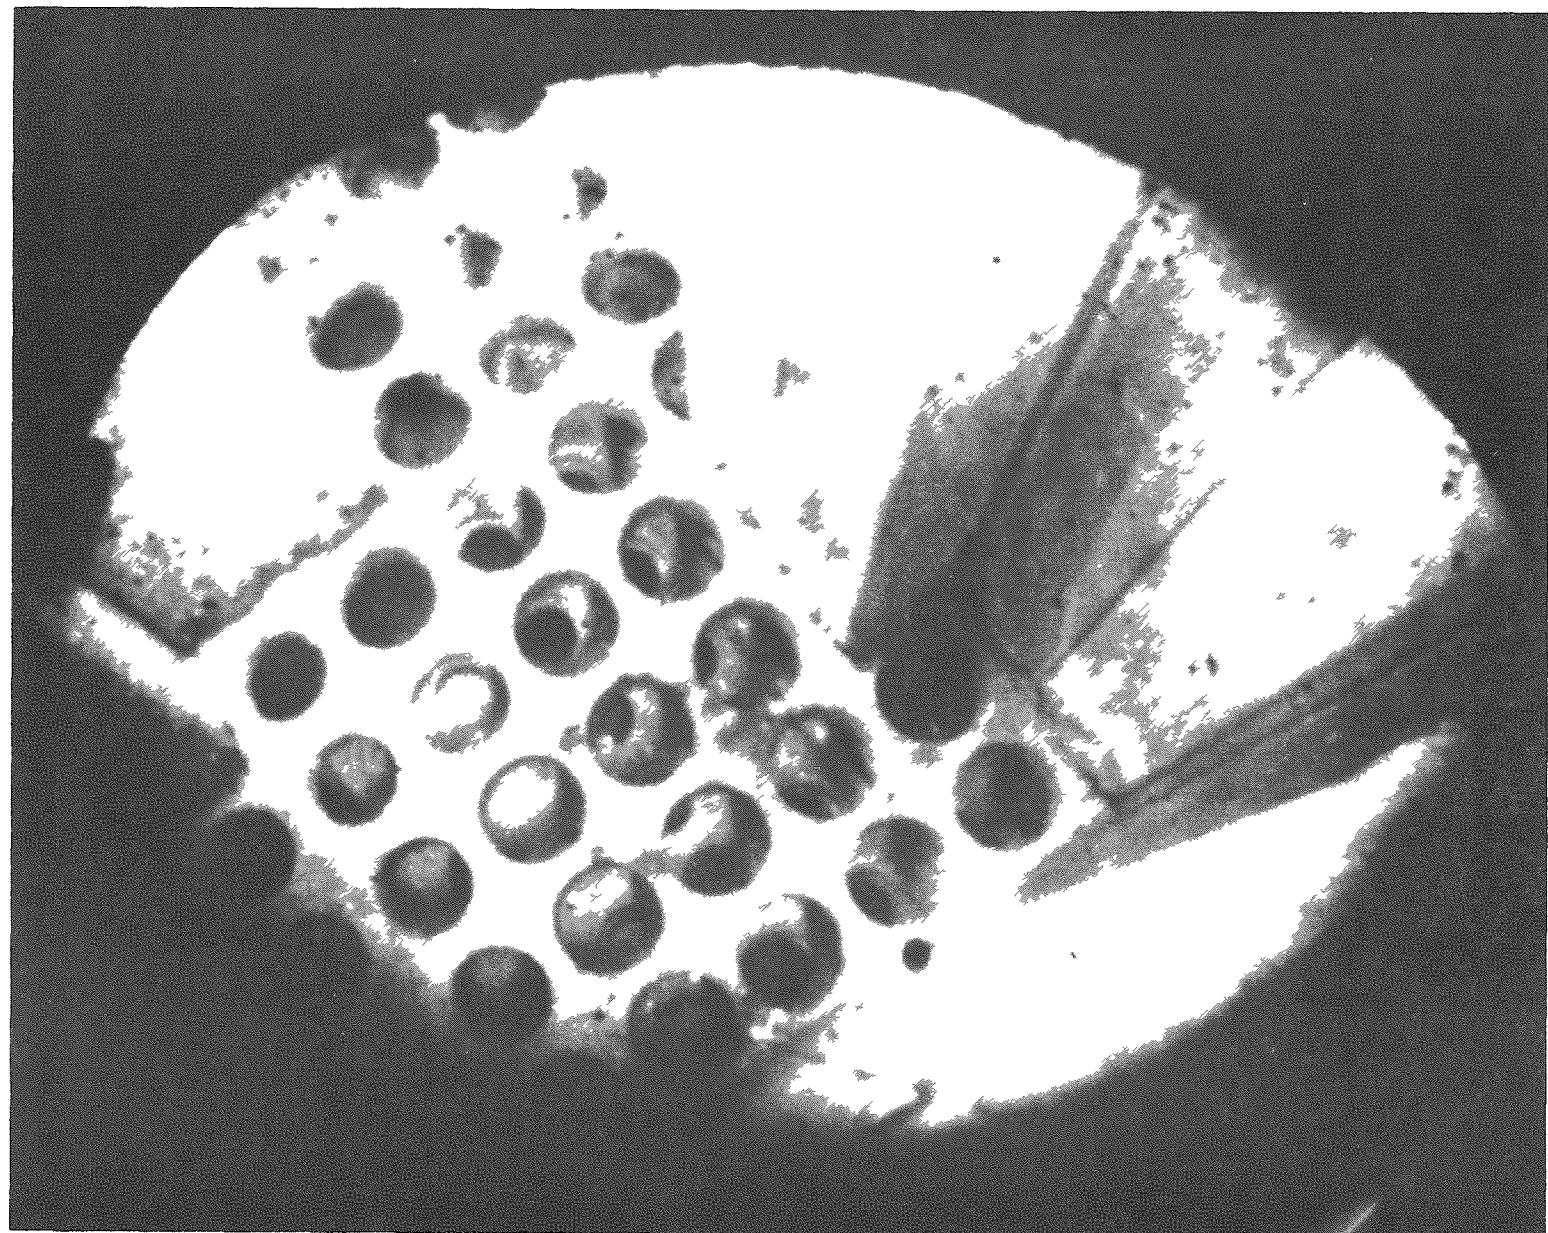
FIG. 4 CLOSE-UP OF SUPPORT PLATE

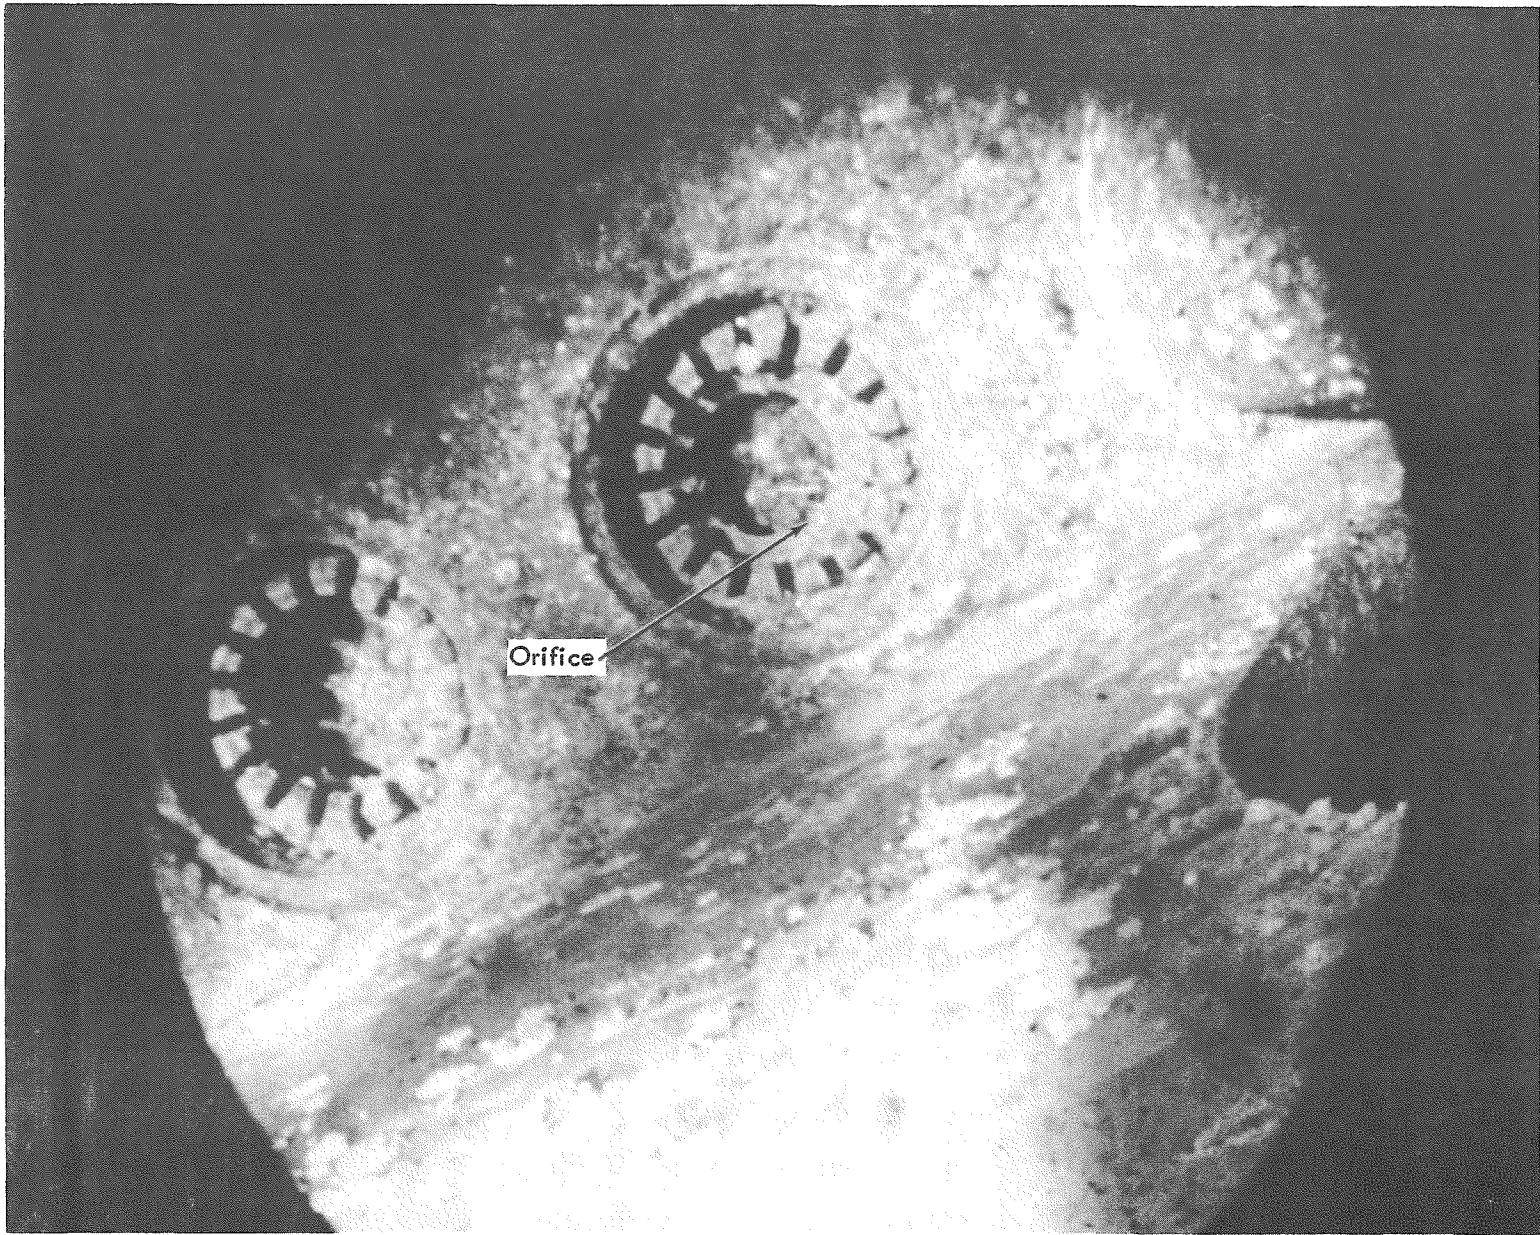
FIG. 5 ORIFICES IN BLANKET POSITIONS IN LOWER SUPPORT PLATE

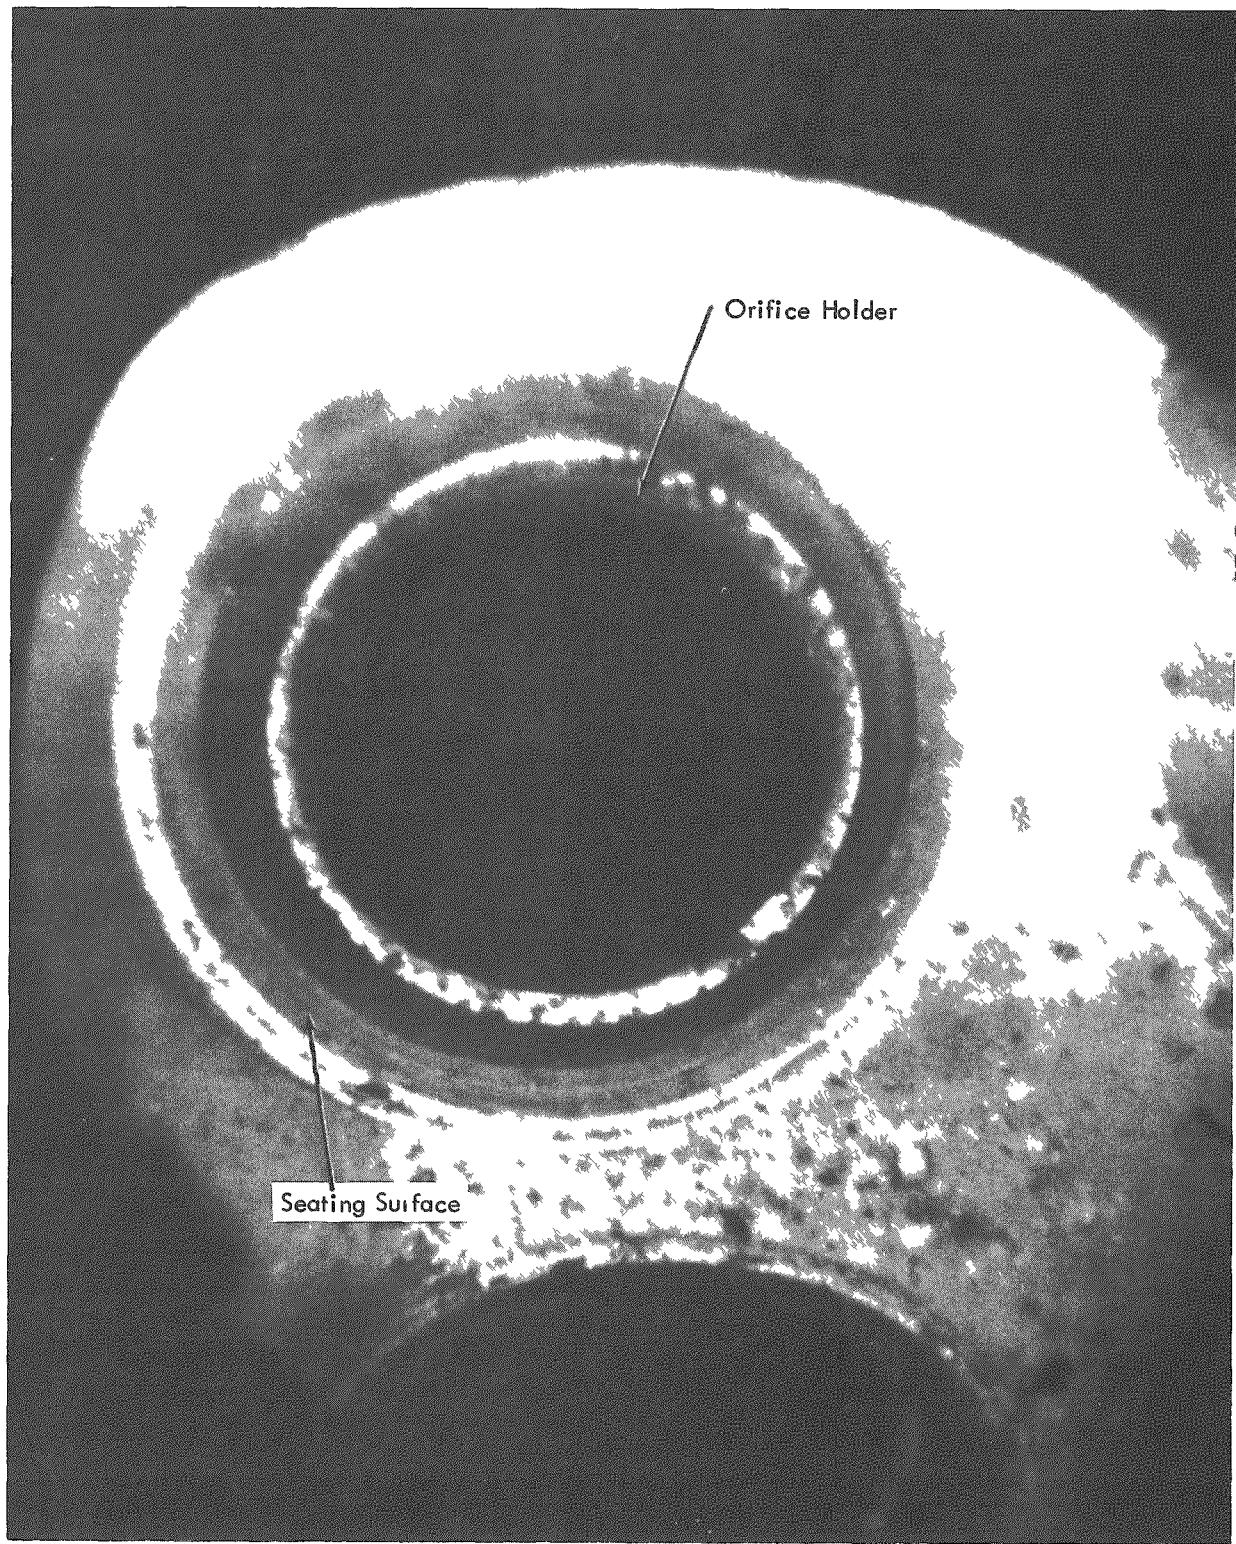
**FIG. 6 SEATING SURFACE IN LOWER SUPPORT PLATE FOR CORE SUBASSEMBLY NOZZLE**

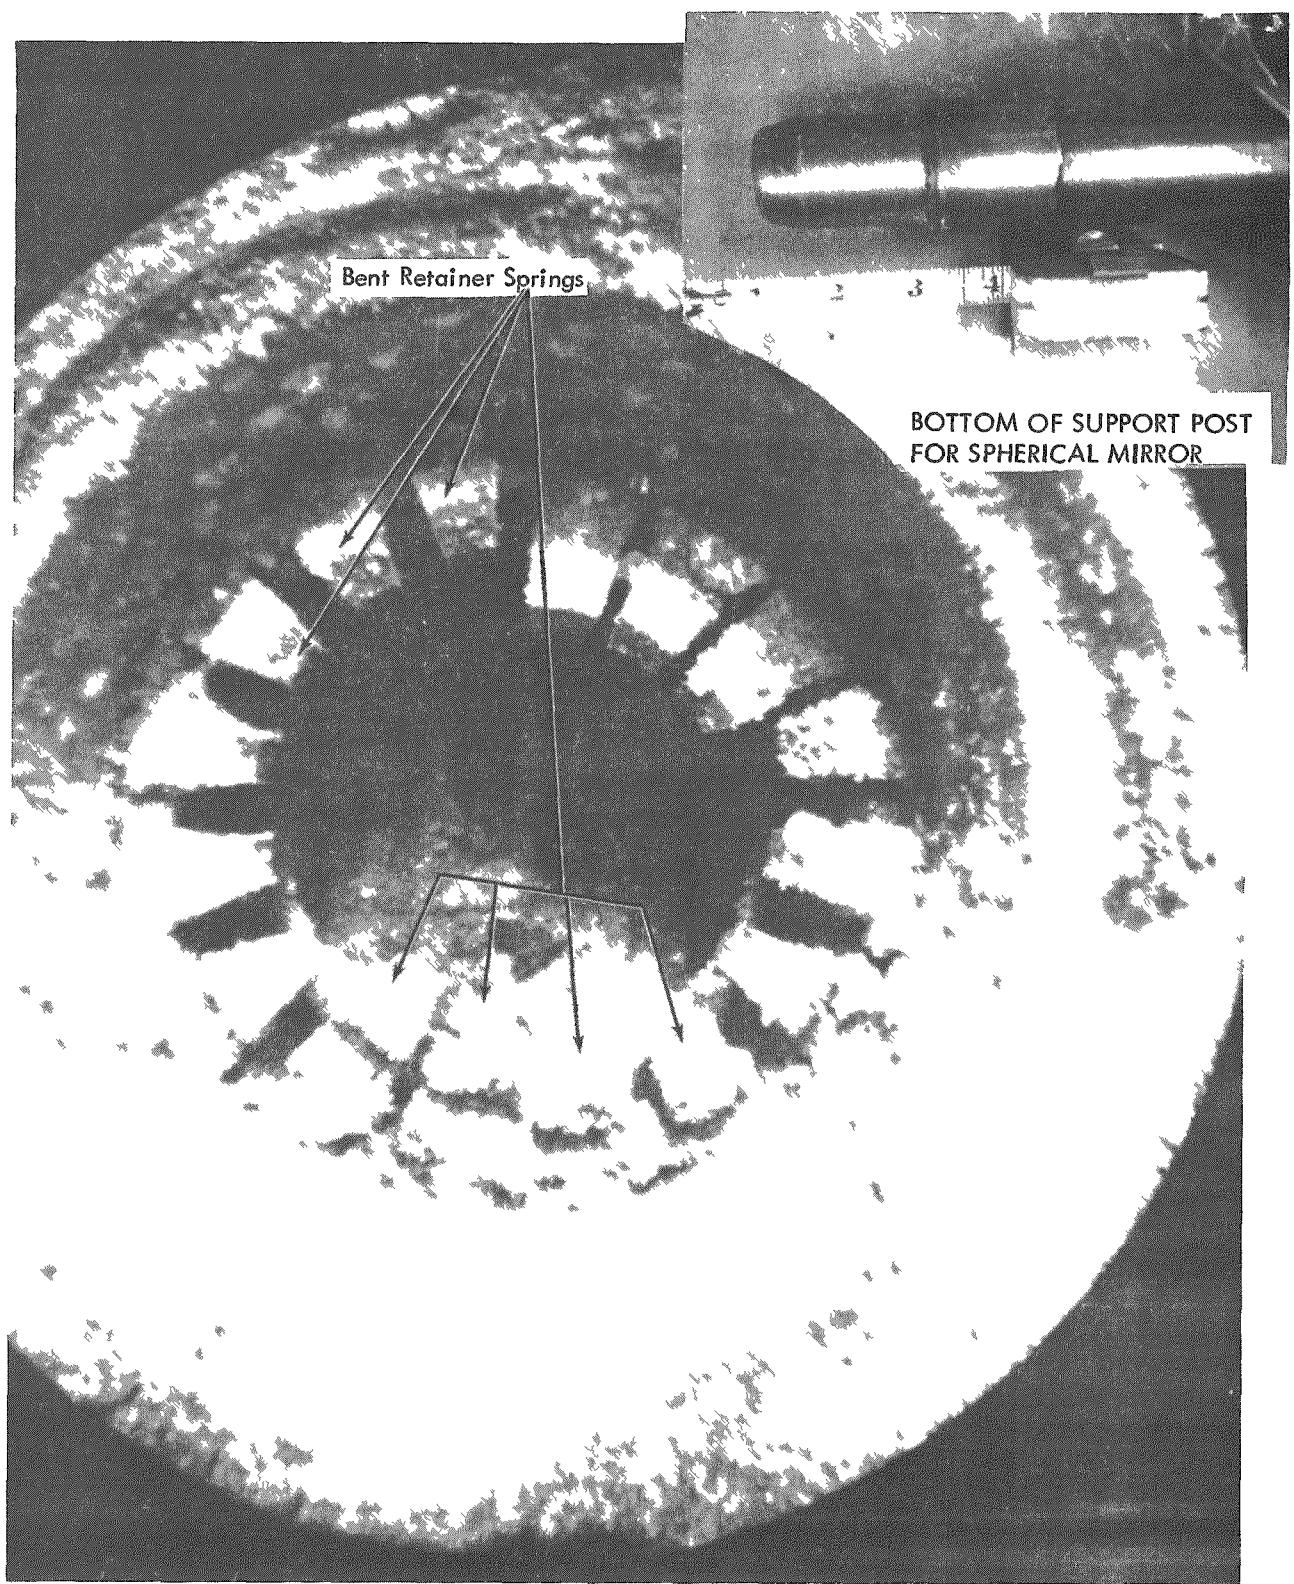
**FIG. 7 BENT ORIFICE RETAINER SPRINGS IN BLANKET POSITION  
N07-P00 IN LOWER SUPPORT PLATE**

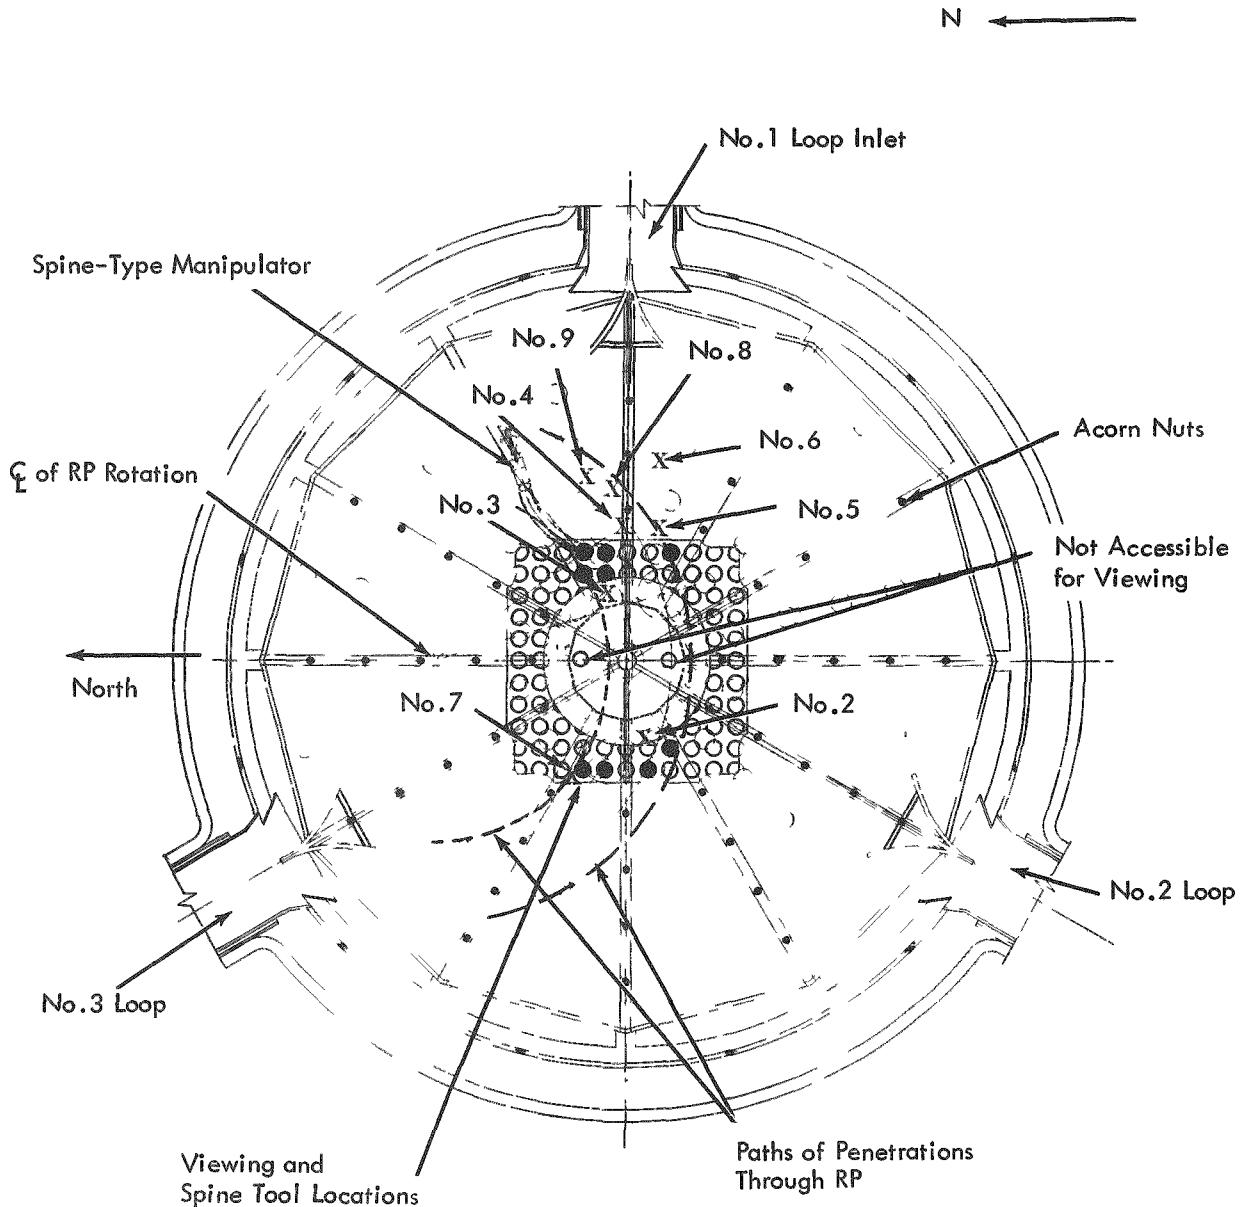
All but two of the acorn nuts fastening the batten strips which cover the joints between sections of the zirconium liner were viewed and found to be properly in place. The positions of the innermost nuts immediately north and south of the center of the plenum were not accessible for viewing because of sweep mechanism and subassembly interference, as indicated in Figure 8.

FIG. 8 LOCATIONS OF SMALL UFOs DISCOVERED IN INLET PLENUM

It is interesting to note that, as can be seen in Figure 8, all the UFOs were found in the path of the rotating plug penetrations. From a subsequent inspection of the borescope, it appears likely that the aluminum UFOs resulted from interferences between the Type 6061 aluminum borescope and light tubes and the walls of the rotating shield plug penetrations or the penetration seals.

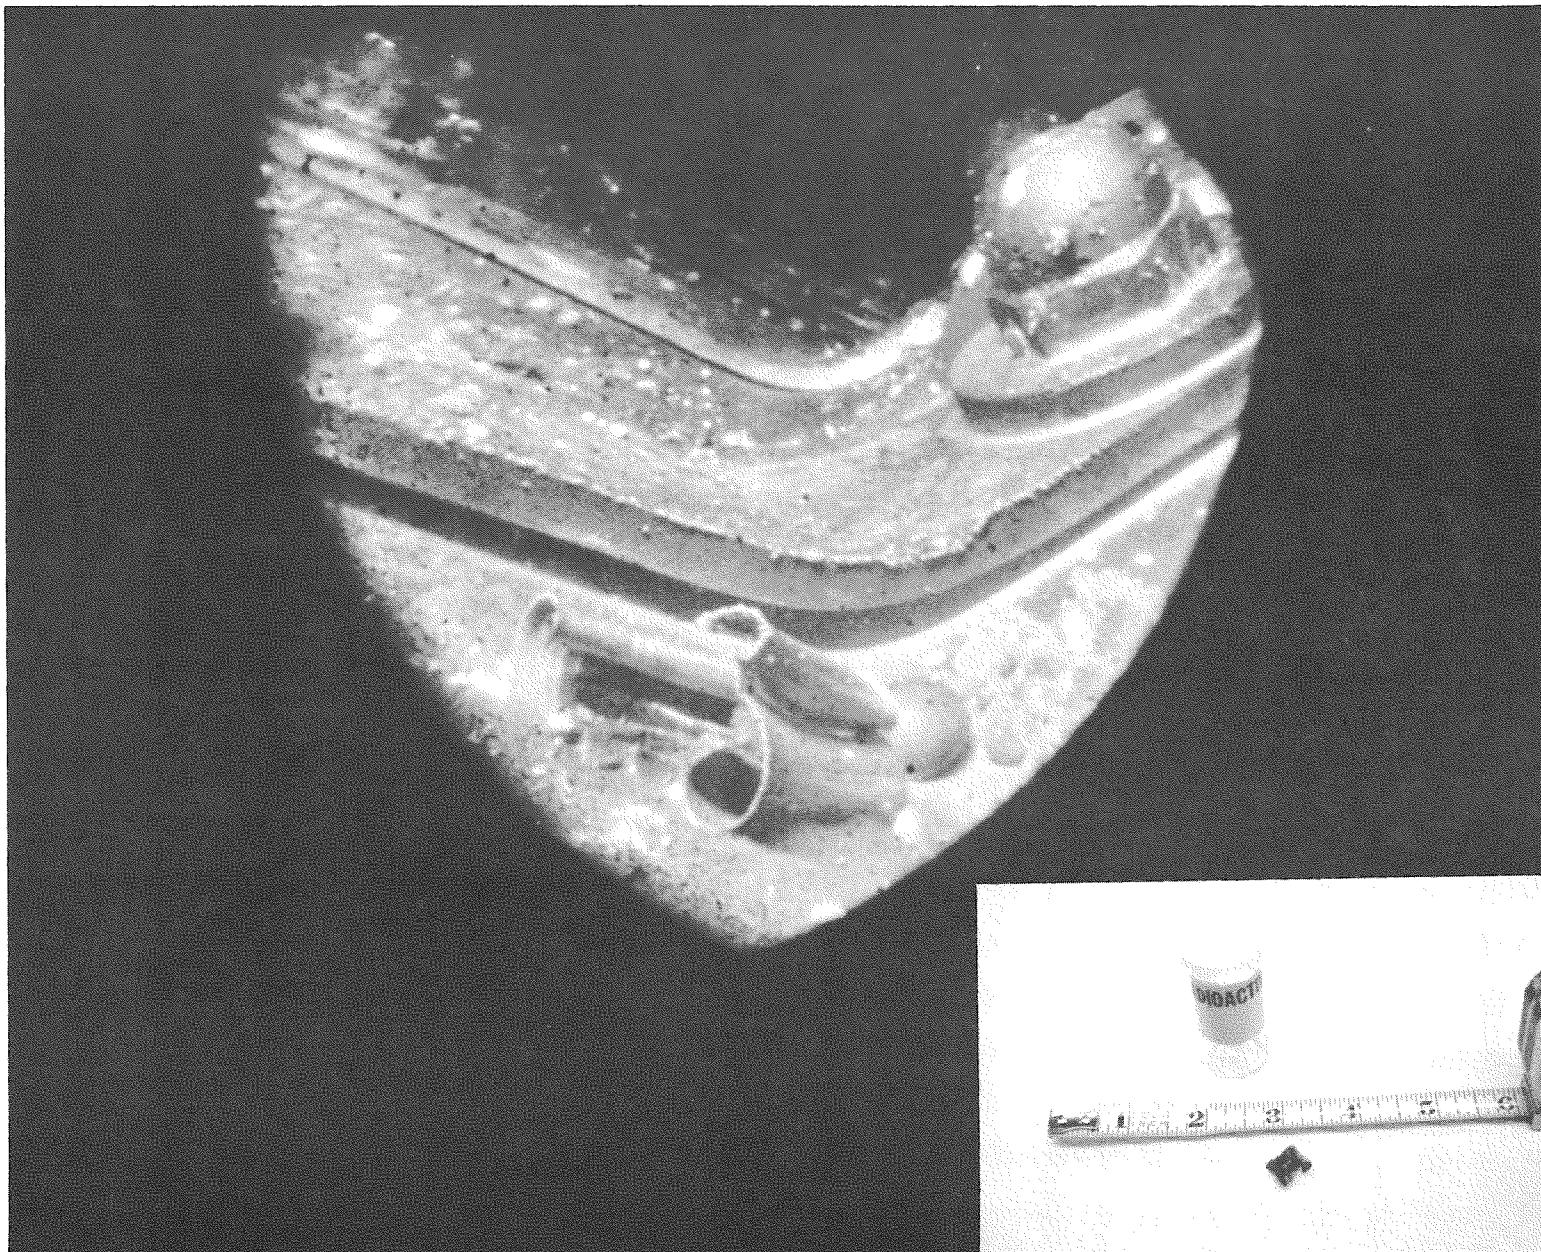
No. 2 (Figure 9) and 4 were removed from the reactor and determined by analysis to be Type 6061 aluminum.

FIG. 9 UFO NO. 2 IN INLET PLENUM

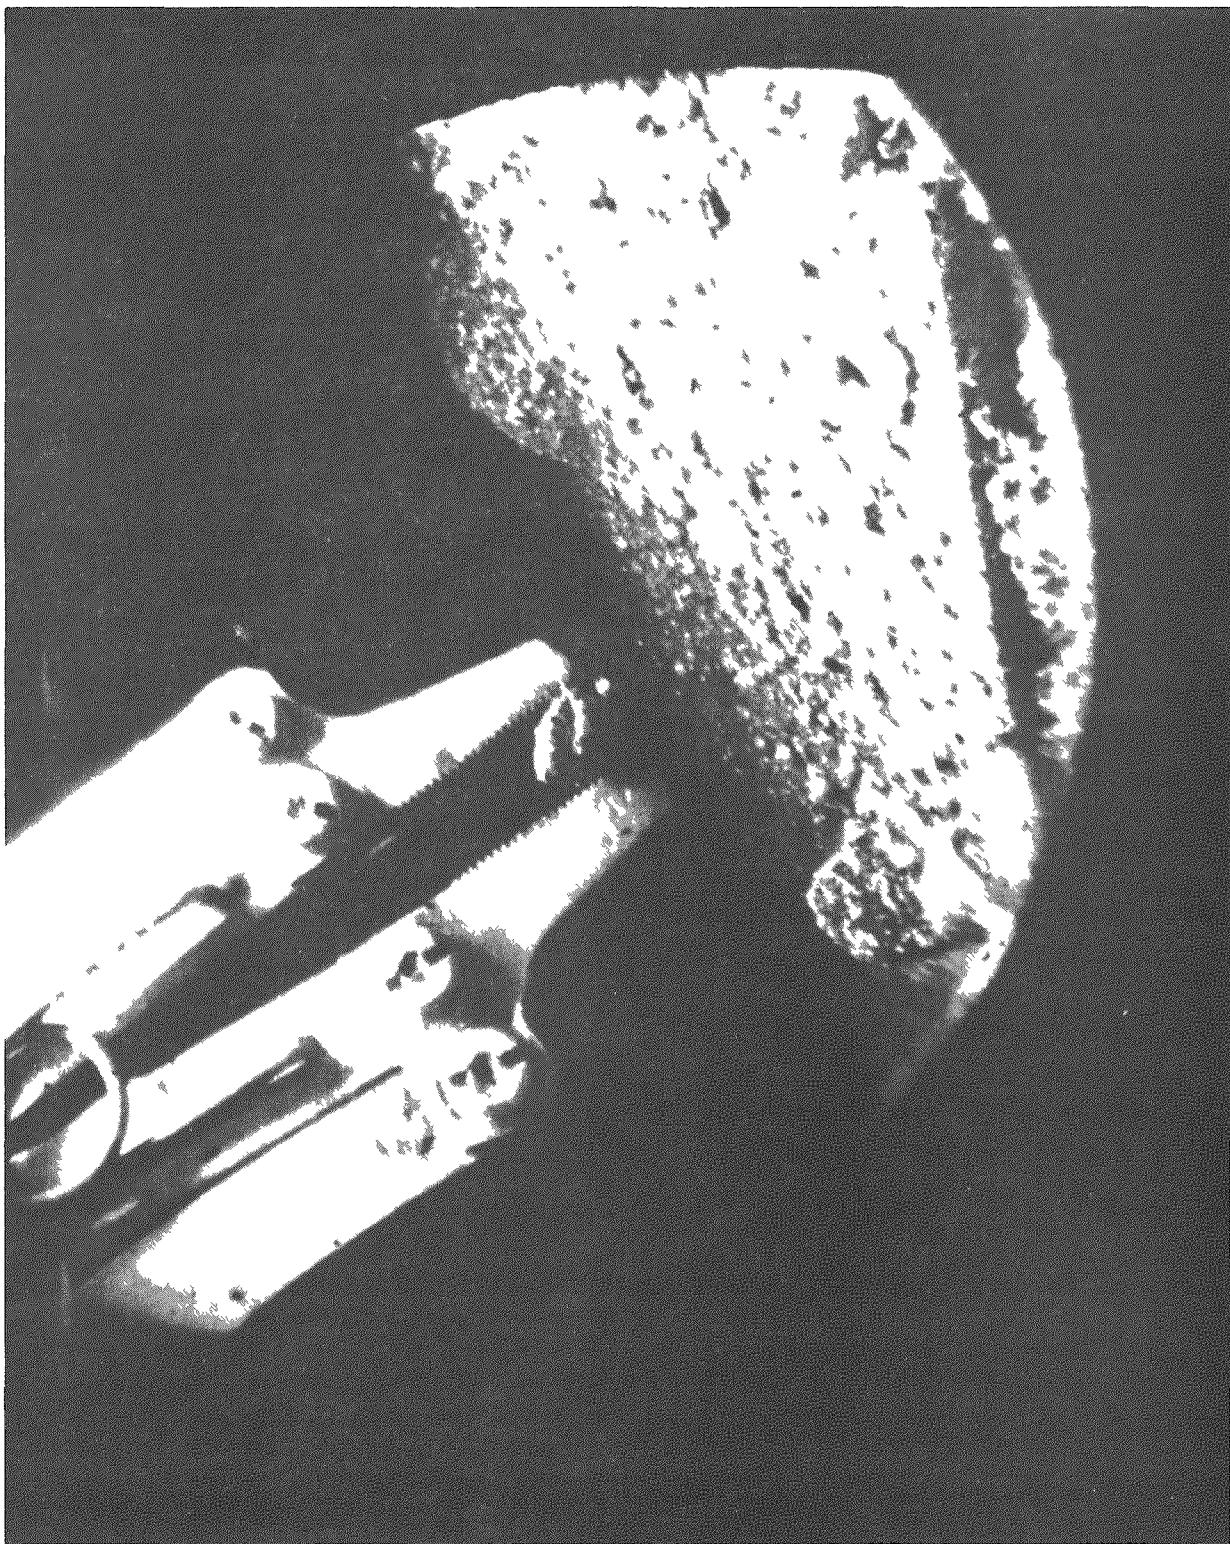
FIG. 10 UFO NO. 6 GRASPED BY SPINE TOOL GRIPPER IN INLET PLENUM

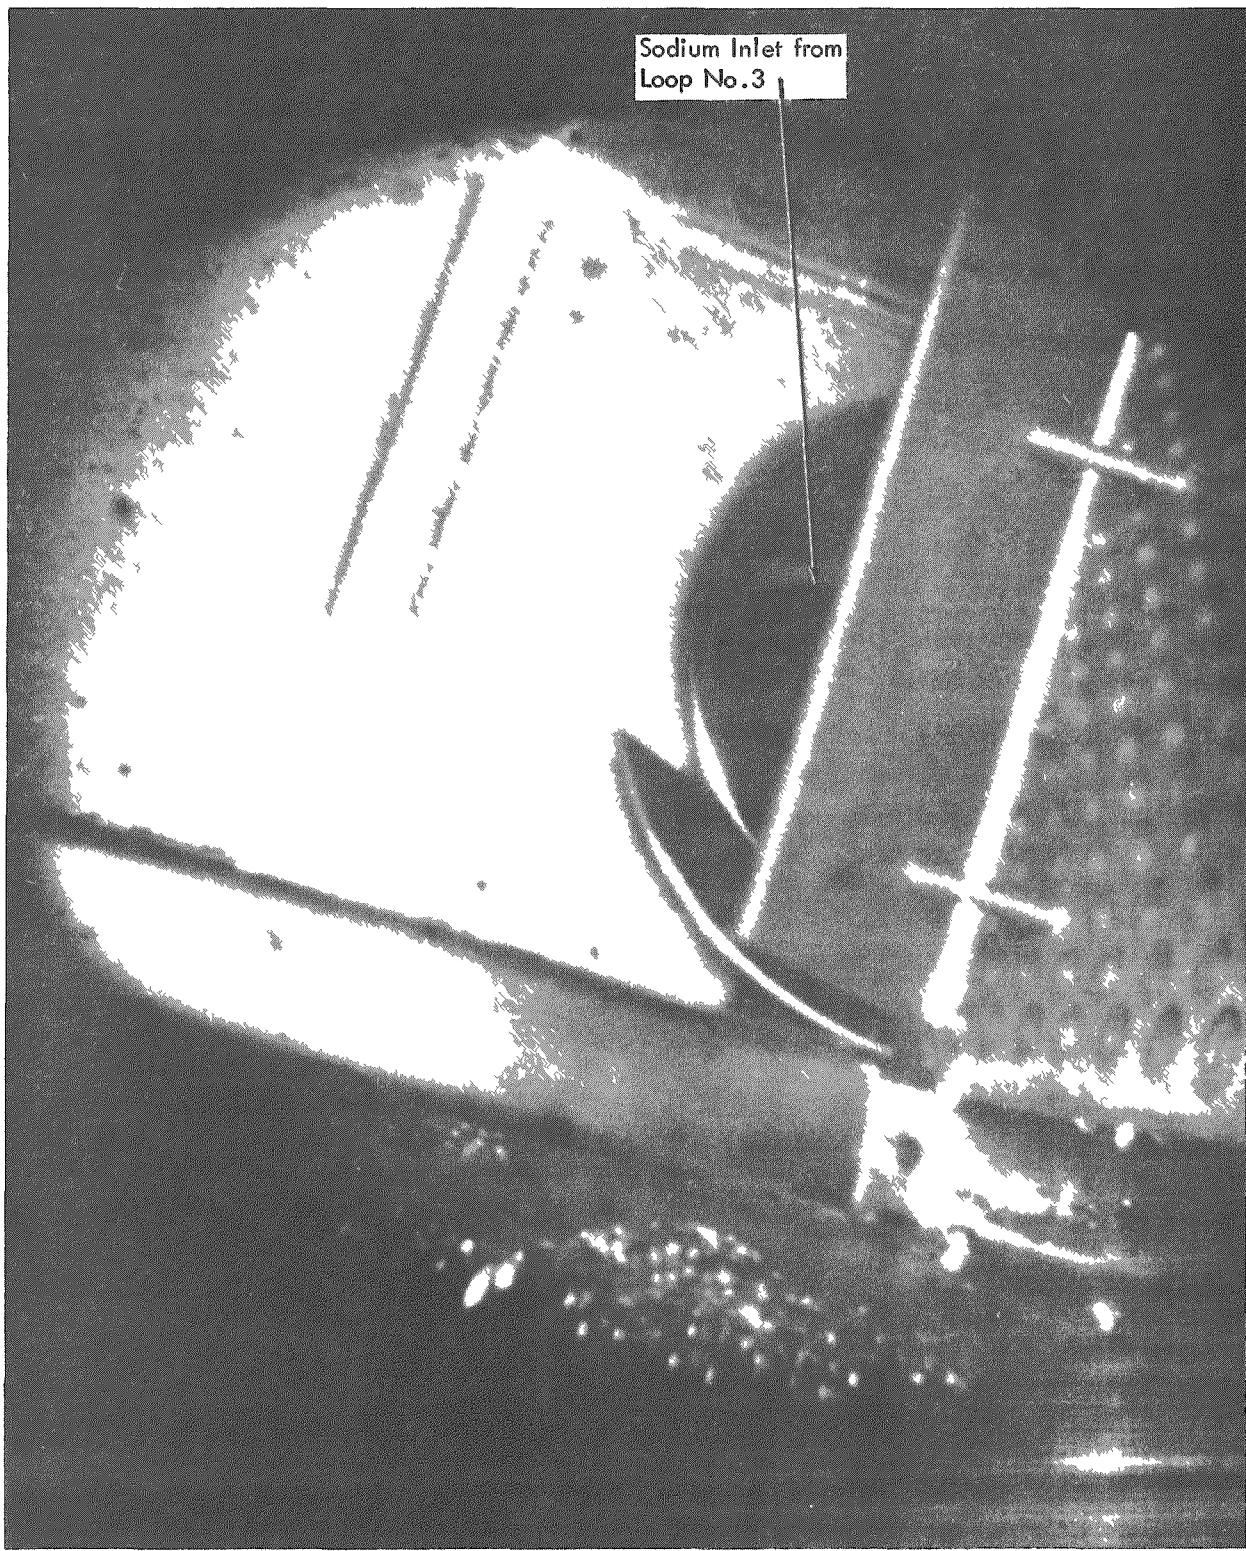
It was observed that the south, southwest, and northwest sectors of the inlet plenum were quite clean, (see Figure 11 showing the loop 3 inlet area) except under the core in the southwest and northwest sectors. These latter two areas and most of the east side of the plenum were dirty, as shown in Figure 12, probably due to the extensive removal operations and tool activity. It is believed that the crud in these dirty areas is the result of solidified sodium and sodium oxide dropping from the sides and bottom of the rotating plug and the penetrations through the plug utilized for the recovery operations. Sodium fill, heat-up, and cold-trapping of the primary system, planned for the near future, are expected to restore the former state of sodium purity and primary system cleanliness.

FIG. 11 CLEAN WEST SIDE OF INLET PLENUM
