# ENRICO FERMI ATOMIC POWER PLANT

## CURRENT EXPERIENCE SERIES

### COMPILED OF CURRENT TECHNICAL EXPERIENCE AT ENRICO FERMI ATOMIC POWER PLANT

APRIL 1968

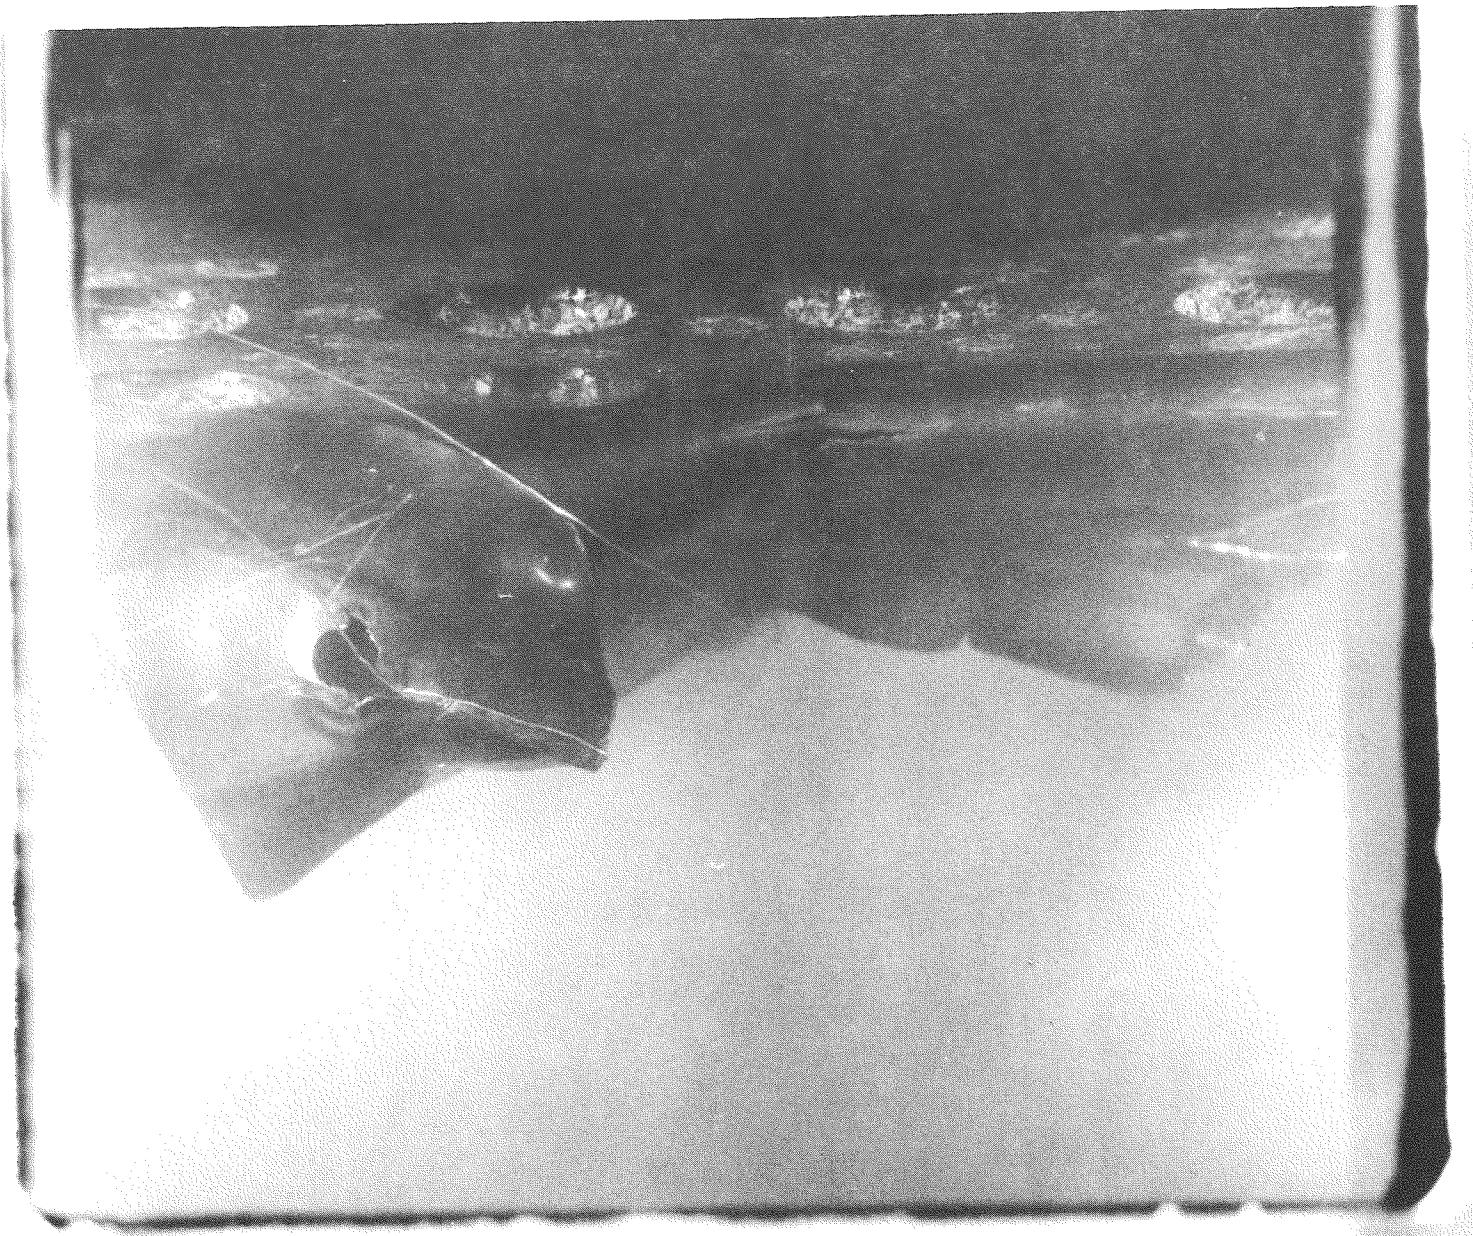
FIG. 16 ZIRCONIUM OBJECT HELD AGAINST UNDERSIDE OF MOCK-UP BOTTOM  
SUPPORT PLATE IN FLOW BLOCKAGE TEST CHAMBER

Even though the estimated blockages of 95% and 96% were not attained under what were thought to be realistic conditions, the experimental results were encouraging enough to provide a reasonable verification that the zirconium object was responsible for blocking coolant flow to the extent that would cause fuel melting in subassemblies M098 and M127. It is possible that the object was more favorably shaped for blocking coolant flow at the time of the incident than it was following removal from the reactor. The object had to be handled very roughly during the removal operations and could easily have been distorted from its original shape.
