ENRICO FERMI ATOMIC POWER PLANT

CURRENT EXPERIENCE SERIES

COMPILED OF CURRENT TECHNICAL EXPERIENCE AT ENRICO FERMI ATOMIC POWER PLANT

APDA-CFE-20
ISSUED: JUNE 1968

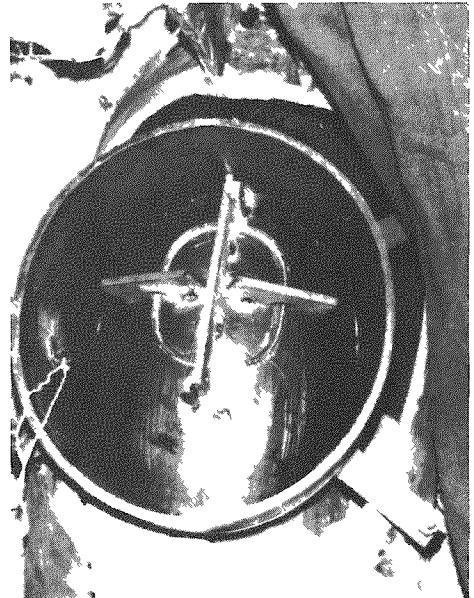
FIG.3 LOCATING PLATES WELDED TO PATCH

For rewelding, the patch was positioned in the elbow penetration by the locating plates and held fast by four equally-spaced tack welds. The 1/8-inch-deep root pass was then applied, using 1/16-inch, 2%-thoriated tungsten electrodes, inert gas, and Type 308 stainless steel filler rods. The welding was done through the glove box, using a glass window in the tool port in the aluminum faceplate for viewing.

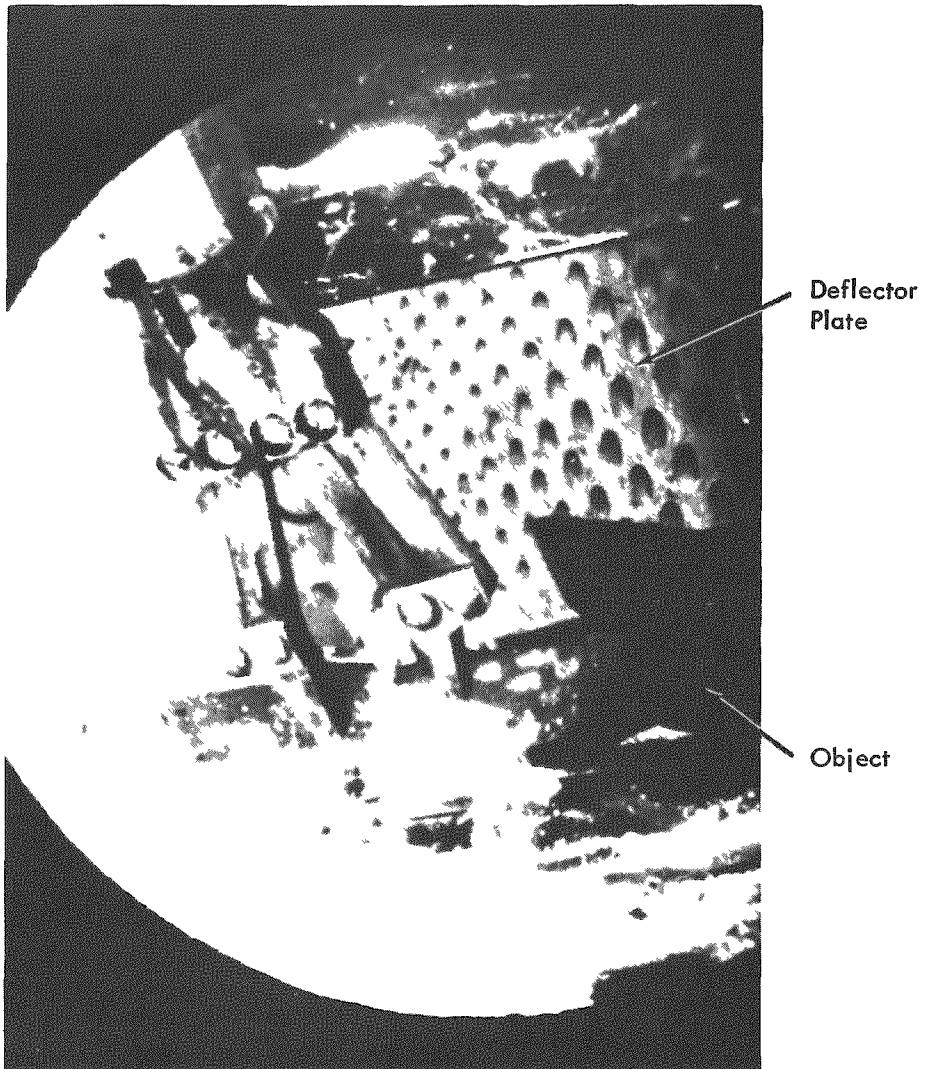
FIG.5 SPINE-TOOL GRIPPER REACHING TO GRASP OBJECT IN INLET PLENUM

Before the breakthrough into the primary pipe was made, the spine-type manipulator was inserted through the support plates into the core inlet plenum to grasp the object in readiness for feeding into the object-retrieval device. Figure 5 shows the spine tool gripper in the reactor inlet plenum nearly in position to grasp the object. The PRDC borescope* and the Sunscope** provided vertical and horizontal viewing and the new articulated lamp*** provided the lighting. The four devices were inserted through lattice positions NO4-NO1, NO4-NO2, NO5-NO1, and NO5-NO2 (see Figure 18) in the northeast sector of the reactor, where the object was located and where it was first discovered. Figure 6 shows the positions of the object and the above devices in relation to the inlet to the plenum from the 14-inch inlet line of the No. 1 loop.

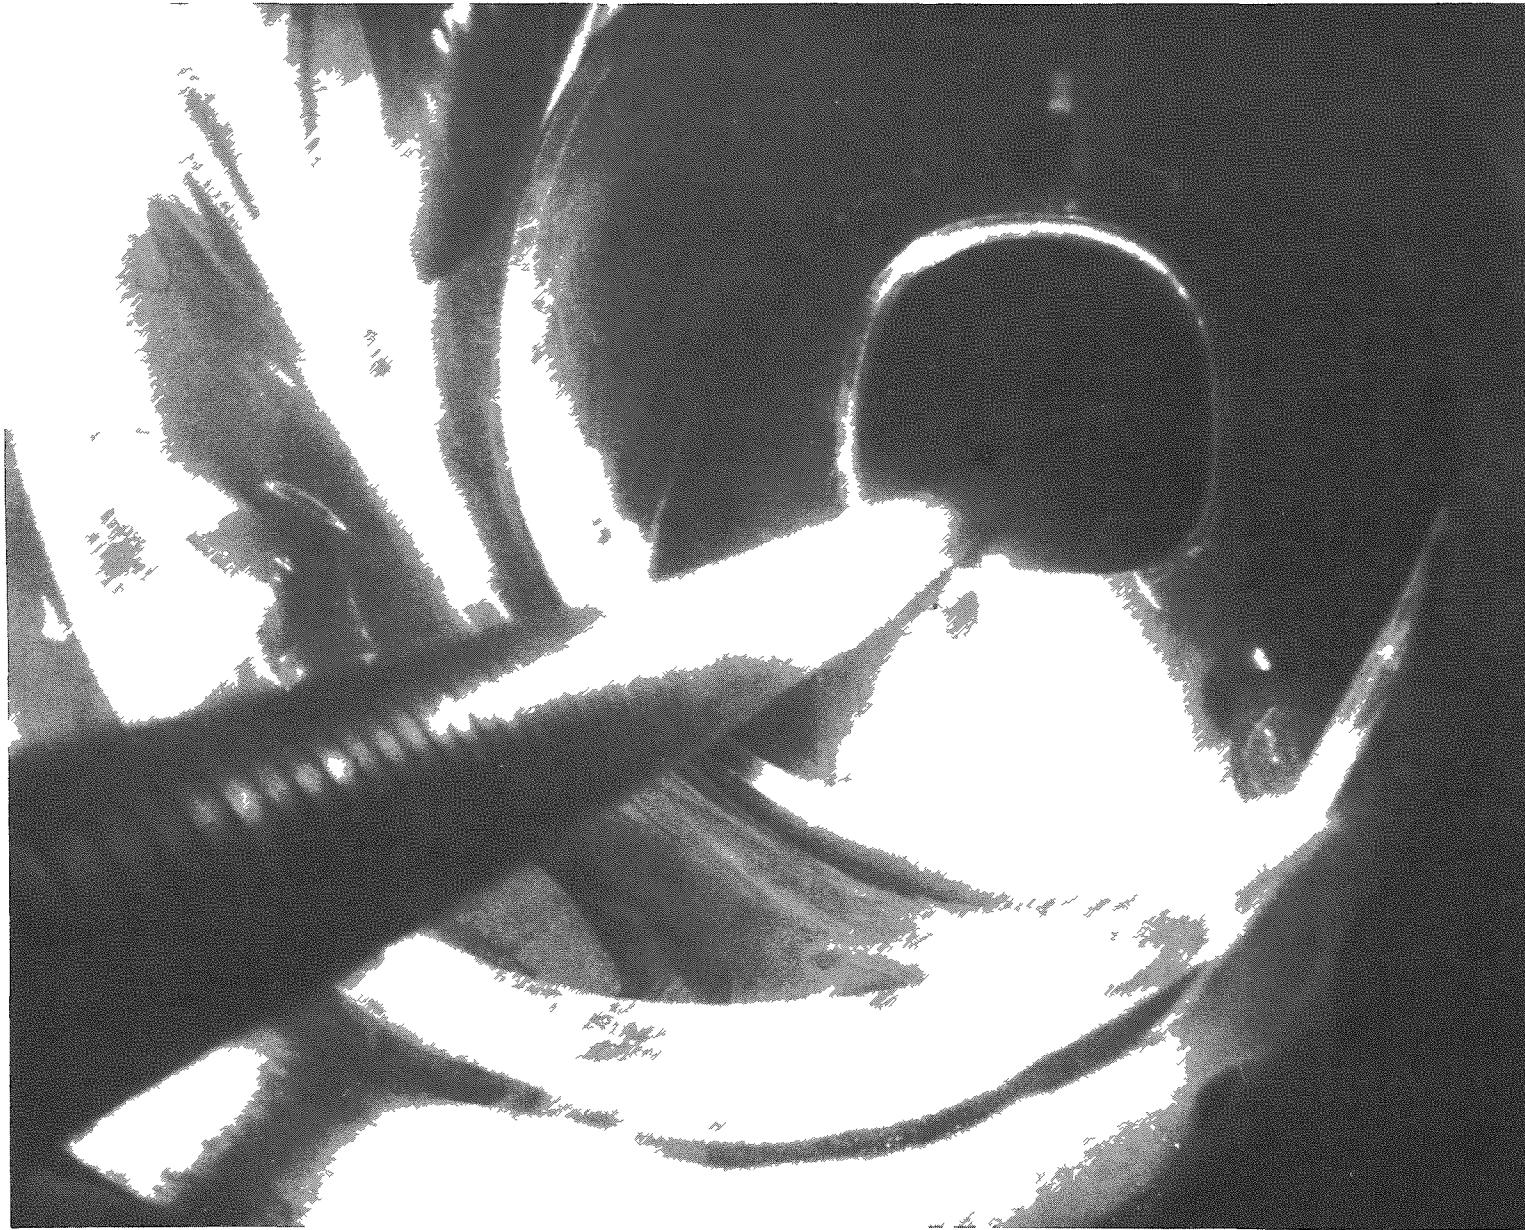
FIG.7 OBJECT-RETRIEVAL DEVICE CABLE INSERTED THROUGH PRIMARY ELBOW PENETRATION

The object-retrieval device was inserted through the elbow penetration and into the 14-inch pipe immediately after the elbow patch was removed. Figure 7 shows the retrieval device cable passing through the elbow penetration. The entire retrieval device was enclosed in a polyvinyl chloride plastic containment bag which, after being purged with inert gas, was connected to the tool port in the glove box aluminum faceplate.

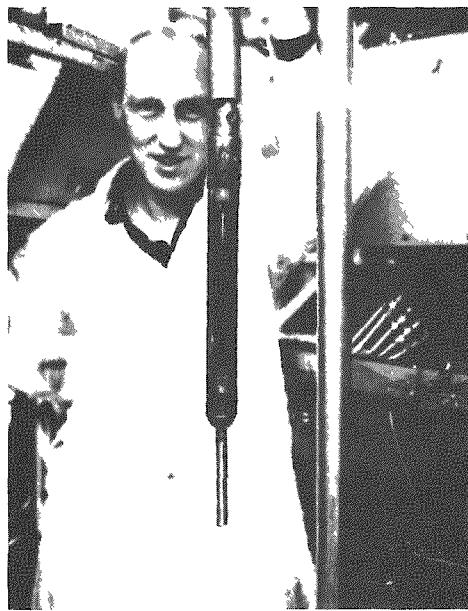
FIG.8 FIVE-INCH LENGTH OF ROD WELDED TO OLD ARTICULATED LAMP TO MANEUVER OBJECT

Further maneuvering in an attempt to force the duct over the object created additional difficulties. The duct was pushed further into the plenum, backing the object against the conical flow guide. When it was observed that the duct was beginning to hump and bend, the device was retracted slightly to straighten out the bends. As the duct started to straighten out, it twisted instead, throwing the object over into the northwest sector of the plenum, out of range of the light and spine-type manipulator (see Figure 6). It was then necessary to enter different support plate holes to locate the object and move it back to the northeast sector. Since there were only two accessible support plate holes in the northwest quadrant, PO5-NO1 and PO5-NO2, a scope was inserted in one position and the old articulated lamp (see Figure 8) in the other. A 1/2-inch-diameter, 5-inch-long rod was welded to the end of the lamp structure* so that this device could also serve to move the object. The object was successfully batted back in hockey stick fashion into the northeast sector of the plenum and without benefit of viewing, because the lamp failed just prior to the operation.

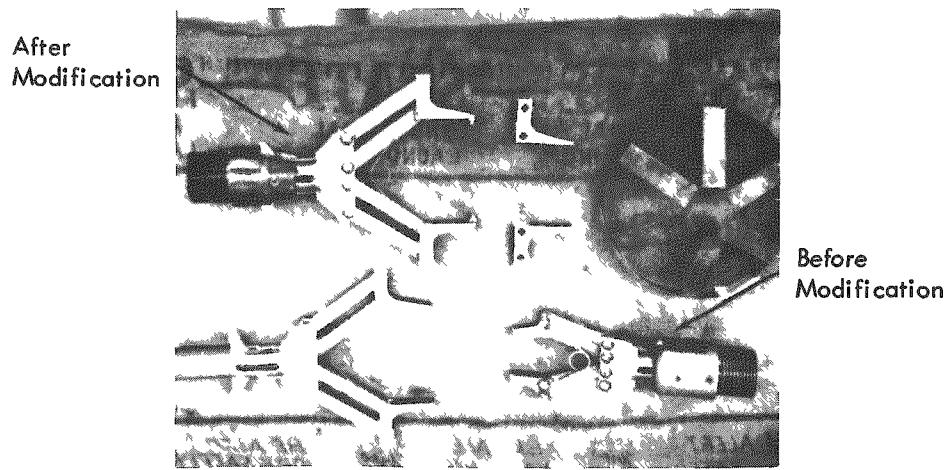
FIG.9 RETRIEVAL GRIPPER AND SPRING FINGERS MODIFIED

In the second retrieval attempt, it became apparent that the object was too wide to fit easily into the retrieval duct; i. e., only about two-thirds of the object could be pulled into the duct and then the object slid from the grasp of the gripper and fell out of the duct. This too was evidence that the retrieval gripper could not be depended upon to maintain a firm grasp on the object.

The retrieval gripper was replaced by another Ameray gripper of modified design to ensure a secure grasp of the object, inasmuch as it was realized that only part of the object could be lodged in the retrieval duct during removal. As can be seen in Figure 9, the jaw opening was increased from 1-1/4 inches to 2-5/8 inches and three fang-like prongs were welded to the jaw faces, two on one jaw and one on the other. At the same time, the spring fingers at the end of the retrieval duct were replaced by another set of stiffer construction. The finger thickness was increased from 0.011 inch to 0.015 inch and the finger width was increased from 1/2 inch to 9/16 inch. The new set of spring fingers, which it was hoped would assist in holding the object firmly, also are shown in Figure 9.

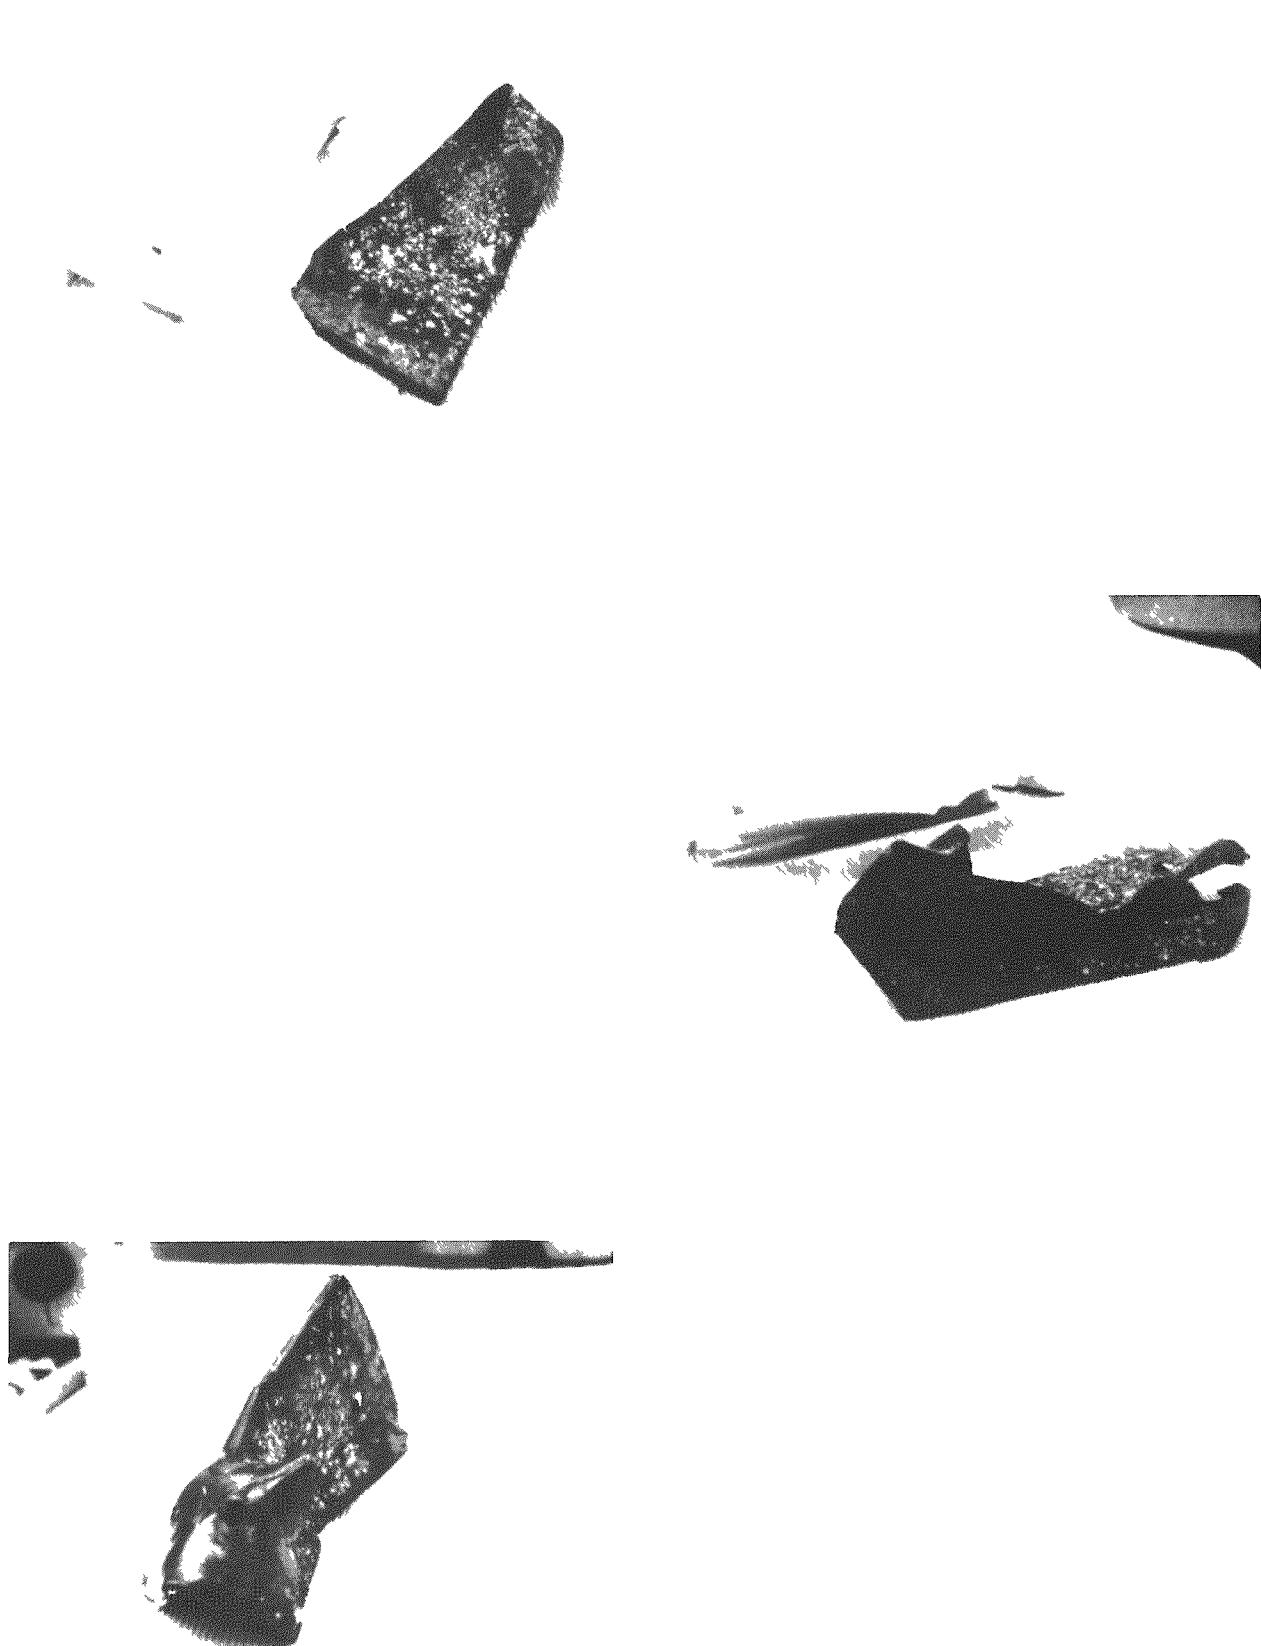
FIG.11 THREE VIEWS OF RETRIEVED OBJECT BEFORE CLEANING

Figure 11 shows three photographs which are representative of many photographs taken of the object before cleaning. Comparison should be made of these photographs with those shown in Figures 2, 3, 4, and 5 of APDA-CFE-16, which were taken of the object in the inlet plenum in November 1967. Figures 12, 13, and 14 are representative of the many photographs taken of the object after cleaning.

Before the object was cleaned, a sample of the deposit on it was removed for analysis in the gamma spectrometer. Results showed the major radioactive isotope to be cesium-137. After being cleaned with alcohol and then steam, and after being decontaminated in an ultrasonic cleaner, the radiation level on the surface of the object was 2 mr per hour.

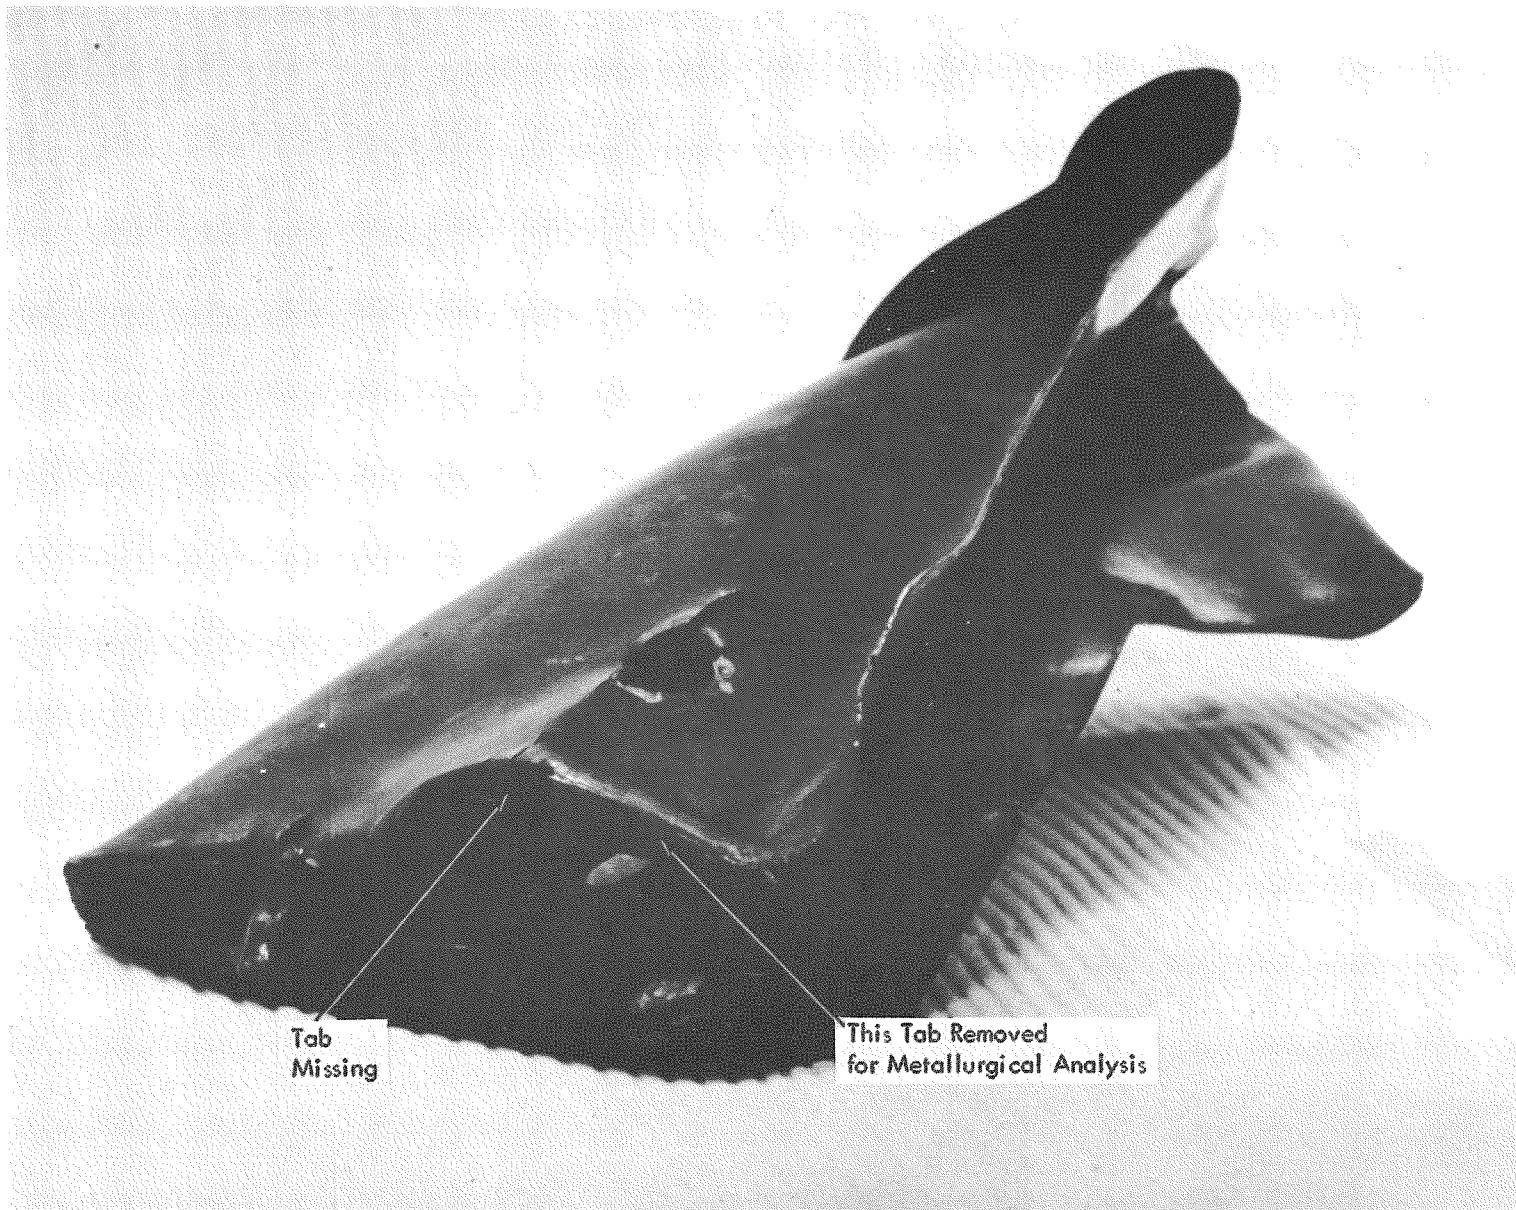
FIG.12 FLAT SIDE OF CLEANED OBJECT

A 1-1/2-inch length of a tab, removed from the object (see Figure 12) for metallurgical analysis, was verified by spark analysis to be zirconium. When etched and examined for hydriding, the sample of the object was found to contain 400 ppm hydrogen, in a preliminary analysis that is subject to verification by further analysis at Battelle Memorial Institute. The result

1. A 2-inch-long tab was missing from the wide end (see Figure 12).
2. Faint circular score marks were found on the flat sections of both sides of the object, indicating that the object may have hammered against the support plate holes.

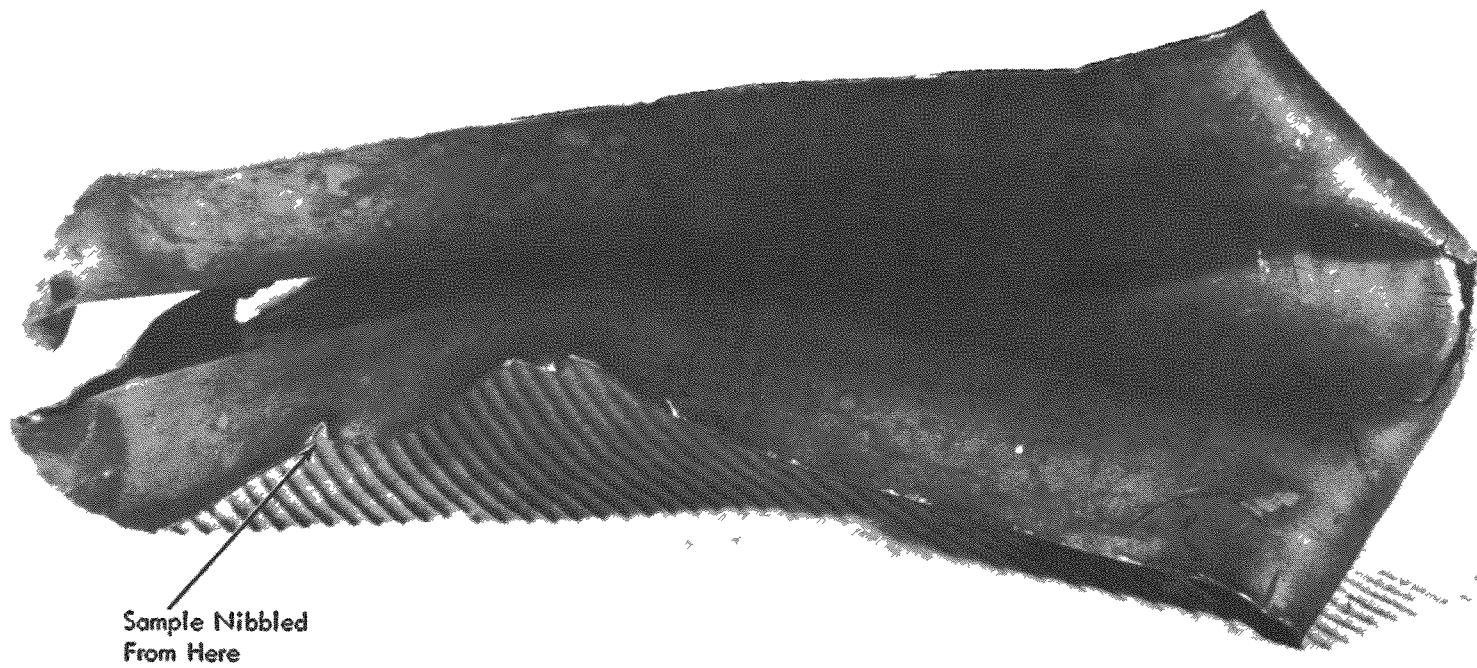
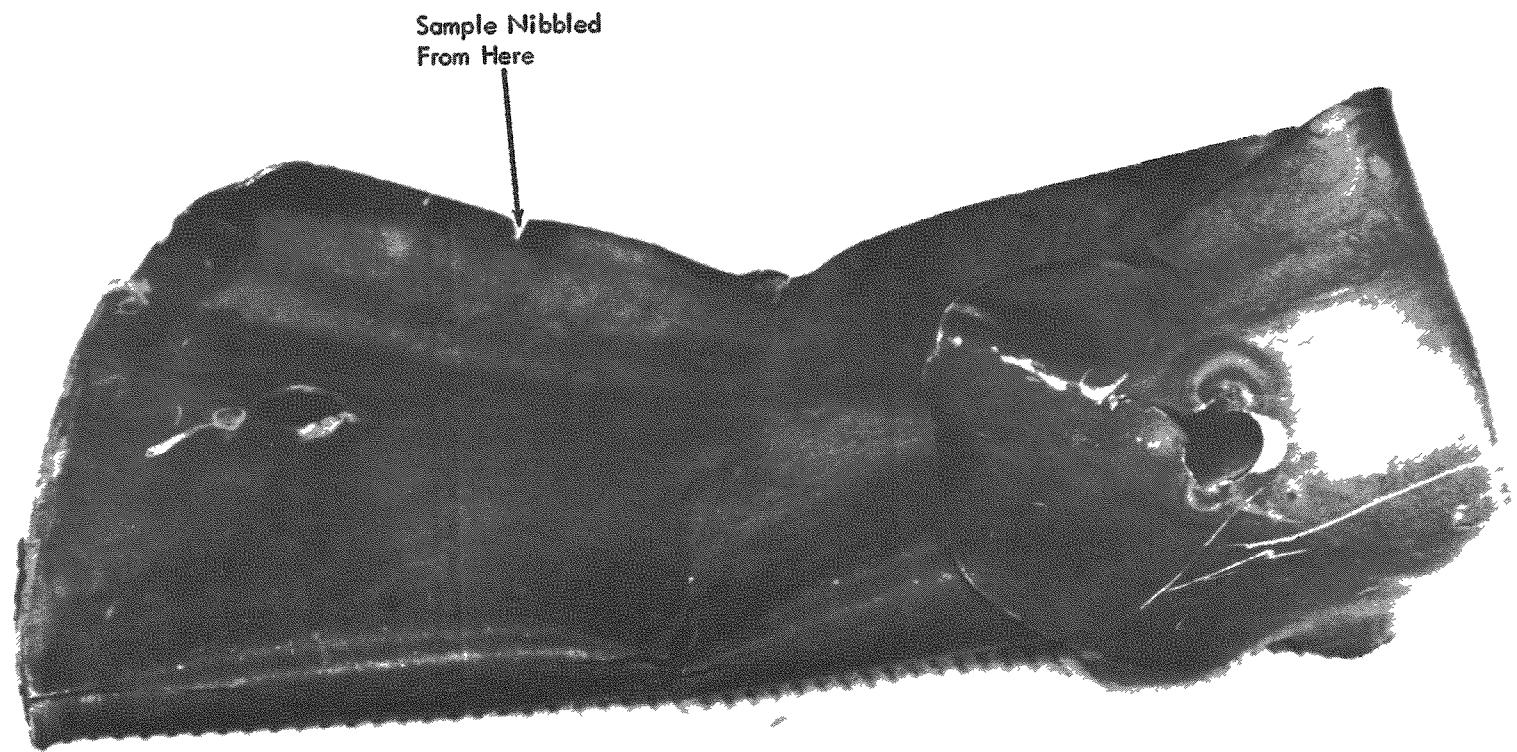
FIG.13 FOLD OF THE CLEANED OBJECT

FIG.14 BENT SIDE OF CLEANED OBJECT

5. A V-shaped notch on the edge of the object was evidence of the sample nipped by the hawk-bill nibbler in December, 1967.* The V-shaped notch is shown in Figures 13 and 14.

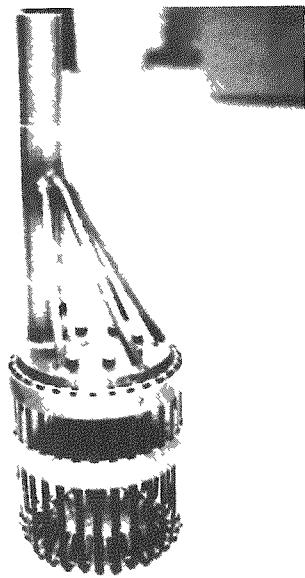
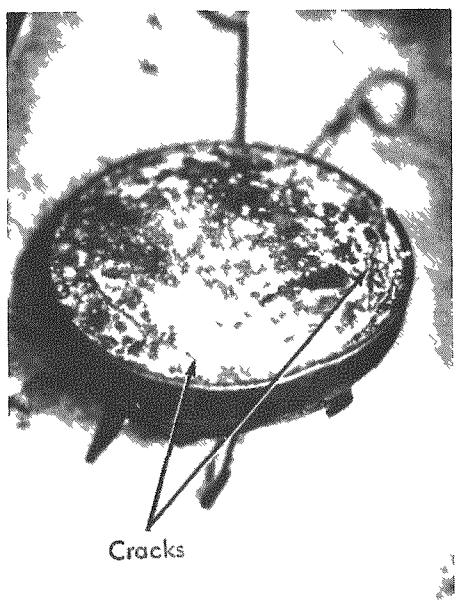
The mirror was removed from the reactor without difficulty and, after being cleaned and decontaminated in the ultrasonic cleaner, was disposed of to radioactive waste, since it was no longer usable. Figure 16 shows the retrieval tool with the mirror withdrawn into an inert chamber above the rotating plug penetration. The mirror after cleaning is shown in Figure 17. The surface of the mirror was cracked and extensively marred, but the piece was still intact.

FIG.15 MIRROR RETRIEVAL TOOL

FIG.16 RETRIEVAL TOOL WITH MIRROR IN INERT CHAMBER AFTER REMOVAL FROM REACTOR

FIG.17 MIRROR AFTER REMOVAL FROM REACTOR
