SANDIA REPORT

SAND94-8235 • UC-404
Unlimited Release
Printed January 1995

NaK Pool-Boiler Solar Receiver Durability Bench Test, Vol. 2: Metallurgical Analysis

S. H. Goods, R. W. Bradshaw

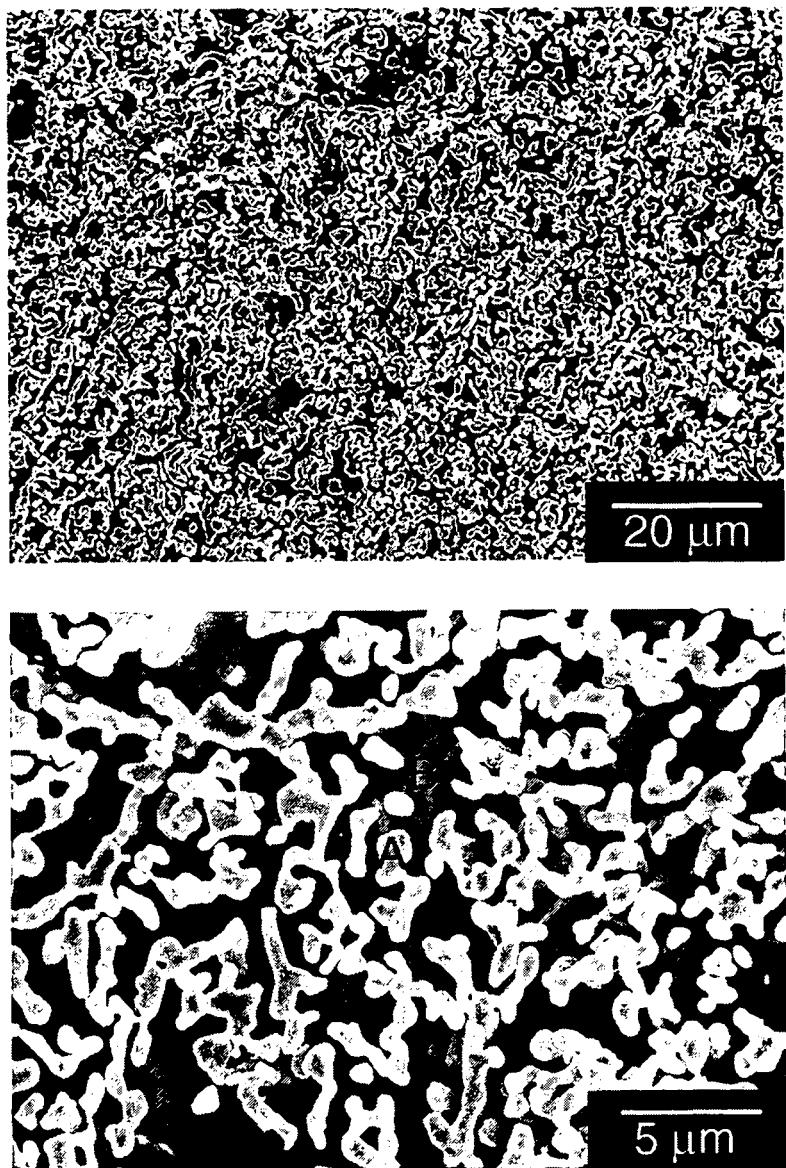
Visual inspection of the pool-boiler surface exposed to boiling NaK for 7500 hours revealed a distinctly "matte" finish unlike the relatively bright finish of the as-received tubing. Scanning electron micrographs of this surface are shown in Figures 6a and b. Figure 6a, a low magnification image, shows a complex surface structure clearly altered from that of the as-received tubing. At higher magnification, Figure 6b reveals that the structure consists of particulates uniformly decorating the surface. As above, EDS analysis was used to assess the composition of these features and the base material to which they are attached. The particulates (indicated in Table II as REGION A) have a composition similar to the second phase particles described in the previous section.

The prominence of these features results from the recession of the alloy matrix. It is reasonable to attribute the recession of the alloy surface to the preferential dissolution of matrix nickel and chromium into the liquid metal pool (relative to the tungsten-rich precipitates). Reliable solubility data for the transition metals and tungsten in liquid NaK are quite limited. Such data as are available for the principal constituents in the alloys studied here are summarized in Figure 7.[10-14] Note that these data concern sodium or potassium as the solvents, rather than NaK. The data in Figure 7 indicate that tungsten should be the most soluble of the principal alloying elements of Haynes 230 at the temperature of the present test, 750°C. These data are contrary to our present observations in that the W-rich precipitates appear to be less soluble than the nickel and

Figure 6. Internal surface of pool-boiler exposed to NaK liquid after 7500 hours at temperature. a) Features on the surface are W-rich precipitates exposed by the recession of the alloy matrix. b) Higher magnification reveals the morphology of the surface structure and the presence of grain boundary dissolution. Regions A and B refer to locations of EDS analysis in Table II.

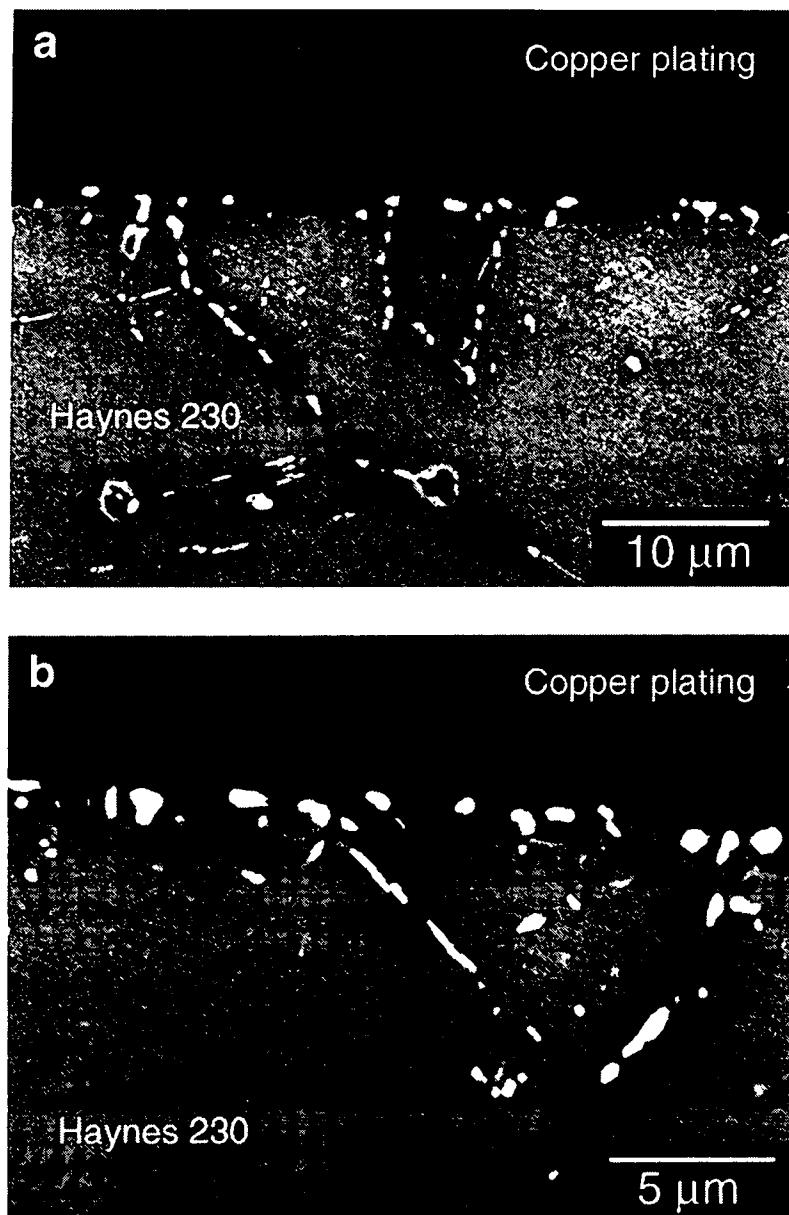
Figure 8. Backscatter electron images of metallographically prepared cross-section of Haynes 230 exposed to NaK liquid. Copper plating was applied prior to sectioning to protect fine surface features. a) Haynes alloy surface is decorated with W-rich precipitates. Grain boundary cavitation is present as the result of the heat treating and surface cleaning procedure. It is not the result of NaK exposure. b) Recession of the alloy matrix from the NaK-exposed surface is evident at higher magnification.

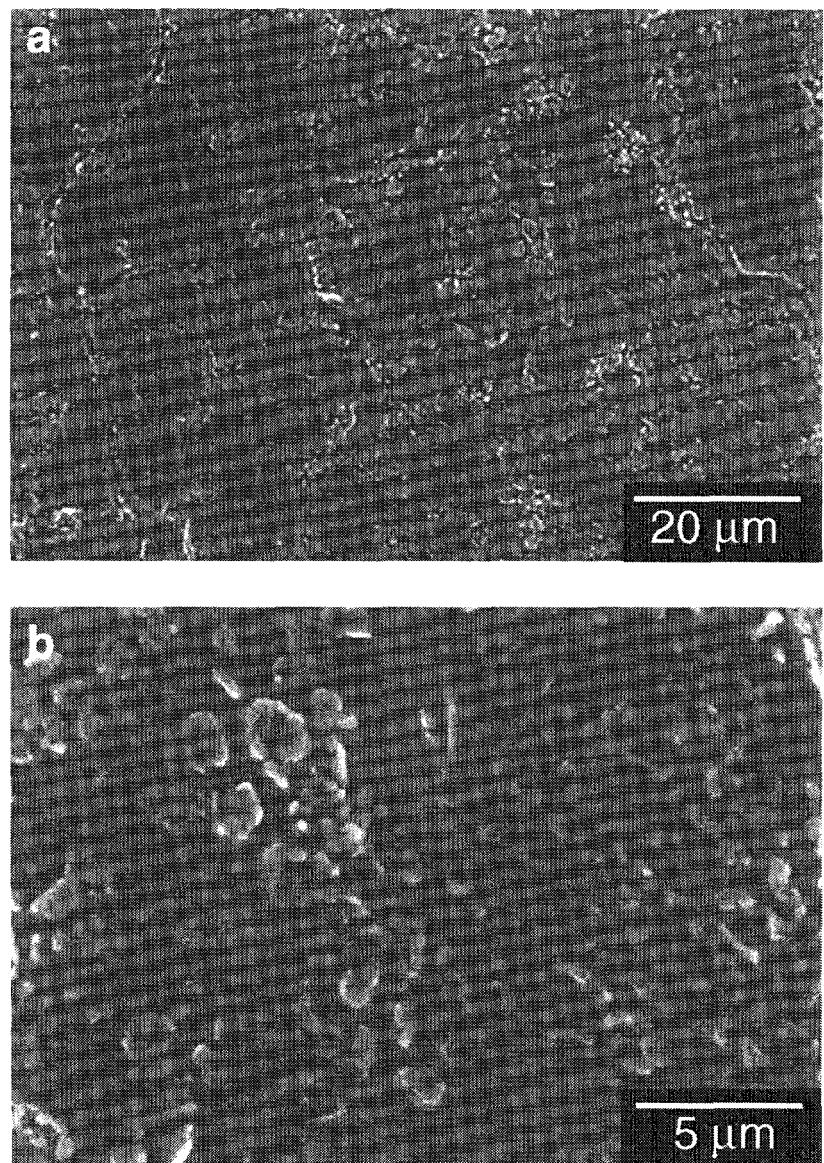
Visual examination of the interior surface of the vessel revealed a distinct "waterline" delineating the pool-boiler from the condensing region. Figures 9a and b are scanning electron micrographs that show the surface of the vessel well above the liquid level. The surface had a morphology intermediate between the as-received material and the surface exposed to liquid NaK. The tungsten-rich particles are less well defined than those shown in the previous figures suggesting that the degree of dissolution of the matrix by the vapor phase was somewhat less extensive. However, the grain boundary etching is more apparent than before simply because the precipitate structure is less well defined and does not mask the grain boundaries. The composition of both the particles and of the underlying matrix are essentially identical to that reported above for the surface

Figure 9. a) Internal surface of pool-boiler exposed to NaK vapor after 7500 hours at temperature. W-rich precipitates are less well pronounced due to less recession of the alloy matrix. Grain boundary dissolution is apparent. b) Higher magnification reveals the morphology of the surface structure.

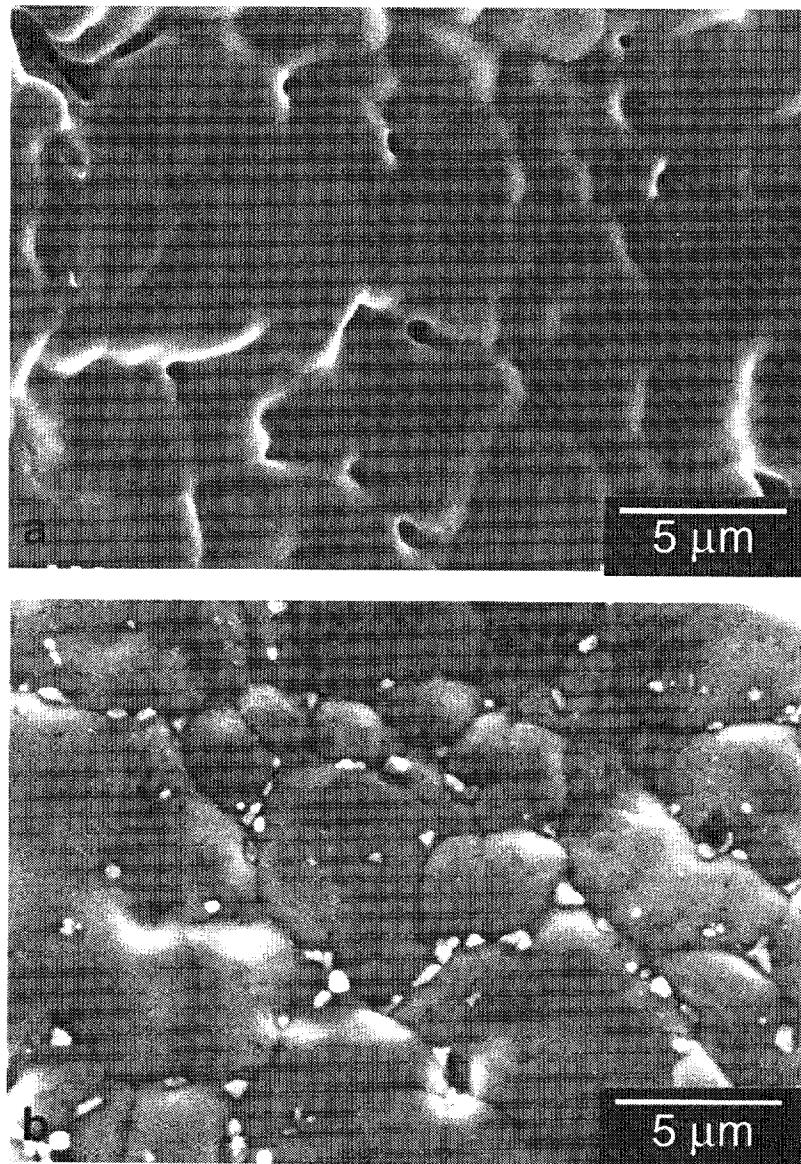
Figure 10. Internal surface of the Haynes 230 fill tubing. a) The grain structure on the ID of the as-received fill tube is revealed as the result of the descaling procedure. b) Deposit is present along the grain boundaries of the fill tube from the pool boiler.

Figure 10. c) ID of fill tubing further away from end cap than that shown in (b). Surface deposition is greater in these colder regions.

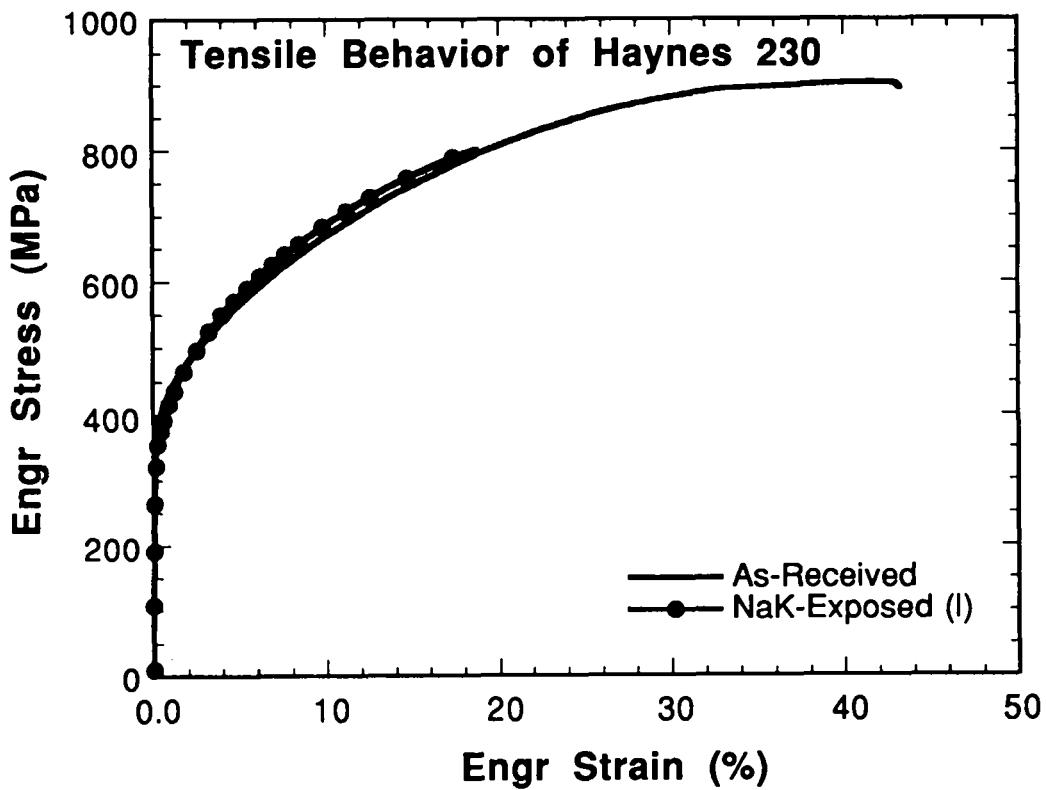
Figure 11. Comparison of uniaxial tensile behavior of as-received Haynes 230 specimen compared to specimen cut from the sidewall of the pool-boiler vessel beneath the liquid level of the NaK. Specimens extracted from the condenser section of the pool-boiler exhibit identical behavior. The data for as-received Haynes 230 presented in Table III was taken from Ref. 15

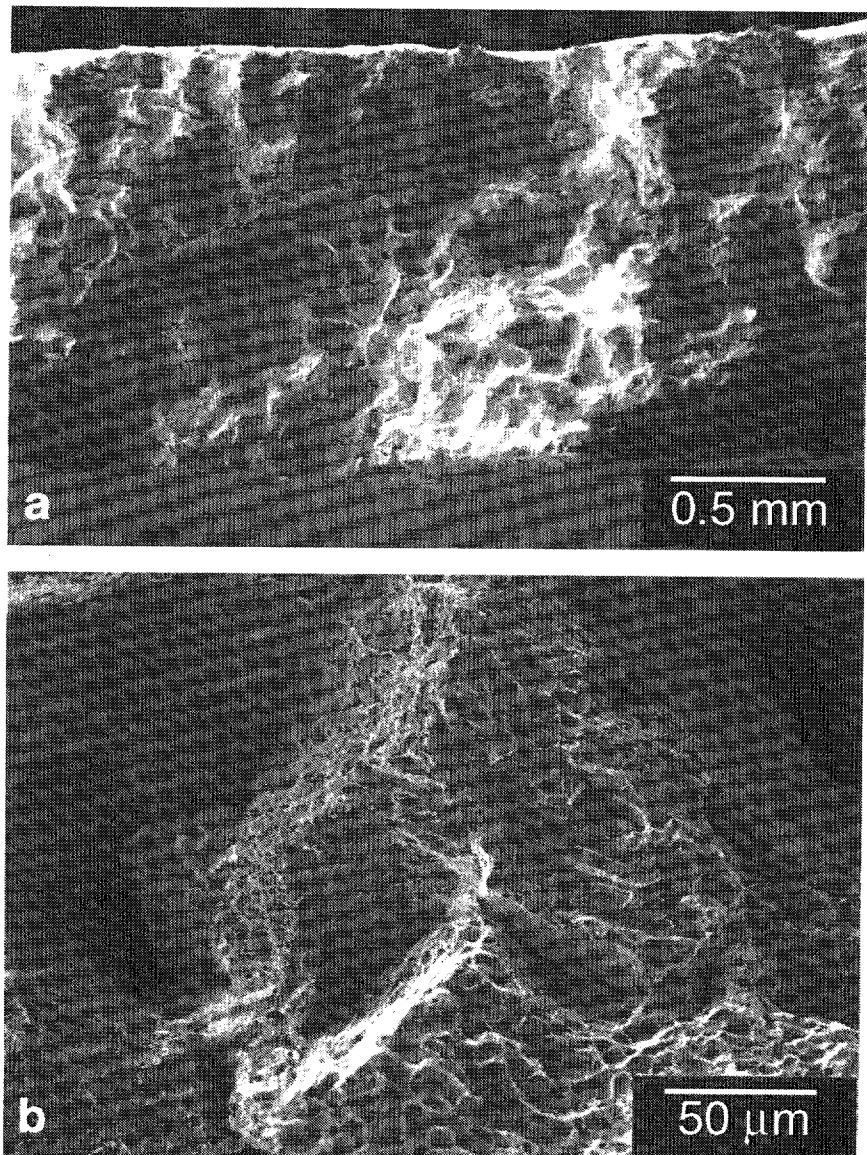
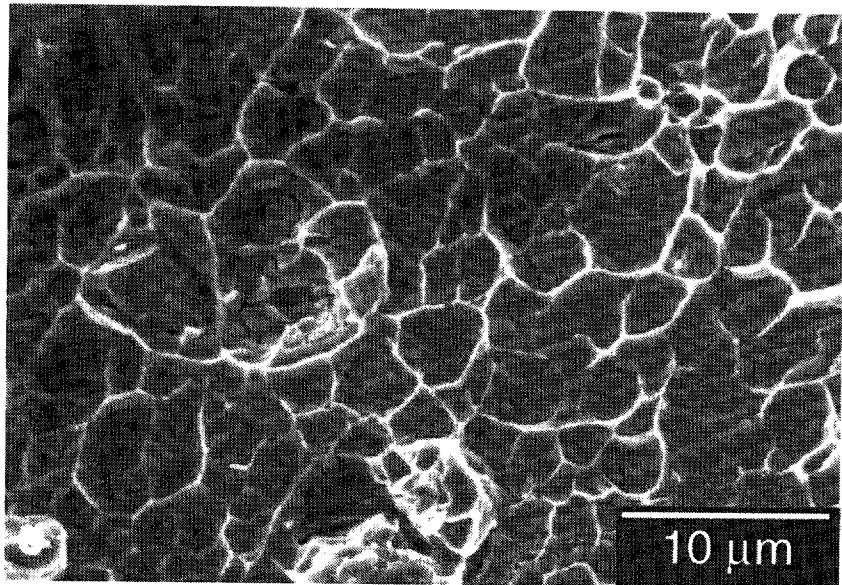
carbides. The fracture surface of the NaK-exposed alloy is shown in Figure 13a. In this instance the fracture surface was intergranular. At higher magnification, Figure 13b reveals that the fracture was still ductile in nature. Figure 13c reveals that the grain boundary facets were decorated with a uniform distribution of dimples with only a few fractured carbides visible.

Figure 13. Fracture surface morphology of NaK exposed-Haynes 230. a) Fracture surface is intergranular. b) Grain boundary facets are decorated with dimples indicating that fracture was still ductile.

Figure 13. c) Grain boundary facets are decorated with a uniform distribution of dimples with only a few fractured carbides visible.

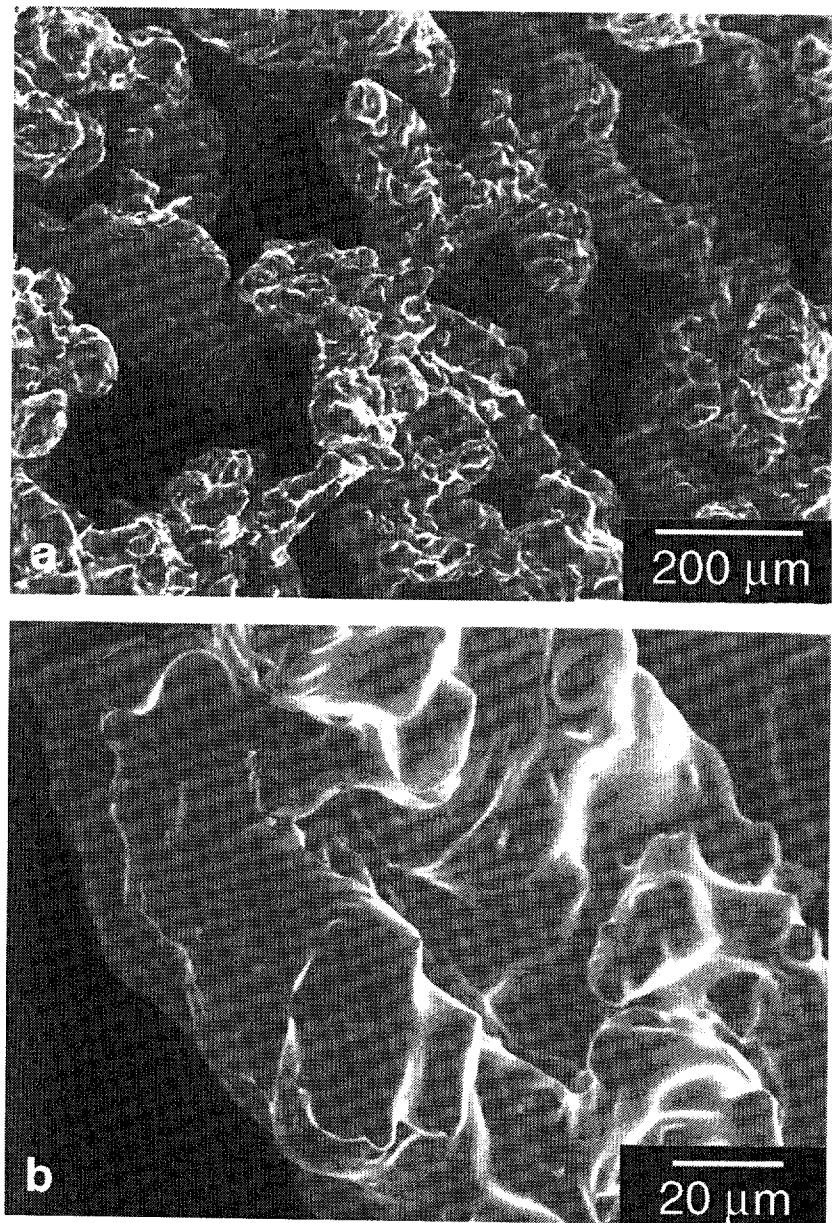
The brazed patch was examined in detail. There was no evidence of spalling, cracking or any other structural degradation resulting from repeated thermal cycling. This was somewhat surprising in light of the relatively rigorous thermal cycling profile imposed on the patch over the operating history of the pool-boiler. Figures 15a and b are micrographs taken from the brazed patch in the pool-boiler. Figure 15a shows that the patch maintained the same general high surface area, open morphology of the as-brazed patch. The surface contamination shown in Figure 14b and c is no longer apparent. Silica will not be reduced by NaK as the alkali metal oxides are less thermodynamically stable than $\text{SiO}_2.$ [16] The absence of the silica contamination is therefore likely the result of some minimal dissolution of the underlying stainless steel allowing the contamination to break free or of thermal cycling which could promote the detachment of weakly bound particles. In addition, the zirconium getter can reduce silica which would facilitate its removal by either loss of adhesion or, possibly, dissolution. Figure 15b shows that the terraced structure on the original stainless steel powder surfaces was no longer visible, suggesting that the stainless steel suffered a very small amount of dissolution due to NaK exposure. This observation supports the argument that the loss of the silica contamination was the result of dissolution of the stainless steel.

Figure 15. Surface morphology of the NaK-exposed enhanced boiling surface. a) The patch maintained the same general high surface area and open morphology of the as-brazed structure. b) Surface contamination and terraced features are no longer apparent after long-term NaK exposure.

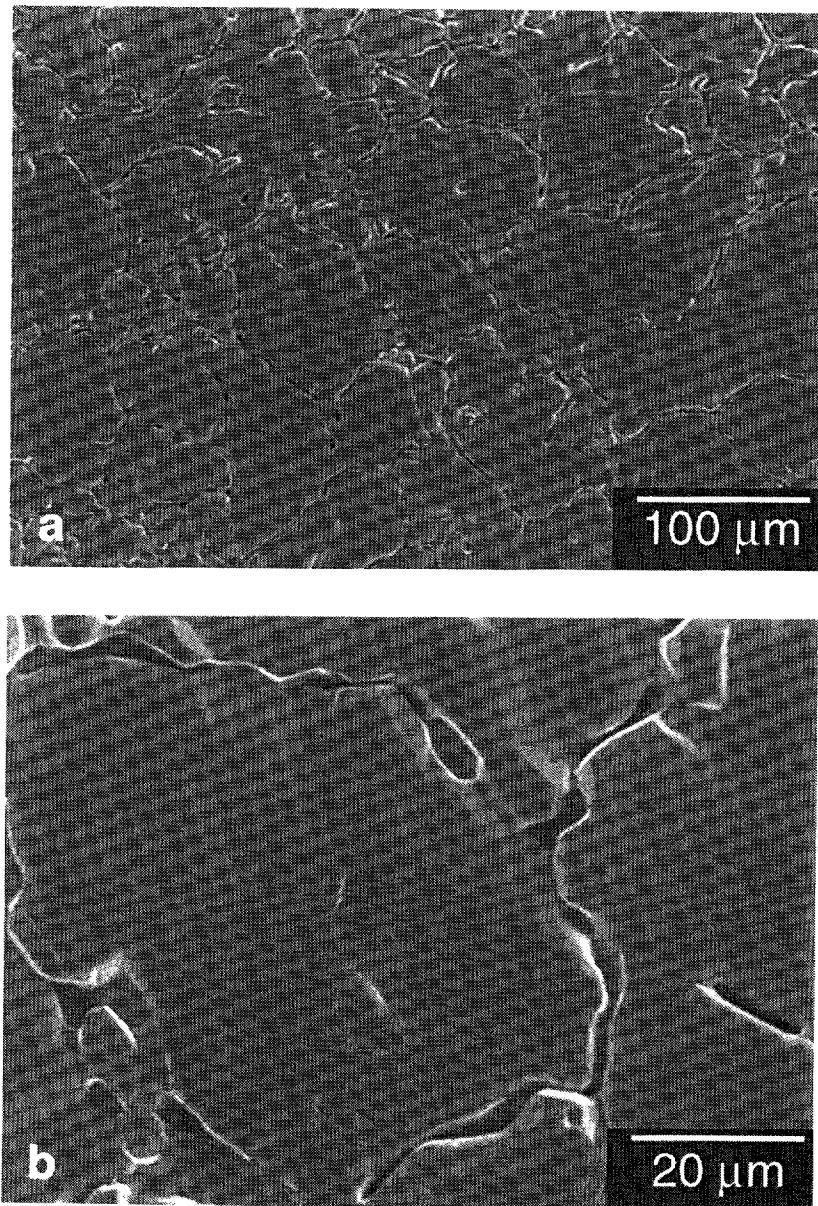
Figure 17. Surface of an IN600 thermowell that was located below the liquid level of the NaK. a) At low magnification, the grain boundary structure is clearly revealed as the result of grain boundary dissolution. b) Dissolved grain boundaries and grain surfaces have a faceted appearance indicated that there was preferential dissolution along certain crystallographic orientations.

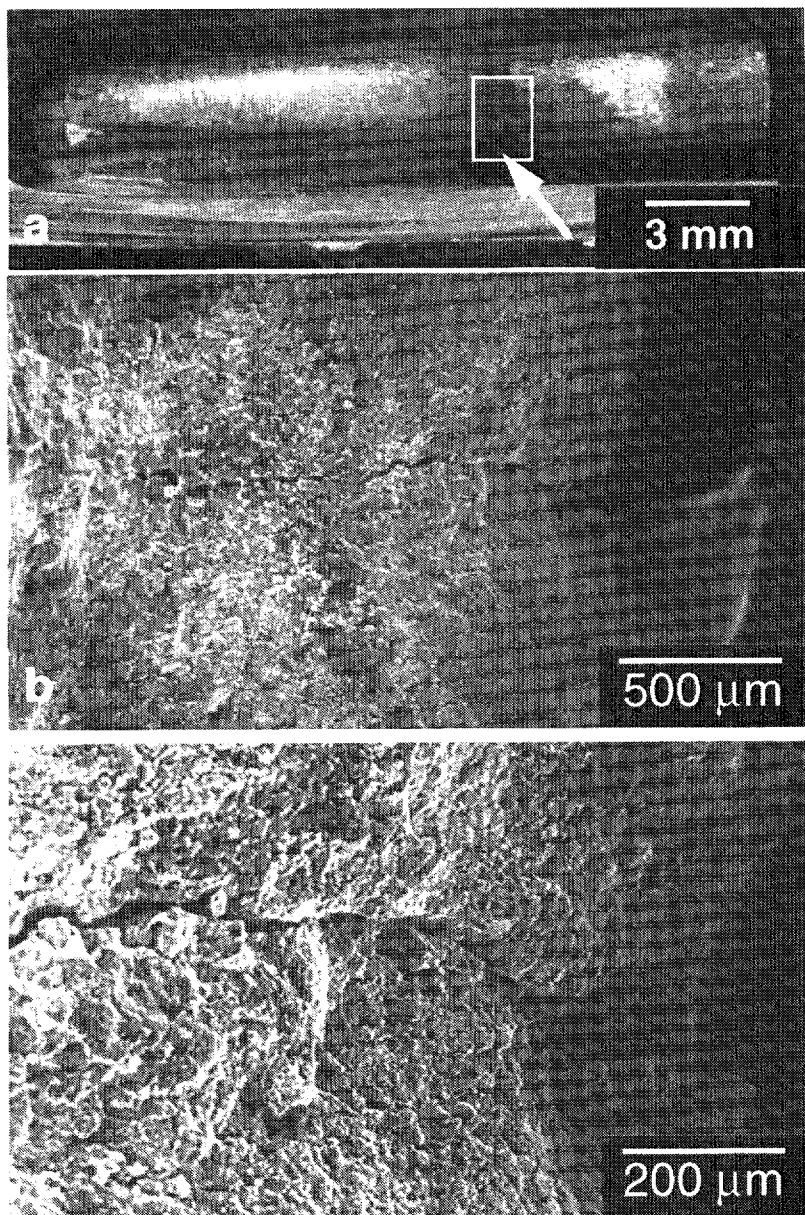
The pool-boiler test was terminated after a small change in the characteristic temperature response was recorded.[2] It was determined that this change resulted from the loss of vacuum due to a very small leak. The recorded pressure rise was \approx 10 torr. The source of this vacuum leak was identified during the course of this analysis. The leak occurred in one of the IN 600 thermowells used to record the temperature of the vessel sidewall in the condenser. In addition to being brazed to the endcap of the pool-boiler, this thermowell was brazed to the vessel sidewall in order to improve thermal coupling and insure continuous contact over the lifetime of the test. The rigid attachment of the thermowell at both ends gave rise to a mechanical fatigue profile induced by thermal cycling. Although the thermal expansion coefficients of Haynes 230 and IN 600 are quite similar [4, 18], the heating rate of the thermowell is likely to have been much more rapid because of its location within the vessel (and therefore the absence of any heat loss) and because of its considerably smaller mass than the pool-boiler vessel. It was this difference in heating rate rather than in thermal expansion coefficient that gave rise to the continuous thermo-mechanical fatigue cycle. The ensuing initiation and growth of a fatigue crack caused the loss of vacuum. Within the pool-boiler, the alloy was particularly sensitive to mechanical fatigue failure due to its susceptibility to grain boundary dissolution as illustrated above.

Figure 18a shows the actual location of the leak site immediately beyond the brazed end of the thermowell. The tube shows clear evidence of "necking" in a fashion similar to a conventional mechanical test specimen and confirms that there was a significant concentration of strain at the point of failure. This thermowell alloy may have been particularly sensitive to mechanical deformation if the brazing procedure annealed the tube, weakening it relative to the rest of the thermowell. The leak site is identified in Figure 18a by the arrow. The leak was located at the minimum diameter in the neck and initiated in the side of the tube opposite (facing) the pool-boiler sidewall. Figure 18b

Figure 18. Scanning electron micrographs of the leak site in the IN600 thermowell. a) Leak is located at the arrow and runs vertically in the necked (boxed) regions of the tube. b,c) Higher magnification images are rotated 90° from that presented in (a). The crack extends nearly half way around the diameter of the tube.

and c are scanning electron micrographs of the section of the thermowell highlighted in Figure 18a. These micrographs show the sidewall of the thermowell $\approx 90^\circ$ away from the initiation site of the crack. Note that images in Figure 18b and c are rotated relative to the image of the thermowell in Figure 18a for ease of presentation. Figure 18b shows that the crack was quite long, extending nearly half way around the diameter of the tube. Rigorous characterization of the fatigue crack (i.e., intergranular vs. transgranular) was not possible for several reasons. First, the crack experienced a tension-compression fatigue profile. The mechanical damage to the crack faces during each compressive loading would obscure their detailed structure. Second, as the NaK was exposed to air, sodium and potassium oxides would form locally. These oxides are quite reactive with respect to the alloying elements of IN 600 and can rapidly obliterate even more of the detailed structure of the leak site. Regardless of the precise details of the thermowell failure, the leak through the IN 600 tube is further reason to preclude its use in similar liquid metal environments. Other studies have reported similar grain-boundary corrosion of IN 600 exposed liquid potassium at 890°C after 500 hours that was especially pronounced at the liquid-vapor interface. [19]

Other nickel-based materials exhibited poor compatibility with this liquid metal environment. IN 600 suffered substantial intergranular attack, while the nickel ribbon experienced extensive dissolution, resulting in the formation of large internal cavities. Although the failure of an IN 600 thermowell resulted in the termination of the experiment after \approx 7500 hours, its use in pool-boiler designs is not essential. Other alloys more suitable for use in this application should be substituted in future experiments.

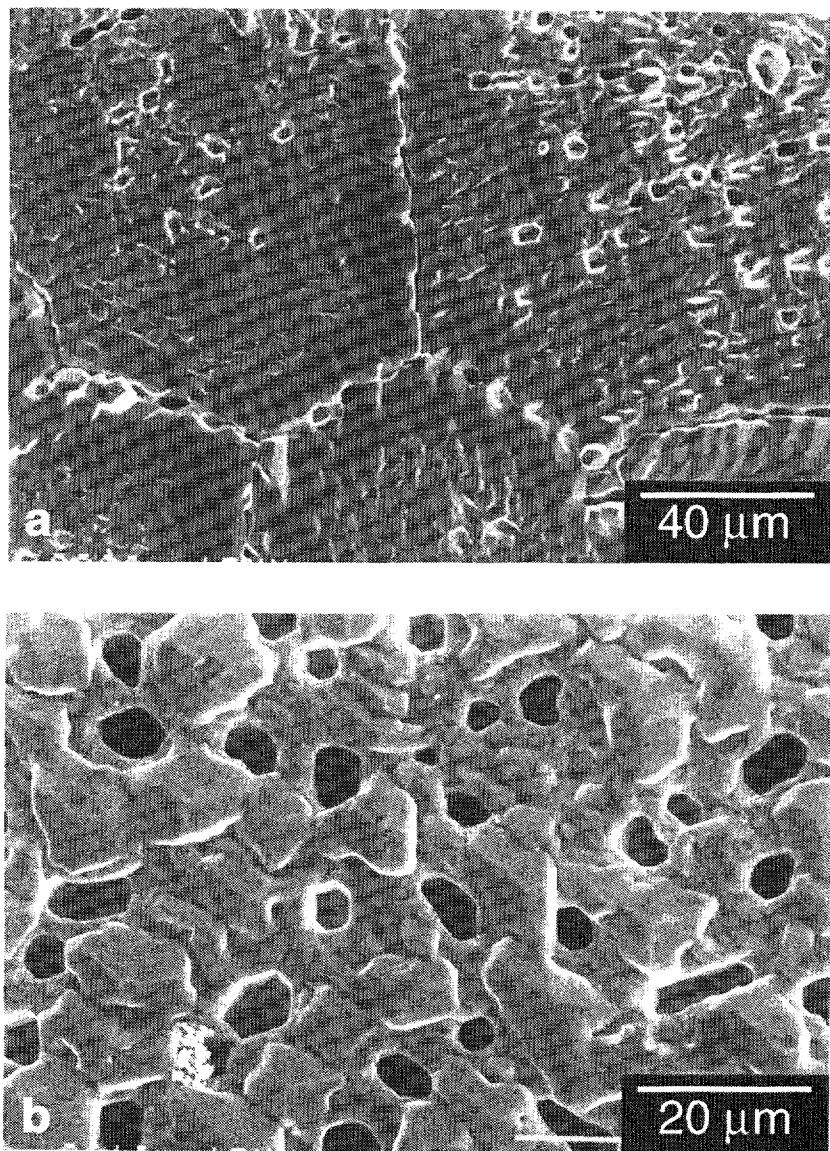
Figure 19. a) SEM micrograph of nickel ribbon immersed in the NaK exhibits evidence of catastrophic attack after 7500 hours at 750°C. The grain boundary structure of the nickel is revealed as the result of pitting and selective dissolution of the nickel near the boundaries, while away from the grain boundaries there is additional pitting. b) At higher magnification, it is clear that dissolution has occurred along preferred crystallographic planes giving rise to the sharply faceted surface features and angular pits.

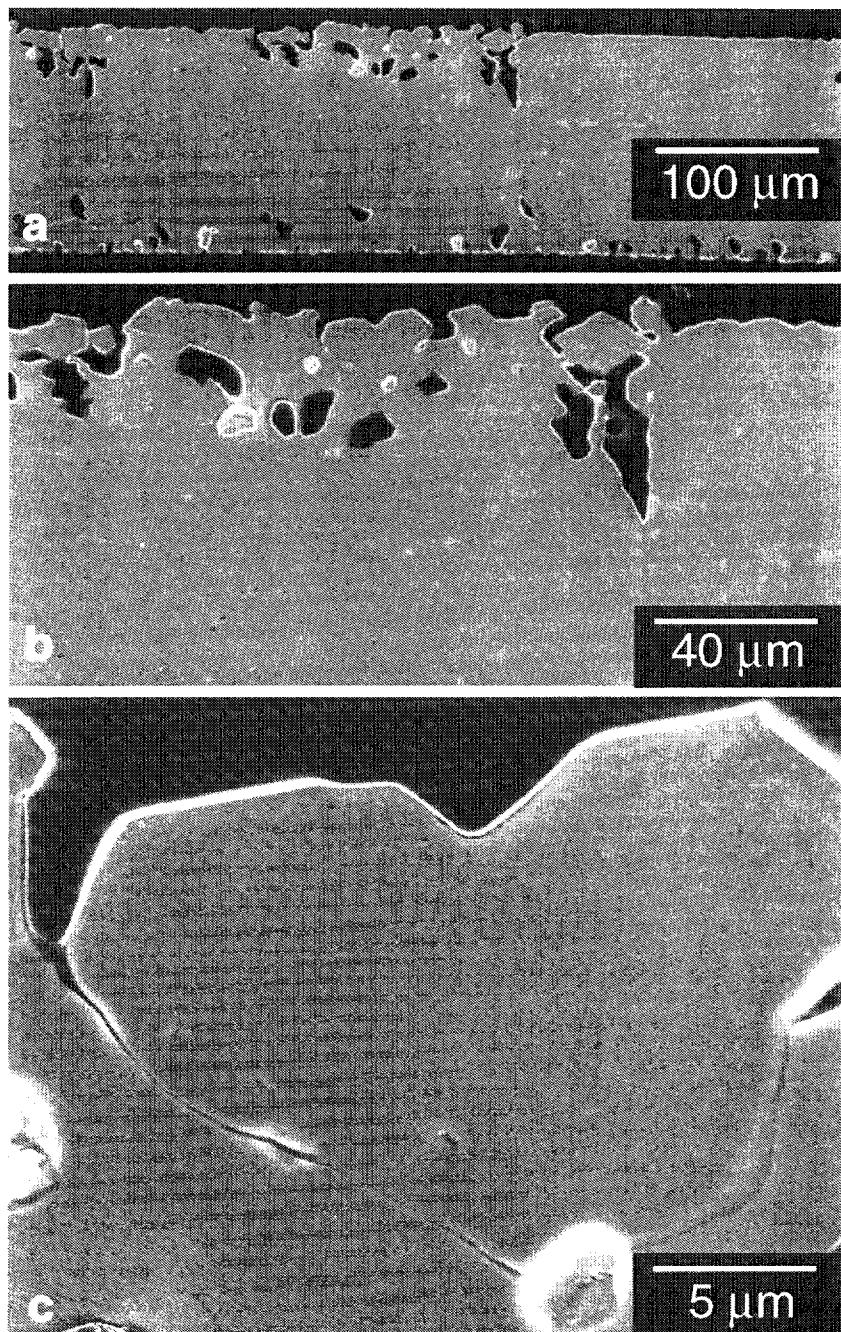
The extent of damage and the depth of pitting is shown in Figures 20a, b and c which are scanning electron micrographs of a polished cross-section of the nickel ribbon. Figure 20a reveals that the cavitation resulting from dissolution of nickel extended more than 30 μm below the ribbon surface. The faceting of the free surfaces of the nickel ribbon in Figure 19b is made more evident in Figure 20b. Figure 20c clearly shows that the dissolution is occurring along the grain boundaries of the nickel ribbon. The cavity microstructure is interconnected, allowing for the rapid dissolution of nickel from deep within the interior of the ribbon. EDS analysis revealed the presence of small concentrations (≤ 1 wt.%) of Cr, Fe and Zr in a surface layer several microns thick. The presence of these elements in the nickel ribbon arise from their dissolution in the NaK (Fe and Cr from the Haynes 230 vessel and IN 600 thermowells and the Zr from the oxygen getter) and subsequent deposition on and diffusion into the nickel foil. While the absolute amounts of these constituents were quite small, their presence was additional confirmation of the occurrence of mass transport within the pool-boiler.

Figure 20. Scanning electron micrographs of a polished cross-section of NaK-exposed nickel ribbon. a) Cavitation extends more than $30\mu\text{m}$ below surface. b) Exposed surface exhibits facets suggesting crystallographic dissolution. c) Grain boundary dissolution is apparent at high magnification.

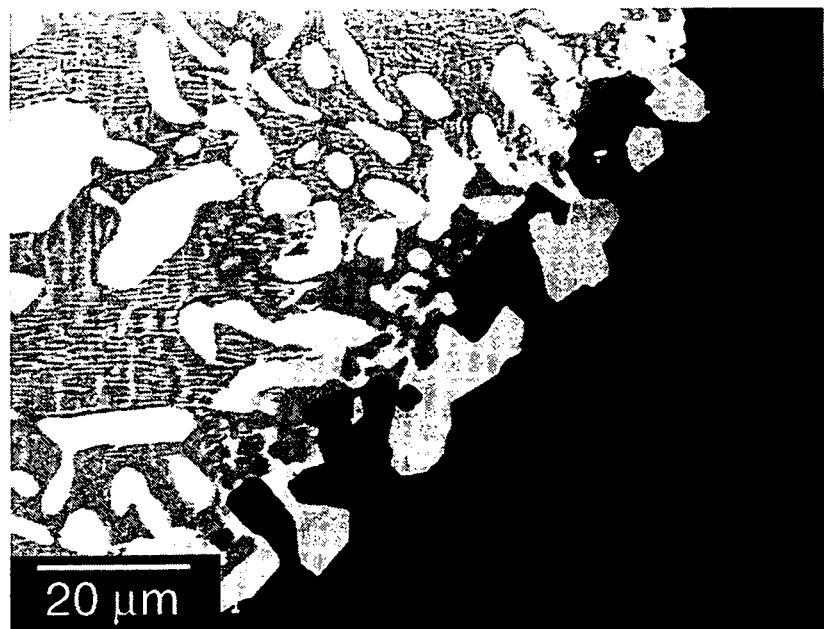
The principal effect of long-term exposure to NaK can be seen in Figure 22 which reveals that there was dissolution of braze alloy at the NaK-exposed surface. It is apparent that most of the loss was confined to the darker, Ni-Si phase. This dissolution was confined to the near-surface of the braze as there was no evidence of the formation of internal porosity beyond that which was observed in the unexposed braze. The preferential attack of the Ni-Si phase arises from its microstructure – specifically its partitioning into regions of nearly pure nickel and nickel-silicon alloy. The regions of nearly pure nickel within the Ni-Si phase are as susceptible to attack as was the nickel ribbon described in the previous section. It is through these regions of nickel that NaK aggressively attacks the braze.

EDS analysis of the cross-section shown in Figure 22 revealed that chromium was present in a narrow band extending from the NaK-exposed surface to a depth of approximately 20 μ m. The only source of chromium in the system is that which was dissolved into the NaK from the Haynes 230 vessel or the IN 600 thermowells. While this observation is only of incidental importance in relation to the interaction of the braze alloy with NaK, it is noteworthy in that it is yet another instance of mass transport and deposition identified in this pool-boiler system.

Figure 22. Backscatter electron image reveals loss of braze alloy at NaK-exposed surface. The darker regions in the micrograph are composed of a nickel-boron phase while the generally lighter regions are a nickel-silicon phase. The complex structure of the Ni-Si phase arises from the partitioning of the silicon into regions of relatively greater and lesser concentrations.

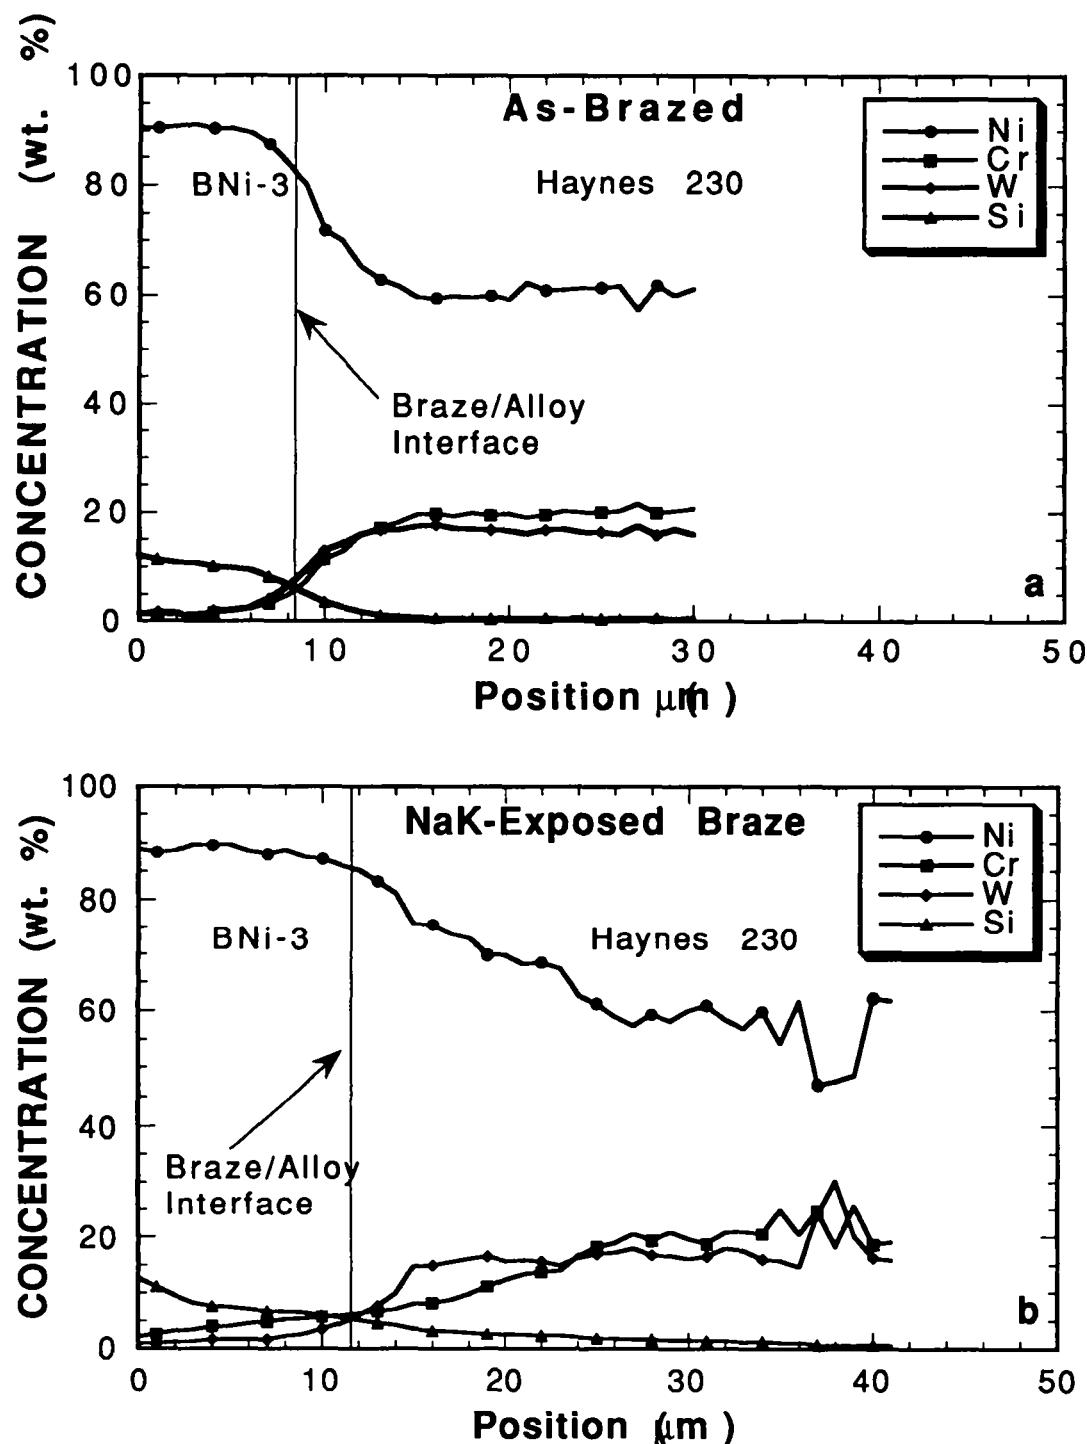
Figure 23b, an elemental trace analysis, illustrates the first effect. After the prolonged exposure, the interdiffusion zone was much broader than that shown in Figure 23a. The diffusion of silicon and boron into the Haynes 230 could be of particular concern if it were to result in the formation of silicides and borides, thus depleting the matrix of alloying constituents or promoting the formation of brittle grain boundary phases. In the present instance though, we have no evidence (e.g. cracking or porosity) of the braze structures or of the vessel alloy being compromised in any way by such processes.

Figure 23 a) EDS analysis of principal alloying constituents at as-received braze/Haynes interface. b) Similar elemental analysis across braze/Haynes interface from pool-boiler.

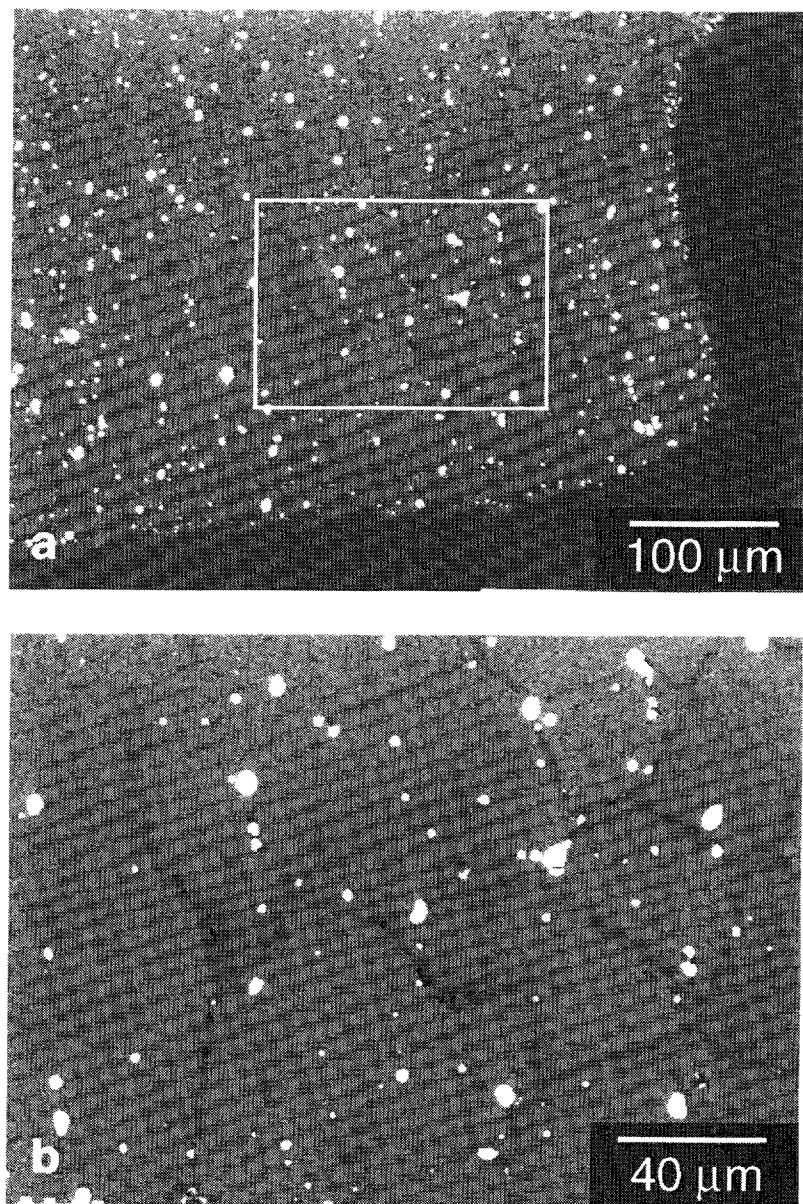
Within the pool-boiler, the interface between the braze and the Haynes 230 exhibited evidence of thermal aging effects. The resulting microstructure was quite complex and an exhaustive analysis of all of the microstructural changes was beyond the scope of the current work. However, it is useful to review the two principal effects: (1) the broadening of the interdiffusion zones on either side of the braze/Haynes interface and (2) the formation of low-Z intragranular and grain boundary structures in the Haynes to a depth of several grain diameters from the interface.

Figure 24. a) Backscatter electron images of the Haynes 230 endcap near a BNi-3 braze from the pool boiler showing low-Z grain boundary structures. b) The extent of segregation is seen more clearly in this higher magnification image of the highlighted region in (a).

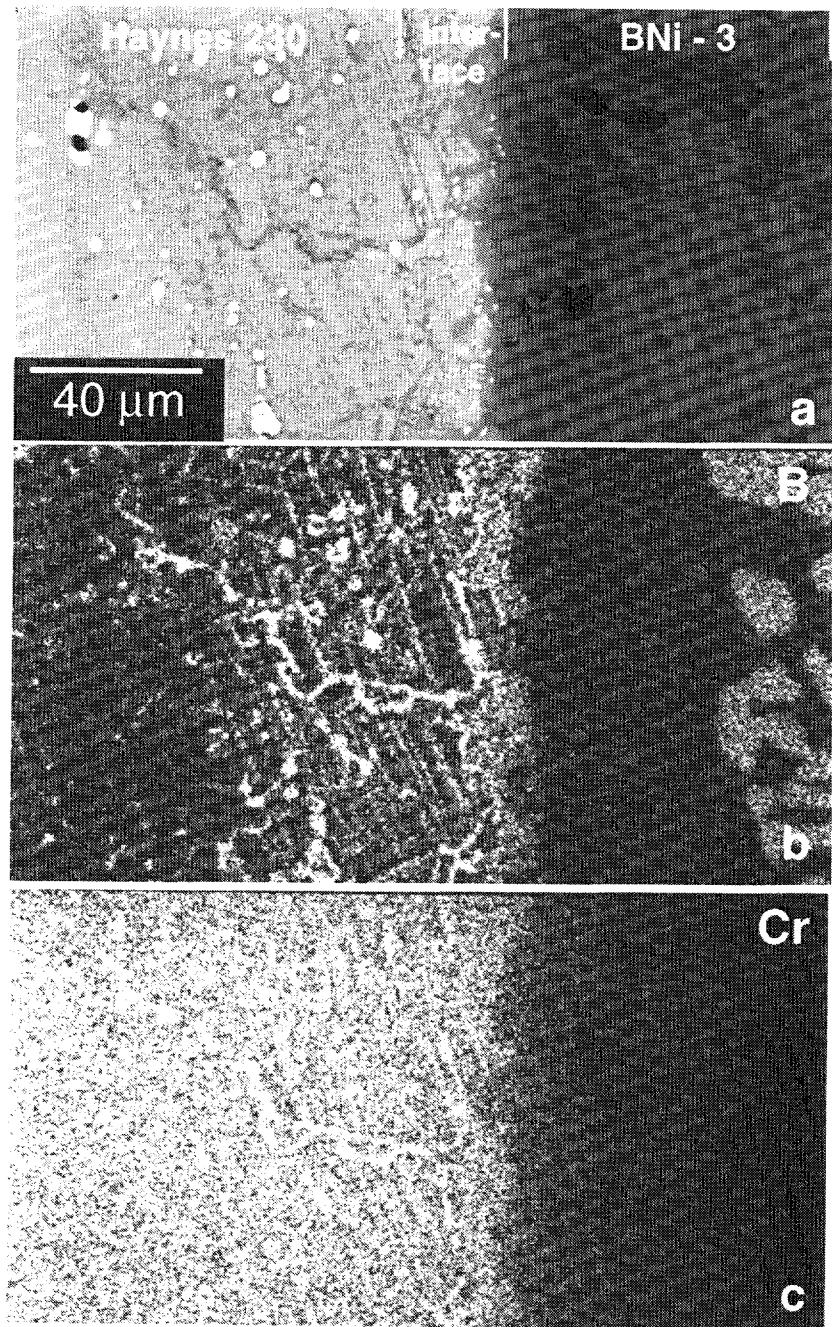
Figure 25a is a backscatter electron image of the braze/Haynes 230 interface after 7500 hours at temperature. As in the previous instance, the specimen shown in this figure was examined in the polished and unetched condition, so that contrast in the micrograph results only from compositional variations between regions within the sample.

Figure 25a reveals both the dark grain boundaries extending to a depth of 100-200 μm illustrated in the previous figure and the dark needle-like intragranular features mentioned above. X-ray mapping of this region was performed in order to identify which elemental species were segregating to these dark features. Such maps for boron and chromium are shown in Figures 25b and c. These maps reveal that the dark intragranular needles, as well as the darkened grain boundaries, contained elevated levels of boron and chromium relative to the surrounding Haynes matrix. No preferential segregation of silicon was observed. In addition, the braze alloy adjacent the interface exhibits a 40 μm wide band

Figure 25. a) Backscatter electron image of the braze/Haynes 230 interface after 7500 hours at temperature. b) Boron X-ray map of the region shown in (a). c) Chromium X-ray map of the same region.

that is depleted in boron. This boron depleted region is the source of the boron found in the Haynes.
