INTERGRANULAR CRACKING OF INOR-8 IN THE MSRE

H. E. McCoy

B. McNabb

NOVEMBER 1972

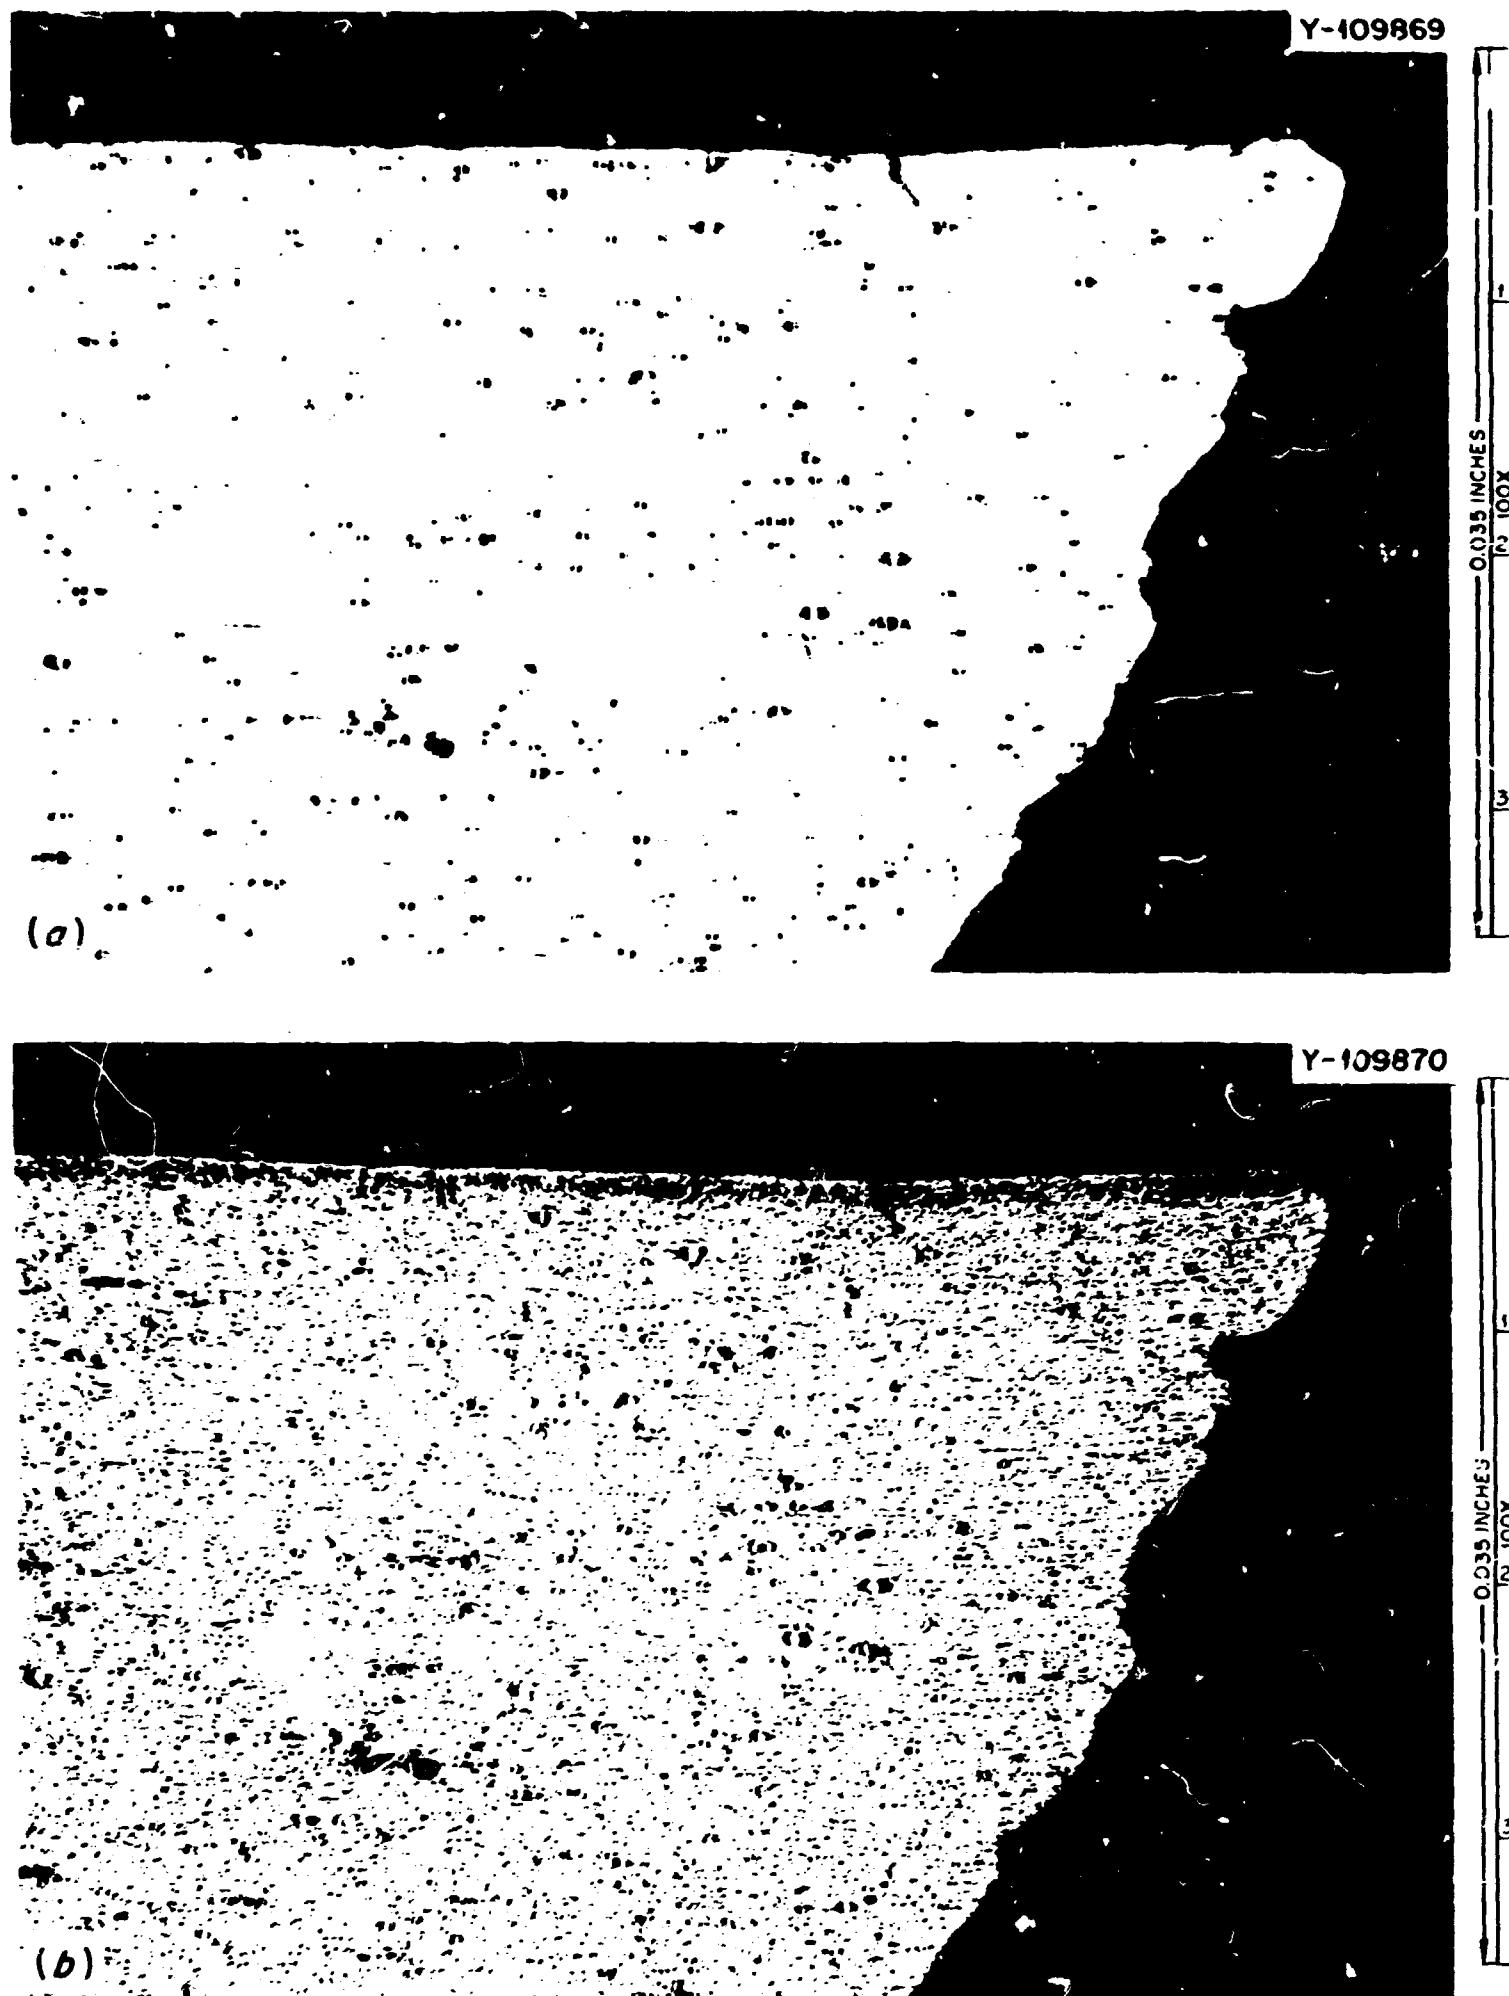
Fig. 7. Microstructure of INOR-8 Sample Held Above 500°C for 3306 hr During the "Zero-power" Run of the MSRE. (Fuel was in system 1090 hr.) (a) As polished. (b) Etched with glyceria regia. The material is cold worked, and the grains are not delineated by etching.

The important point to be noted here is that INOR-8 specimens exposed to fuel salt for a considerable period of time before the generation of substantial nuclear power (and fission-product inventories) showed no intergranular surface cracks upon testing at 25°C.

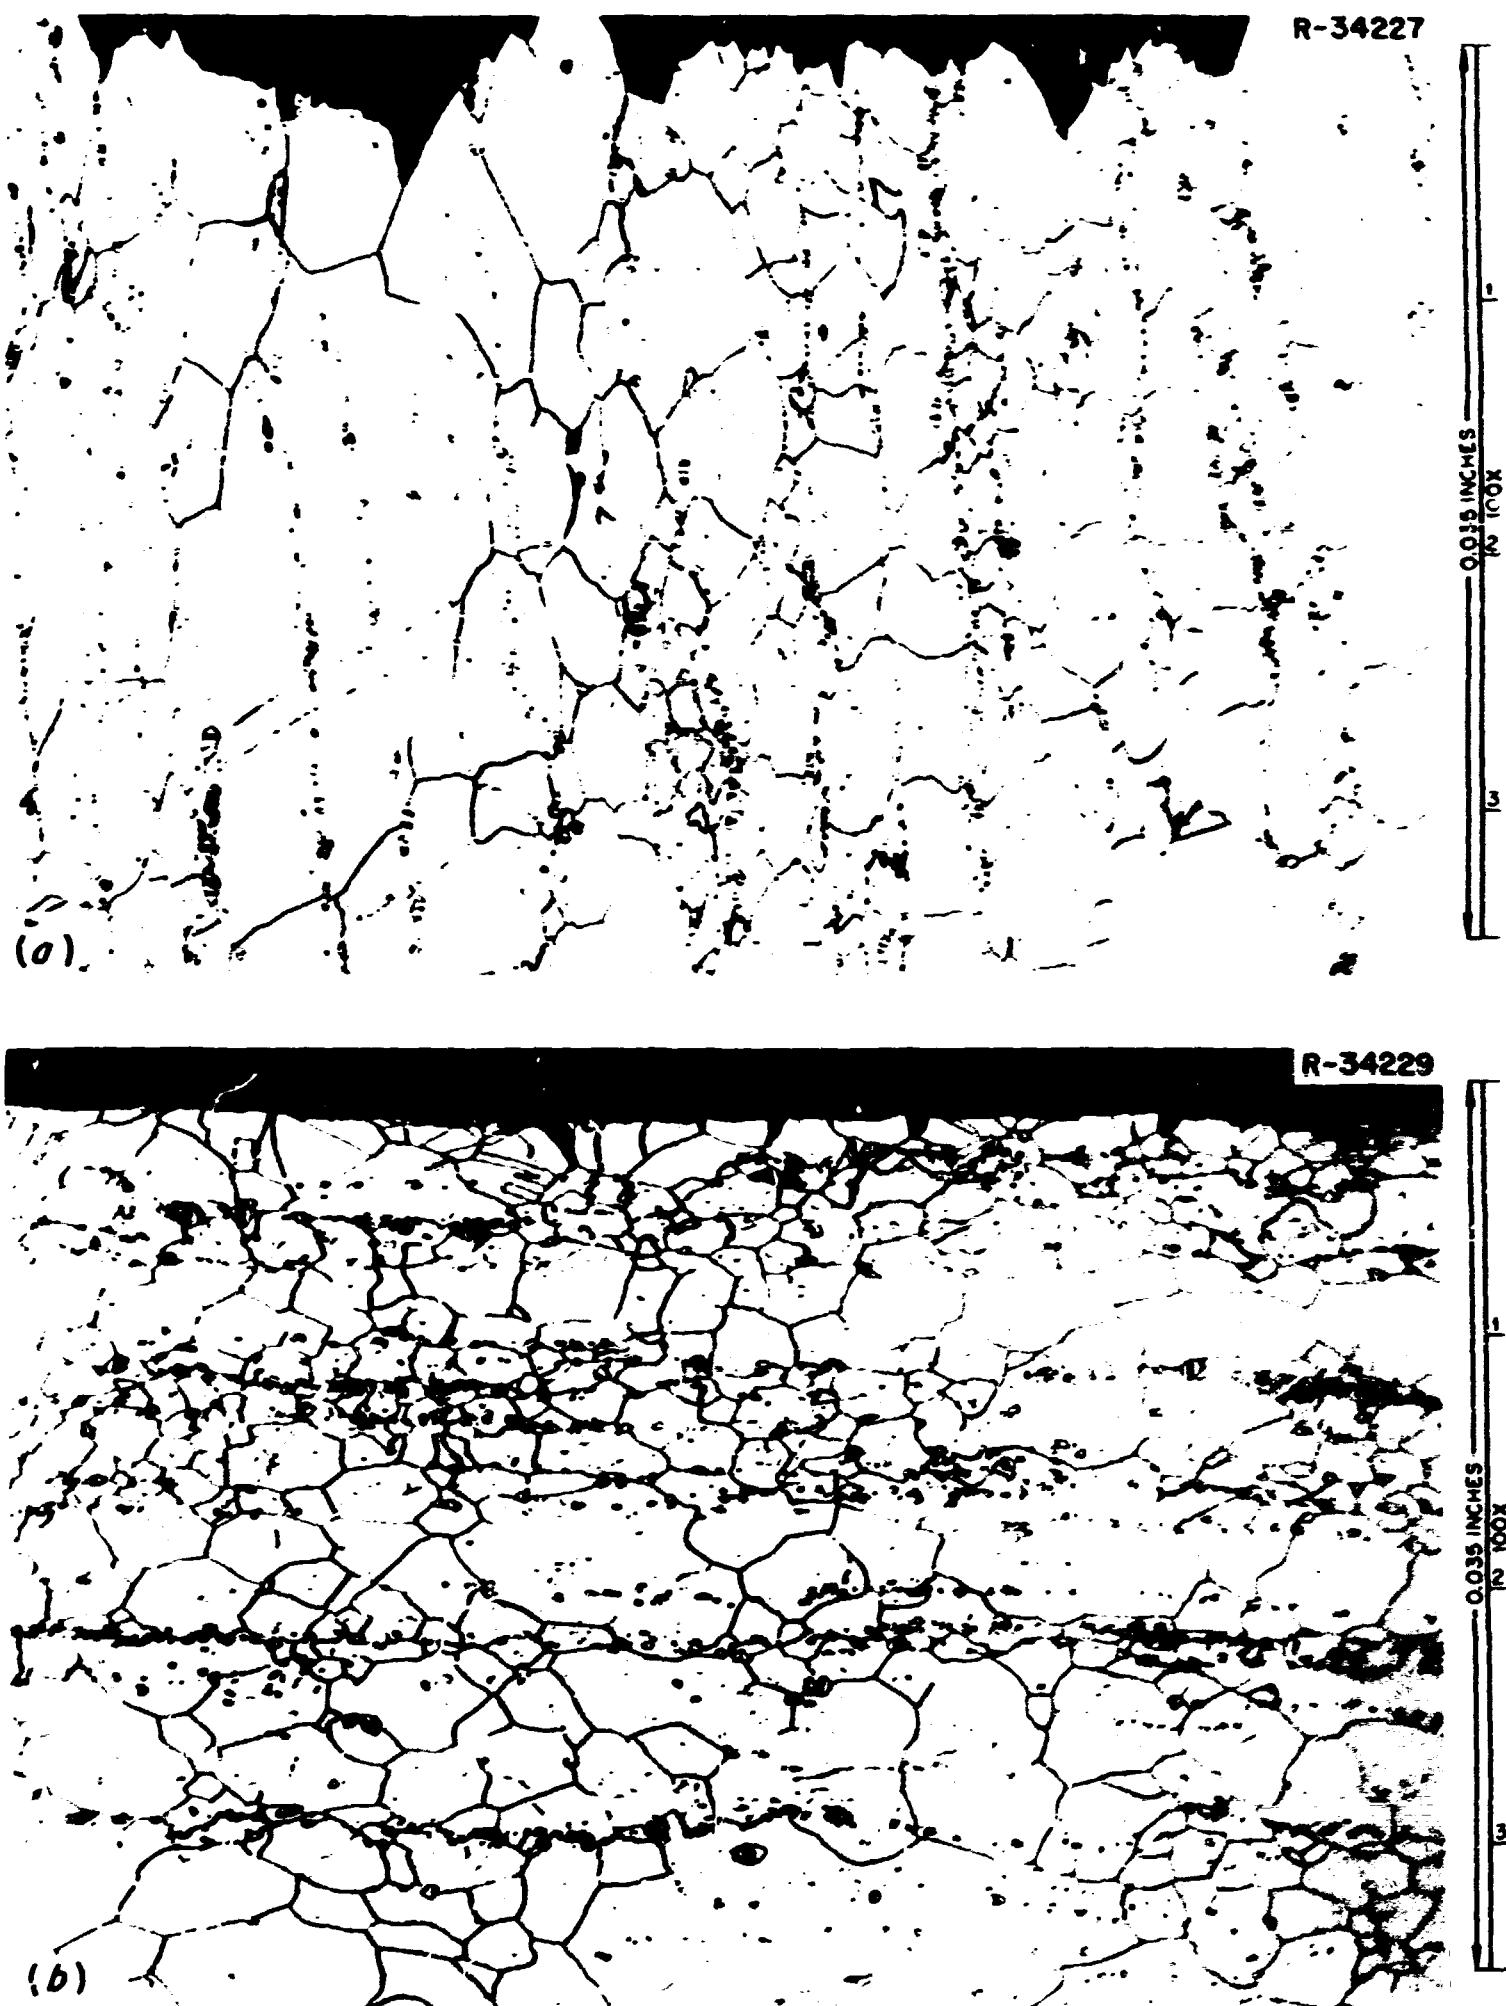
Metallography of specimens broken in tension at 25°C revealed differences in the nature of the fractures in core and control specimens. These differences are believed to be another manifestation of carbide precipitation. Figures 8 and 9 show specimens of heat 5081 from the control facility and from the core. The fracture in the control specimen (Fig. 8) is typical of transgranular shear-type failure (cup-cone appearance). In contrast, the fracture of the core specimen (Fig. 9) is largely intergranular. Heat 5085 specimens are shown in Figs. 10 and 11. The fracture in the 5085 control specimen is mixed transgranular and intergranular, with the elongated grains attesting to the large amount of strain. The fracture in the 5085 core specimen is largely intergranular with numerous intergranular cracks in the microstructure.

Fig. 9. Photomicrographs of Surveillance Specimen D-16 from Heat 5081 Tested at 25°C and at a Strain Rate of 0.05/min. (a) Fracture. (b) Edge of specimen about 1/4 in. from fracture. Etchant: glyceria regia.

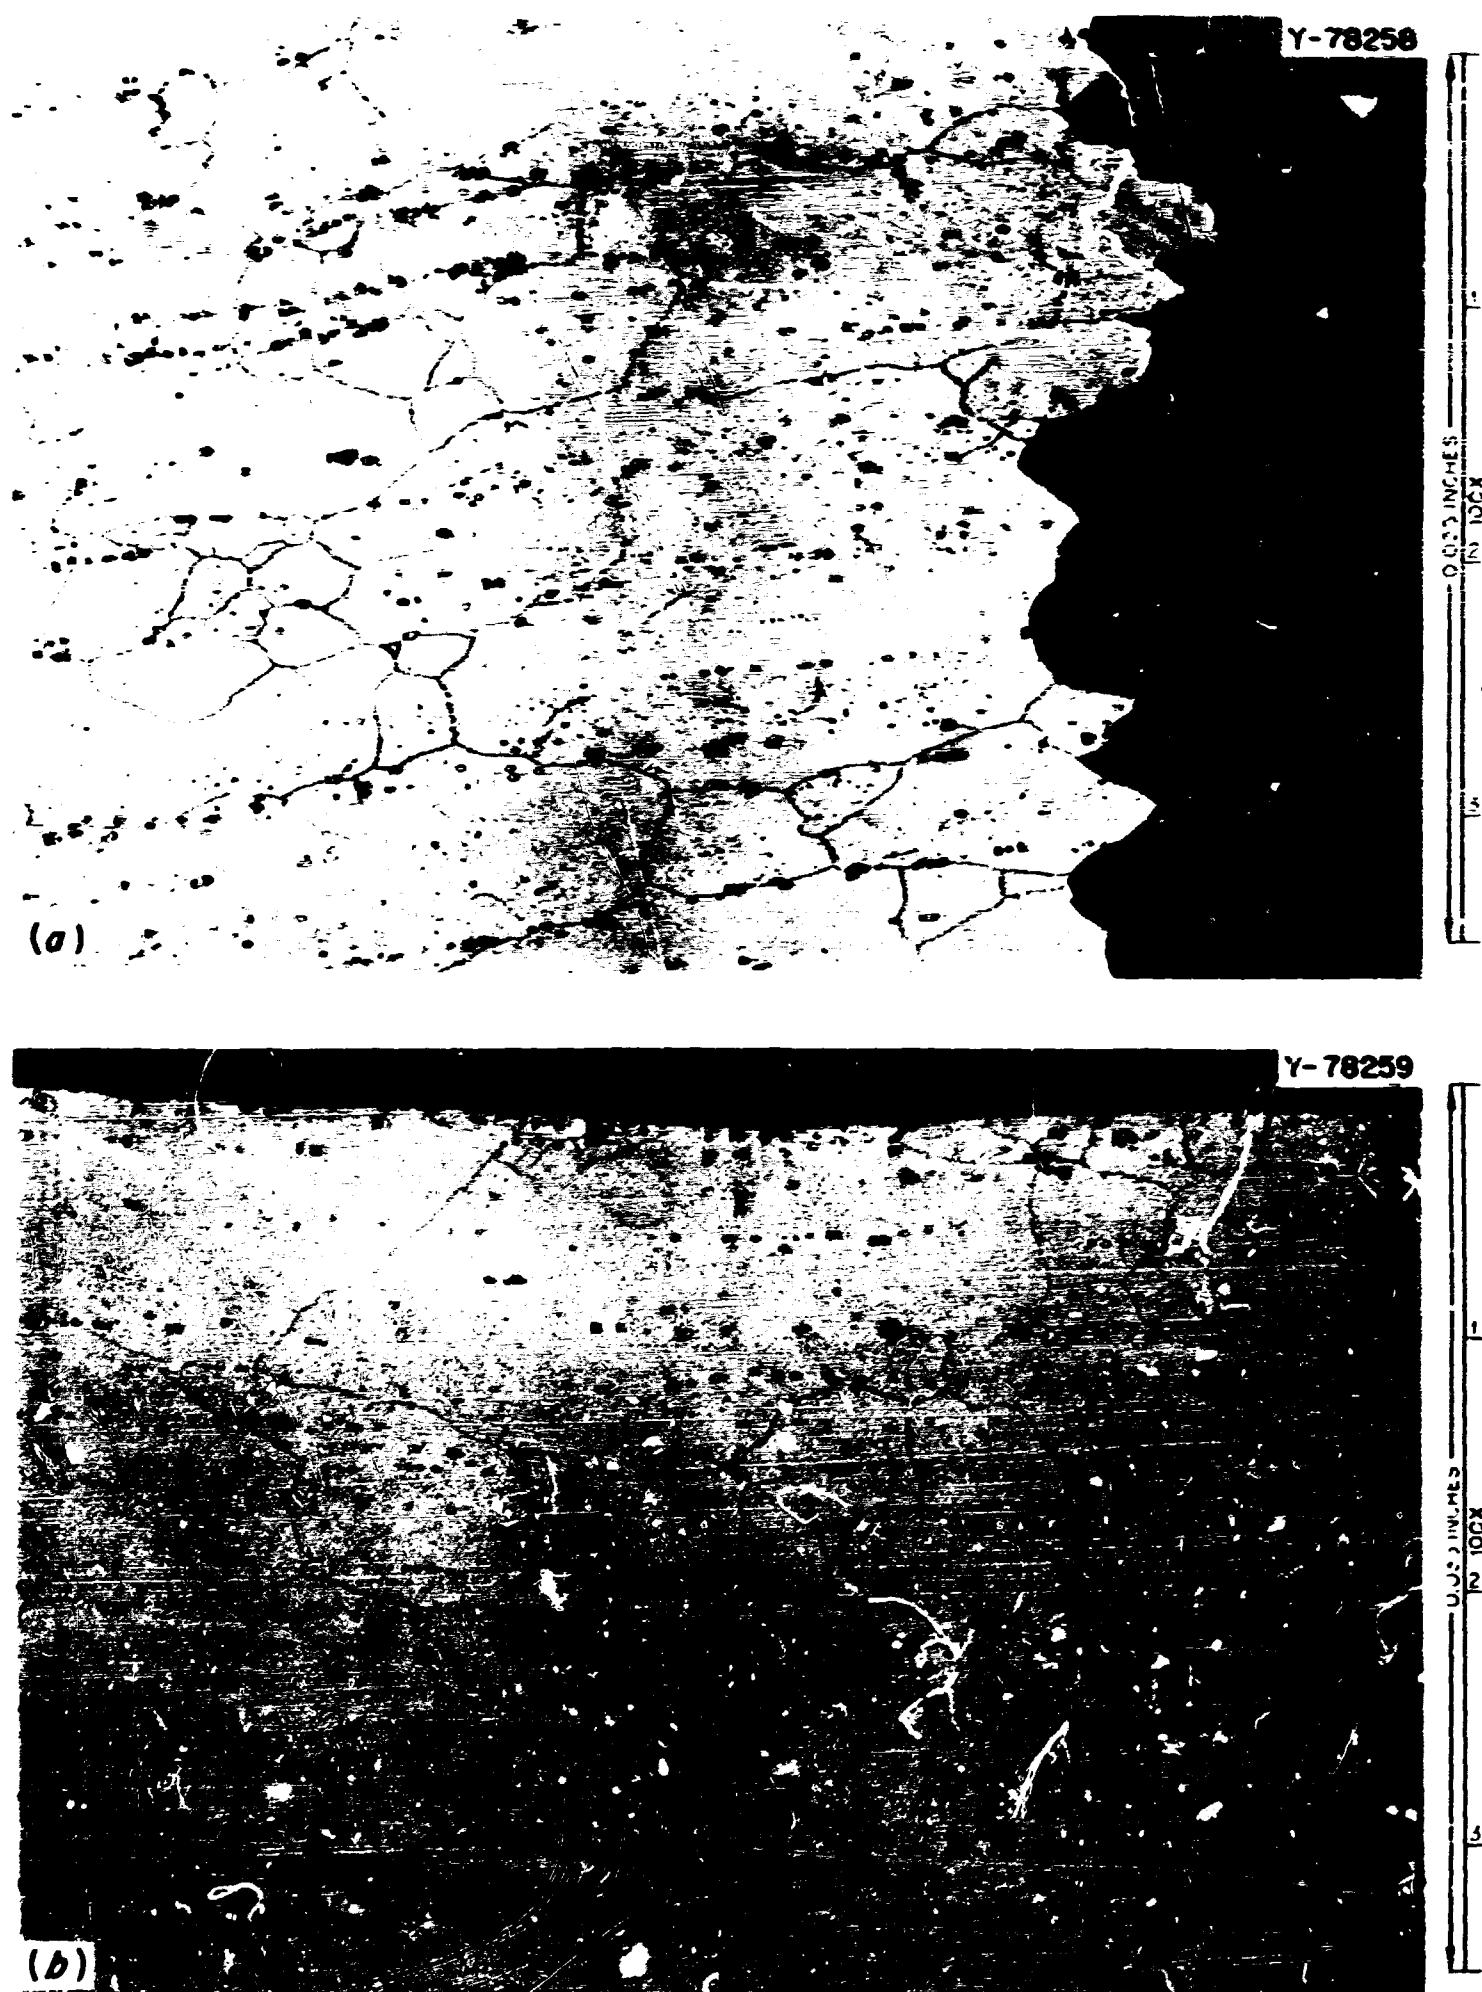
Fig. 10. Photomicrographs of Control Specimen DC-24 from Heat 5085 Tested at 25°C and at a Strain Rate of 0.05/min. (a) Fracture. (b) Edge of specimen about 1/4 in. from fracture. Etchant: glyceria regia.

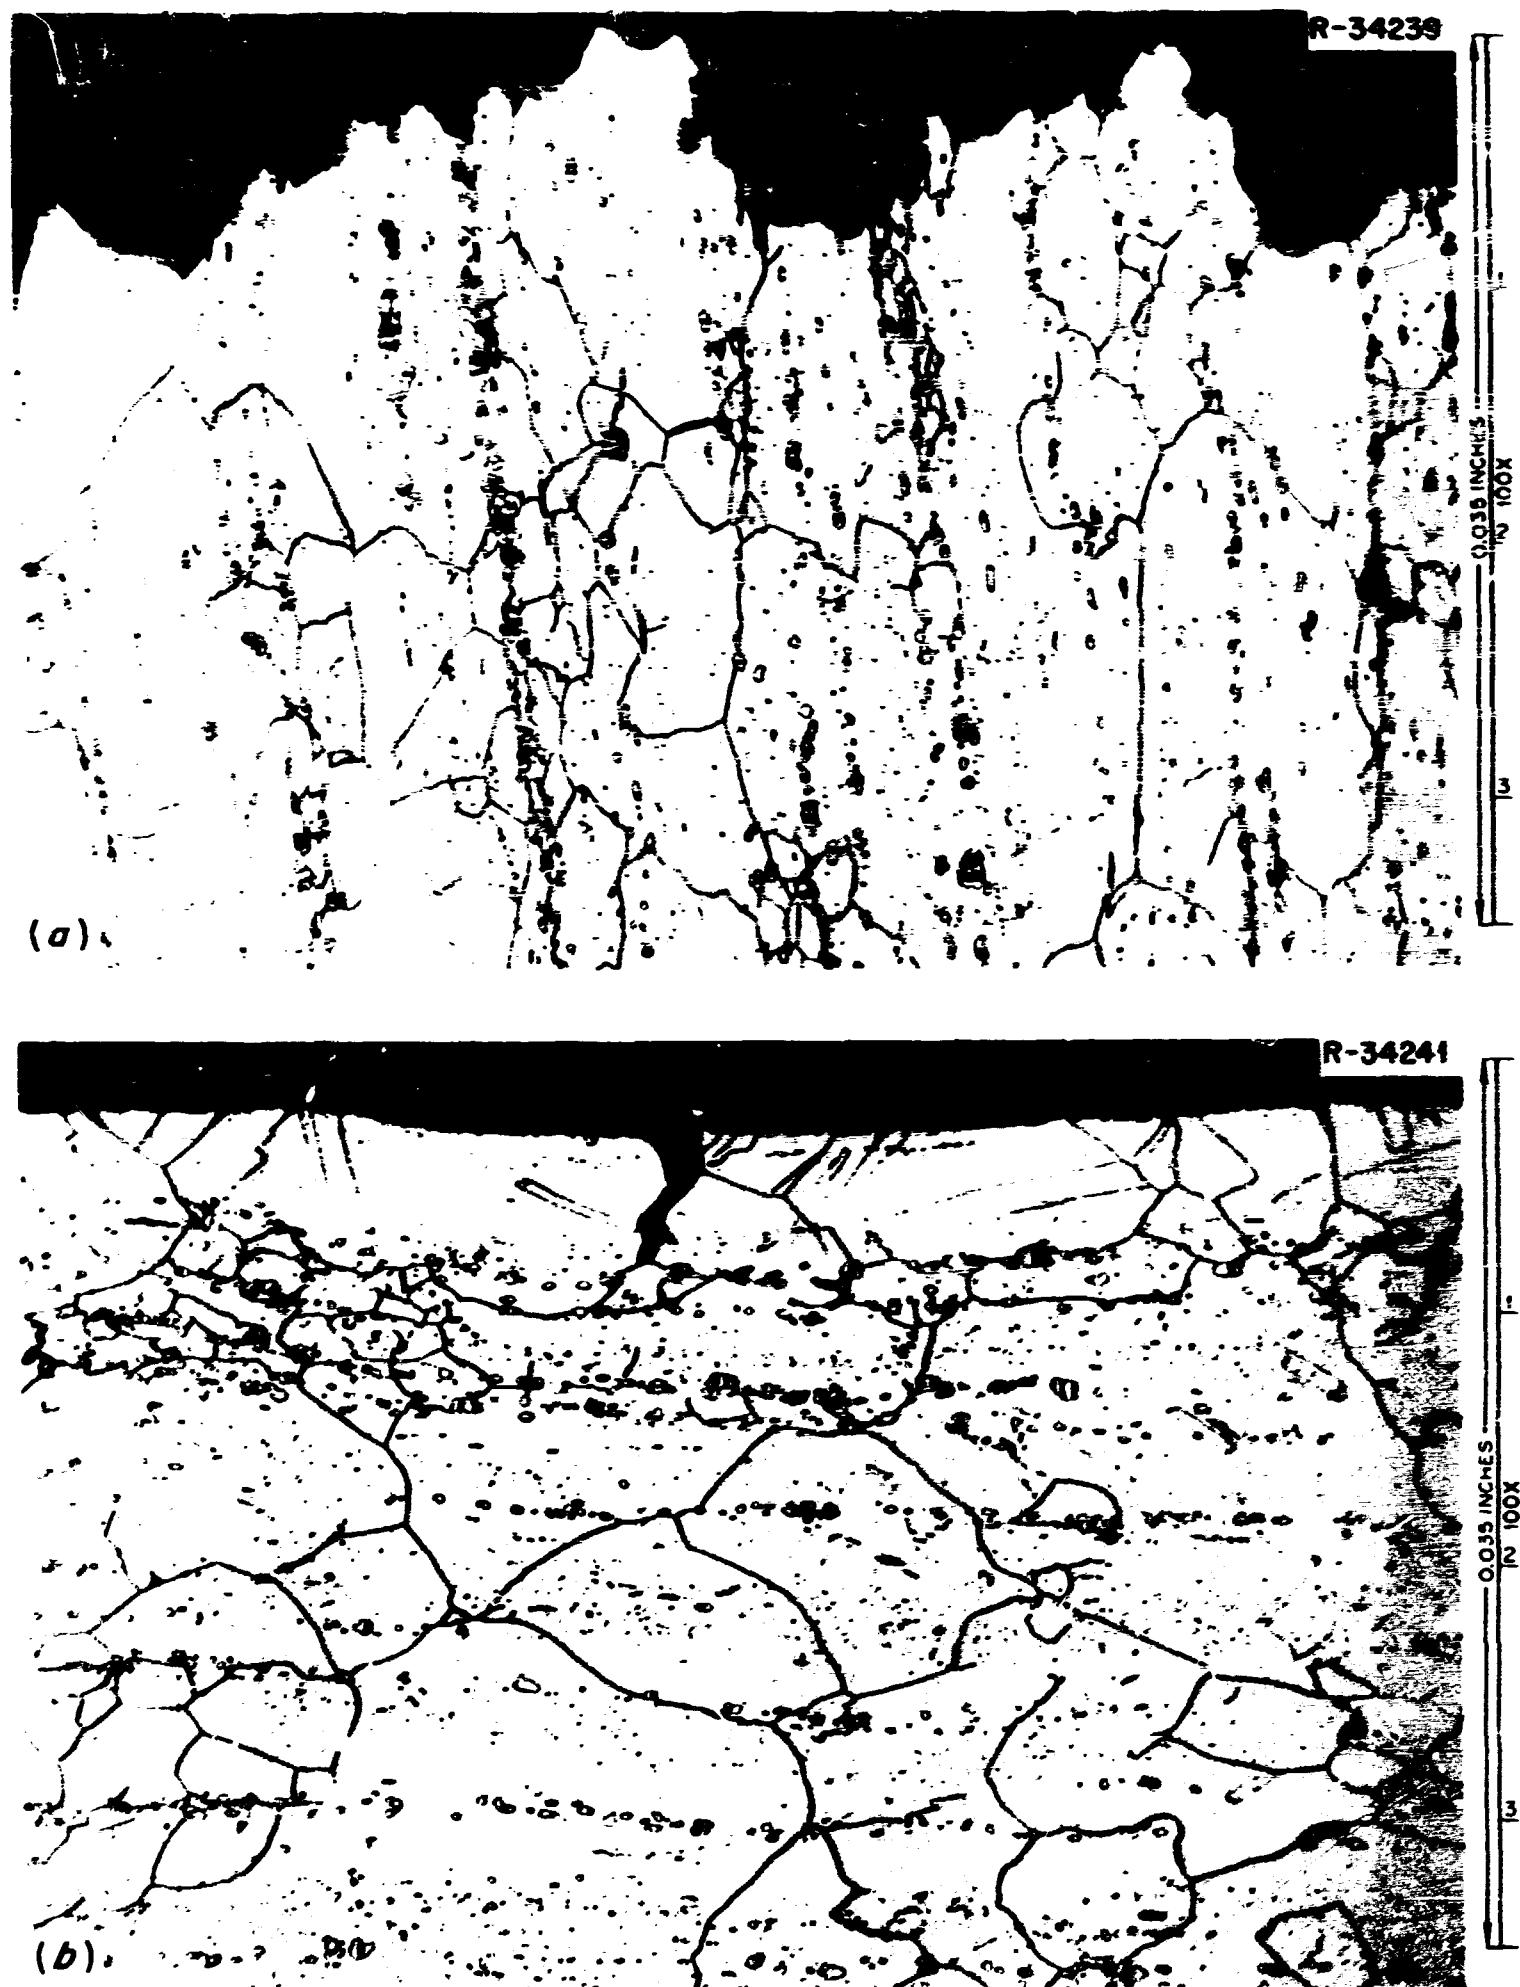
Fig. 11. Photomicrographs of Surveillance Specimen A-16 from Heat 5085 Tested at 25°C and at a Strain Rate of 0.05/min. (a) Fracture. (b) Edge of Specimen about 1/4 in. from fracture. Etchant: glyceria regia.

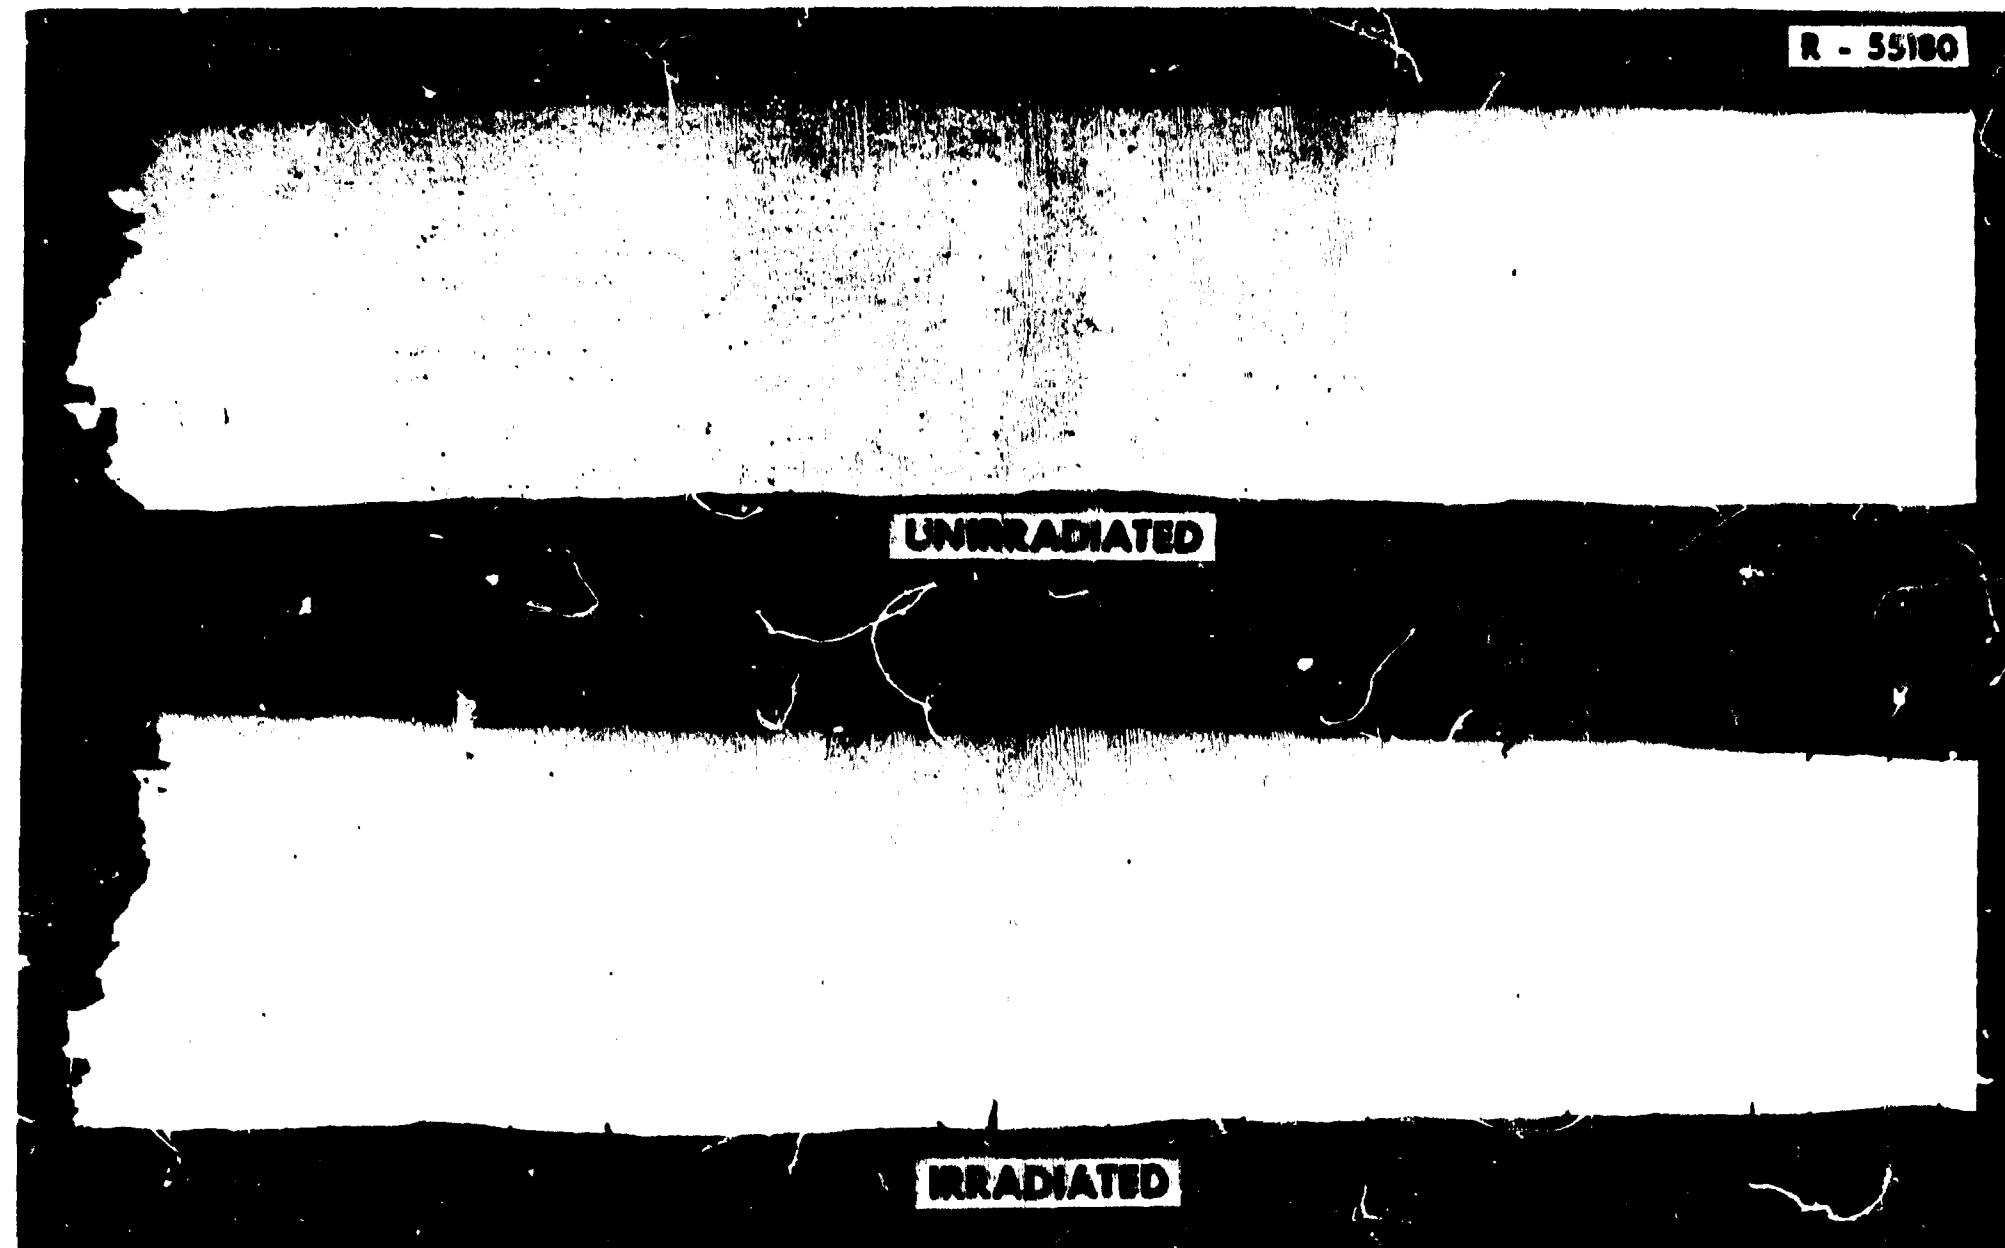
Fig. 12. Photomicrographs of Heat 5085 strained at 25°C After 3350 hr Above 500°C. The top specimen was in static fuel salt containing depleted uranium, and the lower specimen was in the MSRE core. The true specimen diameters are 0.070 and 0.090 in., respectively.

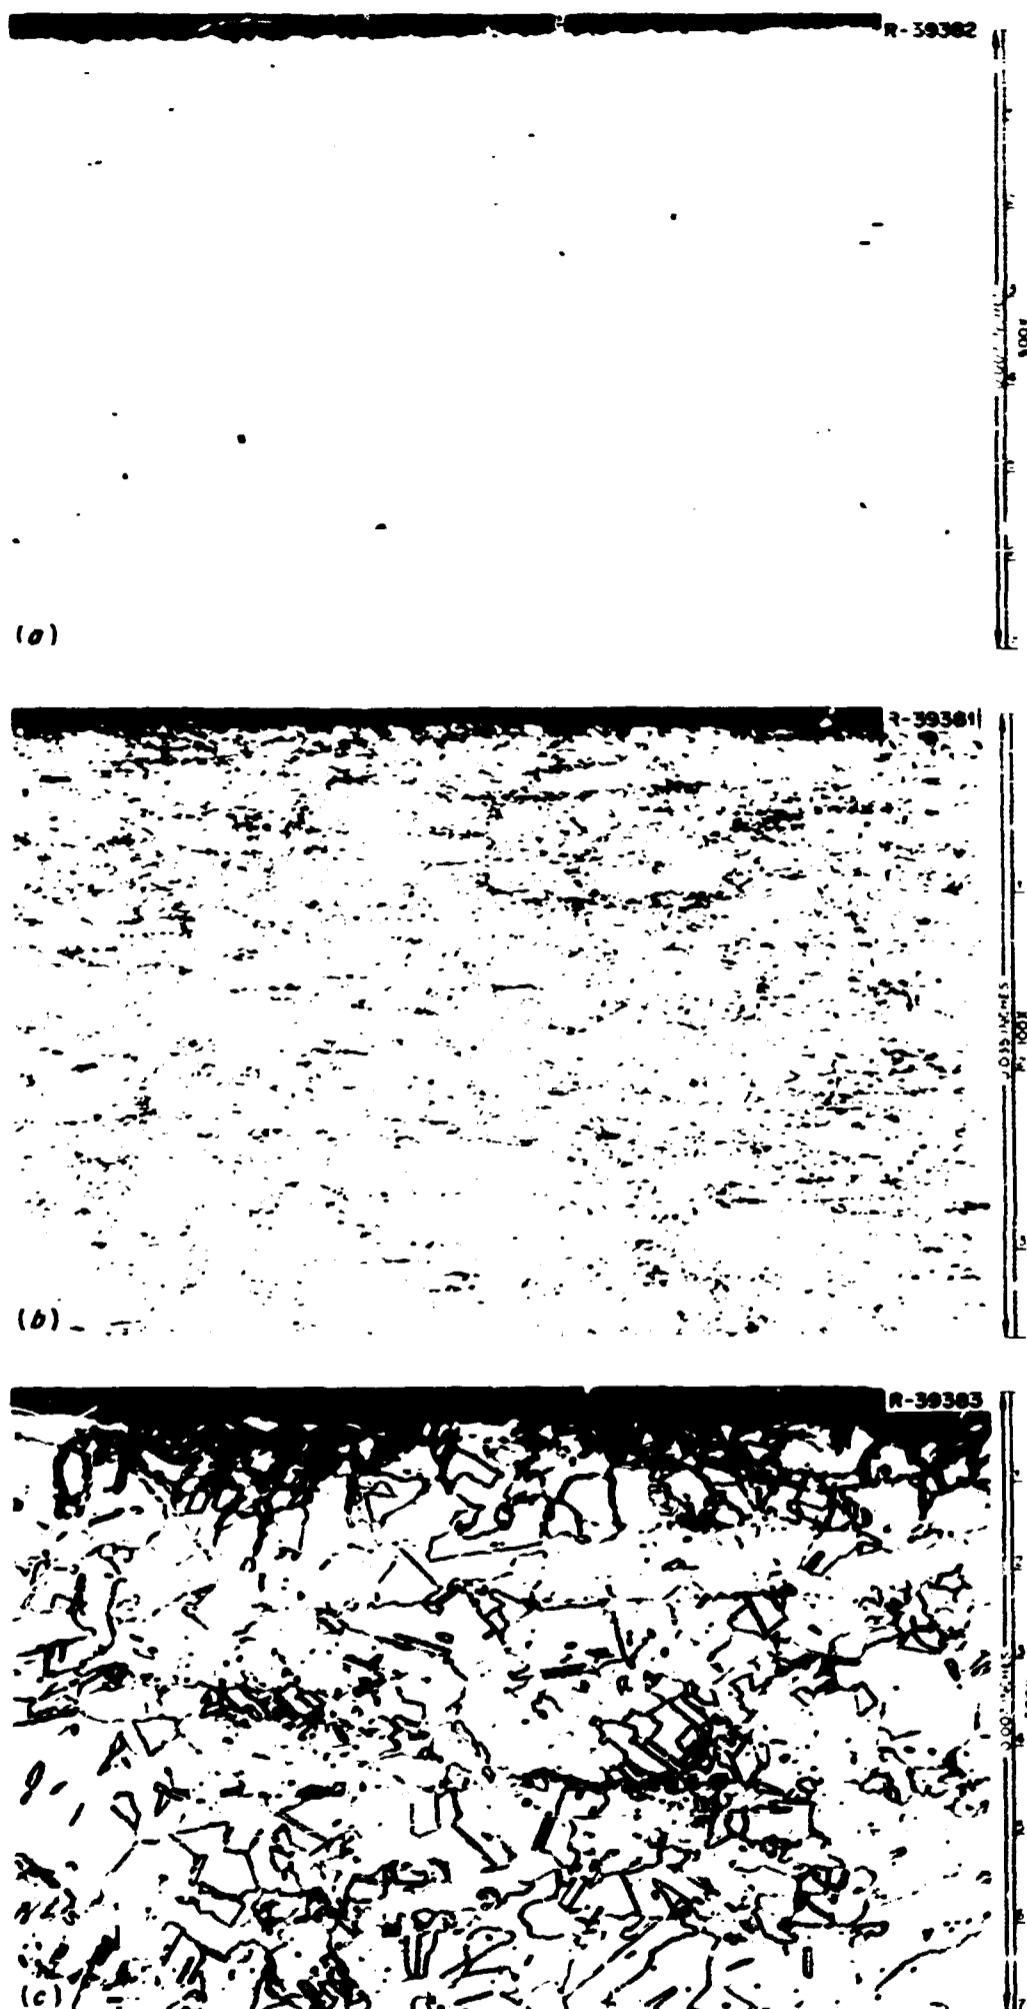
Fig. 13. Photomicrographs of Zirconium-Modified INOR-8 (Heat 21554) Removed from the MSRE after 5554 hr above 500°C. Edge exposed to flowing salt. (a) As polished. 500x. (b) Etchant: aqua regia. 100x. (c) Etchant: aqua regia. 500x. Reduced 30%.

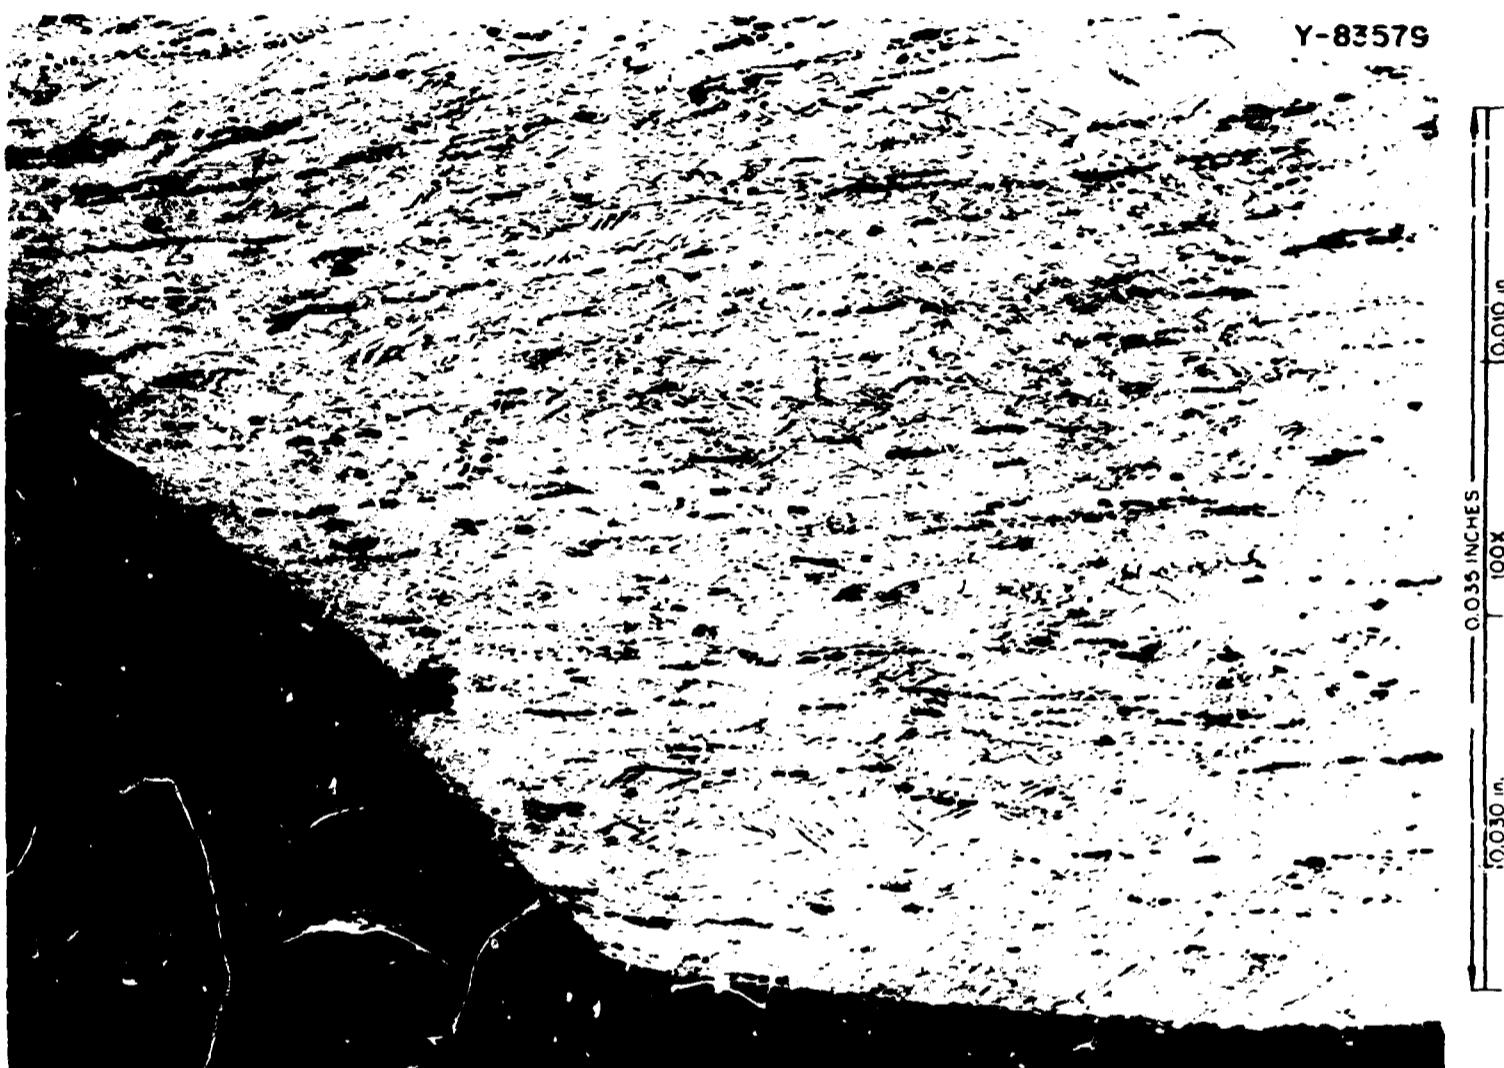
Core specimens of both heats tested to failure in tension developed numerous intergranular cracks along the surfaces, while control specimens tested similarly showed few or no surface cracks. The difference is illustrated in Figs. 15-18. Figure 15 and 16 are control and core specimens respectively of heat 21554. In the core specimen surfaces nearly every grain boundary is cracked to a consistent depth of about 2 mils. In the control specimen there is no evidence of intergranular edge cracking. Figures 17 and 18 show the same thing for heat 21545.

Fig. 15. Photomicrograph of the Fracture of a Zirconium-Modified INOR-8 Sample (Heat 21554) Tested at 25°C at a Strain Rate of 0.05/min. Exposed to a static fluoride salt for 5554 hr above 500°C before testing. Note the shear fracture and the absence of edge cracking. 100x. Etchant. glyceria regia.

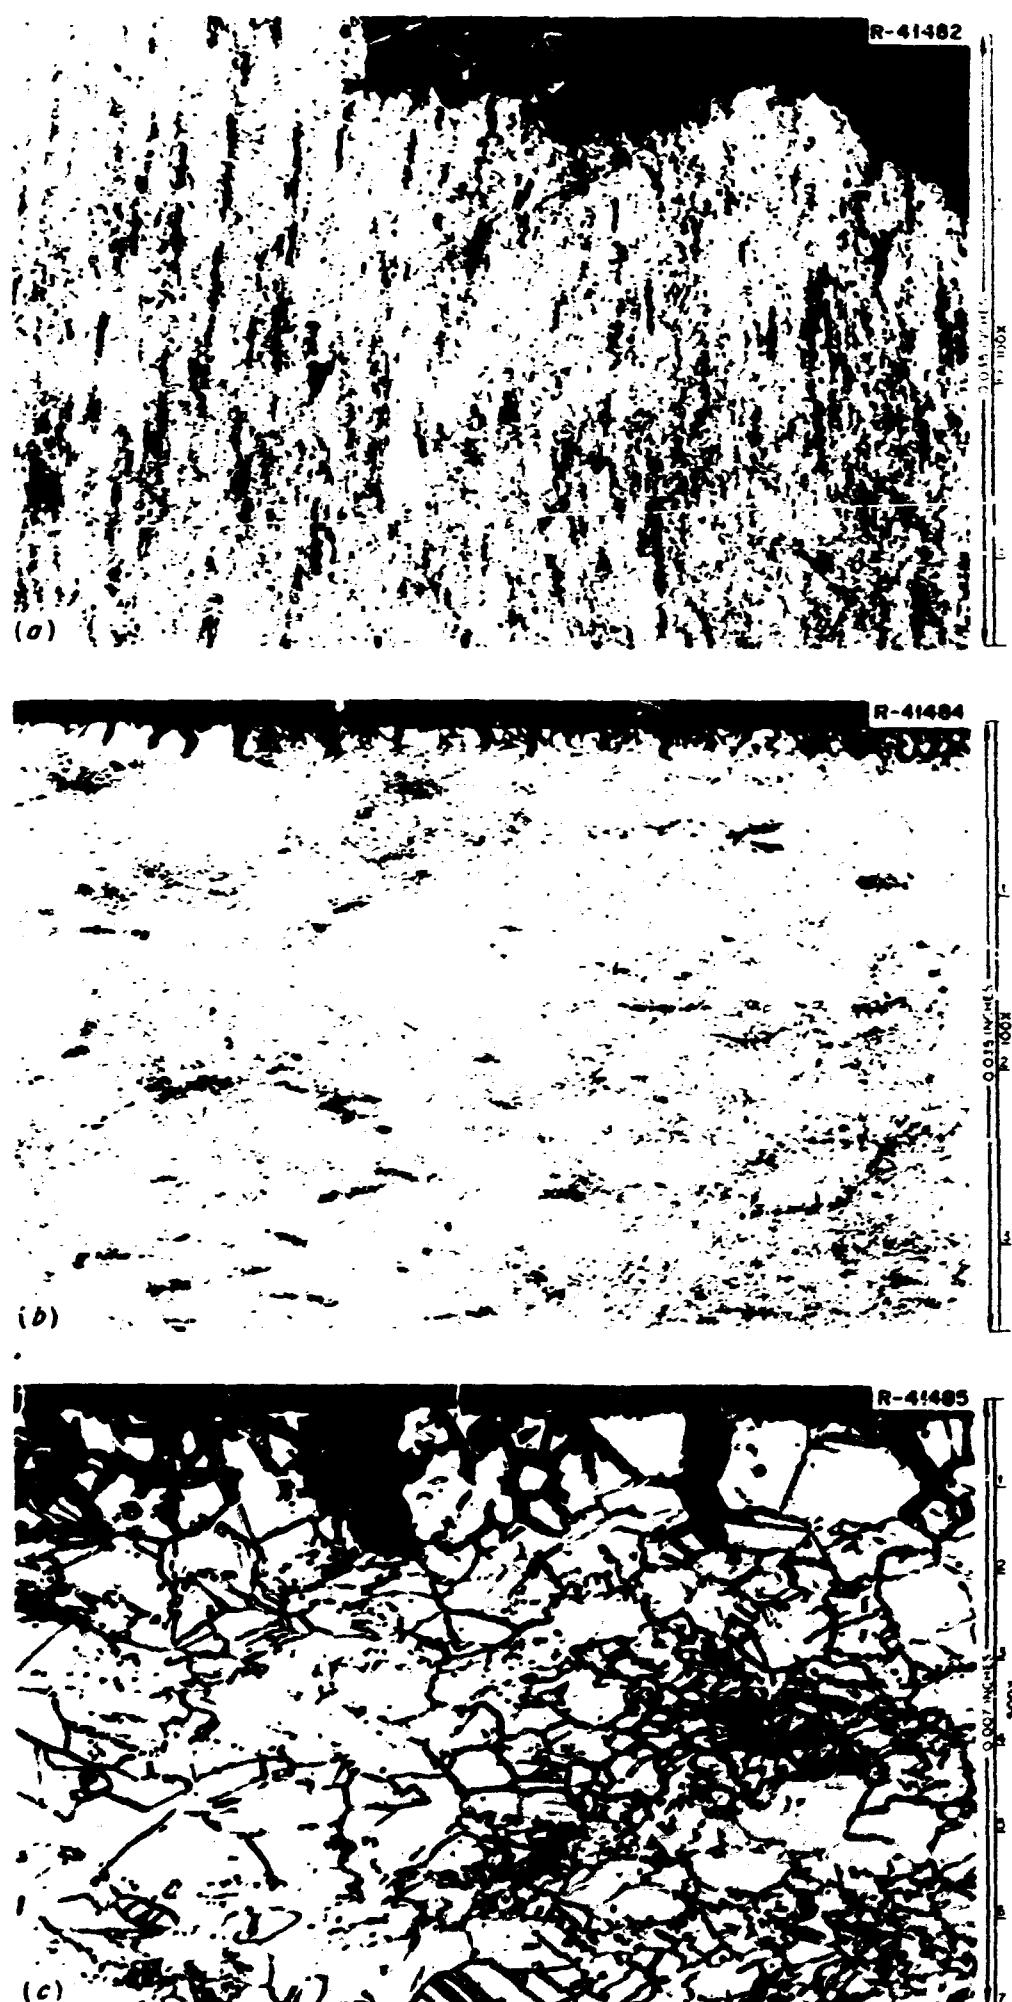
Fig. 16. Photomicrographs of a Zirconium-Modified INOR-8 Surveillance Sample (Heat 21554) Tested at 25°C at a Strain Rate of 0.05/min. Exposed in the MSRE core for 5554 hr above 500°C to a thermal fluence of 4.1×10^{20} neutrons/cm². Etchant: aqua regia. (a) Fracture. 100x. (b) Edge of sample about 1/2 in. from fracture. 100x. (c) Edge of sample showing edge cracking. 500x. Reduced 31.5%.

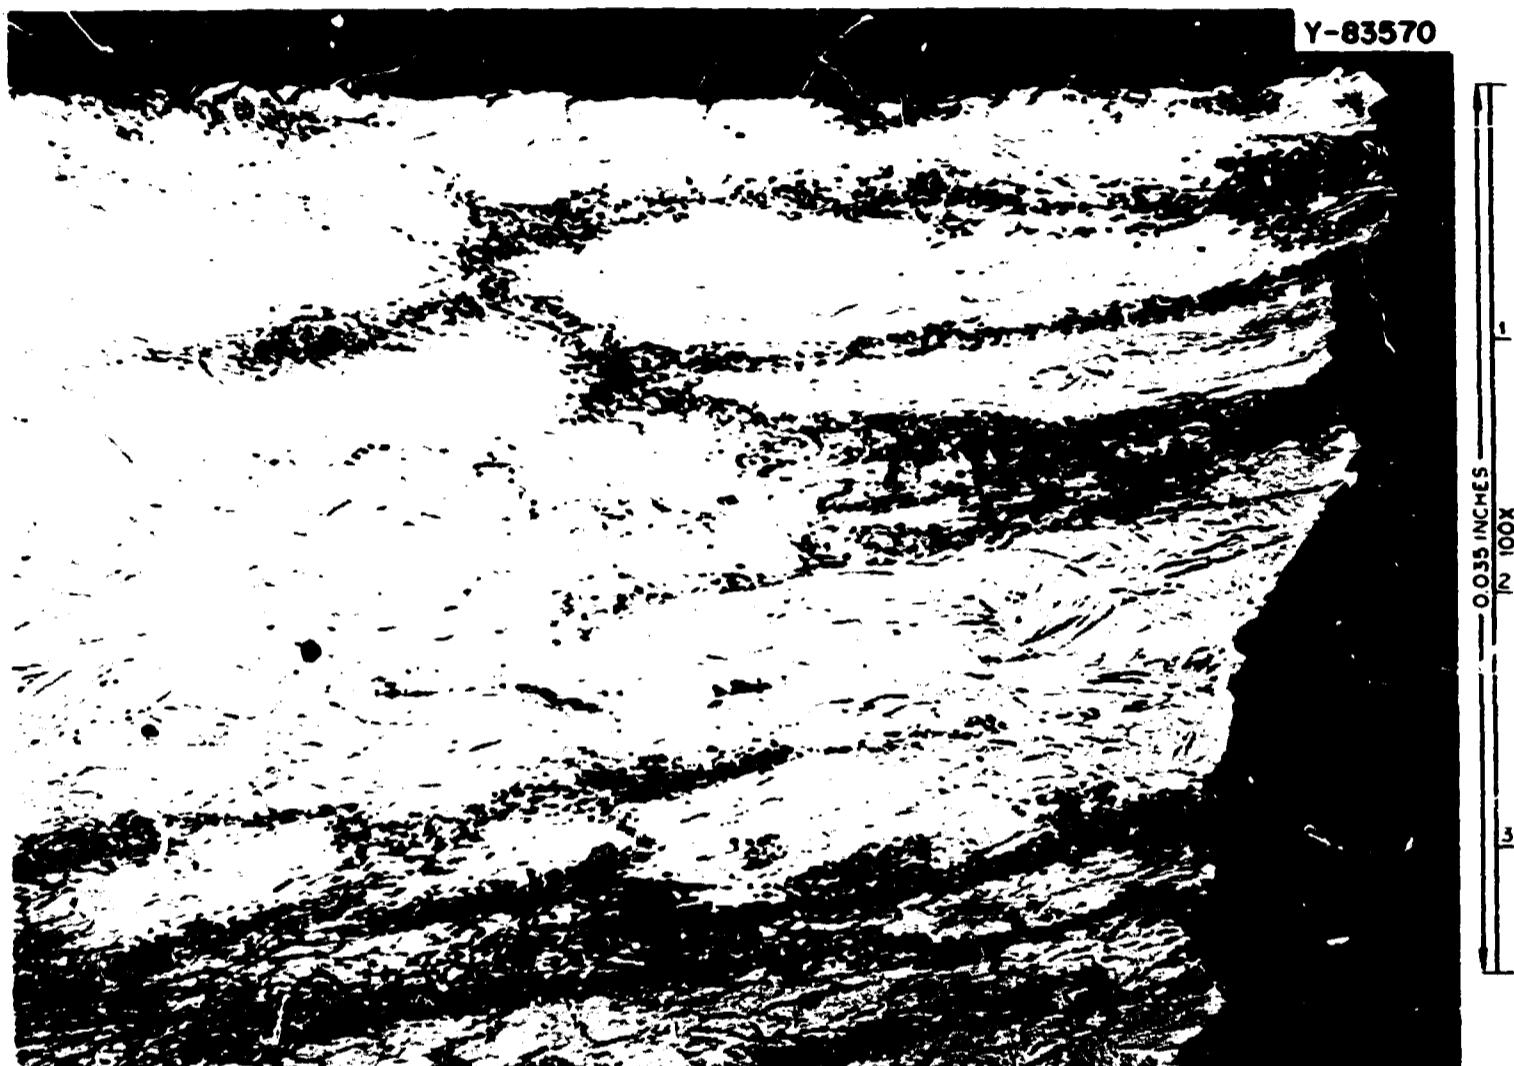
Fig. 17. Photomicrograph of the Fracture of a Titanium-Modified INOR-8 Surveillance Sample (Heat 21545) Tested at 25°C at a Strain Rate of 0.05/min. Exposed to a static fluoride salt for 5554 hr above 500°C before testing. Note the shear fracture and the absence of edge cracking. 100x. Etchant: glyceria regia.
