INTERGRANULAR CRACKING OF INOR-8 IN THE MSRE

H. E. McCoy

B. McNabb

NOVEMBER 1972

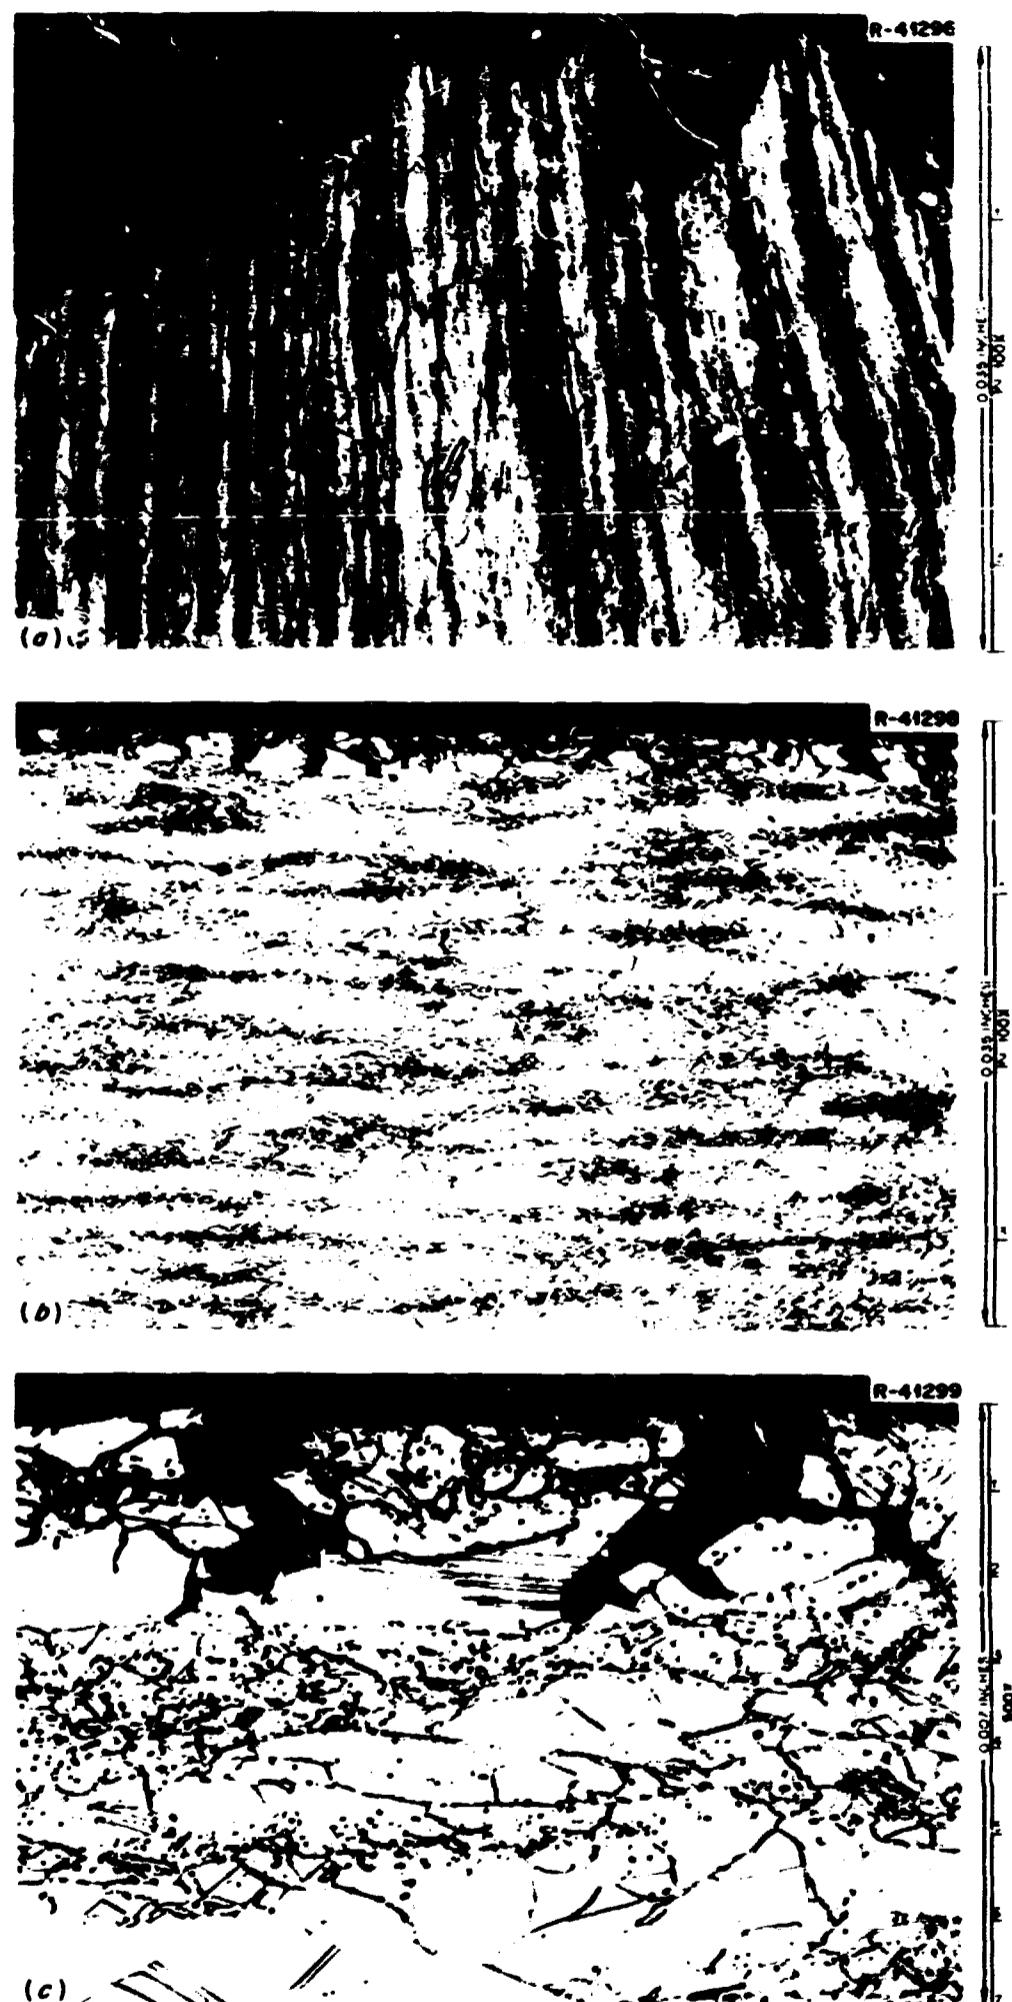
Core specimens of both heats tested to failure in tension developed numerous intergranular cracks along the surfaces, while control specimens tested similarly showed few or no surface cracks. The difference is illustrated in Figs. 15-18. Figure 15 and 16 are control and core specimens respectively of heat 21554. In the core specimen surfaces nearly every grain boundary is cracked to a consistent depth of about 2 mils. In the control specimen there is no evidence of intergranular edge cracking. Figures 17 and 18 show the same thing for heat 21545.

Fig. 18. Photomicrographs of a Titanium-Modified INOR-8 Surveillance Sample (Heat 21545) Tested at 25°C at a Strain Rate of 0.05/min. Exposed in the MSRE core for 5554 hr above 500°C to a thermal fluence of 4.1×10^{20} neutrons/cm². Etchant: aqua regia. (a) Fracture. 100x. (b) Edge of sample about 1/2 in. from fracture. 100x. (c) Edge of sample showing edge cracking. 500x. Reduced 32%.

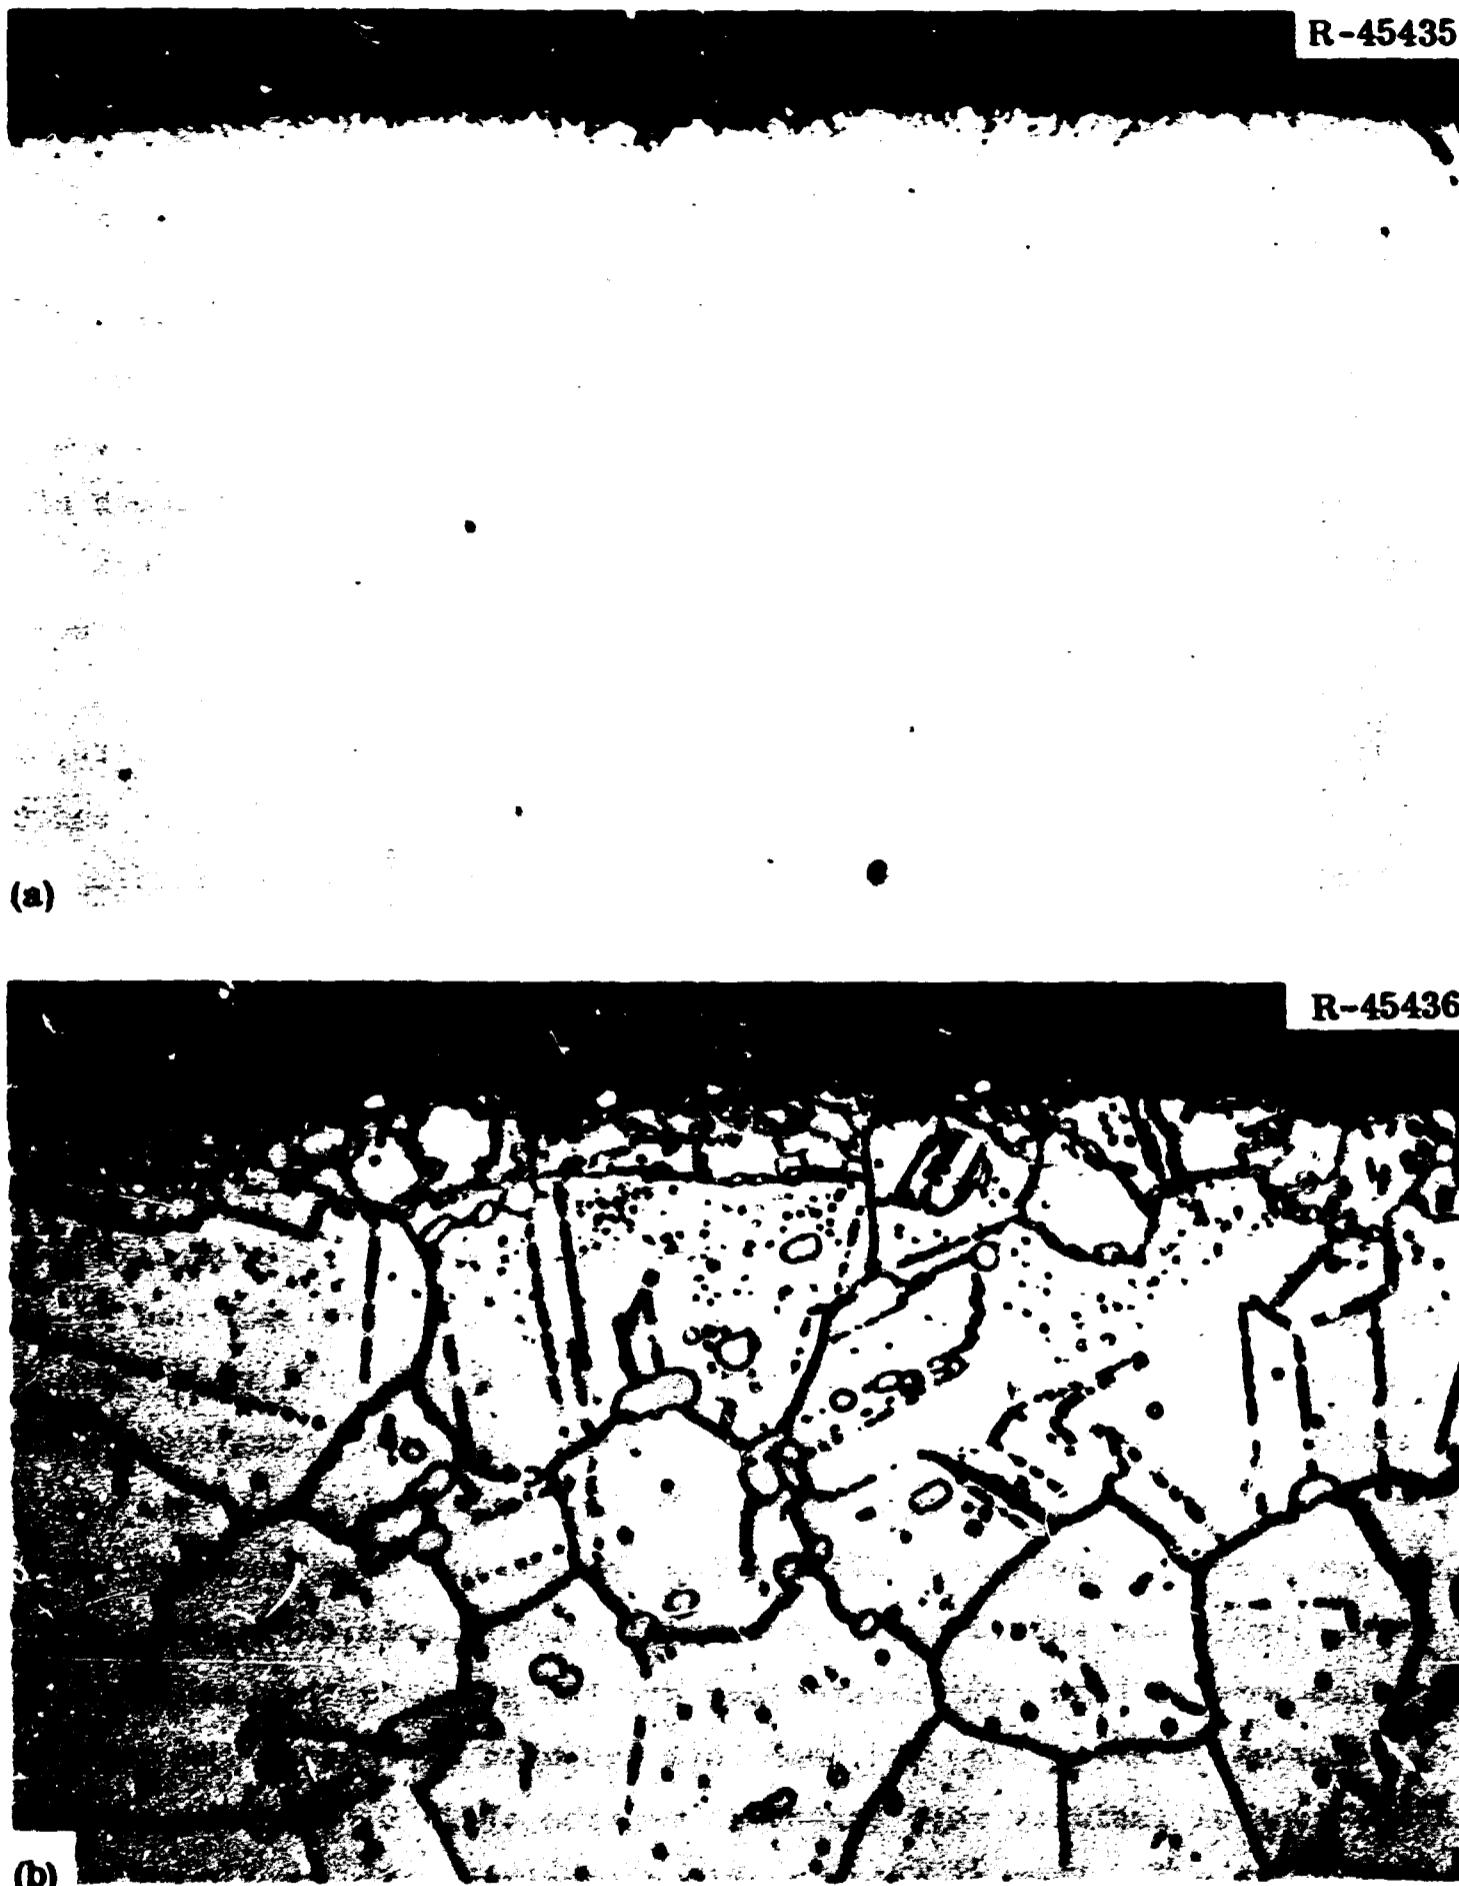
Fig. 19. Photomicrographs of INOR-8 (Heat 5065) Surveillance Specimens Exposed to Fuel Salt for 11,933 hr above 500°C, 500x. Shallow reaction layer is seen near surface. (a) Unetched. (b) Etched (glyceria regia).

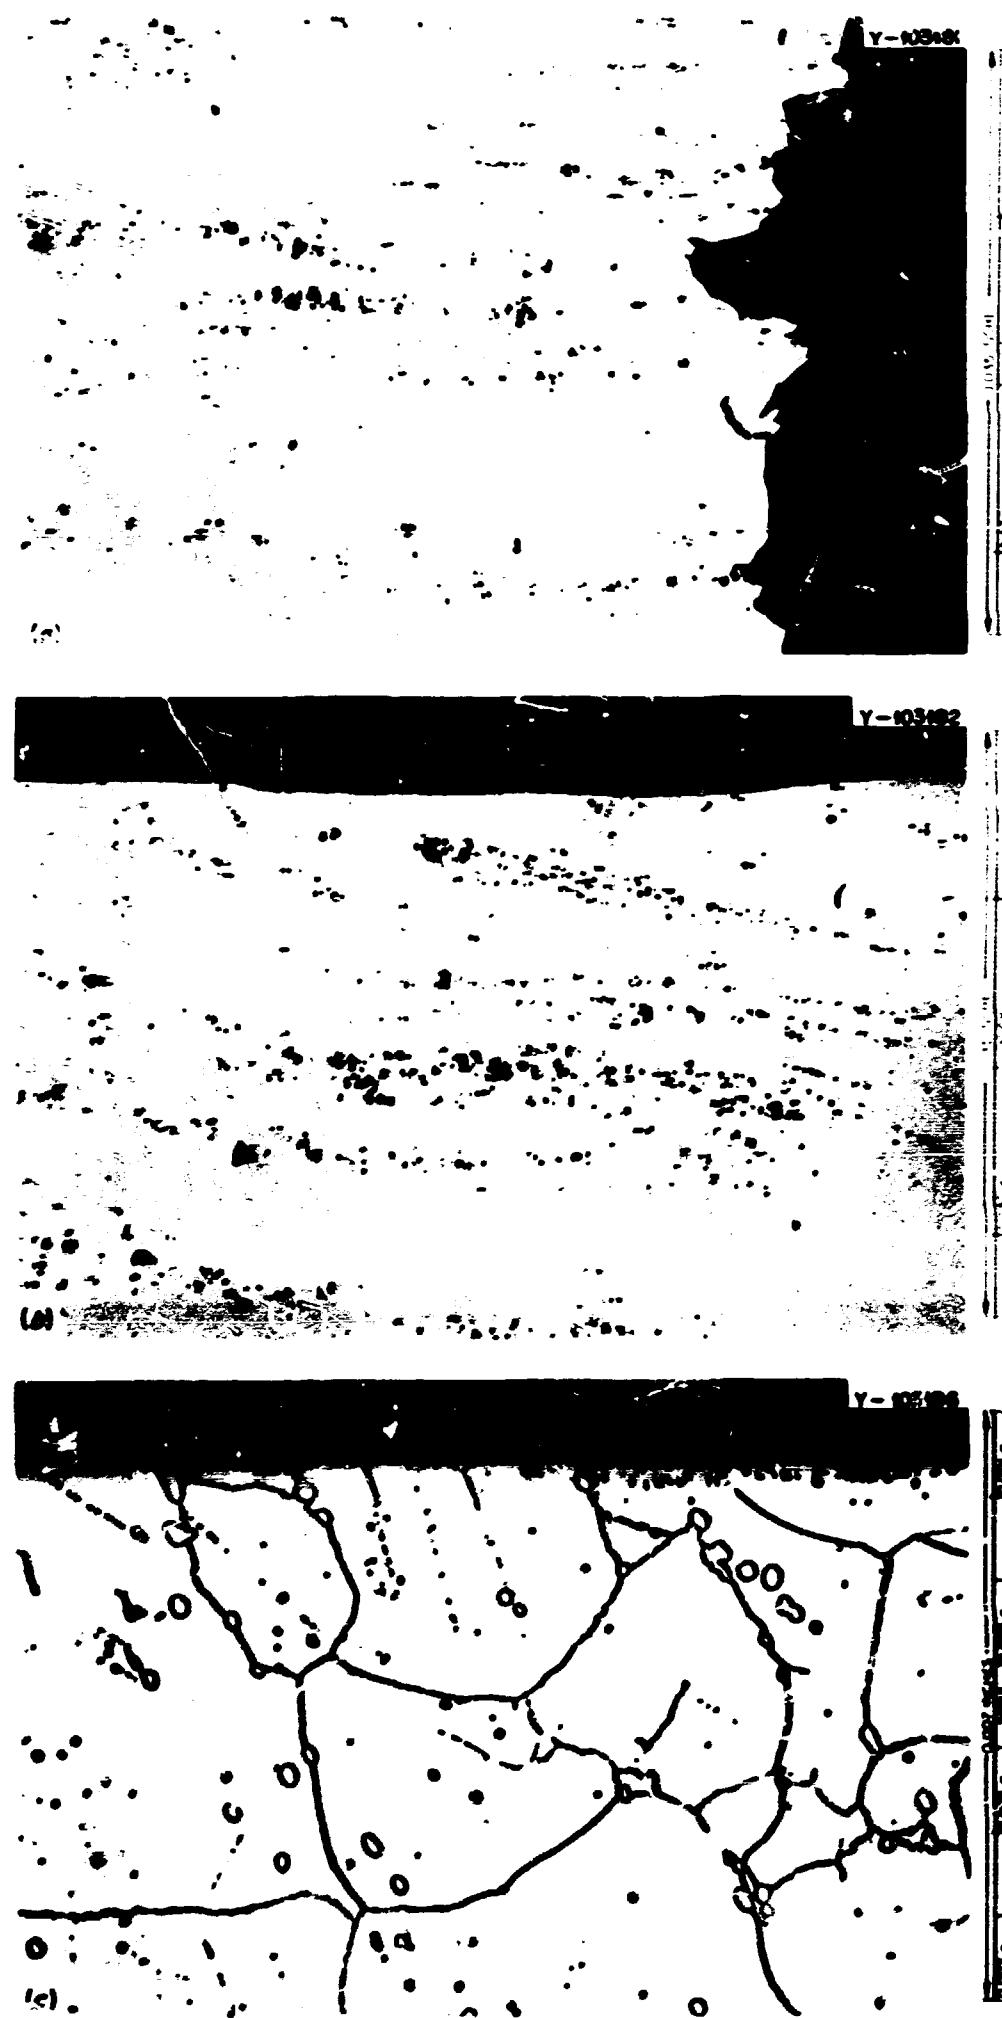
Fig. 25. Photomicrographs of INOR-8 (Heat 5085) Specimen Exposed to Depleted Static Fuel Salt for 11,333 hr at 650° and Strained at 25°C. (a) Fracture, as polished, (b) typical edge of gage section, as polished, (c) typical unstressed edge, etched with glyceria regia.

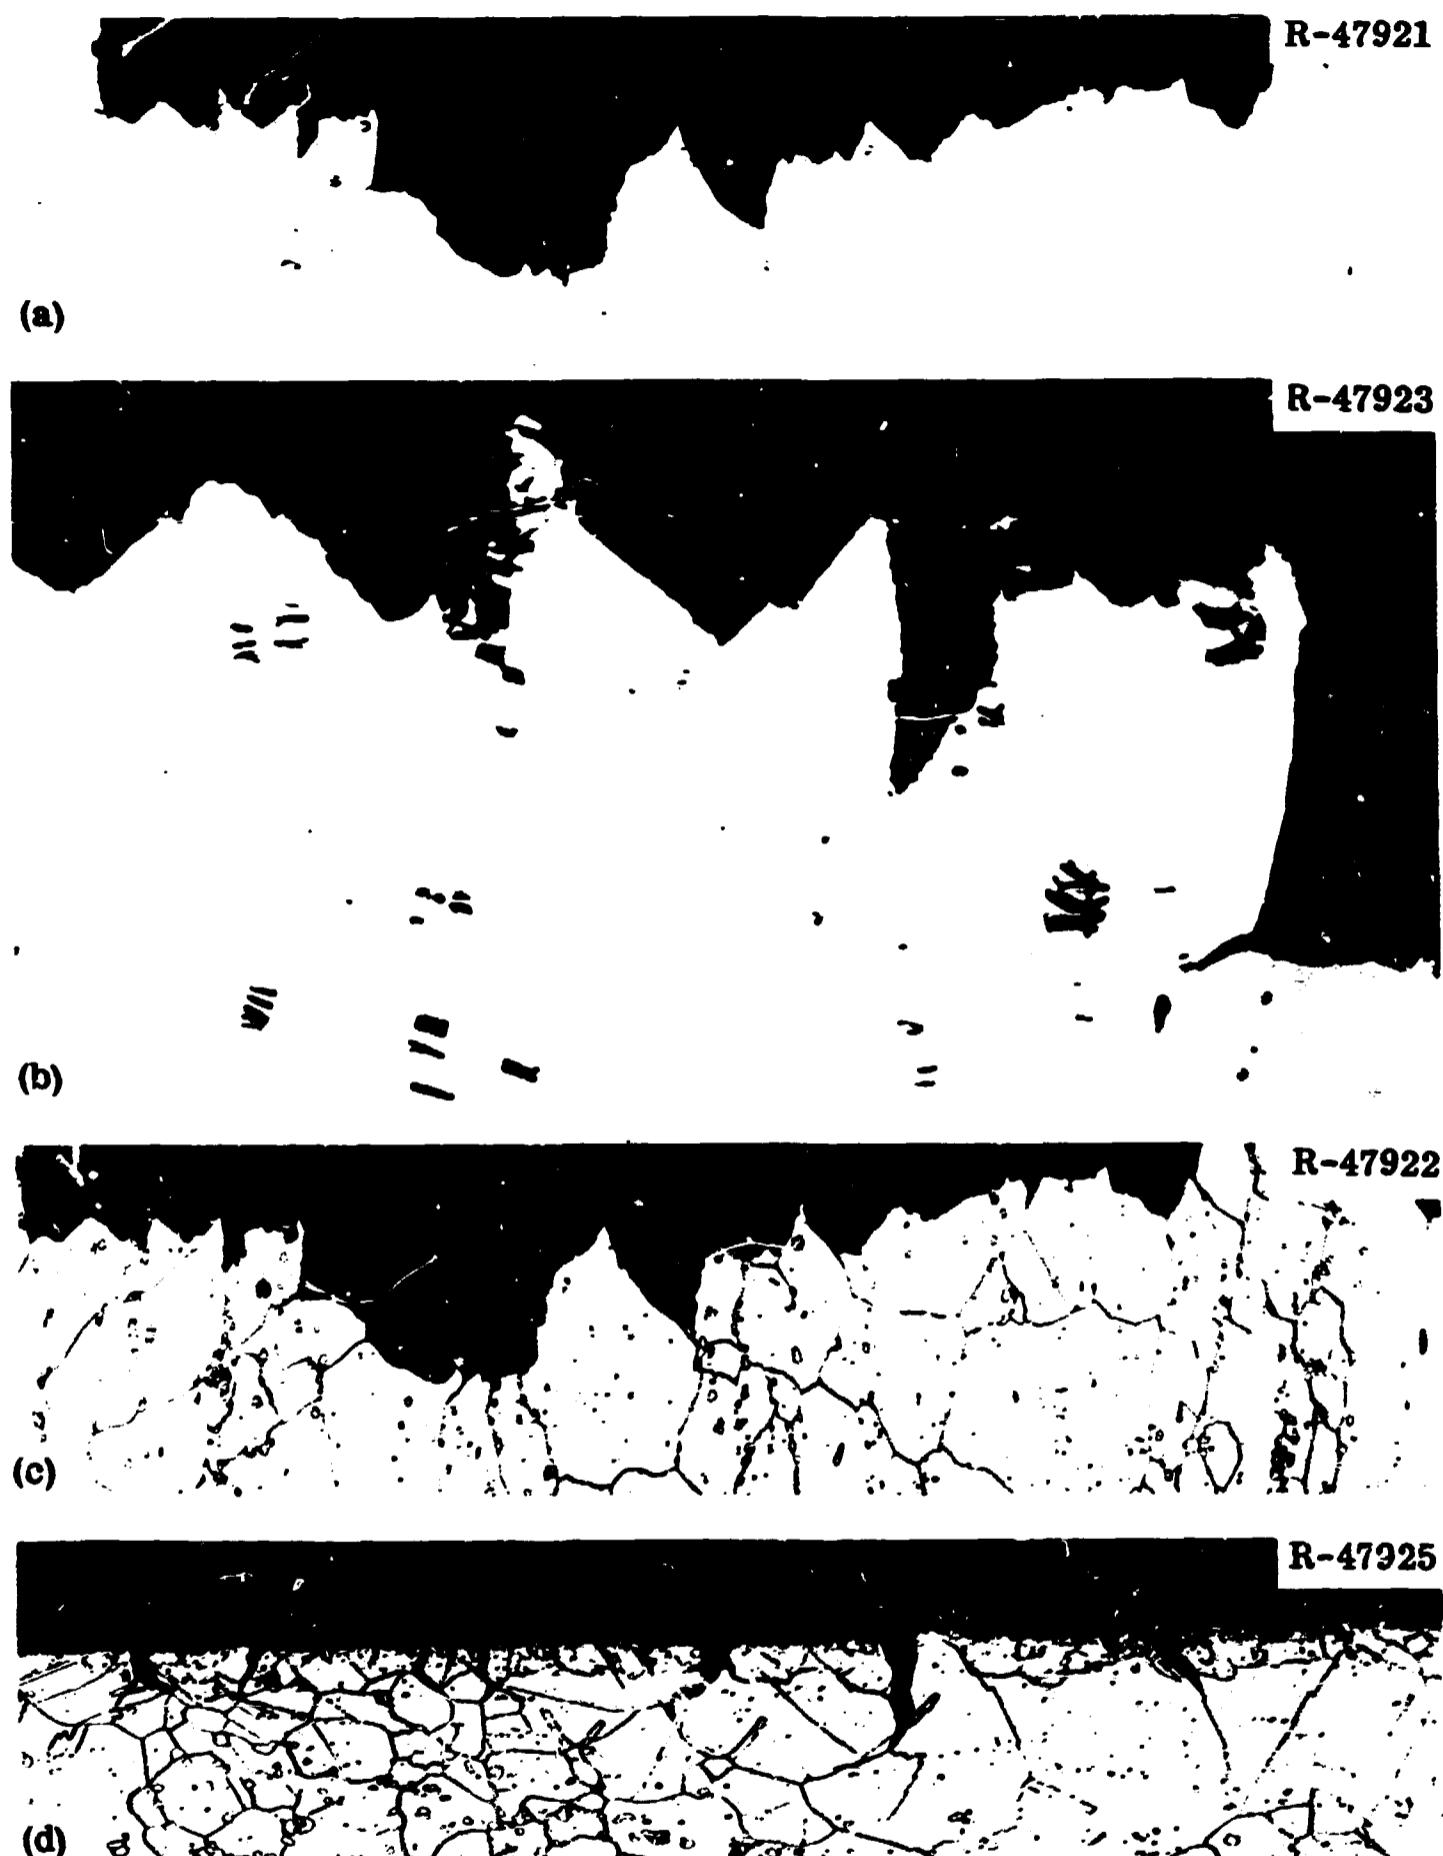
Fig. 26. Photomicrographs of INOR-8 (Heat 5085) Sample Exposed to Fluoride Salt in the MSRE for 11,933 hr above 500°C and then Tested at 25°C. Thermal fluence was 9.4×10^{20} neutrons/cm². (a) Fracture, as polished. 100x. (b) Fracture, as polished. 500x. (c) Fracture, etched. 100x. (d) Edge of stressed portion, etched. 100x. Etchant: aqua regia.

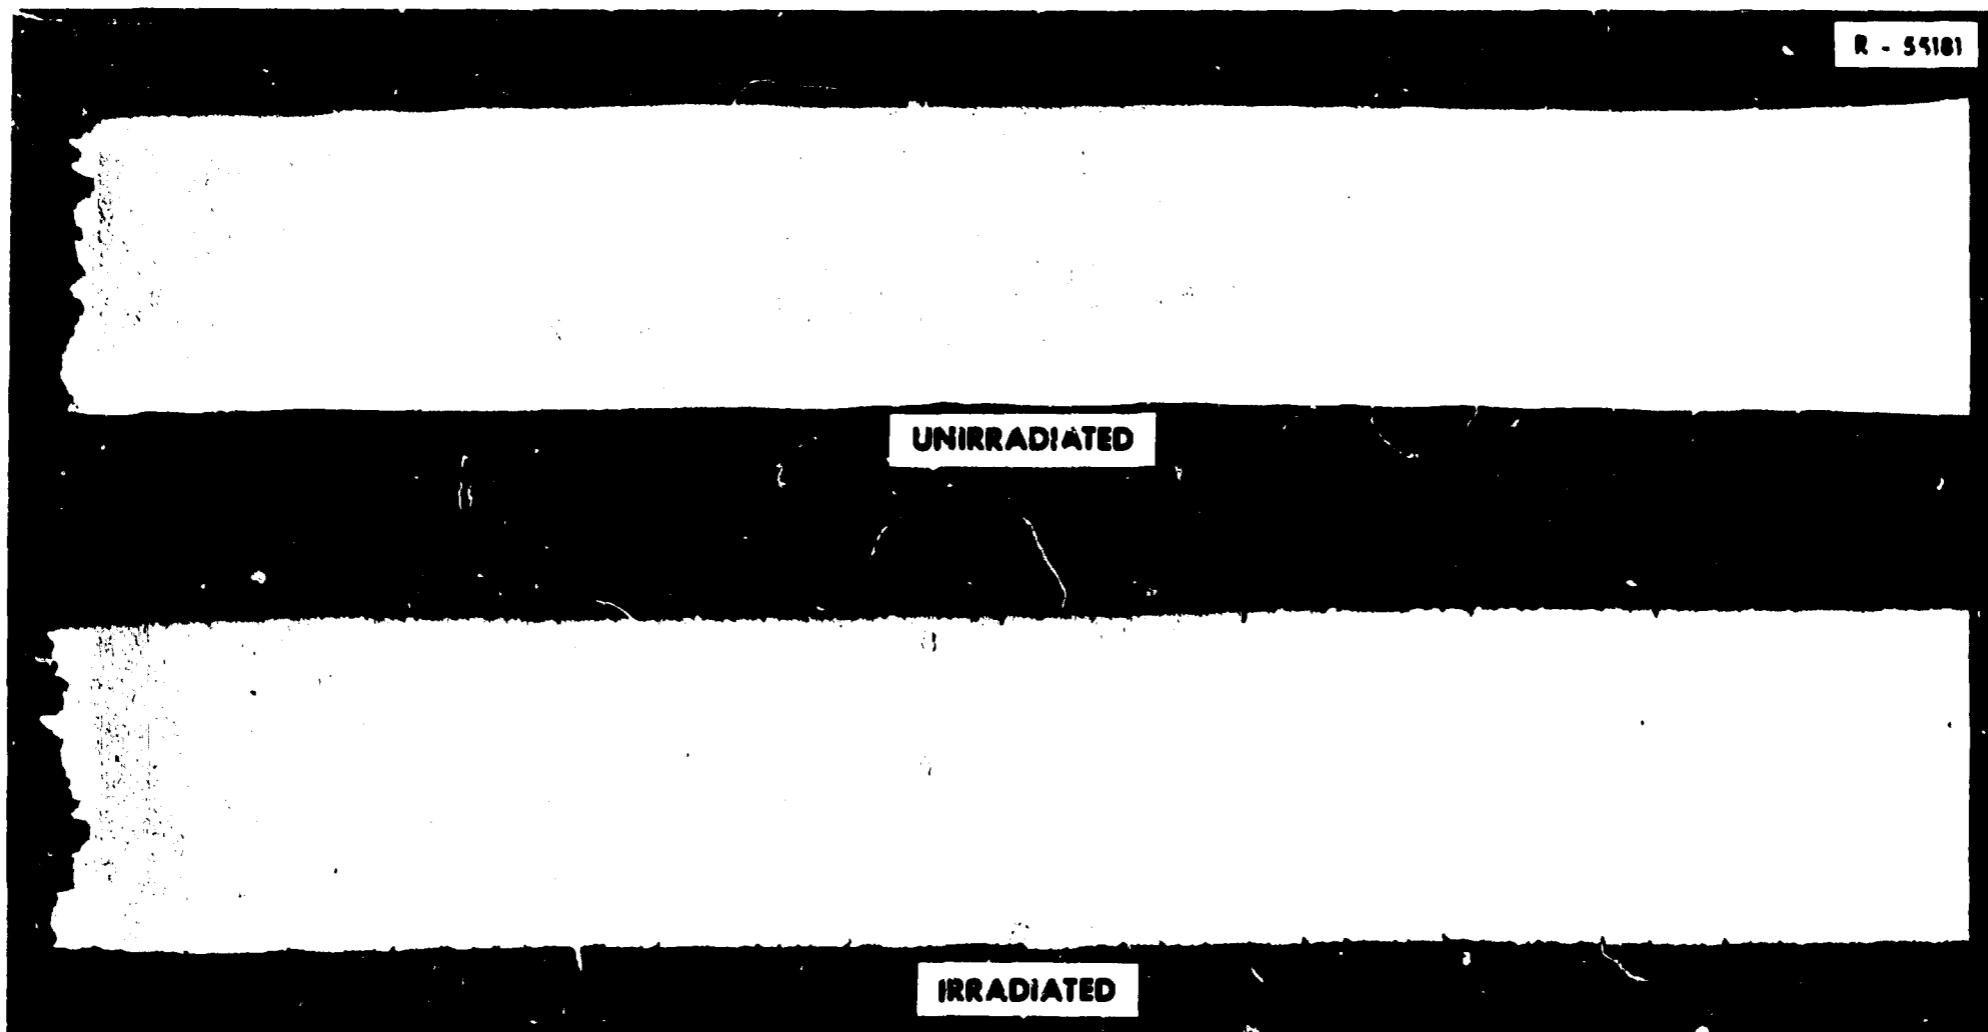
Fig. 28. Photomicrographs of INOR-8 Specimens Strained to Fracture After 11,933 hr above 500°C. The upper sample was in the control facility and the lower sample was in the MSRE core. The sample diameter is about 0.1 in.

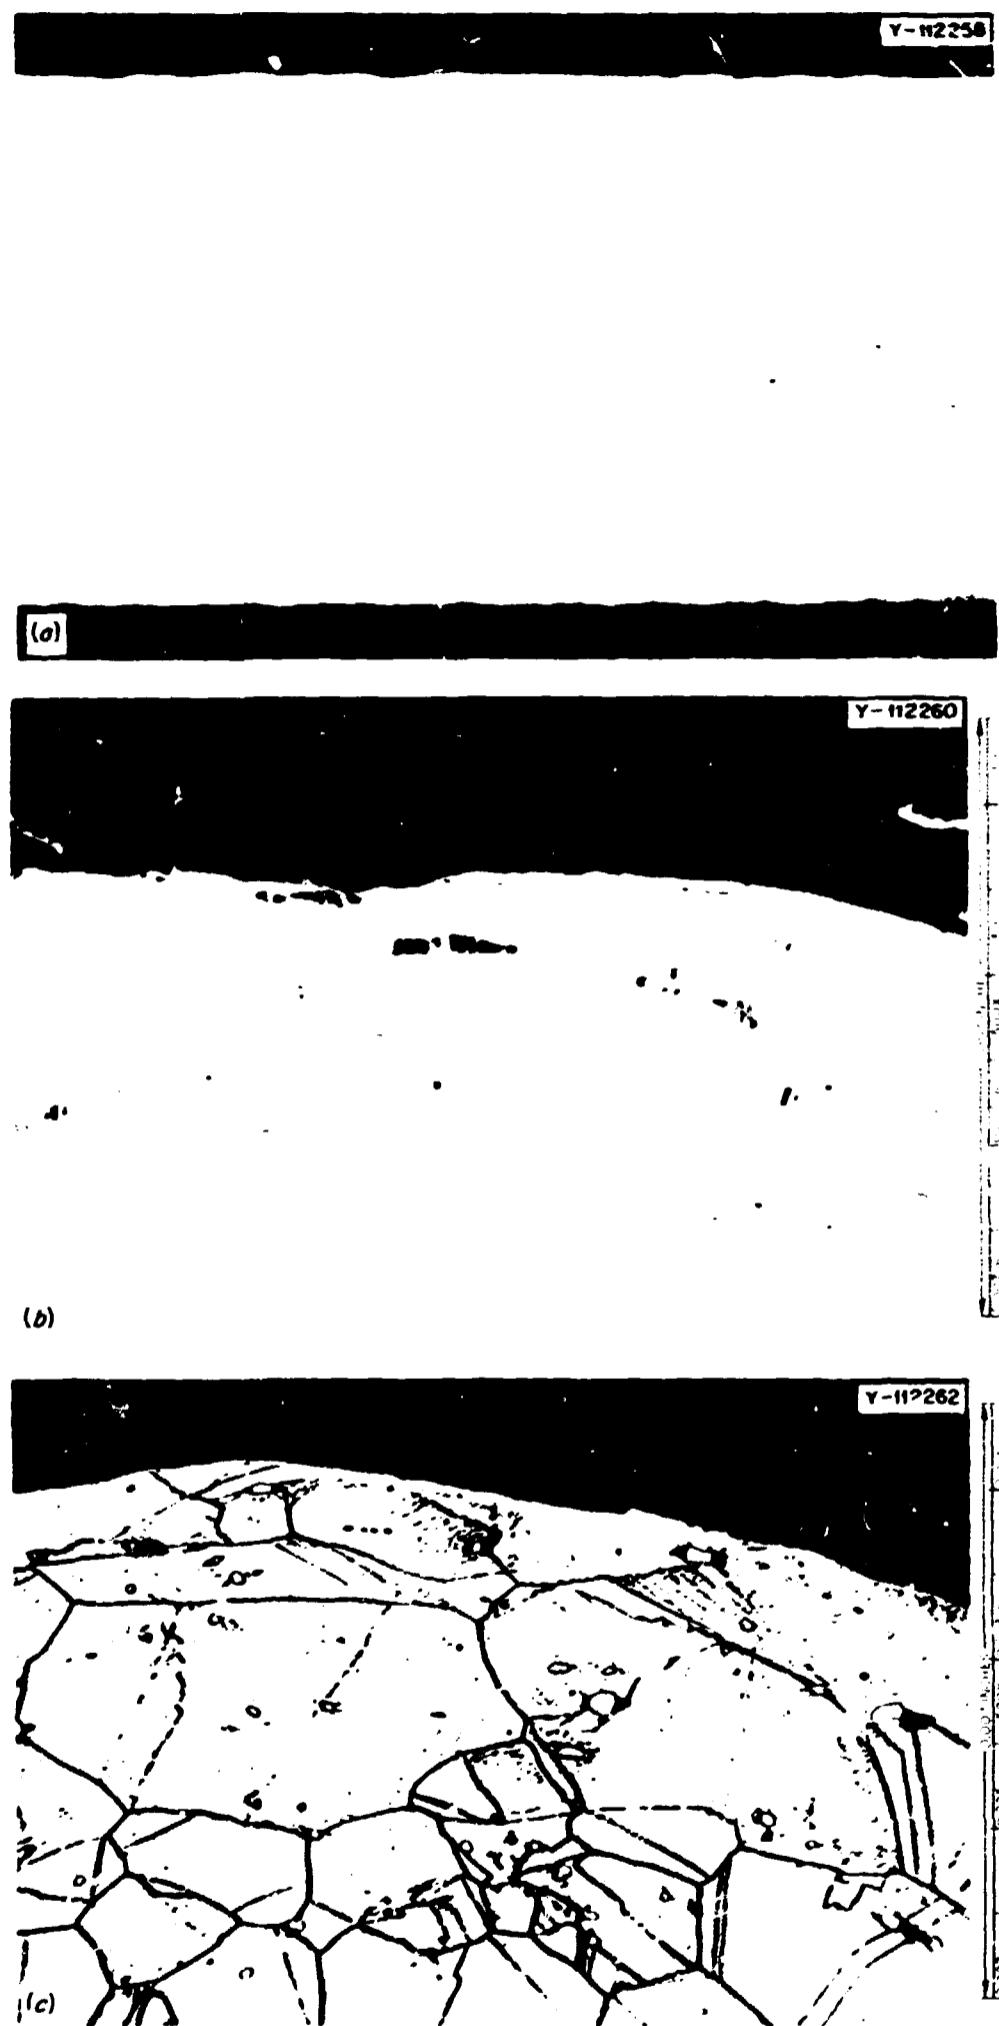
Fig. 40. Photomicrographs of INOR-8 (Heat 5055) Straps Exposed to Static Unenriched Fuel Salt 7203 hr Above 500°C. (a) As-Polished 33x, (b) As Polished, 500x, cracked regions are carbide that fractured during initial forming, (c) Etched with glyceria regia, 500x. Reduced 33%.

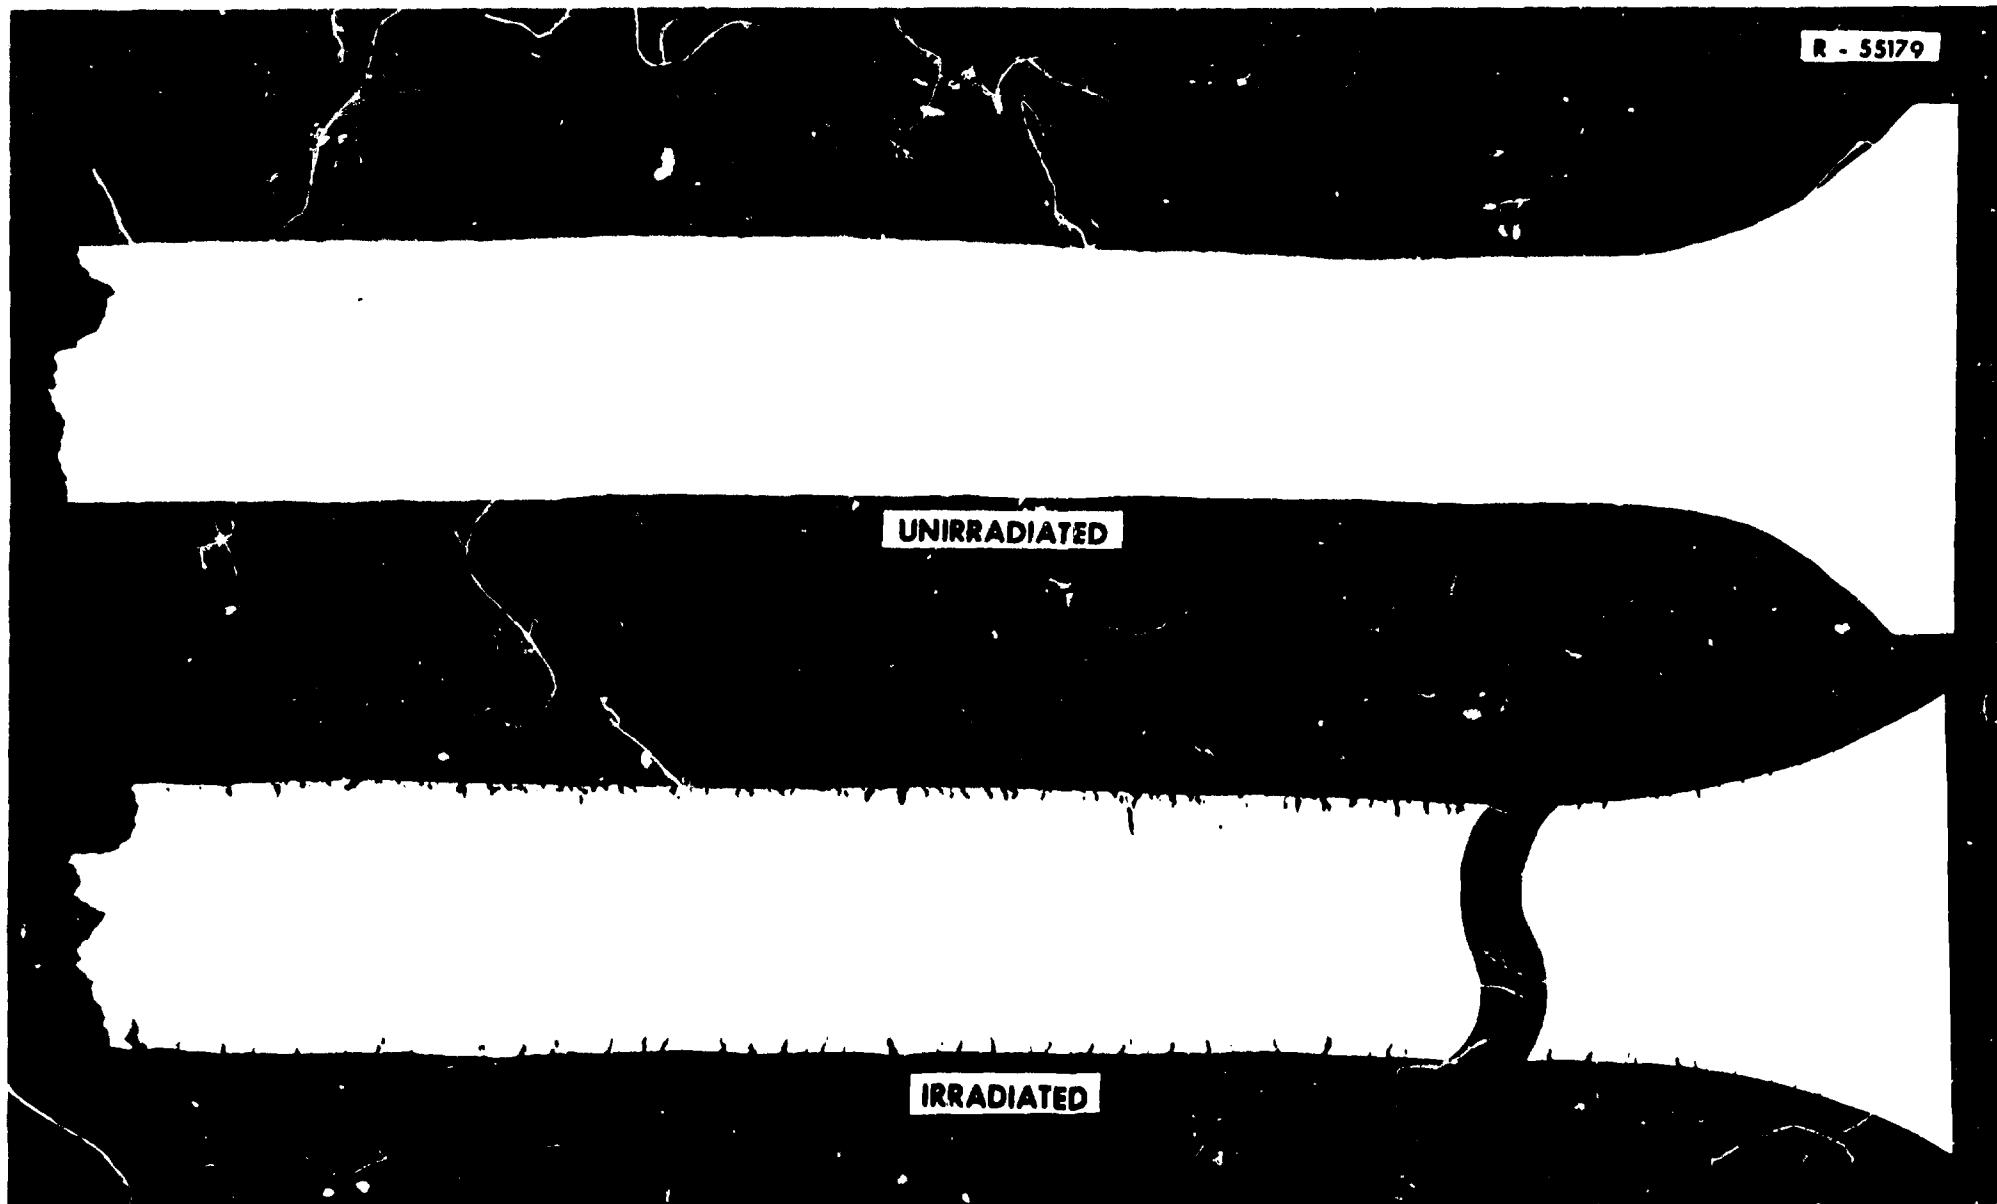
Fig. 48. Photomicrographs of INOR-8 (Heat 5085) Strained to Fracture at 25°C. The top specimen was exposed to static unenriched fuel salt for 19,136 hr above 500°C and the lower specimen was exposed to the MSRE core for the same time. The diameters are about 0.1 in.

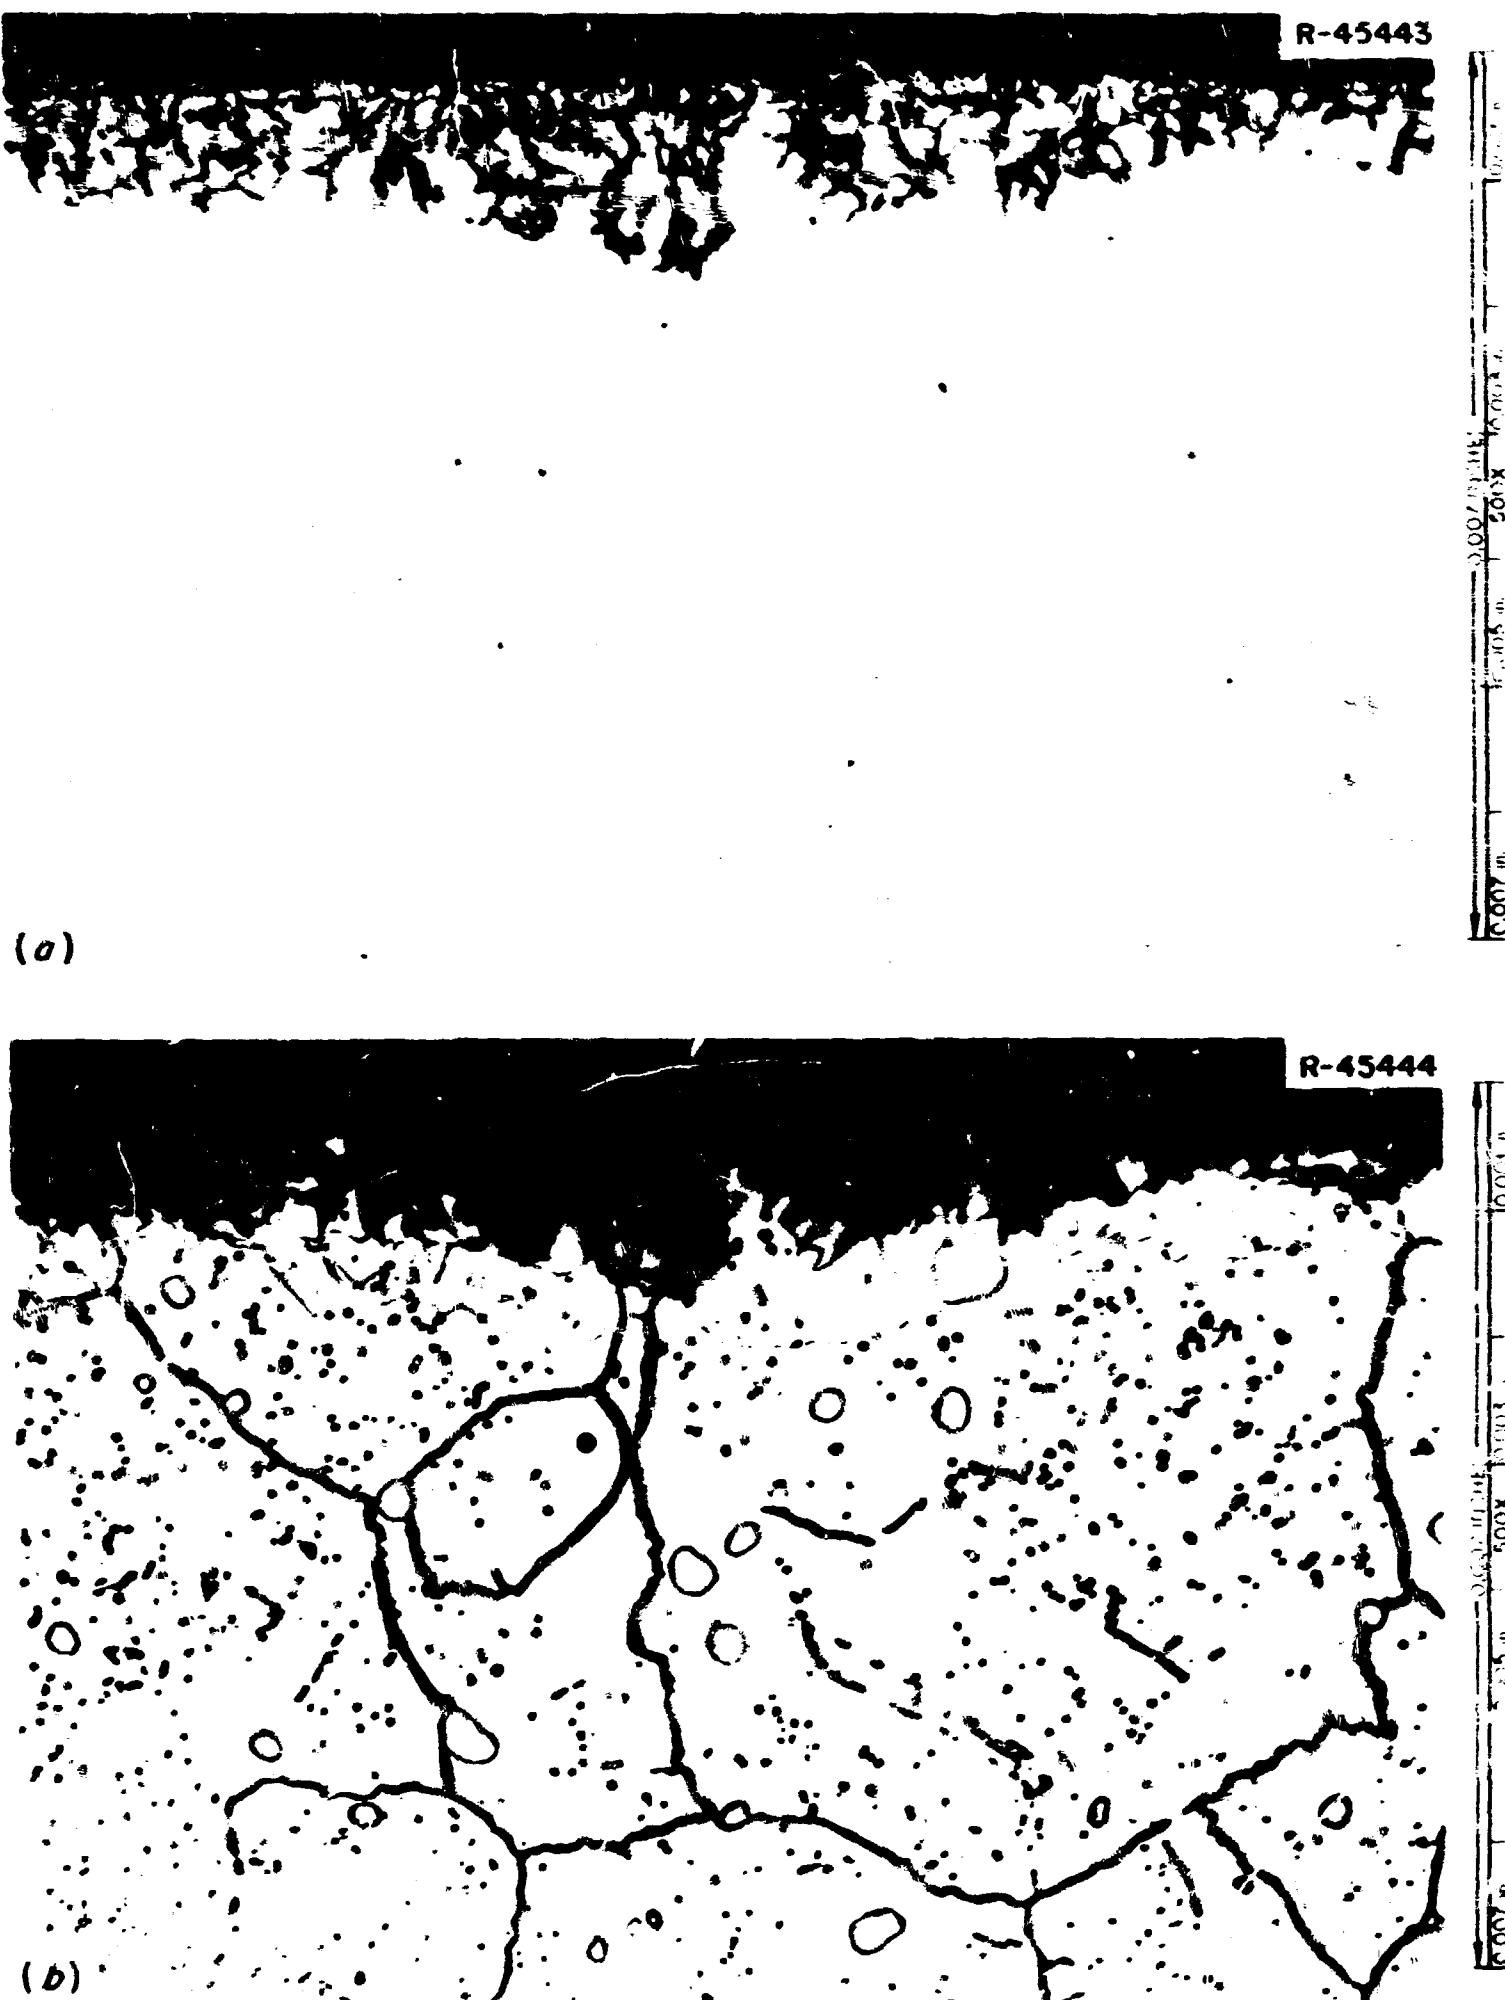
Fig. 54. Photomicrographs of Hastelloy N (Heat 5065) Surveillance Specimens Exposed to the Cell Environment of N_2 + 2 to 5% O_2 for 20,789 hr at 650°C. 500x. (a) Unetched showing surface oxidation (b) Etched (glyceria regia) showing shallow modification of microstructure due to reaction with cell environment.

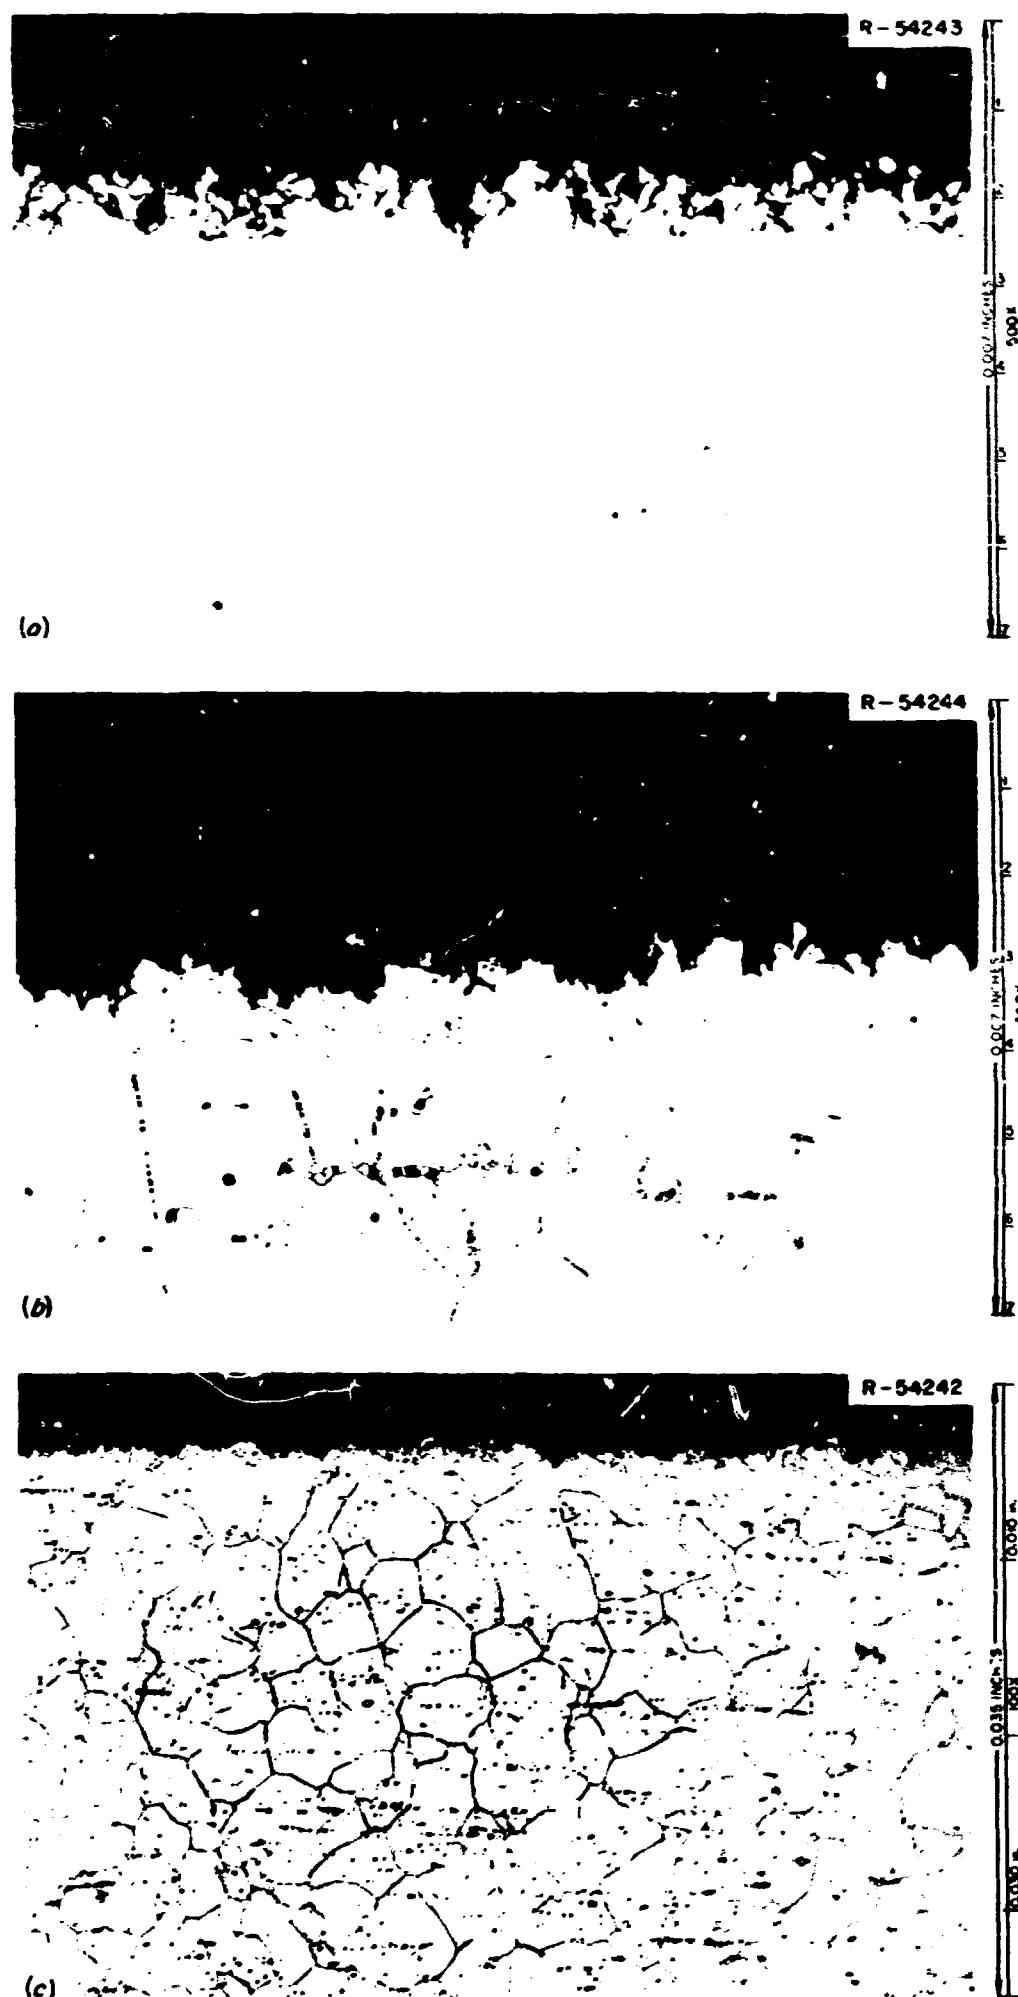
Fig. 61. Photomicrographs of the Inner Surface of the Control Thimble in the As-removed Condition. This surface was exposed to cell environment of N_2 containing 2 to 5% O_2 . (a) As polished. (b) Etched. (c) Etched, typical microstructure. Etchant: Aqua regia. Reduced 30.5%.
