INTERGRANULAR CRACKING OF INOR-8 IN THE MSRE

H. E. McCoy

B. McNabb

NOVEMBER 1972

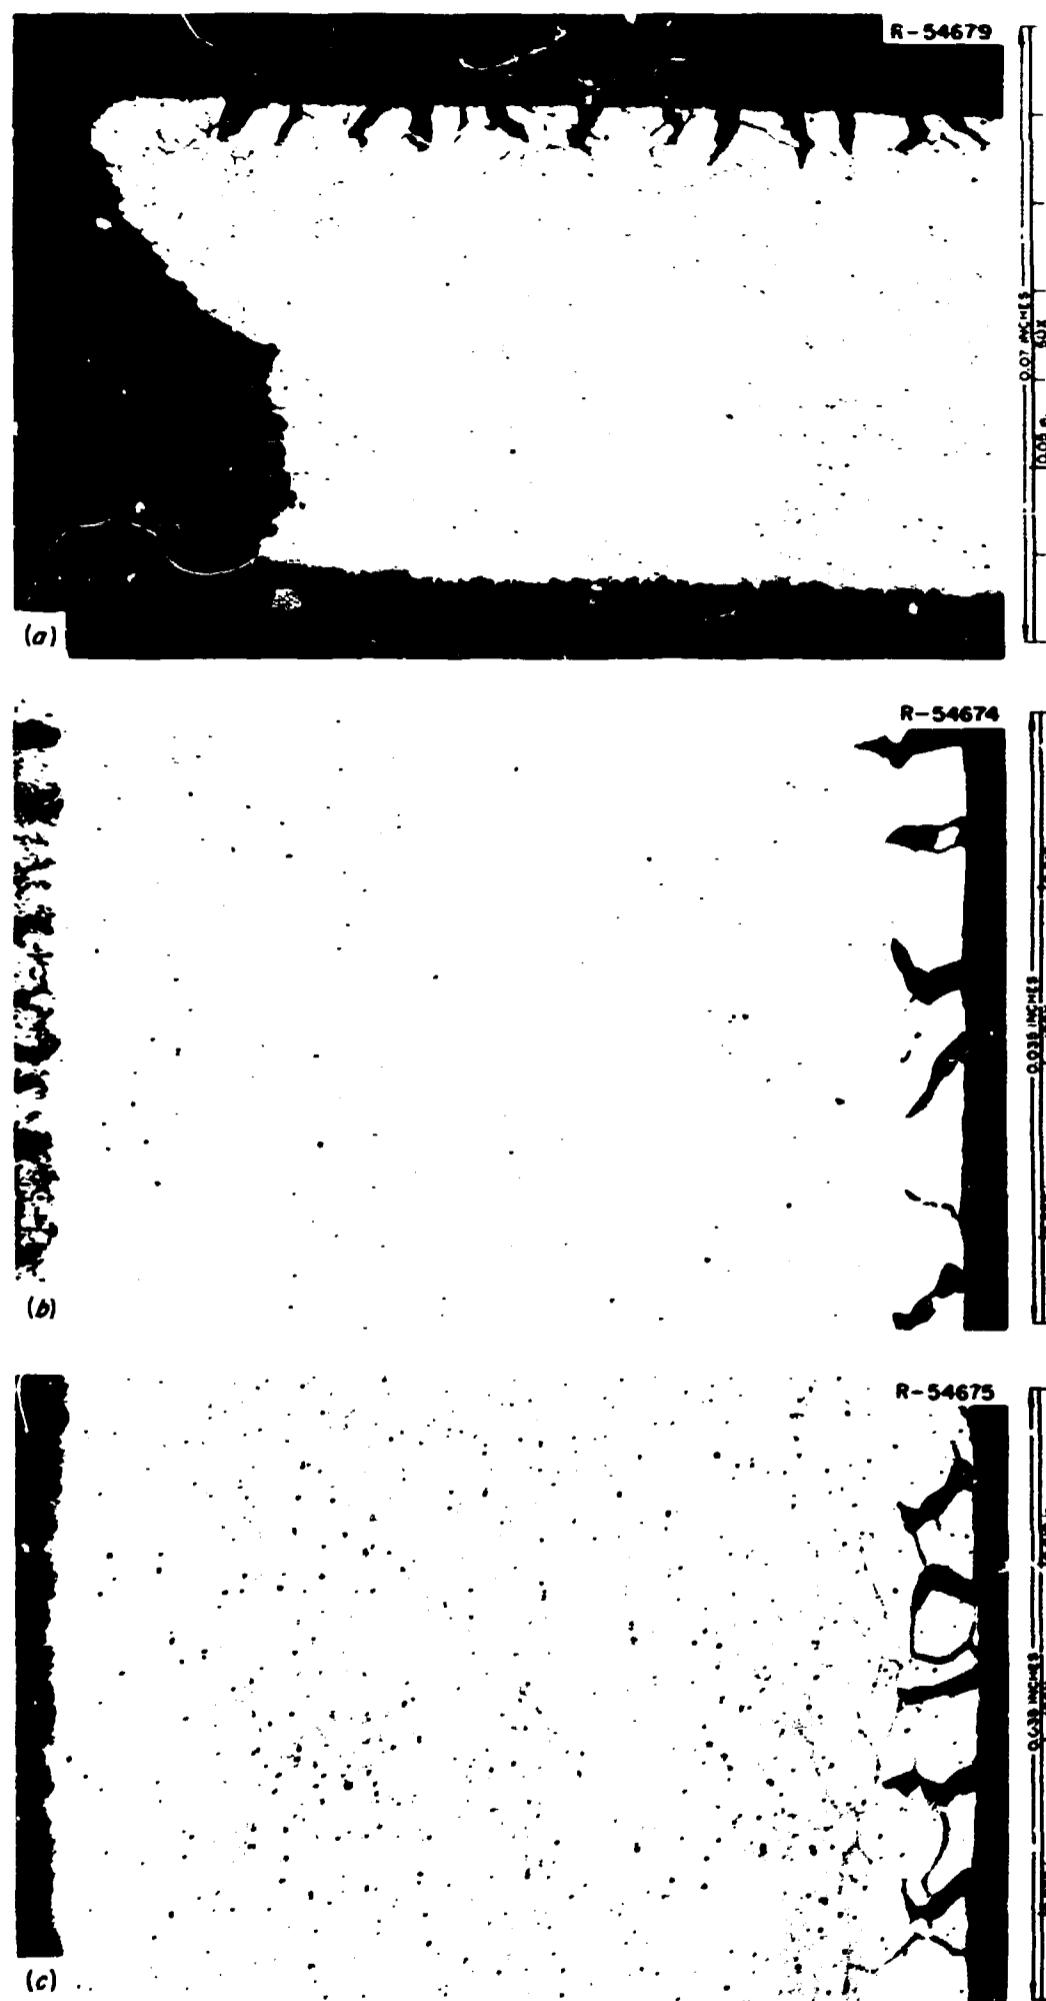
Fig. 68. Photomicrographs of Control Rod Thimble Specimen Exposed to Flowing Salt and Tested at 25°C. (a) Fracture - dark edge is oxide on inner surface of tube, and cracks formed on the outer surface; etched. (b) Cracks in outer surface of tubing as polished. (c) Cracks in outer surface of tubing etched. Etchant: Aqua regia. Reduced 30.5%.

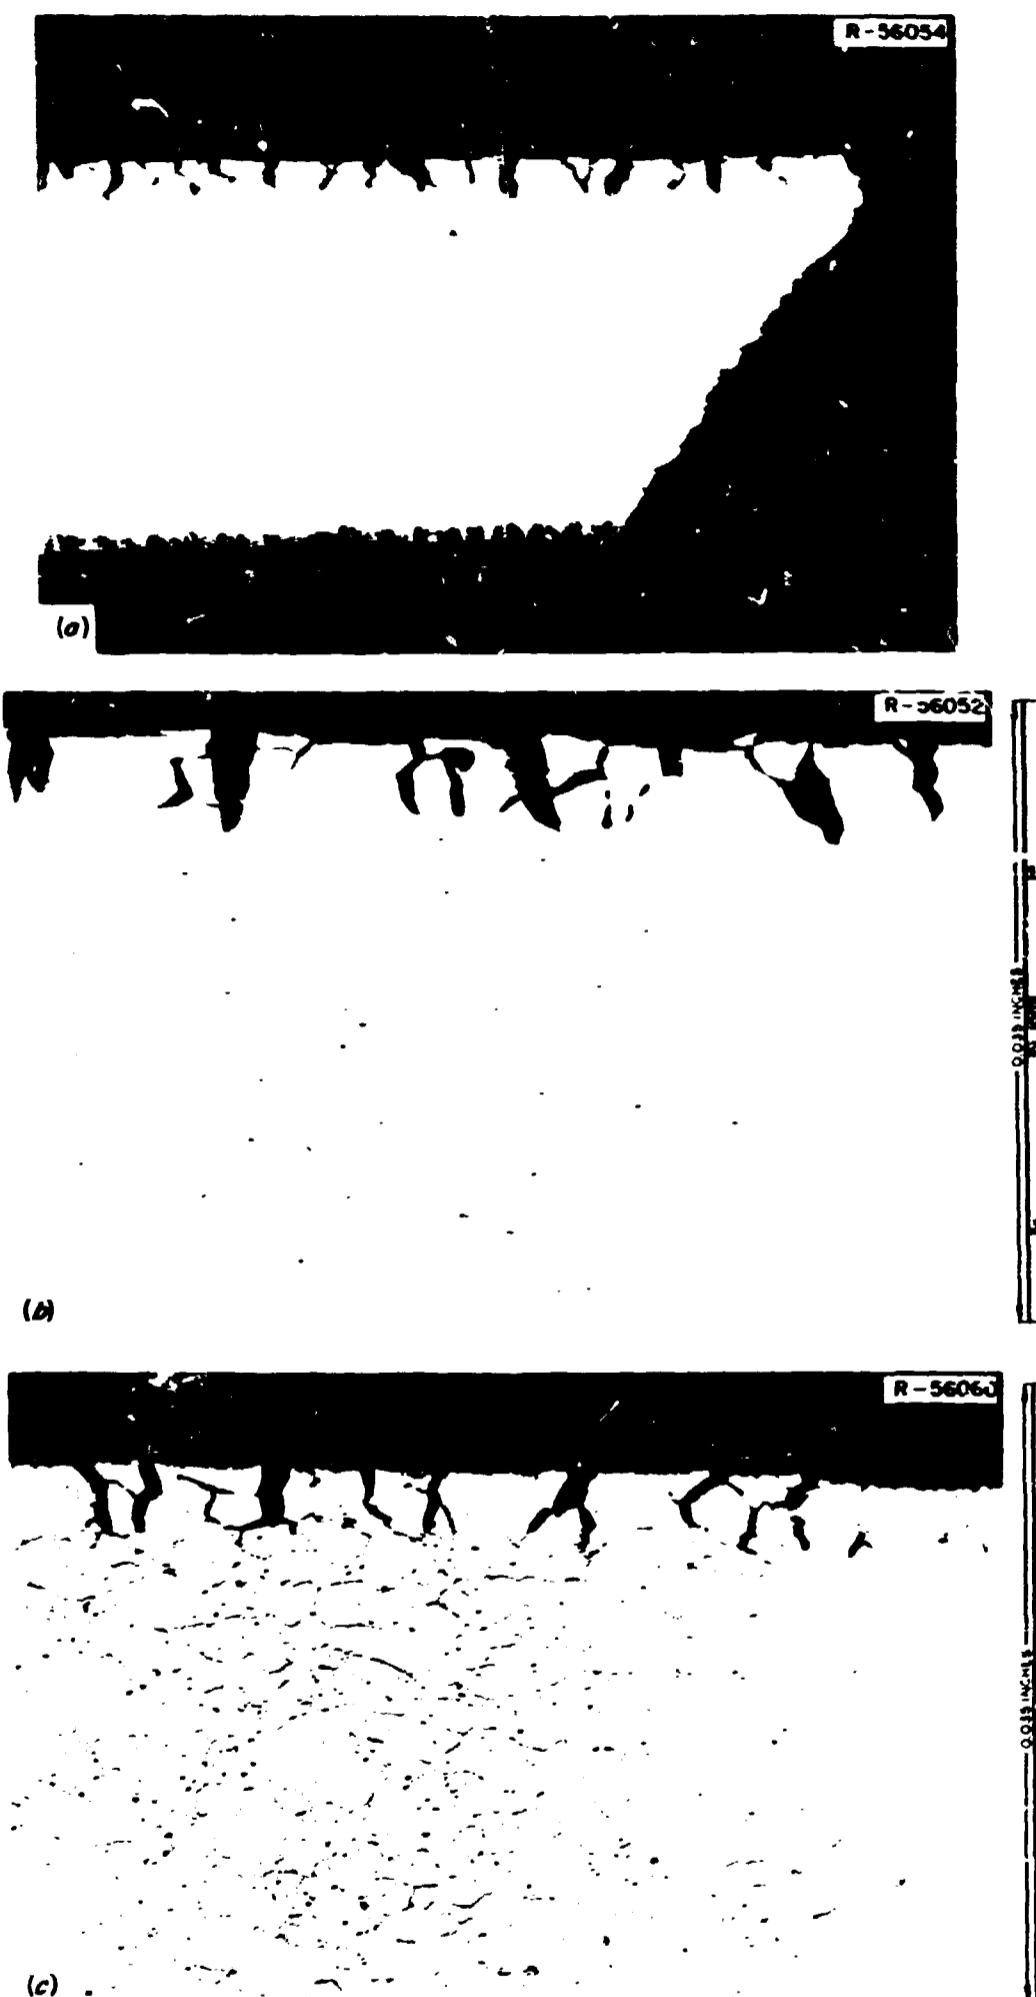
Fig. 70. Photomicrographs of Control Rod Thimble Exposed to Fuel Salt Under a Spacer Sleeve and Tested at 25°C. (a) As-polished view of fracture. 40x. (b) As-polished view of cracks. (c) Etched view of cracks. Etchant: Aqua regia. Reduced 30.5%

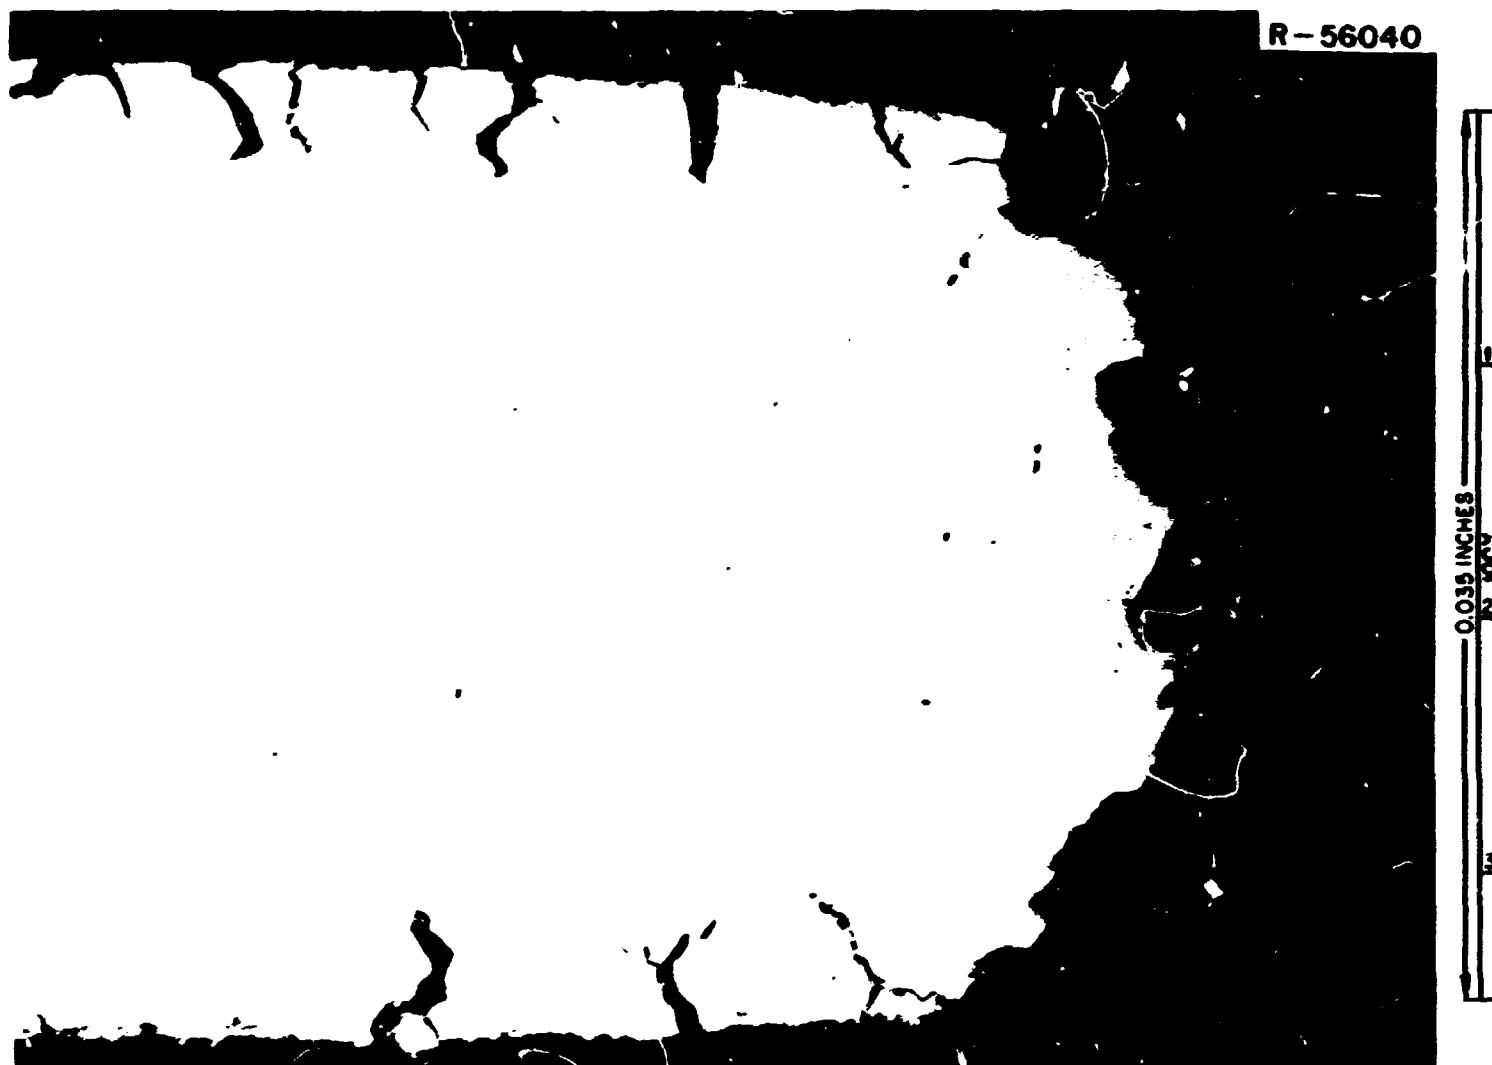
Fig. 72. Photomicrograph of a Section of Spacer Sleeve Tested at 25°C. As polished. The upper surface was exposed to almost static fuel salt and the lower surface was exposed to rapidly flowing fuel salt.

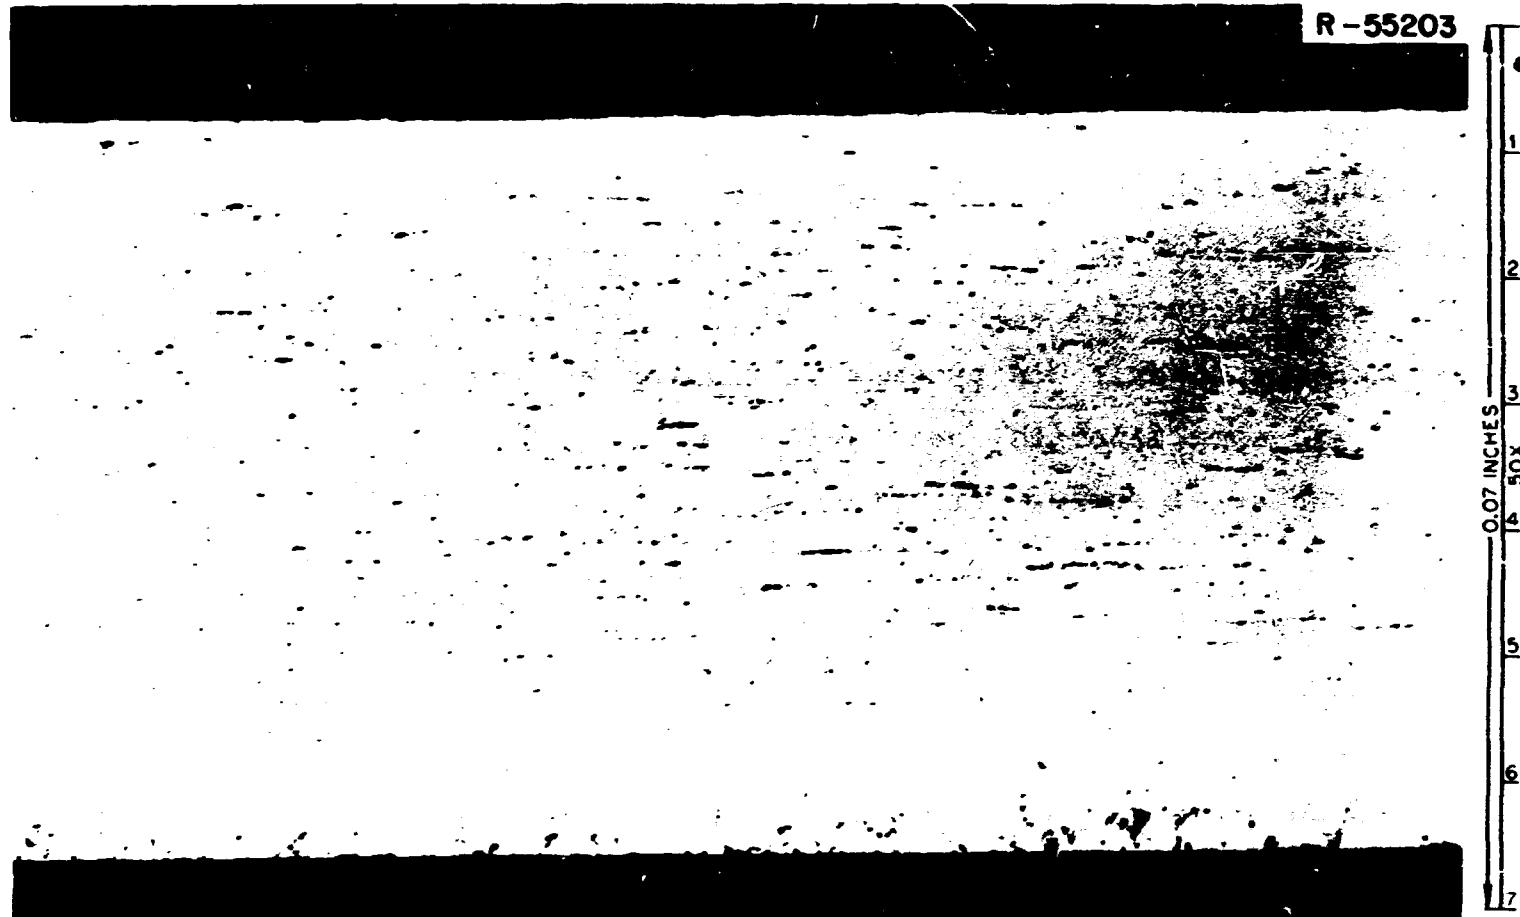
Fig. 82. Photomicrograph of Heat Exchanger Tubing in the Unstressed Condition. The side with the small cracks was exposed to fuel salt and the other was exposed to coolant salt.

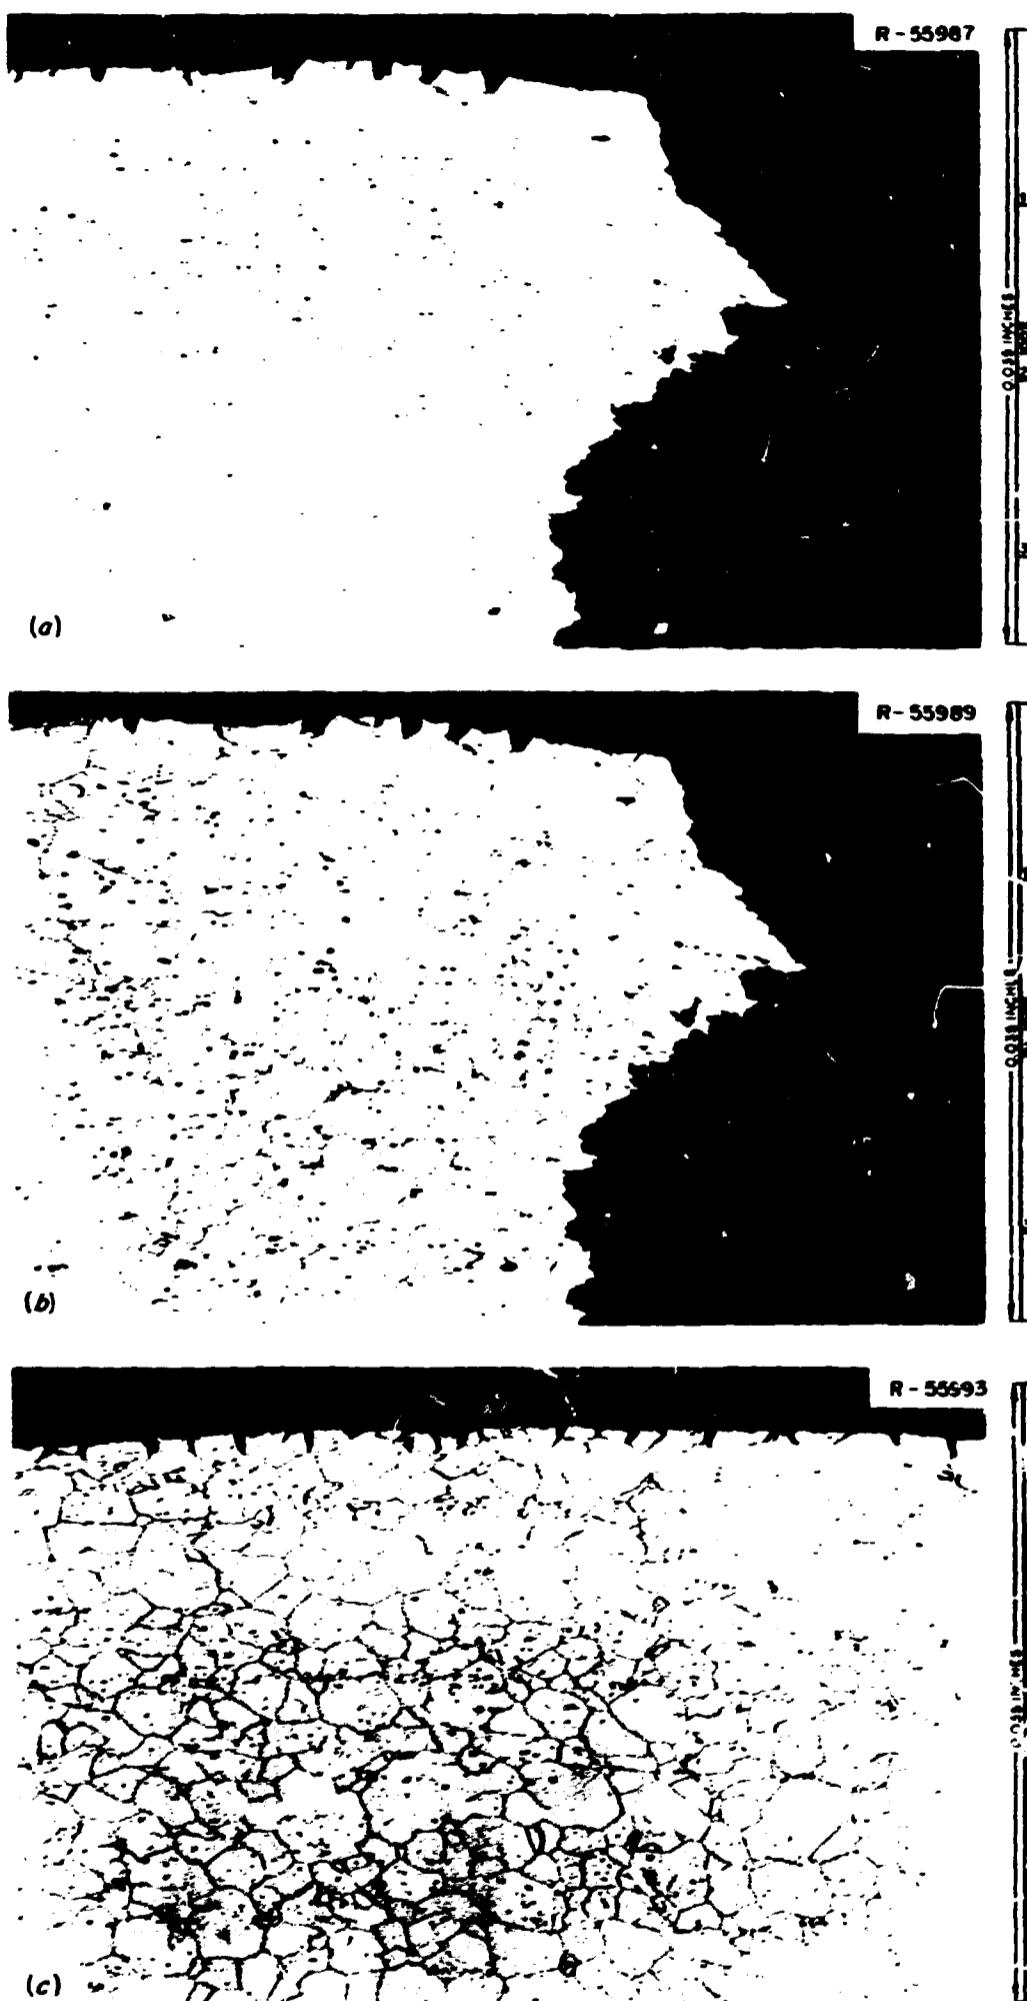
Fig. 92. Photomicrographs of Bend Specimen of Mist Shield from Inside Vapor Region. (a) Fracture and tension side, as polished. (b) Fracture and tension side, etched. (c) Tension side, etched. Etchant: Aqua regia. Reduced 31%.

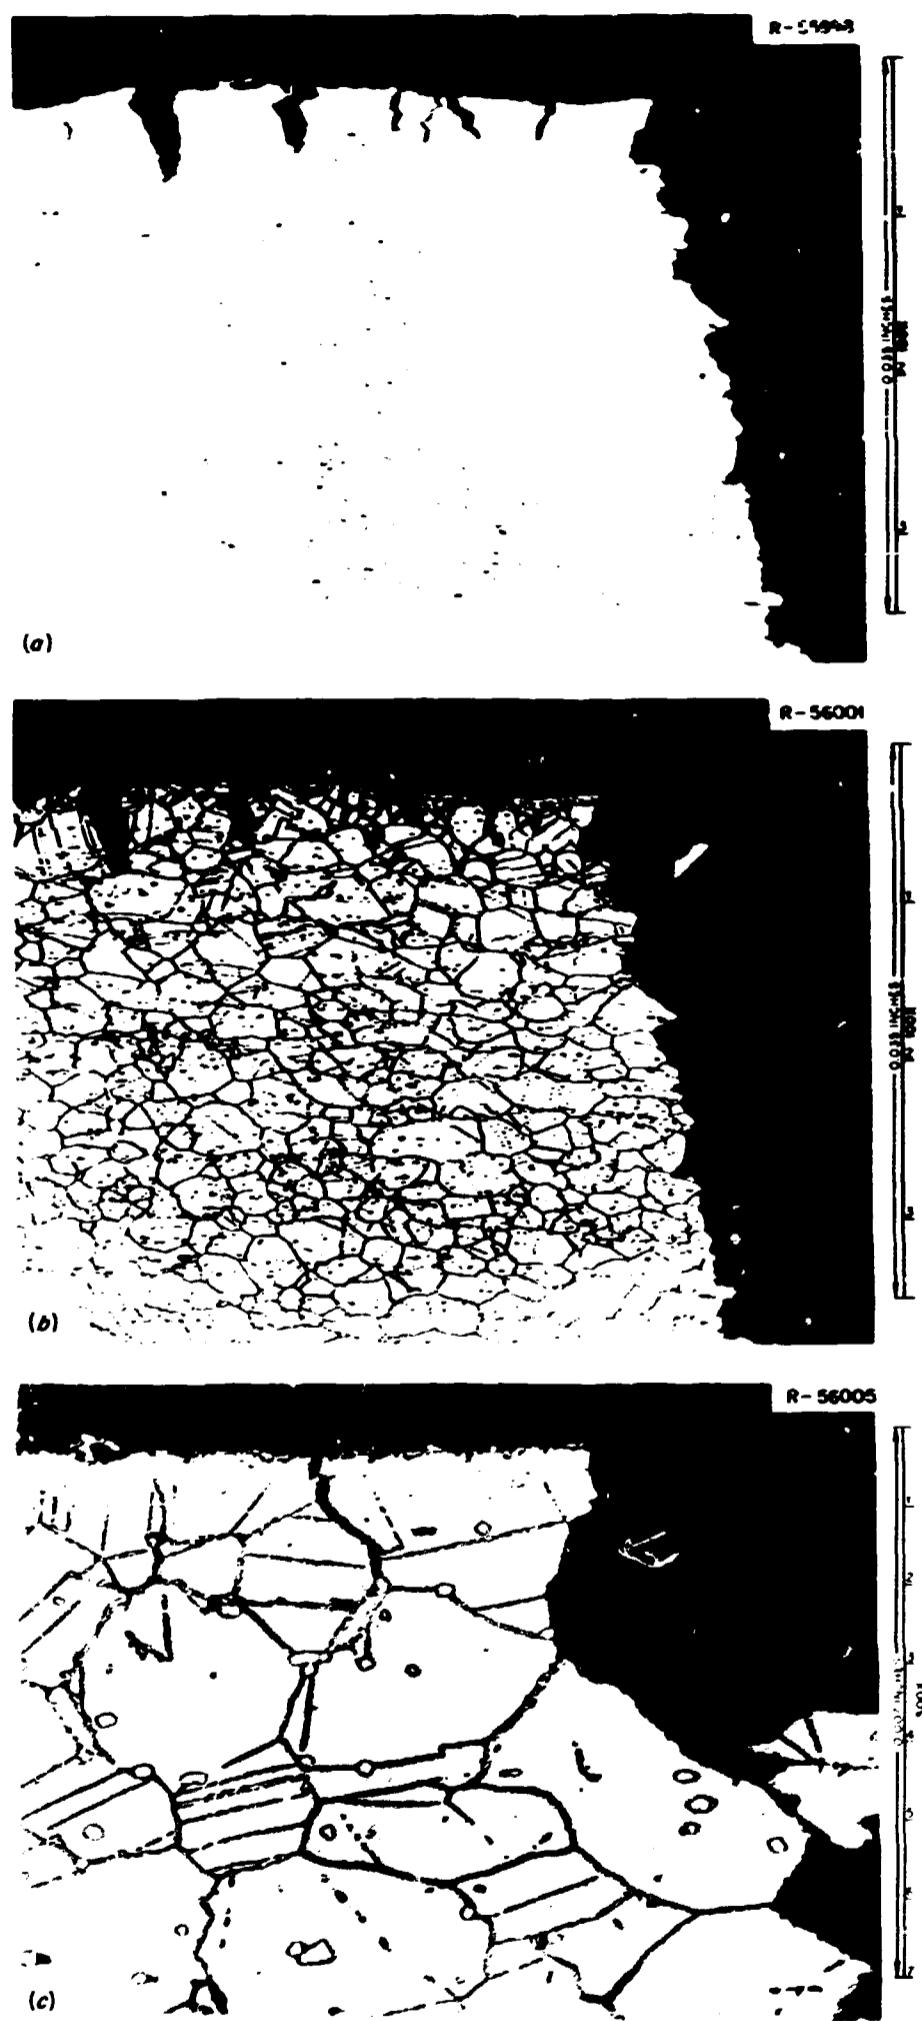
Fig. 94. Photomicrographs of Bend Specimen of Mist Shield from Inside Liquid Region. (a) Fracture and tension side, as polished. (b) Fracture and tension side, etched. (c) Fracture and tension side, etched. Etchant: Aqua Regia.
