PERFORMANCE OF THE NRX SHUT-OFF RODS

R.E. MANSON

August, 1965

AECL-2299

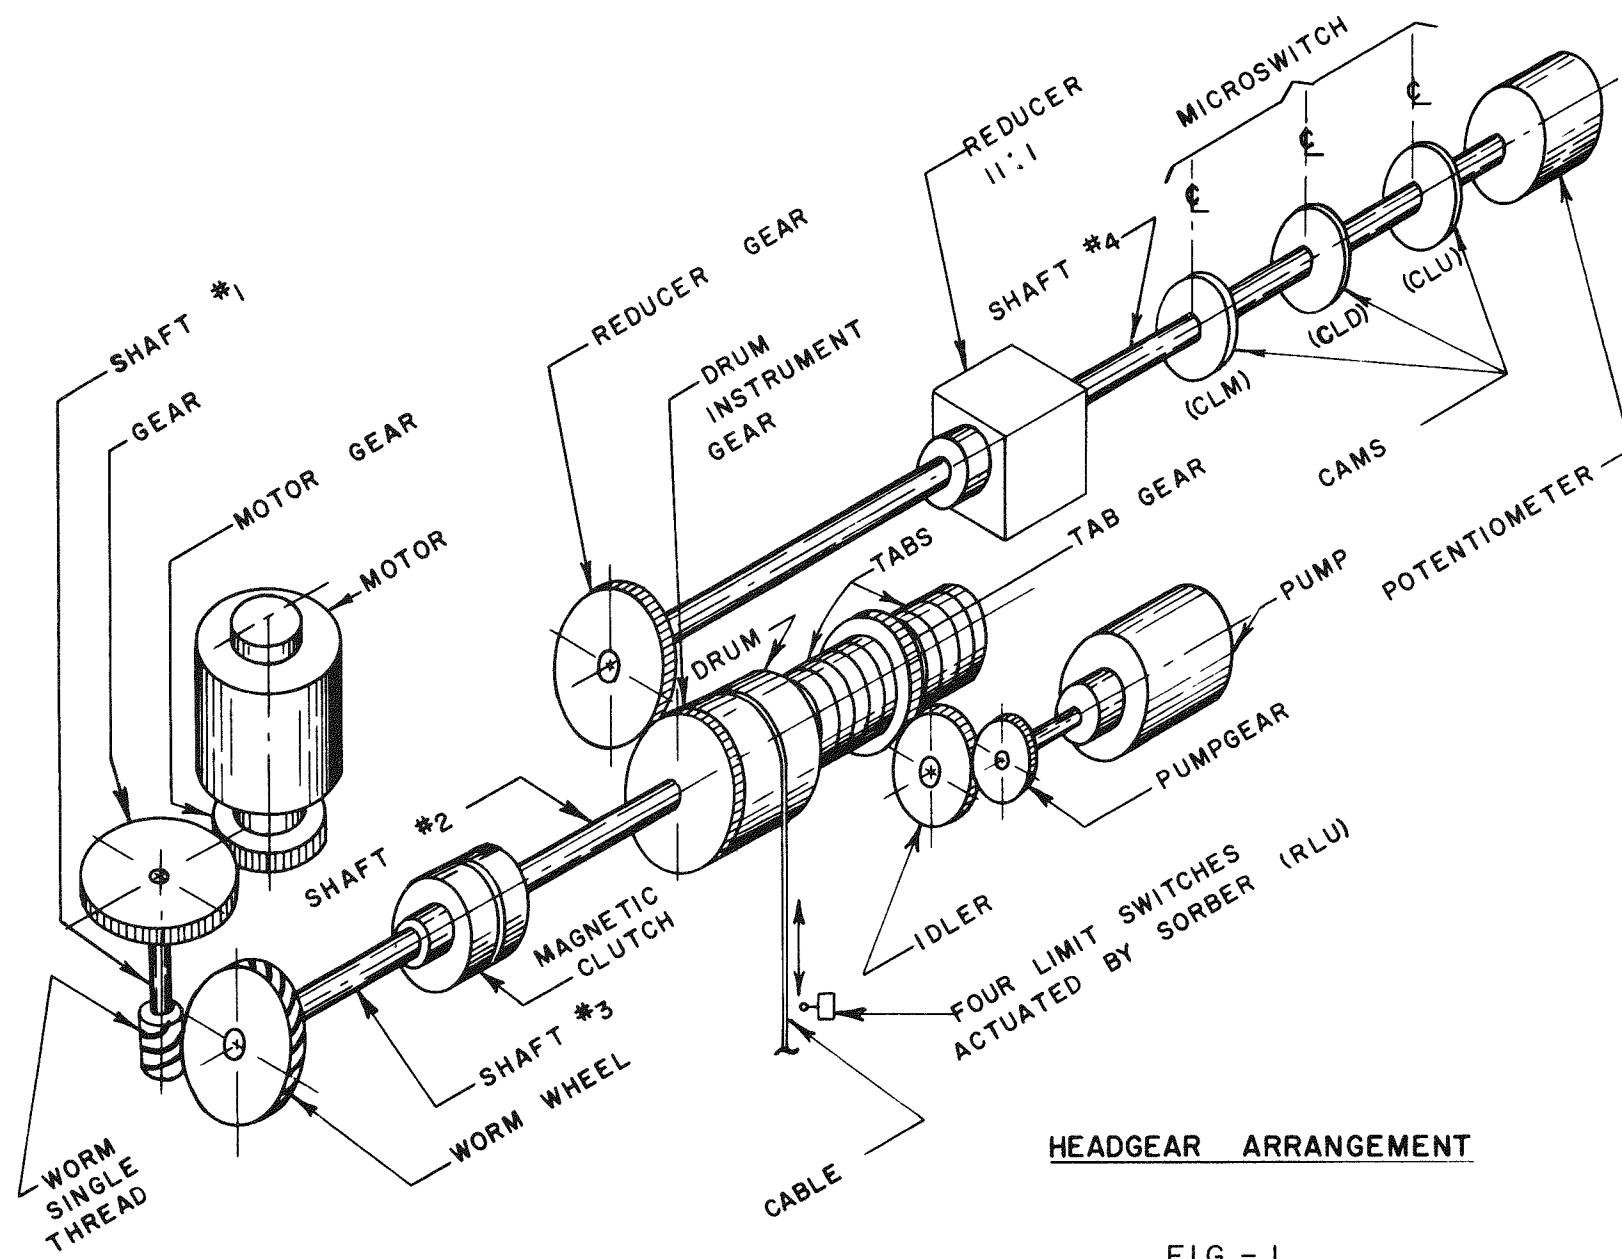
FIG - 1

The absorber is raised or lowered in an outer assembly by a two-phase motor which drives the drum through a worm gear and a magnetic disc clutch (see Figures 1 and 2). The rod is raised by energizing the clutch and driving the motor to turn the drum. To release the rod, the clutch is de-energized and the rod falls by gravity, a compression spring in the headgear giving the initial acceleration from the top position.

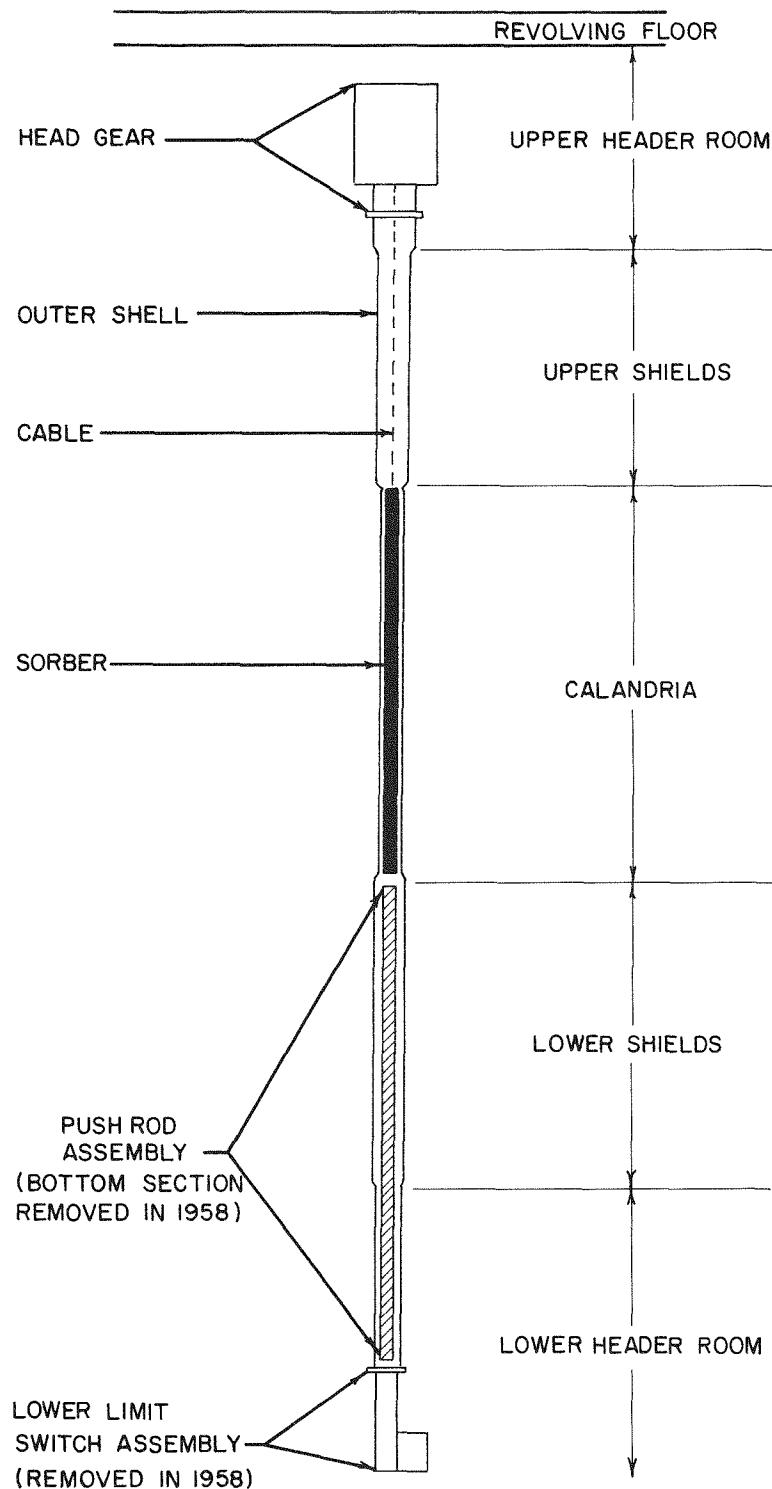
FIG. 2
A.M.F. SHUT-OFF ROD

A rotary hydraulic pump acts as a snubber during the bottom third of the rod's travel. A stack of twelve pick-up rings ride on the drum shaft. As the rod falls, the rings pick up each other in sequence, the last ring engaging a

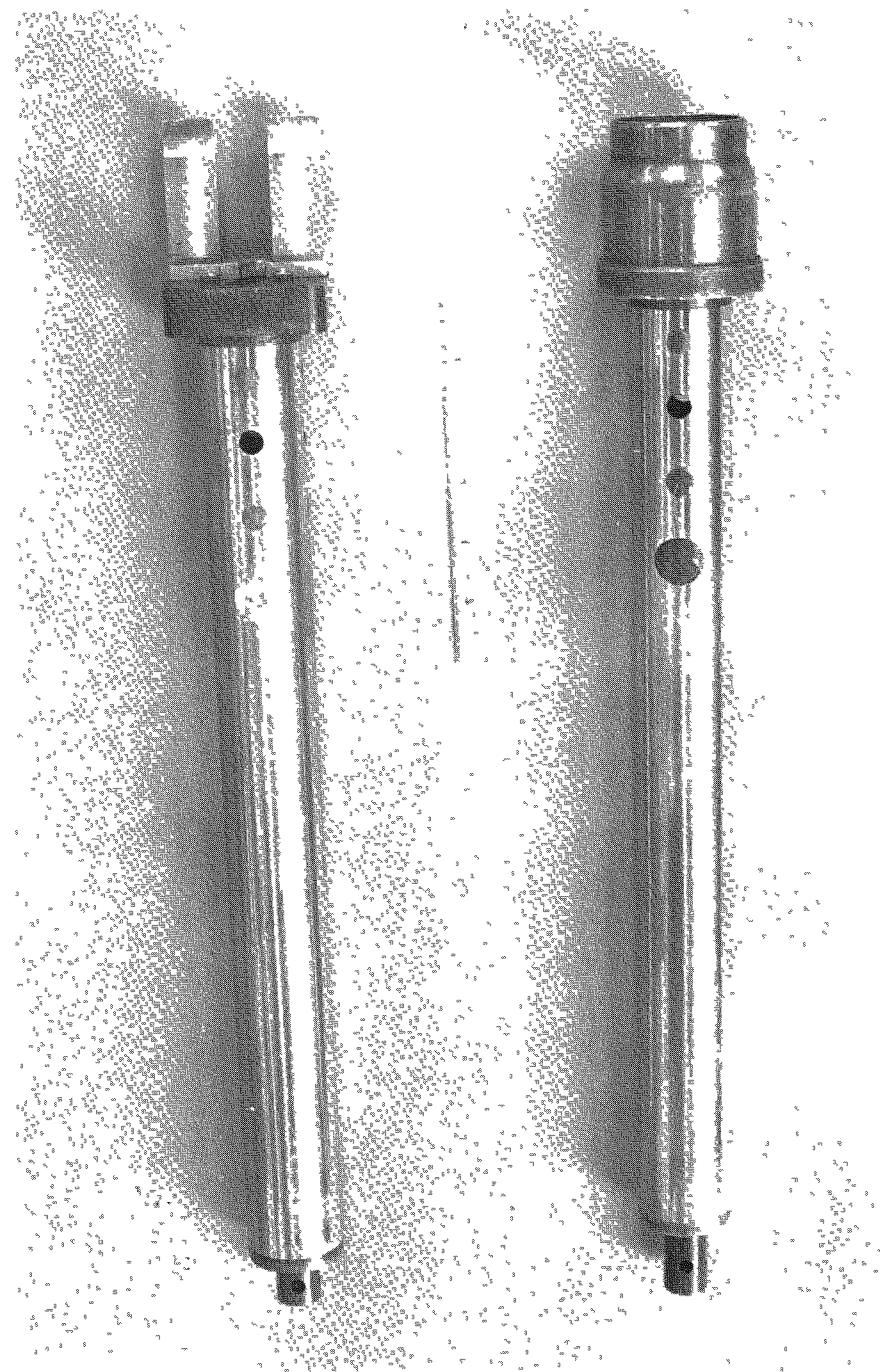
FIGURE 3
Top Section of Absorber CAM Actuators

Also geared to the drum is a shaft on which are mounted three cams for operating limit switches, and a potentiometer for position indication. The neck of the headgear originally contained four limit switches actuated by two flat finger-type cams at the top of the rod. These four switches proved difficult to synchronize and were replaced in 1957 by one switch having four contacts. Difficulty was also encountered with bending of the neck limit switches due to misalignment of the cams. To solve this problem, the two original cams were replaced by one simple circular cam (see Figure 3) and the limit switches in the neck were moved to the outside with actuation by a single pin passing through the neck. This eliminated all wiring and limit switches inside the neck and resulted in much improved operation.

As mentioned previously, the operation of the neck limit switches was considerably improved by changing from a double prong type cam to a single circular cam actuating a single pin passing through the neck. There has been some wear of the pin but this is a minor problem.

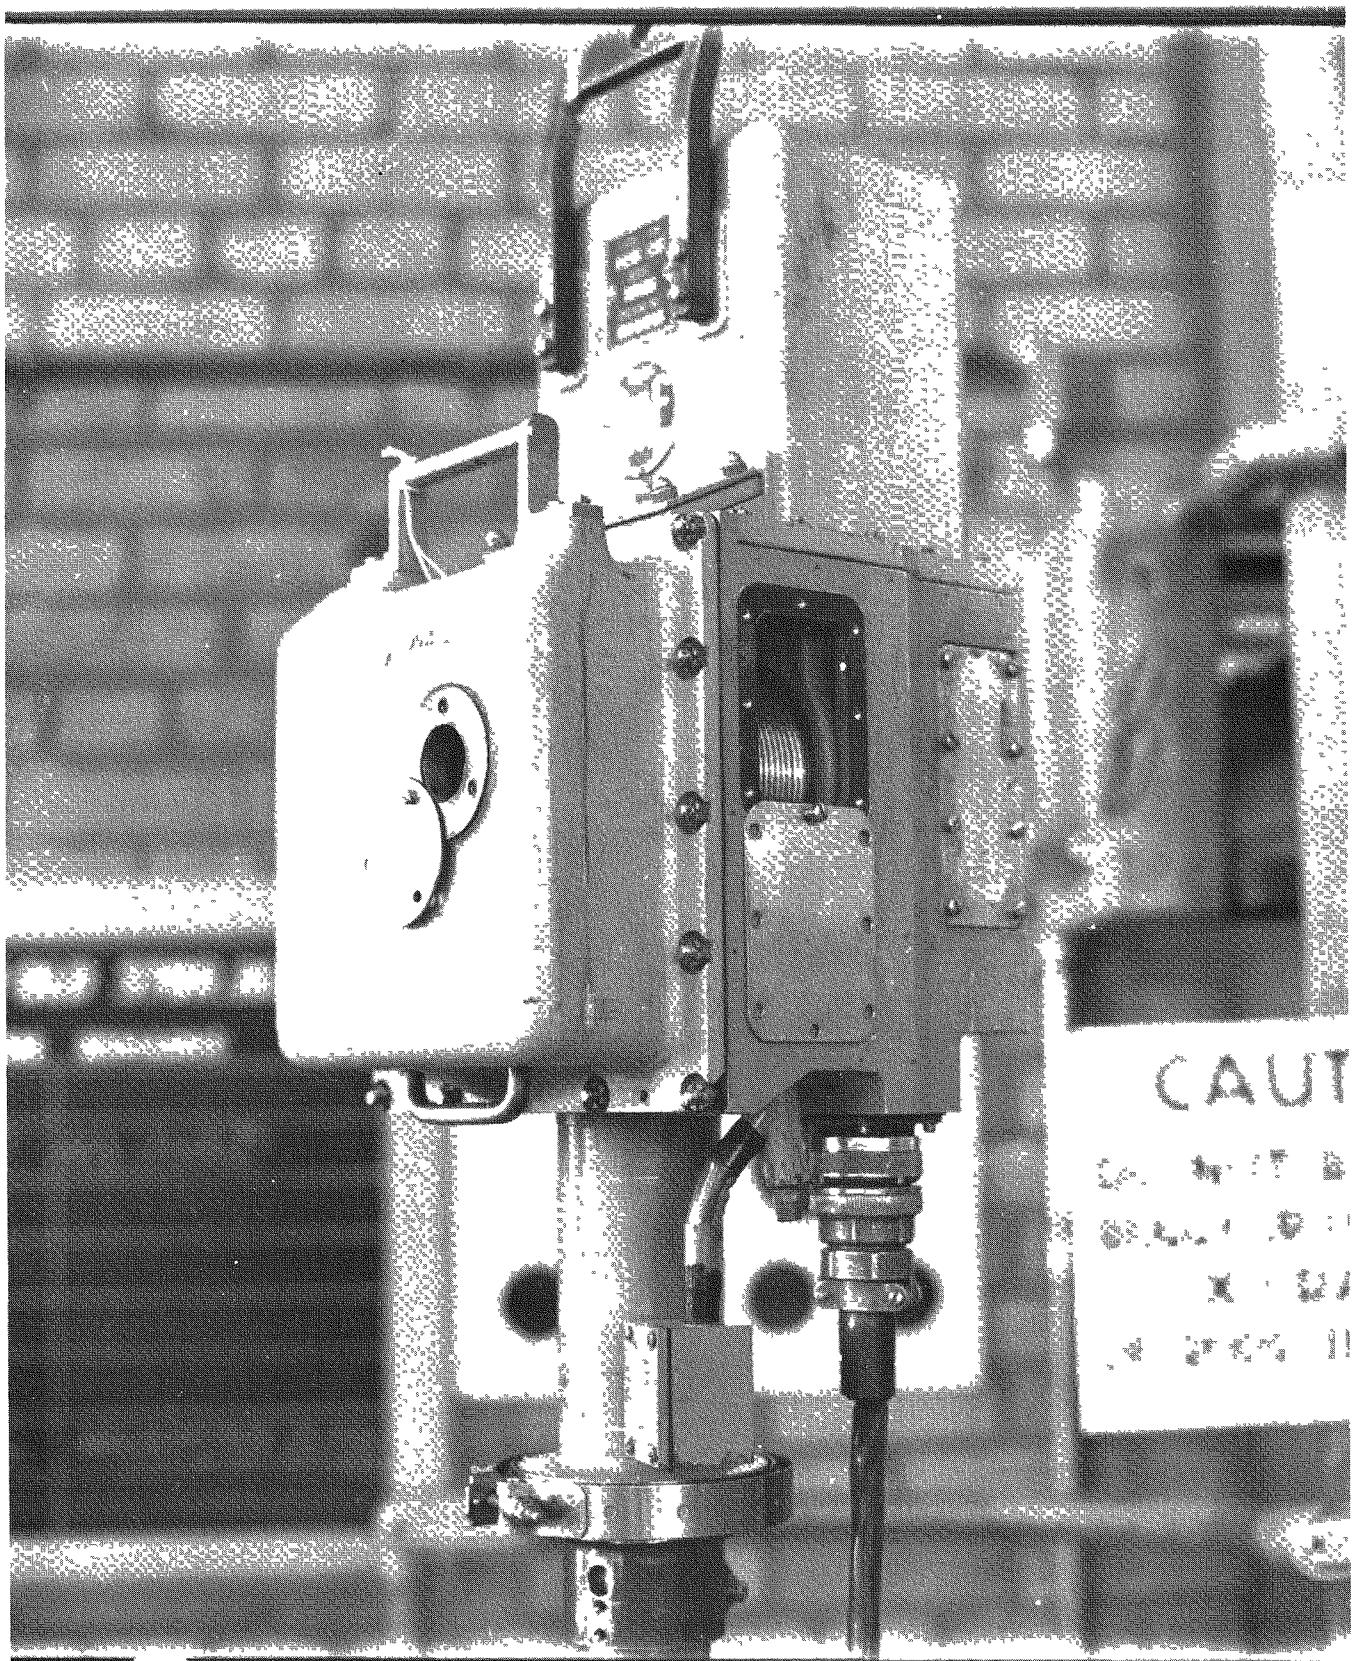
FIGURE 4
Headgear Assembly NRX Shut-Off Rod

- Limit switch trouble (by far the greatest number)
- Ground fault (Failure of insulation, wire cut, wet conditions)
- Noisy operation (Worn gears or bearings, clutch maladjustments, lubricant needed)
- Drop time too fast or slow (Snubber adjustment, change of snubber oil)
- Absorber sticking (screw fallen into barrel, cable broken)
- Cable broke (faulty limit switch operation)
- Clutch trouble (clutch needs re-facing).

Replace all bearings, motor pinion and associated brass gear
Rewire completely
Inspect tabs and shaft
Inspect drum, shaft and associated gear
Inspect gear on snubber assembly
Lubricate
Adjust tension on spring
Adjust cams and limit switches
Check clutch assembly, reface clutch
Change snubber oil. Put orifice in vane if required.
Test for drop-time.

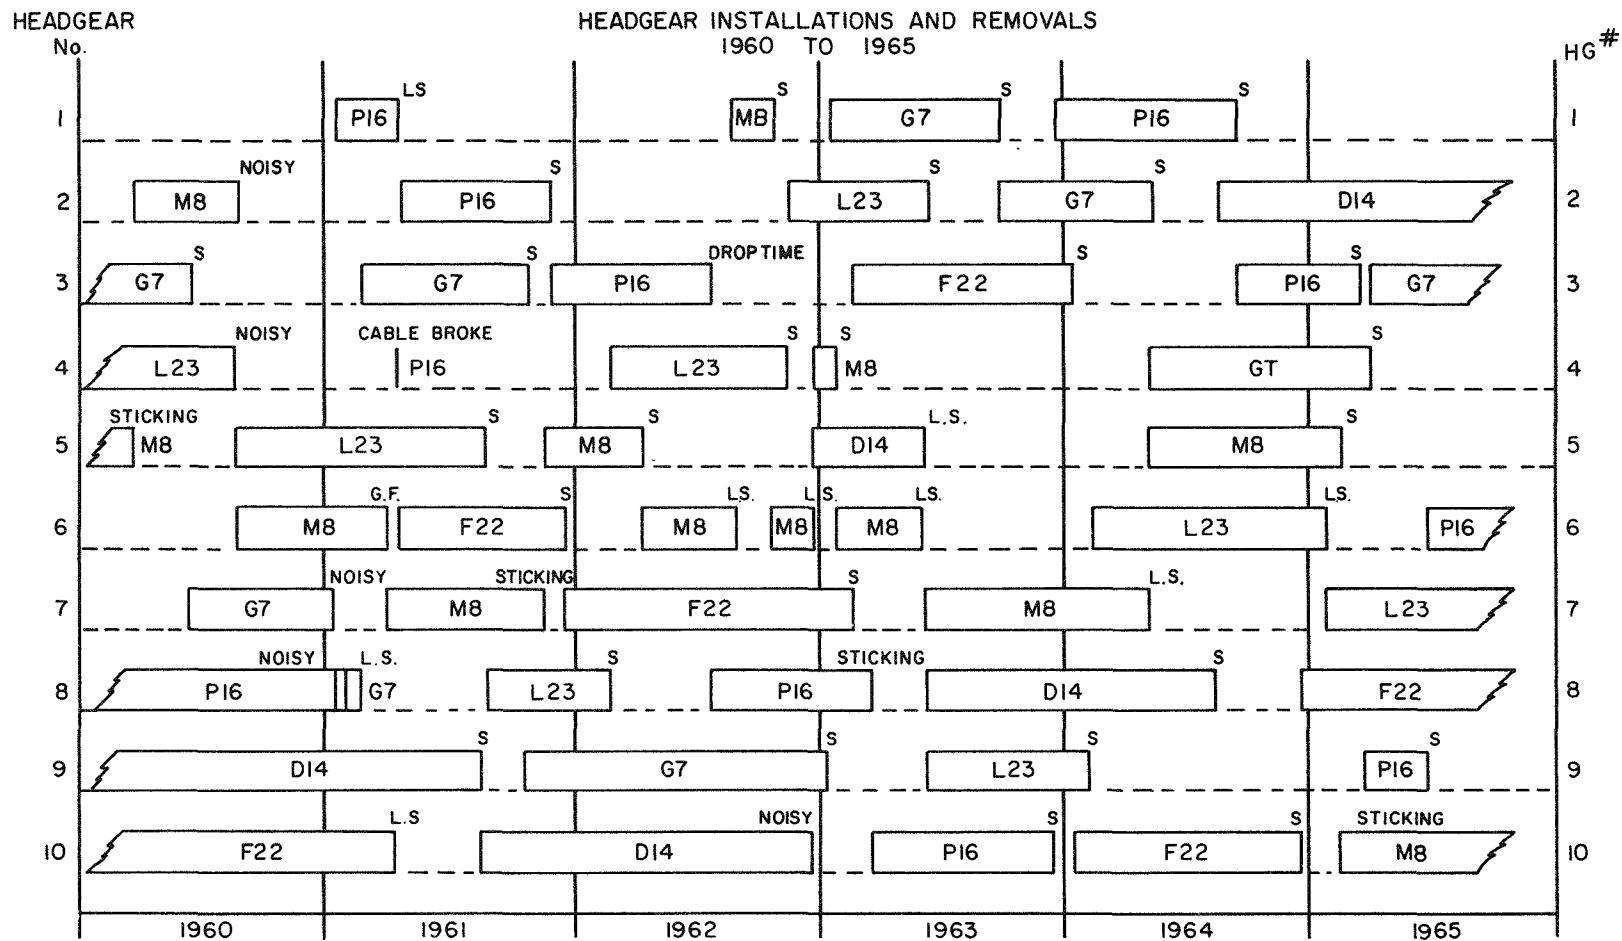
PERFORMANCE OF NRX SHUT-OFF RODS

The headgear removals and installations, as recorded in the Rod Office records, have been plotted in the form of bar charts, Figures 5 and 6. Figure 5 gives the operating history of headgear Nos. 1 to 10 for the period 1960 to 1965. The reactor position for each installation is indicated and the reason for each removal is given. In Figure 6, the same records are used to indicate the successive and continuing occupancy of the sequence positions Nos. 1 to 6 by the various headgear. In this case, the number in each box represents the particular headgear occupying the reactor position during the period indicated. Only the long-term installations have been plotted.

The reasons for removal are not always given in the rod records. They are usually listed as "for repairs", "routine maintenance", "modifications", "faulty operation" etc. The reasons for malfunction of a rod may not be known at the time of removal and sometimes cannot even be determined when the headgear is later inspected and tested. The following is a list of some of the faults that have been recorded, and some of the possible causes:

The headgear are removed once a year for general overhaul and preventive maintenance, most of the removals shown in the chart being for this reason. The headgear service record, as summarized from the Instrument Shop log book, is shown in Appendix "A" of this report. During the annual overhaul, the following maintenance is done as required.
