DOE/OR/01-1501&D1

**Removal Site Evaluation Report
for the Isotope Facilities
at Oak Ridge National Laboratory,
Oak Ridge, Tennessee**

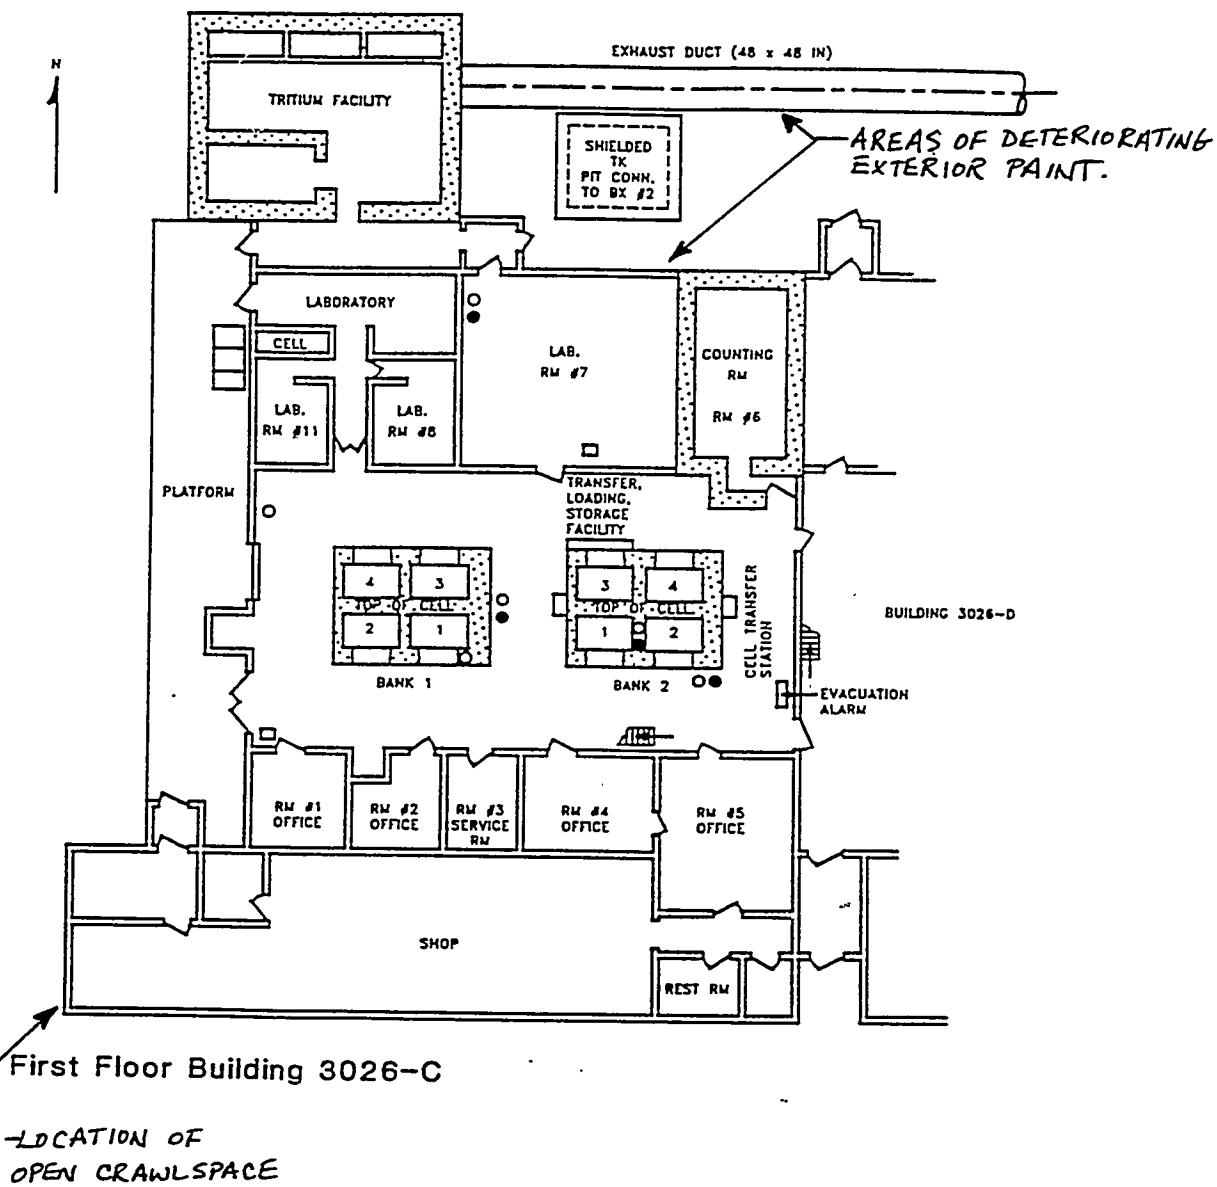
Fig. 1. Diagram of the first floor of Building 3026-C.

There were, however, two external imminent hazard areas identified to be associated with Building 3026-C. One involved the crawl space area located at the southwest corner of the facility. The area is posted as a RAD hazard area due to contaminated soil. Openings in the foundation surrounding the crawl space were observed during the site inspection. Soil in the crawl space appeared dry, with a loose surface layer. As a result, strong air movement through this area due to winds could potentially disturb the loose soil and carry contaminated particles away from the crawl space. This poses an exposure potential to personnel who might be in the immediate area during a wind episode. Additionally, these foundation openings allow access to small animals, which could become contaminated and leave the crawl space carrying contamination away from the area. Regarding the recommended maintenance action to control air movement and access in this area, a request for repair of the opening to the crawl space under Building 3026-C was prepared and is scheduled for completion by the end of July 1996.

The other imminent hazard area involves deteriorating painted, wooden exterior walls and cell ventilation duct work surfaces adjacent to the north side of the building. The paint in this building has been assumed to contain lead by the ORNL Lead Management Program based on the age of the facility. Paint in the areas mentioned is peeling off, posing a potential direct impact to the soil below and an indirect impact to surface water as a result of runoff with storm water. The paint on the building has been sampled, and the analysis is expected by the end of June 1996. If the paint contains lead, a maintenance action will be necessary to prevent further deterioration and dislodging of this paint. In addition, an RSE should be conducted to determine whether lead from fallen paint chips has impacted the soil in the immediate area. (See the Building 3026-C RmSE information form for additional information concerning these areas.)

The only existing immediate threat to soils identified in the area of Building 3026-C is located adjacent to the north side of the facility. Paint on the exterior of the north wall is badly deteriorated and is peeling off the building. Paint on the cell ventilation system duct work in this area also shows evidence of localized deterioration. This paint is assumed to contain lead by the ORNL Lead Management Office. The soil in this area is at risk of being impacted by lead contamination from paint that has peeled or chipped off the wall or duct work if, in fact, the paint does contain lead.

There is also evidence that soil beneath the building has been historically impacted by radiologic contamination. Postings at the entry points to the building's crawlspace indicate radioactive soil contamination in the crawlspace. Access to the crawlspace is restricted; however, it is not controlled. Access doors to the crawlspace were found to be open leaving the area easily accessible should the RAD warning sign be removed somehow (by strong wind, for example). In addition, soil in the crawlspace was observed to be very dry with a loose surface. Openings in the building's foundation can allow wind to enter the crawlspace stirring up potentially contaminated dust which can subsequently exit the crawlspace through these openings. This would pose a pathway for migration of radiologic contamination as well as a potential airborne contamination hazard to those in the immediate area during a wind episode. These openings could also allow small animals to enter the crawlspace and become contaminated internally and externally from dust. Contamination could then migrate from the crawlspace in the animals coat, fecal matter, urine, and decaying body upon death.

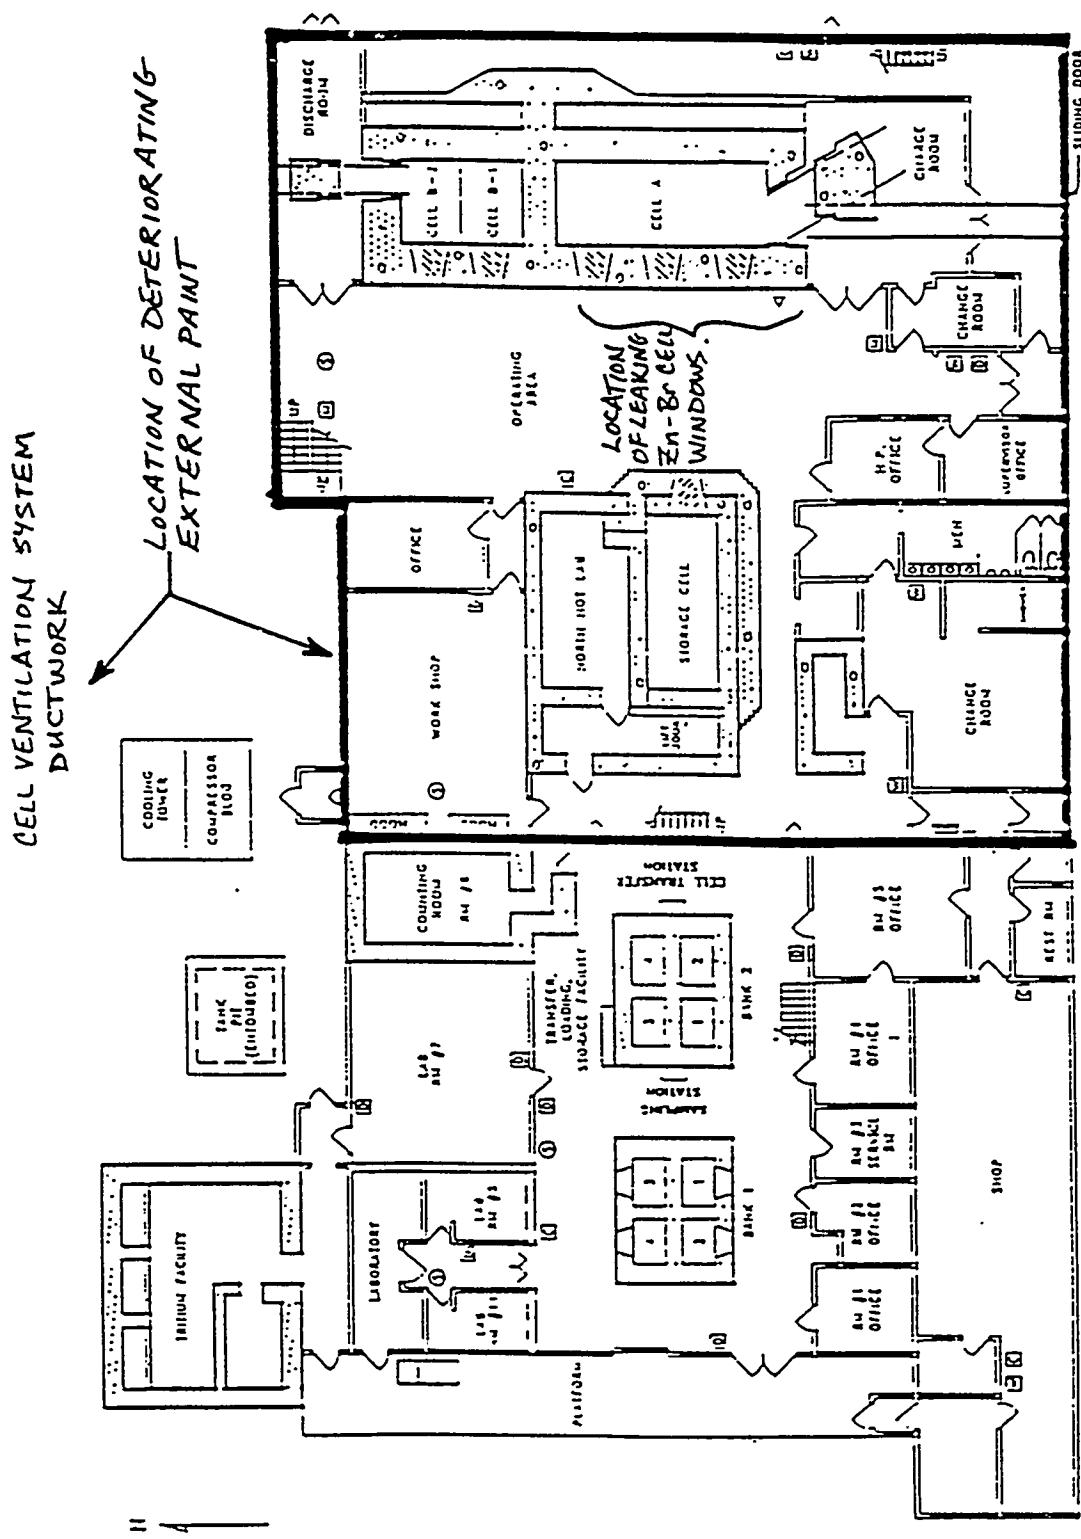
Fig. 2. Diagram of first floor of Building 3026-D (perimeter is in **bold**).

There was, however, one external imminent hazard area identified to be associated with Building 3026-D. This is an area involving deteriorating painted, wooden exterior walls and cell ventilation duct work surfaces adjacent to the north side of the building. The paint in this building has been assumed to contain lead by the ORNL Lead Management Program based on the age of the facility. Paint in the areas mentioned is peeling off, posing a potential direct impact to the soil below and an indirect impact to surface water as a result of runoff with storm water. The paint on the building has been sampled, and the analysis is expected by the end of June 1996. If the paint contains lead, a maintenance action will be necessary to prevent further deterioration and dislodging of this paint. In addition, an RSE should be conducted to determine whether lead from fallen paint chips has impacted the soil in the immediate area.

It should also be noted that zinc-bromide is leaking from some of the viewing windows in the east cell bank. These leaks are currently controlled by collecting leaking fluid in a drum and pumping it back into the window. While this provides a temporary means of control and does not present an immediate threat, it is recommended that either the leaking windows be repaired and the leaks stopped or that the fluid be drained and disposed of if it is no longer needed. This will reduce or eliminate the potential for an inadvertent hazardous material (HAZMAT) release within the facility. (See Building 3026-D RmSE information form for additional information concerning these areas.)

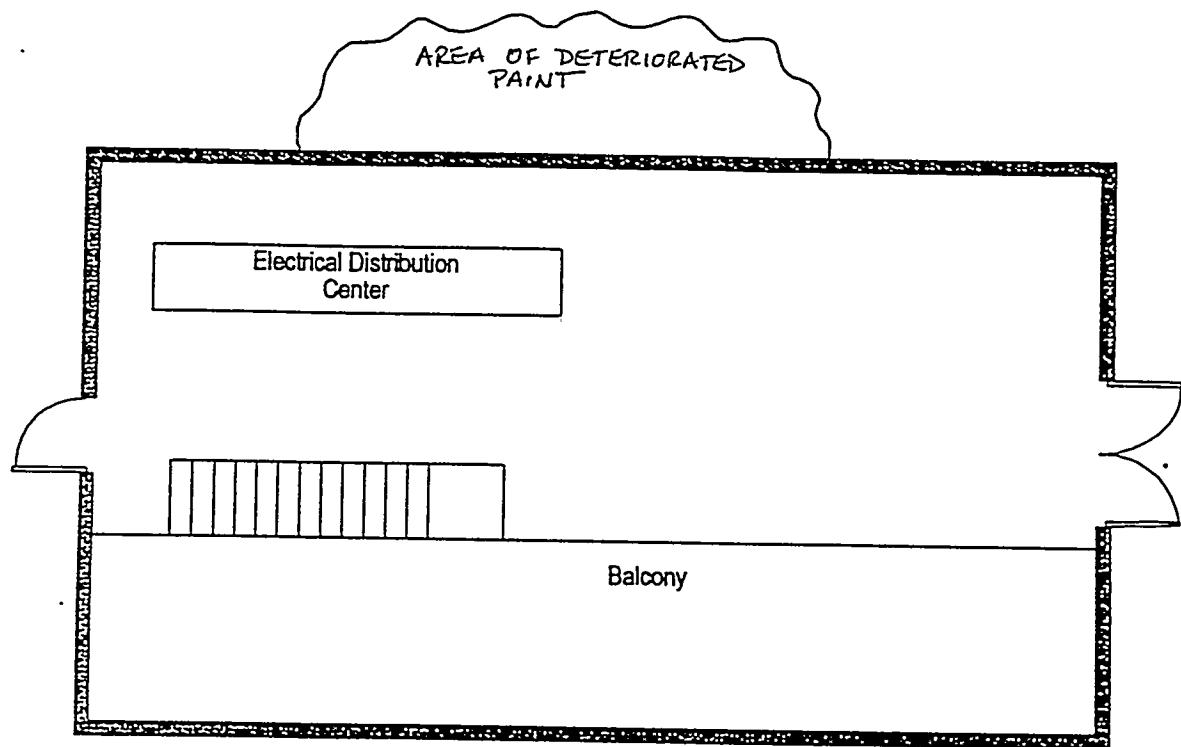
Fig. 12. Diagram of Building 3034.

There was, however, one notable, exterior, imminent hazard area identified to be associated with Building 3034. This is an area involving deteriorating, painted exterior piping adjacent to the east side of the building. The paint in this and surrounding buildings has been assumed to contain lead by the ORNL Lead Management Program based on the age of the facilities. Paint on the piping is peeling off and has fallen to the ground below. This poses a potential direct impact to the soil below and an indirect impact to surface water as a result of runoff with storm water. The paint on this piping should be sampled and analyzed for lead content to determine if, in fact, a hazard exists. If so, a maintenance action will be necessary to prevent further deterioration and dislodging of this paint. In addition, an RSE should be conducted to determine whether lead from fallen paint chips has impacted

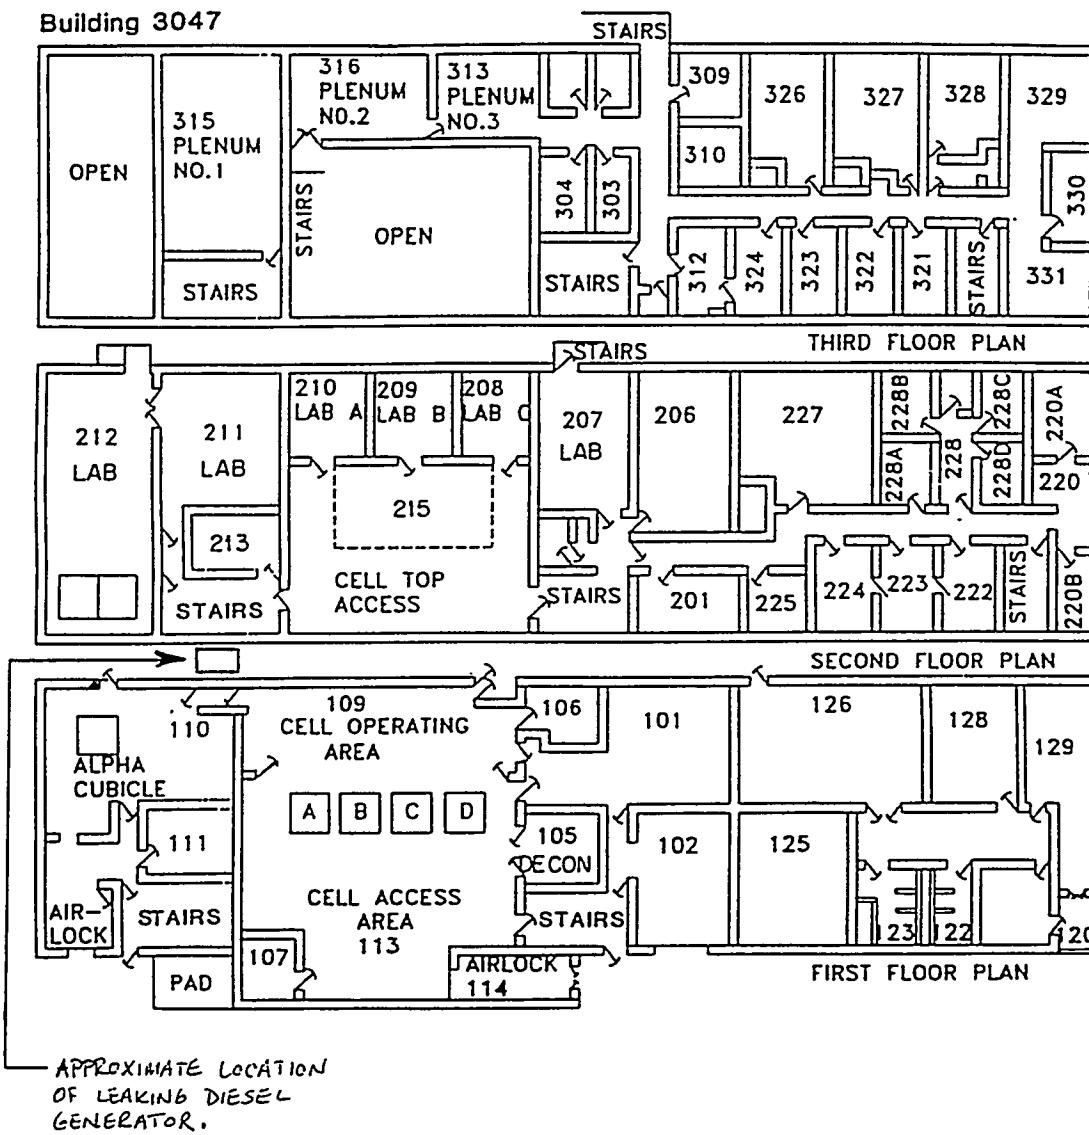
Fig. 17. Diagram of Building 3047.

There was, however, one notable, exterior, imminent hazard area identified to be associated with Building 3047. This is an area involving the emergency diesel generator adjacent to the north side of the facility. A follow-up inspection of the diesel generator was conducted, and no leak was found. During routine maintenance, small quantities of fuel may be generated. Maintenance personnel have been reminded of precautions that need to be taken to prevent spills of fuel while performing repairs to the generator. No other actions are planned. (See the Building 3047 RmSE information form for additional information concerning this area.)

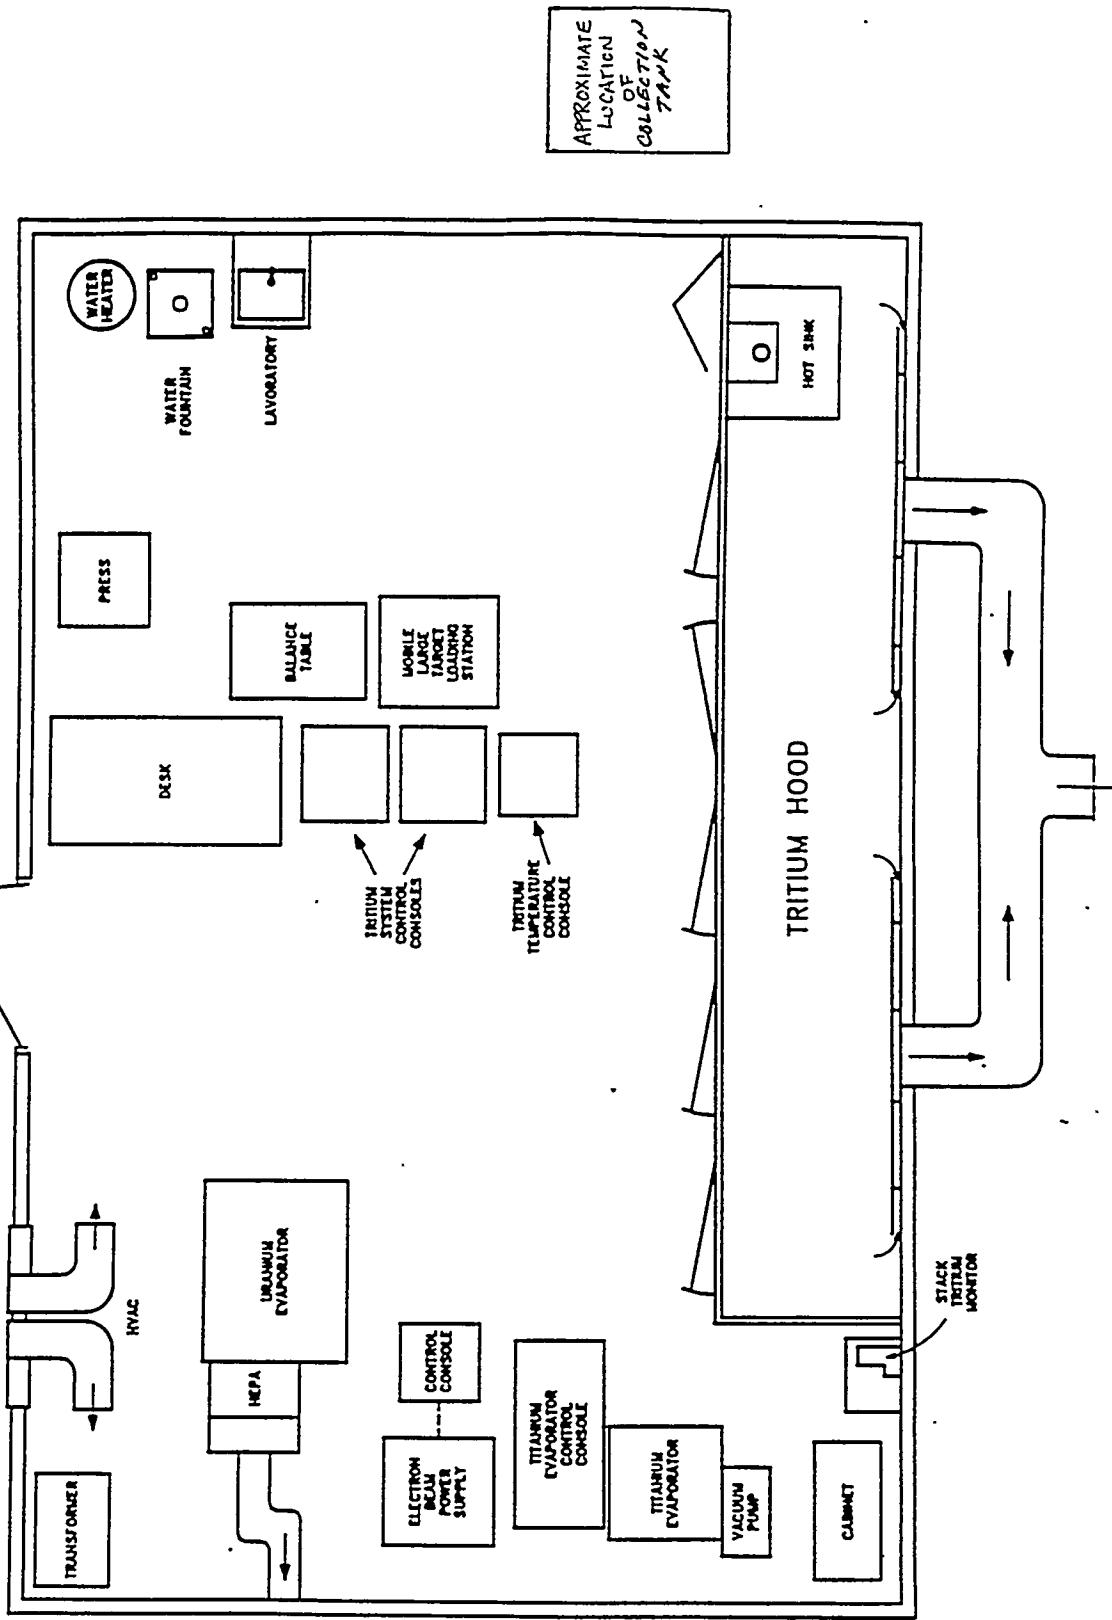
Fig. 19. Diagram of Building 7025.

It should be noted, however, that an underground collection tank exists adjacent to the east side of the facility. This tank was reportedly the discharge point for the hot sink located in the tritium hood within the facility. It was also reported that the processes in this hood did not generate liquid waste; therefore, the sink was only used by personnel for washing and decontamination. The contents have reportedly been removed, and the tank currently sits empty. No evidence was identified during this RmSE to indicate whether or not the tank has leaked. An internal tank inspection will be conducted by September 30, 1996. Based upon this inspection, additional actions may be merited. (See the Building 7025 RmSE information form for additional information concerning this area.)
