Effect of Conductivity  
Between Fasteners and Aluminum Skin  
On Eddy Current Specimens

David G. Moore  
Sandia National Laboratories  
Federal Aviation Administration  
Airworthiness Assurance NDI Validation Center  
Albuquerque, New Mexico 87185  
(505) 844-7095

M. C. Hutchinson 9503821  
Boeing Commercial Airplane Group  
P.O. Box 3707  
M/S 9U-EA  
Seattle, Washington 98124-2207  
(206) 234-8392

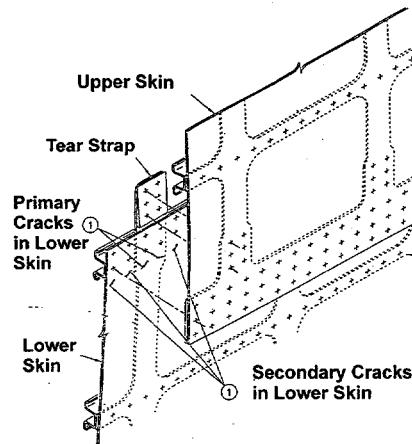
During a fleet survey of a Boeing 737 aircraft in September of 1994, cracks were found in the lower fastener row, lower skin (Figure 1) in a high cycle time aircraft. Because the primary crack location was covered by tear straps, a low frequency eddy current procedure was developed to detect this type of cracking from the exterior of the aircraft. On November 8, 1994 Boeing Commercial Aircraft Group issued Service Bulletin 737-53A1177 which specified the inspection of the lower fastener row of 737 lap splices for line numbers 292 through 2565. During a 1995 NDI Reliability Workshop sponsored by the FAA, the AANC was asked to assist the Seattle Aircraft Certification Office in developing Probability of Detection (PoD) curves for primary inspection called out in the Service Bulletin.

Figure 1. Crack locations  
in the Boeing lap joint.

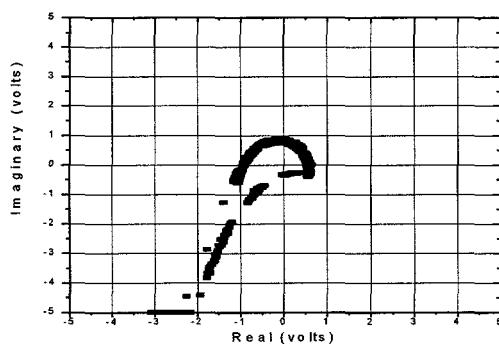
However, most sites produced a smaller than expected signal. Of course this meant that the amount of signal variation among similar sites on the specimen panels is much greater than found on an aircraft. It was concluded that the specimen panels had not been properly lubricated. Therefore, the generation of artificially aged fastener sites was not obtained on the test specimens. Figure 3 documents the characteristics of a rivet site with an abnormal conductivity between the rivet and hole. This impedance plane signal is not representative of sites found on aircraft.

Figure 3. Signal from rivet that exhibits high conductivity between the hole and rivet.

To remedy the signal response discrepancy found during the initial characterization, each top and bottom row of rivets was removed. Following is the removal process developed for these specimens: 1) remove the back side of the rivet using an air powered metal shaver and 2) drive out each rivet using a rivet press. After this process is complete, the specimens were re-inspected. Each hole and rivet was then coated with Sharpie® permanent marker. Petroleum lubricant was applied to each site and rivets were then driven back into the existing holes. The specimens were re-inspected using the low frequency eddy technique and data acquisition software. The re-inspection data was compared to the original data. The purpose of this comparison was to document that removal and re-installation of rivets does substantially change the impedance plane signal and the most significant factor affecting original response in the lap joint specimens was the result of poor lubricant during rivet installation. Figure 4 displays the results of the re-manufacturing process (removing the rivet, applying permanent marker to the hole and rivet, adding petroleum lubricant to the rivet hole and re-installing the rivet). The impedance plane signal is representative of fasteners found on actual aircraft.

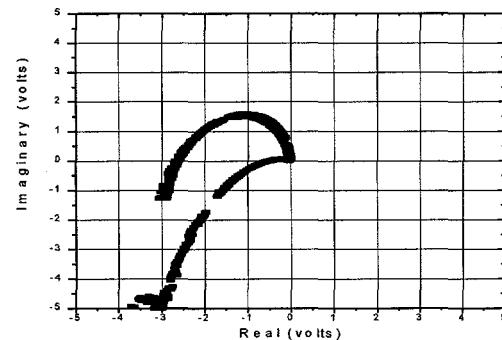
Figure 4. Signal from the same rivet site after remanufacturing.
