Plutonium-239/Beryllium Neutron Source Surveillance and Testing

R. D. Madding, Jr. and R. E. Vallée

February 15, 1973

MOUND LABORATORY

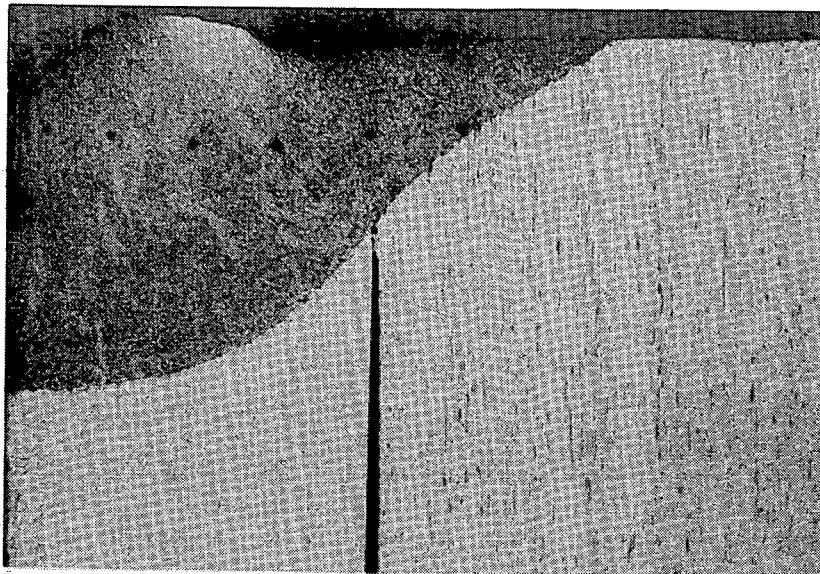
FIGURE 6 - Source M-71; stainless steel outer container; top weld (60.5X).

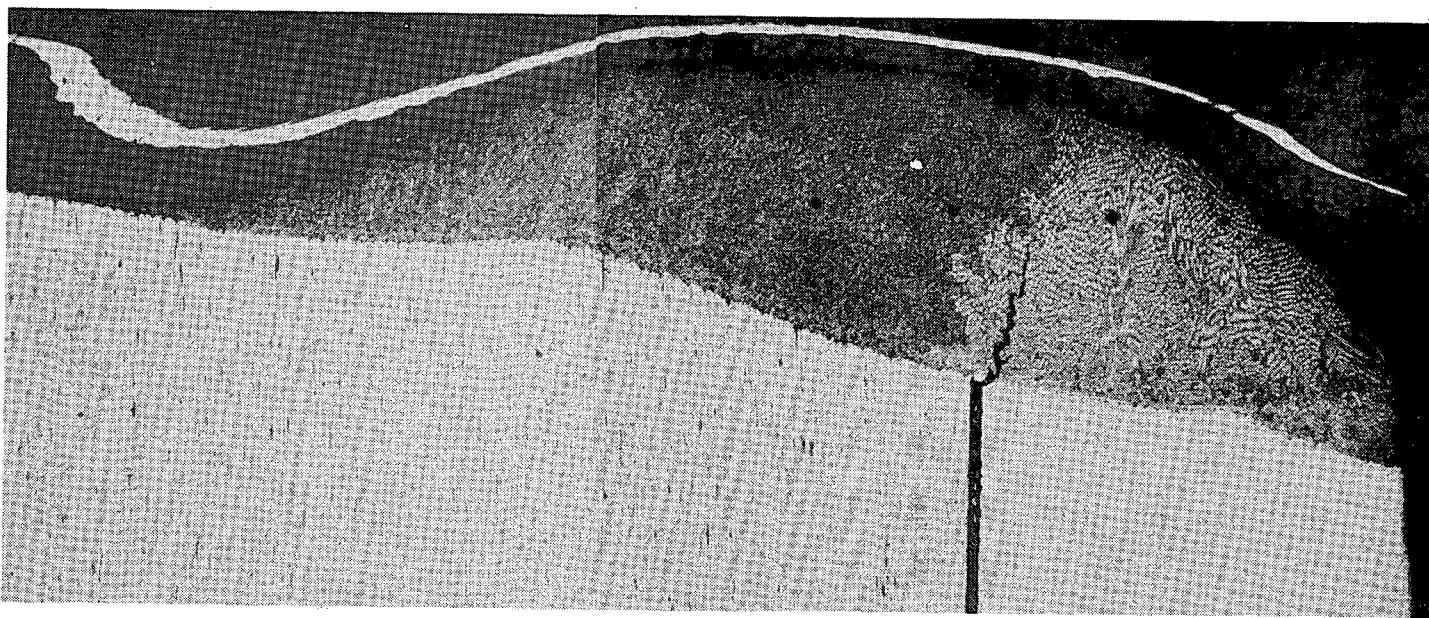
FIGURE 7 - Source M-1053S; stainless steel outer container; top weld (60.5X).

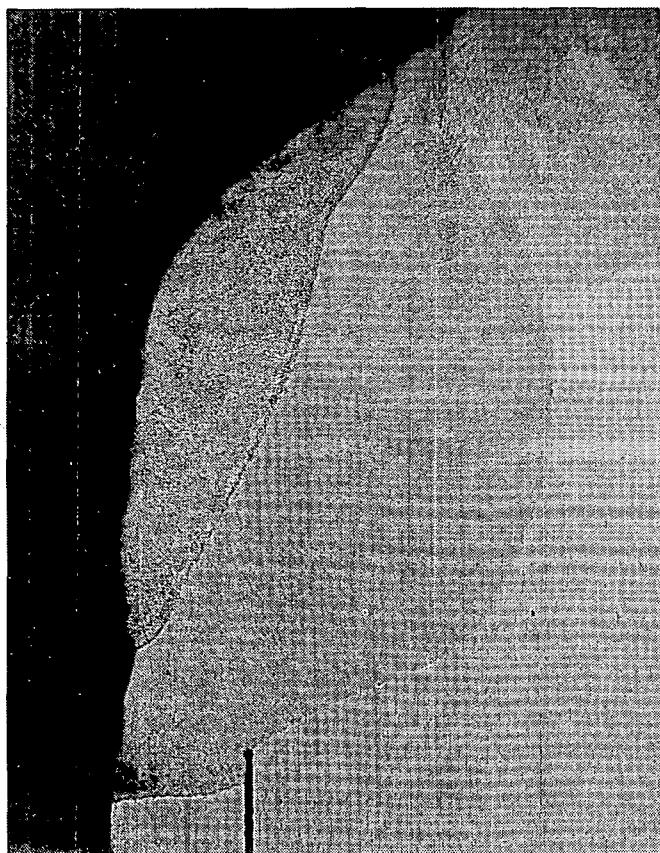
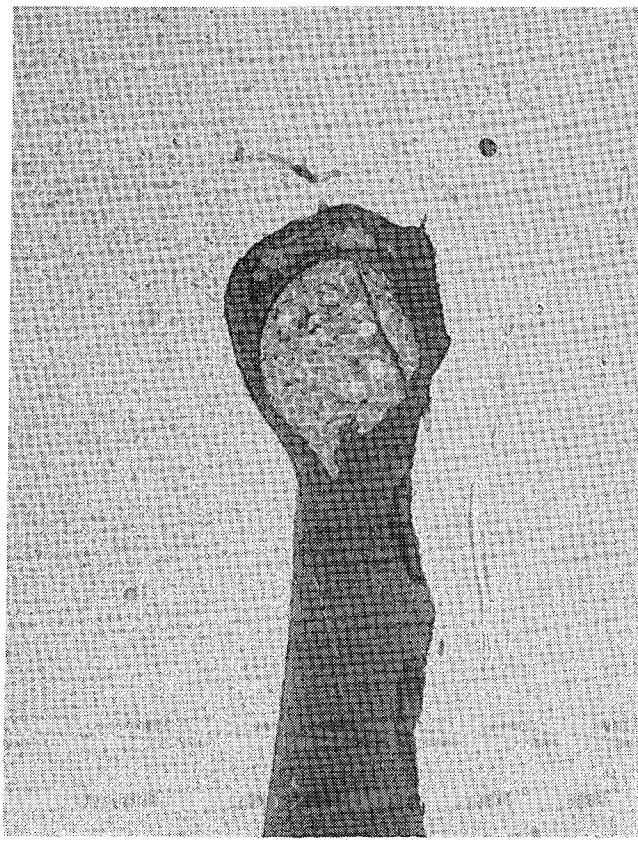
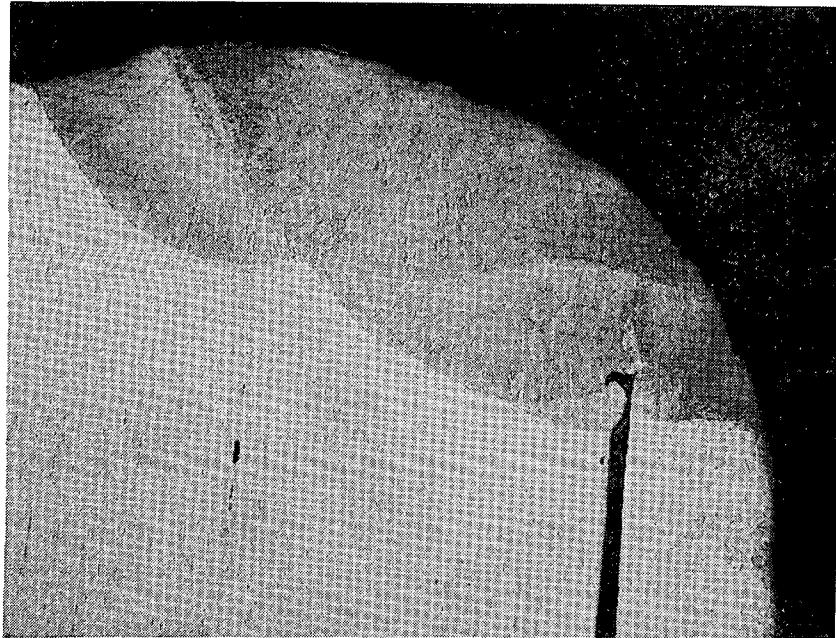
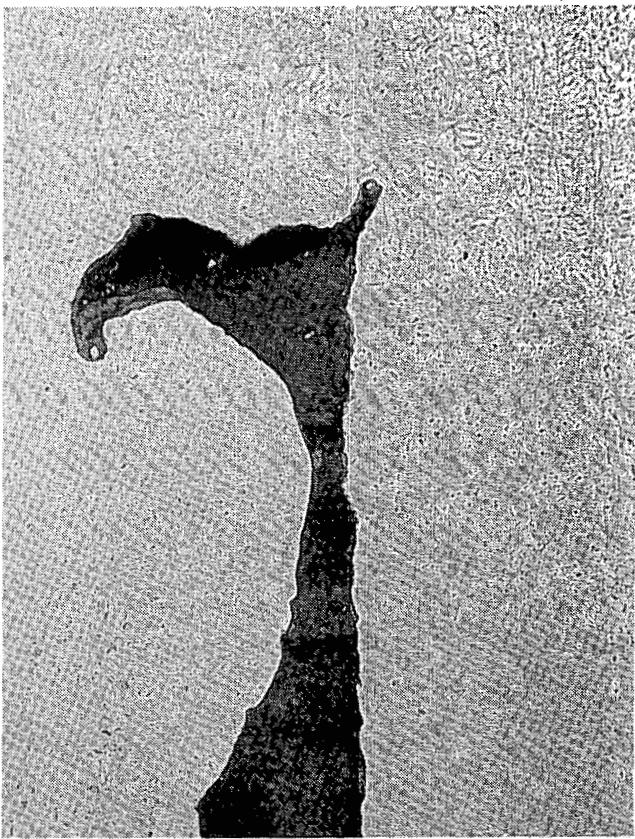
Examples of a slag inclusion in the weld joint are shown in Figures 8 - 11. The rounded ends to these separations are typical of this type of artifact. Round-ended separations such as these would not be expected to propagate. A small crack is shown in Figure 12. Under certain circumstances a sharp-ended crack could conceivably propagate, but in a ductile material such as 304 stainless steel this is not probable.

FIGURE 8 - Source M-259; stainless steel outer container; top weld (24.8X).

FIGURE 9 - Source M-259; stainless steel outer container; top weld (620X).

FIGURE 10 - Source M-9; stainless steel outer container; top weld (24.8X).

FIGURE 11 - Source M-9;
stainless steel outer container;
top weld (250X).

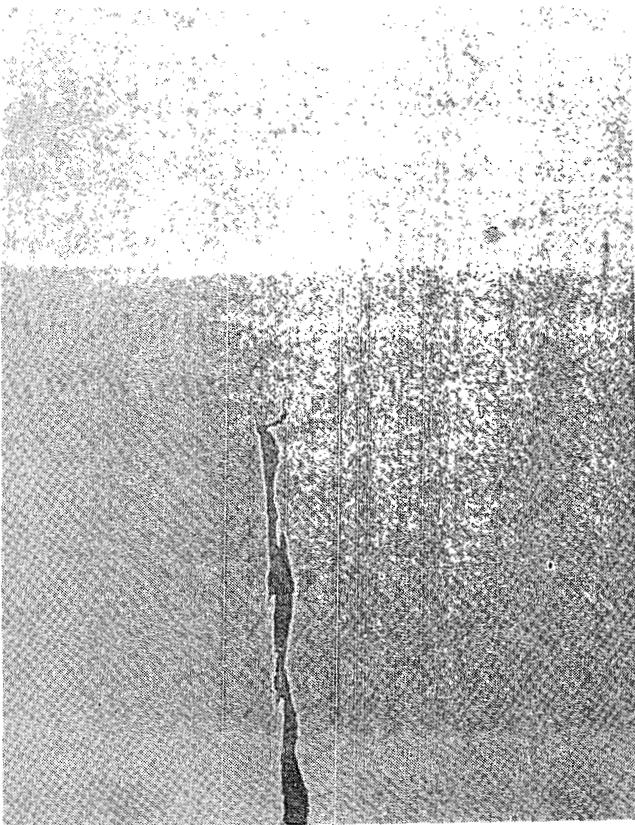
FIGURE 12 - Source M-1166;
stainless steel outer container;
top weld (250X).

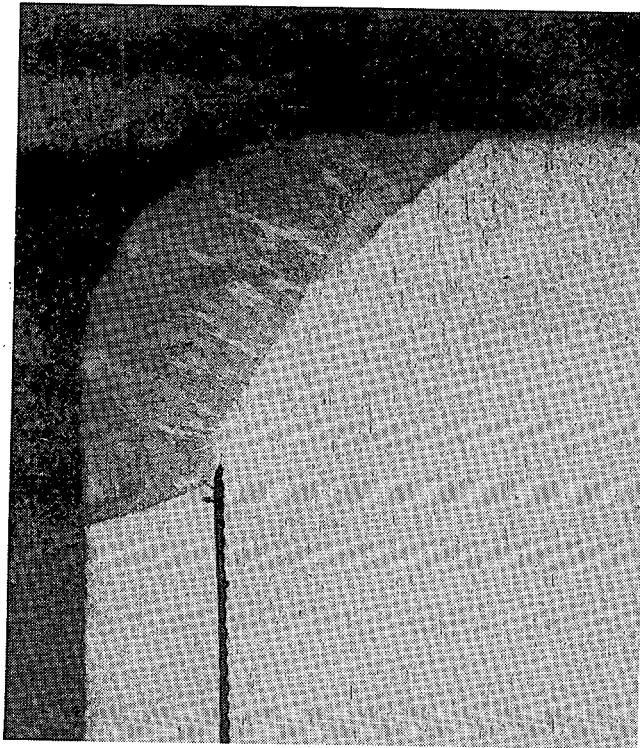
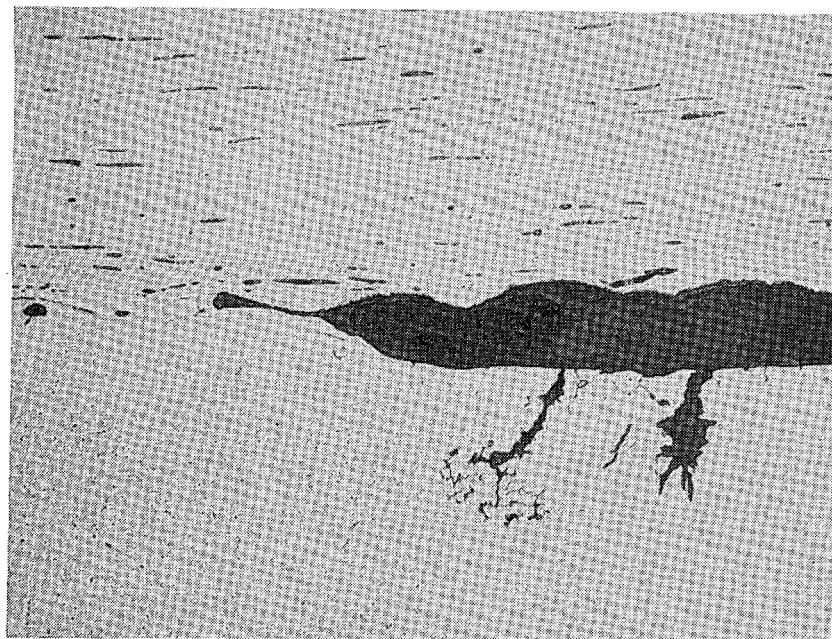
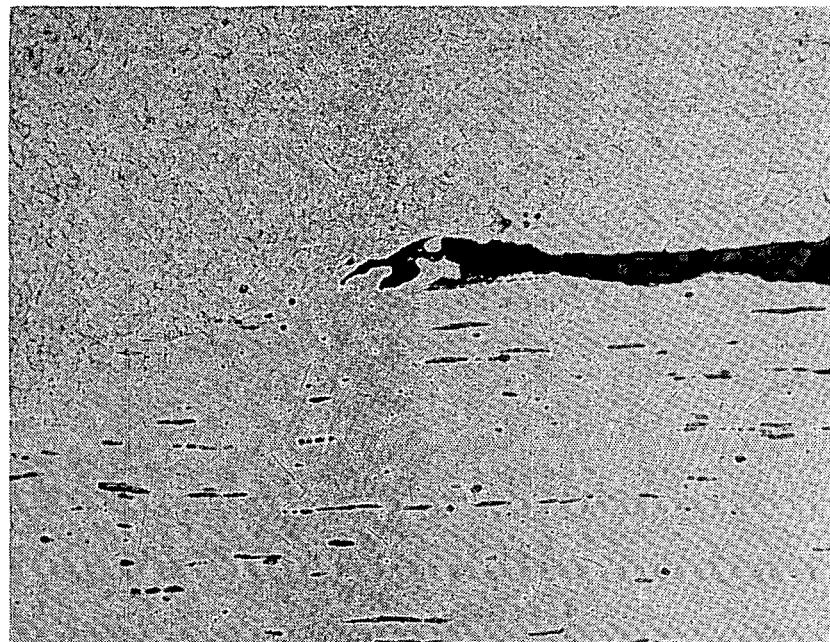
Photomicrographs of the top and bottom welds of source M-436, which had exhibited a leak, are shown in Figures 13 - 15. The small cracks or pores emanating from the side of the joint may have been responsible for the leaks. The reason for this phenomenon is not known at this time. Although corrosion could be the cause, electron microprobe analysis could not detect any reaction product in these areas. Either these are voids, or the reaction product pulled out during metallographic preparation.

FIGURE 13 - Source M-436; stainless steel outer container; top weld (24.8X)

FIGURE 14 - Source M-436; stainless steel outer container; top weld (250X).

FIGURE 15 - Source M-436; stainless steel outer container; bottom weld (250X).

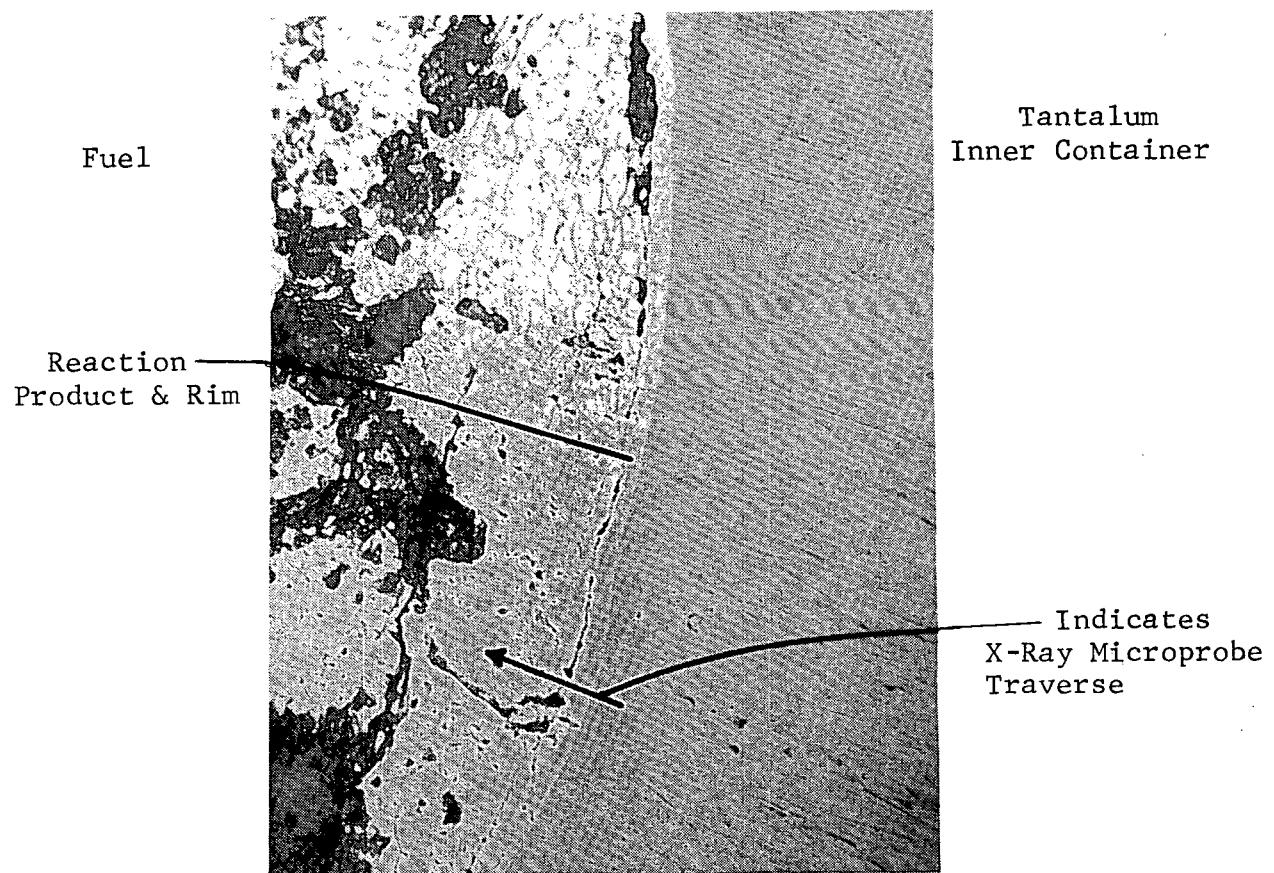
Samples of the fuel and the fuel-tantalum interface were examined and analyzed on the electron microprobe. Photomicrographs of the areas examined are shown in Figures 16-19. Superimposed on each photomicrograph is the direction of the beam and the areas examined. In each case where beryllium is indicated, it should be emphasized that this is implied by the data. The electron microprobe did not detect beryllium. The fact that great inhomogeneity exists in the fuel, usually associated with tantalum and probably beryllium, suggests that free unreacted plutonium may be present in the fuel, although no positive indication of unreacted plutonium was found.

FIGURE 16 - Source M-1053S; tantalum inner container; tantalum reaction product. Reaction rim increases in plutonium, decreases in tantalum. Presence of beryllium indicated (250X).

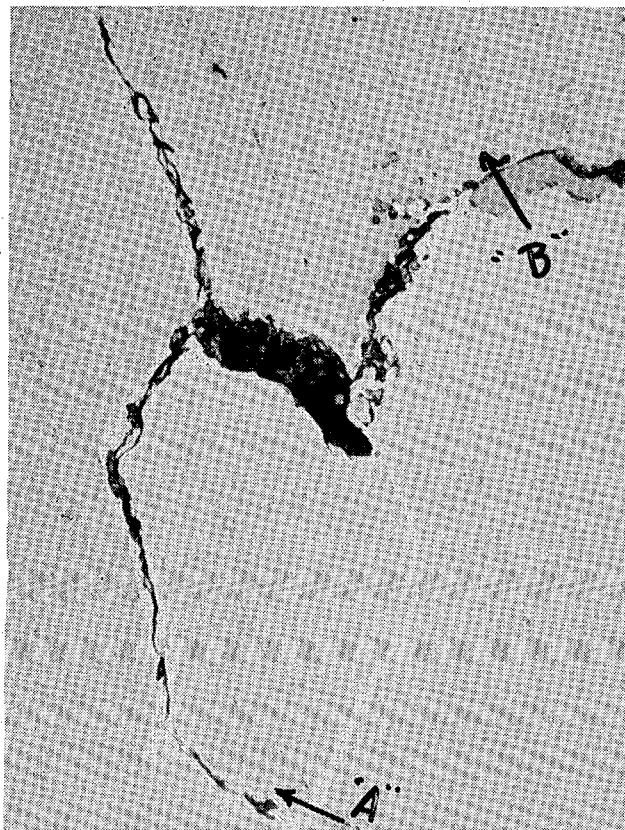
FIGURE 17 - Source M-1053S; tantalum inner container. X-ray microprobe traverse "A": grain boundary reaction product, plutonium decrease in tantalum, oxygen may be present. Presence of beryllium indicated. X-ray microprobe traverse "B": dark gray phase, plutonium + oxygen, no tantalum (250X).

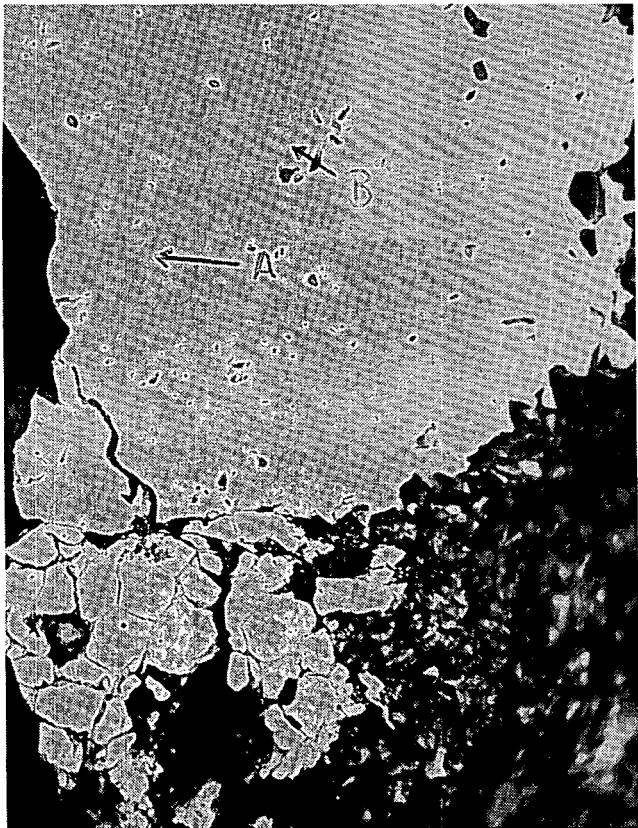
FIGURE 18 - Source M-1053S fuel chunk. X-ray microprobe traverse "A": white grain boundary reaction product, increase in tantalum, no plutonium, slight decrease in oxygen, presence of beryllium indicated. X-ray microprobe traverse "B": black phase seems to be pull-out (250X).

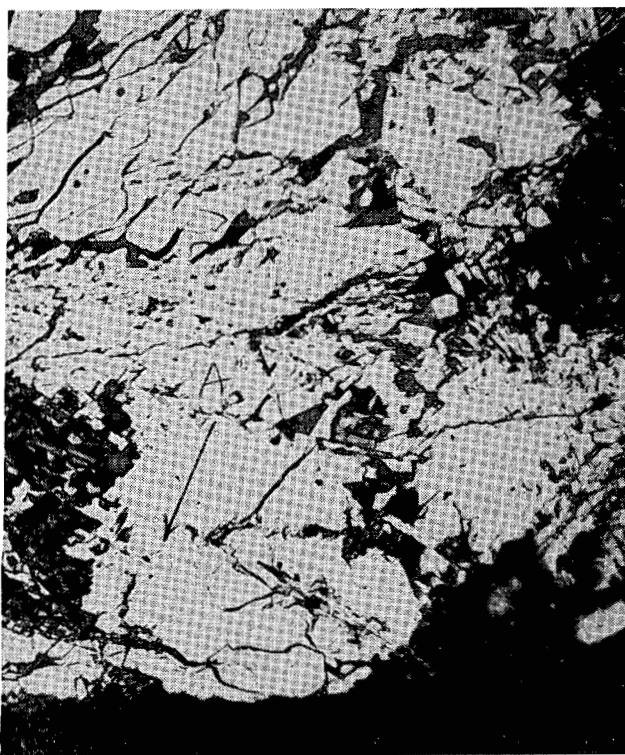
FIGURE 19 - Source M-1053S fuel chunk; x-ray microprobe traverse "A": layering, as tantalum goes up plutonium goes down, some high peaks of oxygen (250X).

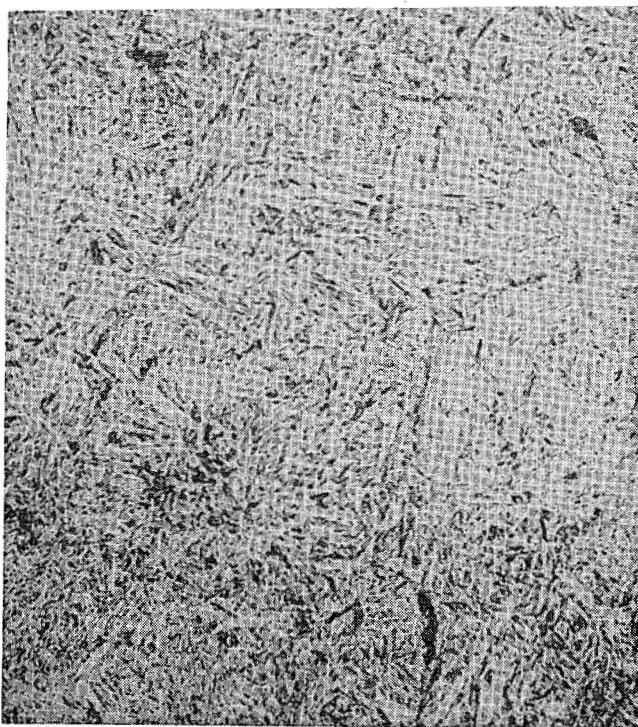
All of the sources, with the exception of M-1019 (Schlumberger), had outer containers of 304 stainless steel. Source M-1019 was apparently made from an air hardening tool steel called Vega steel. This material nominally contains 0.7 wt % C, 2.0 wt % Mn, 1.0 wt % Cr, 1.35 wt % Mo. Electron microprobe analysis, while not quantitative in this case, indicated high iron with small amounts of manganese, chromium, and molybdenum, which tends to verify this composition.

FIGURE 20 - Source M-1019; structure of Vega steel outer container (620X).

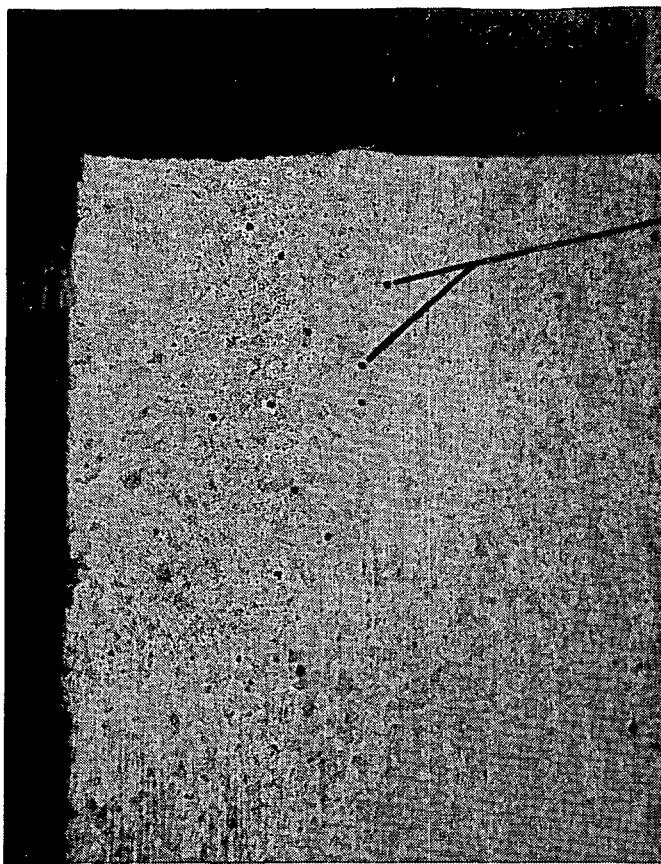
Examination of M-1019 showed the weld of the outer container, a martensitic steel as shown in Figure 20, to be completely severed from the sidewall; the cap lifted off. Figure 21 shows the weld area. Some small voids are observed, which may be attributable to gas evolution during welding. As indicated in Table 7, the bottom corners of the capsule were machined from one piece, not welded. Visual observations made during sectioning are listed in Table 6.

FIGURE 21 - Source M-1019; Vega steel outer container; top weld (24.8X).

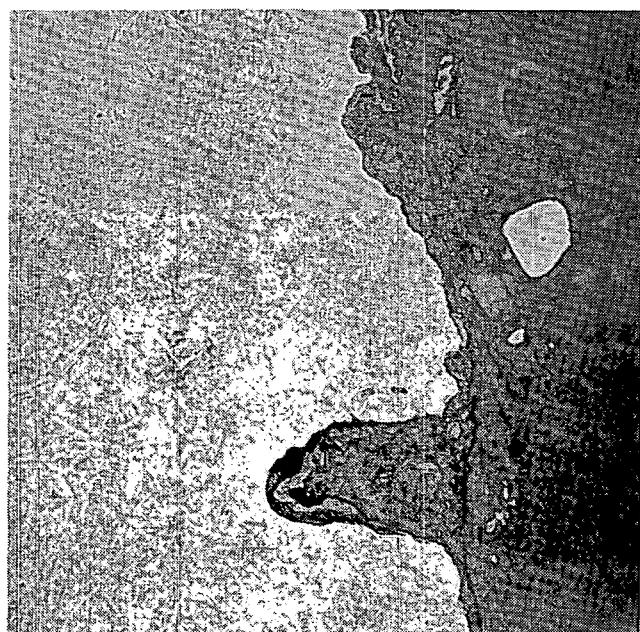
No cracks were observed in these corners. Figure 22 shows a reaction product containing various concentrations of iron, oxygen, and chromium, with oxygen and silicon in one particle on the outside wall of the container. Penetration of this reaction product is readily observed. These data suggest that the source was subjected to elevated temperature which may have contributed to the degradation.

FIGURE 22 - Source M-1019; Vega steel outer container; top weld outside edge (250X).
