NUREG/CR-6456
INEL-96/0089
AEOD/E97-01

Review of Industry Efforts To Manage Pressurized Water Reactor Feedwater Nozzle, Piping, and Feedring Cracking and Wall Thinning

Prepared by
V. N. Shah, A. G. Ware, A. M. Porter

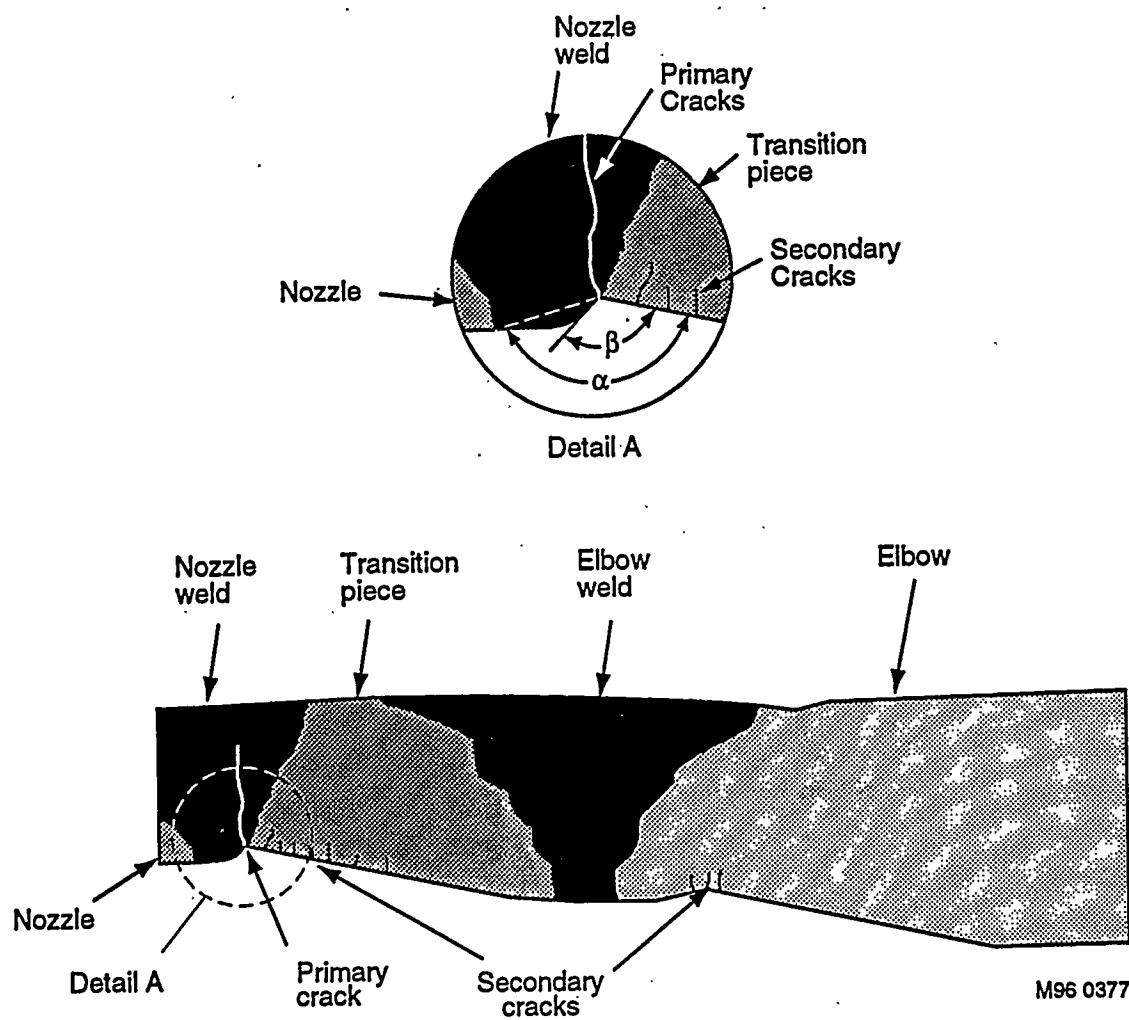
between the nozzle and the transition piece which is smaller than the design angle α ; this causes a stress concentration greater than the design value. This higher stress concentration factor contributed to the initiation of a primary crack at this location (discussed in Section 6.3.1).

Figure 18. Geometric discontinuity introduced by the field welding between the feedwater nozzle and the transition piece (TVA 1992) (modified).

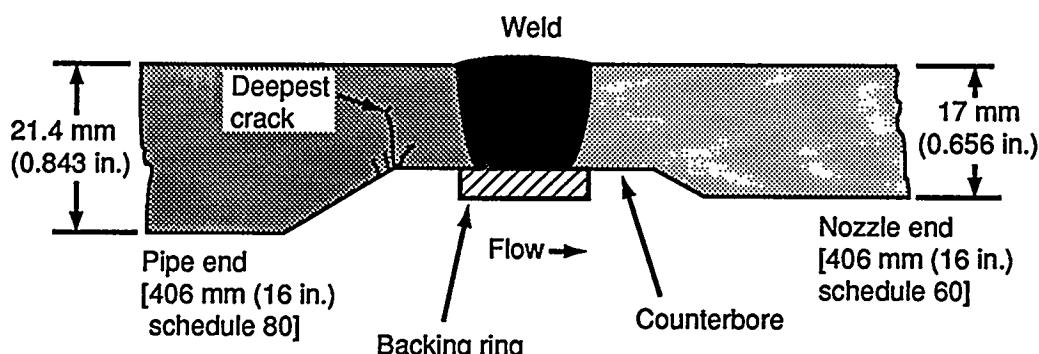
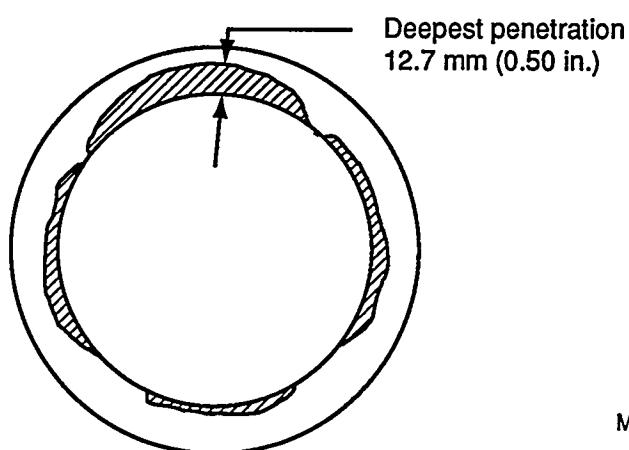
(a) Crack profile in degraded feedwater piping.

(b) Crack location in the D.C. Cook nozzle (USNRC 1980).

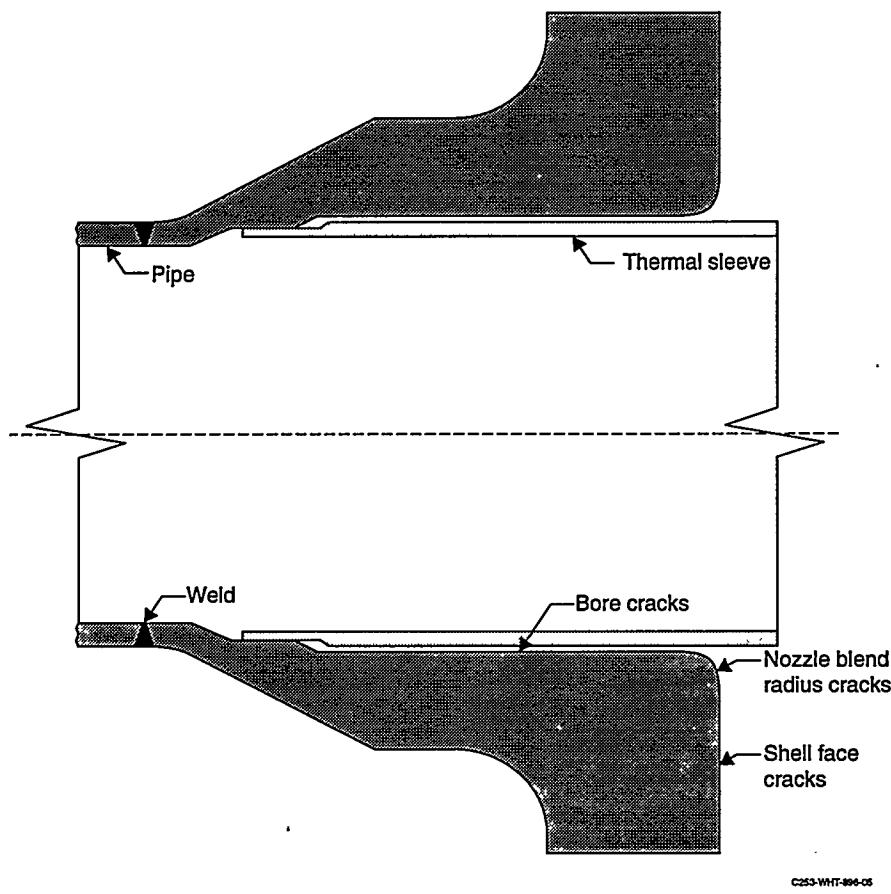
Figure 23. Locations of thermal fatigue cracks in an Indian Point Unit 2 feedwater nozzle and steam generator shell caused by bypass leakage of cold feedwater (Westinghouse 1989).

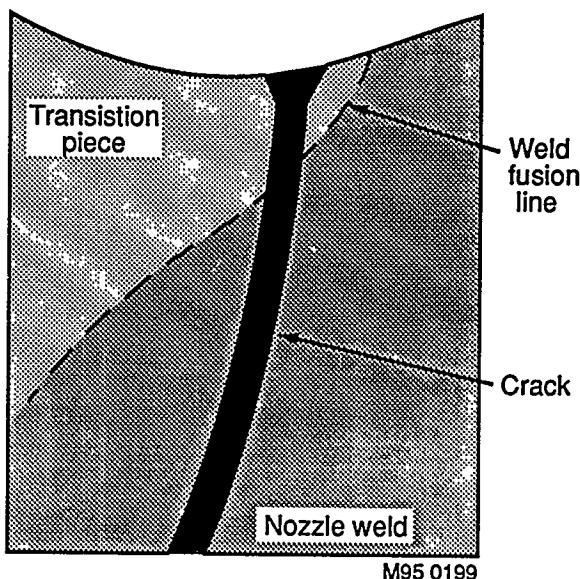
Figure 26. Through-wall crack in the feedwater nozzle weld at Sequoyah Unit 1 (TVA 1992b).

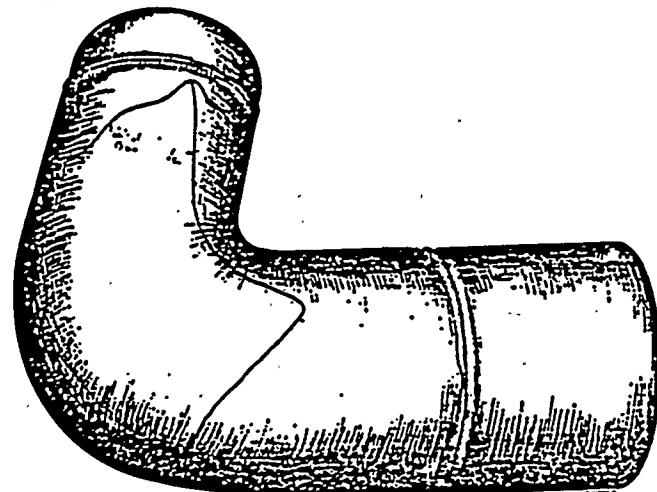
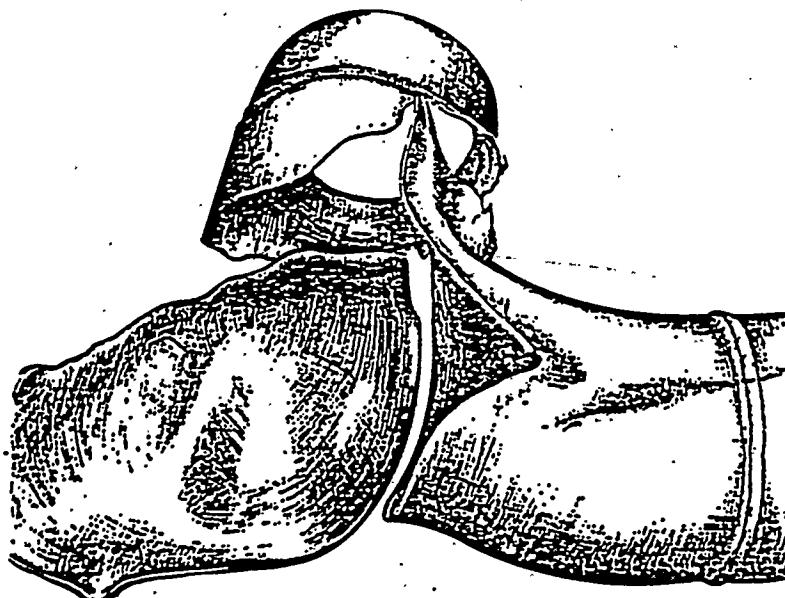
(a) Rupture lines in intact pipe.

(b) Pipe after rupture.
