NUREG/CR-6220  
SAND94-0769

# An Assessment of Fire Vulnerability for Aged Electrical Relays

Prepared by  
R. A. Vigil, S. P. Nowlen

Prepared for  
**U.S. Nuclear Regulatory Commission**

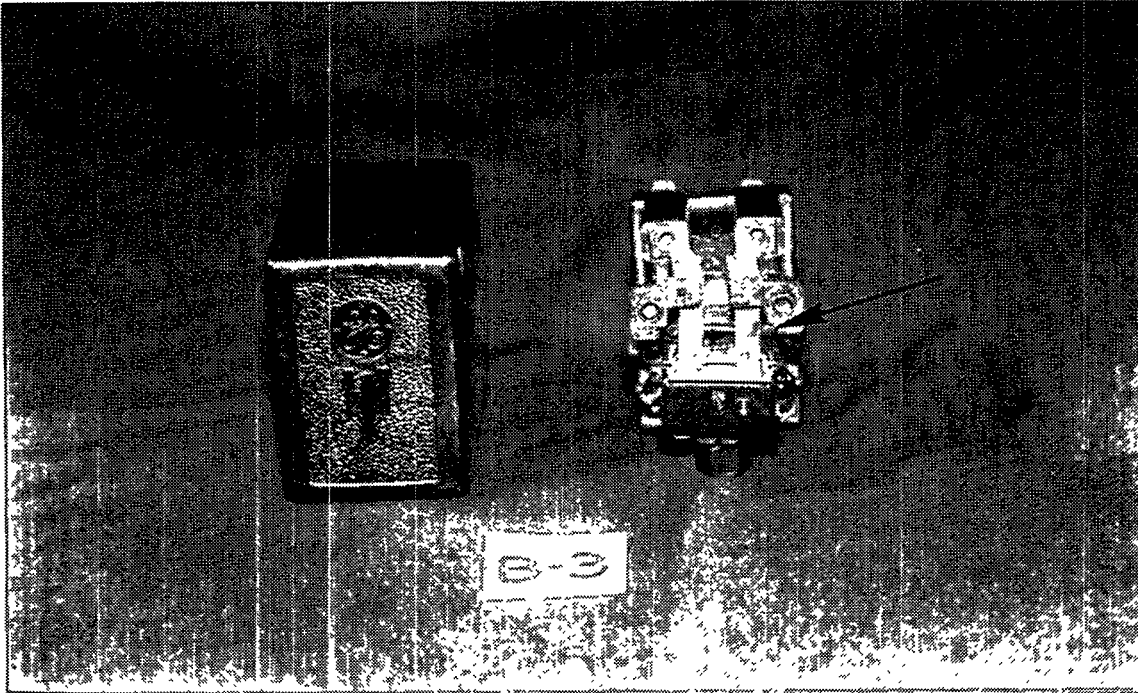
The first unaged relay, B3, was tested in the moderate profile and failed midway through the plateau period. The temperature at the time of failure was 348 °C. The mode of failure was again associated with an armature failure. However, in this case a closer inspection revealed that the armature had fused to the relay's housing. The point of the fusing is shown in Figure 6. The armature arm was separated from the housing when slight pressure was applied. However, it still did not actuate freely because of warpage of the relay's housing.

Figure 6 General Electric HMA relay B-3 after thermal exposure

an unknown substance on top of the coil and under the armature. The fourth failure was attributed to fusing of the armature to the relay housing.

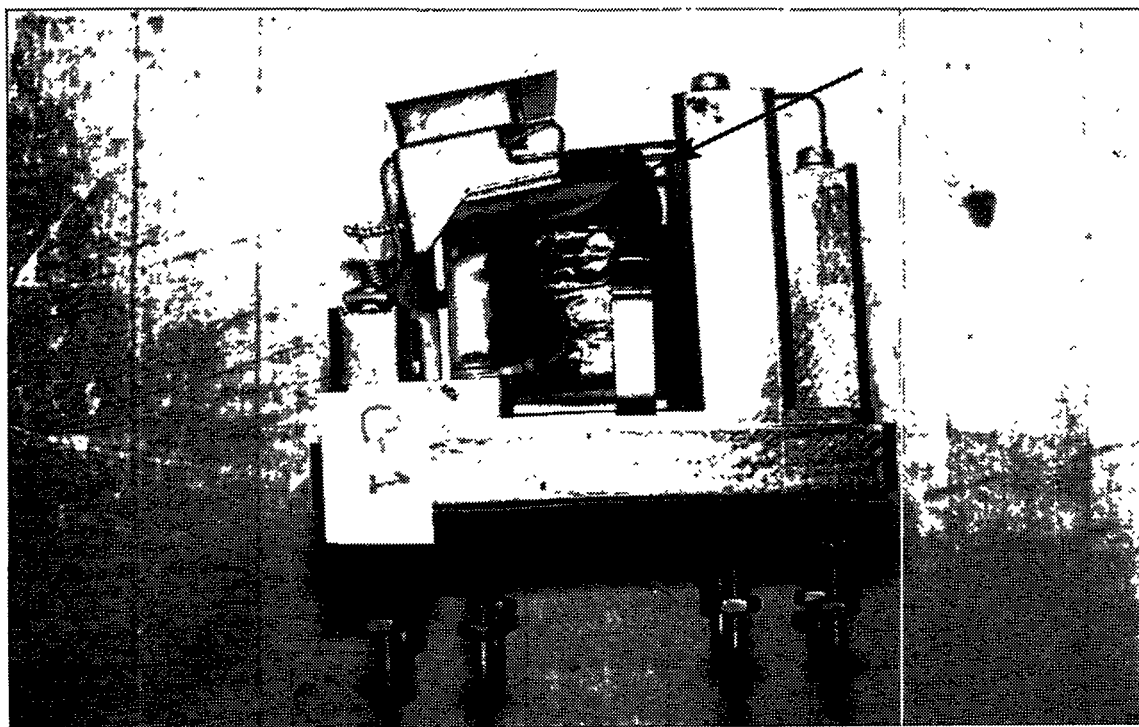
The first aged relay, C1, was tested in the moderate profile and failed during the late stages of the cool-down. The peak exposure temperature was 353 °C, and the temperature at the time of failure was approximately 150 °C.

(Note: data during the cool-down portion of the exposure were not recorded because of a data logging error. The time of failure was recorded by the test operator, but the final temperature was not recorded. The temperature shown in Figure A-11 of Appendix A is an estimate based on other profiles.) The failure was caused by warpage of the top plate of the coil's spool, which curled upwards and prevented the armature from actuating as shown in Figure 7. Note that this was the only instance in which this particular failure mode was observed.

Figure 7 General Electric HGA relay C-1 failure of the spool's top plate

capability. Inspection of the charred remains of the coil and the armature showed that the armature and coil had become fused together because of the accumulation of an unknown substance beneath the armature. (Recall that similar behavior was noted in three of the four HMA relays tested.)

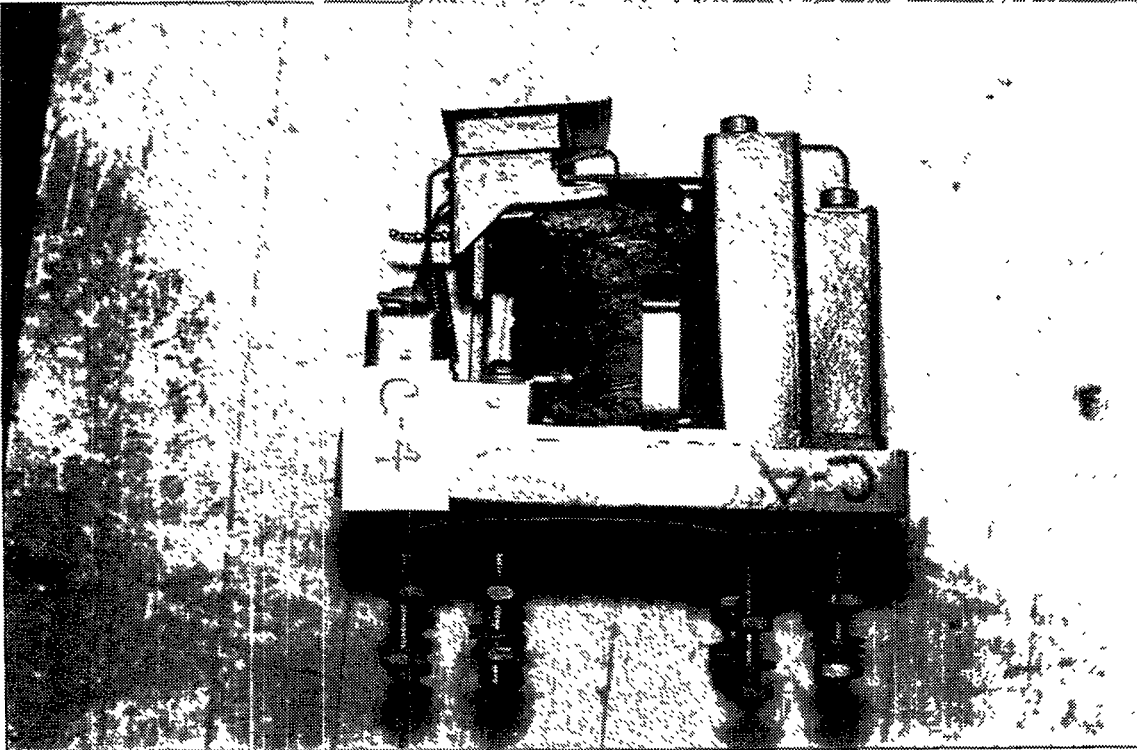
The second unaged relay, C4, was tested in the severe profile and failed at the end of the plateau period. The temperature at the time of failure was 453 °C. The failure mode was identical to that of relay C3; namely, an accumulation of an unknown substance underneath the armature prevented the armature from actuating. This substance can be seen in Figure 8.

Figure 8 General Electric HGA relay C-4 failure of the armature because of blockage

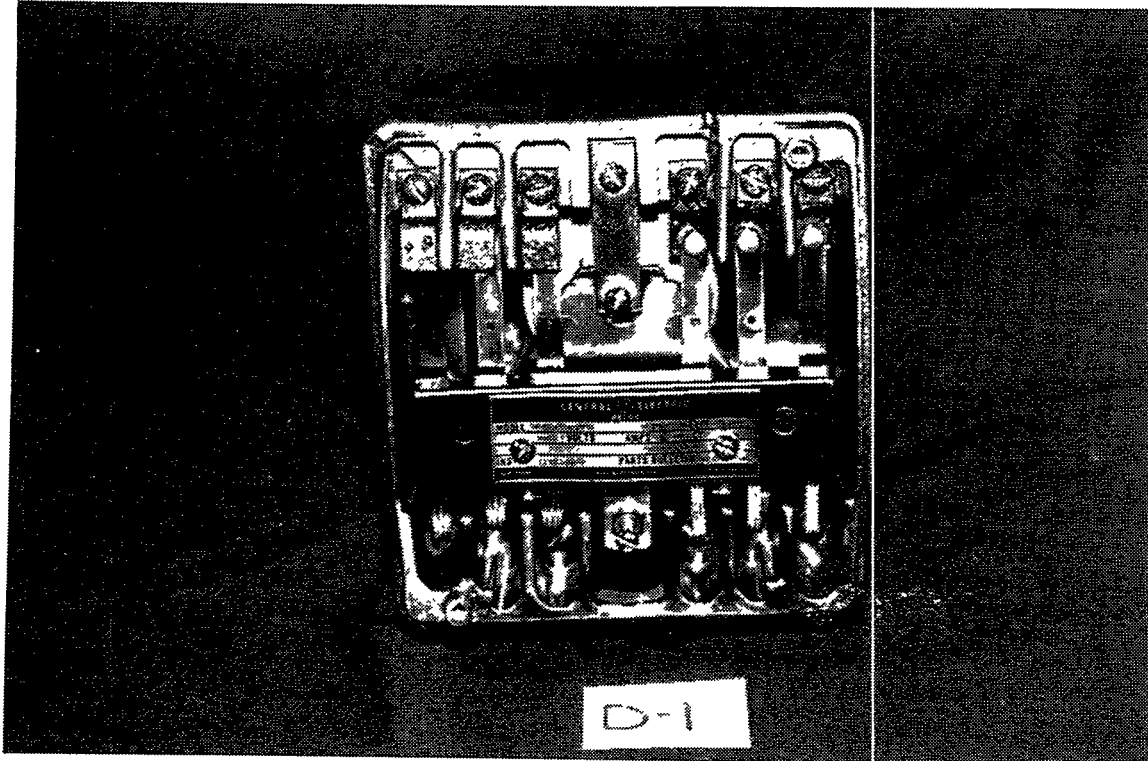
The first aged relay, D1, was tested in the moderate profile and failed early in the cool-down period. The peak exposure temperature was 359 °C, and the temperature at failure was 349 °C. The failure of two of the six contact pairs was noted in load current measurements. Upon inspection, it was noted that the armature was warped or bowed. This warpage was severe enough to prevent the closure of two of the six contact pairs. However, the coil remained functional during post-test analysis.

All of the relays tested showed signs of deformation of the relay body. Many of the outer shells were cracked. Most of the relay bodies were also bowed or warped, as can be seen in Figure 9. The deformation of the relay body was evident in each of the GE HFA relays, with some more severe than others. The failures for four of the GE HFA relays were attributed to warpage of the armature.

Figure 9 General Electric HEA relay D-1 after thermal exposure
